Draft Final Report

Eurobodalla Shire Coastal Hazards Scoping Study

October 2010

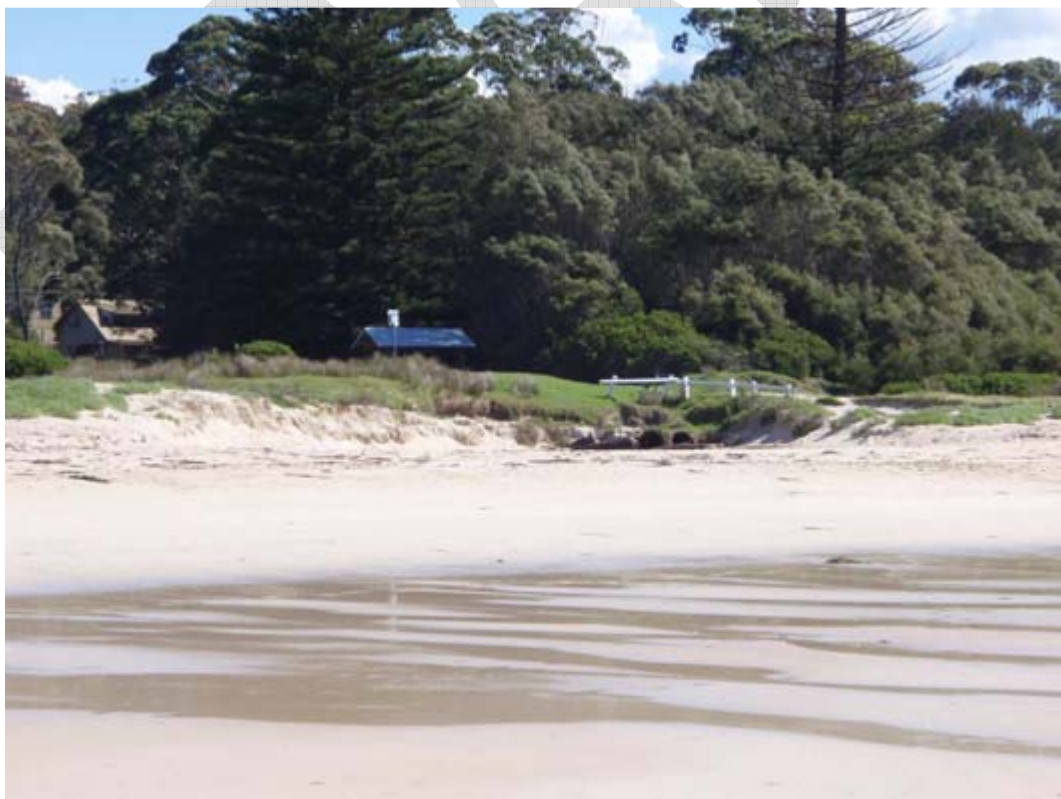
Some stormwater erosion was noticeable at the southern end of the beach north of the resort (Figure 3.4). The small ICOLL located behind this beach is currently closed and does not appear to generate a major immediate hazard but may generate some flooding issues for a couple of lots (but no dwellings) in case of breakthrough. In the long term, the hazards may be more significant due to an increased risk of breakthrough of the beach berm and an elevated tailwater level.

*Figure 3.4 – Stormwater erosion at the southern end of South Durras southern beach
(March 15th 2010)*

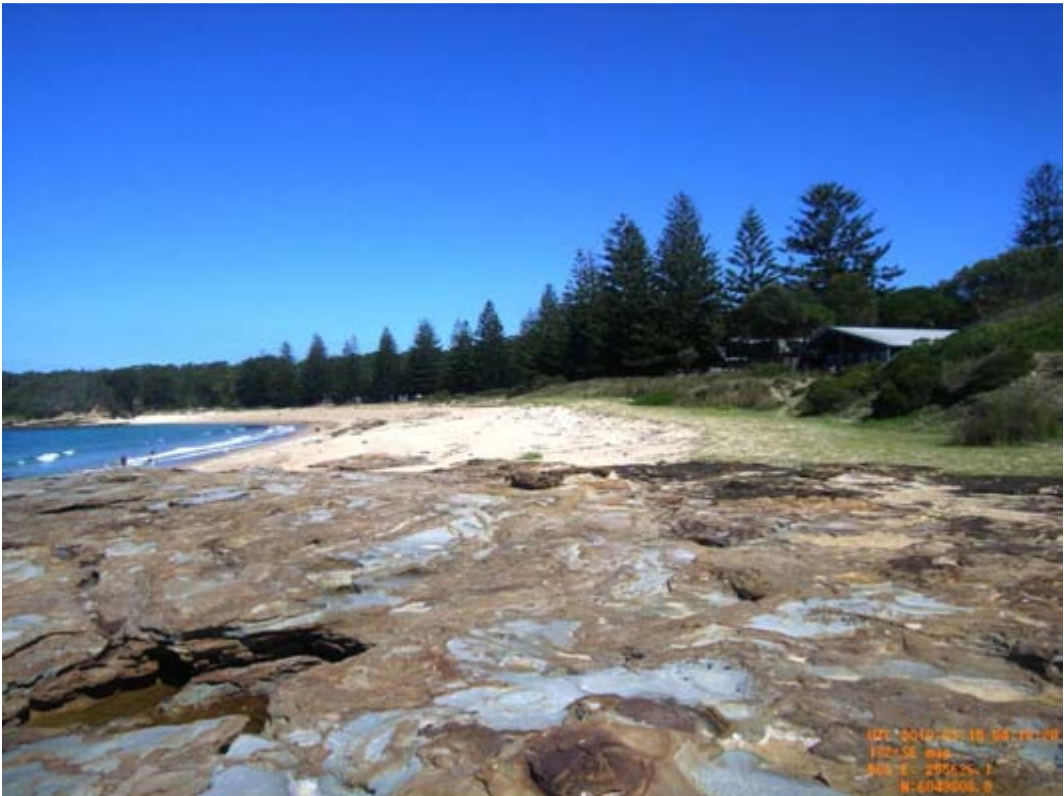
Figure 3.5 – Cabin close to the edge of the beach at South Durras Murramarrang Resort (March 15th 2010)

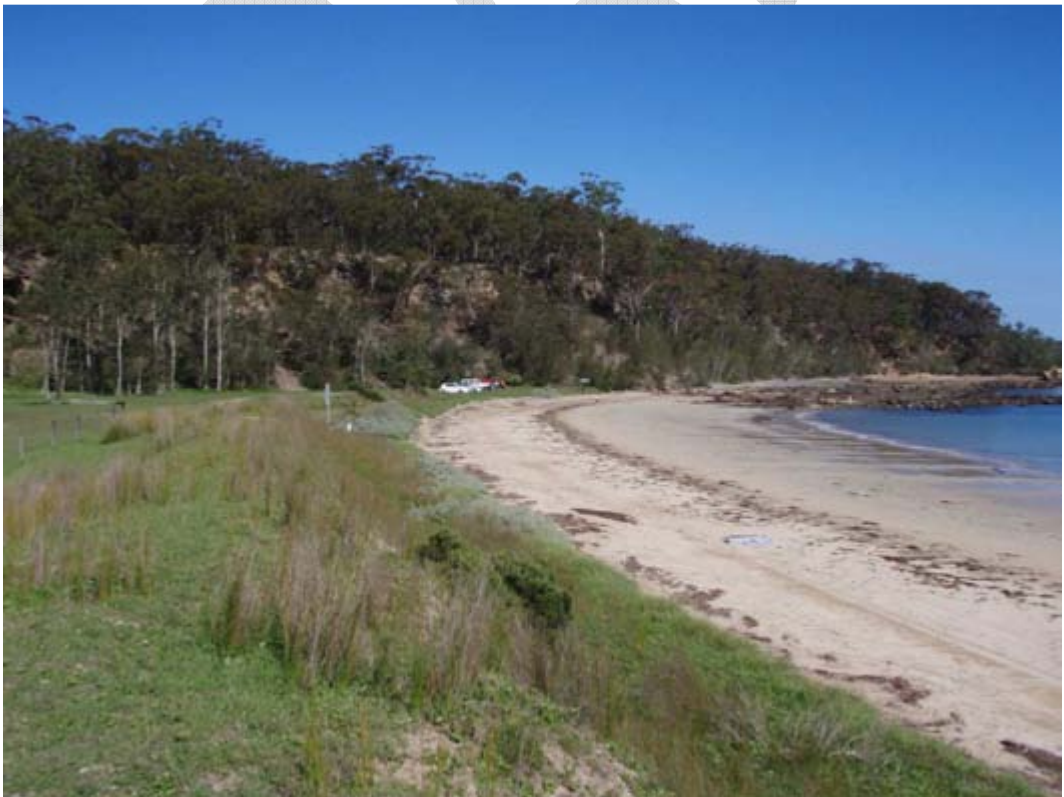
Figure 3.6 – Mown over dune at Maloneys Beach (March 15th 2010)

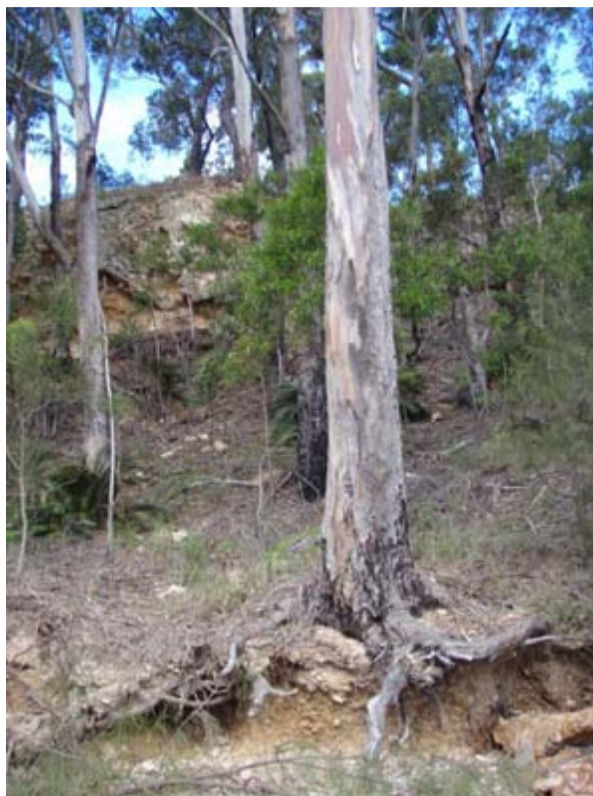
The dune is very low at the eastern end of the beach with the road and housing behind it (Figure 3.8). The beach is very narrow at high tide. The embankment on the eastern side is very steep and some erosion is undercutting the slope (Figure 3.9). There is a stormwater outlet at the end of Fauna Avenue with buried rock seawall along either end but the full extent of the seawall – possibly all along Fauna Avenue – is unknown (Figure 3.10). An erosion scarp was observed at the western end of Bay Road.

Figure 3.9 – Undercutting due to wave action at the bottom of a very steep slope east of Long Beach (March 15th 2010)

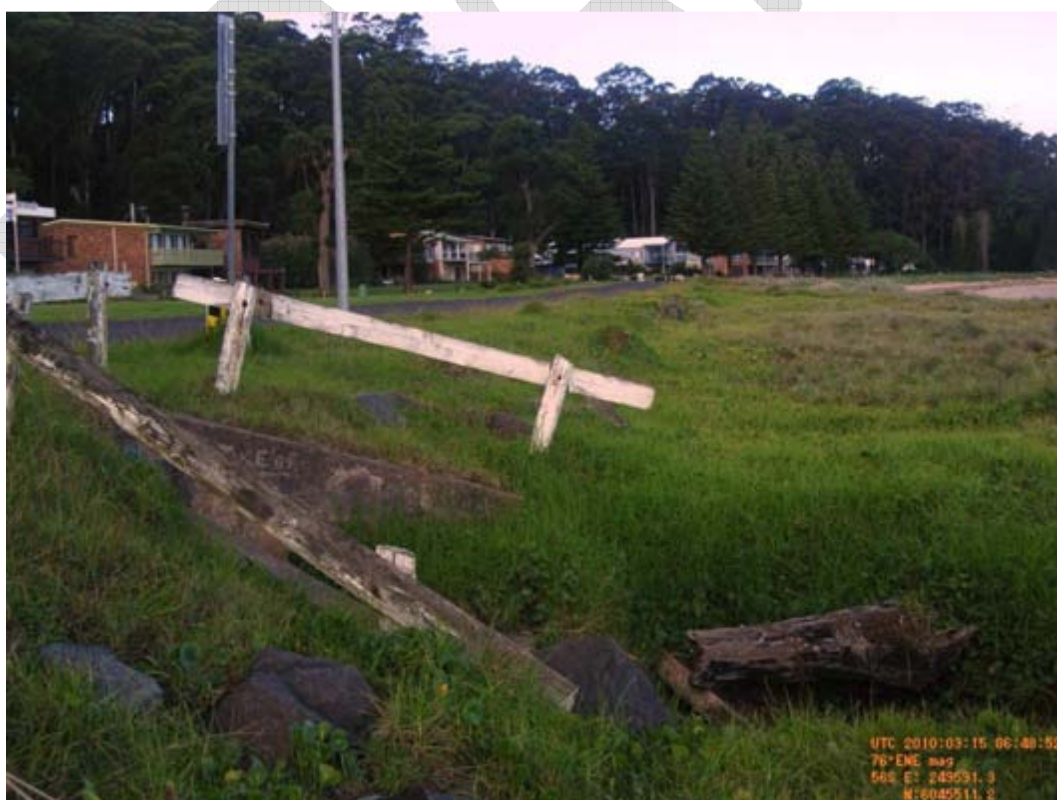
Figure 3.10 – Stormwater outlet protected by a buried rock seawall in front of Fauna Avenue at Long Beach (March 15th 2010)

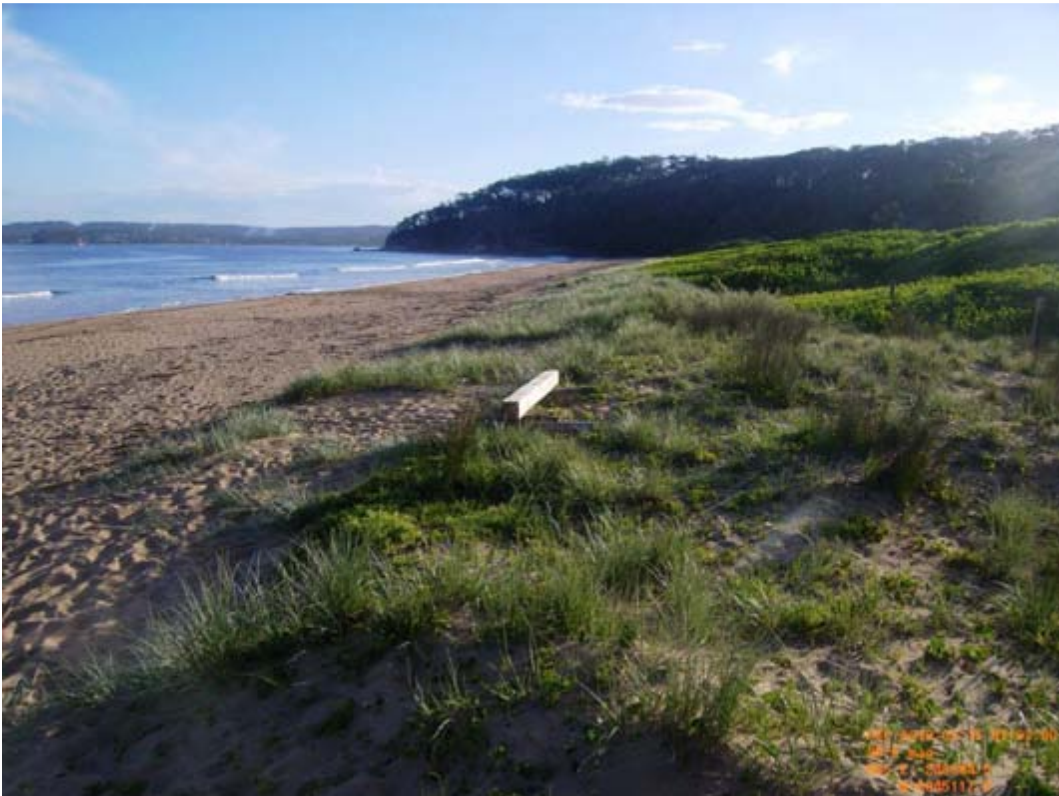
The dune increases in height at the western end as does the wave climate (perhaps 50% of the full ocean wave energy). The new estate located behind the main dune heavily invaded by lawn grass is not at immediate risk (Figure 3.11). Rabbits were observed during the site visit which may be damaging the dune vegetation.

Figure 3.11 – Higher dune at the western end of Long Beach but heavily covered in lawn grass (March 15th 2010)

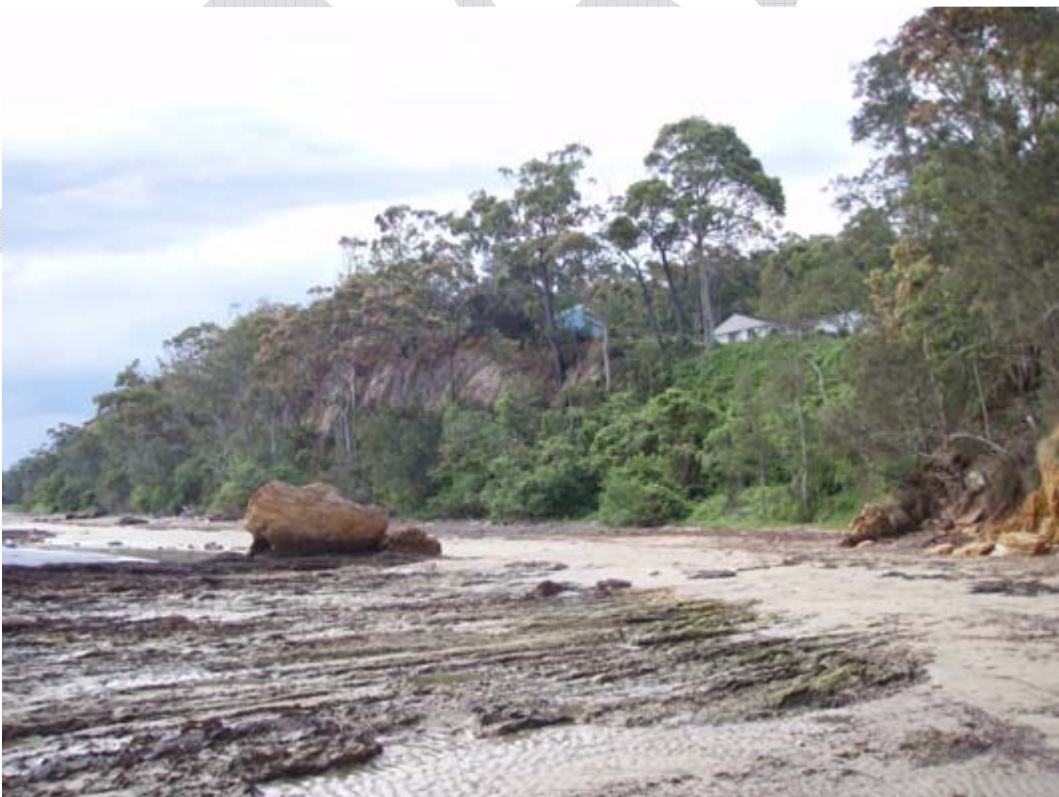
Between Long Beach and Maloneys Beach, the rock is composed of soft siltstone and several houses are located directly on the edge of the cliff (Figure 3.12). The wave climate there is low. Some malodorous sludge was seen to be leaking through the groundwater onto a small beach below the cliff (Figure 3.13).

Figure 3.12 – Houses located at the edge of the cliff between Long and Maloneys Beach (March 15th 2010)

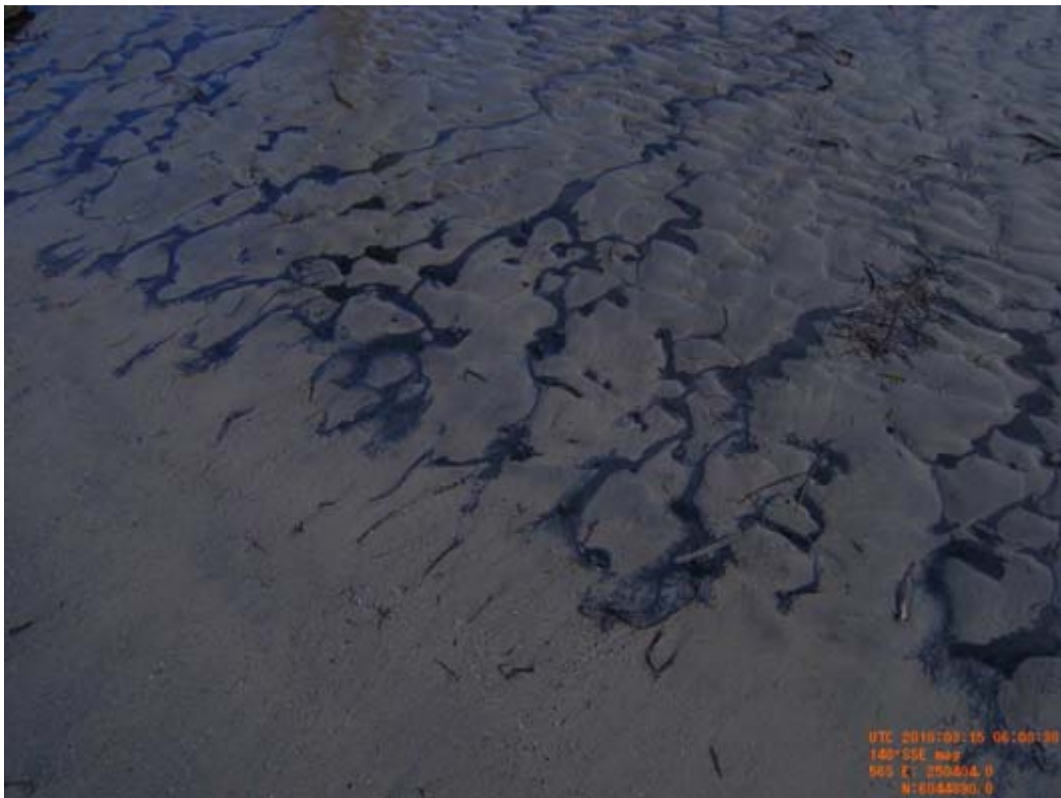
*Figure 3.13 – Septic sludge leaking through groundwater between Long and Maloneys Beach
(March 15th 2010)*

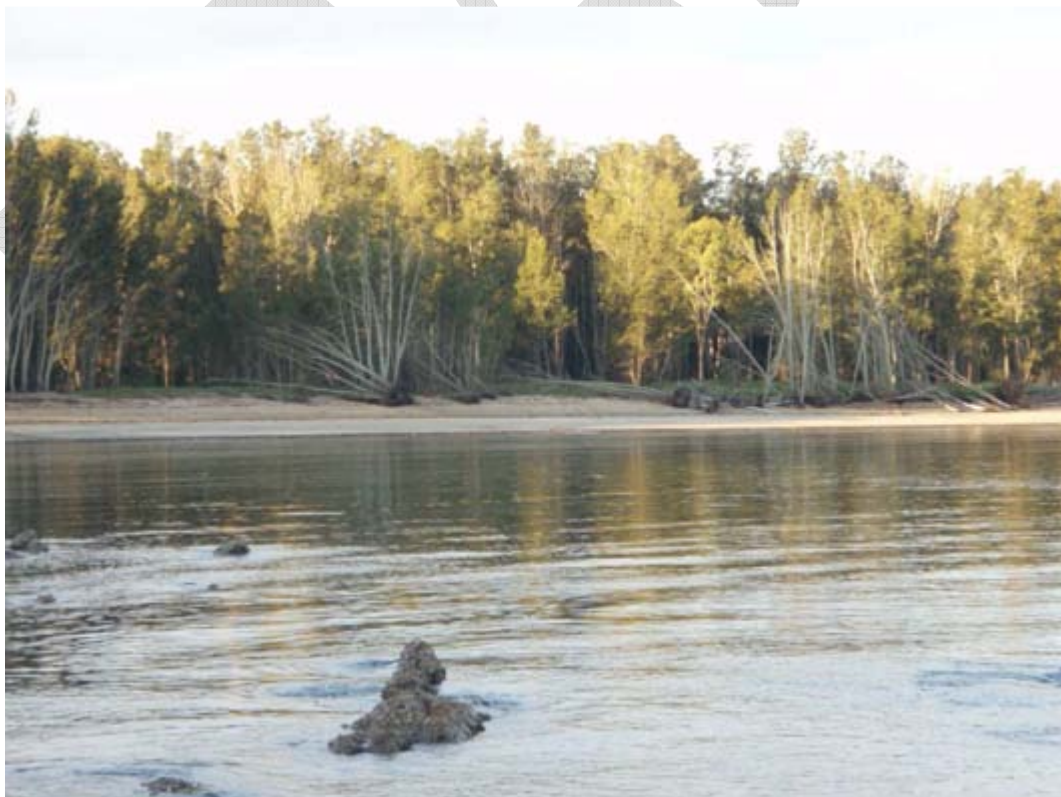
*Figure 3.14 – Erosion and falling trees at Cullendulla Beach
(March 15th 2010)*

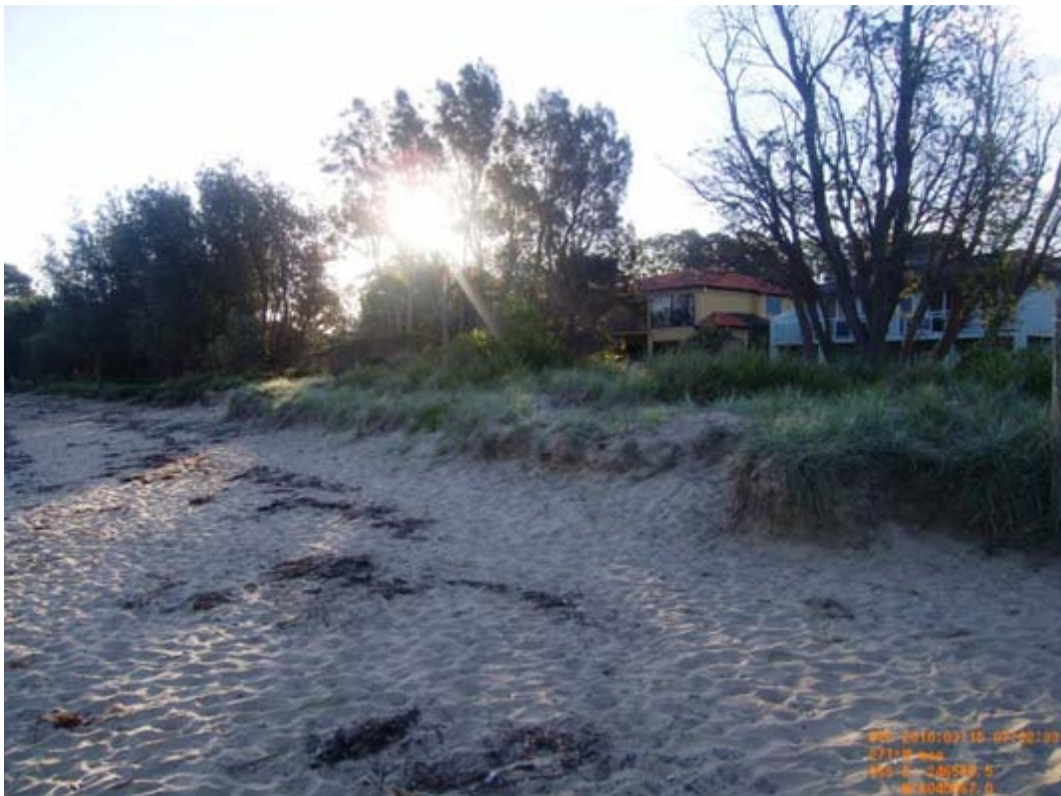
Figure 3.15 – Low-lying houses close to the eroding dune at the eastern end of Surfside Beach (March 15th 2010)

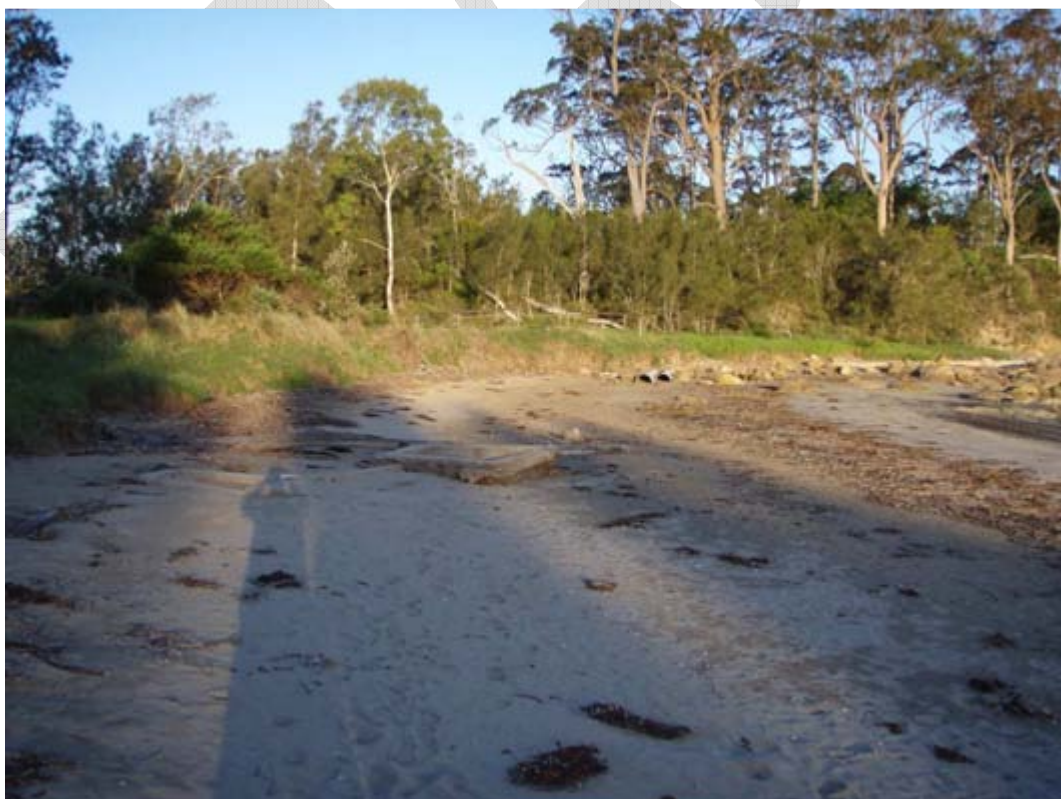
Figure 3.16 – Damaged stormwater pipe at Surfside Beach (March 15th 2010)

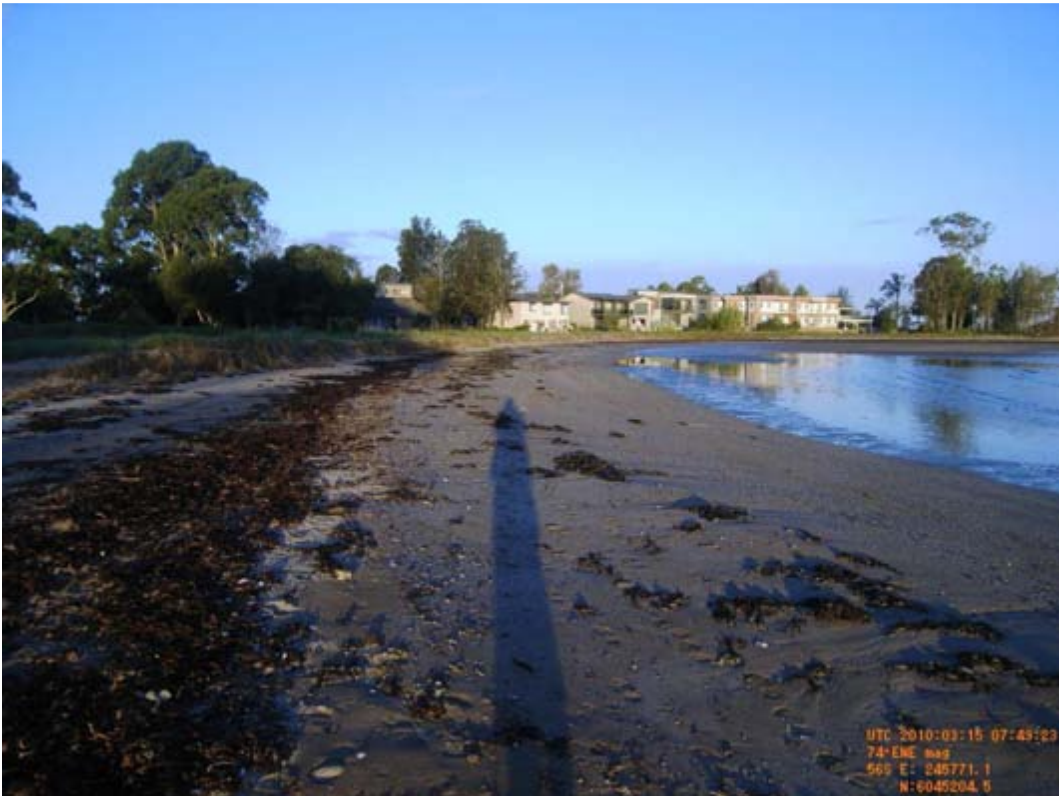
Figure 3.17 – Very low-lying houses located very close to the shore and visible erosion at the western end of Surfside (March 15th 2010)

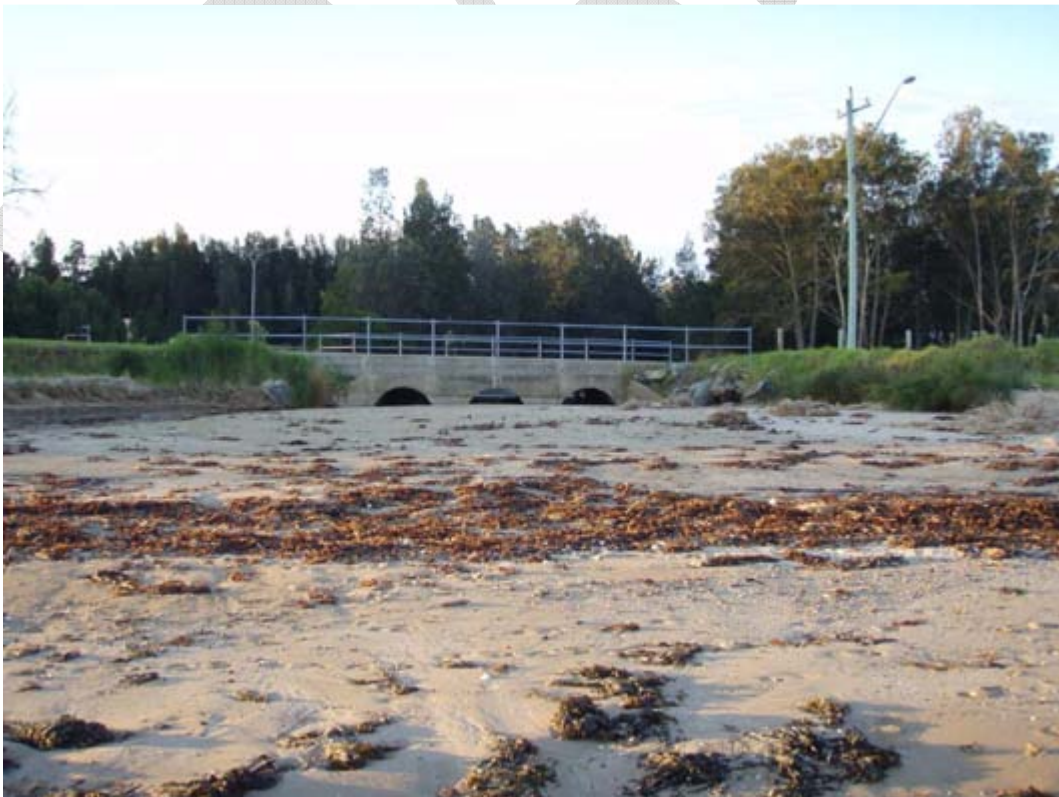
Figure 3.18 – Visible erosion along McLeod Road damaging bridge's seawall protection and pipes under bridge covered with sand (March 15th 2010)

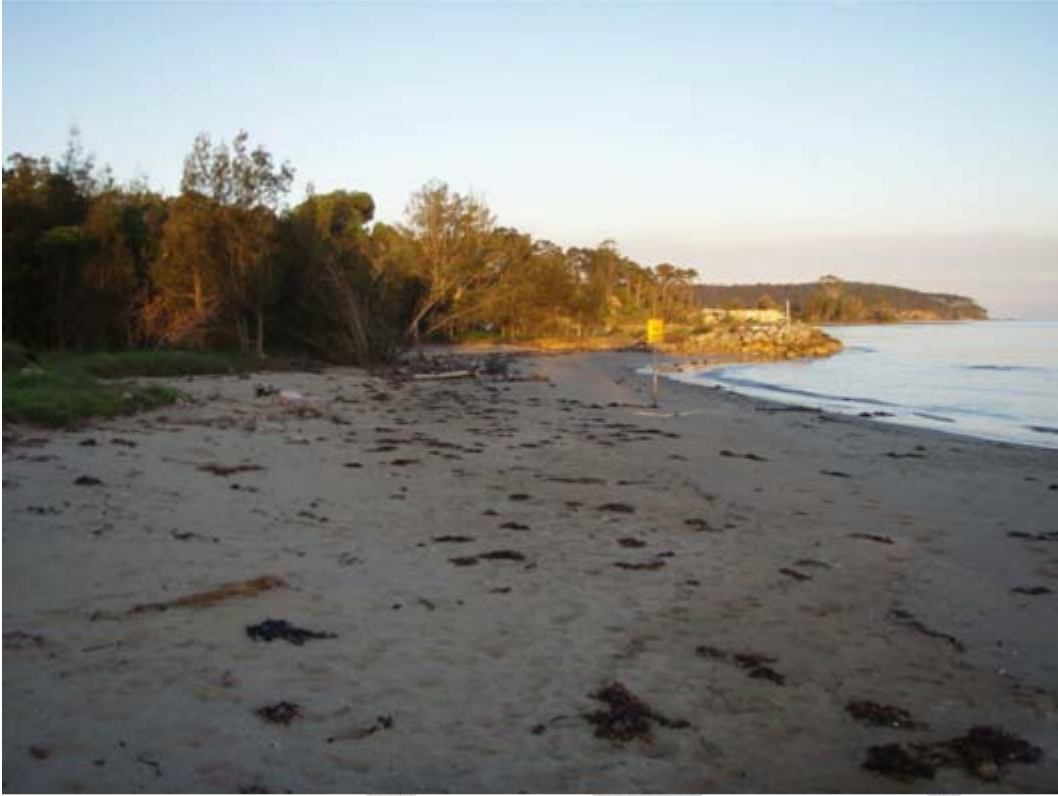
*Figure 3.19 – Active erosion with scarp and exposed vegetation
(March 15th 2010)*

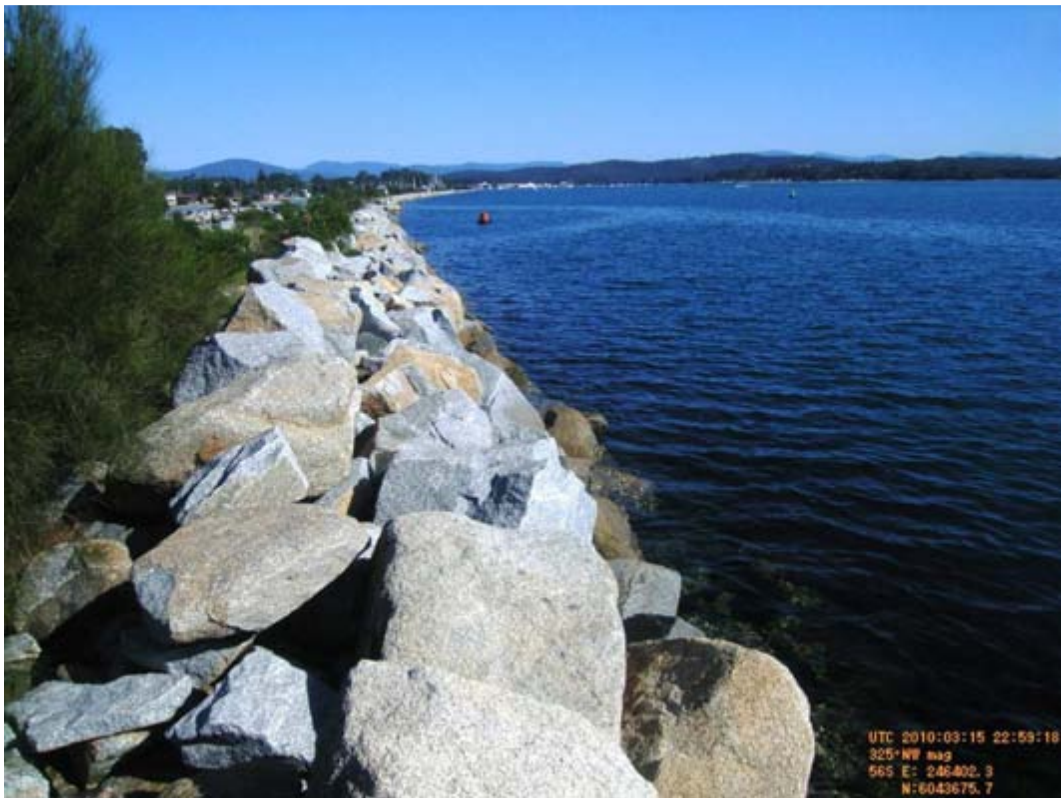
The seawall all along the harbour (from Batemans Bay CBD to Hanging Rock) is in fairly good condition (Figure 3.21). CBD shops located along the water have elevated floor levels. Houses inside the marina near Hanging Rock are very low and protected by different types of seawalls in varying condition. Some housing has no protection (Figure 3.22). A lot of sand is present within the marina. Hanging Rock boat ramp is in good condition (Figure 3.23). The area is protected from waves with waves breaking on offshore shoals (Figure 3.24).

*Figure 3.21 – Seawall protecting Batemans Bay Boat Harbour
(March 16th 2010)*

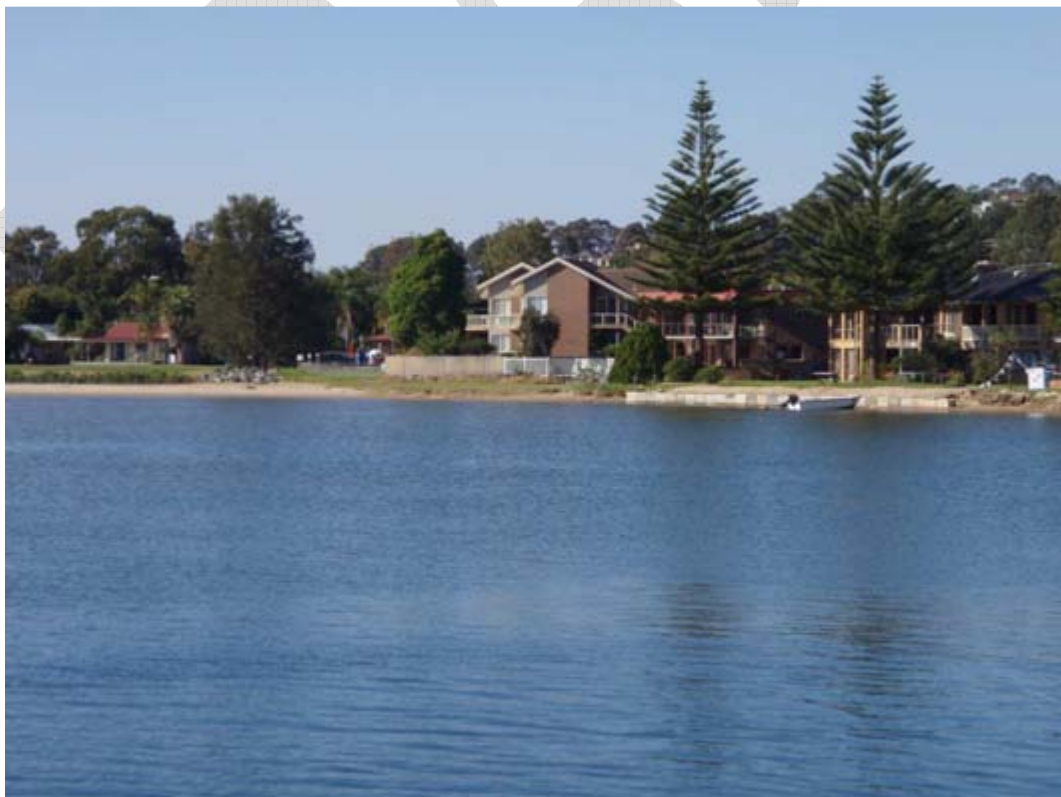
*Figure 3.22 – Varying condition of seawall and unprotected low-lying houses within Batemans Bay Marina
(March 16th 2010)*

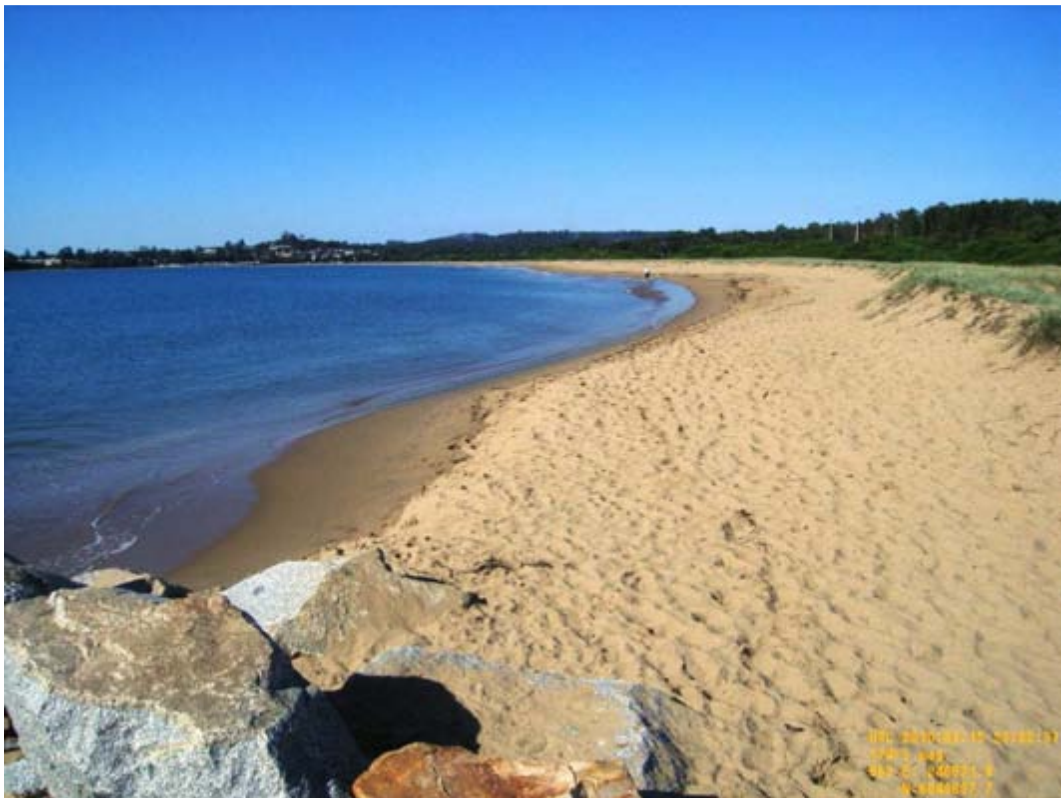
The northern end is more exposed to wave climate than the southern end which is protected by reefs. The dune is steeper and in poor condition at the northern end. There are many weeds and no formal access (Figure 3.25). However, there is a significant buffer to development. Joes Creek coming out within the northern half of the beach is relatively high and may create inundation issues in the future.

*Figure 3.25 – Northern end of Corrigans Beach
(March 16th 2010)*

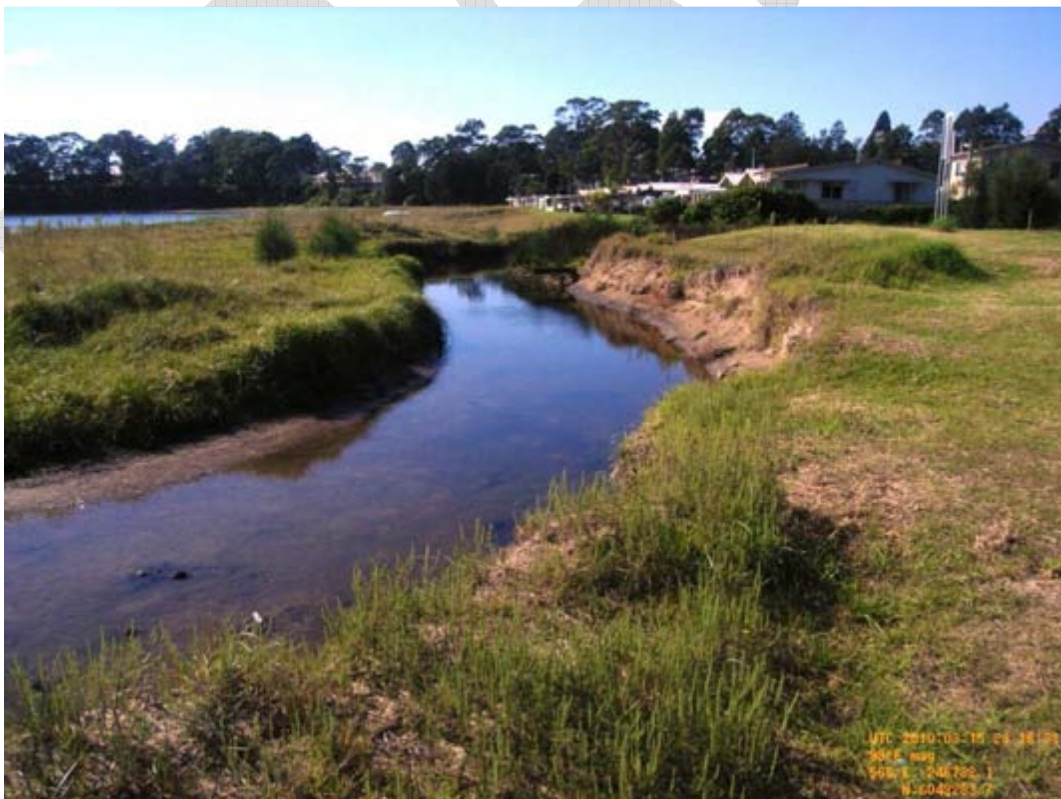
At the southern end, it was observed that only around 20% of the swell wave energy is reaching the beach. The creek leading to the beach is polluted with an incised morphology (Figure 3.26). A Gross Pollutant Trap within the creek (GPT) is blocked by sediments and rubbish (Figure 3.27). The caravan park is very close to both the beach and the creek. Hence it may be at risk from inundation. The beach has a flat gradient. However there would be enough buffer to build a new vegetated dune to protect the caravan park currently at immediate inundation risk.

*Figure 3.26 – Erosion of creek along the low-lying caravan park at the southern end of Corrigans Beach
(March 16th 2010)*

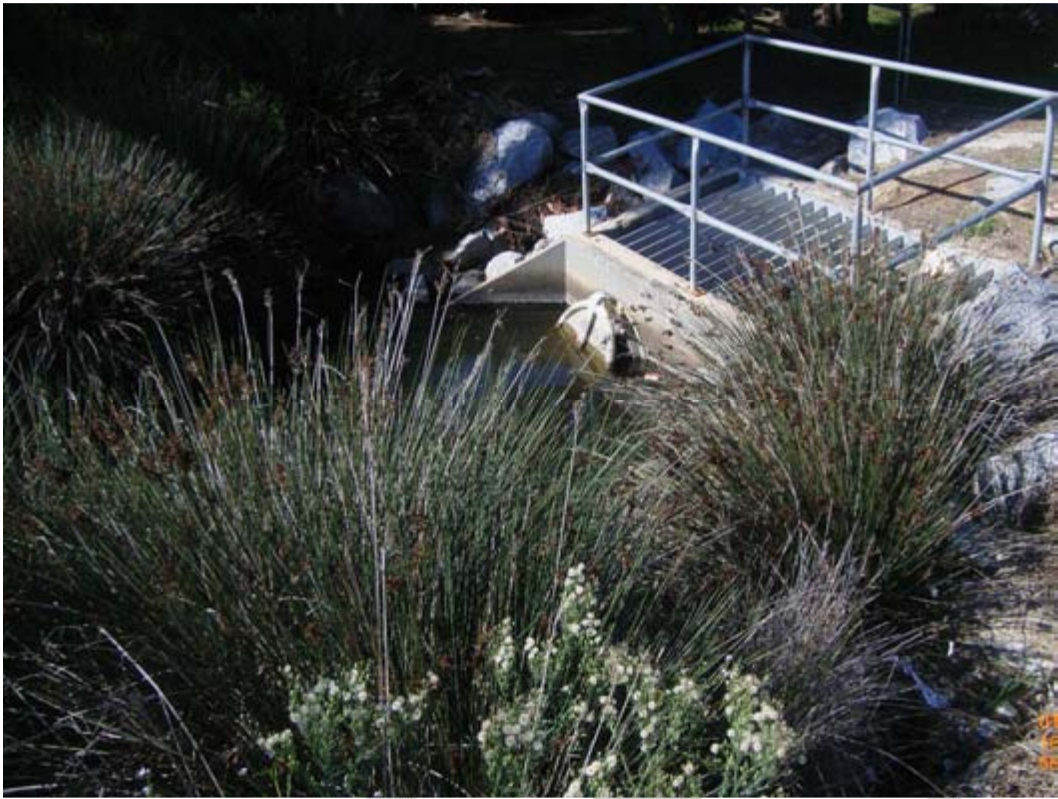
Figure 3.27 – GPT blocked by rubbish behind southern caravan park at Corrigans Beach (March 16th 2010)

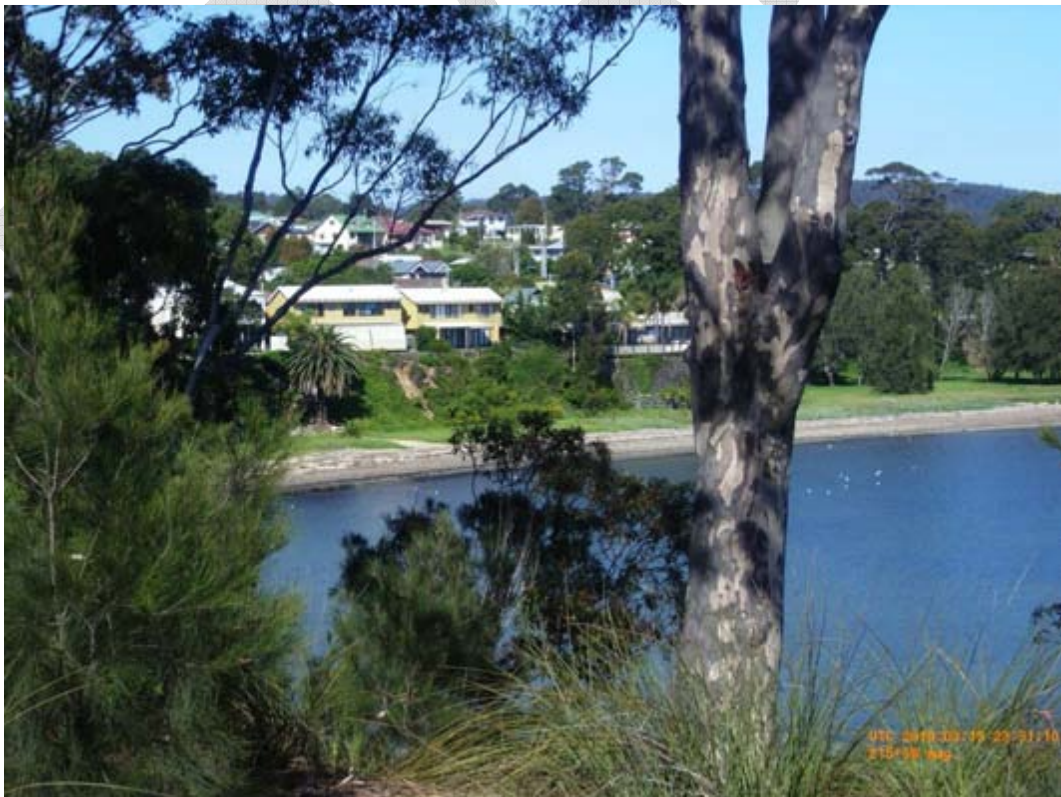
Figure 3.28 – Houses possibly at geotechnical risk at the southern end of Corrigans Beach (March 16th 2010)
