MORUYA/DEUA ESTUARINE PROCESSES STUDY

Summary Report

November 2003

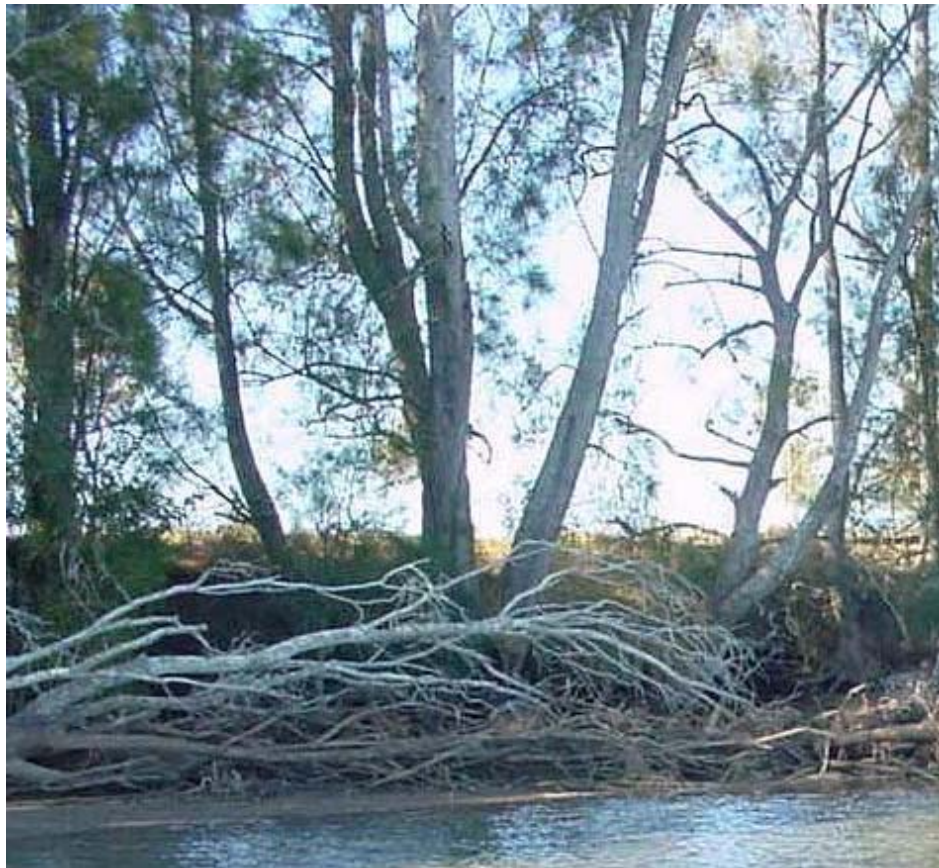
Figure 3: Loss of natural vegetation by erosion.

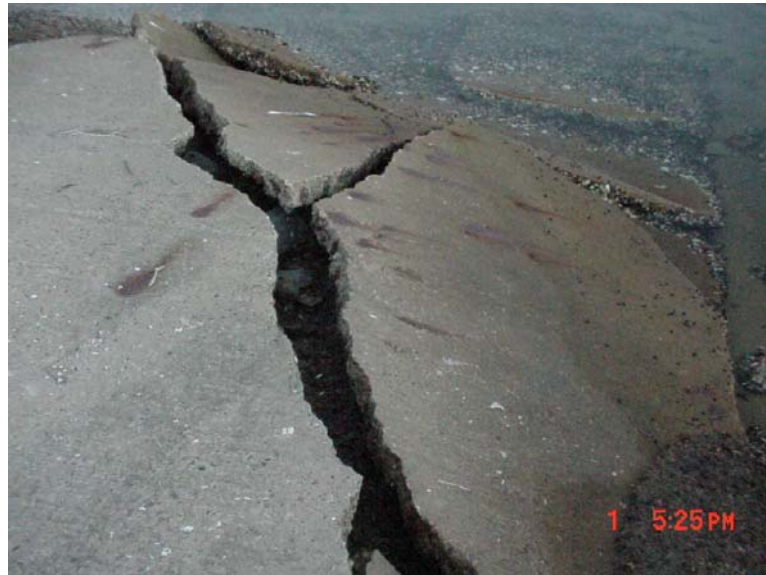
Figure 15: Infrastructure damage caused by erosion.

Bank erosion is considered by the community to be a major problem in need of management. Erosion is a natural process due to natural meandering of river, wave action and sometimes flood events. The Moruya Estuary is highly susceptible to erosion because in a large number of places the banks are composed of unconsolidated fine materials with sands and silts mixed in different proportions.

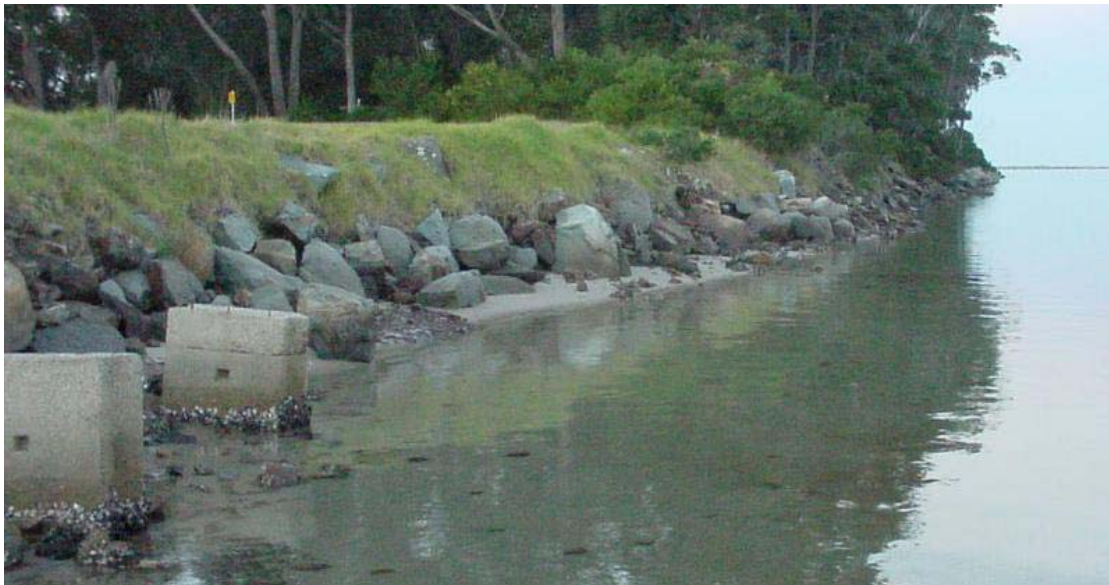
Figure 16: Rock riprap lining only at high tide.

The vertical extent of the rock riprap lining in some areas is limited to the area around and just above high tide level.

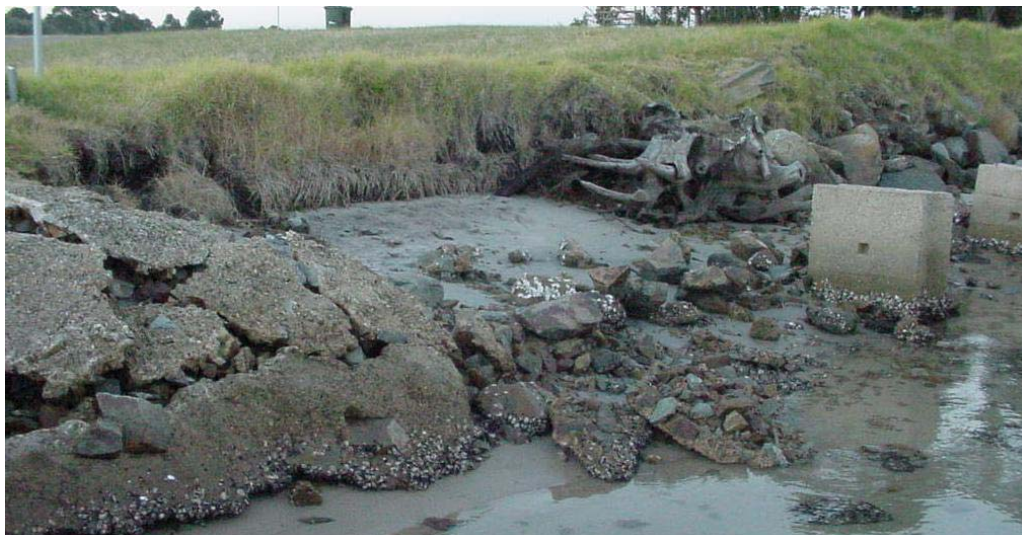
Most of the banks in the lower estuary have had rock walls erected to protect them from erosion. These walls are basically dumped rocks and do not appear to be withstanding the loads due to currents, water level fluctuations and wave action.

Figure 17: Bank erosion behind the rock riprap.
Bank erosion behind the rock riprap lining was observed in a number of places.

Site inspections of the rock walls revealed:

- Slumping of rock walls due to loss of toe support;
- Erosion of banks above and behind rock walls; and
- Large voids in the walls, reducing their effectiveness and increasing their susceptibility to failure.

There is a need to undertake an engineering audit to determine where the walls need to be replaced or strengthened. Remedial measures such as repair or rebuilding of the walls, the provision of filter layers under the main rock armour, the raising of crest heights, and the termination of walls can then be designed, costed and planned.

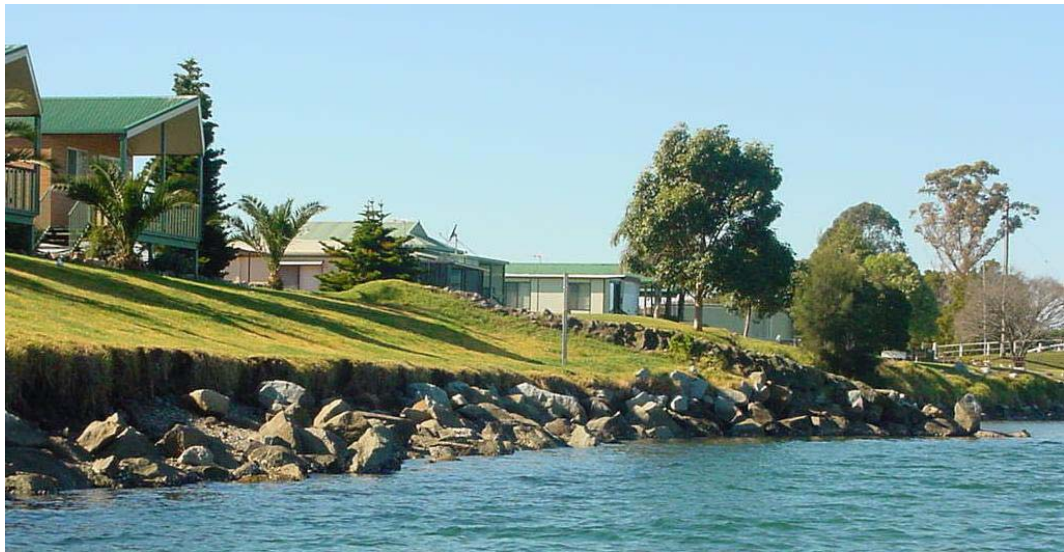
Our field investigations found that in the upper estuary undercutting of the bank was common but generally not severe. Undercutting of the bank is caused by the action of waves, with the sediment then being carried away by the currents. These waves can be generated by wind and boat wash. Bank undercutting occurred both at Yarragee and higher up the estuary, such as near Kiora Bridge where boating would be infrequent indicating that wind generated waves play an important part in bank erosion of the upper estuary.

Figure 18: Vertical banks subject to bank erosion at the rear of the motel.

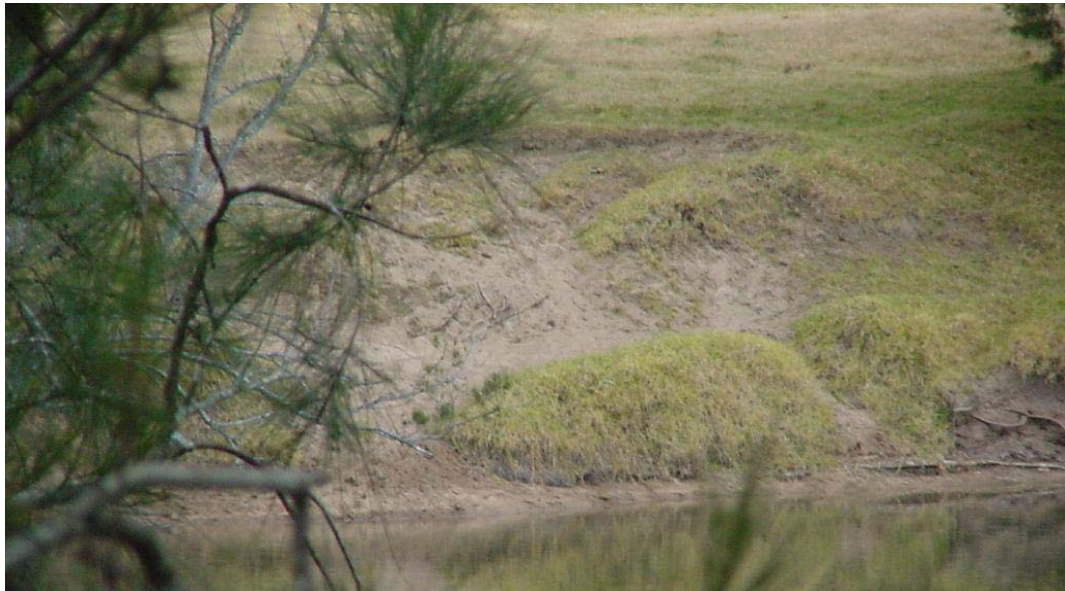
Problems of trampling and overgrazing associated with both stock and wildlife were also contributing to the minor erosion problems in the upper estuary.

Figure 19: Upper-estuary bank erosion due to stock and wildlife.
Animal damage, either stock or wildlife, is a contributory factor in bank erosion in some places particularly where the banks are of unconsolidated sediments.
