Appendix B: Location Summaries

B.1 Durras and Cookies Beaches

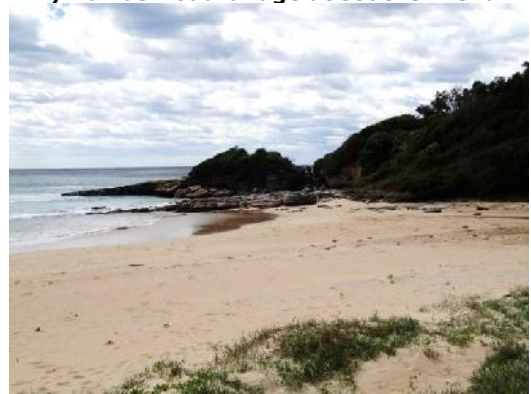
g) Dune scarp at the centre of the beach

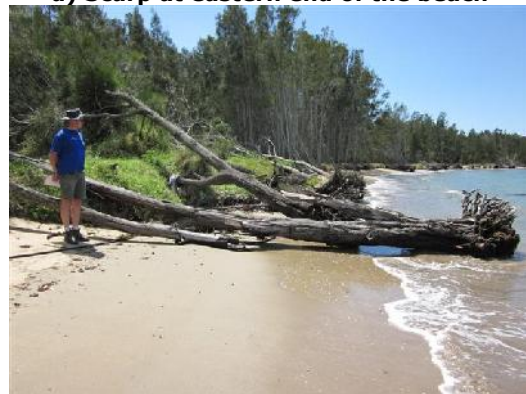
e) Scarp at the centre of the beach

f) Loss of vegetation due to recession

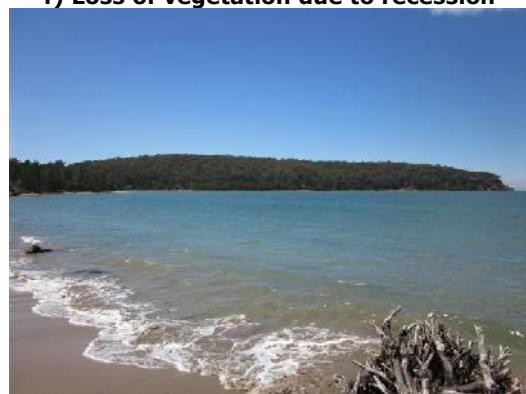
g) Evidence of recession along the beach

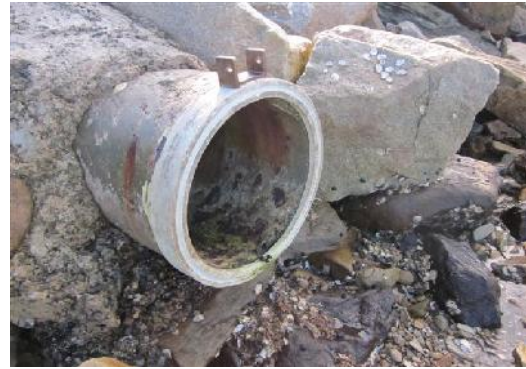
b) Stormwater outlet (missing floodgate)

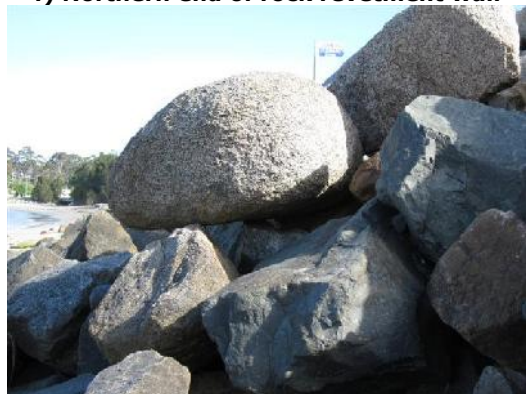
Overall, the condition of the seawall along the northern part of Caseys Beach is considered to be poor and requires immediate action and ongoing monitoring by ESC. The reader is referred to WRL's detailed condition assessment and design advice report for this seawall (Blacka and Coghlan, 2016).

g) Some slumping of armour at the crest

h) Example of precariously positioned rock

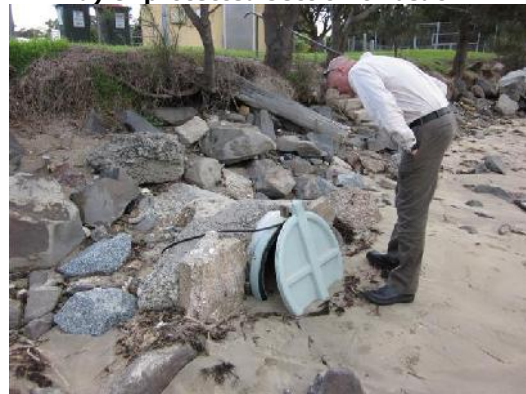
f) Stormwater outlet (blocked floodgate)

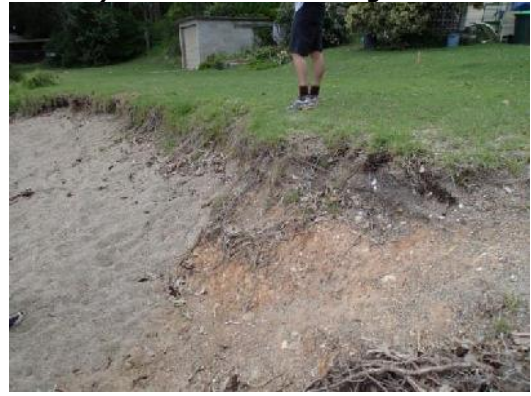
c) Loss of vegetation

d) Scarp at the southern end of the beach

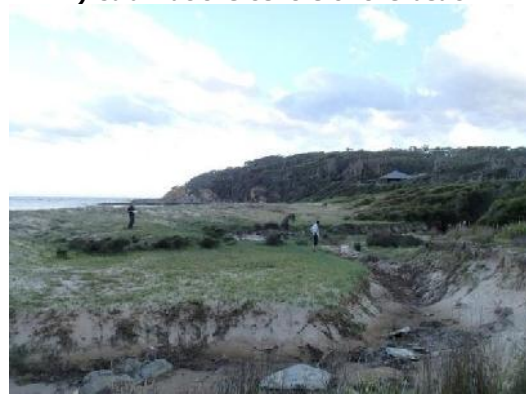
g) Scour of the banks of the creek
