APPENDIX 1 – RISK ASSESSMENT

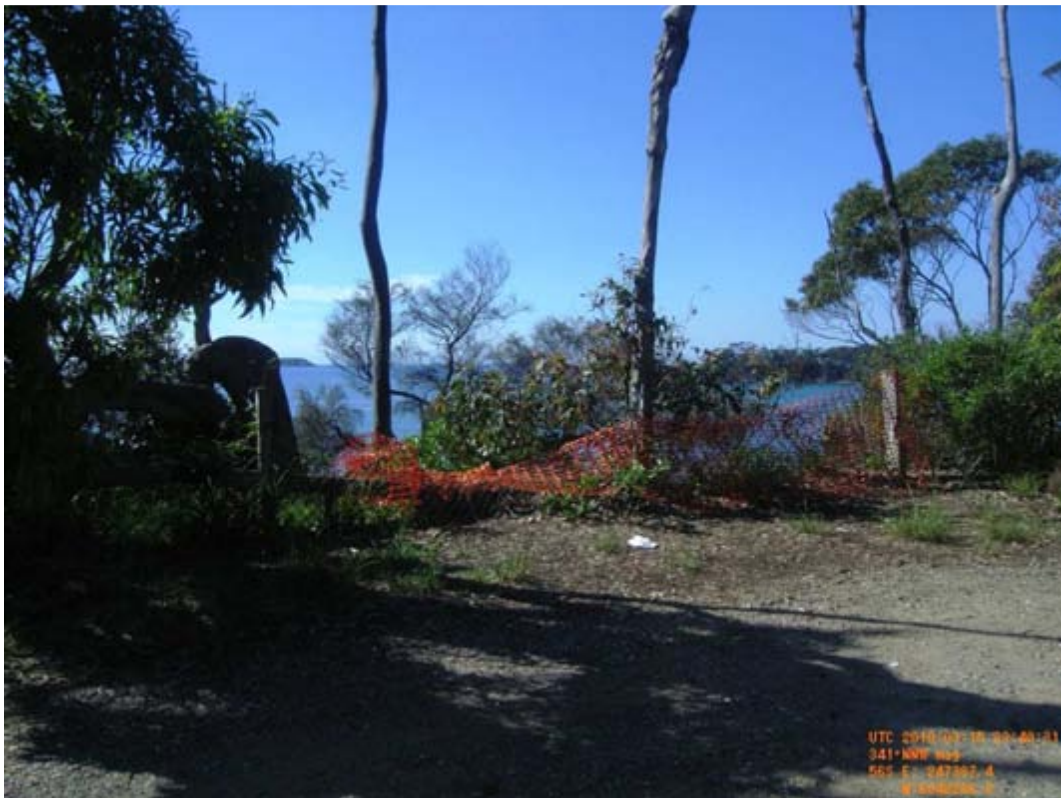
Figure 3.29 – Damaged fencing at the top of the bluff facing Casey Beach (March 16th 2010)

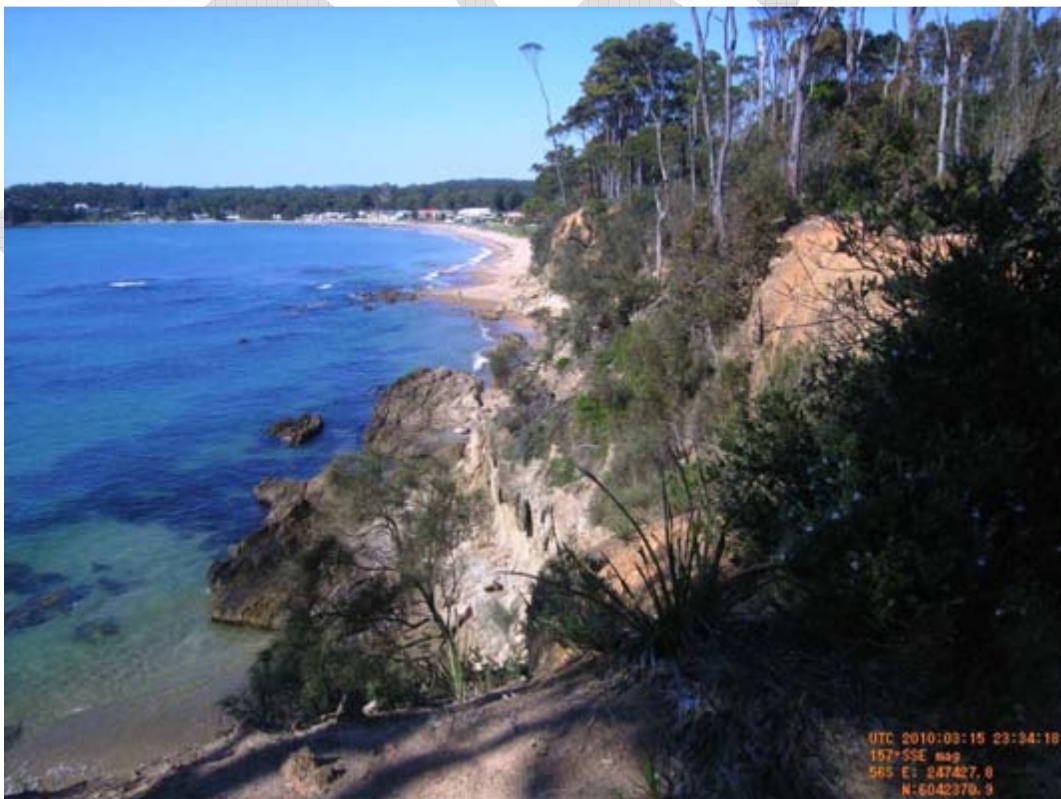
Figure 3.30 – Actively eroding bluff at the lookout facing Casey Beach (March 16th 2010)

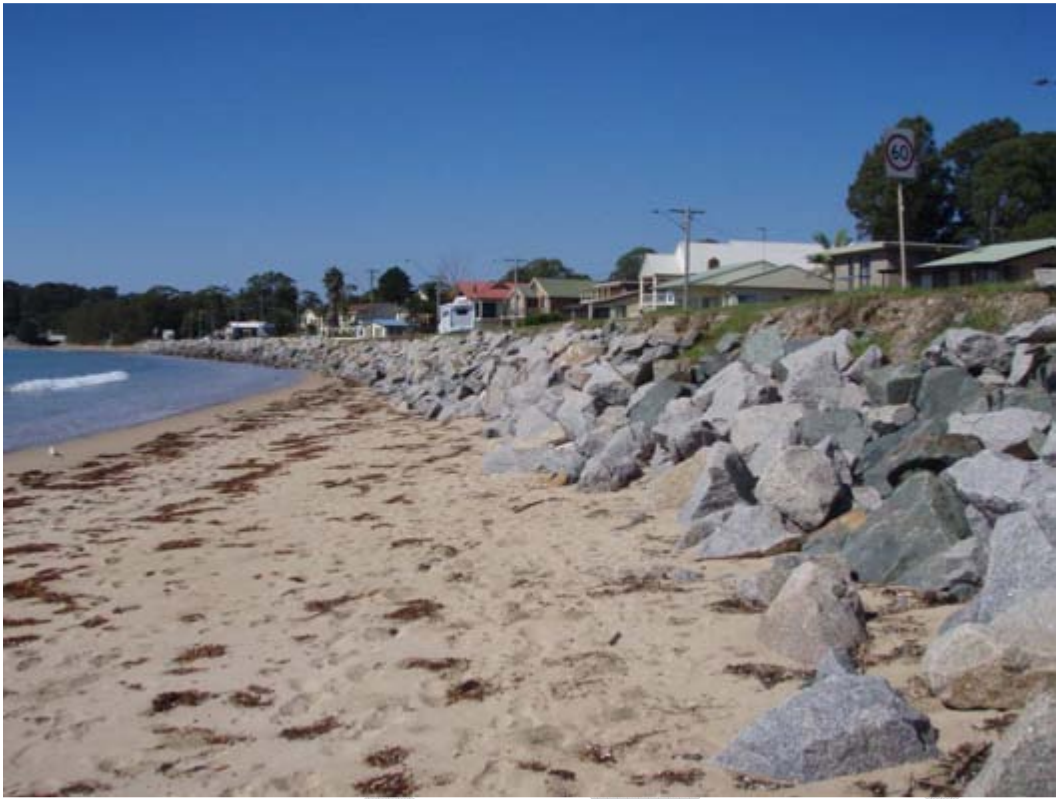
*Figure 3.31 – Casey Beach seawall overtopped at northern end
(March 16th 2010)*

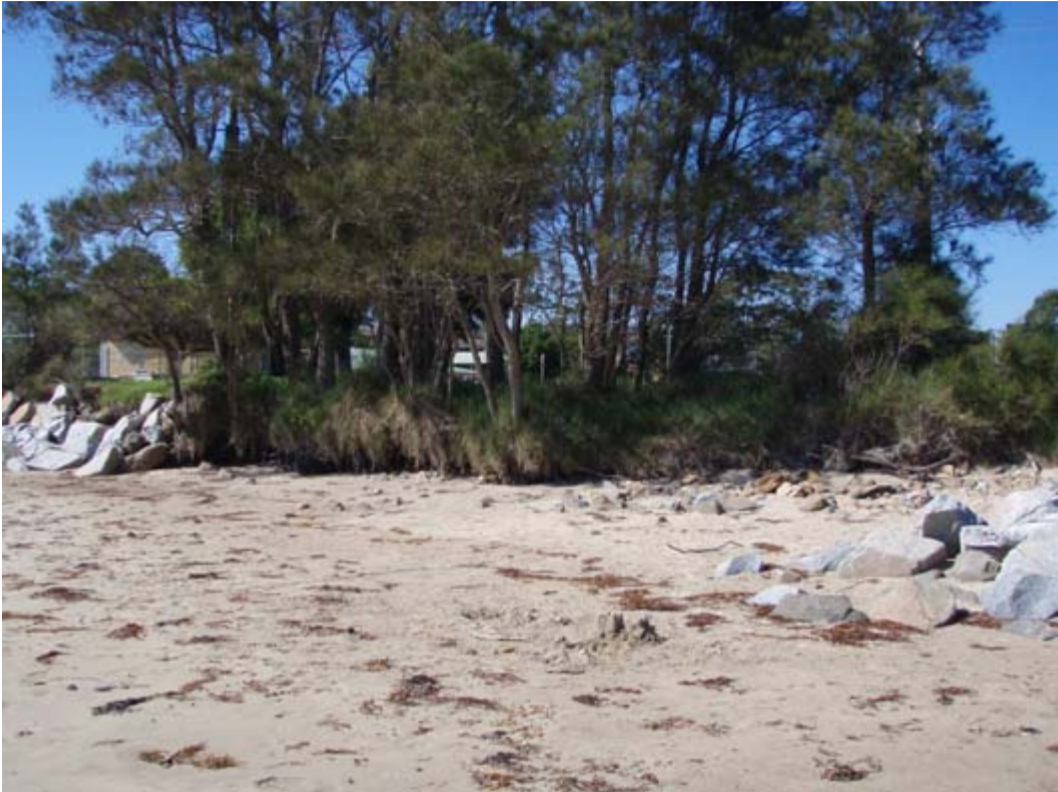
*Figure 3.33 – Undercutting of trees where no protection at Casey Beach
(March 16th 2010)*

30	Central section of Casey Beach	Erosion	4	Seawall failure. Loss of road and properties behind seawall	4	16	Coastal and Riverine Management Directorate (1996) WMA (2006)	Update of Coastal Hazard Study with new benchmarks from the NSW Sea Level Rise Policy (2009)	Mostly fair condition rock seawall with some part of the seawall to be fixed	Seawall is mostly in good condition where most exposed to wave climate and in front of properties
31	Short Beach Creek	Inundation	4	Inundation of Holiday Park and houses at the southern end of Casey Beach by tailwater	3	12	Willing & Partners (1989a) WBM (2004)	Update of Tailwater Level Study with new benchmarks from the NSW Sea Level Rise Policy (2009)	Fair condition rock seawall protection the creek entrance under the bridge	Existing tailwater study does not take the rainfall into account
32	South of Short Beach Creek, Casey Beach	Erosion	5	Sewage pumping station at direct risk behind eroding area located south of Short Beach Creek Entrance	2	10	Coastal and Riverine Management Directorate (1996) WMA (2006)	Update of Coastal Hazard Study with new benchmarks from the NSW Sea Level Rise Policy (2009)	Mostly fair condition rock seawall with some part of the seawall to be fixed	Visible undercutting of trees where no seawall protection. Erosion noticeable at the top of seawall

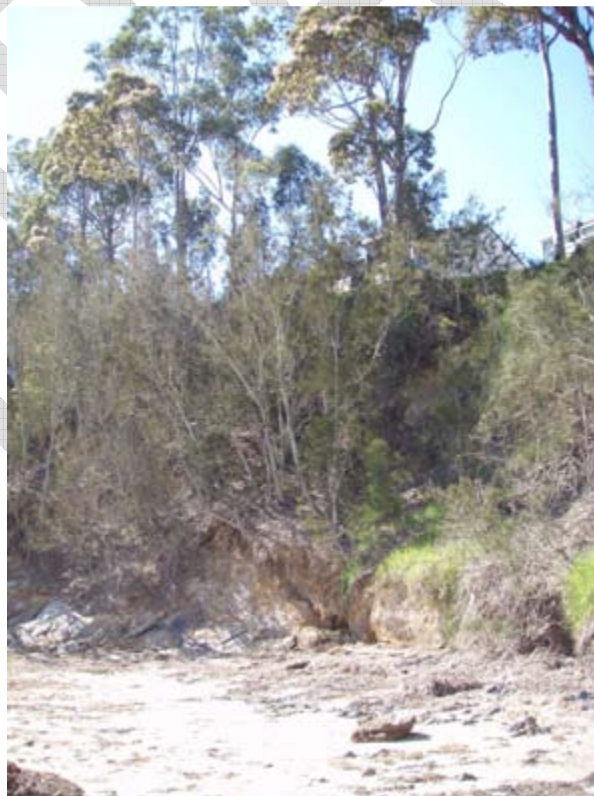
*Figure 3.34 – Houses at the top of the eroding bluff at the southern end of Casey Beach
(March 16th 2010)*

33	Southern end of Casey Beach	Cliff stability	3	Loss of houses at the top of cliff along Bronte Crescent	3	9	Coastal and Riverine Management Directorate (1996)	Coastal Geotechnical Study	N/A	Obvious erosion at the bottom of cliff
34	Sunshine Bay	Erosion	5	Loss of timber shack on the beach and carpark	1	5	N/A	Coastal Hazard Study	N/A	Visible scarp in front of carpark. Very low-lying shack directly on the duneless beach
35	Sunshine Bay	Bluff stability	3	Loss of houses located at the edge of bluff along the beach	3	9	N/A	Coastal Geotechnical Study	N/A	Properties directly on the edge of steep dune but seem founded on hard clay
36	Denhams Beach	Bluff stability	1	Loss of houses located at the edge of bluff	2	2	N/A	Coastal Geotechnical Study	N/A	Houses on the cliff have some buffer
37	Headlands north and south of Surf Beach	Bluff stability	1	Loss of houses located at the edge of bluff	3	3	N/A	Coastal Geotechnical Study	N/A	Houses on the cliff have relatively good buffer

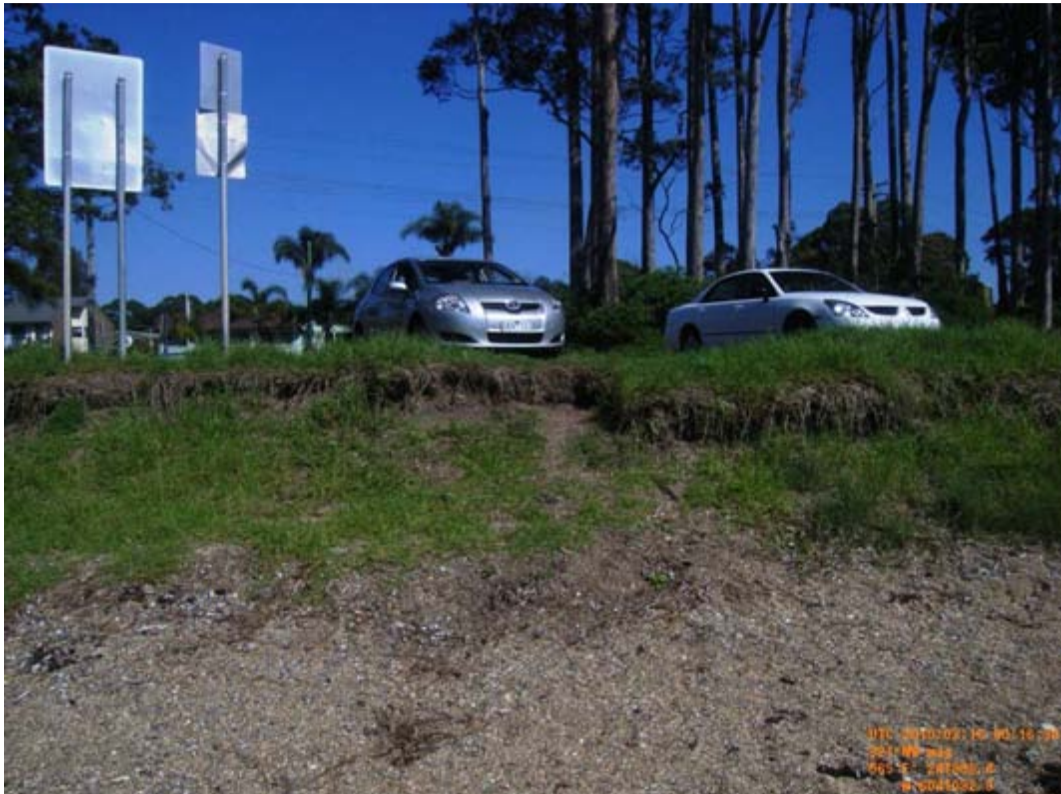
*Figure 3.35 – Visible erosion in front of the car park at Sunshine Bay
(March 16th 2010)*

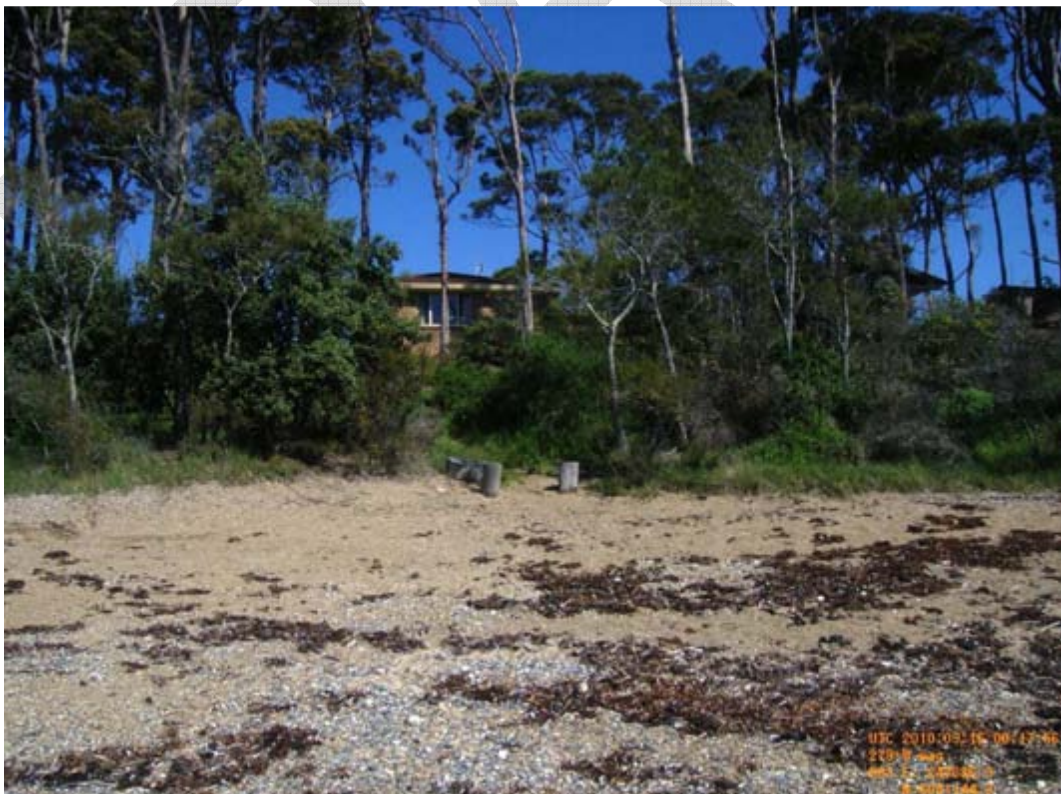
*Figure 3.36 – Houses directly behind the beach at Sunshine Bay
(March 16th 2010)*

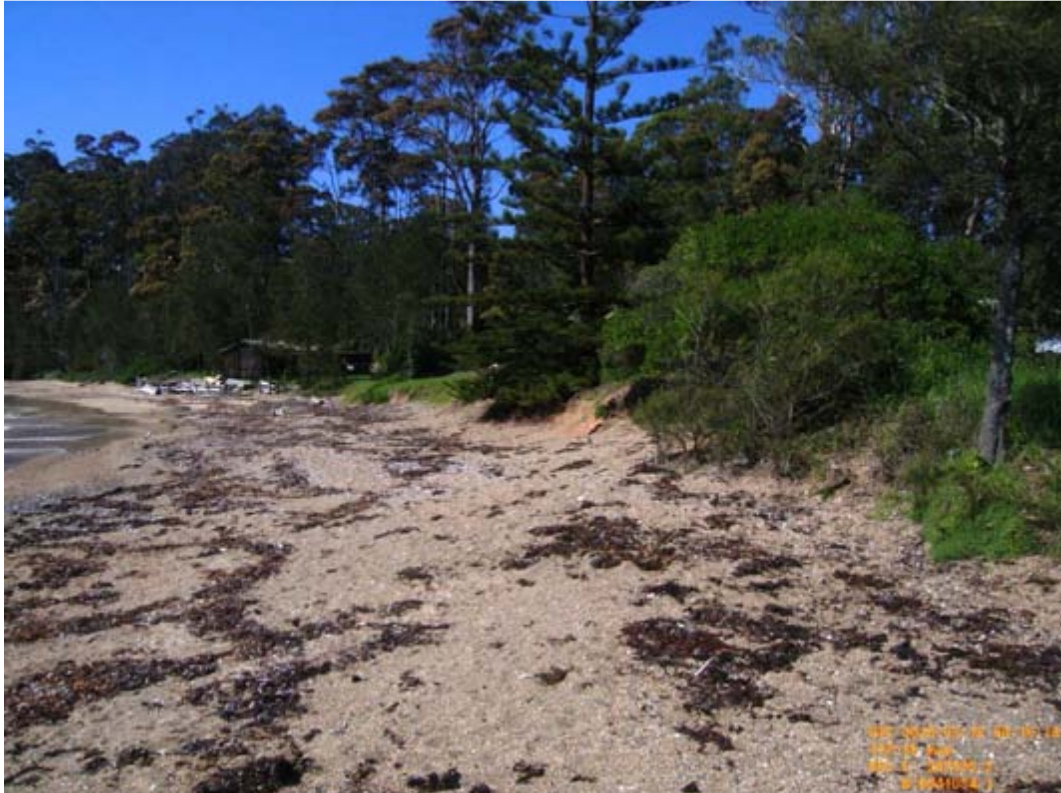
*Figure 3.37 – Low-lying shack at the back of the beach at Sunshine Bay
(March 16th 2010)*

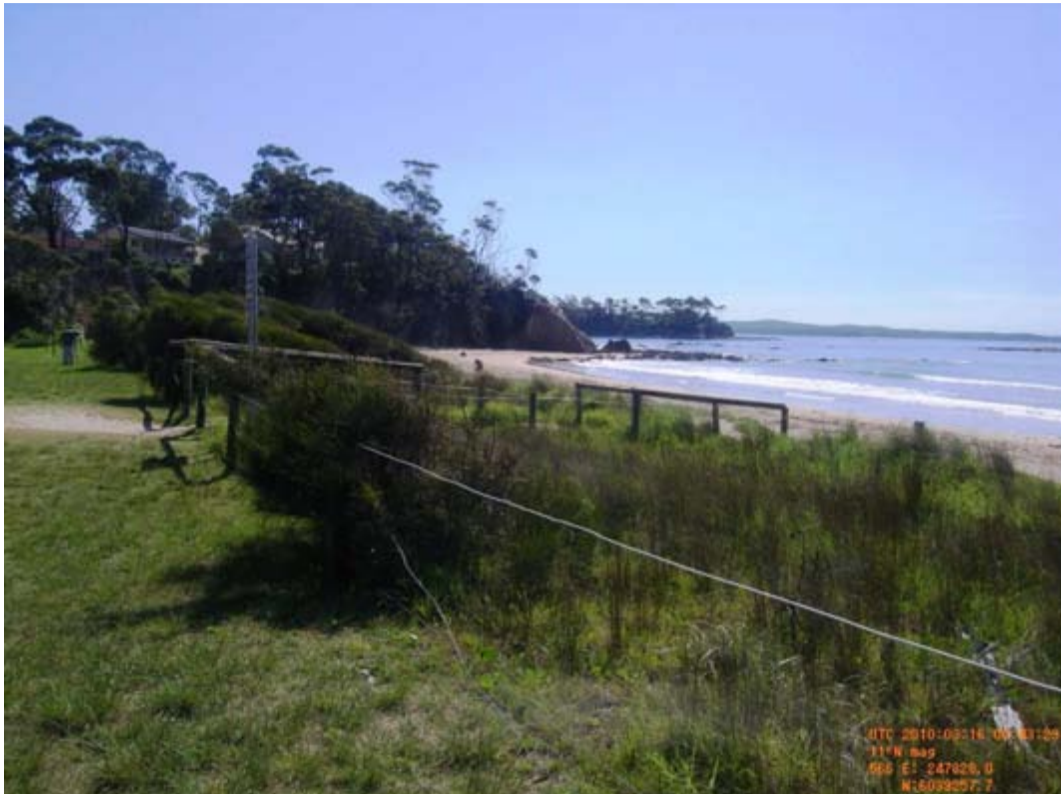
*Figure 3.39 – Good condition dune at Surf Beach
(March 16th 2010)*

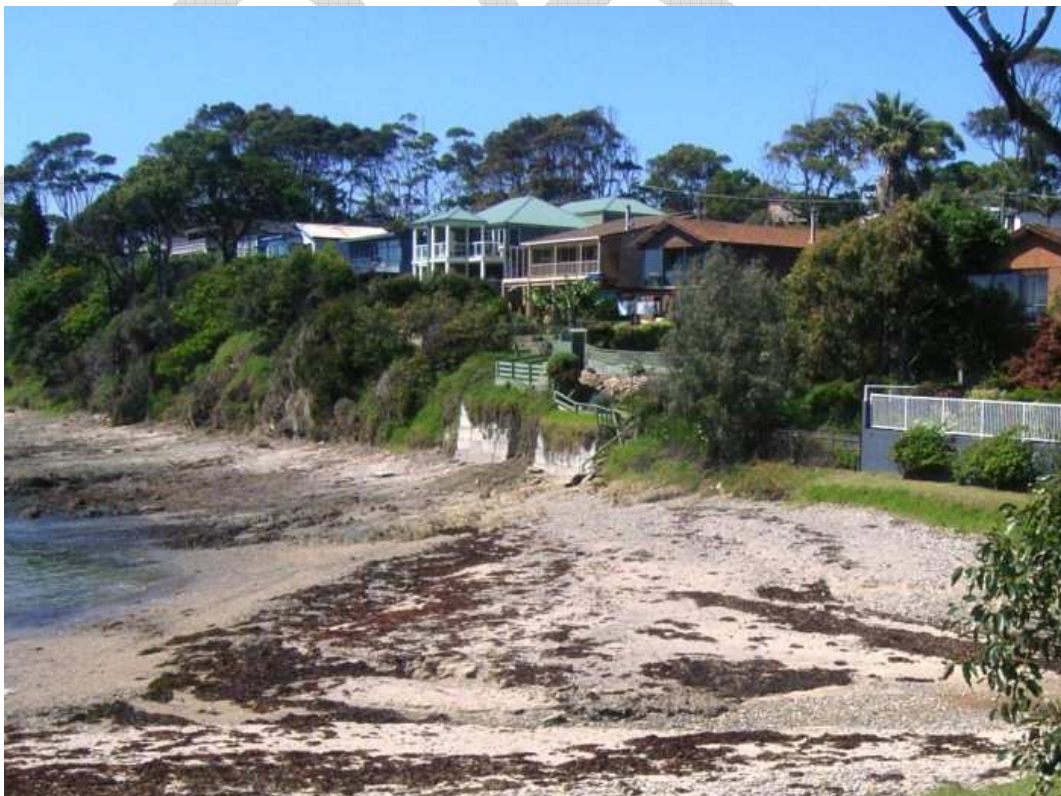
*Figure 3.40 – Seaward house access subject to slope stability issue in Mosquito Bay
(March 16th 2010)*

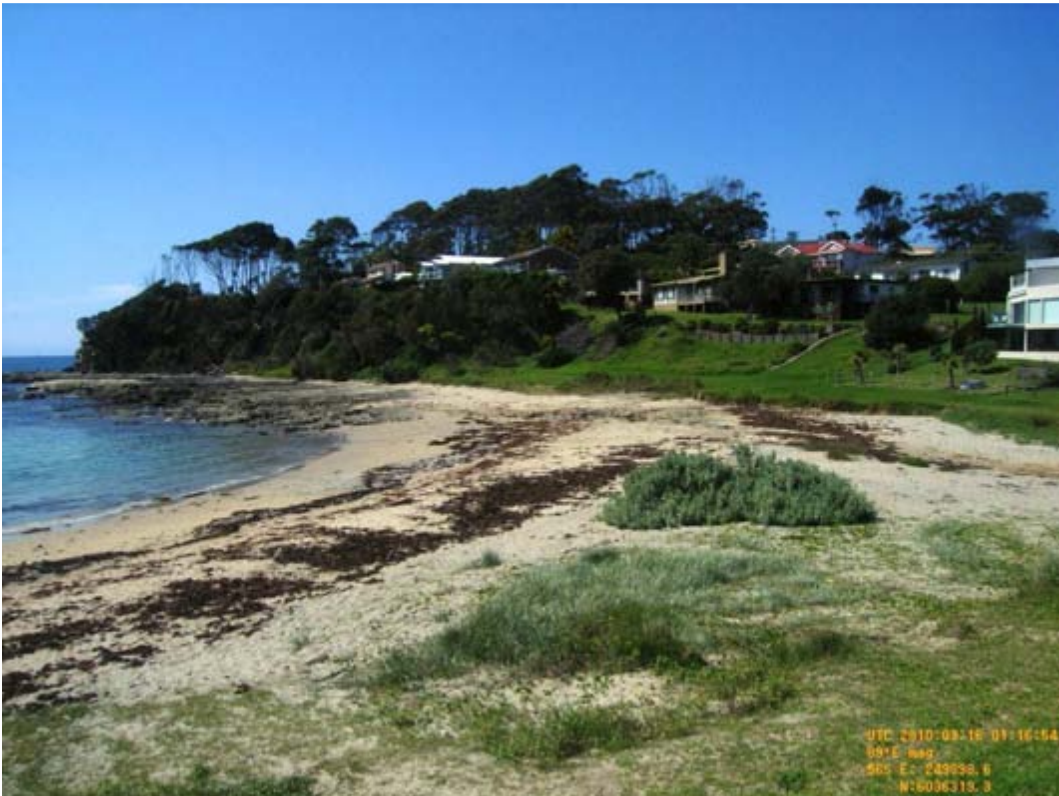
Figure 3.41 – Light beach erosion at the bottom of the slope and houses close to the edge at Garden Bay (March 16th 2010)

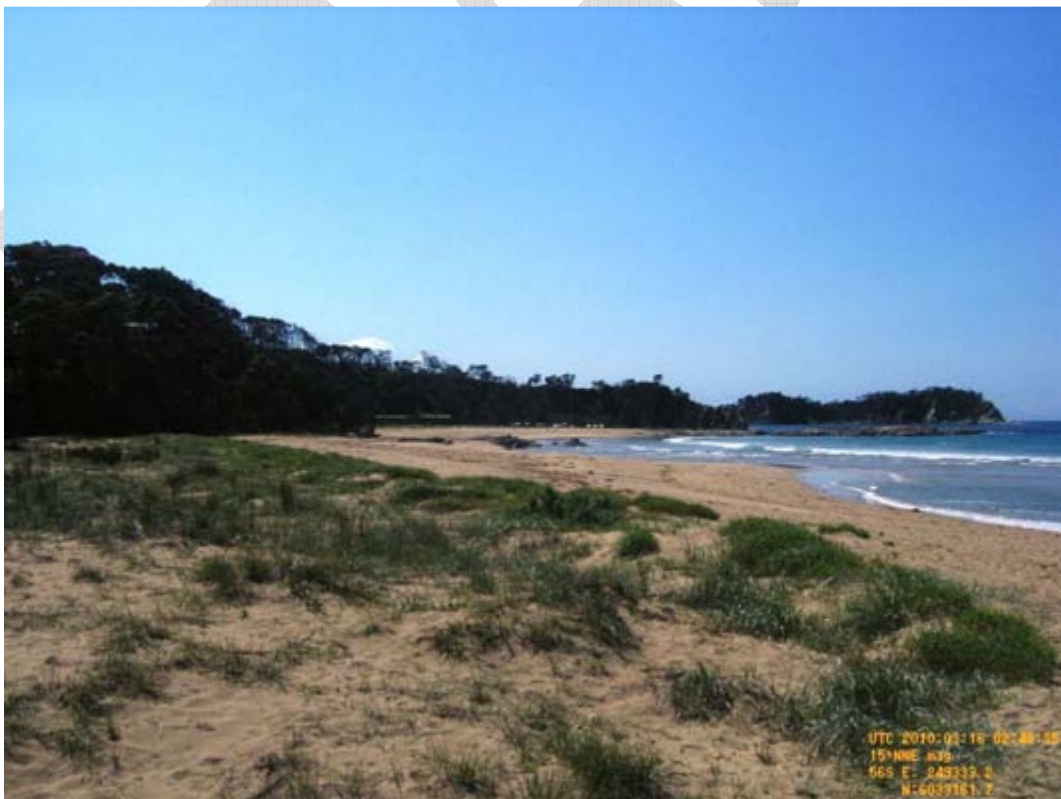
*Figure 3.44 – Boatshed at the northern end of Rosedale Beach
(March 16th 2010)*

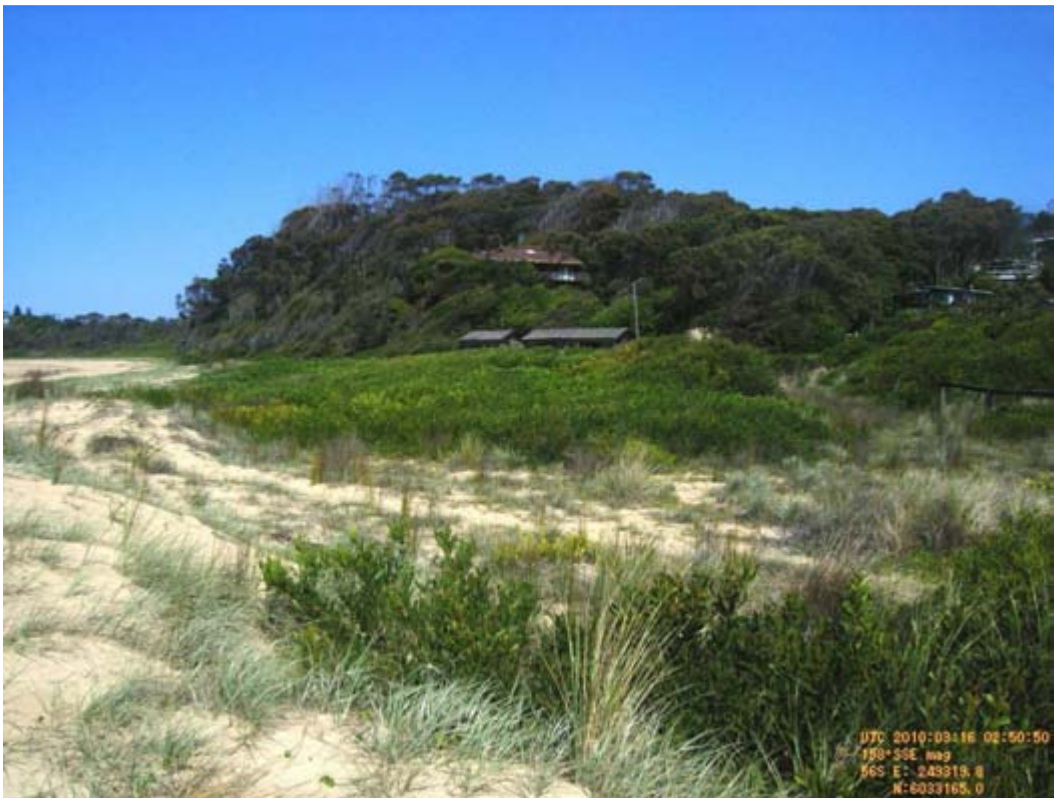
*Figure 3.45 – Shacks at the southern end of Rosedale Beach
(March 16th 2010)*

46	Southern end of Rosedale Beach	Erosion	5	Erosion of shacks located on the beach	1	5	N/A	Coastal Hazard Study	N/A	
47	Guerilla Bay	Inundation	4	Inundation of a couple of houses located at the back of the Beach	2	8	N/A	Coastal Hazard Study	N/A	
48	Barlings Beach	Inundation	4	Inundation of the holiday park at the eastern end of the beach	1	4	An independent study is being undertaken for the new developments on Barlings Beach	N/A	N/A	
49	Tomaga River Entrance	Breakthrough of dune into estuary	3	Inundation of several houses along Tomaga River channel	4	12	N/A	Tailwater Level Study for Tomaga River	Dune arm is fenced at the narrowest location	Dune arm is very narrow. Visible high scarp along the dune. Whole estuarine dynamic processes and morphology could change. Many low lying houses along the river Exacerbation of risk is expected with sea level rise.
50	Tomaga River	Inundation	4	Inundation of the caravan park north of the Tomaga River entrance by tailwater	1	4	N/A	Tailwater Level Study for Tomaga River	N/A

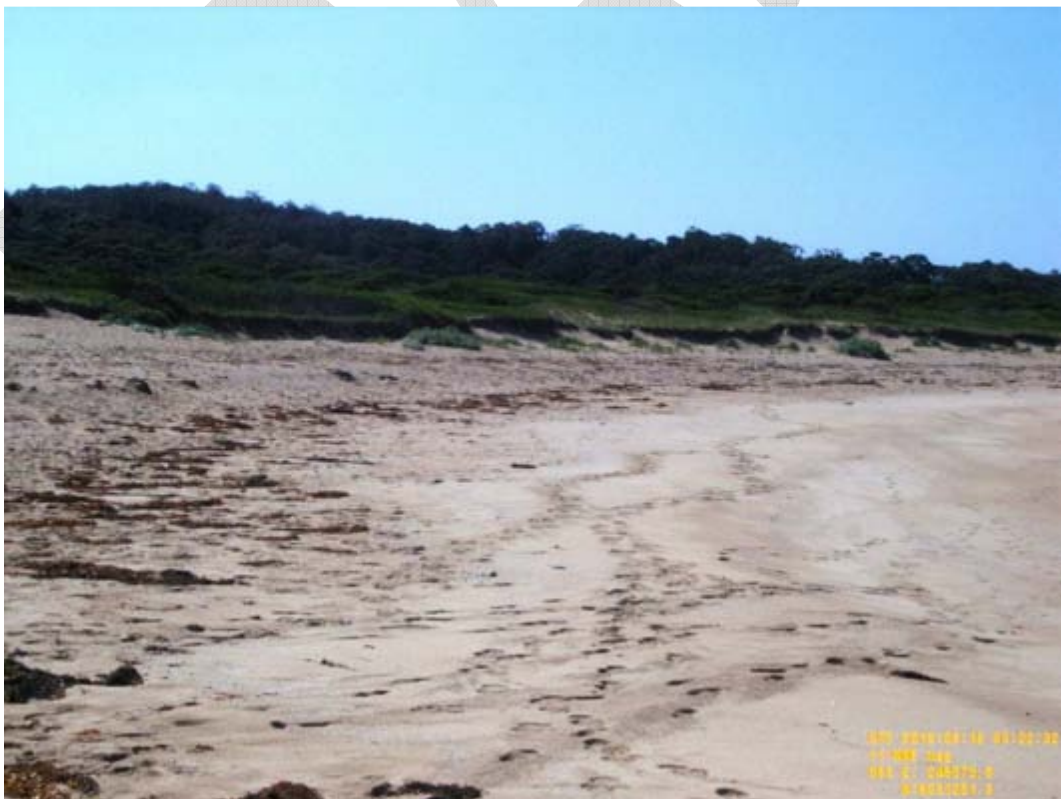
*Figure 3.46 – Healthy dune and high scarp at Barlings Beach
(March 16th 2010)*

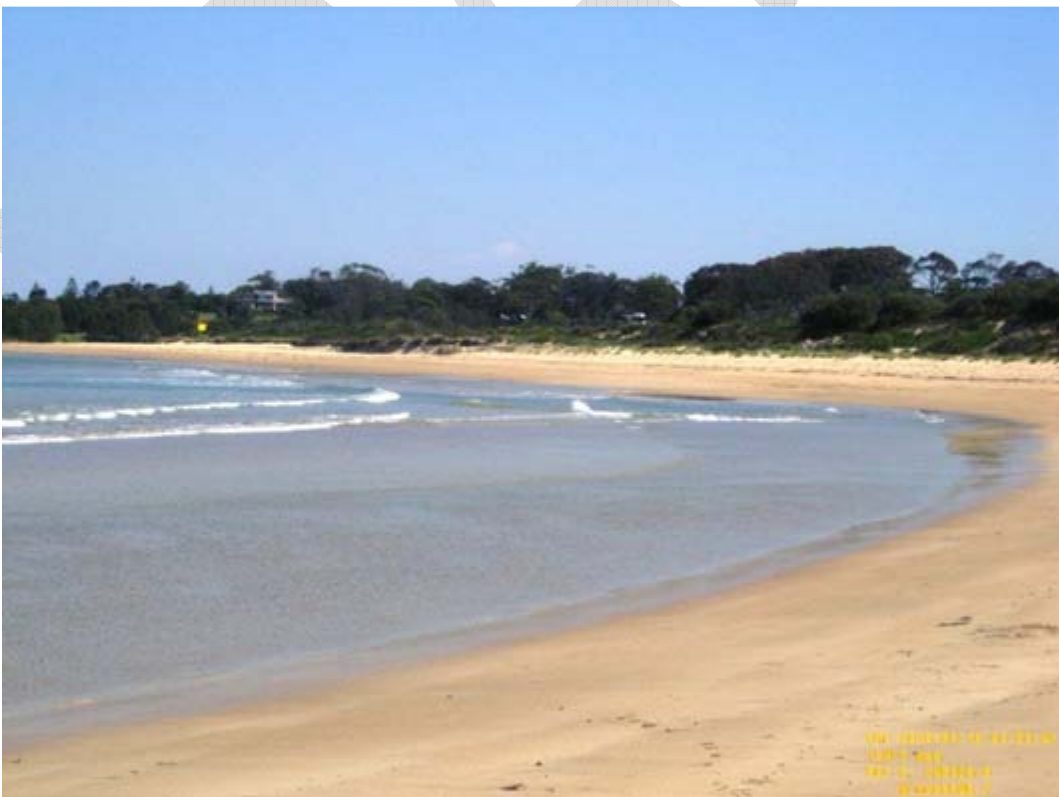
*Figure 3.48 – High scarp at the southern end of Tomakin Beach
(March 16th 2010)*

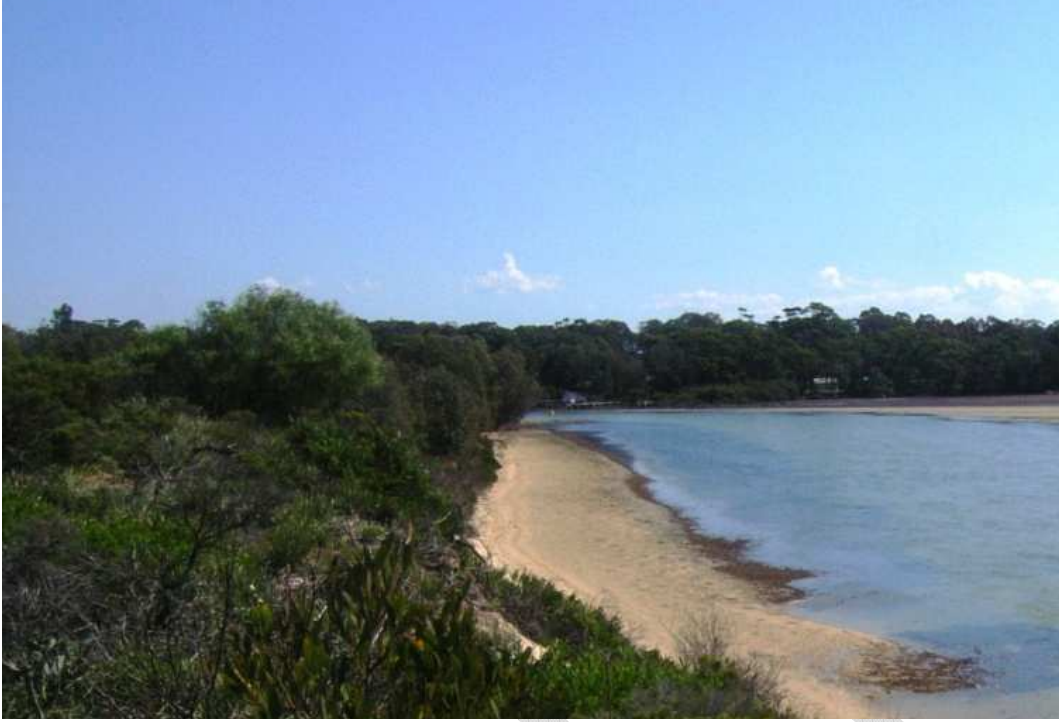
Figure 3.49 – Low-lying development along the southern embankment of the Tomaga River directly upstream of the river mouth (March 16th 2010)

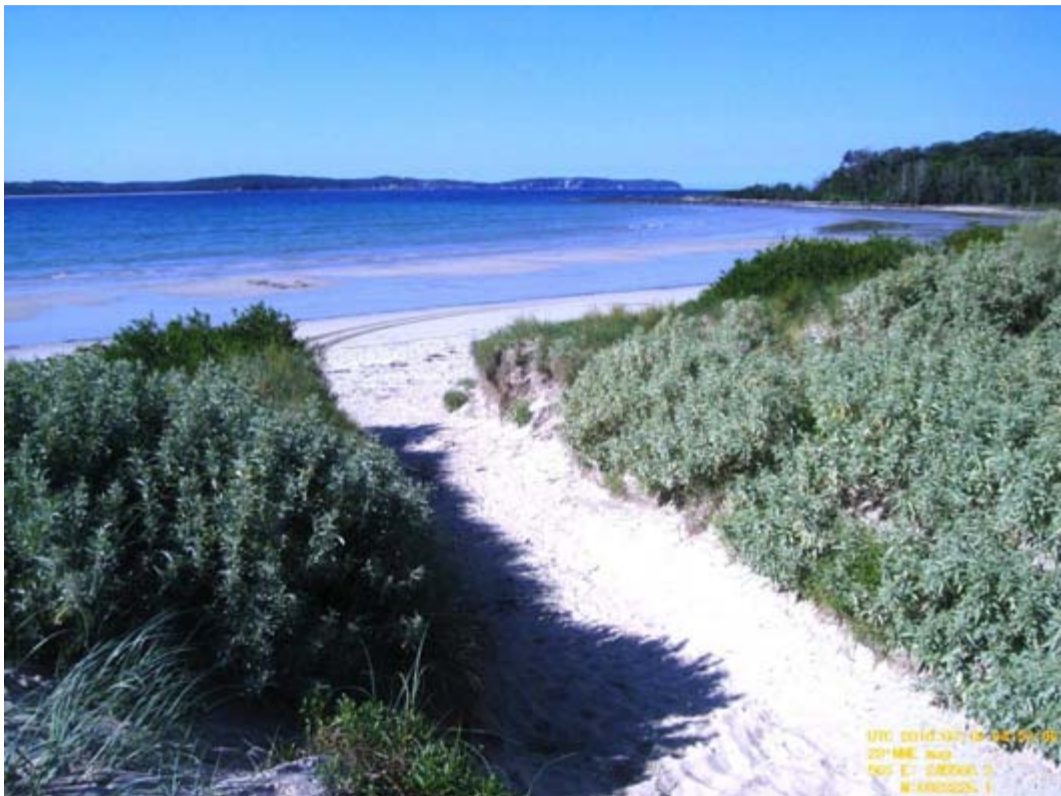
Figure 3.51 – Informal 4-wheel drive access on the tombolo leading to Broulee Island (March 16th 2010)

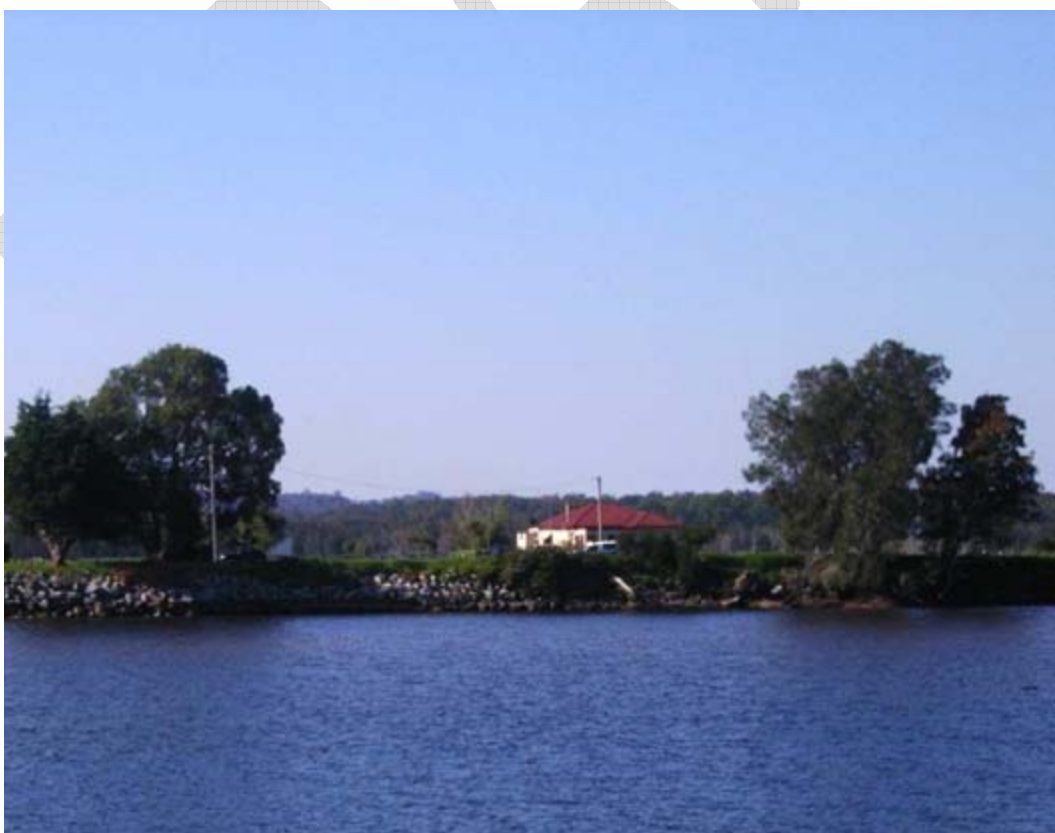
*Figure 3.54 – Bank erosion with falling trees along Moruya River
(March 16th 2010)*

59	Moruya River	Bank erosion	3	Loss of section of Georges Bass Drive	3	9	N/A	Tailwater Level Study for Moruya River	Poor condition rock seawall along the river bank	Some trees are falling along Moruya River
60	Moruya Beach	Erosion	3	Loss of toilet block	1	3	N/A	Coastal Hazard Study	N/A	Toilet block are relatively far back
61	Northern end of Congo	Inundation	4	Flooding of road and houses along Congo Creek	3	12	Willing & Partners (1997)	Update of Tailwater Level Study with new benchmarks from the NSW Sea Level Rise Policy (2009)	N/A	Houses along Congo Creek are low-lying
62	Congo	Inundation	2	Flooding of access to Congo on both access roads. Isolation of the town	4	8	N/A	Coastal Hazard Study	N/A	Both access roads are private and unsealed
63	Coila Lake, Tuross Head	Inundation	2	Flooding of 3-4 low-lying properties along Monash Avenue (West)	2	4	BMT WBM (2010)	Tailwater Level Study	N/A	
64	One Tree Beach south, Tuross Head	Erosion	5	Loss of carpark behind the beach	1	5	N/A	Coastal Hazard Study	N/A	Visible scarp seaward of the carpark

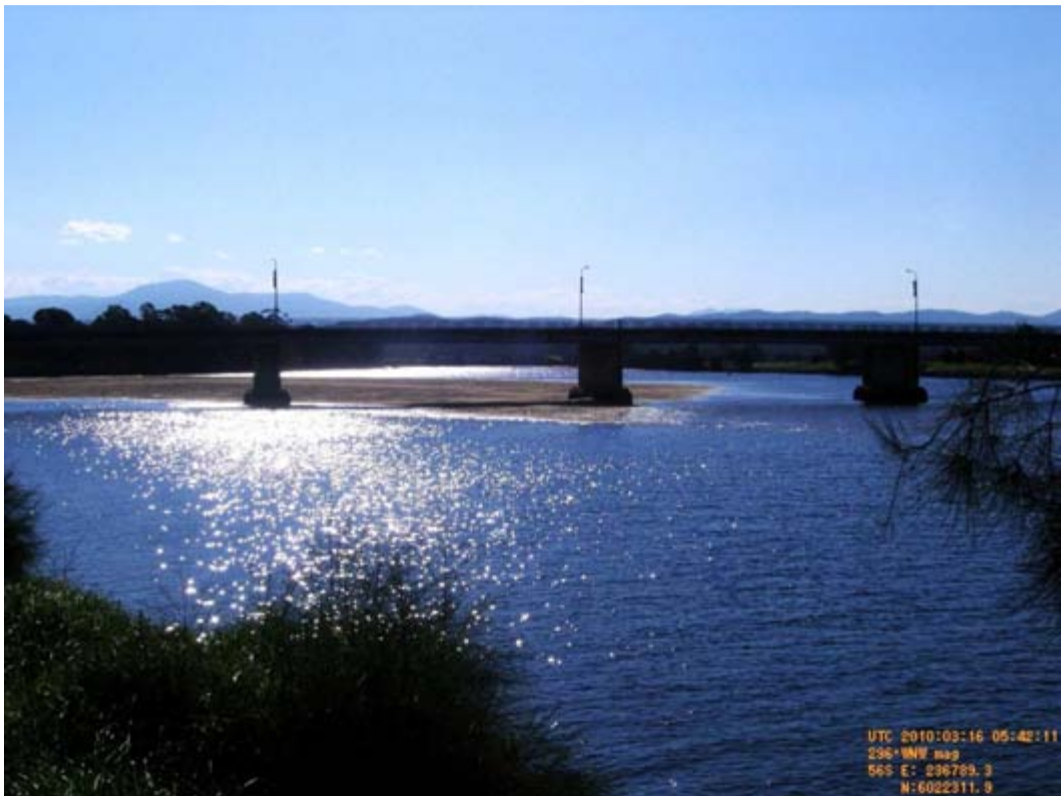
Figure 3.55 – Sand deposition upstream of Princes Highway Bridge along Moruya River (March 16th 2010)

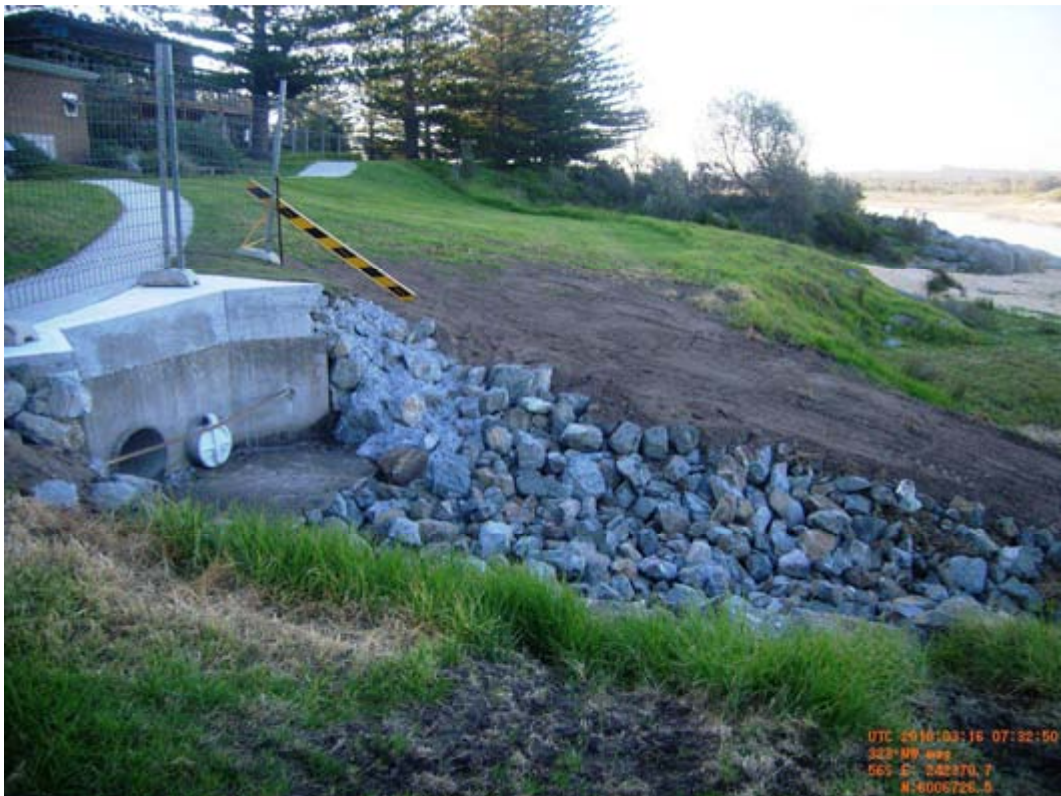
Figure 3.57 – Stormwater outlet under repair at Coila Lake entrance
(March 16th 2010)

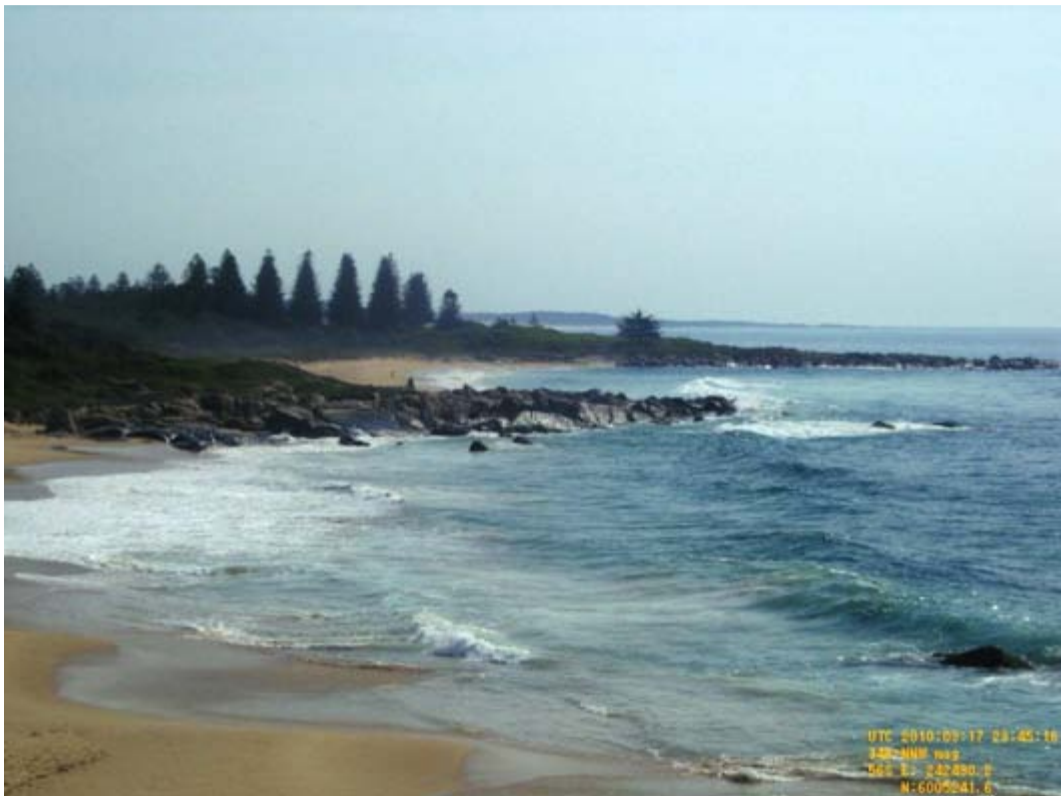
Figure 3.59 – Scarp along Tuross Head coastline
(March 18th 2010)

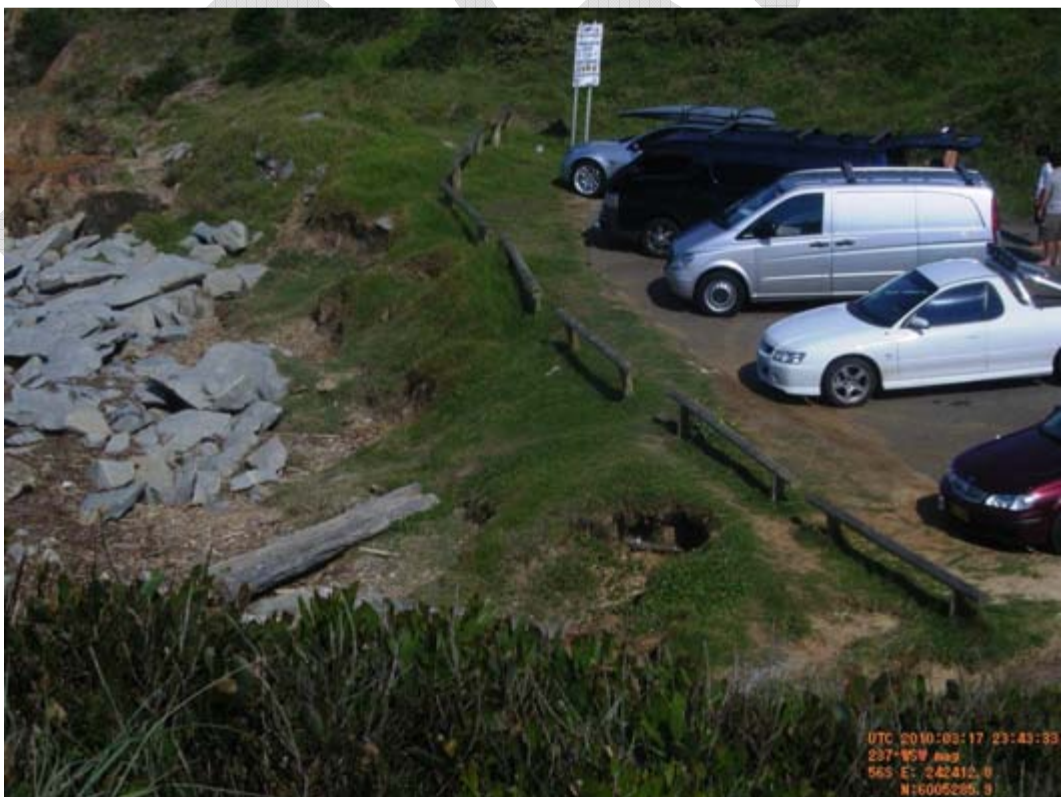
Figure 3.60 – Erosion in front of carpark at One Tree Beach south
(March 18th 2010)

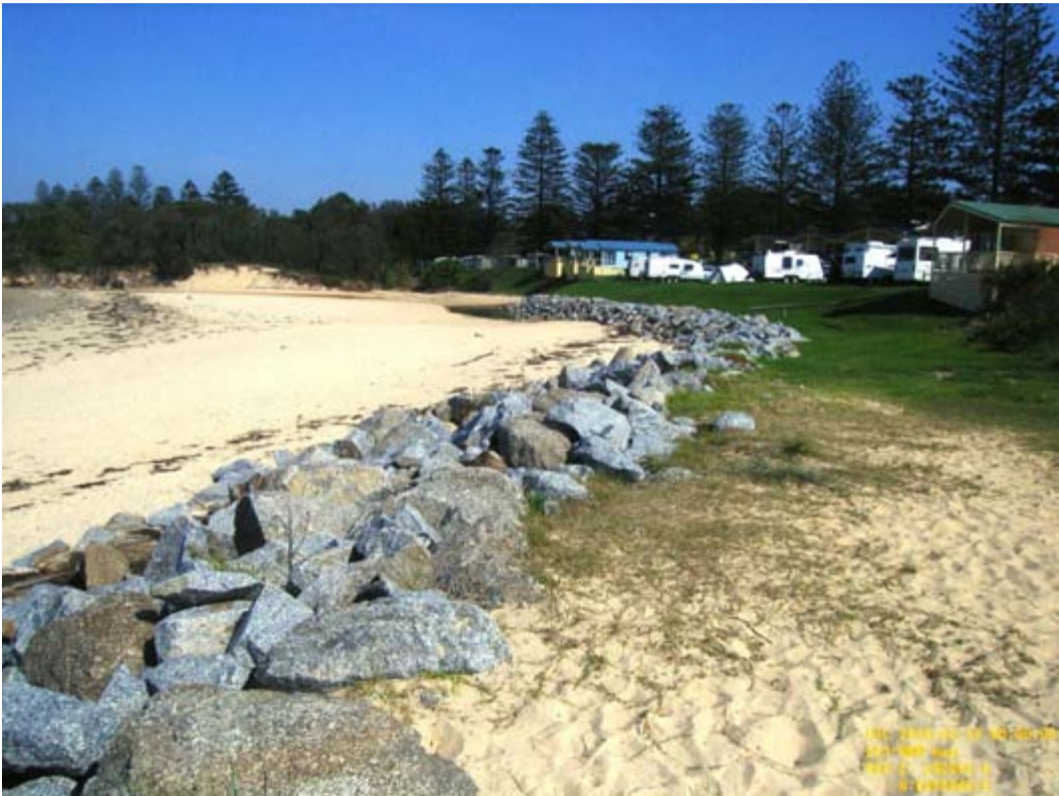
Figure 3.61 – Seawall in front of Tuross Beach Holiday Park
(March 18th 2010)

65	Tuross Beach Holiday Park, Tuross Head	Erosion	4	Failure of seawall. Loss of seaward cabins	1	4	N/A	Coastal Hazard Study	Caravan Park protected by relatively new seawall with geotextile	Cabins very close to beach. Erosion visible at the entrance of a creek directly south of the caravan park
66	Tuross Lake, Tuross Head	Inundation	4	Inundation of shops at the south-western tip of Tuross Head	2	8	BMT WBM (2010)	Tailwater Level Study	N/A	Shops very low-lying. 2m trigger for lake opening or 0.8m during more than 14 days due to the low-lying shops
67	Tuross Lakeside Holiday Park	Inundation	4	Inundation of the holiday park and Hector McWilliams Drive at the level of the holiday park	3	12	N/A	Tailwater Level Study	N/A	Park and section of the road very low-lying
68	Beachcomber Holiday Park between Tuross Head and Potato Point	Inundation	3	Loss of access to the caravan park and inundation of the caravan park	2	6	N/A	Coastal Hazard Study	N/A	Access to the caravan park is via Potato Point and is located directly behind the dune along the beach

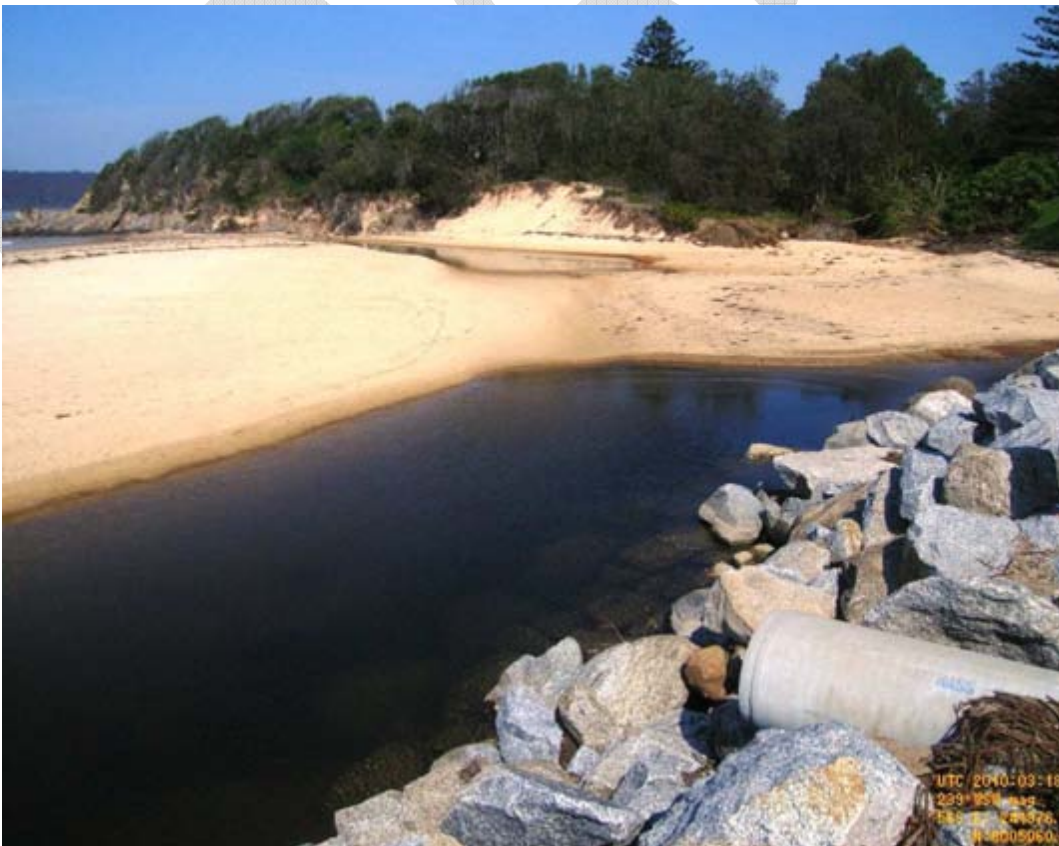
Figure 3.62 – Recent culvert and erosion on dune facing Tuross Beach Holiday Park
(March 18th 2010)

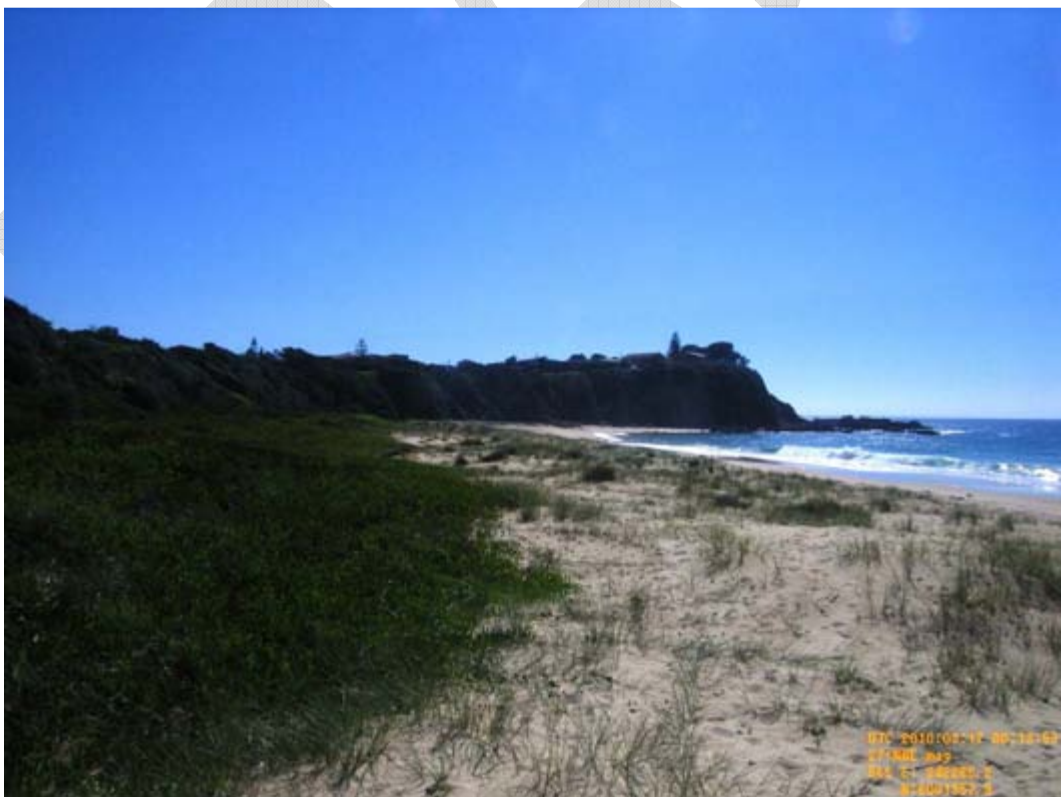
*Figure 3.64 – Houses at the top of the cliff at Potato Point
(March 17th 2010)*
