APPENDIX 1 – RISK ASSESSMENT

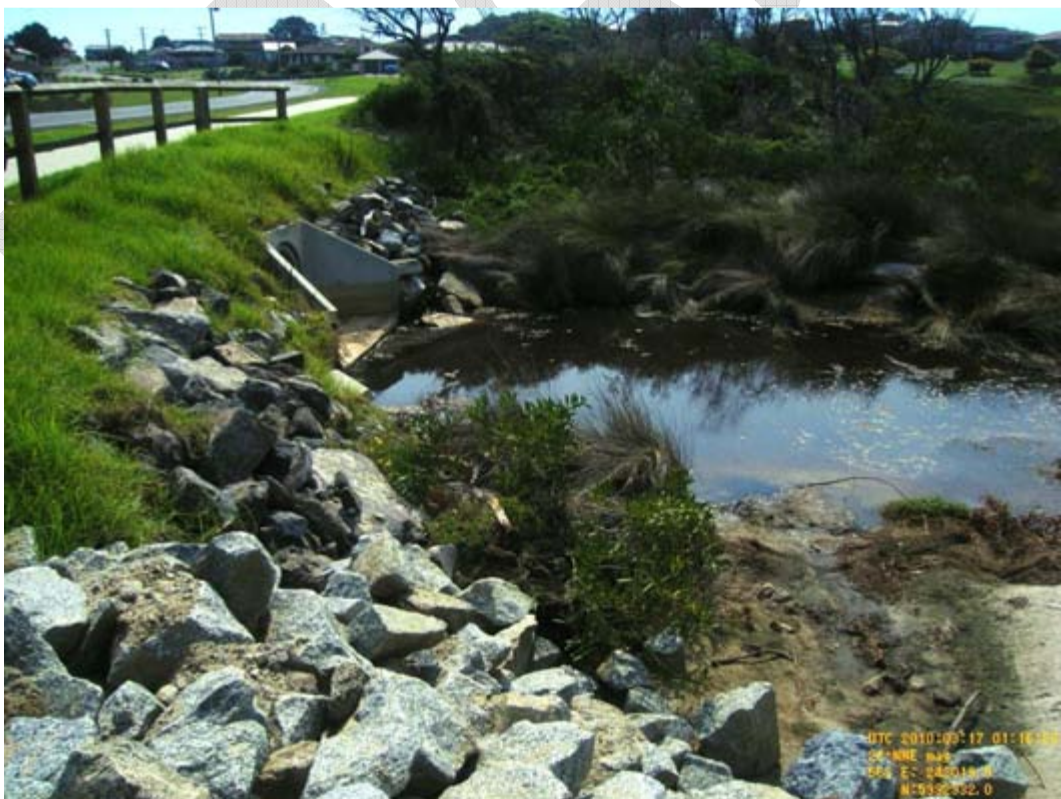
*Figure 3.66 – Culvert under Ocean Drive Bridge
(March 17th 2010)*

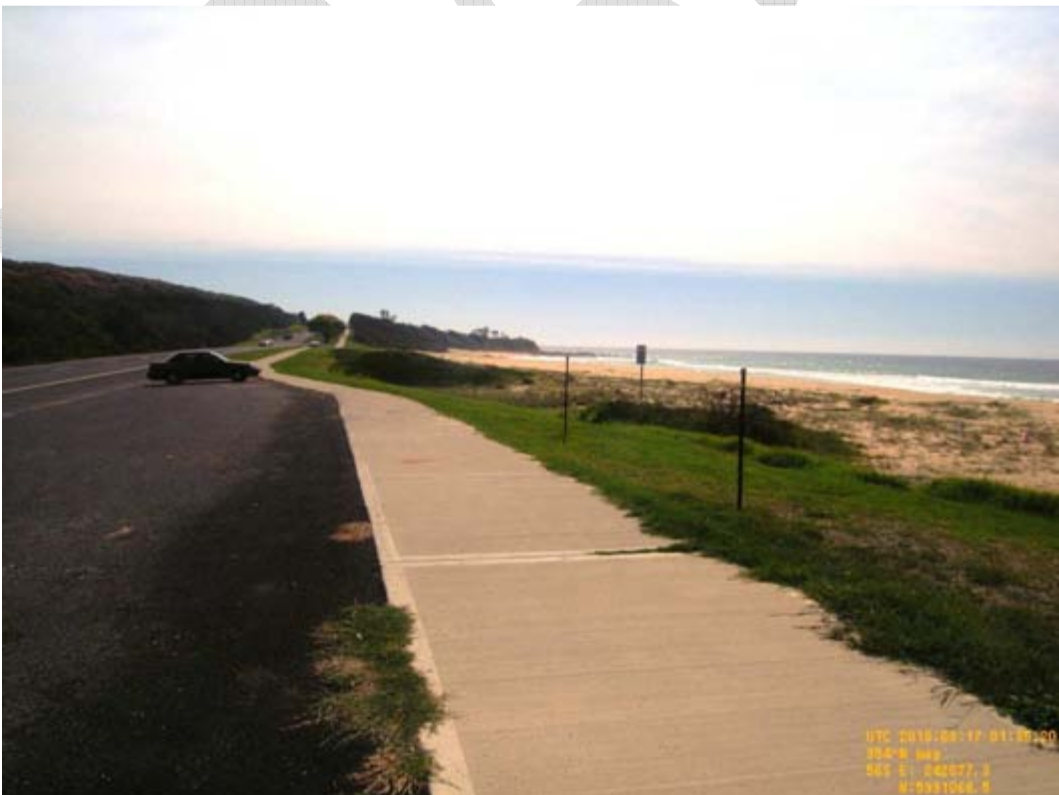
Figure 3.68 – Low-lying sections of Ocean/Dalmeny Drive between Dalmeny and Kianga
(March 17th 2010)

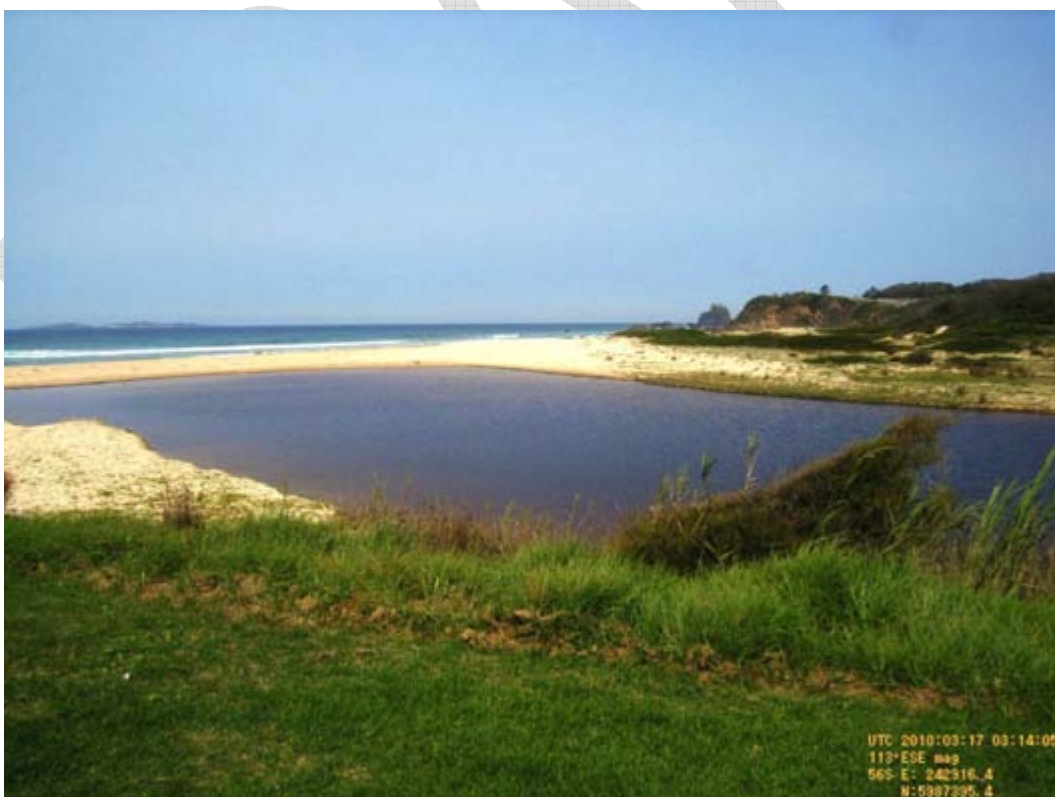
Figure 3.70 – Low berm at Little Lake entrance
(March 17th 2010)

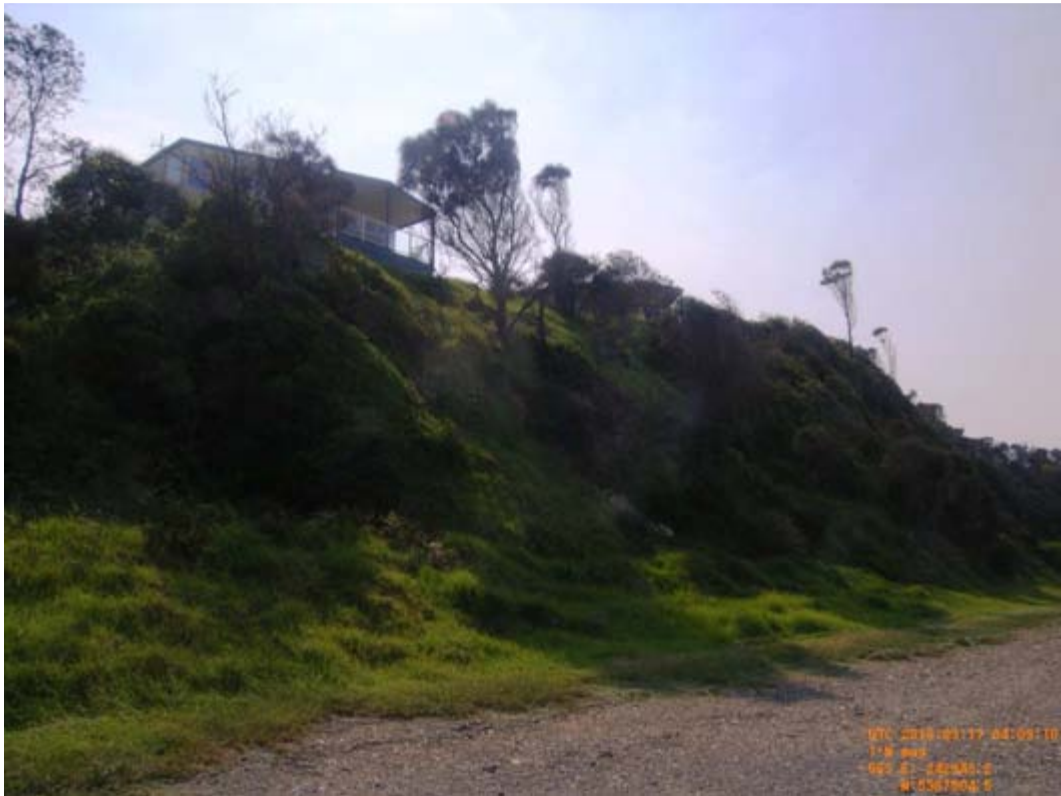
Figure 3.71 – Cabins close to the edge of the cliff near Narooma SLSC (March 17th 2010)

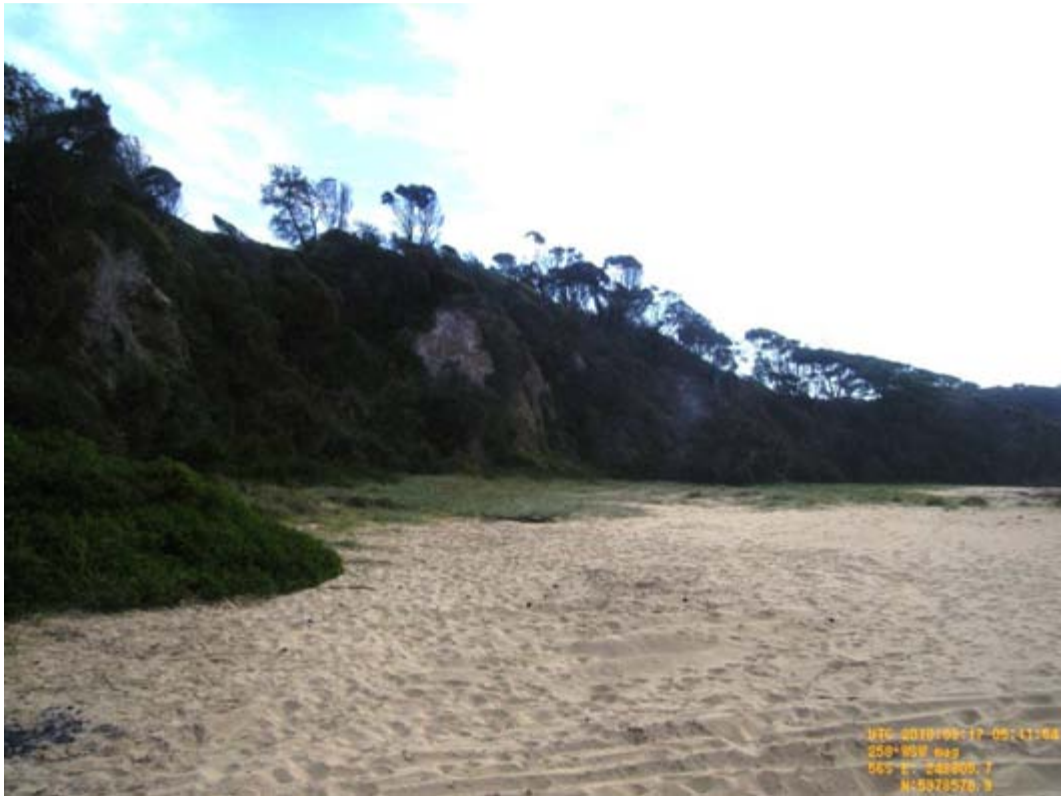
Figure 3.73 – High cliff along Mystery Bay
(March 17th 2010)

83	Mystery Bay	Cliff stability	3	Loss of section of Mystery Bay Road near Negus Drive	2	6	N/A	Coastal Geotechnical Study	N/A	Cliff is eroding and road is right on the edge
84	Akolele/Wallaga Lake	Inundation/Erosion	3	Inundation of Wallaga Lake Road at the southern end of Akolele	2	6	N/A	Tailwater Level Study for Wallaga Lake	N/A	Road is very low-lying and in relatively poor condition

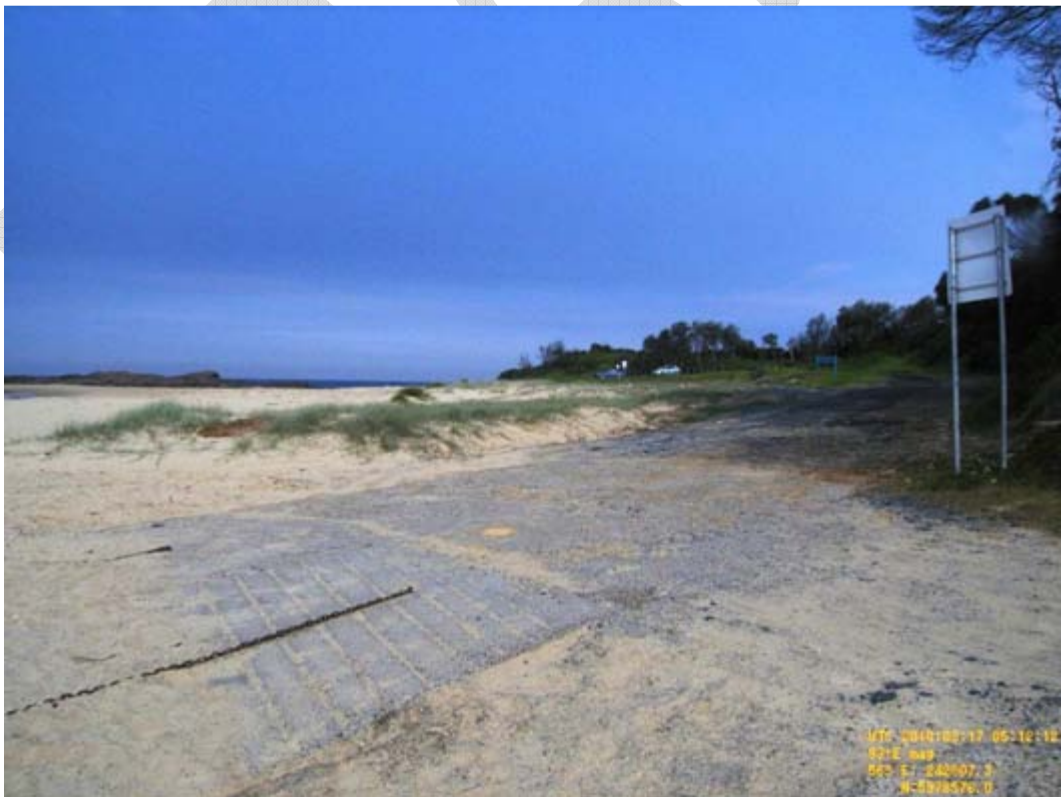
Figure 3.74 - Low-lying carpark south of Mystery Bay
(March 17th 2010)
