MORUYA/DEUA ESTUARINE PROCESSES STUDY

November 2003

Document Number	AC.2002.J021.0311.R01
Document Title	Moruya/Deua Estuarine Processes Study
Client	Eurobodalla Shire Council
Job Number	AC.2002.J021
Job Title	Moruya Estuary Process and Management Study
Copy Number	1

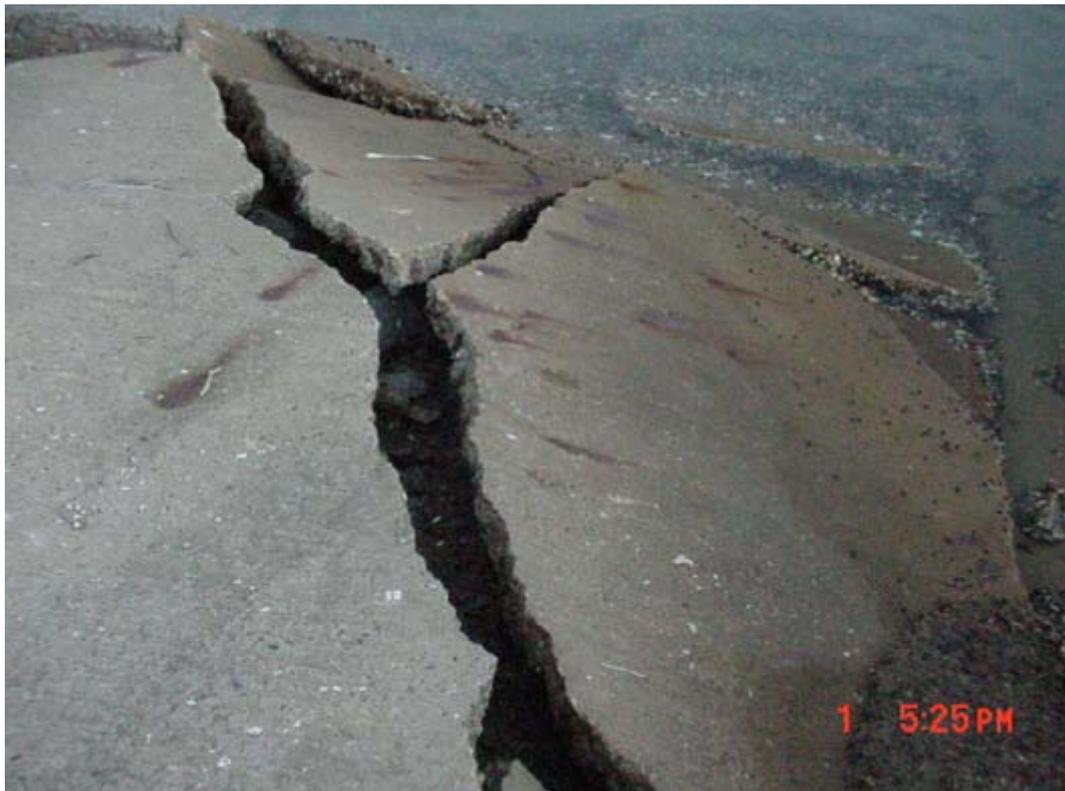
Figure 1.7: Infrastructure damage caused by erosion.

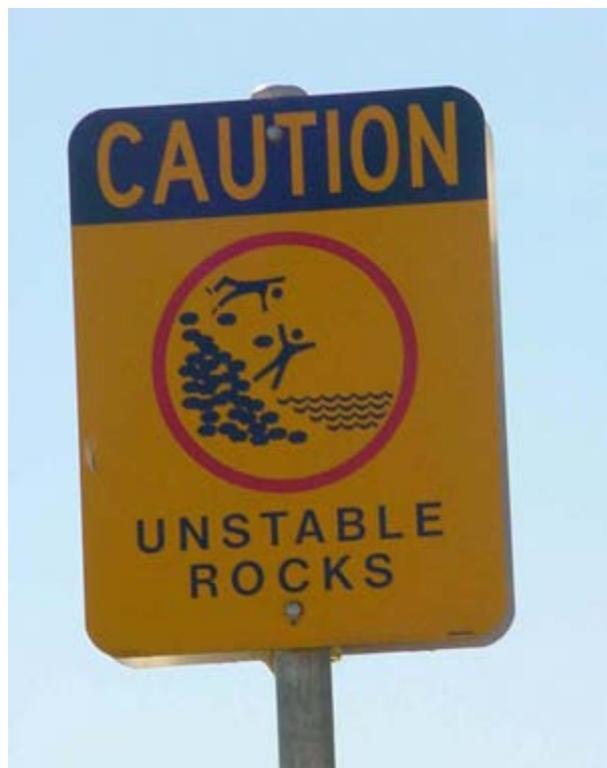
Figure 5.1: Stability of rock-lined banks is a key issue in the lower estuary.

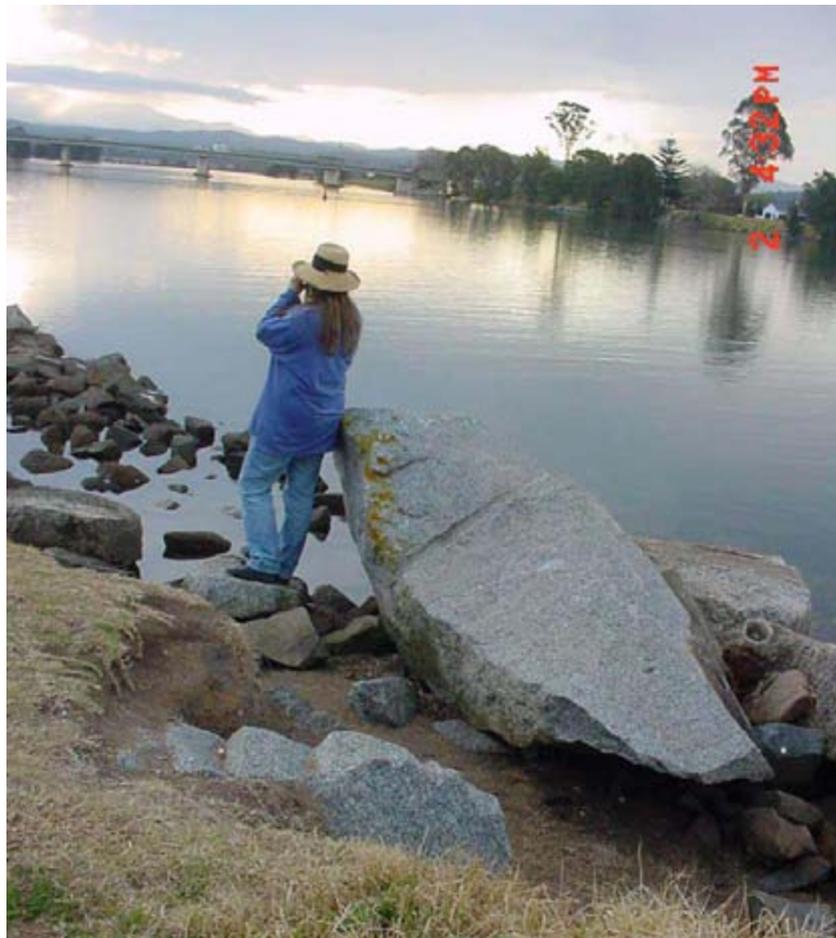
Figure 5.2: Bank scour due to large rocks.
Very large rocks do not necessarily provide effective bank protection. The large rock in the foreground of this photograph appears to have contributed to erosion by inducing scour behind it.

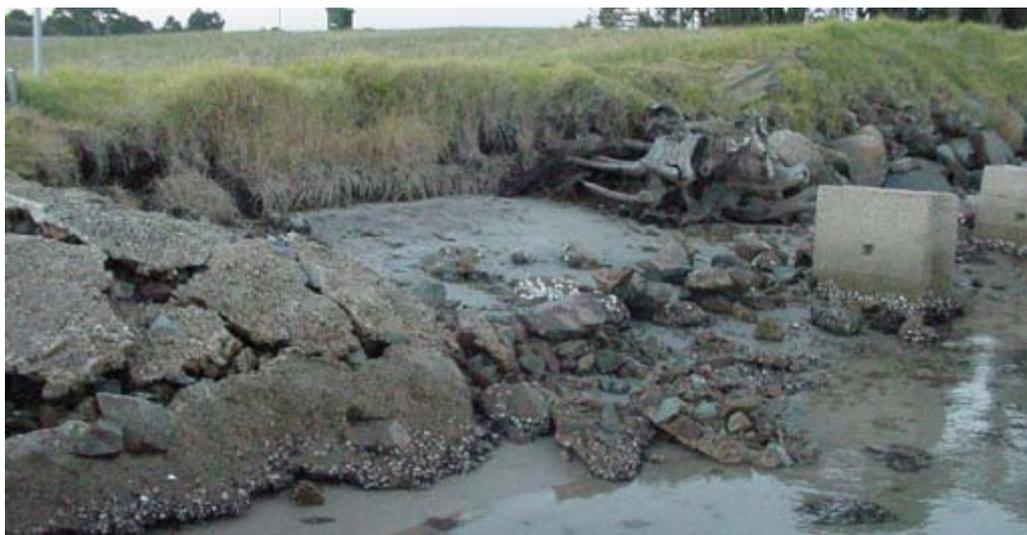
Figure 5.3: Bank erosion behind the rock riprap.
Bank erosion behind the rock riprap lining was observed in a number of places.

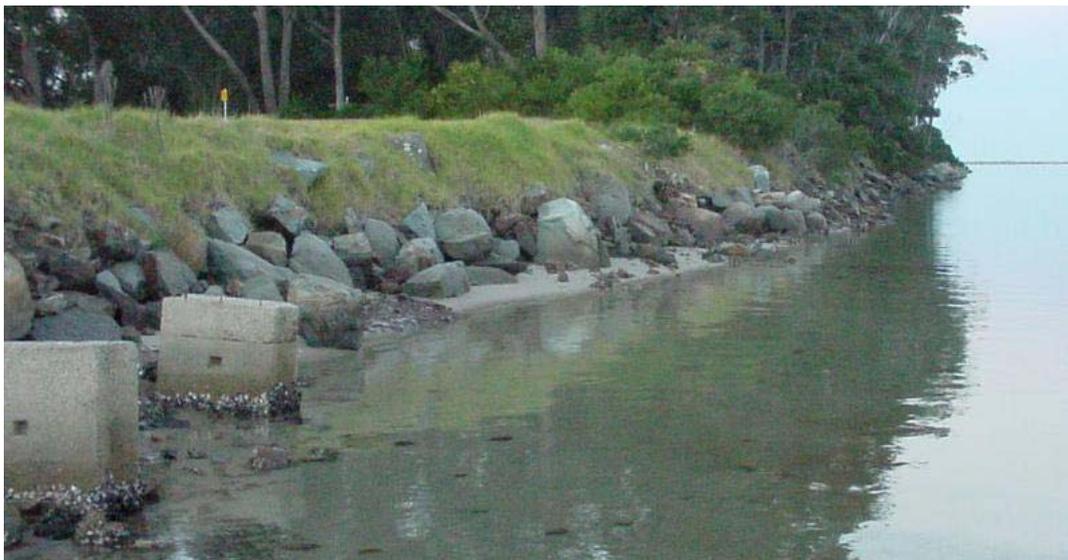
Figure 5.4: Rock riprap lining only at high tide.
The vertical extent of the rock riprap lining in some areas is limited to the area around and just above high tide level.

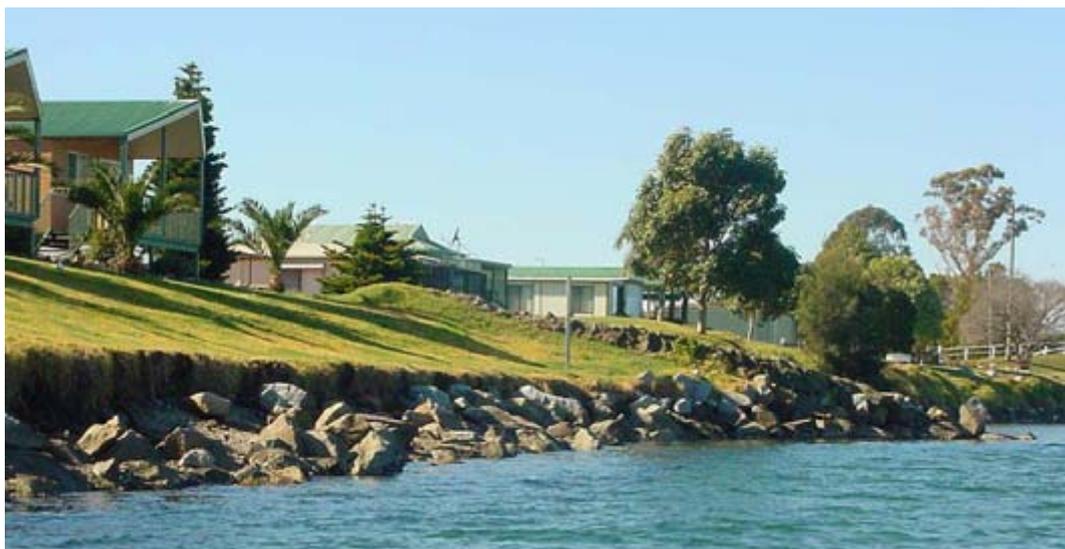
Figure 5.5: Vertical banks subject to bank erosion at the rear of the motel.

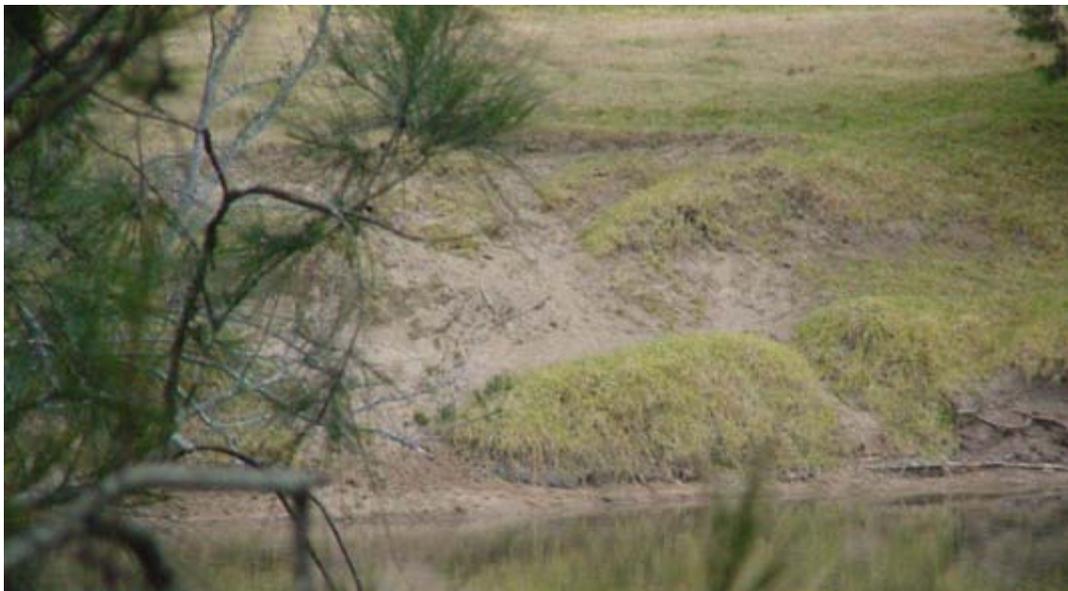
Figure 5.7: Bank erosion due to stock damage.

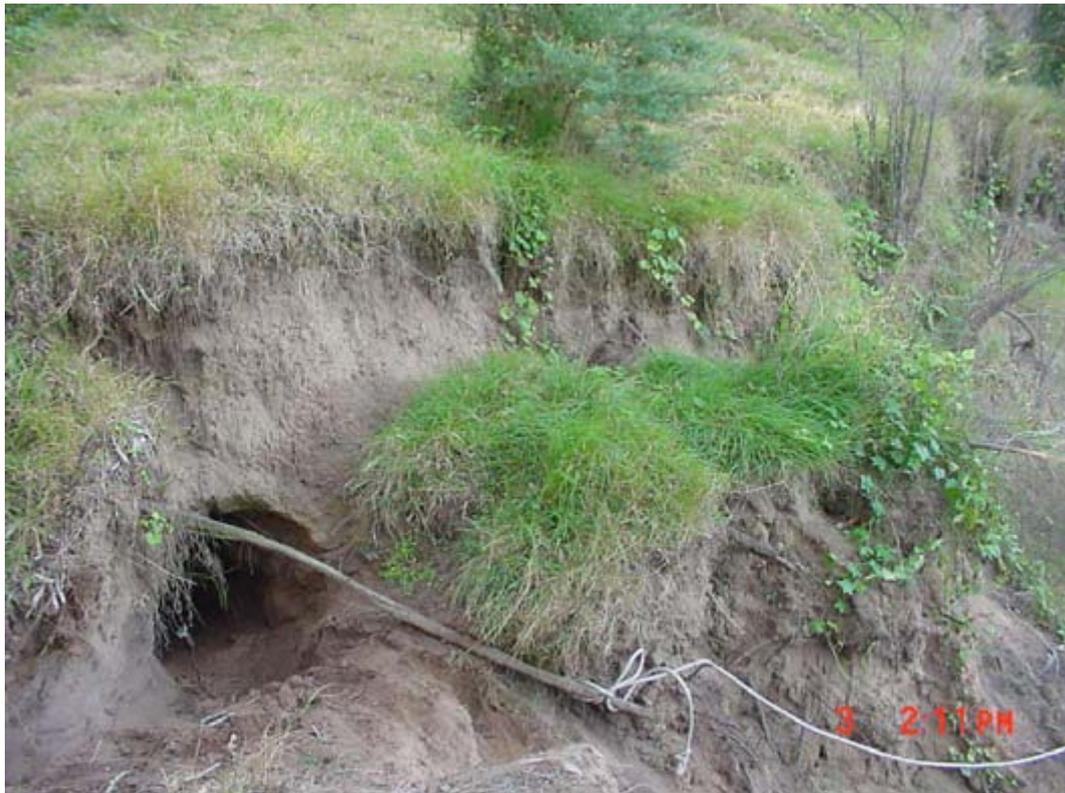
Figure 5.8: Burrowing animal damage of eroding bank.
Burrowing animals take advantage of the eroded banks and may make minor local contributions to bank erosion processes.

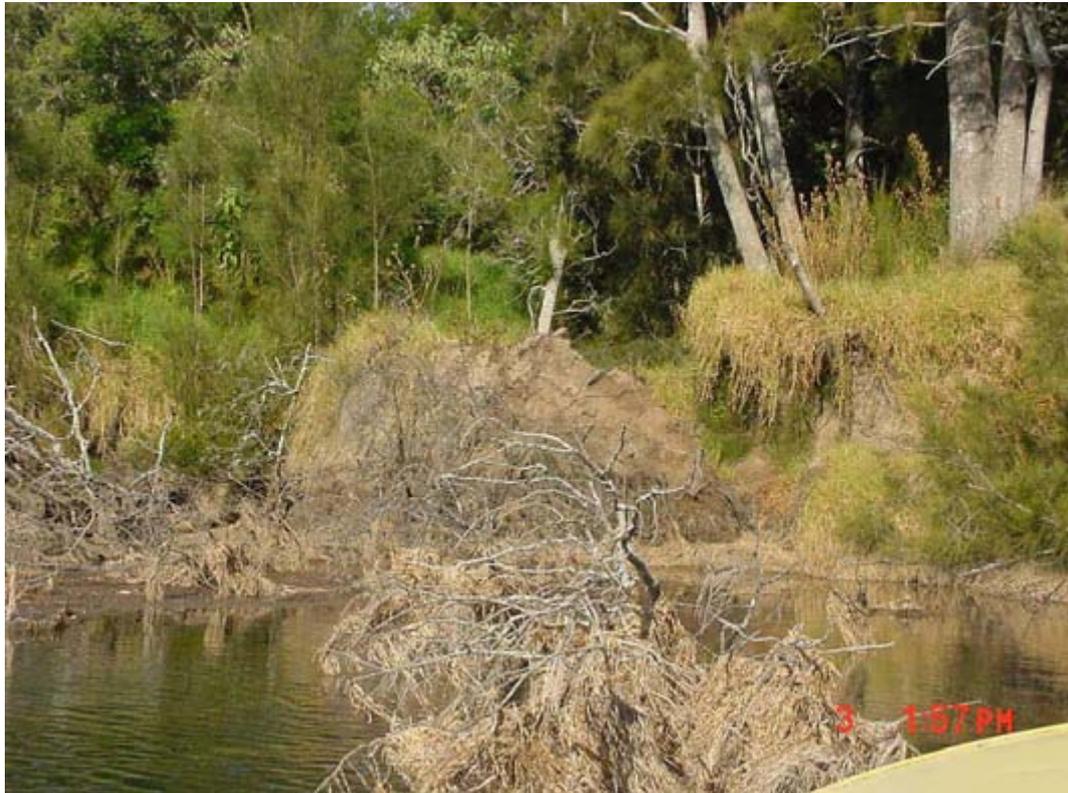
Figure 5.9: Fallen trees associated with bank slumping.
A significant number of tree falls associated with bank slumping or collapse were observed in the Moruya River Estuary upstream of the Princes Highway Bridge.

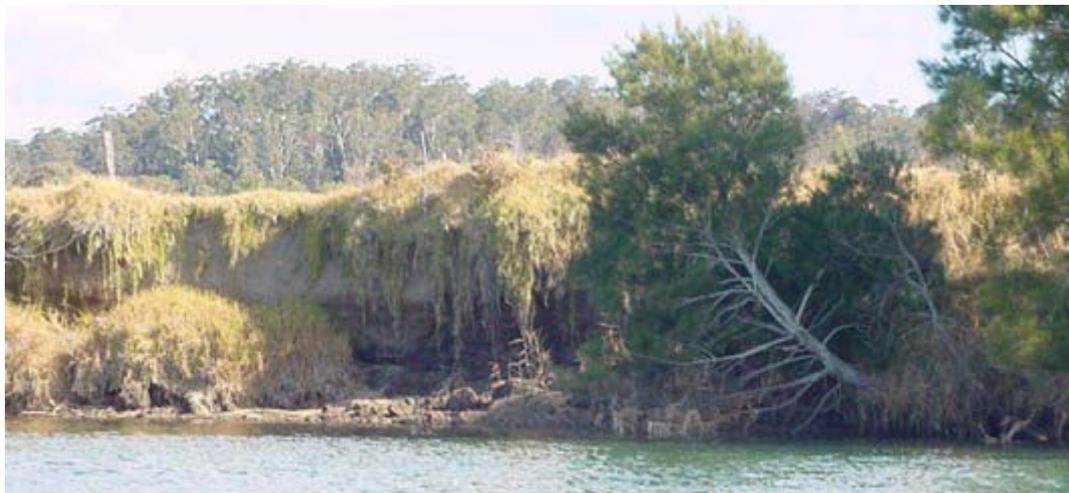
Figure 5.11: Eroding bank upstream of the Princes Highway Bridge with no remnant indigenous riparian vegetation. Factors contributing to erosion at this site include natural meander processes (see sediment transport results for the 1 year flood), and wetting and wave action under low flow conditions. The erosion has possibly been exacerbated by boat wash.

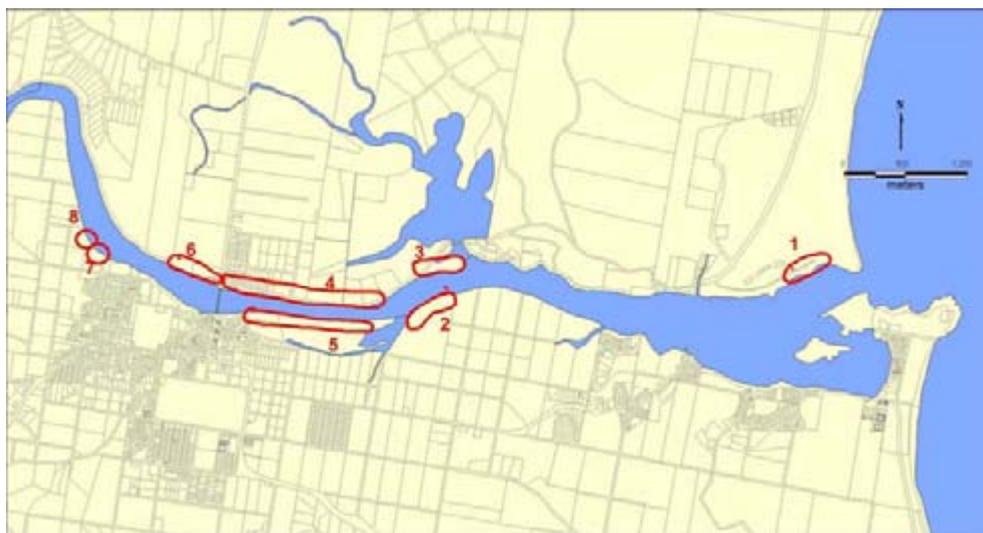
- Slumping of rock walls due to loss of toe support;
- Erosion of banks above and behind rock walls; and
- Large voids in the walls, reducing their effectiveness and increasing their susceptibility to failure.

Figure 5.12: Areas with different problems in the rock riprap walls identified.

There is a need to undertake an engineering audit to determine where the walls need to be replaced or strengthened. Remedial measures such as repair or rebuilding of the walls, the provision of filter layers under the main rock armour, the raising of crest heights, and the termination of walls can then be designed, costed and planned.
