Background Information Document for Joes, Wimbie, Short Beach and Surfside Creeks *FINAL REPORT*

Prepared For: Eurobodalla Shire Council

Prepared By: WBM Oceanics Australia

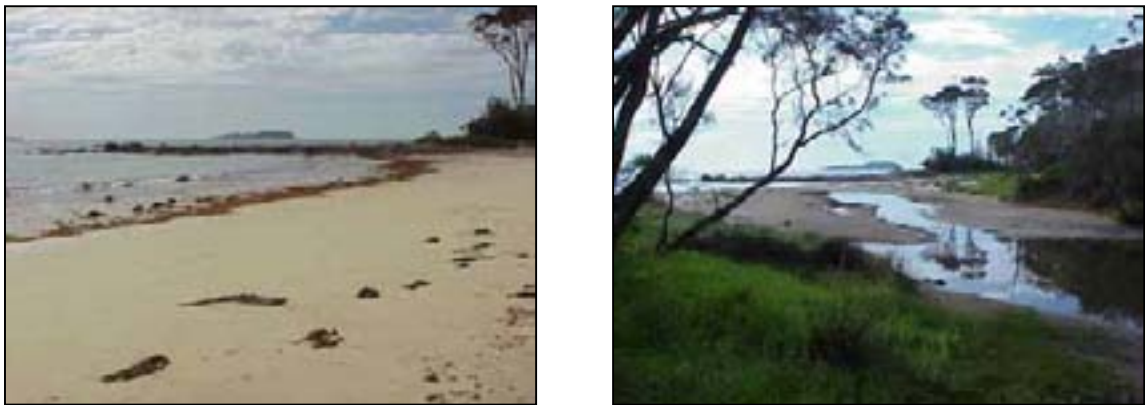
The substrate in the entrance area is dominated by unconsolidated and unsorted sand with varying amounts of broken shell and at times significant amounts of drying algae, such as kelp, which has been washed ashore from nearby rocky reefs. The entrance of Wimbie Creek is highly dynamic with several openings possible in any given year. Figure 2-1 shows Wimbie Creek and the beach entrance/exit zone on 7 April 2003.

Figure 2-1 Entrance/exit zone of Wimbie Creek to Wimbie Beach

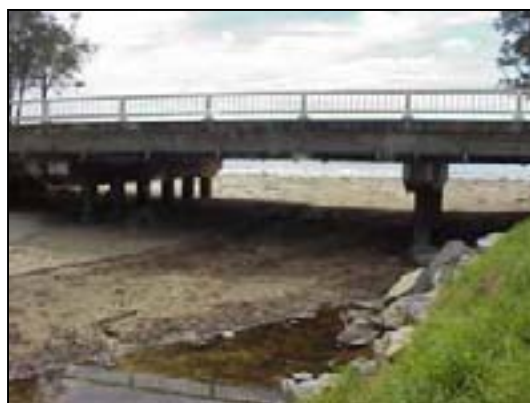
The substrate in the entrance area is dominated by unconsolidated and unsorted sand with varying amounts of broken shell. Small pieces of drying algae and kelp had been washed ashore. The entrance behaviour of Short Beach Creek is dynamic with a number of openings possible in any given year. Figure 2-3 shows the entrance/exit zone of Short Beach Creek.

Figure 2-3 Entrance/exit zone of Short Beach Creek

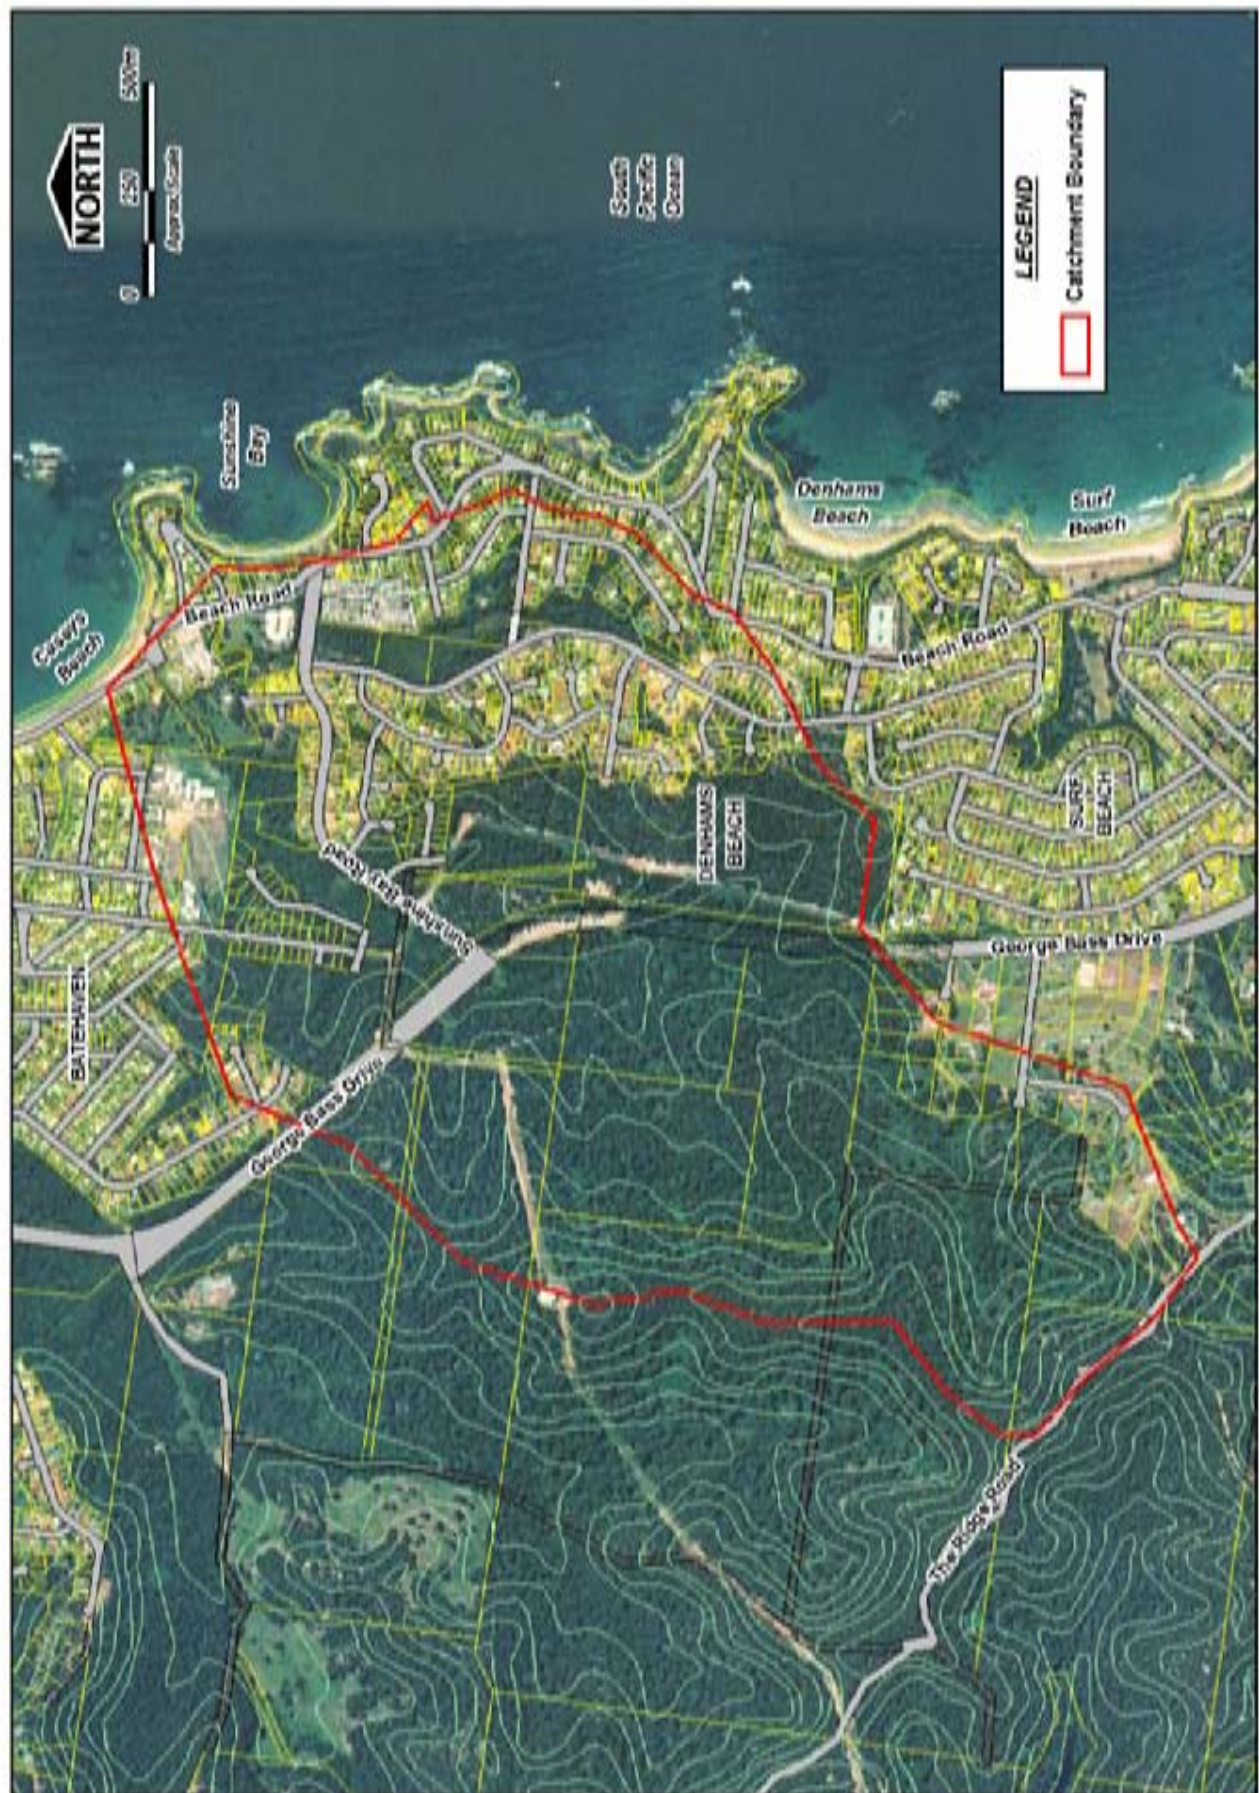
Figure 2-4

Short Beach Creek Catchment

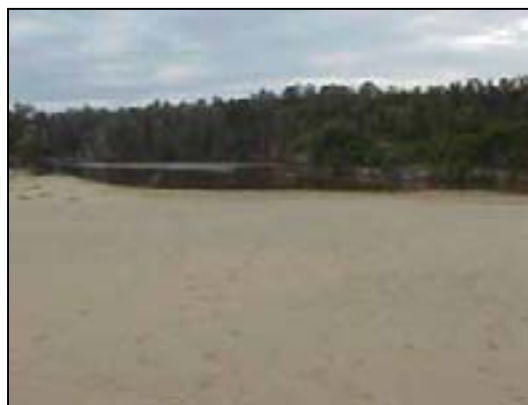
The creek discharges to Batemans Bay via Corrigan's Beach. The exit location of the Creek is on the northern end of the beach and is situated between Birdland Animal Park and the Glenhaven Caravan Park. The entrance area itself is characterised by an expanse of unvegetated sand. At the time of inspection (7 April 2003) the creek entrance was shoaled as shown in Figure 2-5.

Figure 2-5 Entrance/exit zone of Joes Creek

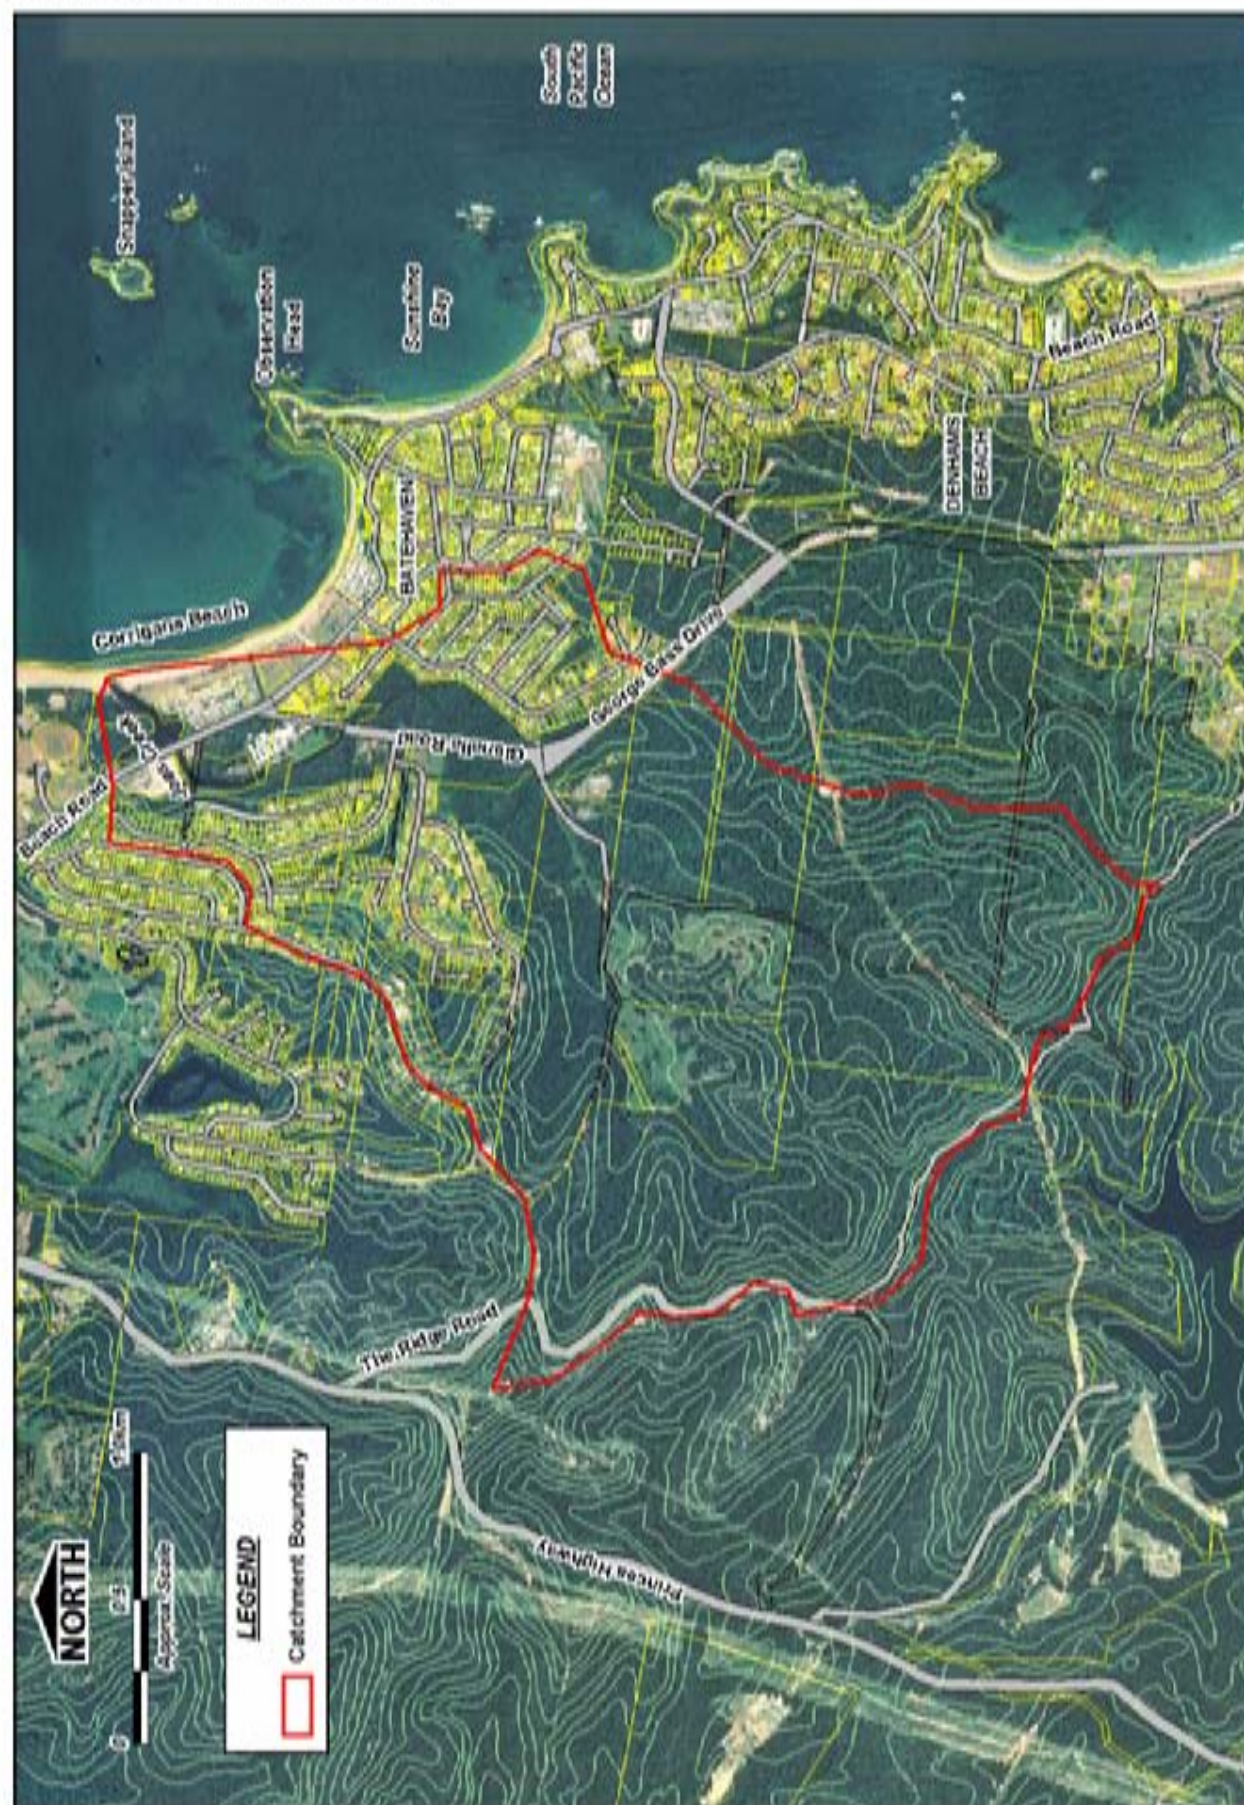
Figure 2-6

Joes Creek Catchment

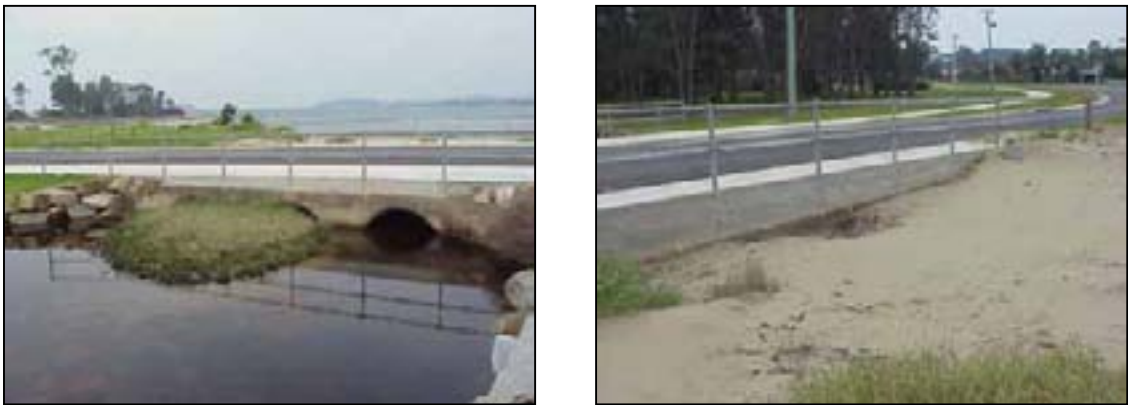
The creek exits to Batemans Bay via culverts under Wharf Road on the western end of Surfside Beach. The entrance area itself is characterised by an expanse of unvegetated sand. At the time of inspection, the creek entrance was shoaled at the culverts (7 April 2003) as shown in Figure 2-7.

Figure 2-7 Exit/entrance zone of Surfside Creek

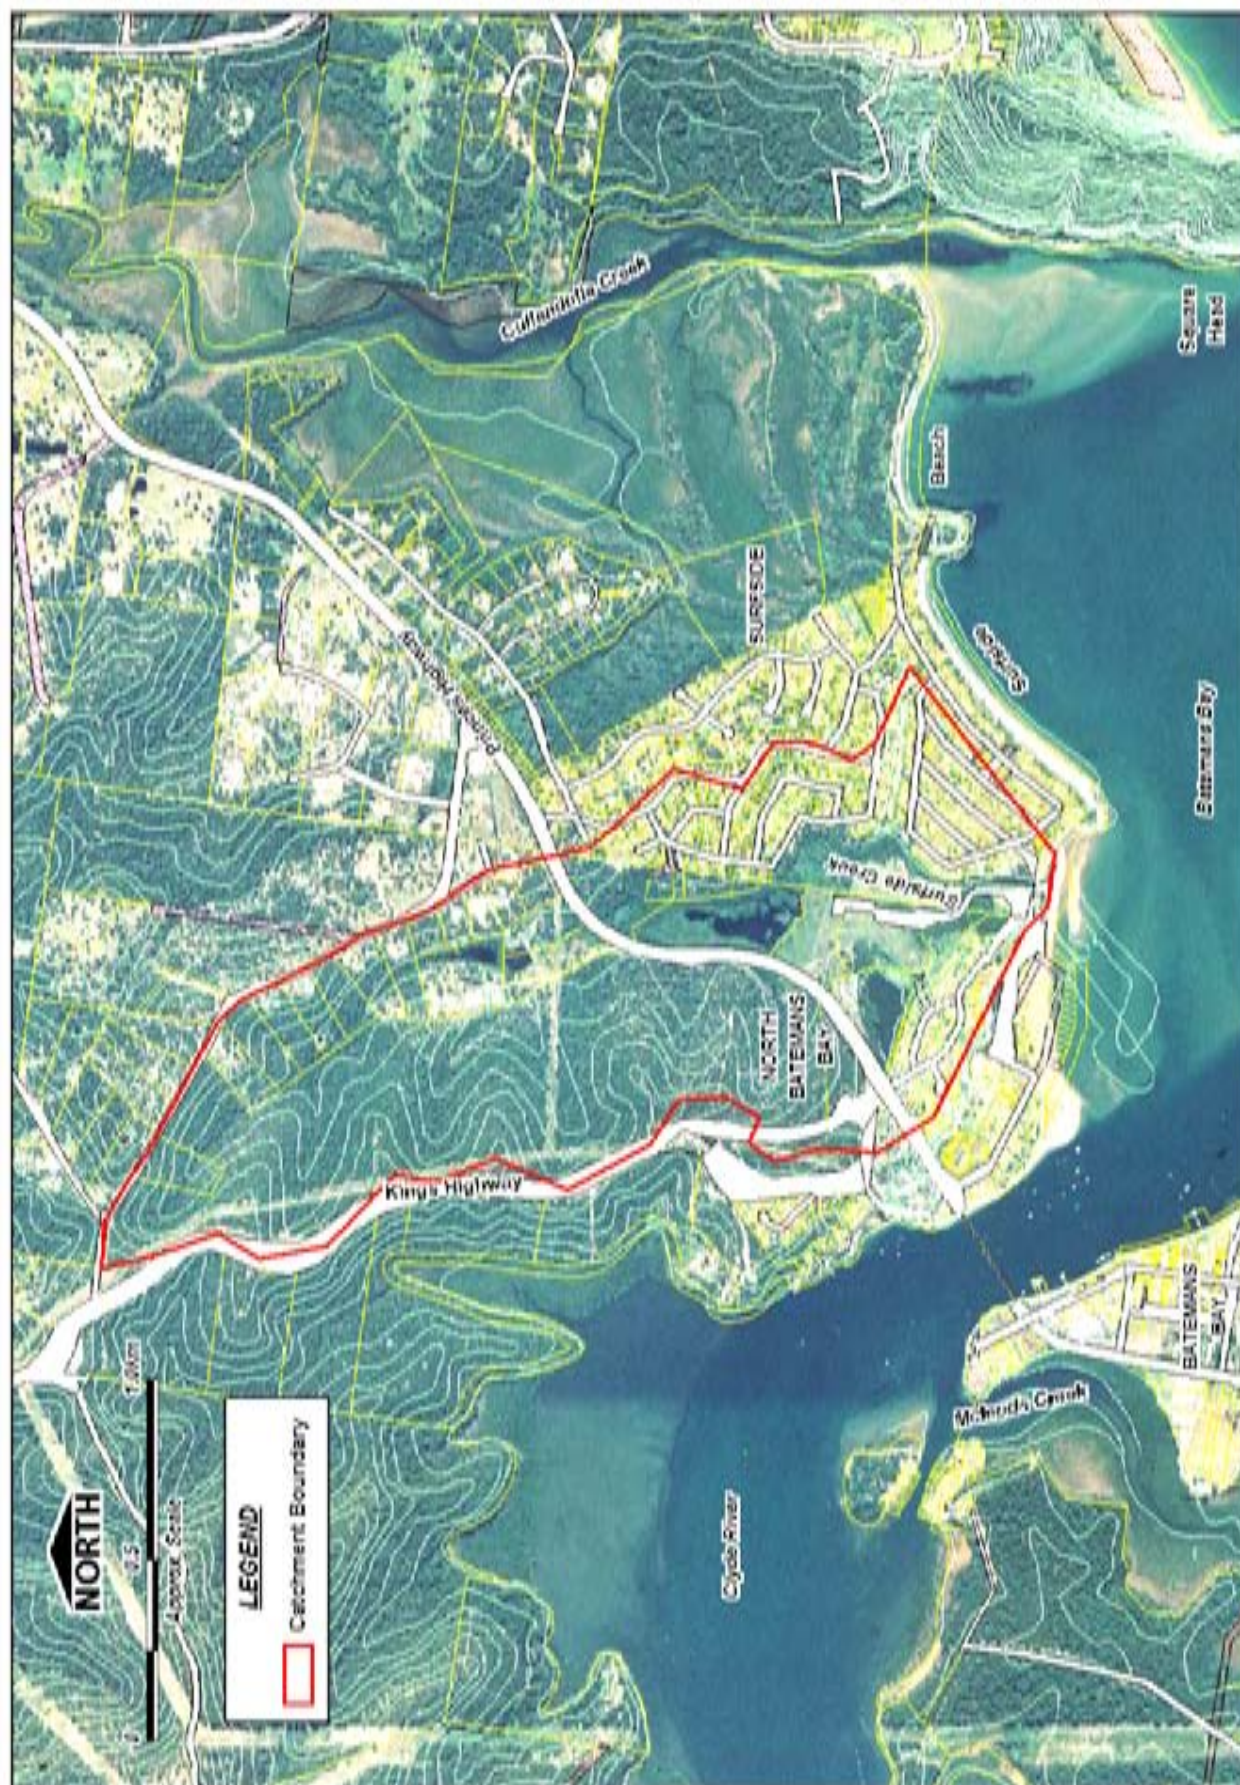
Figure 2-8

Surfside Creek Catchment

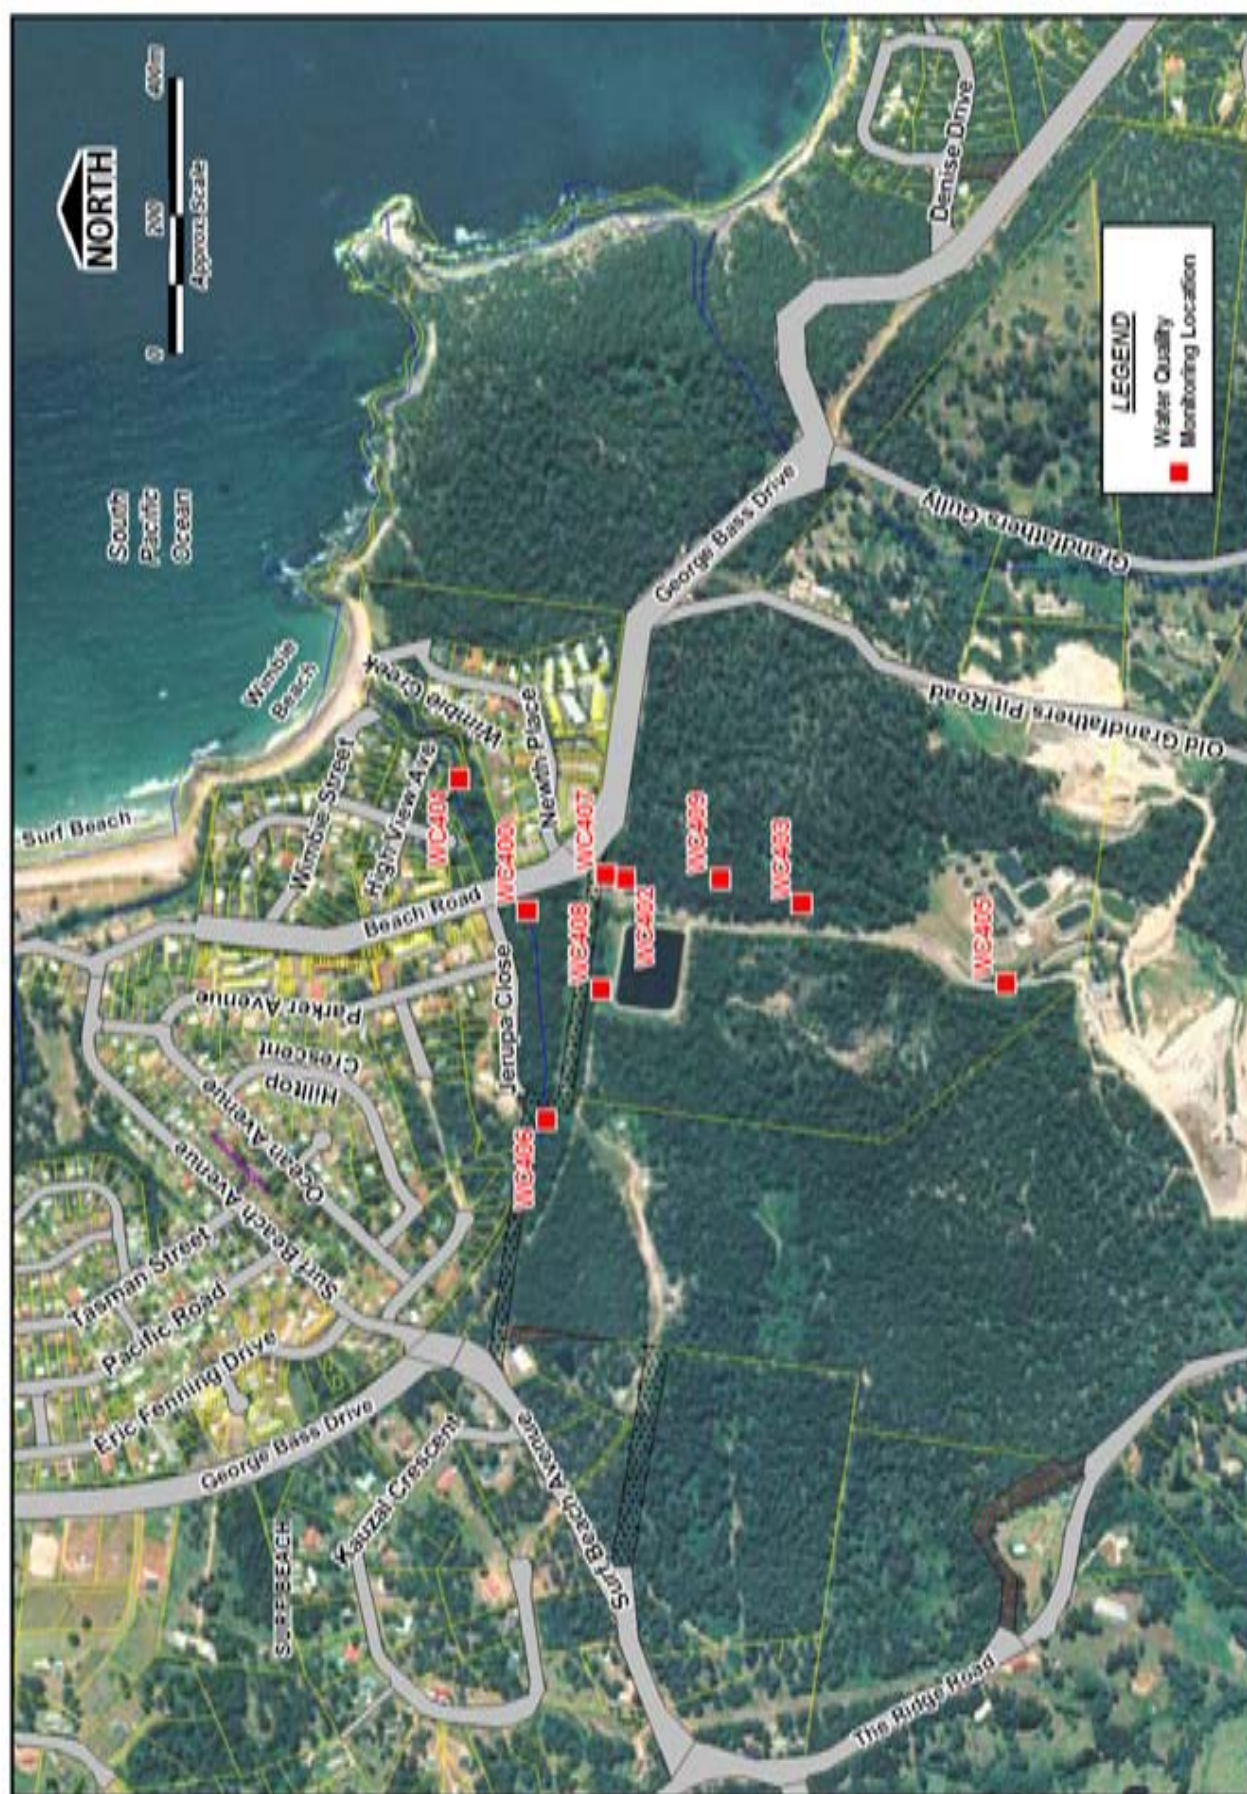
Figure 5-1

Wimbie Creek Water Quality
Monitoring Locations

Table 5-1 presents a summary of water quality data for Wimbie Creek from 1992 to 2003. Data has been included for several sampling locations, WC401, WC405, WJC406, WC407, WC408 and WJC409. The majority of the water quality data has been collected at these monitoring sites. WC401 has been sampled at several depths, i.e., 40cm, 60, 80 cm below the water surface as denoted by JC401 – 40 etc. The number of samples taken at a particular location is denoted in the “number” row. In viewing the results, it is important to keep in mind that samples have been taken over a long period of time and through a range of climatic and environmental conditions and can at best be interpreted as a series of snapshots of water quality in Wimbie Creek. Also for a number of the sites, the number of samples taken is very low, i.e. only 1 or 2 samples taken over the past ten years. Low sampling numbers do not allow a high degree of statistical certainty to be drawn from the results.

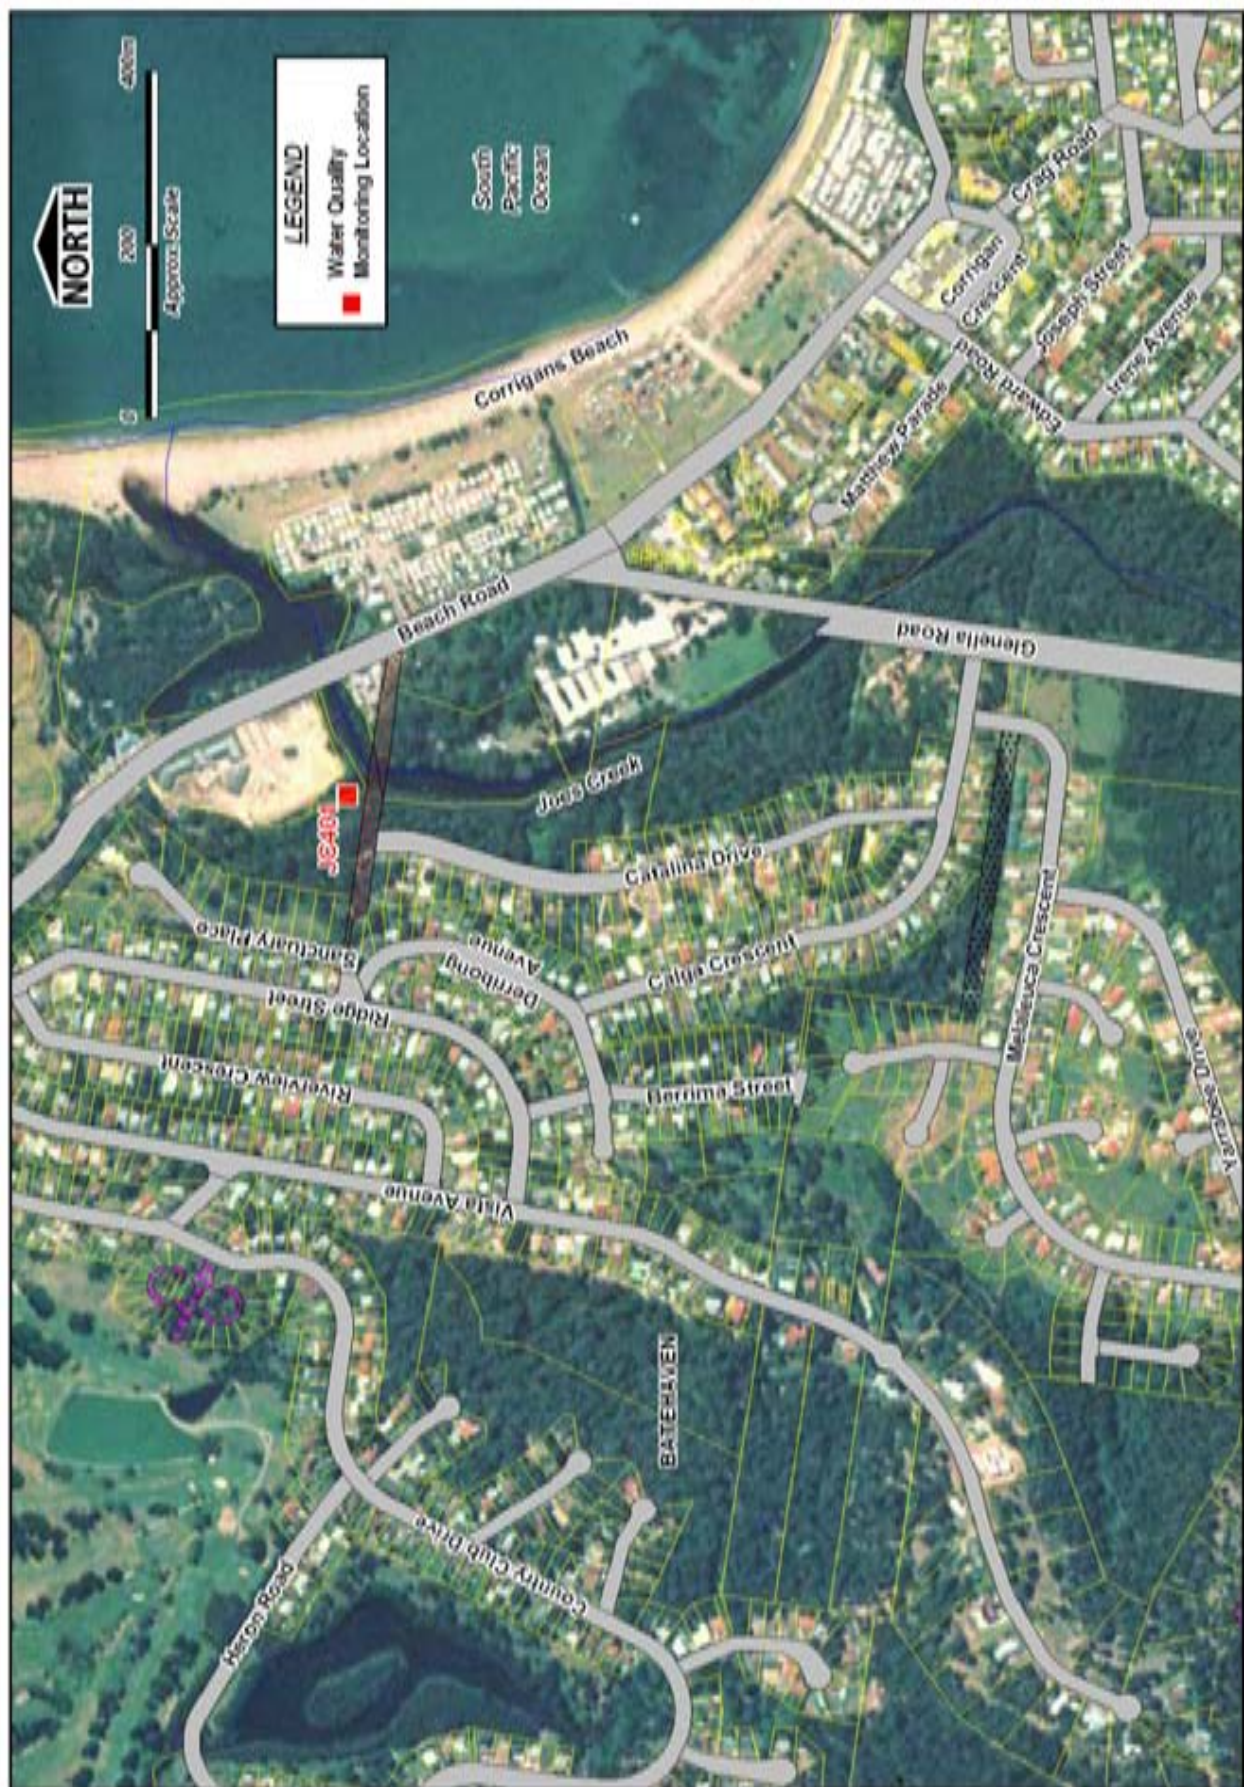
Figure 5-2

Joes Creek Water Quality
Monitoring Locations

Table 5-2 presents a summary of water quality data from Joes Creek from 1992 to 2003. Data has been included for the three sampling locations, JC401, JC402 and JC403. JC401 has been sampled at several depths, i.e., 40cm, 60, 80, 100, 120 and 140 cm below the water surface as denoted by JC401 – 40 etc. The number of samples taken at a particular location is denoted in the “number” row. In viewing the results it is important to keep in mind that samples have been taken over a long period of time over a range of climatic and environmental conditions and can at best be interpreted as snapshots of water quality in Joes Creek. Also for a number of the sites, the number of samples taken is very low, i.e. only 1 or 2 samples taken over the past ten years. Low sampling numbers do not allow for a high degree of statistical certainty to be drawn from the results.

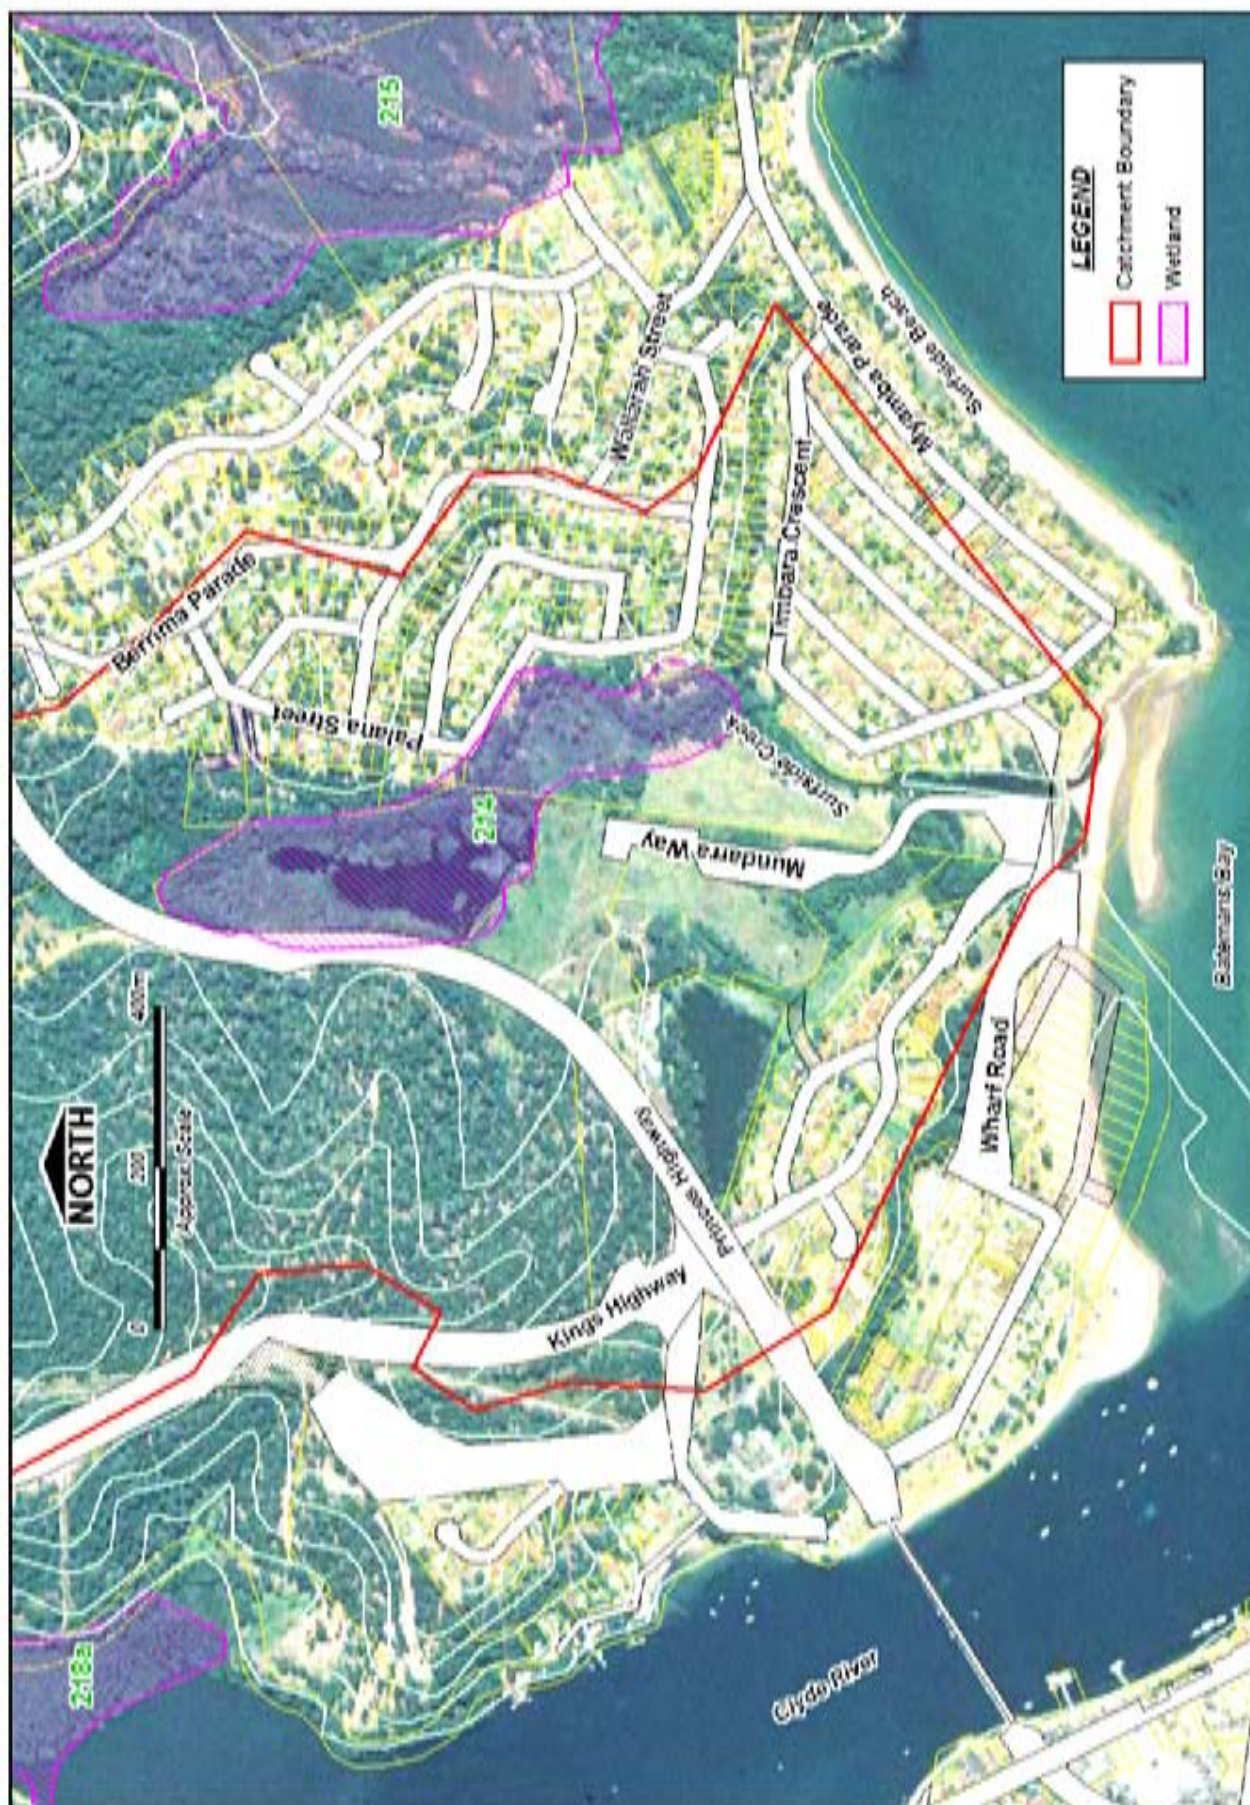
Figure 7-1

Wetland No. 214

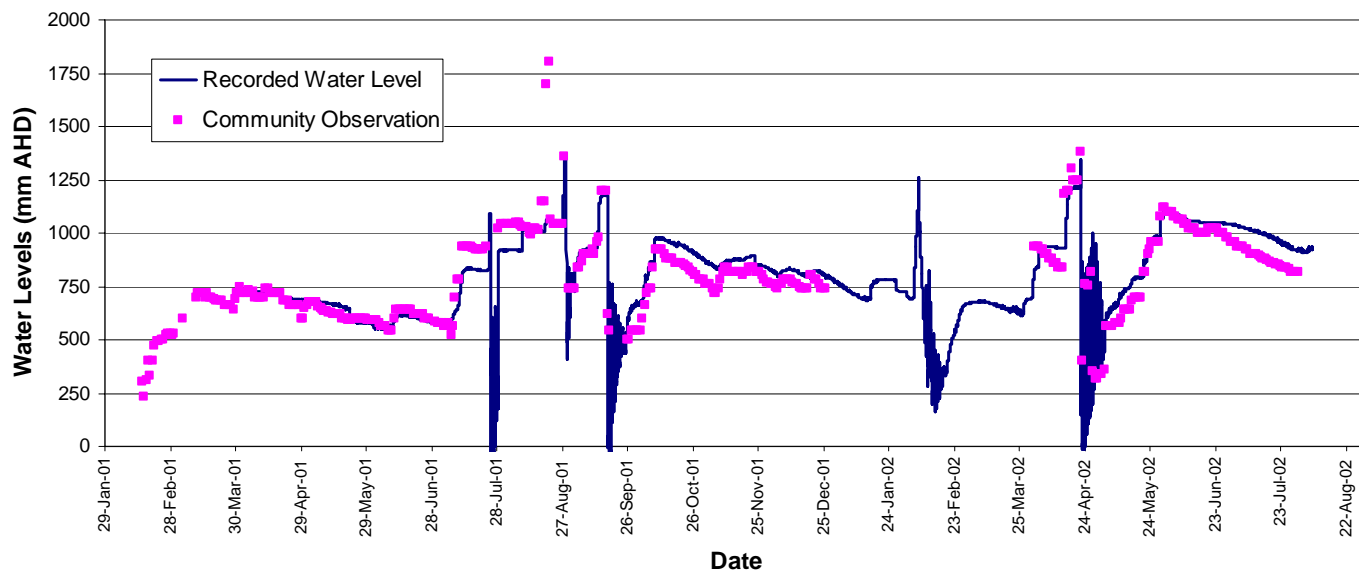
Joes Creek Water Levels
