# **Coastal Zone Management Plan for the Tomaga River Estuary**

December 2014

**PROJECT 14-017 – CZMP FOR TOMAGA ESTUARY**

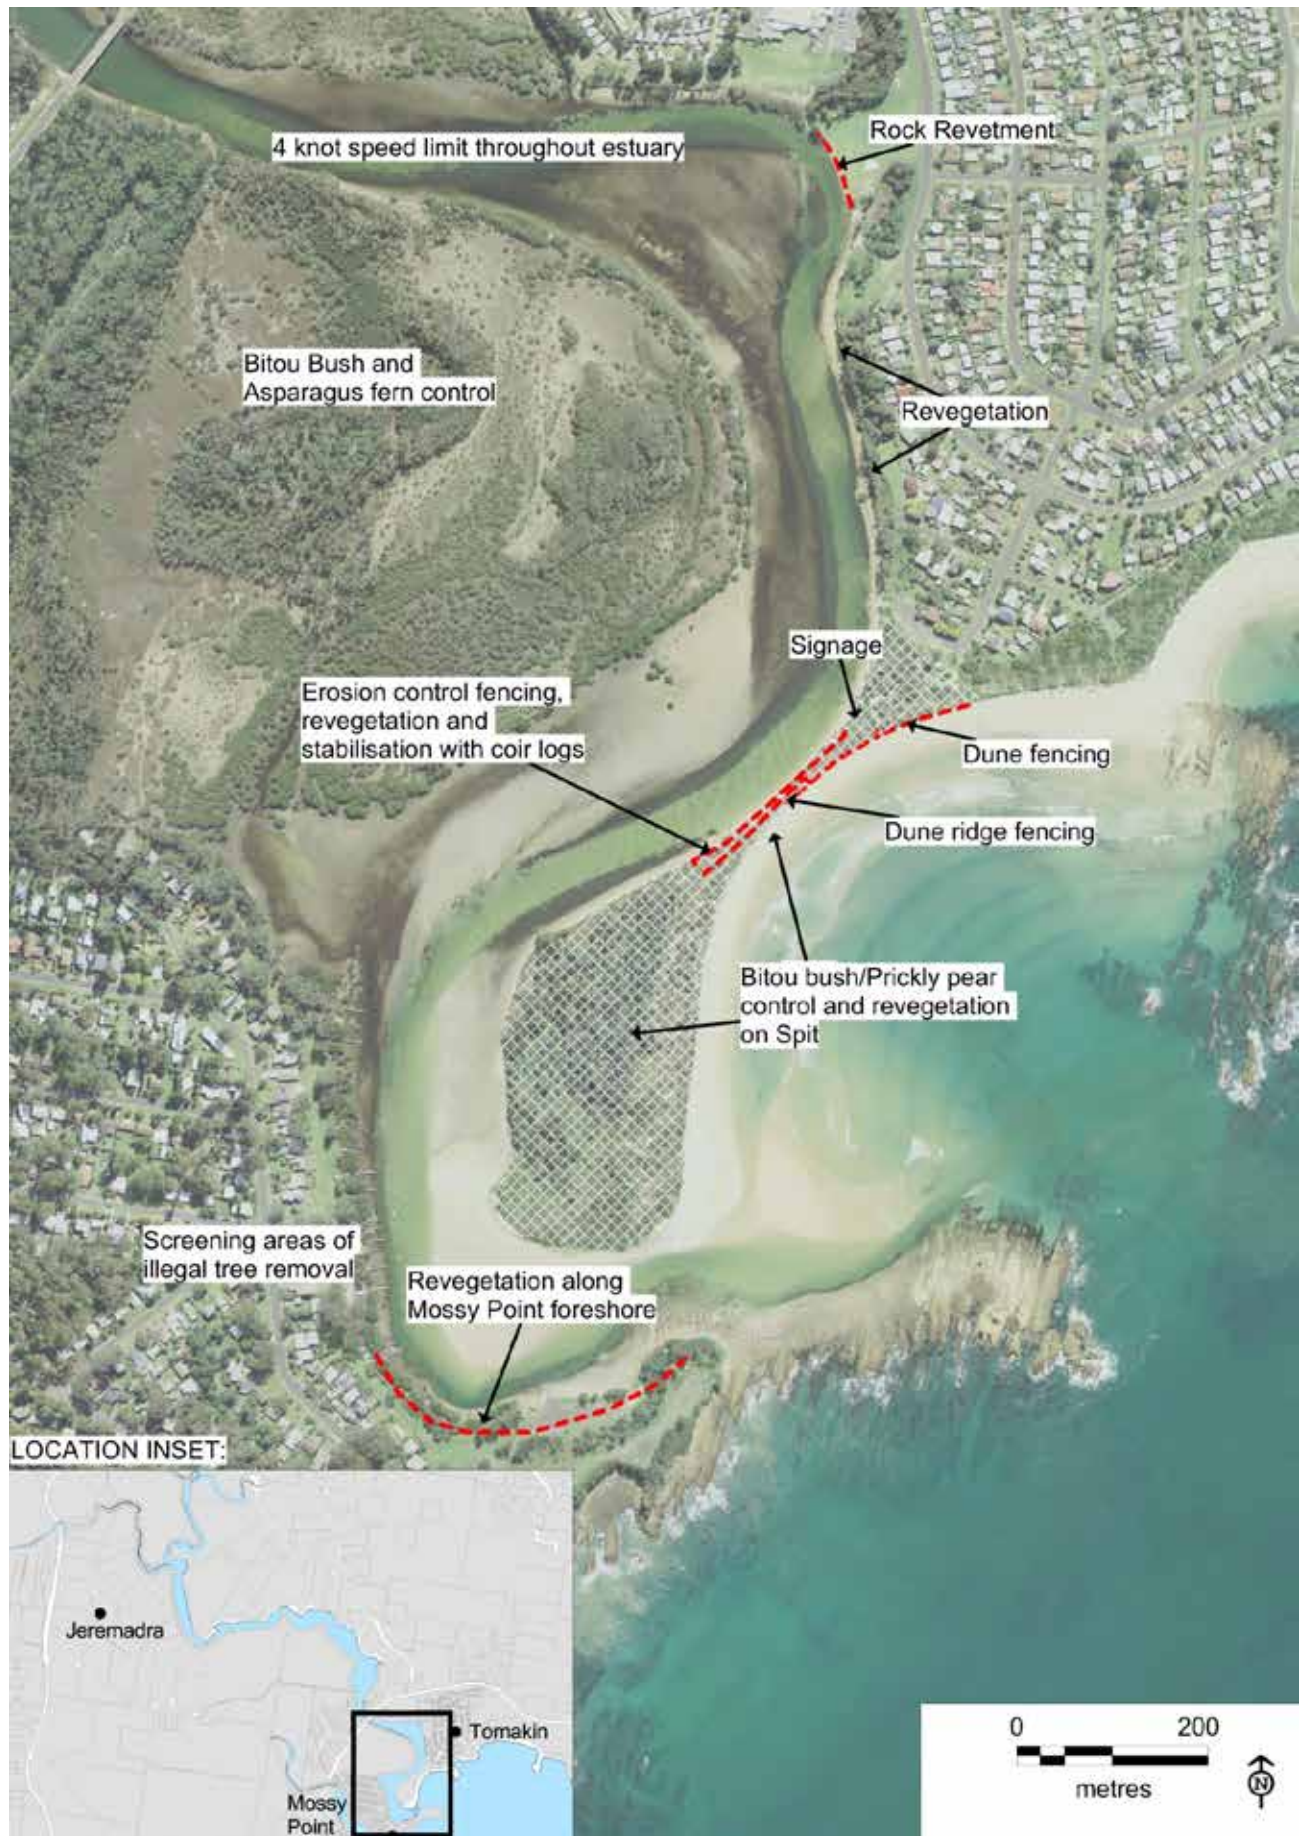
Figure 2: Locations of on-ground works implemented since 2005 – lower estuary

Further discussion is provided in Section 8 and Appendix 3. Completed on ground works are shown on Figure 2 (Lower Estuary), Figure 3 (Mid Estuary) and Figure 4 (Upper Estuary).

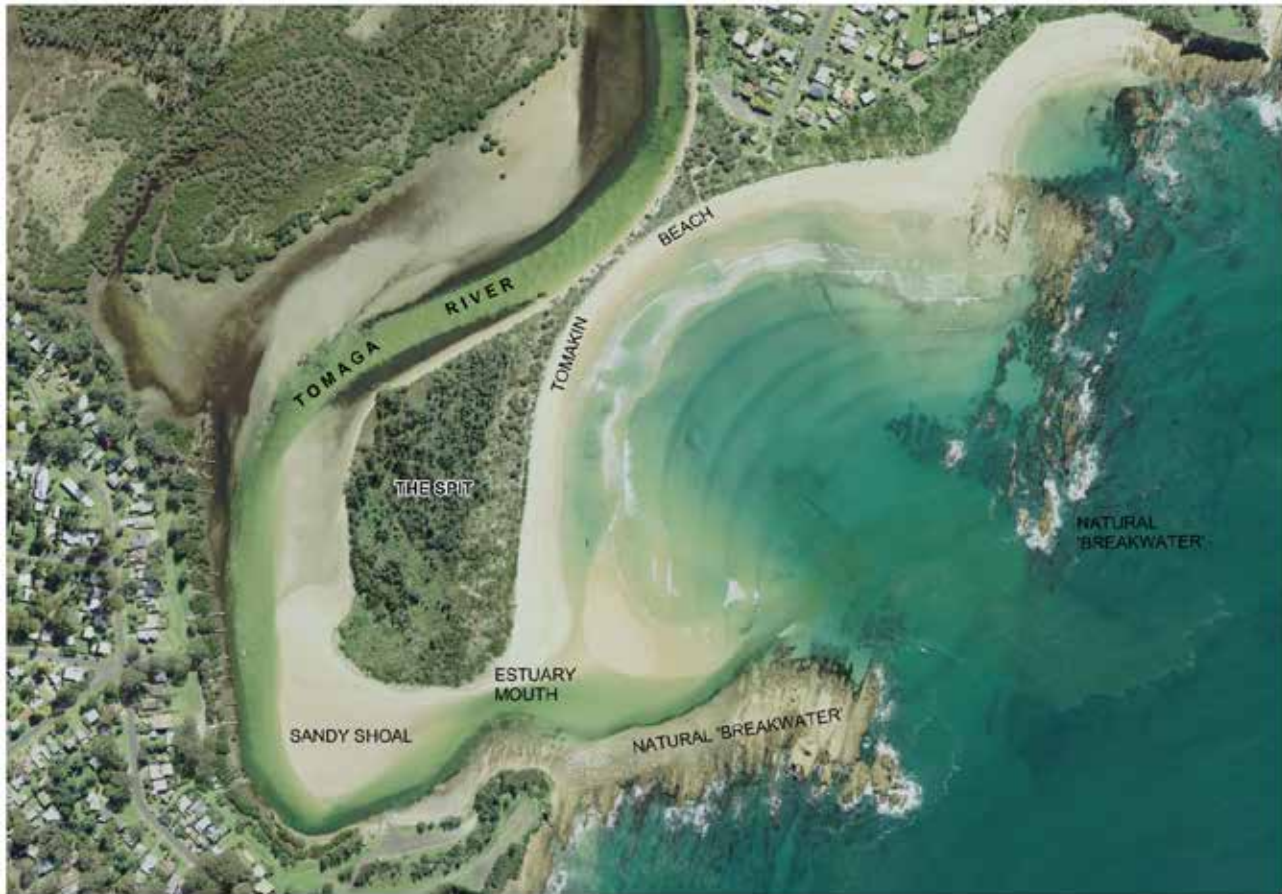
Coastal sediments are carried into the estuary by the incoming tide during normal flow conditions. During floods, the much stronger outgoing currents reverse the process, picking up sediment and moving it out of the estuary. The configuration of sandbanks around the mouth (Figure 6) is the result of river flow (and hence rainfall), wind and tidal patterns. The shoal at the southern end of the spit changes shape and location under the action of storm waves and currents flowing out of the Tomaga River. Consequently sandbanks near the entrance are continually changing (Amog, 2003). At times, this results in navigational problems in this area.

**Figure 5: Current location of Tomaga River Estuary mouth**

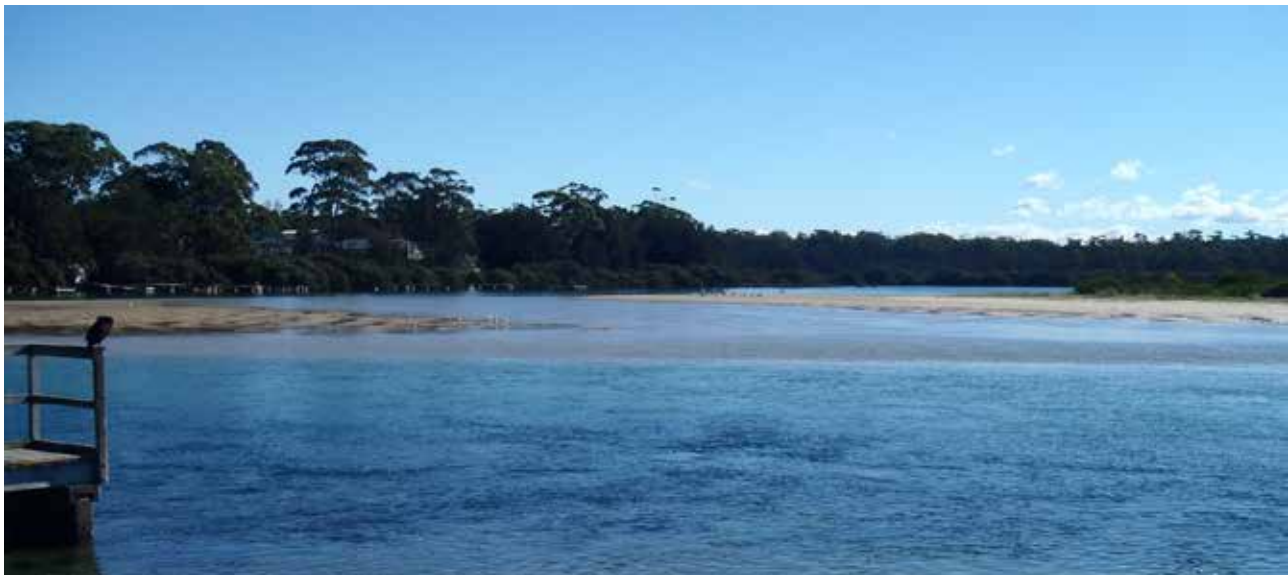
**Figure 6: Lower estuary sand shoals**

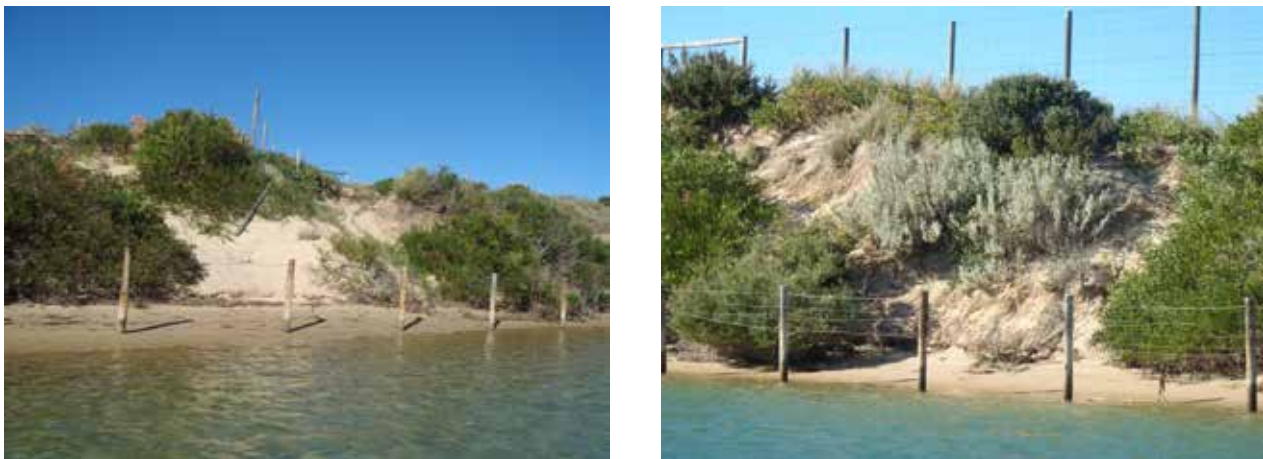
The sand spit adjacent to the entrance has experienced erosion from both the ocean side and the river side (Figure 11). The extent of historical erosion has resulted in a risk that extreme flooding and/or wave erosion may cause a breach in the spit, redirecting the entrance and isolating the present entrance near Mossy Point. A sketch map by a surveyor in 1828 shows the Tomaga inlet to the north with a sand spit extending to the rocks at Mossy Point.

**Figure 11: Erosion of the spit (river side), fencing at base of dune and along ridge (May 2014)**

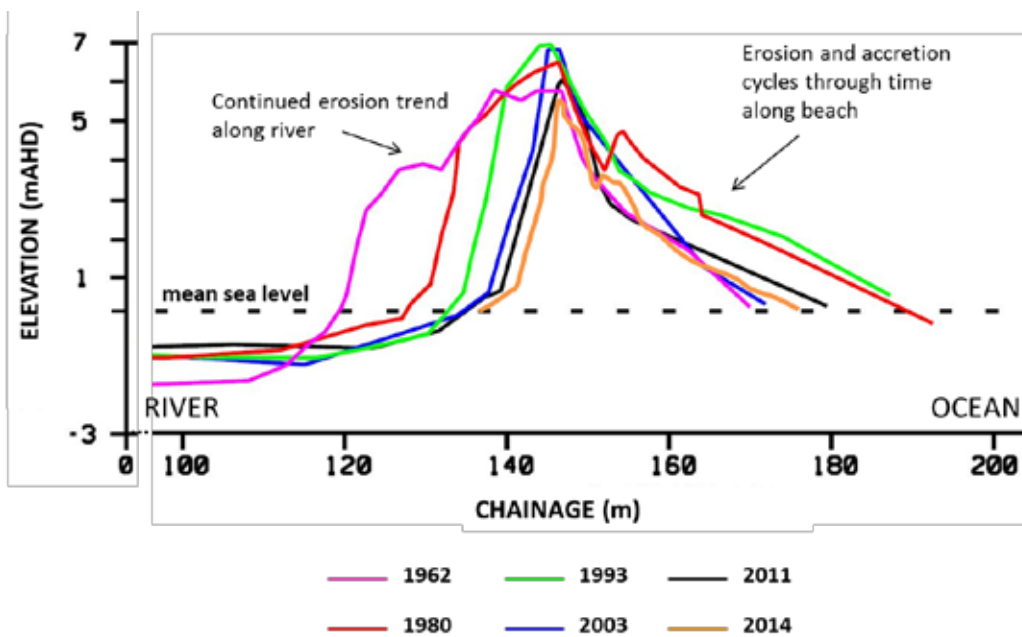
It is clear that the spit is eroding along the river side and this trend has continued throughout all years of analysis. This erosion trend is evident at the narrowest point shown in Figure 13, and across all the OEH profiles, although the effect is less pronounced at the most northern profiles (9 and 10) and the southern profiles (1, 2, 3 and 4) away from the main bend in the river (refer Appendix 6). In the 49 years between 1962 and 2011, the spit had eroded by approximately 20 m along the river side at the narrowest point. This distance increased by approximately another 3 m between 2011 and 2014, equating to an erosion rate of approximately 1 m/year. This was the same rate reported in the EPS for the years 1993 - 2003.

**Figure 13: Comparison of Tomakin spit morphology over time**

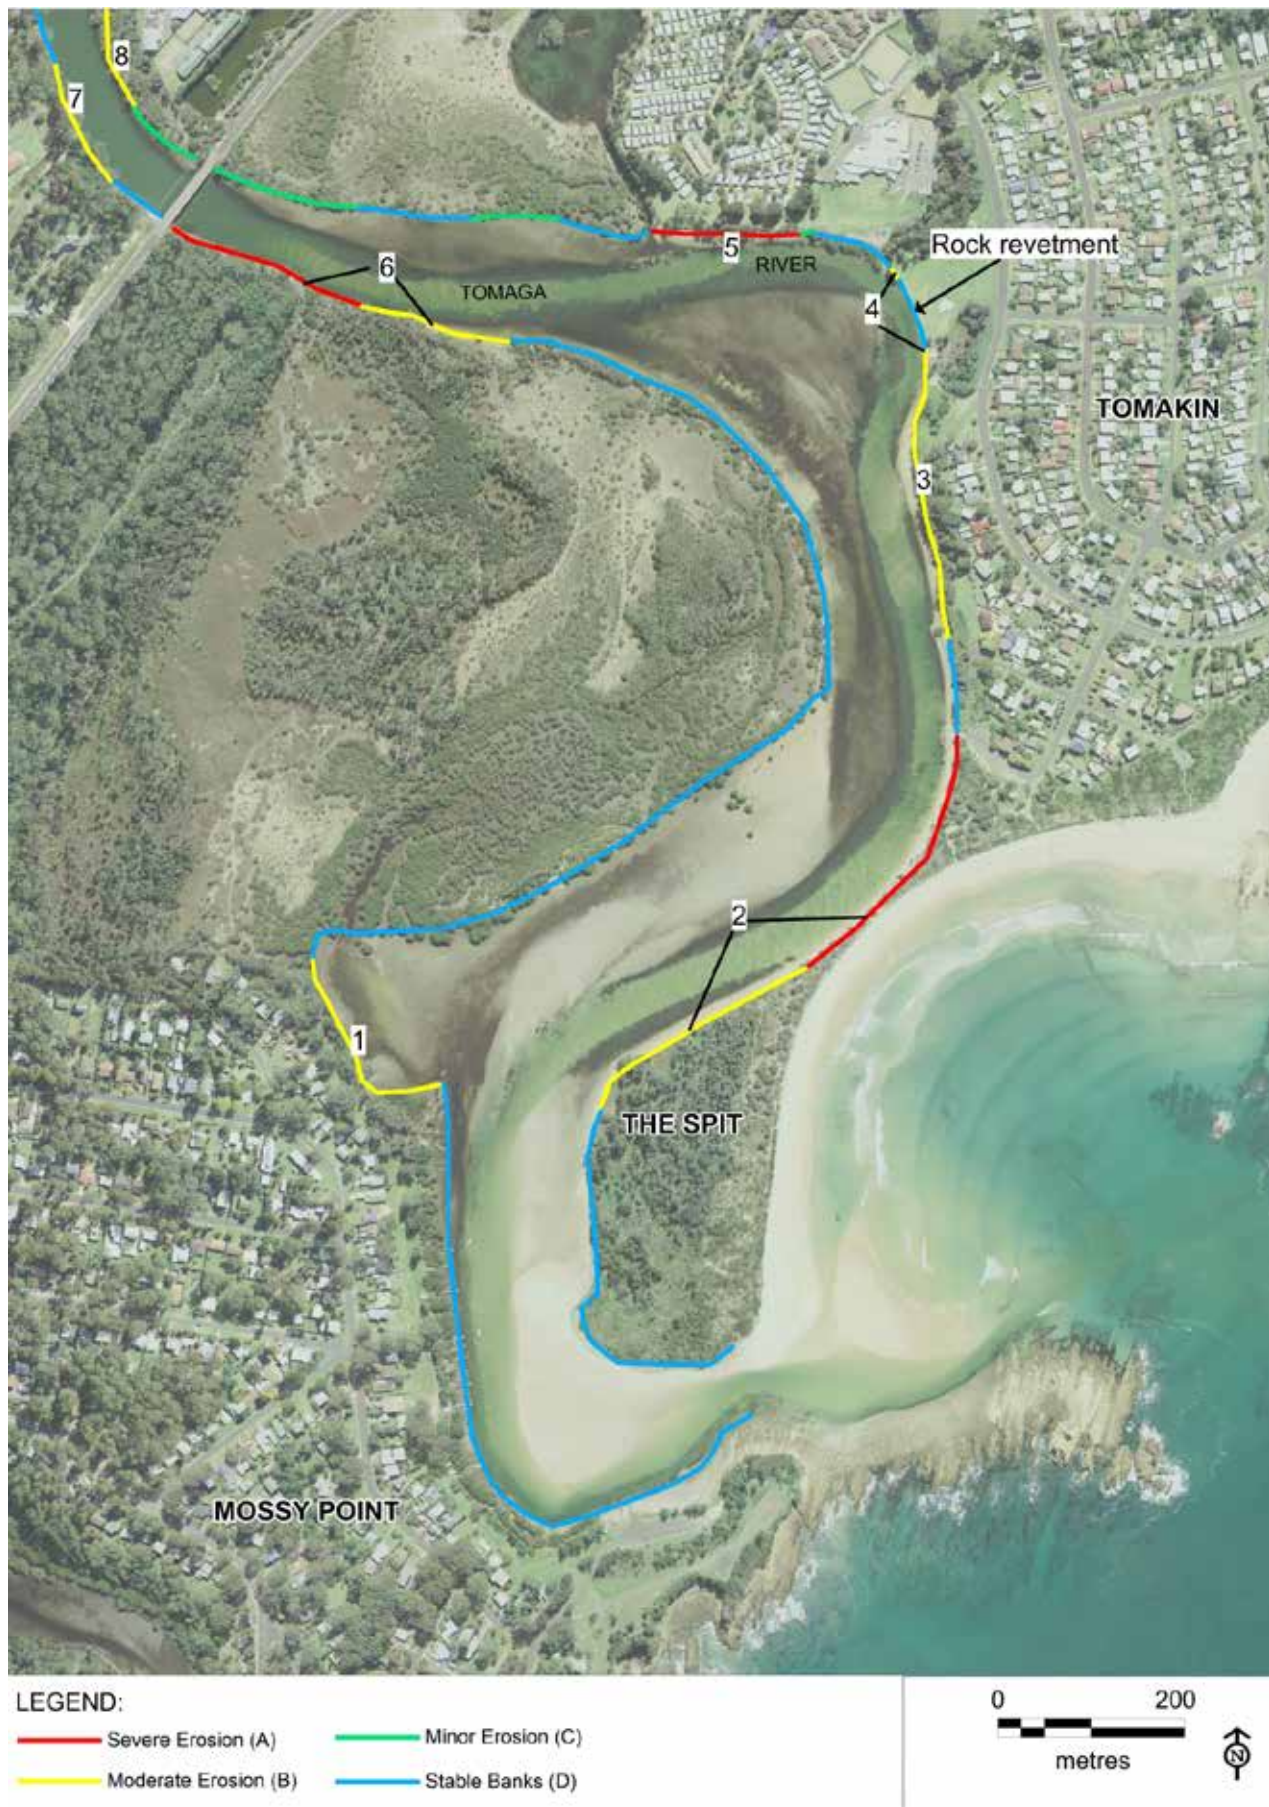
**Figure 16: Current areas of erosion lower estuary**

See Table 9 for descriptions of numbered sections.

Mod = moderate erosion, Sev = severe erosion assessed in 2014, refer Figure 16 and Figure 17 for locations.

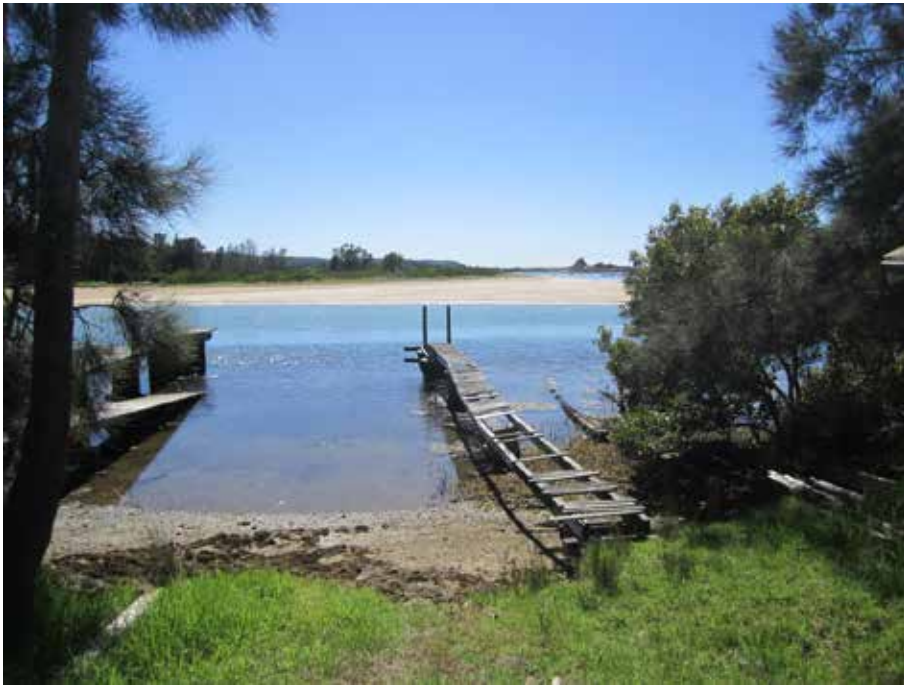
The construction of private jetties along the foreshore at Mossy Point has resulted in clearing of mangroves as shown in Figure 19. In addition, access tracks through mangroves have been established in this area.

**Figure 19: Clearing of mangroves and understorey at Mossy Point**

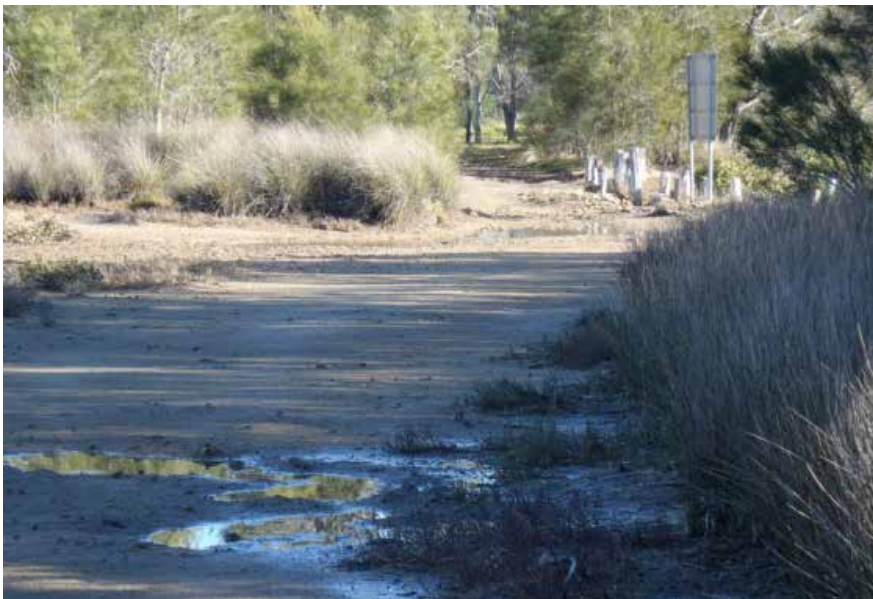
- Damage to Coastal Saltmarsh EEC caused by horse riding and motorbikes, in the mid-estuary upstream of George Bass Drive bridge. Figure 20 shows a section of the wide track devoid of vegetation through the saltmarsh. The track extends over a distance of approximately 1.4 km. The land is zoned E2 (Environmental Conservation) and is mapped as Coastal Saltmarsh EEC by ESC under the Eurobodalla LEP (2012). Estuarine vegetation mapping by Fisheries NSW does not include the track as part of saltmarsh mapping. Land ownership is split between Crown Land and private ownership. Changes due to sea level rise mean that saltmarsh migrating upslope will be further curtailed by the continued use of these tracks (refer Section 6.5.3);

**Figure 20: Track through Coastal Saltmarsh EEC, mid-estuary upstream of George Bass Drive Bridge**

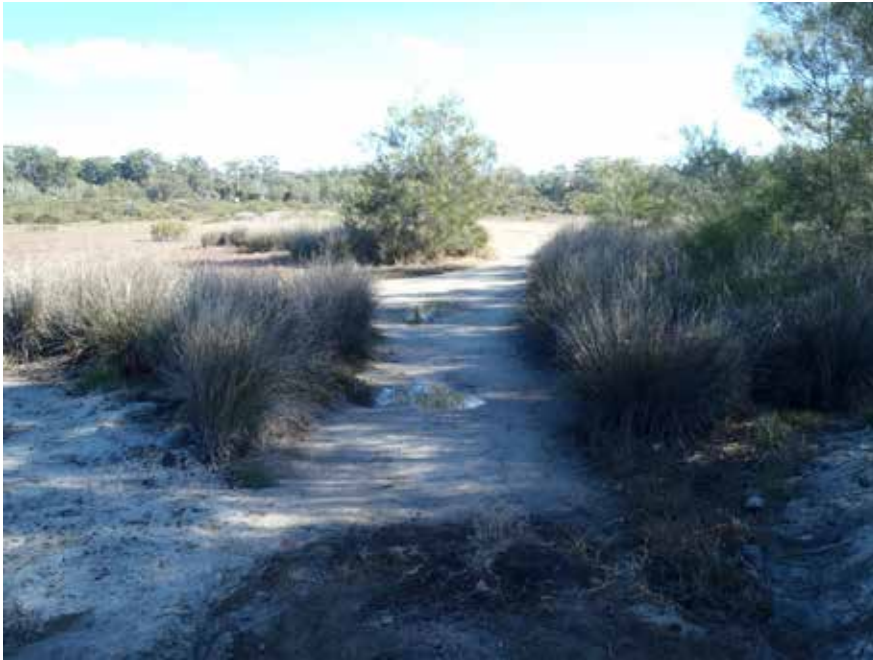
- Damage to saltmarsh caused by illegal clearing north-west of the Tomakin Caravan Park and pedestrian access between the caravan park and the IGA supermarket (Figure 22). Due to safety issues with road crossing in this area, Council has provided alternative pedestrian access to the shopping centre consistent with approved safety standards. Therefore pedestrian access along this route through the saltmarsh is not required; and

**Figure 22: Track through Coastal Saltmarsh EEC, lower estuary upstream of Tomakin Caravan Park**

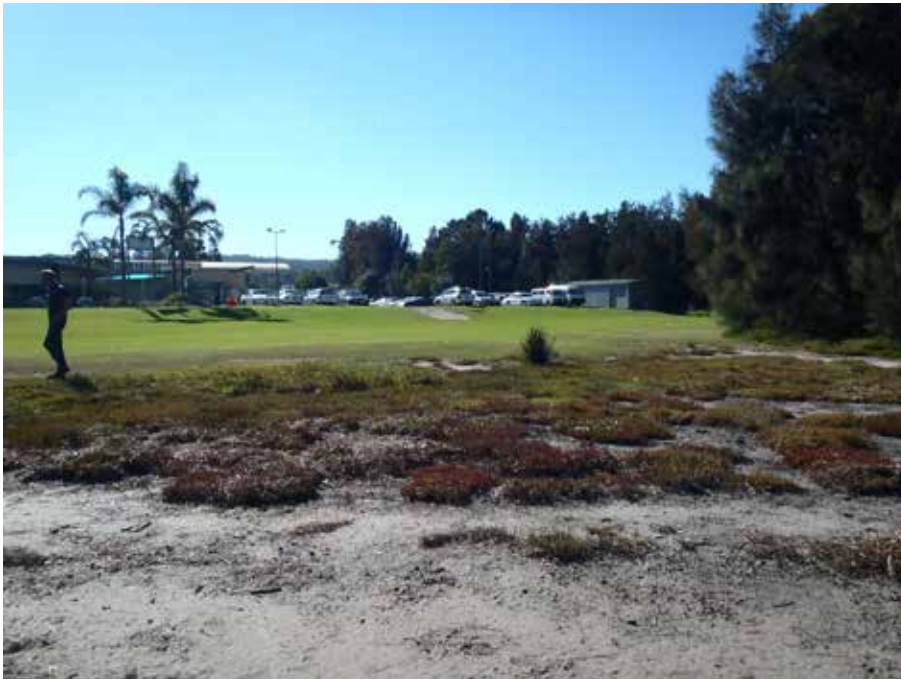
- The area in between the Tomakin Club and the river is currently used as overflow parking for the club. The land is partly owned by Mogo LALC and includes areas of saltmarsh which is being damaged by mowing and vehicular access (Figure 23).

**Figure 23: Saltmarsh land in front of Tomakin Club used for overflow parking**

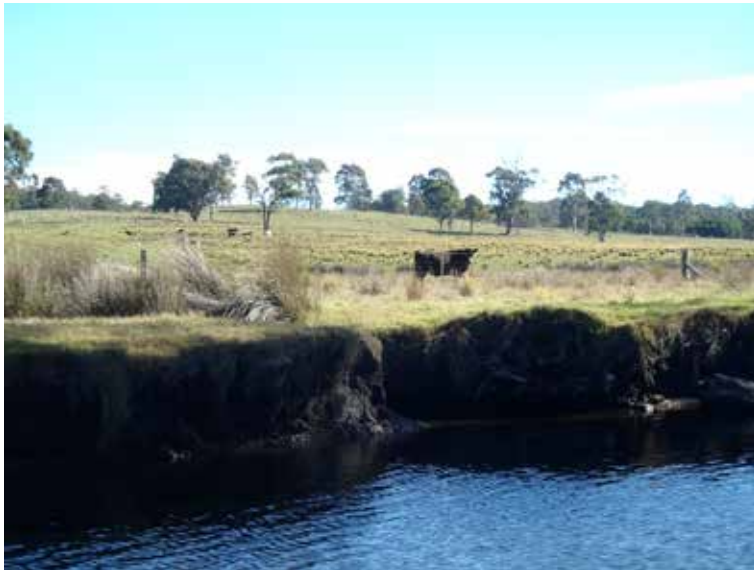
- Vegetation clearing in riparian zones;
- Bank erosion destabilising vegetation; and
- Livestock access, contributing to vegetation damage through grazing and trampling and contributing to bank erosion (Figure 29).

**Figure 29: Livestock fencing with active grazing of buffer zone (May 2104)**

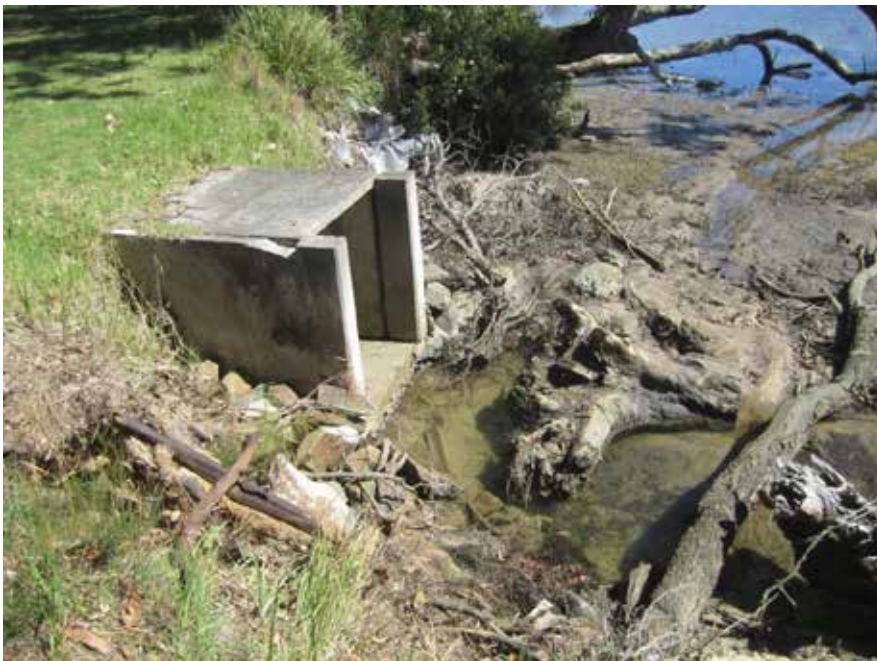
As discussed in Section 6.4.2, there are examples of scour of stormwater outlets contributing to bank erosion (e.g. site 1, Figure 39).

**Figure 39: Stormwater outlet at Mossy Point causing scour of bank**

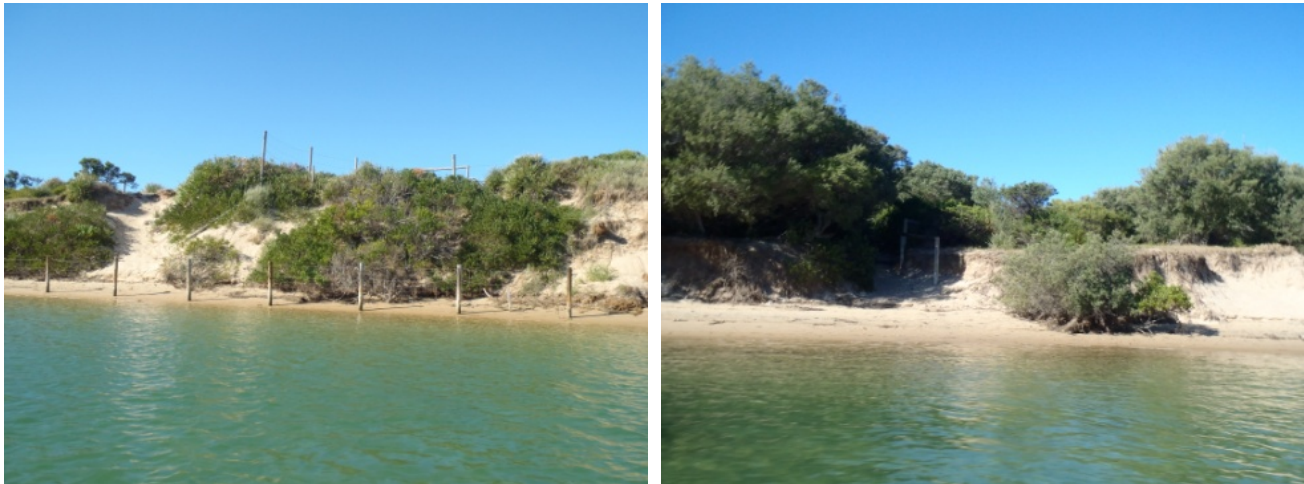
Pedestrian access to other foreshore areas is causing similar issues with vegetation damage and bank erosion.

**Figure 41: Pedestrian access and sand boarding contributing to erosion of the spit (May 2014)**

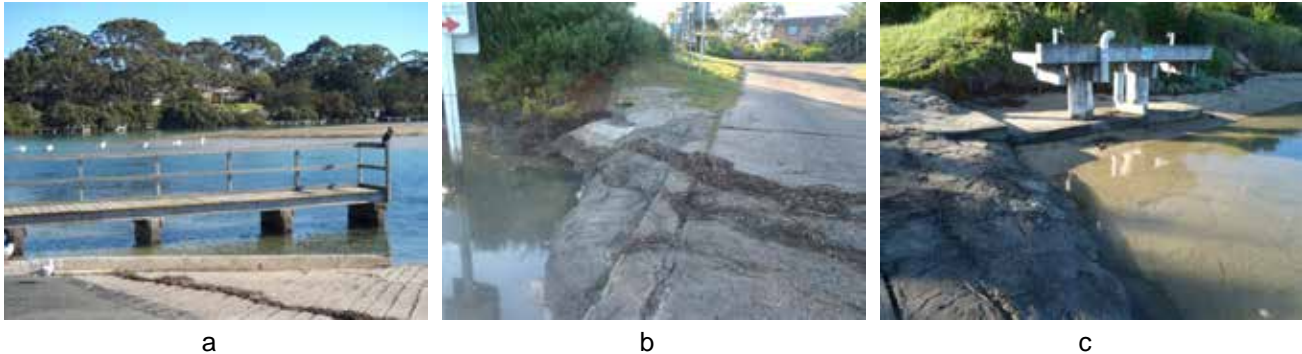
A public jetty is located at Pacific Street, Mossy Point and a boat ramp at Mossy Point provides access to the estuary and off-shore areas. The Tomakin boat ramp provides alternative access to the estuary and includes a fish cleaning table. The ESC Waterways Infrastructure Strategy (ESC, 2002a) found deficiencies in the Tomakin boat ramp and identified the need for surface and edge support improvements and remediation of hazardous gaps between the ramp surface and adjacent rocks (Figure 43). The Tomakin boat ramp and parking facilities are currently being upgraded by Council, although this has been delayed by the discovery of a suspected human bone sample in the car park. The area remains fenced off as the issue is unresolved.

**Figure 43: a: Mossy Point jetty and boat ramp and b/c: Tomakin boat ramp (May 2014)**

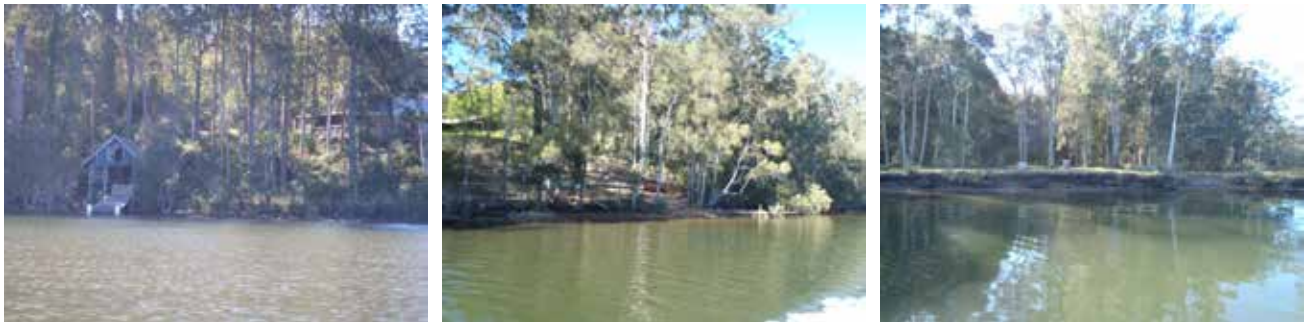
The Moorings Resort has a private ramp and wharf which is also popular with hire boats, fishing craft and canoeists. Another ramp exists at the former Goldfields caravan park. Informal launching points have also been established at various locations along the river including at Tomakin east of Jack Buckley Park (since blocked with bollards), east of the Tomakin Social Club and at Tomakin Caravan Park. These ramps are in poor condition.

**Figure 44: Private waterway access – upper estuary (May 2014)**

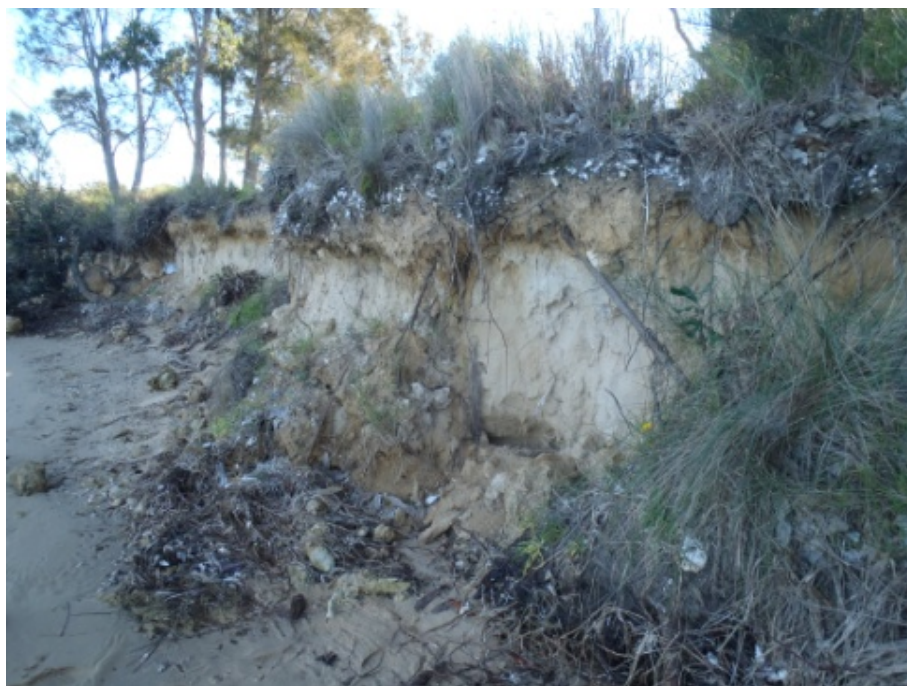
**Figure 46: Midden being damaged by erosion – Tomakin (May 2014)**

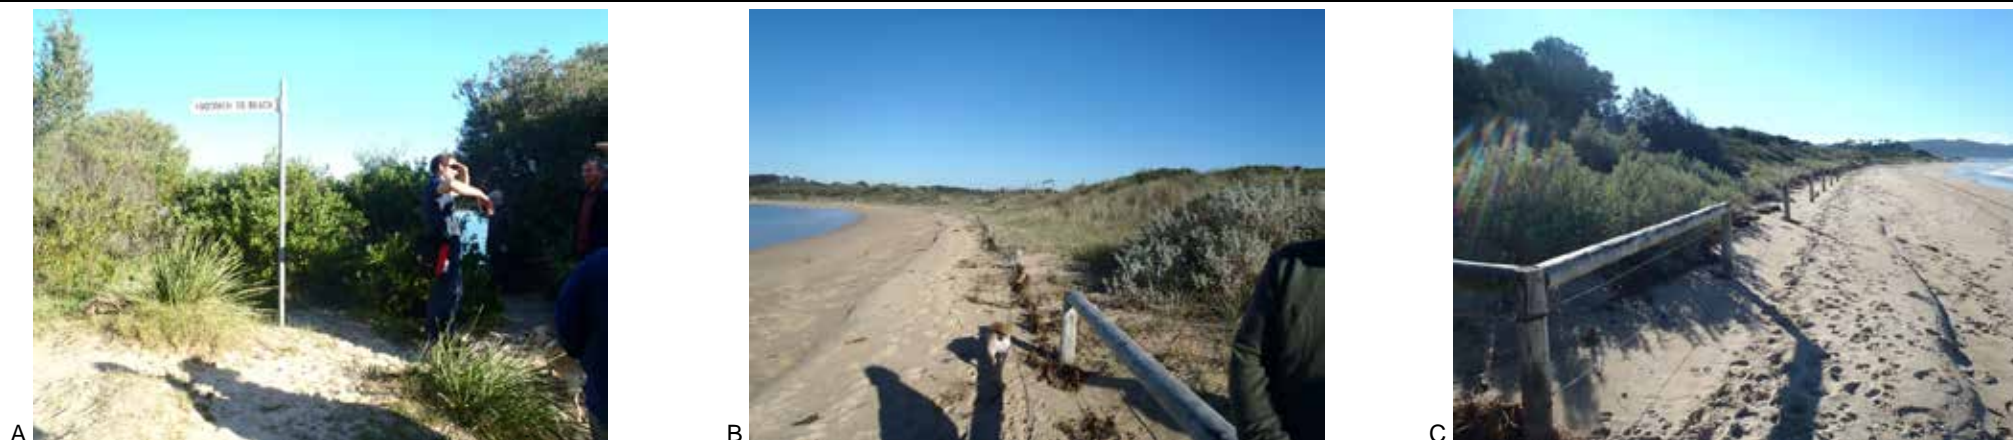
**Figure 70: A - Signage installed at Tomakin spit, B – fencing on ocean side and dune crest (looking south), C – fencing on ocean side looking north**

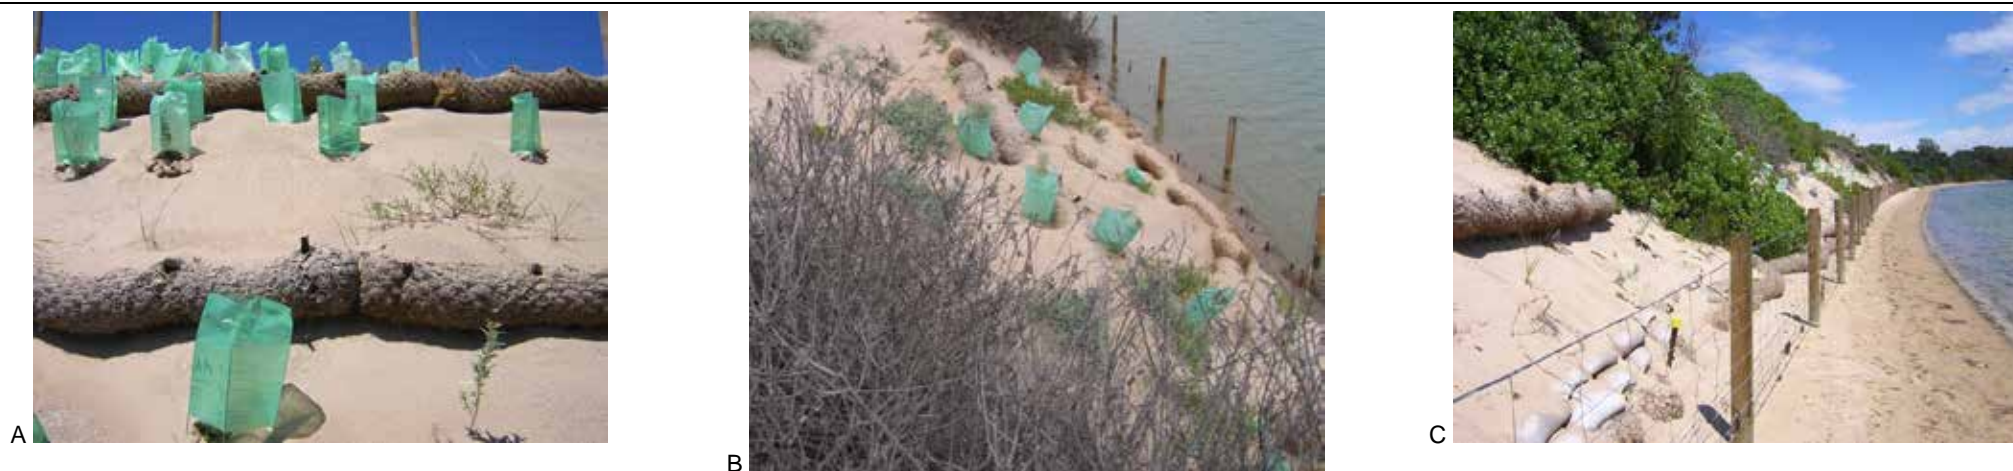
**Figure 71: Coir log terrace, original fence and revegetation at Tomakin Spit**

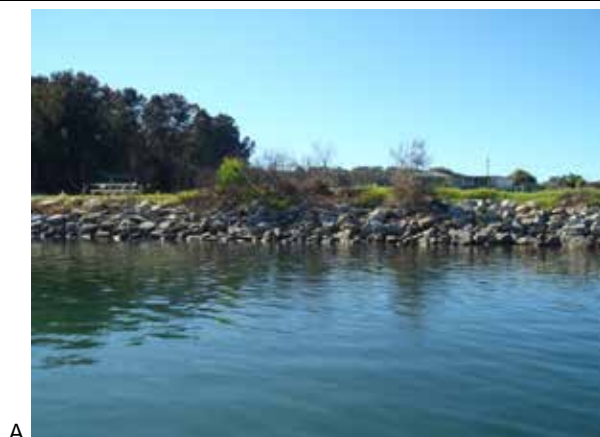
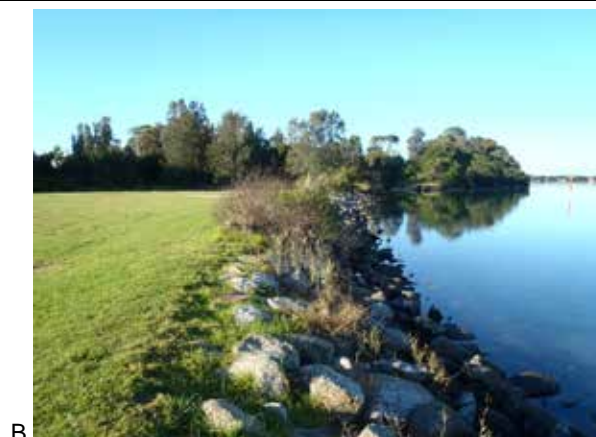
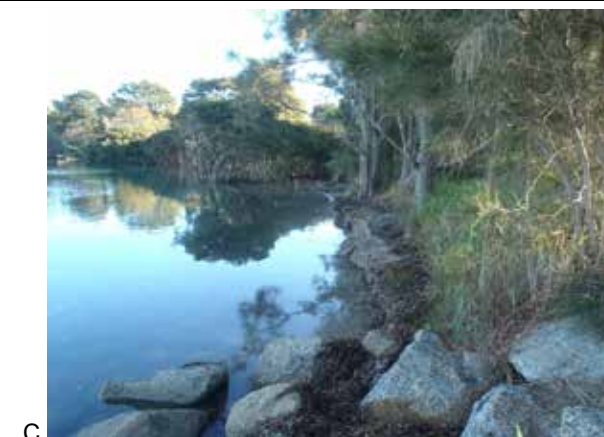
**Figure 72: A and B – Rock wall bordering Jack Buckley Park, C – upstream end of rock wall**

7.3.1	Toe protection using timber logs (Jack Buckley Park)	All	A rock wall has been installed at the Park.
7.3.2	Control runoff through trenching, infiltration bed and planting with coarse grasses etc. (Jack Buckley Park)	Trenching and infiltration bed	Detailed evaluation revealed that planting alone is the most appropriate way to address the runoff. Coarse grasses planted behind wall.
