**TUROSS ESTUARY
WATER QUALITY IMPROVEMENT PLAN
MARCH 2016**

Document title: TUROSS ESTUARY WATER QUALITY IMPROVEMENT PLAN

Prepared by: Southeast Engineering & Environment

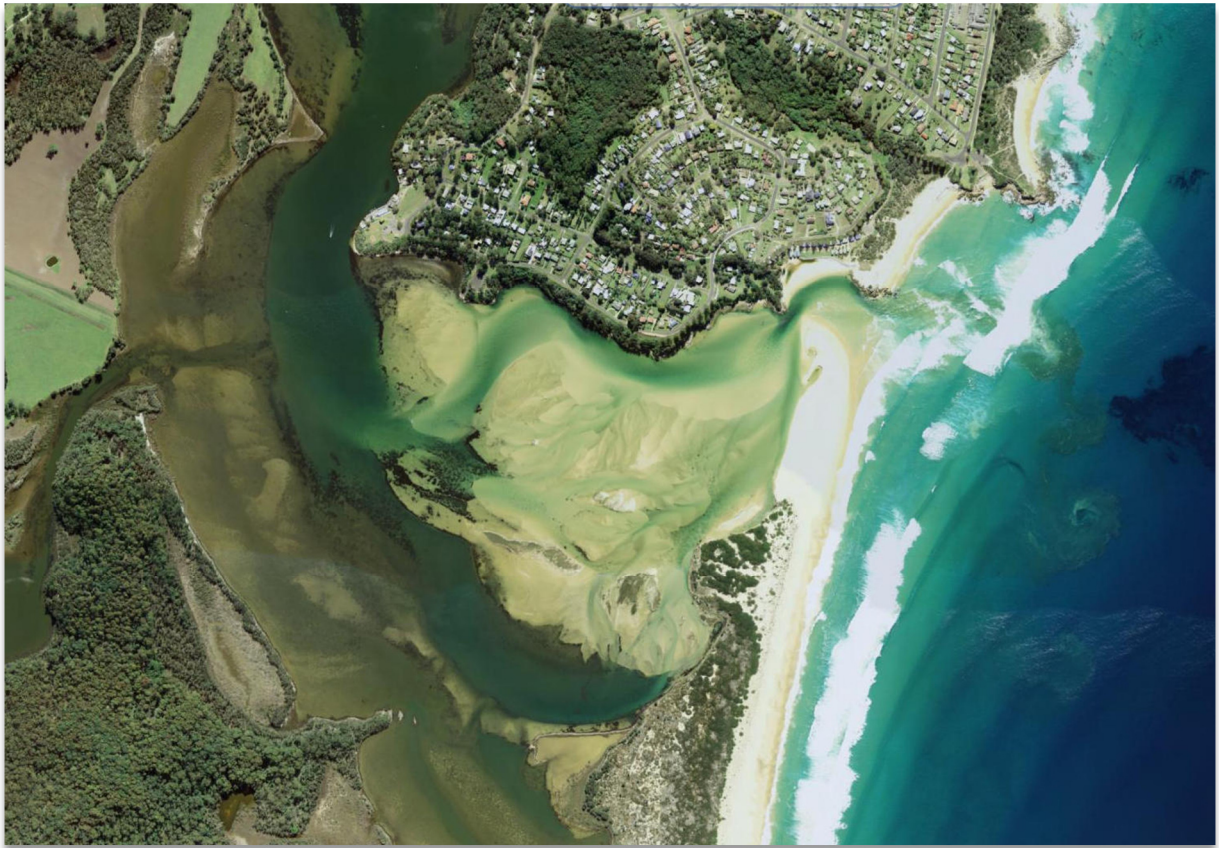
Figure 2.1 Tuross Estuary ocean entrance (SIX Viewer Feb 2016)

The estuary environment has evolved over thousands of years as a result of interactions between ocean and catchment processes. The ocean entrance allows clean ocean water to be introduced into the lower estuary on incoming tides. Volumes of ocean water, and hence tidal flushing, are dependent on the entrance condition. The tidal range in the lake can vary between a metre and 0.1 metres depending on the condition of the entrance bar. During an unusually extended dry period with low freshwater inflows, the bar has been known to close completely.

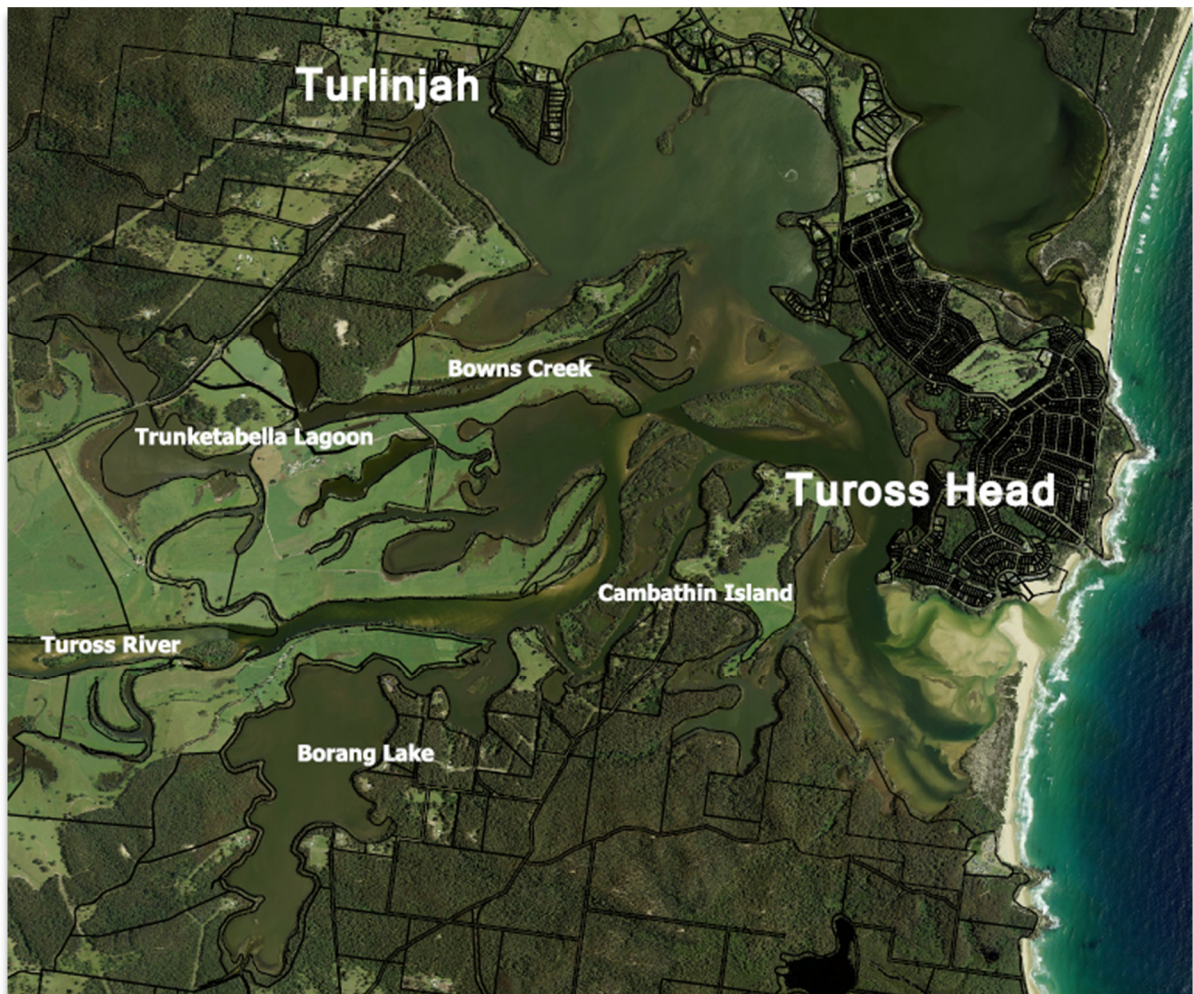
Figure 2.2 Tuross Estuary with backwater lakes

One unique attribute of this estuary is a number of backwater lakes such as Trunketabella Lagoon, Borang Lake and Bumbo Lake which have poor tidal flushing due to their restricted connection to the main lake body (Brown and Root 2001). These vulnerable water bodies are thought to be functioning independent of the remainder of the estuary. They routinely display signs of elevated nutrients concentrations and algal blooms in warmer months. Their water quality is determined by internal chemical processes that self-sustain them despite an elevated level of nutrients. These systems are still vulnerable to overload from catchment inputs, but their water quality has little impact on the main lake body due to low tidal exchange rates (Brown and Root 2001 and WBM Oceanics 2002).

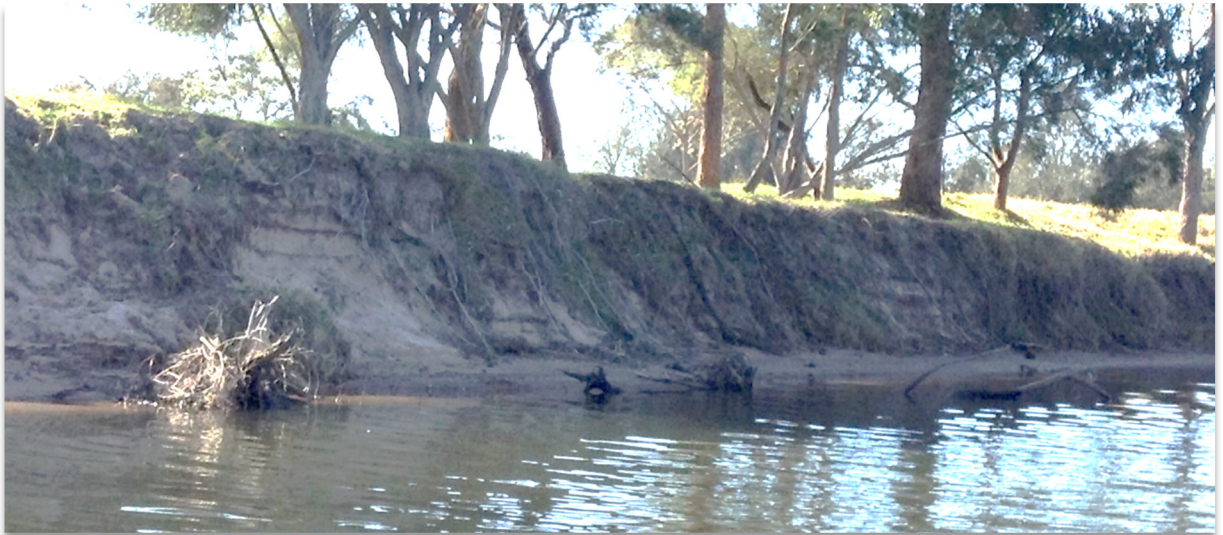
Figure 2.3 Example of an exposed sandy sub vertical bank with active erosion

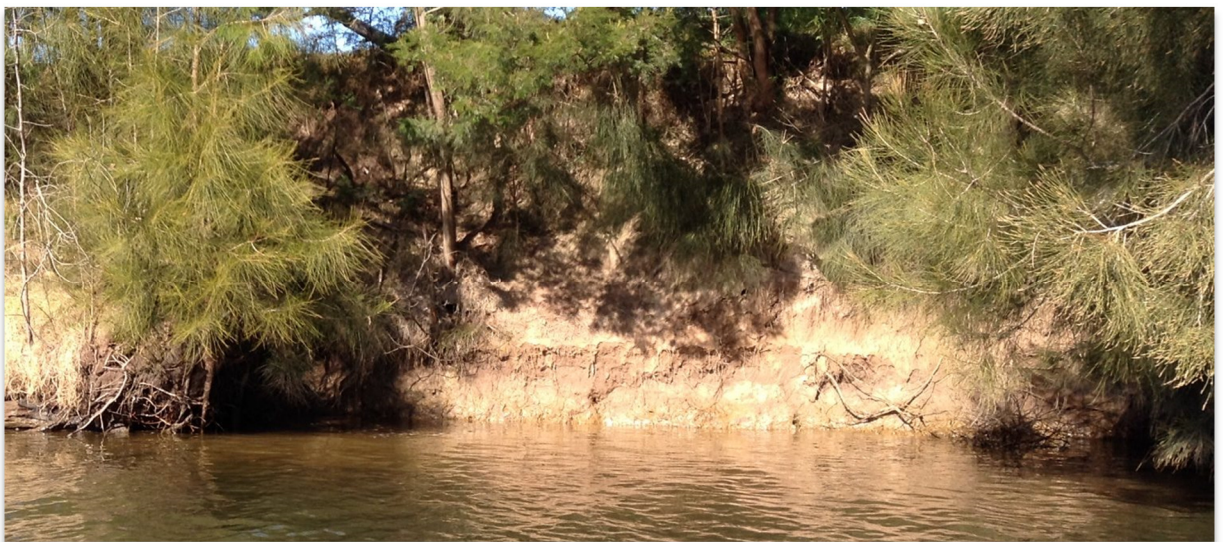
Figure 2.4 Example of recent bank failure as a result of flows being directed at this bank

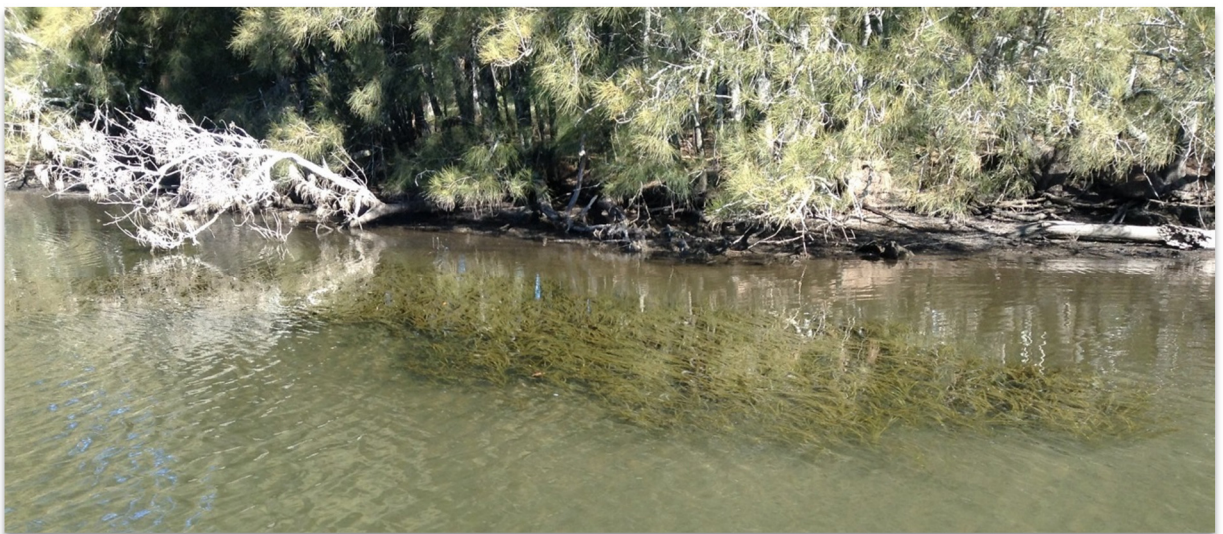
Figure 2.5 Example of seagrasses in the lower reaches of the Tuross estuary.

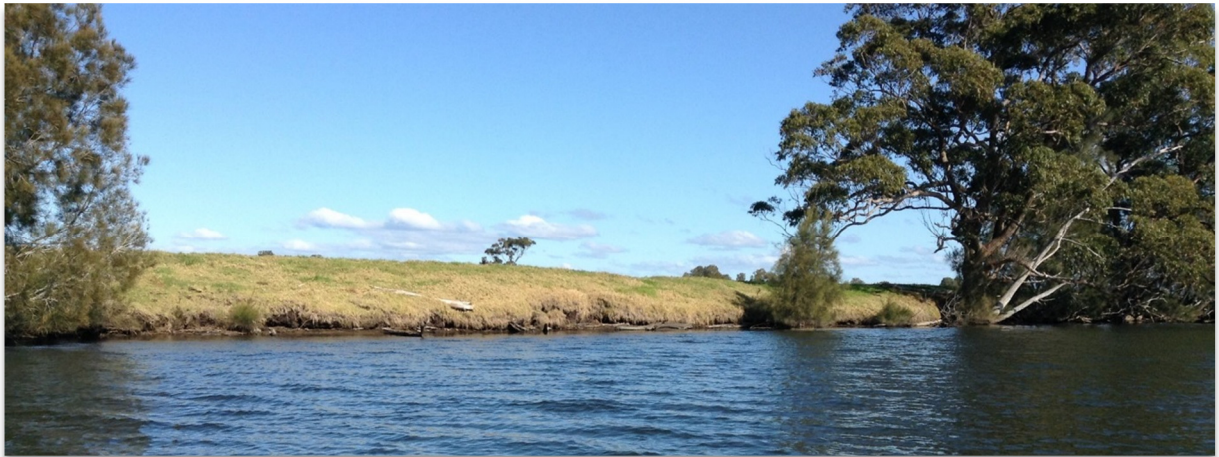
Figure 3.1 Many areas along the estuary are void of mature vegetation

Vegetation along a river or estuary bank serves three purposes related to water quality. Firstly, its deep root system can help to hold a bank together. Secondly a healthy riparian buffer can assist to absorb flood flows, reducing velocity locally close to banks. And thirdly, a healthy vegetation strip forms a buffer or filter for runoff and shallow groundwater flows, intercepting sediment and some nutrients before they reach the waterway. Overhanging vegetation can also provide shading of the watercourse which aids in habitat, although this is of less relevance to this project.

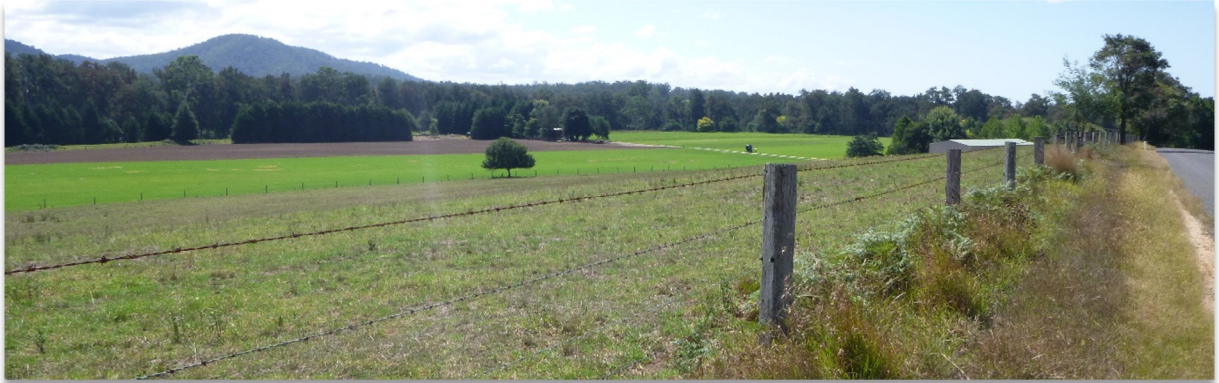
Figure 3.3 Intensive agricultural practices can result in higher nutrient export in runoff compared to a natural catchment

As an example, land used for cropping can contribute nutrient pollution through the application of fertilisers or land used for dairy farming can contribute nutrient pollution through stock manure, (both sources rich in nitrogen and phosphorus).

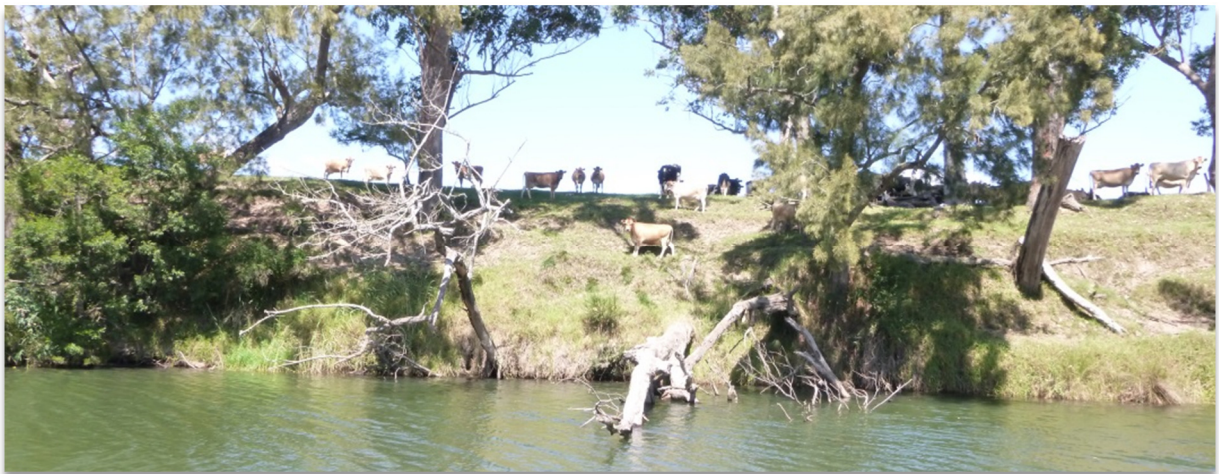
Figure 3.4 Direct stock access can have a detrimental impact to water quality and can also be a safety issue for stock

Impacts of uncontrolled stock access could range from direct defecation into the estuary, to simply destabilising riparian vegetation and wear of banks from regular track use and the erosion associated with this.

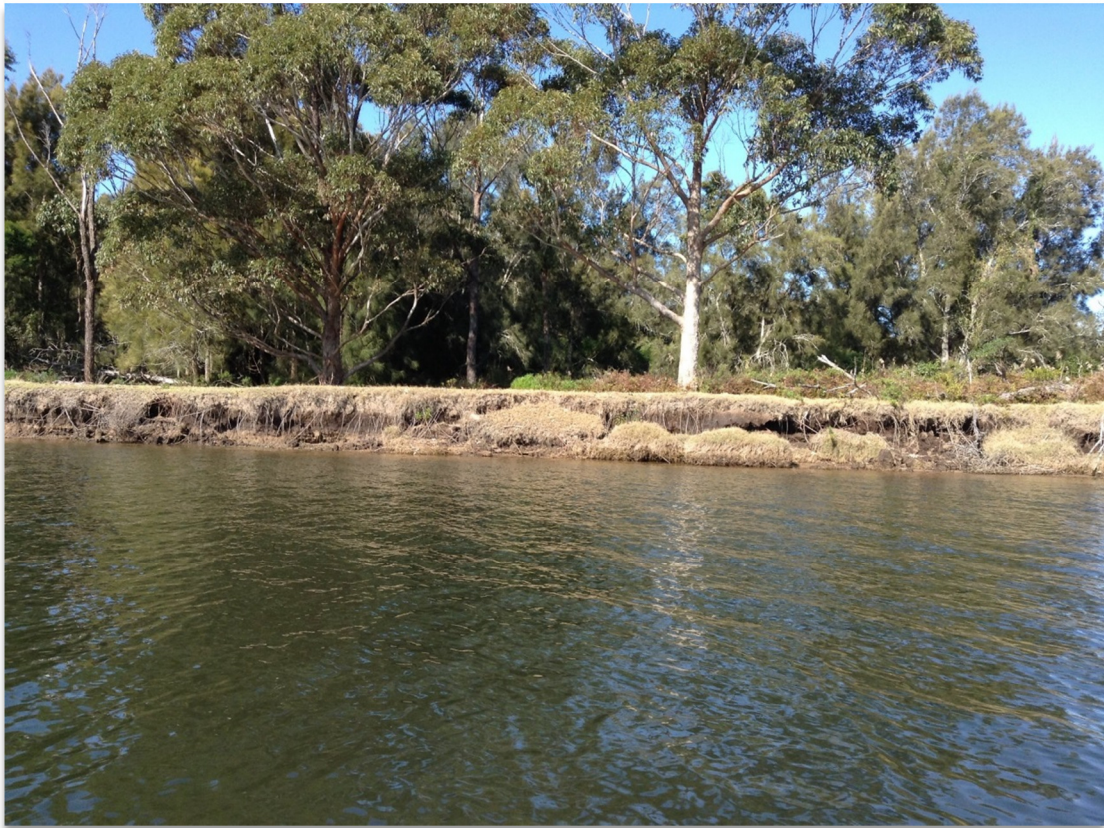
Figure 3.7 Bank erosion on north-west side of Cambathin Island

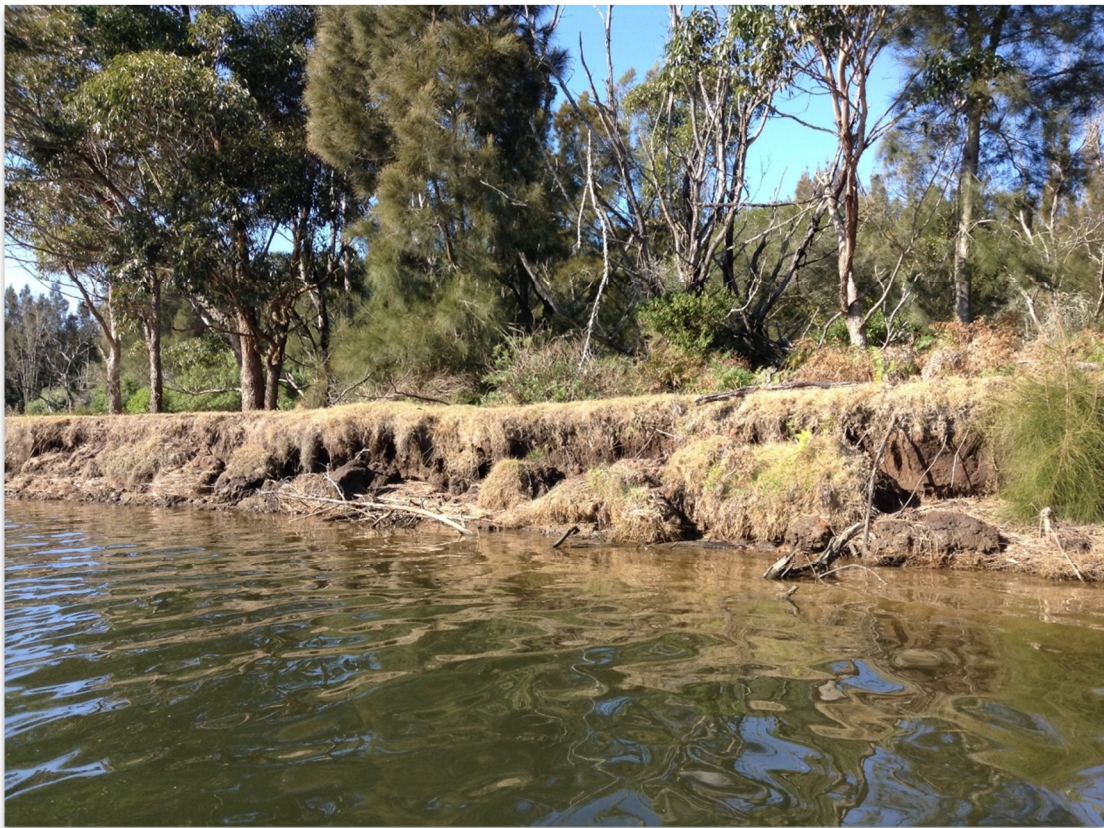
Figure 3.8 Bank erosion on north-west side of Cambathin Island

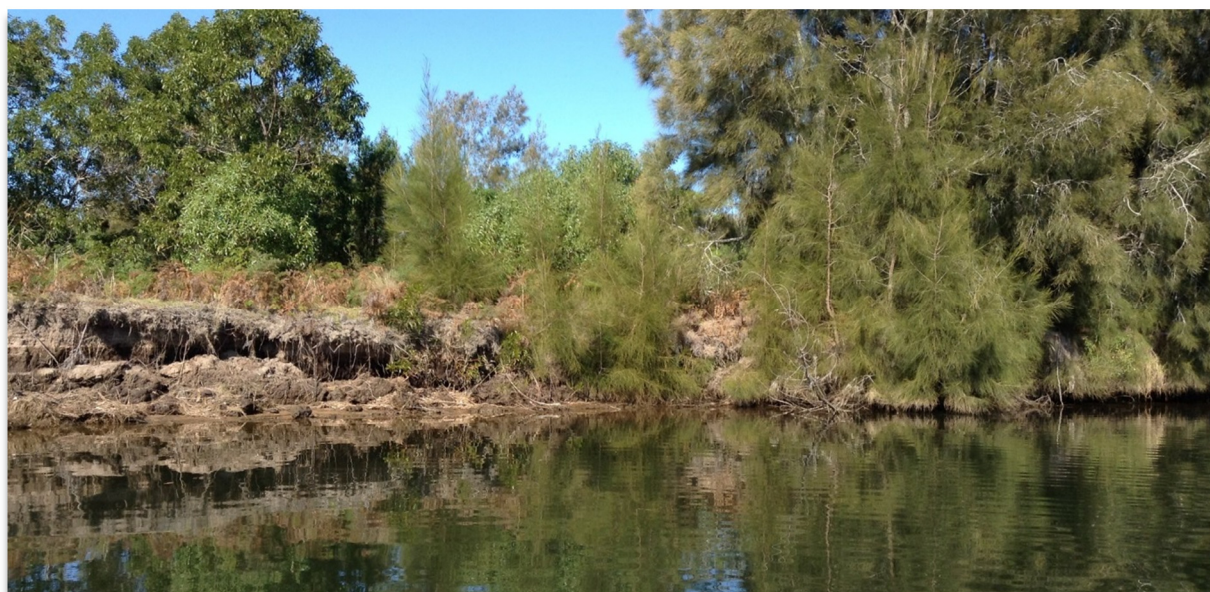
Figure 4.1 Cambathin Island, note clump of casuarinas adjacent to section of failing bank. This may a suitable location to start rock and reduce the risk of outflanking.

Depending on evidence and investigations from Stage 1 design and construct protection to prevent breakthrough; using a groyne field, rock armoured embankment or other. This requires detailed consideration of extents and tie-in with natural bank to prevent outflanking. Priority should be given to protection of bank where narrowest band of island exists and where breakthrough is most likely.

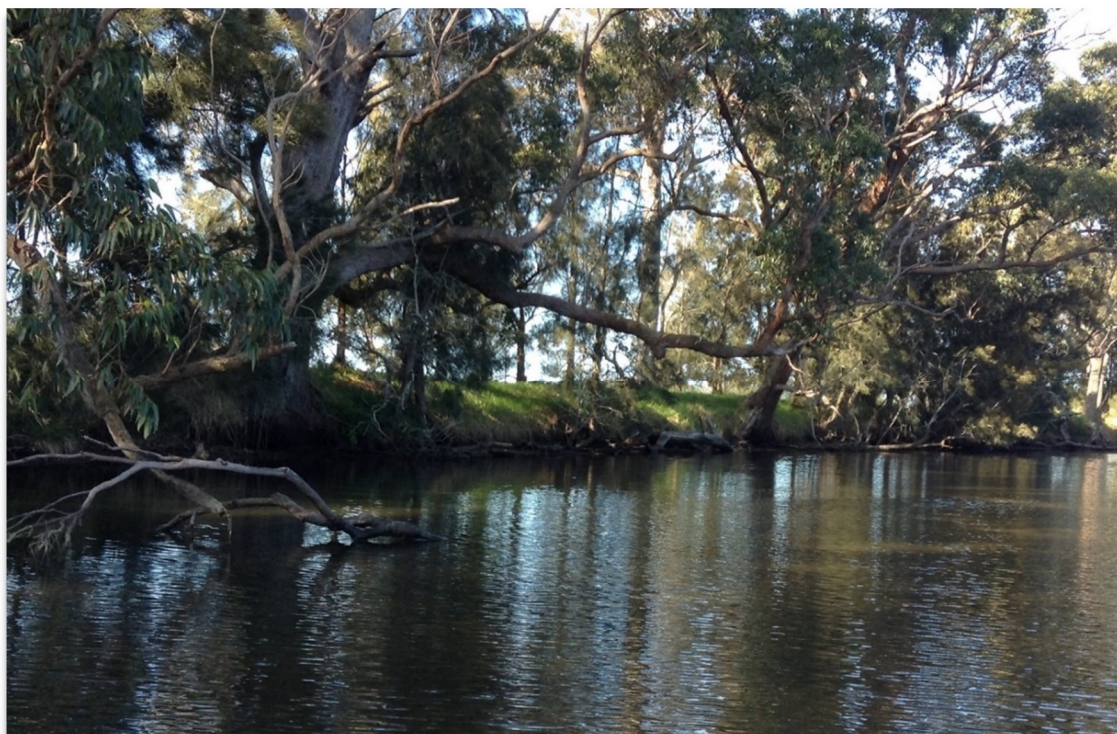
Figure 6.1 Large Bangalays in the lower reaches of the Tuross Estuary

The riparian vegetation communities considered for revegetation works along the Tuross River should include River flat eucalypt forest, Swamp oak floodplain forest and Bangalay sand forest.

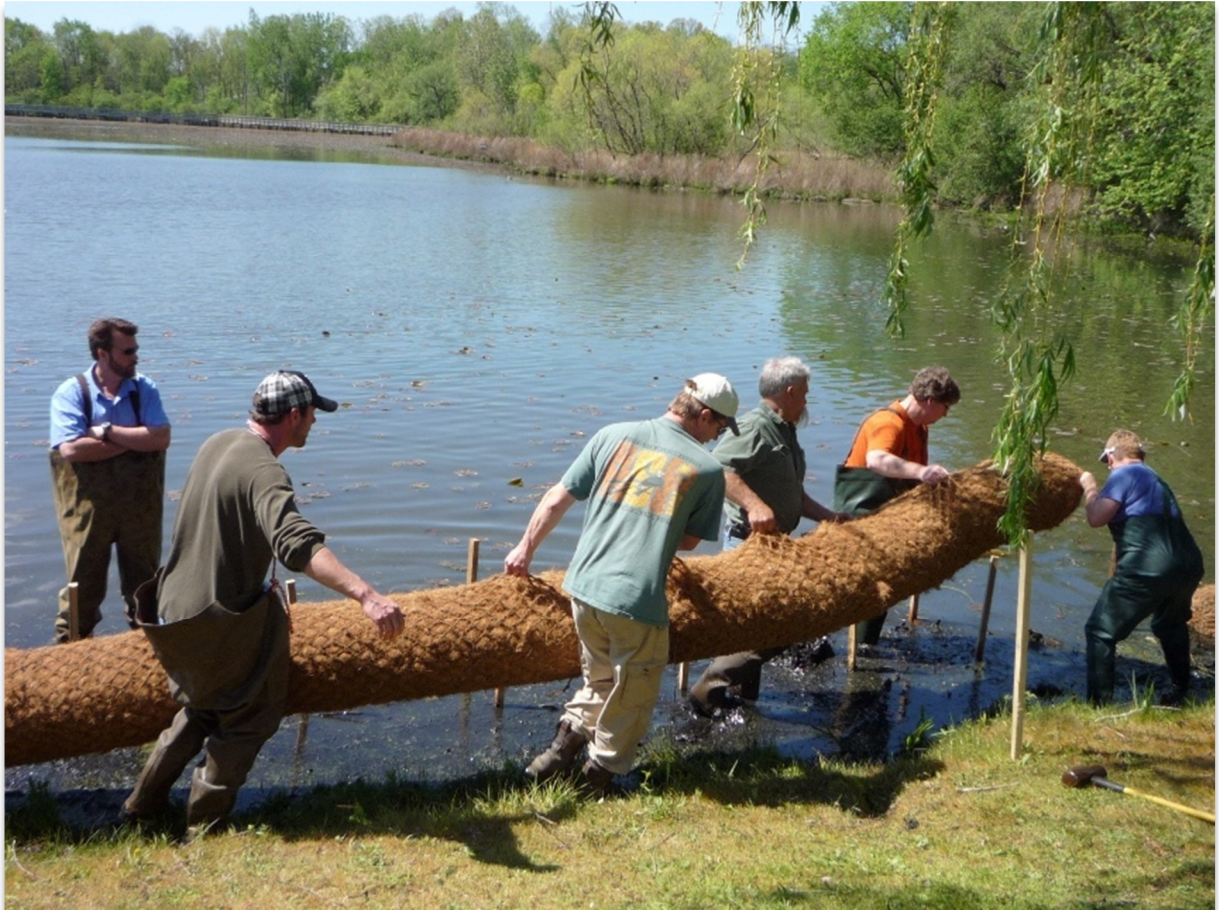
The Coir Log is a roll of organic coir fibre enclosed in a robust coir mesh. Coir Logs provide erosion and wave control structures in riparian zones, and sediment capture in drainage lines and swales. Coir Logs provide protection while vegetation establishes and takes over the long-term stabilisation. These are particularly useful where machinery access is limited as they can be carried and placed by hand.

Figure 6.2 Example of coir log installation (<http://www.hrwc.org/2010/05/building-a-natural-alternative-to-breakwalls/>)

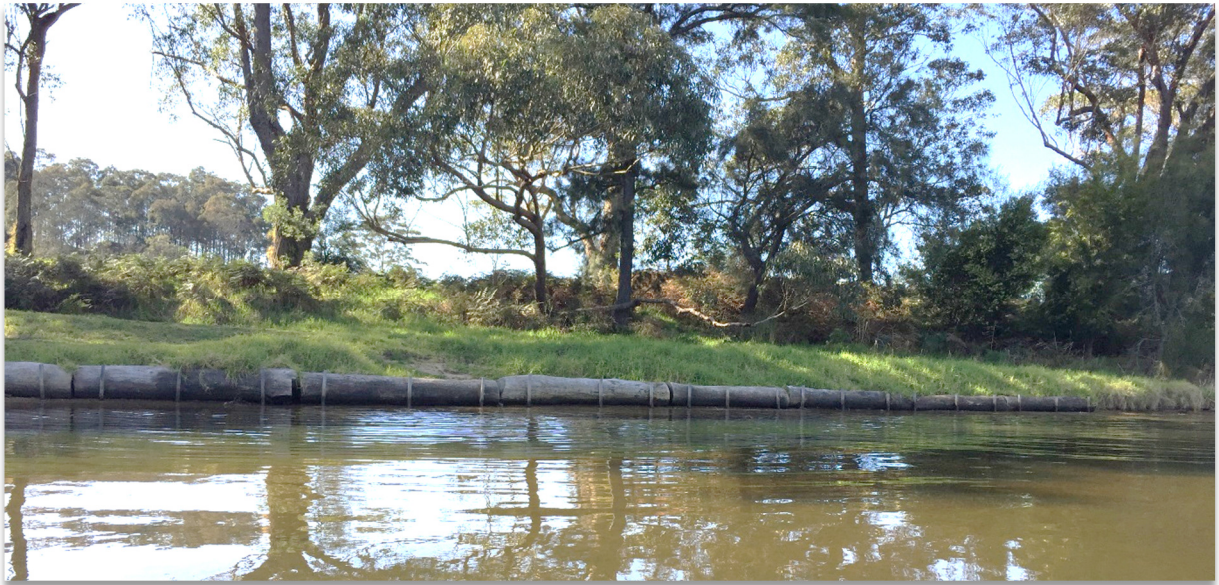
Walling to protect a bank from impact can take the form of sandbags or log structures. These would protect the toe of an embankment where bank slumping was an issue.

Figure 6.3 Example of a log structure at Snake Flat

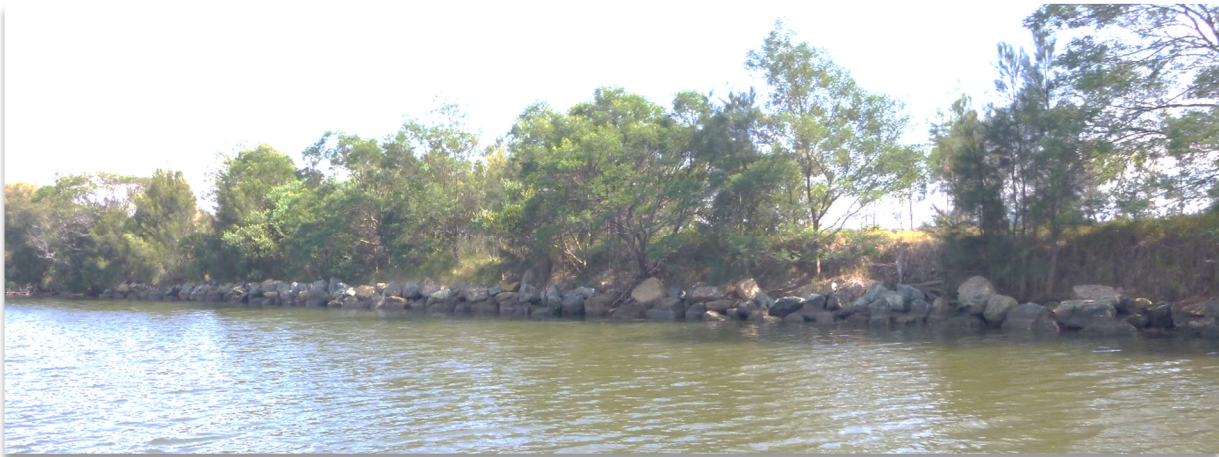
Revetments protect the face of an embankment by placement of a physical barrier. This can be placed rock over geotextile, or sandbags although these techniques are unlikely to be appropriate for the Tuross due to the scale of erosion and subsequent cost of works.

Figure 6.4 Example of a rock revetment in the main channel of the Tuross River

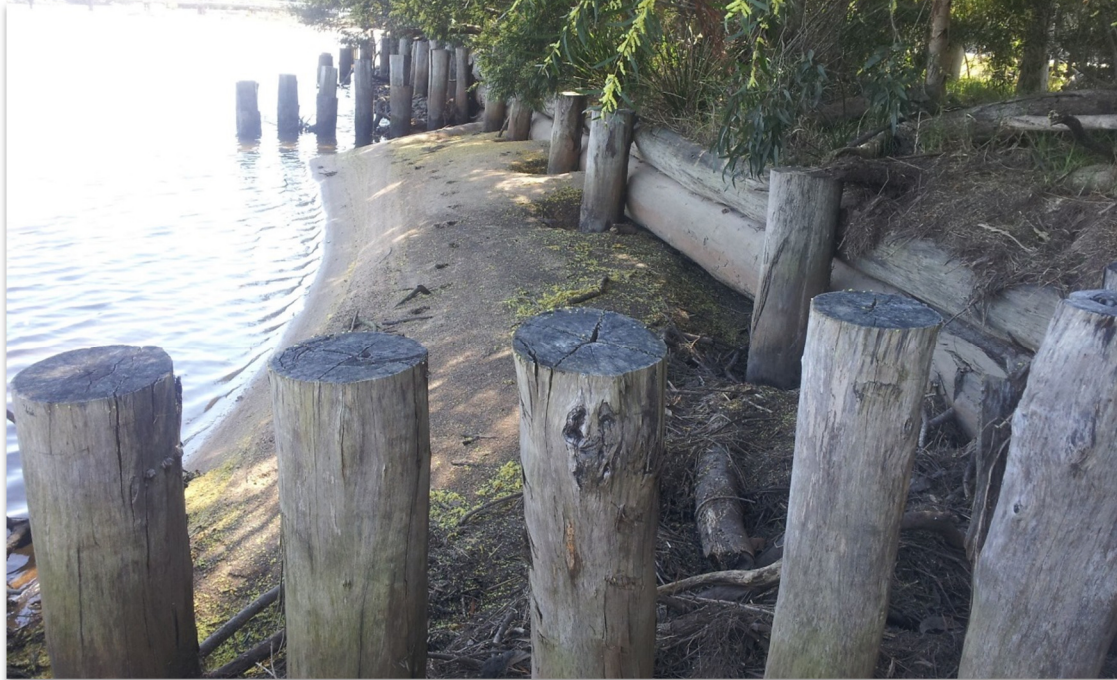
Groynes provide indirect protection to eroding banks by diverting flow and encouraging sediment deposition. They should be engineered for a particular site to determine the most appropriate spacing along the bank. Groynes can be rock or logs depending on the water depth.

Figure 6.5 Example of timber groynes in the Murrumbidgee River

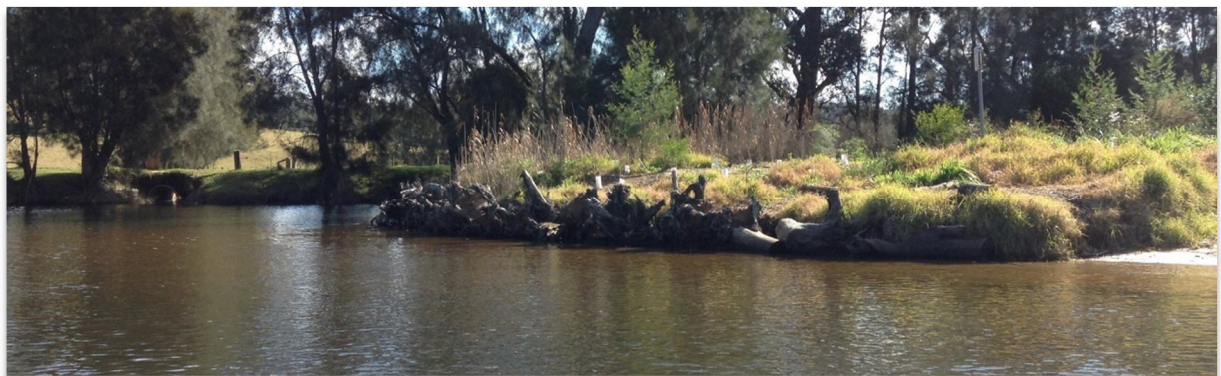
Baffles or large woody debris aim to baffle or deflect flow such that a bank is not subject to the full brunt of erosive velocities.

Figure 6.6 Example of a woody debris in the Tuross to protect an exposed section of bank
