# Akolele Sewerage Scheme Review of Environmental Factors

**Eurobodalla Shire Council**

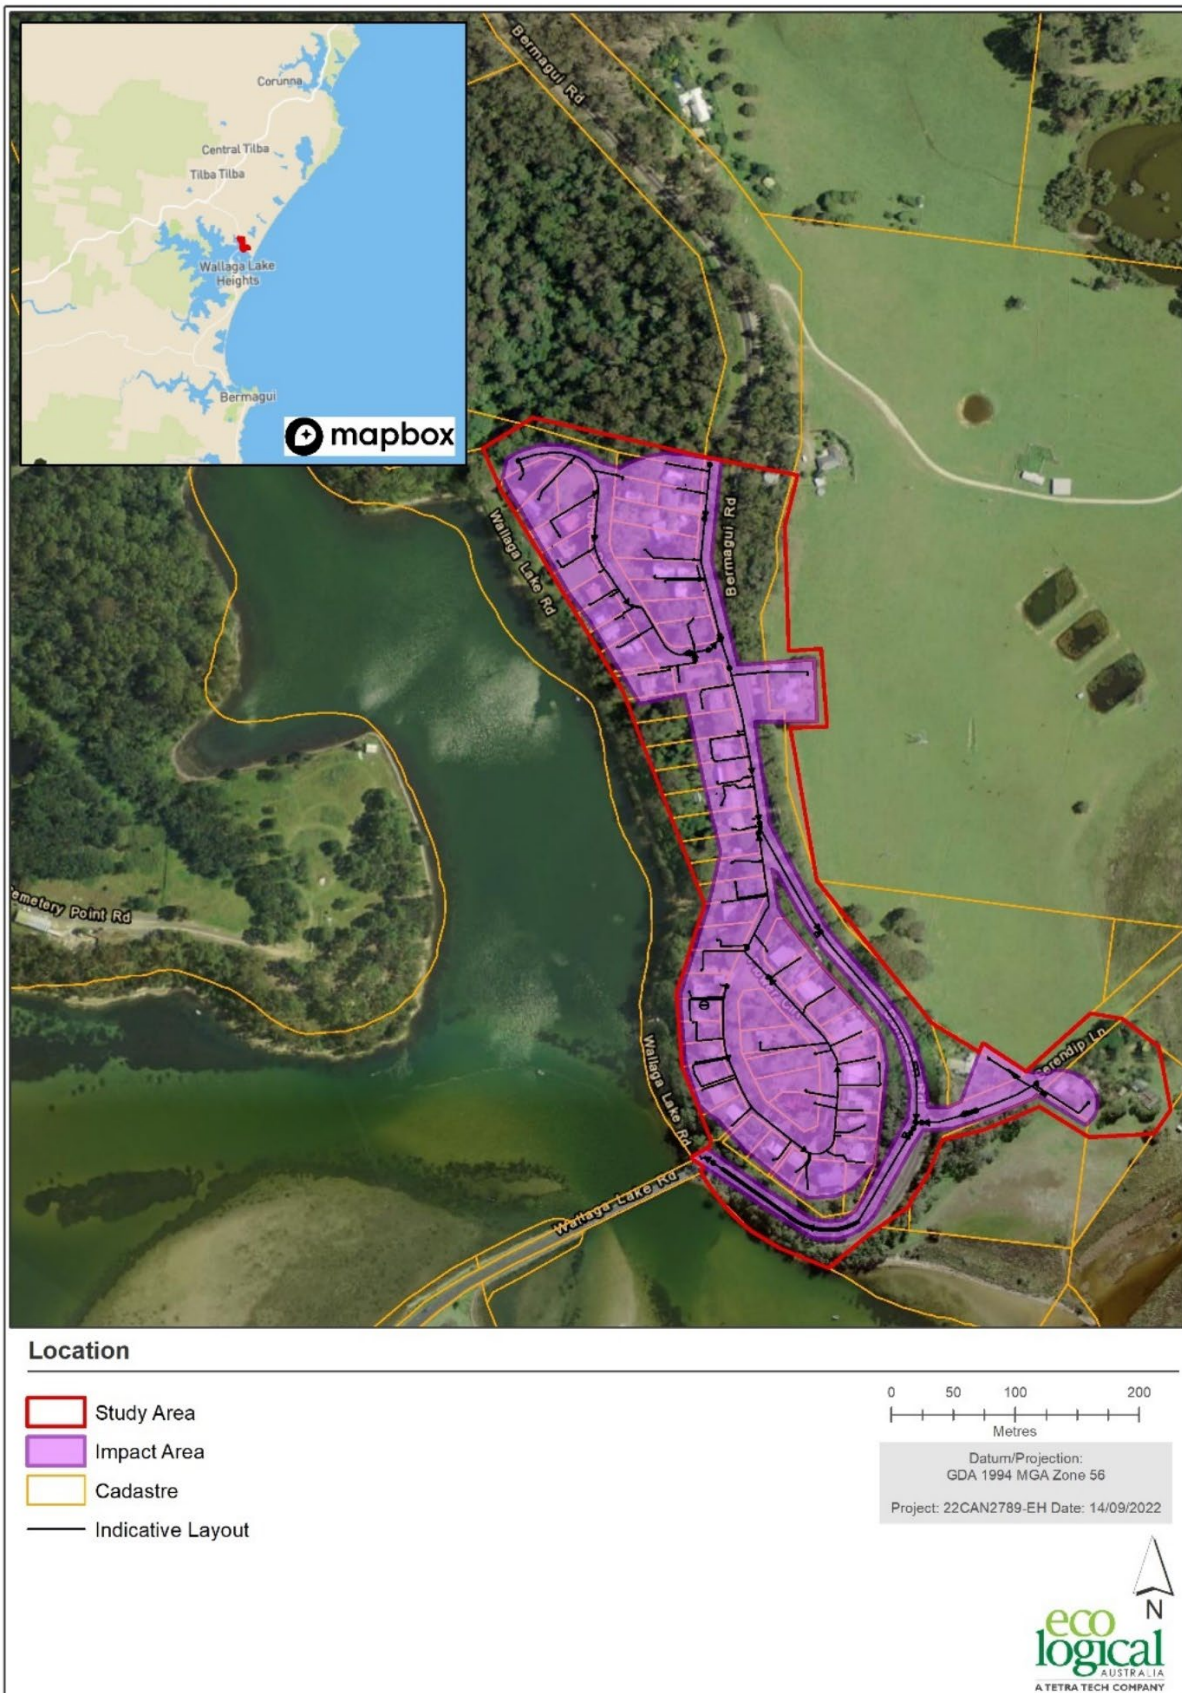
Figure 1: Akolele Village project location overview

Figure 1 identifies the location of the study area, impact area and indicative layout of the pressure sewer mains and discharge pipes to each lot associated with the project that is subject to this REF.

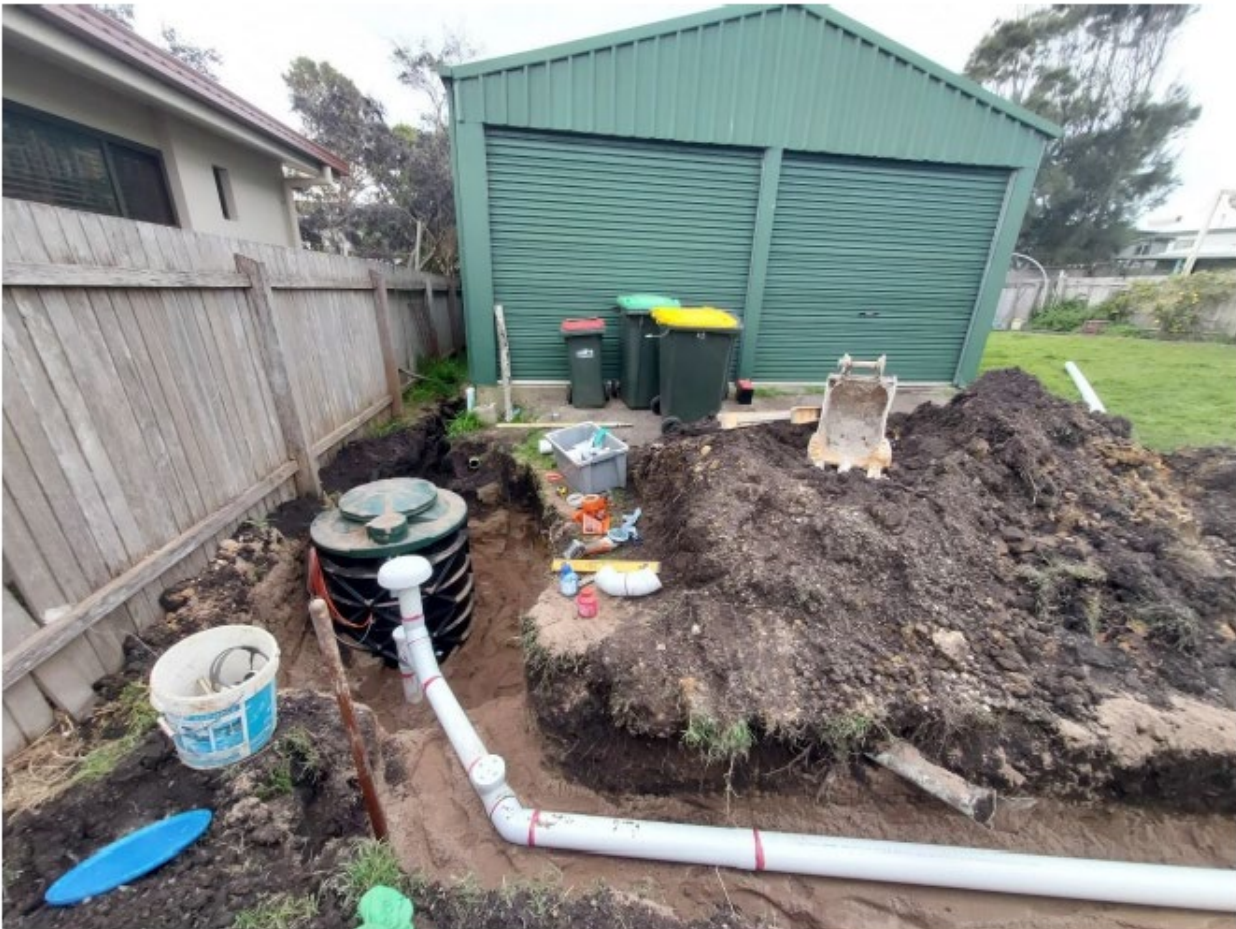
**Photo 1: Installation of PSU and gravity sewer line**

The below-ground collection tank/PSU is installed at a depth of approximately 2 m and collects household sewage via a gravity sewer pipe similarly to a septic tank. The PSU contains a pump which grinds up solids and transports waste through small diameter pipes to the street mains. The pump unit is activated once the tank volume reaches a certain level which is set low as a contingency in the event of power failure. The unit is accessible via a lid above ground level for maintenance and repairs.

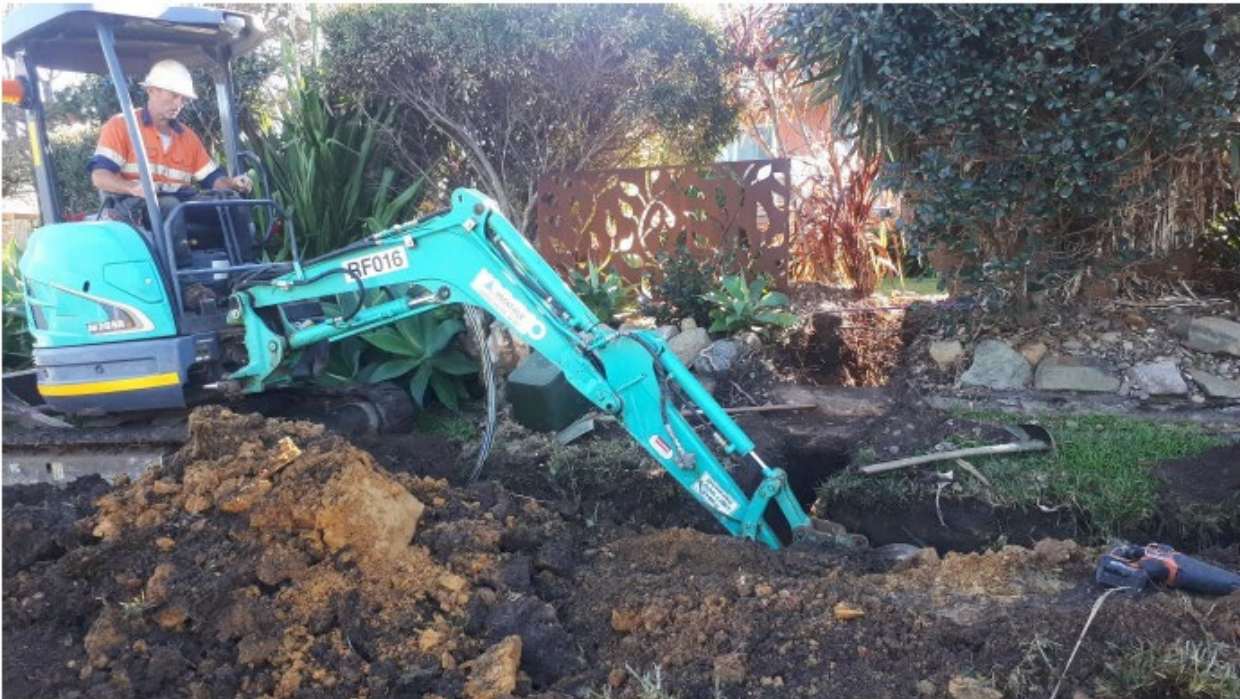
**Photo 2: Excavation for pressure sewer lateral and boundary kit**

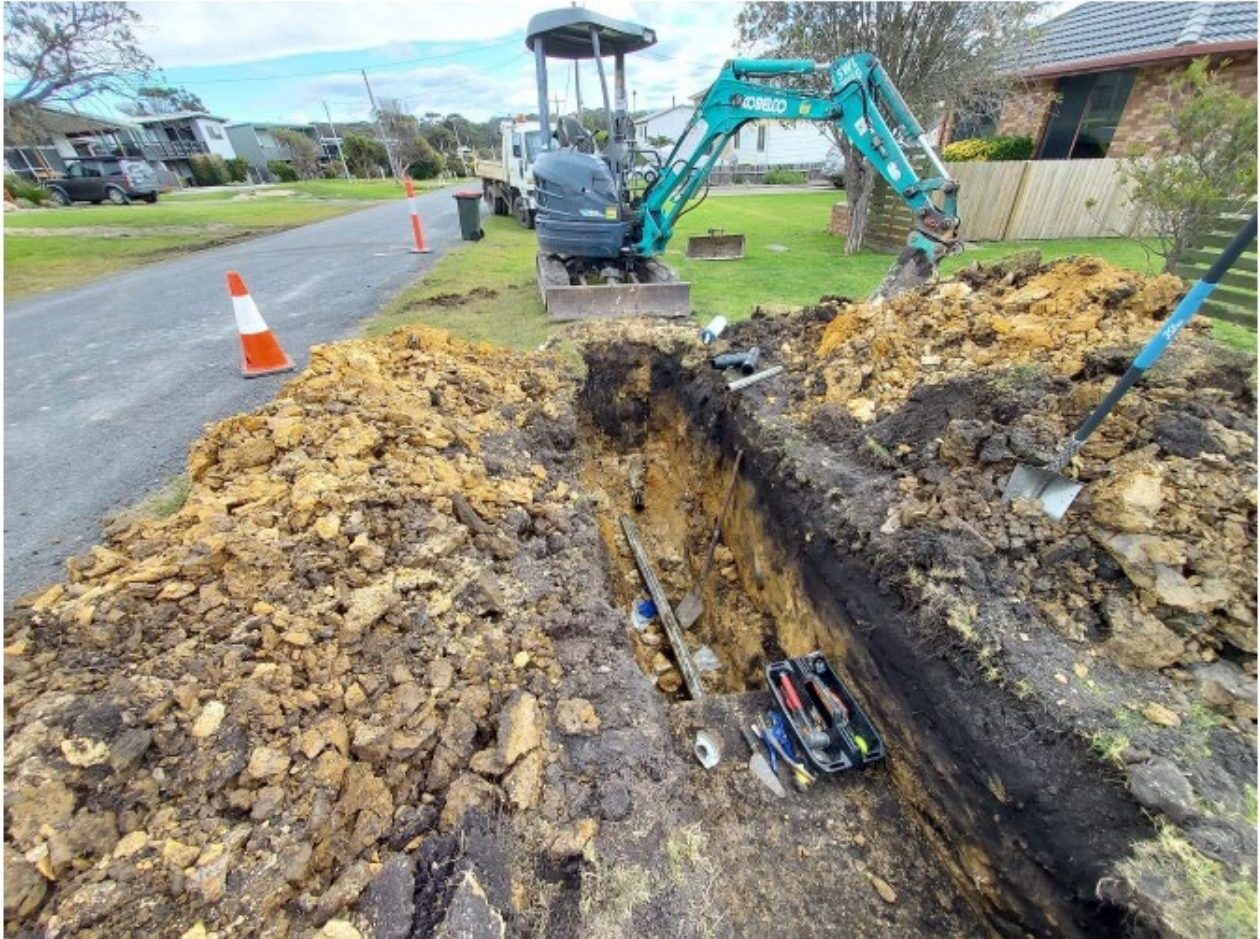
**Photo 3** Excavation for isolation valve and wye connection

- Installation of small diameter HDPE sewer rising mains (< 75 mm) in the road reserve by horizontal directional drilling (HDD). HDD will be used in selected locations such as street crossings to avoid impacts to roads (Photo 4)
- Installation of boundary kits and pressure sewer laterals using small excavator
- Installation of air valve pits and flushing kits using small excavator
- Installation of isolation valves using small excavator (Photo 3)

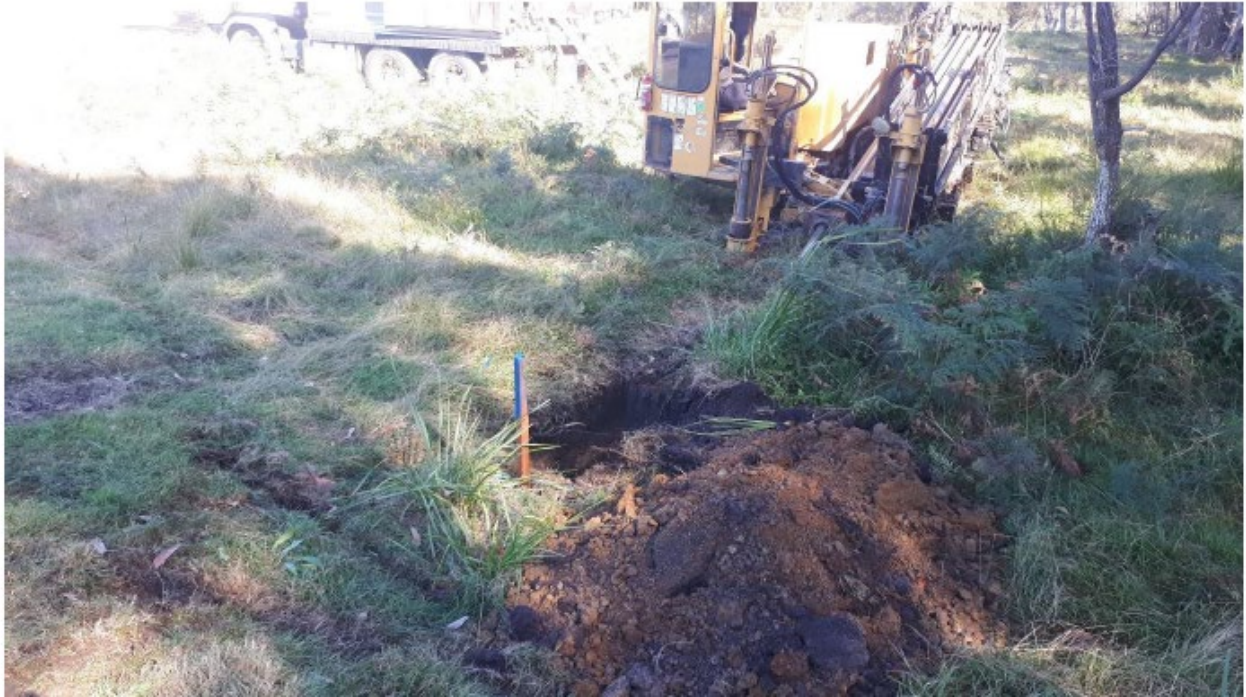
**Photo 4: HDD equipment installing street main**

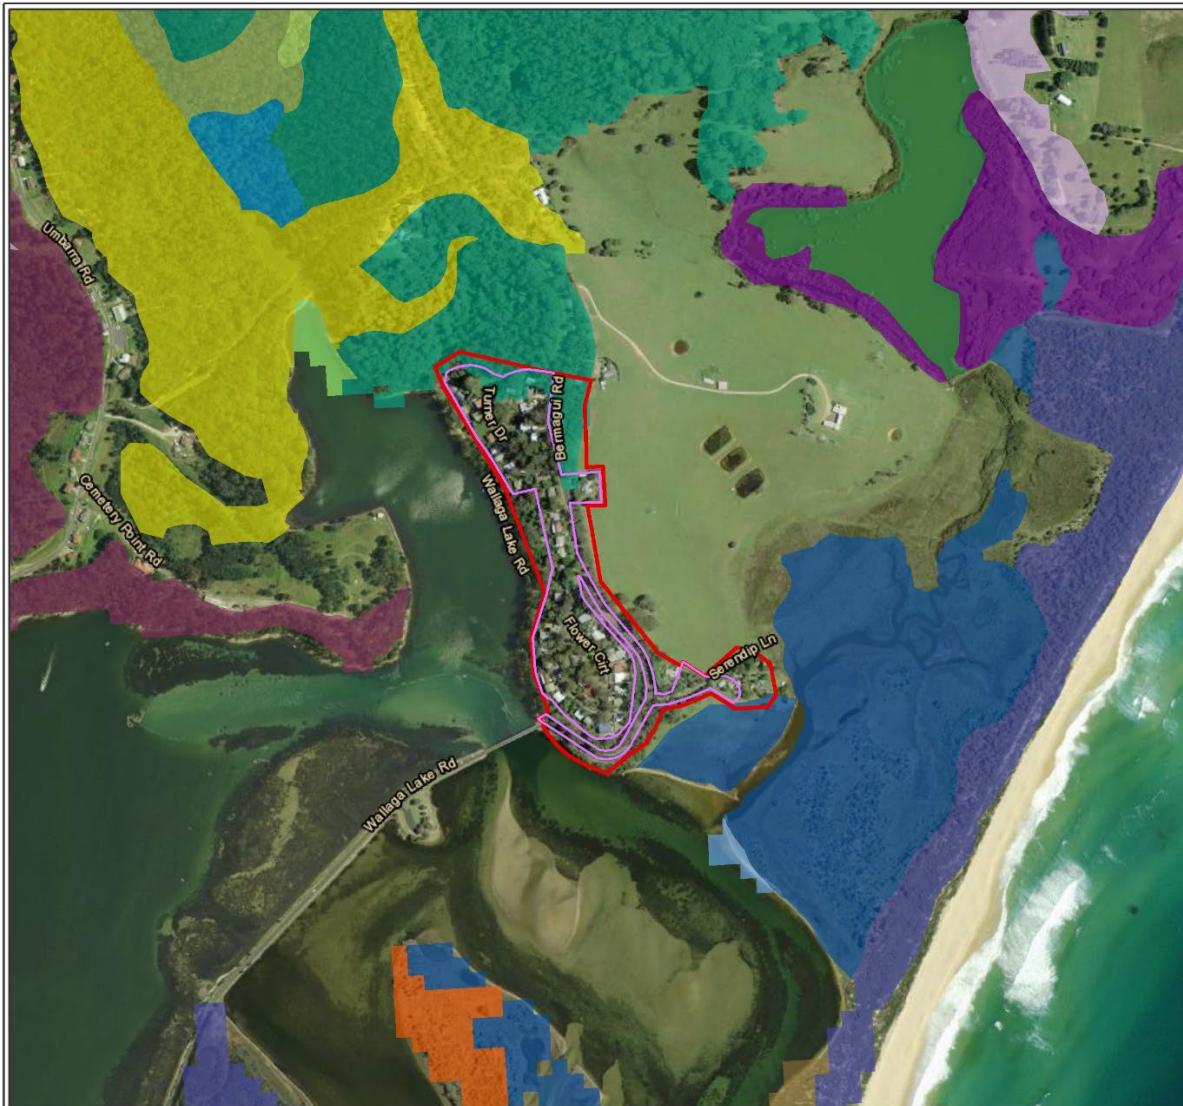
Mapped vegetation is shown in Figure 5.

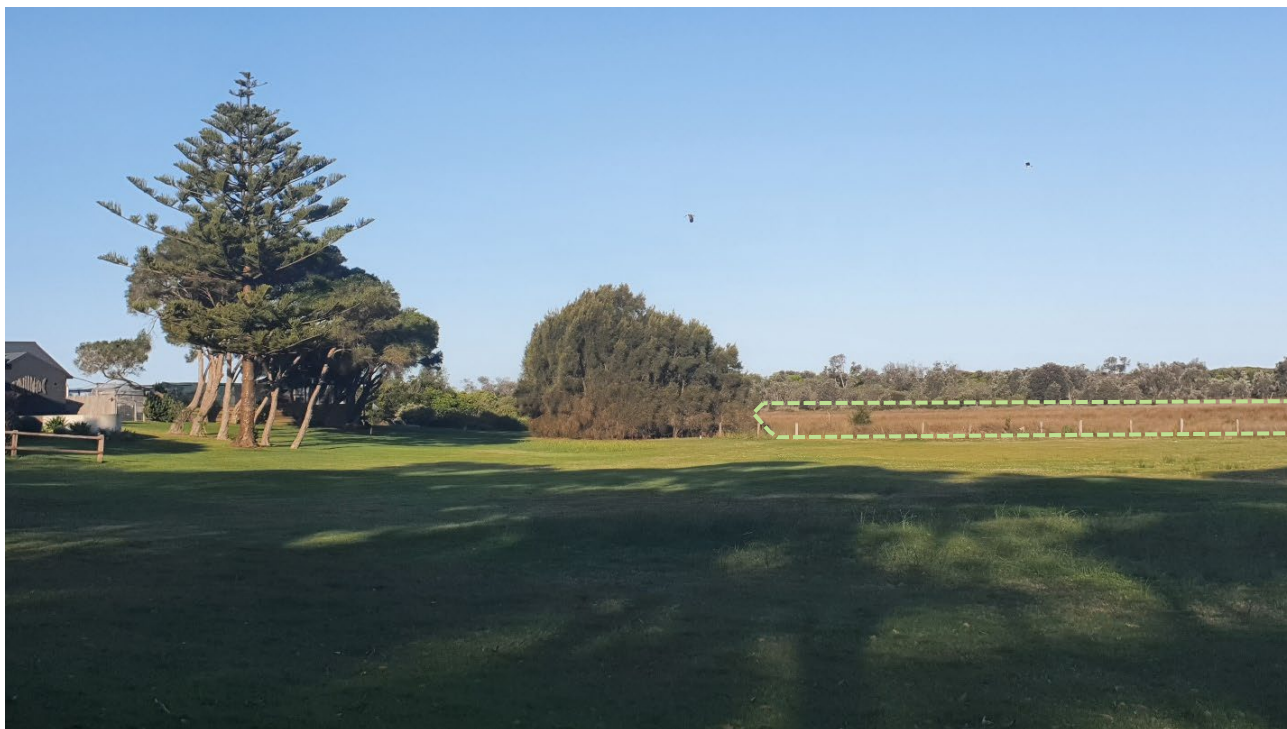
**Photo 7: Saltmarsh (TEC) south of the property in Serendip Lane. The saltmarsh extends only as far as the property fence line 56 m from the proposed impact area (see green dotted line).**

The TEC PCT 1126 *Coastal Saltmarsh in estuaries of the Sydney Basin and South East Corner* was identified consistent with areas mapped to the east of Serendip Lane and north of Merriwina Creek (Photo 6). This TEC is located primarily outside the study area and impact area of the project, however a small section of this TEC is present within the southern border of the study area below Serendip Lane. The saltmarsh is not consistent with mapped modelling (shown in Figure 5) South of Serendip Lane and is only present to the fence line of the property (Photo 7). There is no TEC within the impact footprint which will be within the grassed area of the property 56 m away from the nearest identified saltmarsh, however this TEC may be subject to indirect impacts due to the close proximity to the project. This is assessed further within Appendix C and D and a Test of Significance (ToS) has been performed in Appendix G. None of the vegetation within the impact footprint of the project comprises any TEC listed on the BC Act or EPBC Act.

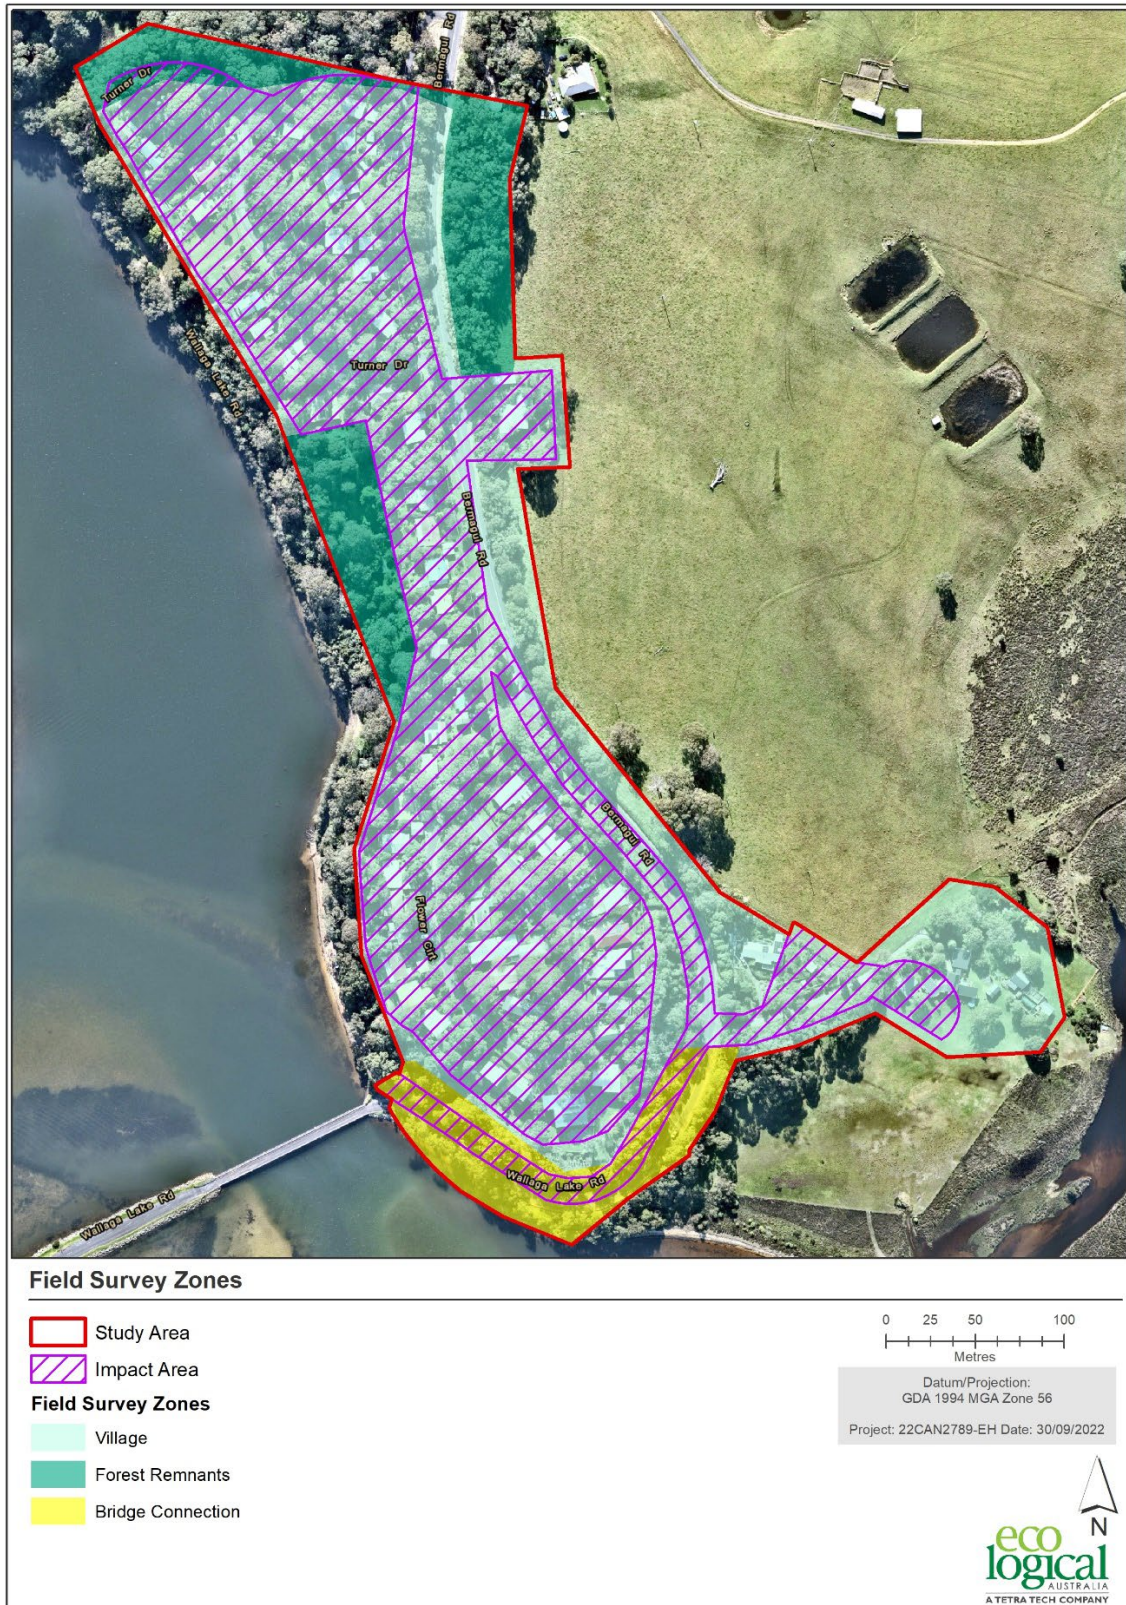
Figure 7: Survey zones

The field survey was split into three zones (Village – Zone 1, Bridge Connection – Zone 2 and Forest Remnant – Zone 3) as demonstrated in Figure 7 below.

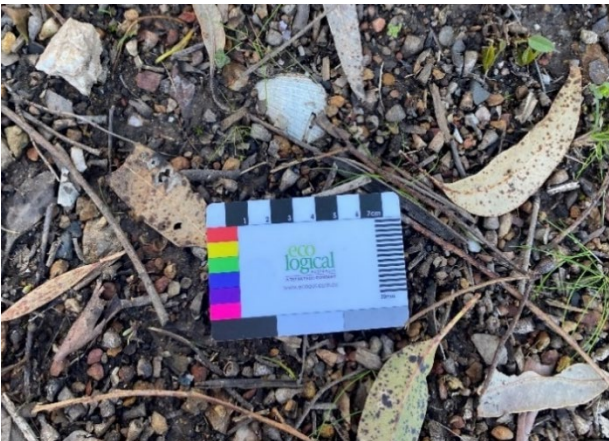
Photo 28: Area of exposure showing shell, gravel and brown underlying soil profile

Photo 26 - Photo 27). There was limited surface visibility to the east and west of Turner Drive, though areas of visibility revealed mixed deposits of gravel, shale, rock and leaf litter (Photo 28). One isolated shell was observed in an exposed area along the slope to the east of Turner Drive, however, this shell appeared to be in a disturbed context and no surface artefacts were observed in association with the shell (Photo 28, Photo 29).

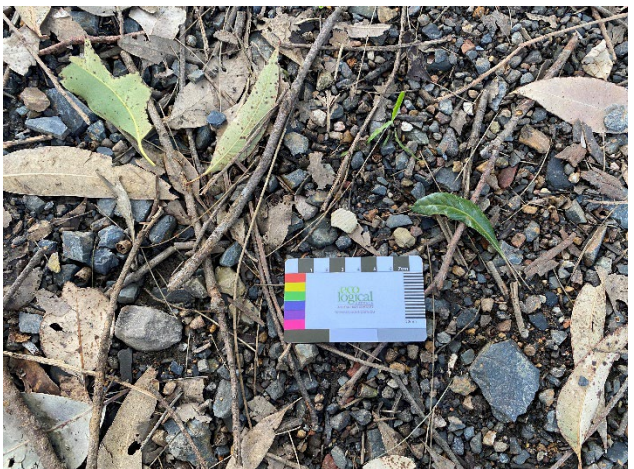
**Photo 35:** Eroded exposure in driveway adjacent to Wallaga Lake, near previously recorded location of AHIMS ID 62-7-0386 showing one shell fragment, gravel, leaf litter and shale

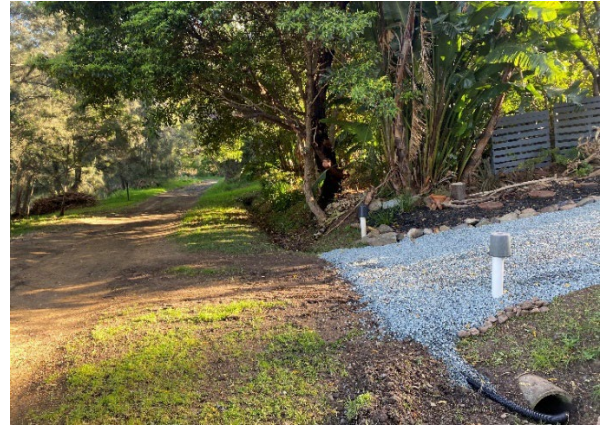
**Photo 37:** View north showing exposures along Wallaga Lake Road and previously recorded general location of AHIMS ID 62-7-0386, with vegetation, pipeline to east of road and sewer main to west

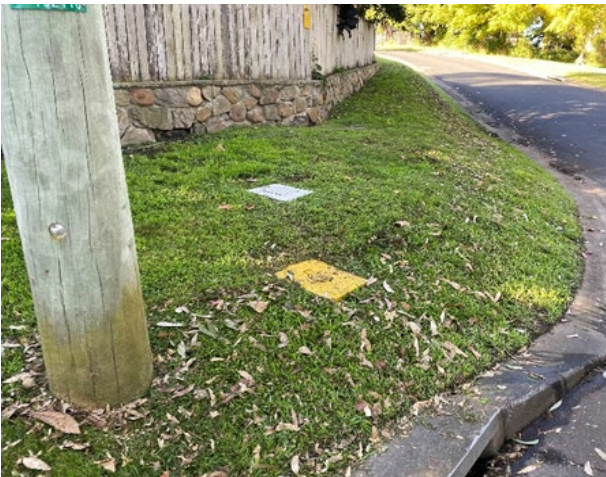
Photo 44: View west showing installation of services along Flower Circuit Drive

The south-eastern extent of the study area, comprising of Bermagui Road, had undergone extensive disturbance related to the construction and levelling of the road (Photo 39 - Photo 42). The central portion of the southern extent of the study area, the area comprising of Flower Circuit Drive, had been extensively disturbed related to the construction and levelling of the road, residential dwellings and the installation of services (Photo 42 - Photo 47).

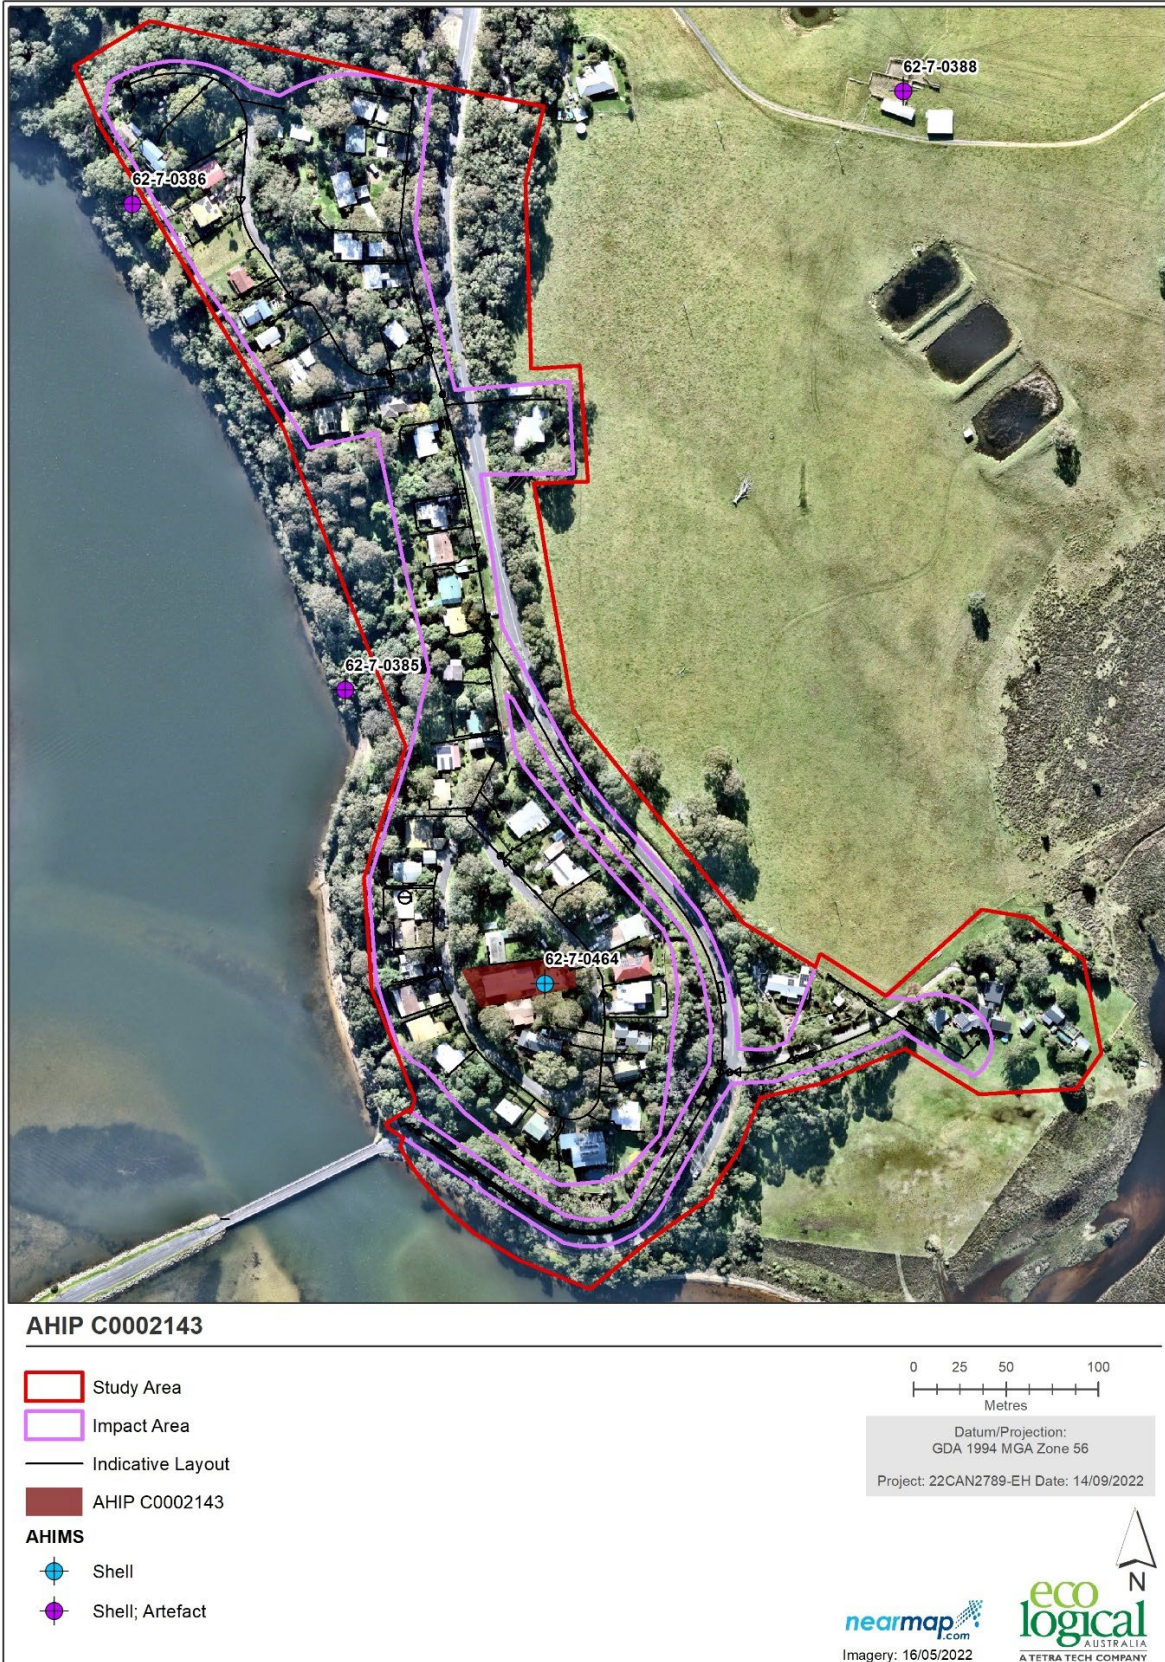
Figure 11: location of curtilage covered by AHIP no. C0002143

Two Aboriginal sites have been recorded in close proximity to the study area, AHIMS ID 62-7-0386, AHIMS ID 62-7-0385 and one site, AHIMS ID 62-7-0464 has been recorded within the proposed impact area. Any proposed impacts to AHIMS ID 62-7-0464 must abide by the conditions of AHIP no. C0002143, issued to John and Kathryn McNamara in September 2016 and active until September 2036. A map showing the land applicable to this AHIP is shown in Figure 11.

62-7-0464	Akolele 1	Shell	<p>Recorded by Sarah Robertson, site is located at 8 Flower Circuit, Akolele. The site comprises of a midden, with a dense, narrow lense of <i>Anadara trapezia</i> (cockle) exposed approximately 20cm beneath the ground surface.</p> <p>The site has been partially destroyed under AHIP no. C0002143, which is valid until September 2036. A map showing the curtilage covered by AHIP no. C0002143 is found in Figure 11. Impacts within the curtilage do not require any further approval.</p>

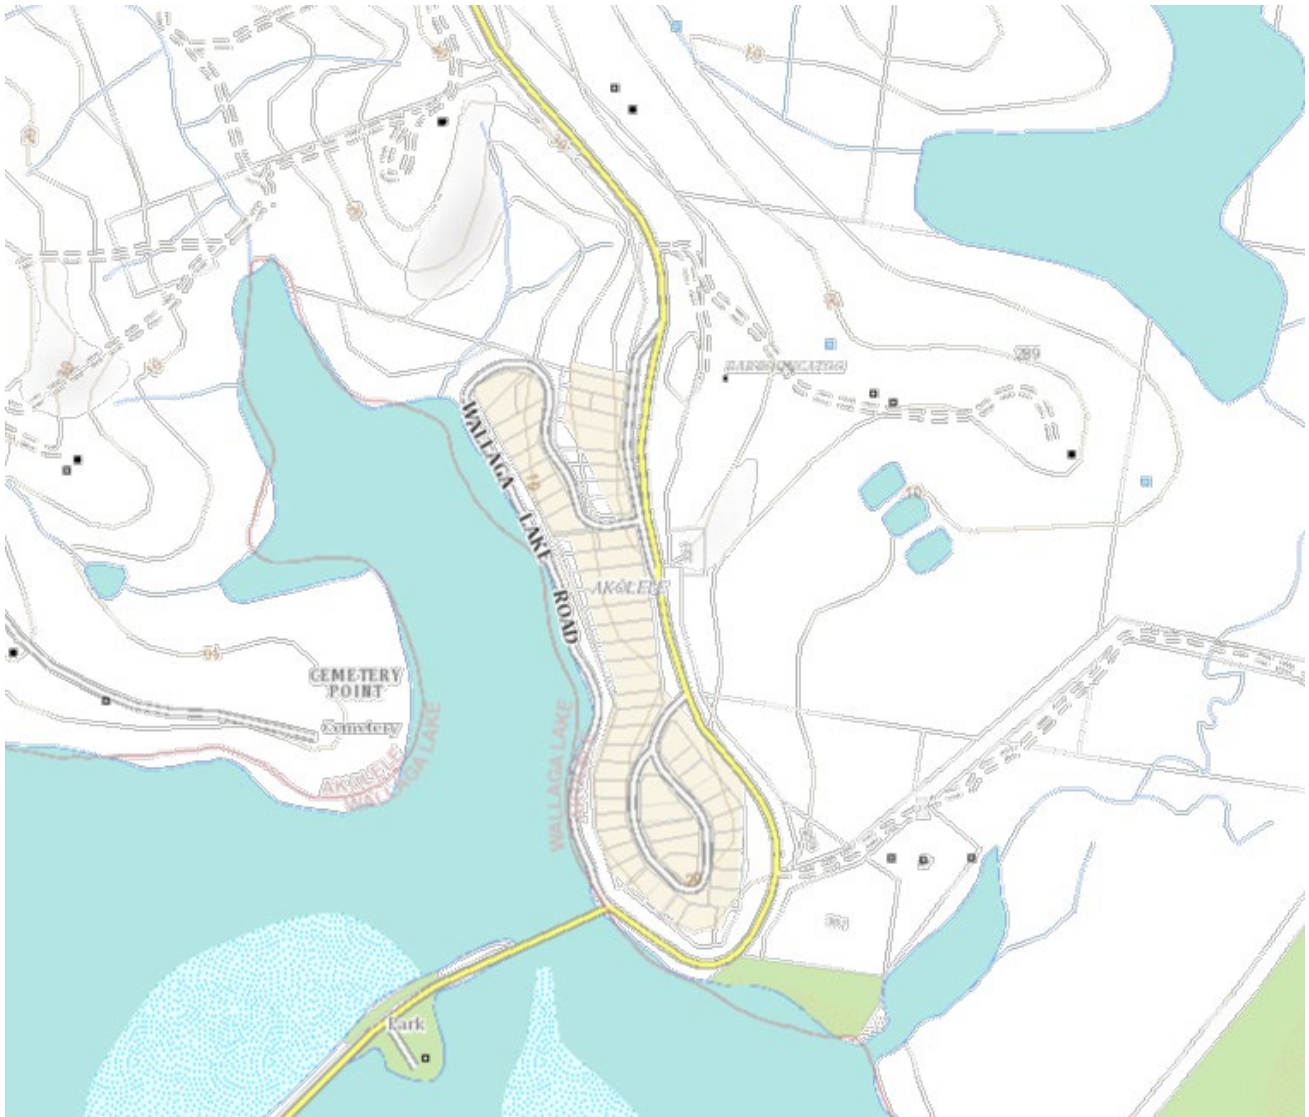
Figure 13: Topographic map of Akolele

The impact area is situated on a low rolling hill comprised of a moderately broad ridge that falls to the south towards Wallaga Lake in the west (Terra, 2022), and with elevations between 5 and 30m above sea level (Figure 13).
