Moruya Showground Design Guidelines

December 2018

Prepared by Pip Giovanelli

Heritage Advisor, Eurobodalla Shire Council

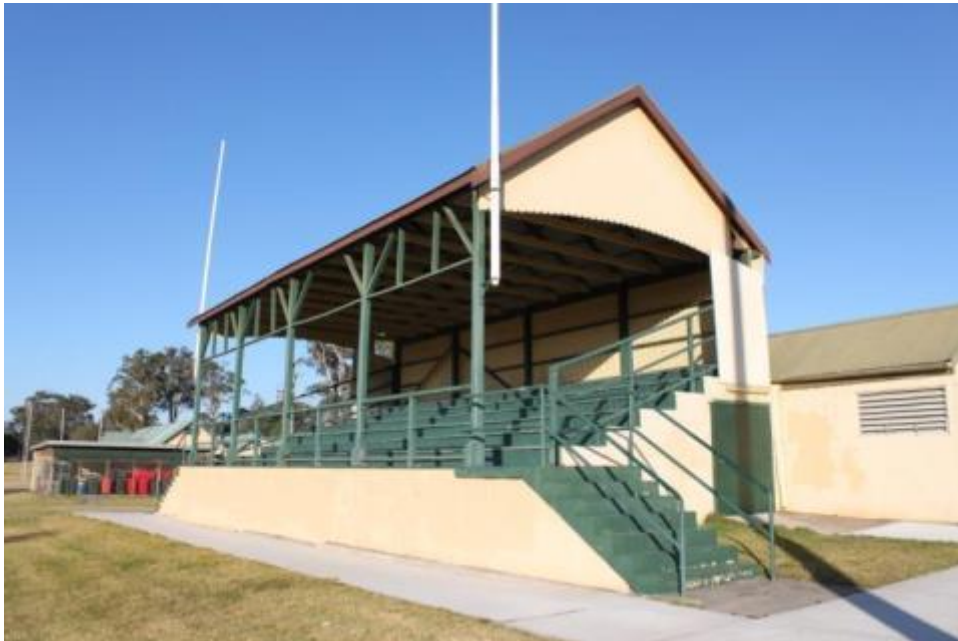
Moruya Showground Grandstand 2018

The structure was built on the current site in 1904 – 05 to view the racecourse that was there at that time (presumably in the approximate location of the main ring and football oval). The Agricultural and Pastoral Show was still being held at its former location by the river.

Structurally the grandstand appears stable however the frame and posts beneath the seating were not inspected as part of this report. It is possible the seating is still supported on timber stumps. Two of the vertical struts in the front upper frame are missing and there is some subsidence in the horizontal member. There may have been more detail in this upper section, and it would not be inappropriate to add additional screening to provide more shade.

The seating area is in poor condition and uninviting. The surface is steel sheet that is now rusting, although the Armes study noted it as 'compressed sheet and steel handrails'. There is no differentiation between seating and walking surfaces and no central or side aisle. It has been commented that the grandstand does not provide good protection from the sun, especially in the afternoon.

1. Obtain historic photographs.
2. Obtain structural assessment, especially beneath the seating area.
3. Upgrade tiered seating allowing for separation between walking and sitting surfaces.

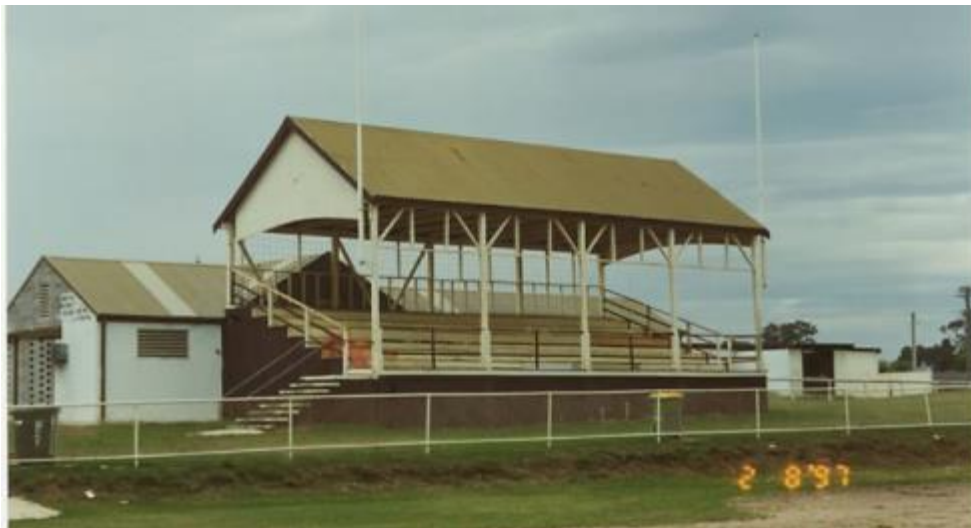
Photo by EJE Consultants 1997. Note the lack of a rear wall, plus white and 'mission brown' colour scheme.

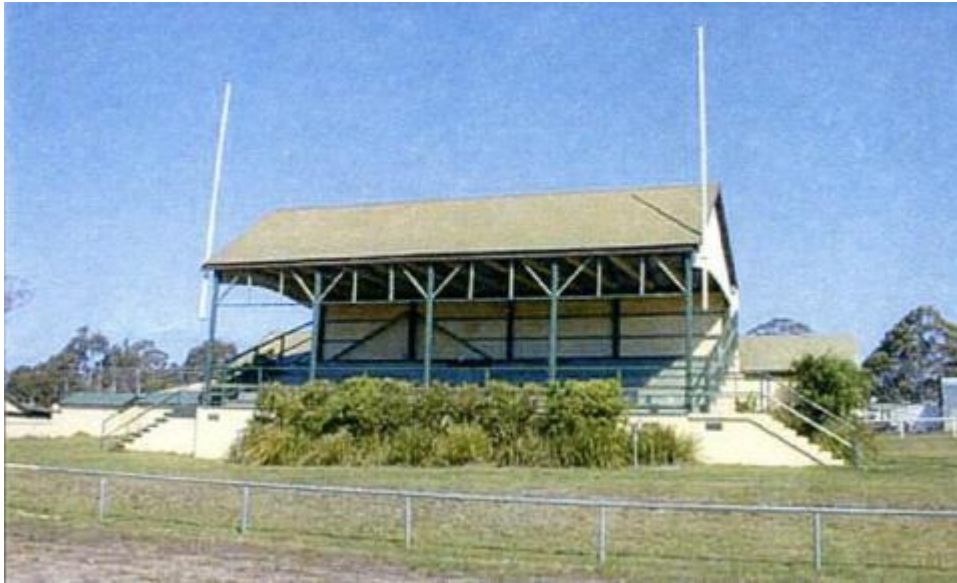
Photo by John Armes and Associates 2004 showing planted area at front and at ends of grandstand. Colour scheme has been altered to 'off white' and green, with the front upper framing in contrasting colours. Historic photos of the grandstand have yet to come to light.

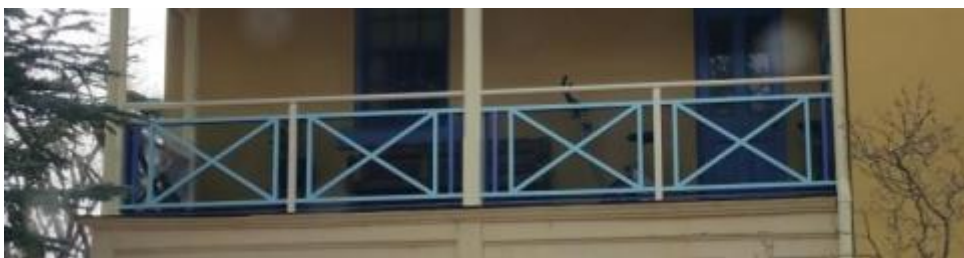
A building in Braidwood with mesh behind diagonal timbers.

7. Upgrade mesh in the side rails to vertical alignment and powder coated to black. Side and front balustrades need to be BCA compliant. A more attractive alternative would be to replace the mesh with vertical slats of timber or powder coated steel, although mesh presumably allows better visibility of events. A common balustrade treatment for many grandstands from the turn of the 19th century is to infill railings with diagonal timbers. These can be backed with fine mesh to meet BCA where necessary and are relatively transparent.

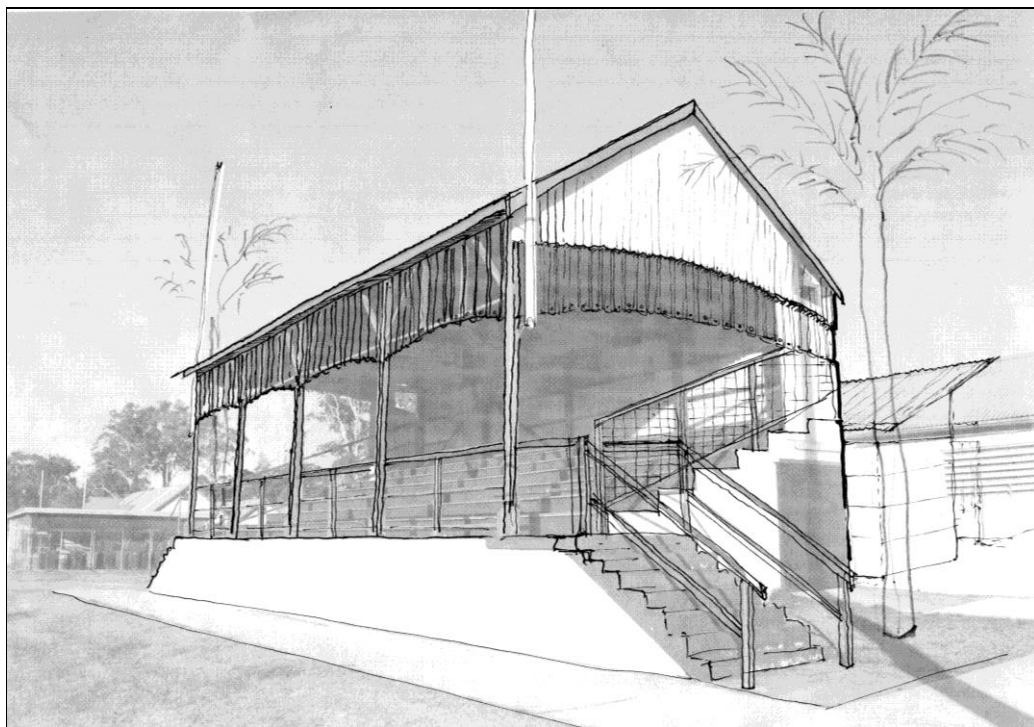
Indicative conservation option showing additional sun-screening and palm trees.

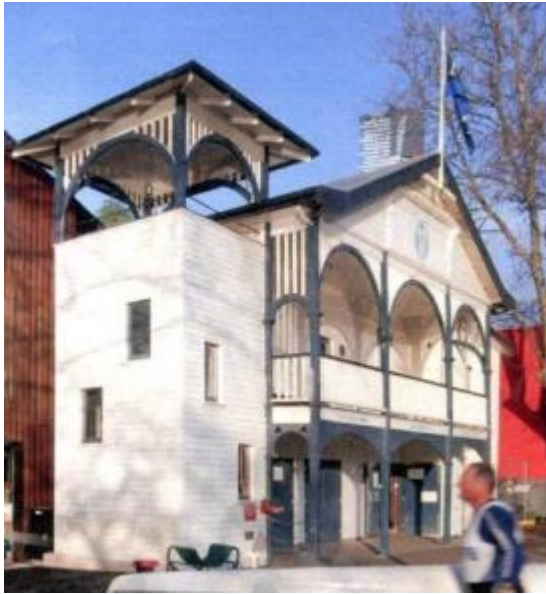
Suggested grandstand colour scheme

It's not known if there is any historical basis for cream and green having been used on the grandstand, however that colour scheme is now tired and has been overused at the showground.

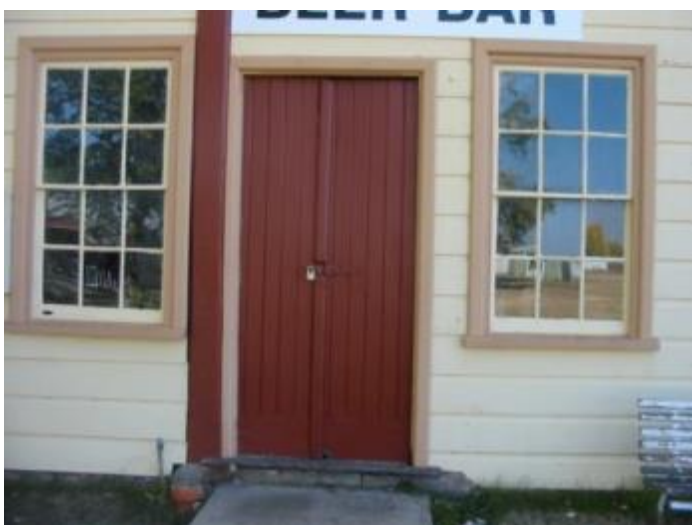
Polo flat – door and window to underside of grandstand

- Good historic integrity,
- Well maintained fabric,
- Simple but attractive colour scheme of three colours – off white, pale tan and Indian red.
- Strong use of diagonal bracing that is also reflected in the diagonal balustrades.
- Seating extending forward of the roofline
- Sky light visible between rear wall and roof,
- Bench type seating along back wall
- Separation between stepped access aisles seating surfaces,
- Very high quality of under-seating infill using traditional weatherboards, vertically panelled timber doors and multi-pane sash windows. See lower photo

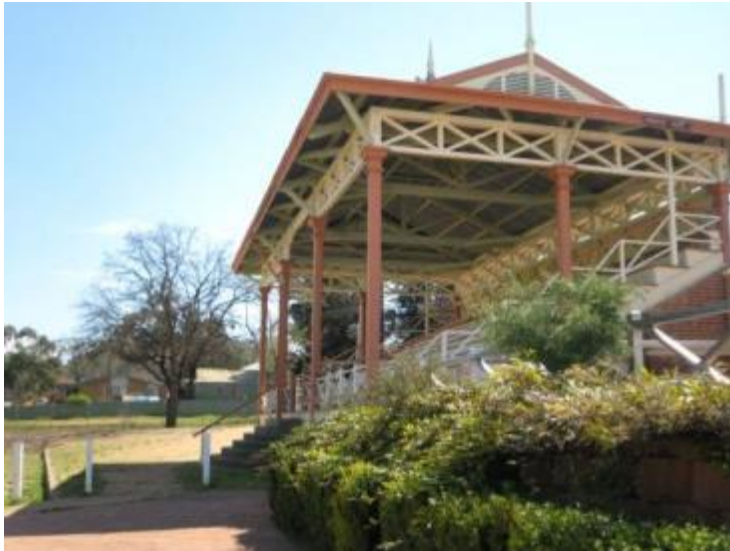
Cooma showground grandstand

The Cooma Showground grandstand has a number of similarities with that at Polo Flat. However it is a larger grandstand with slightly richer detailing. This grandstand uses garden beds to the side to help define spaces and pathways. Note that diagonal balustrading is also used above the garden bed. This extends the attention to detail into the landscape.

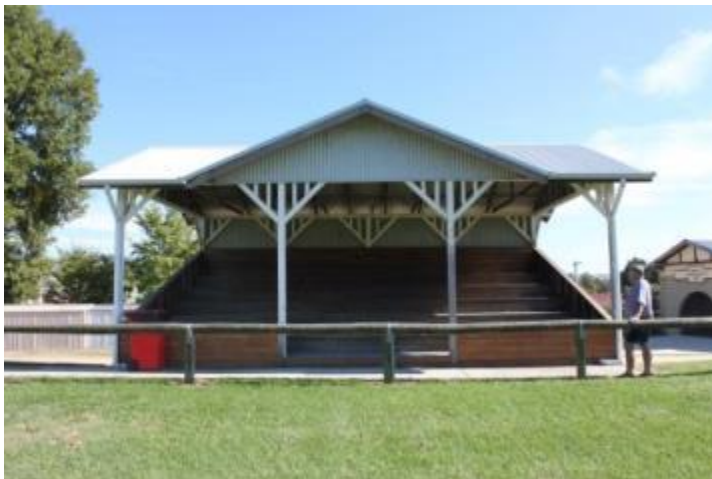
Bombala grandstand – the gable reflects that used on the animal pavilion.

The Bombala Showground grandstand is a relatively new (or extensively restored) small scaled structure.

Note the use of timber for seating and side wall enclosure.

Roof and gables are clad in galvanised iron, not colourbond or zincalume.

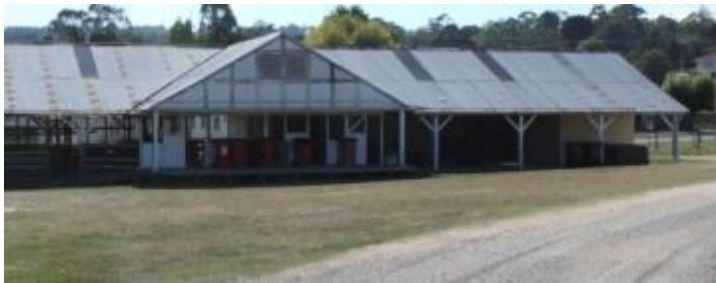
Bombala Showground animal pavilion with prominent gable and visually strong diagonals

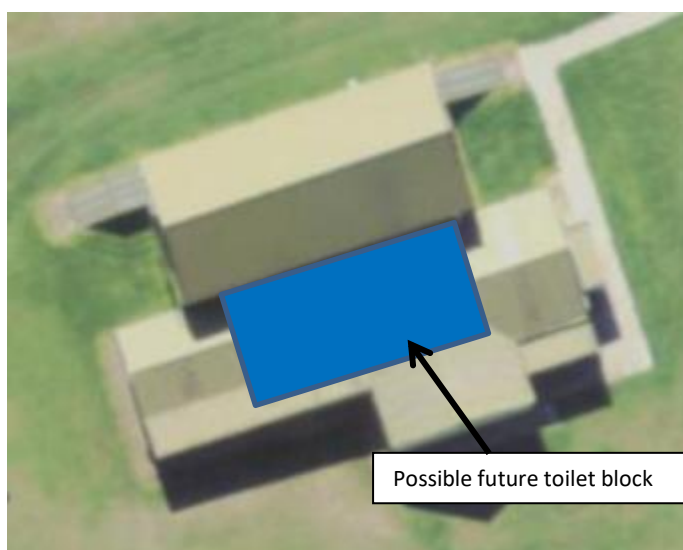
The new toilet block should ensure that the original proportions of the grandstand remain clearly evident.

12. The amenities block should be at the rear of the grandstand, and have less of an east-west dimension so that the original proportions of the grandstand remain clearly evident.
13. Current heritage philosophy suggests that new structures adjacent historic buildings be in a style of their time. The building could be conceived either as a simple skillion attached to the main building, or as a more modern skillion attached to the grandstand by a lower-roofed link. Another option is to link the toilet block roof to the grandstand with a narrower and lower flat roof. This enables the toilet block to have a reverse skillion and more modern styling. Of the two options, the use of a linked, modern but sympathetic skillion is preferred.

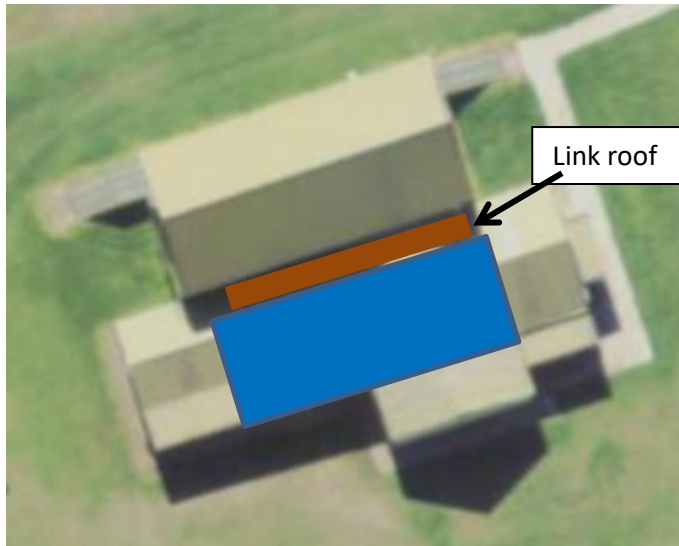
An option is to link the toilet block roof to the grandstand with a narrower and lower flat roof.

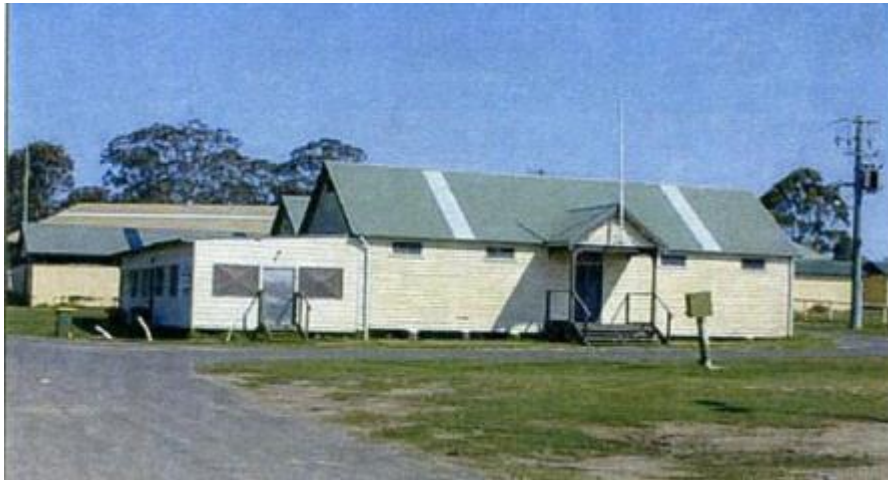
Exhibits Pavilion 2004

By 2004 the building had an additional pavilion attached to the rear with a matching pitched roof and valley gutter, plus a shallow roofed skillion on the eastern side.

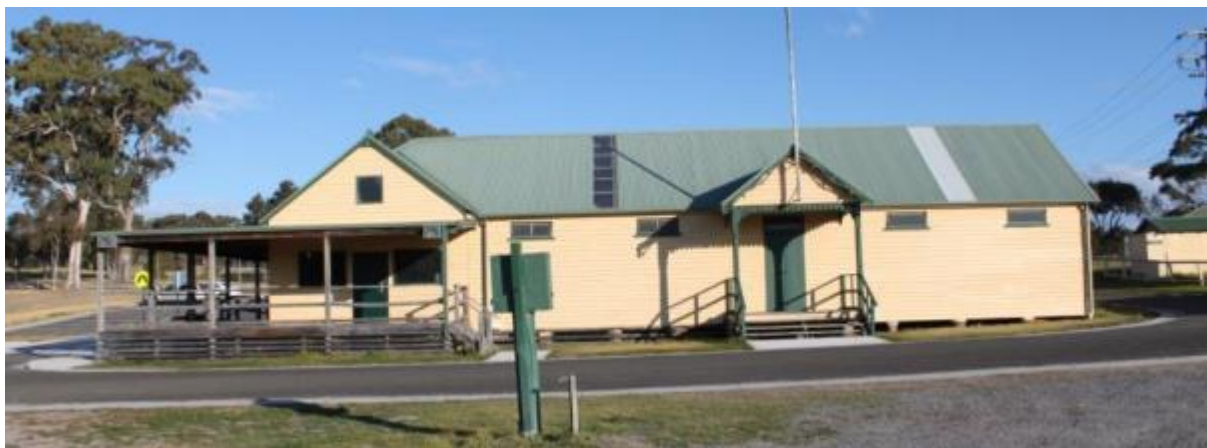
Extension on the eastern side of the Exhibits Pavilion

In about 2007 the shallow skillion roofed section was replaced with the current gable-roofed structure with skillion verandah on the north and east sides.

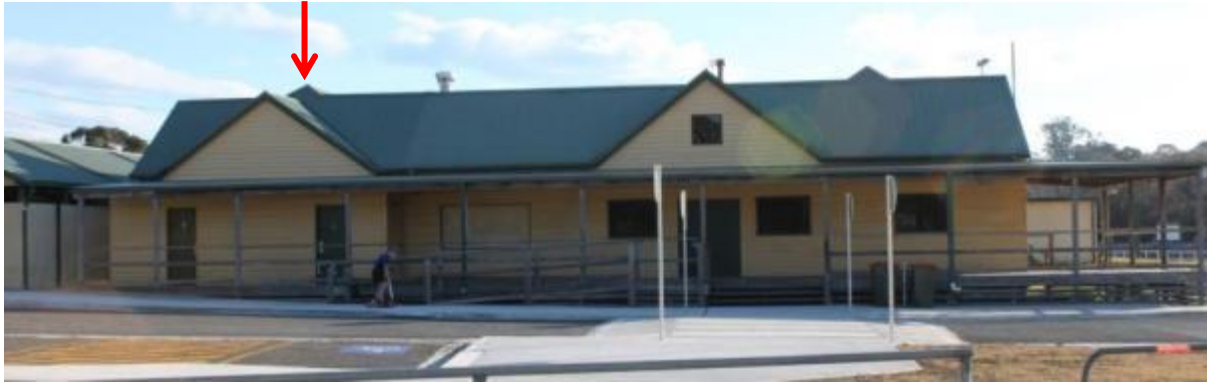
Toilet and change room addition behind the Exhibits and Poultry Pavilions

Also around 2011, a third gable roofed structure (arrowed below) was added between the front two pavilions and the Poultry Pavilion to provide toilet and change room facilities for the adjacent sports field.

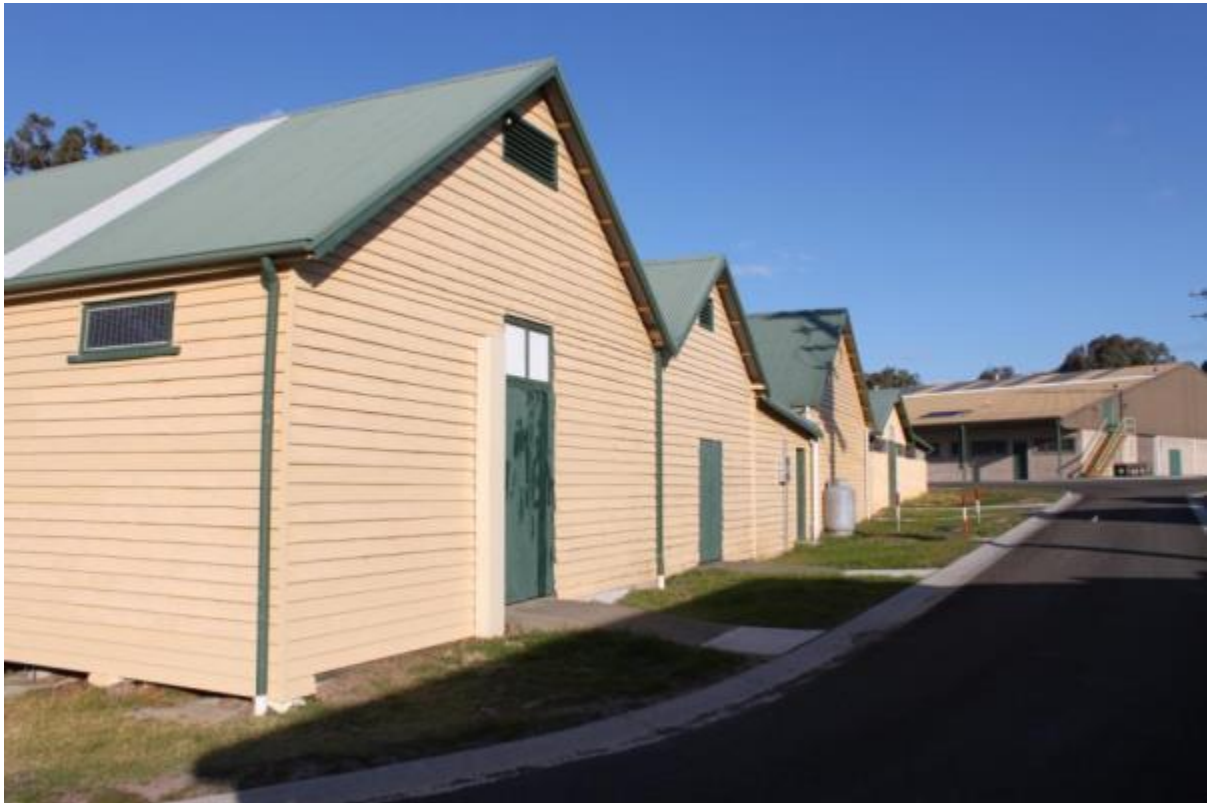
The buildings have consistent roof pitch, gable treatment and external weatherboard cladding and create an interesting 'streetscape' of building elevations on their western side that extends to, and includes, the poultry pavilion. The ubiquitous cream and green colour scheme has been applied to all the buildings.

The potential character of the repeated forms is not fully developed.

The western face of the Exhibits and Poultry Pavilions

The recommended strategy for the renovation of this group of buildings is to make minor alterations to upgrade their performance and appearance and develop a new colour scheme to highlight their character. An example of this can be seen elsewhere in Eurobodalla, as per the below images.

16. To provide weather and sun protection, and to enhance the historic character of the west elevation it is recommended that simple corrugated iron awnings be installed over each central doorway as per the below image.

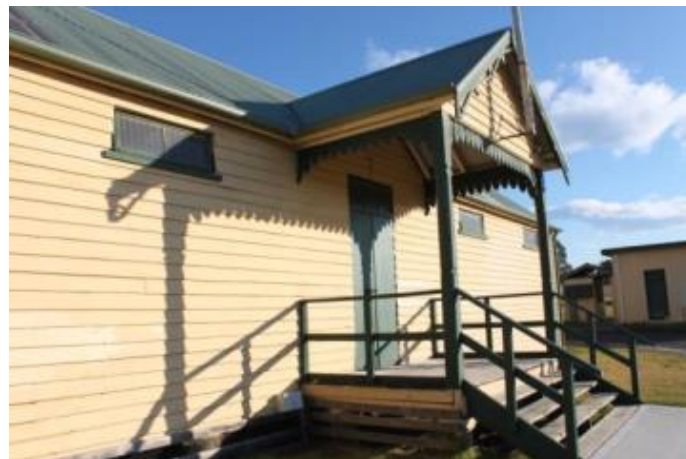
The decorated entry porch is a key heritage feature of the Exhibits Pavilion

- *Dulux Lime White* - walls and gable to match the Grandstand
- *Dulux Blue Accolade* - a darker blue /grey for posts, top of handrail and barge capping, door frame
- *Dulux Bay's Water quarter* - a soft pastel blue for decorative barge board, porch valance, intermediate handrails, vertical panelled door

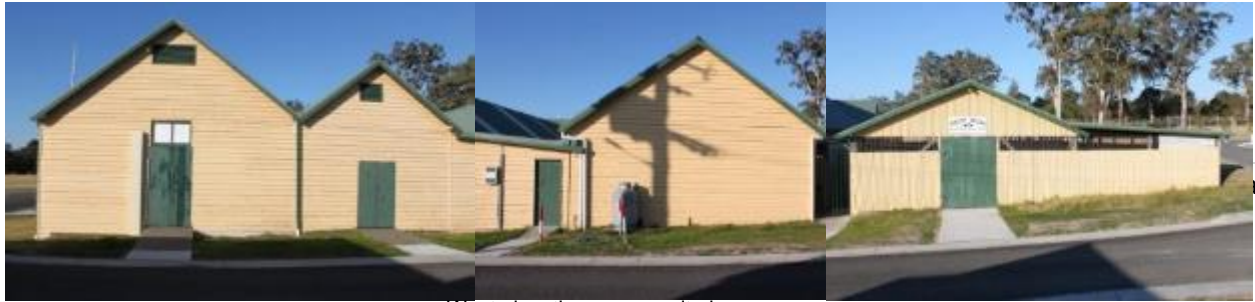
West elevation - composite image

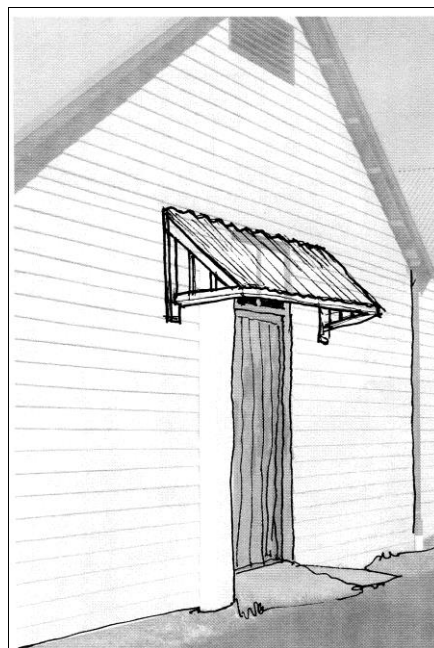
Suggested awning for western doorways

- Dulux White Box (pale pastel green) walls with Natural White trim – Poultry Pavilion
16. To provide weather and sun protection, and to enhance the historic character of the west elevation it is recommended that simple corrugated iron awnings be installed over each central doorway as per the below image.

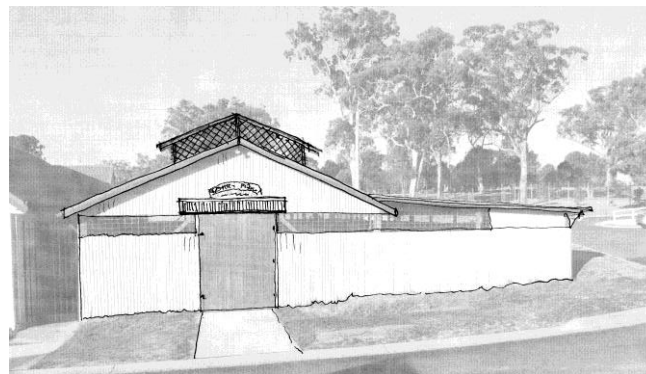
Recommended clerestory addition to the Poultry Pavilion

17. To improve ventilation in the Poultry Pavilion it is recommended that a ventilated clerestory be added into the roof as indicated below. An awning should be added over the western doorway to provide additional sun and rain protection. This could also be extended the full width of the gable if desired.

17. To improve ventilation in the Poultry Pavilion it is recommended that a ventilated clerestory be added into the roof as indicated below. An awning should be added over the western doorway to provide additional sun and rain protection. This could also be extended the full width of the gable if desired

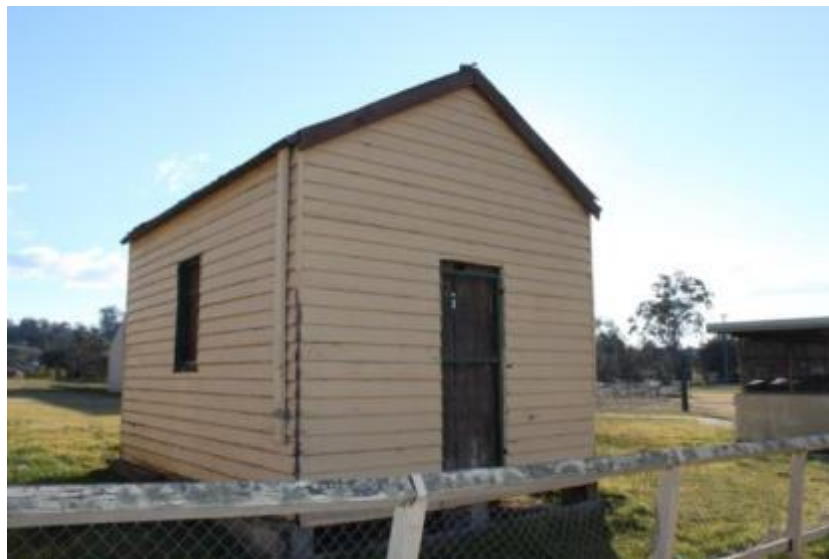
This small building is sometimes referred to as the 'original secretary's office' from the old showground site. Armes notes *that it was possibly one of the original buildings built from 1881, and relocated in 1914*. He assesses its heritage significance as '*Moderate*' and recommends that it is *conserved for continued storage, or possibly new small scale compatible use*.

The building was subsequently relocated from its former location next to the poultry pavilion in about 2011. It is a simple structure and although its condition is poor, it would be a relatively easy building to restore or up-date for a compatible new use.

Former storage building/original secretary's office. Photo 2018

18. Sympathetic adaptation of the windows and doors of the original secretary's office would be appropriate and detailing should generally follow the existing.
19. Location, orientation, window and door arrangements plus colour scheme will all depend on the building's final location. It is recommended the building be co-located with the proposed secretary's office and linked with paving, decking or a covered walkway.

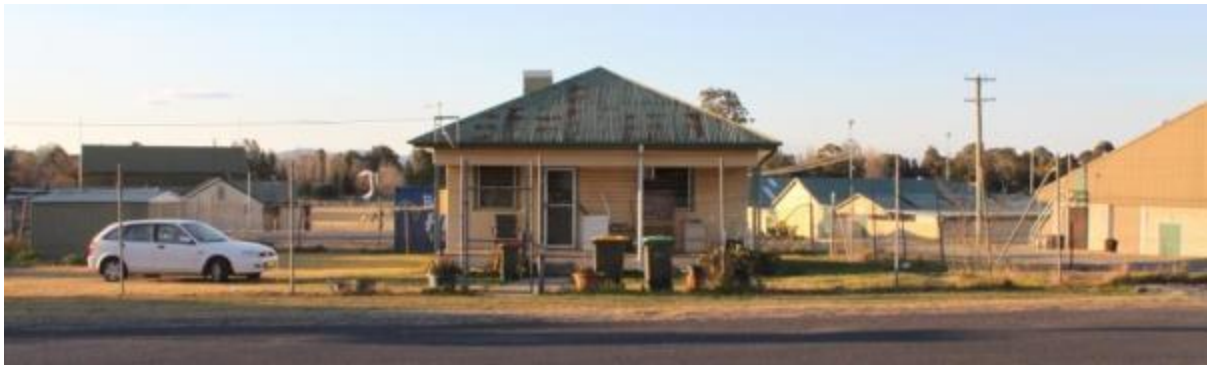
The cottage is effectively a square building with weatherboard walls and a pyramidal roof, built in the 1950s and presumed to have been built on-site rather than relocated from elsewhere. It is a simple but attractive structure in generally good condition.

Caretaker's cottage, Albert St elevation, 2018

20. It is recommended that the caretaker's cottage not be realigned and that the final arrangement of these structures be resolved as part of the detailed architectural design and layout of the group H2, H3, and M3.
21. The caretaker's cottage could be extended through the addition of shallow pitched skillions or linked pavilions with a roof pitch similar to existing. A small addition could be done as an attached skillion, but a large addition should have a pyramidal roof with a small connecting link. Additions would best be located on the east west or north sides depending on internal design layout.

22. Recommend colour scheme is walls Dulux *Warm Neutral* with *Natural White* trim.

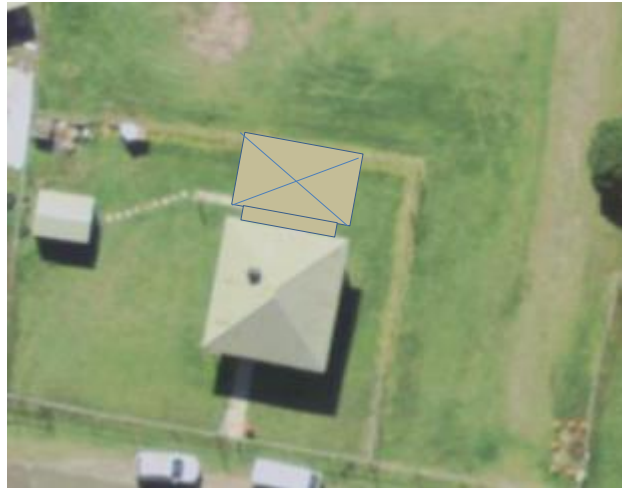
Caretaker's cottage with linked addition.

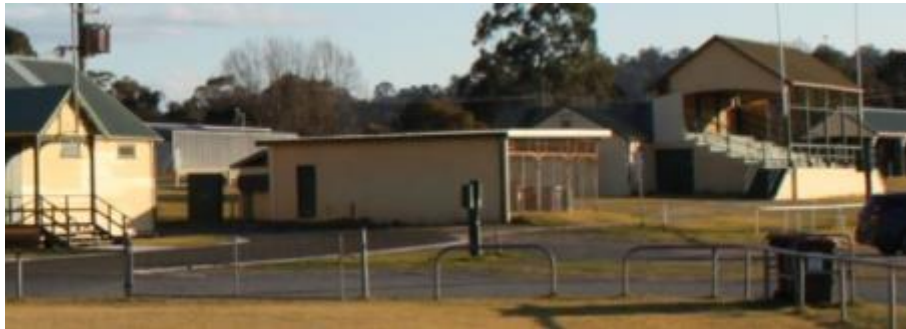
Eastern elevation

The current bar has no heritage value and should be demolished. It comprises a cement block wall on the eastern side with bar and covered serving area on the west. The bar is used for bin storage between events.

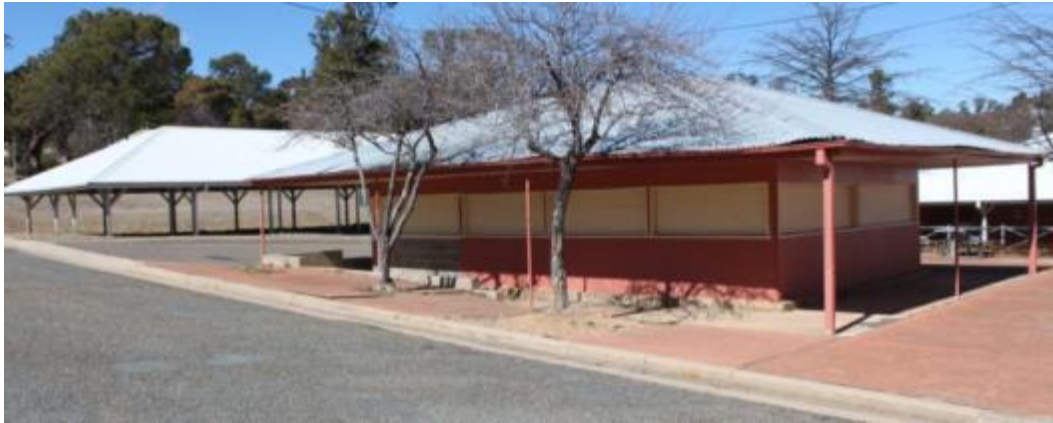
The facility is set within a hard landscaped area that includes two medium sized deciduous trees on the north side and tables with seats under trees in a fenced area on the south west. These tables are a short distance from the bar which minimises crowding and congestion.

The bar roof reflects the form of the roof over the nearby animal pavilion and because of this fits harmoniously into its context. The space is enclosed by a metal fence with diagonal infill struts that visually link to the grandstand. Toilets are located nearby under the grandstand and in the large multipurpose centre. Toilets are not included within the bar itself.

Cooma Showground bar with two trees on north side

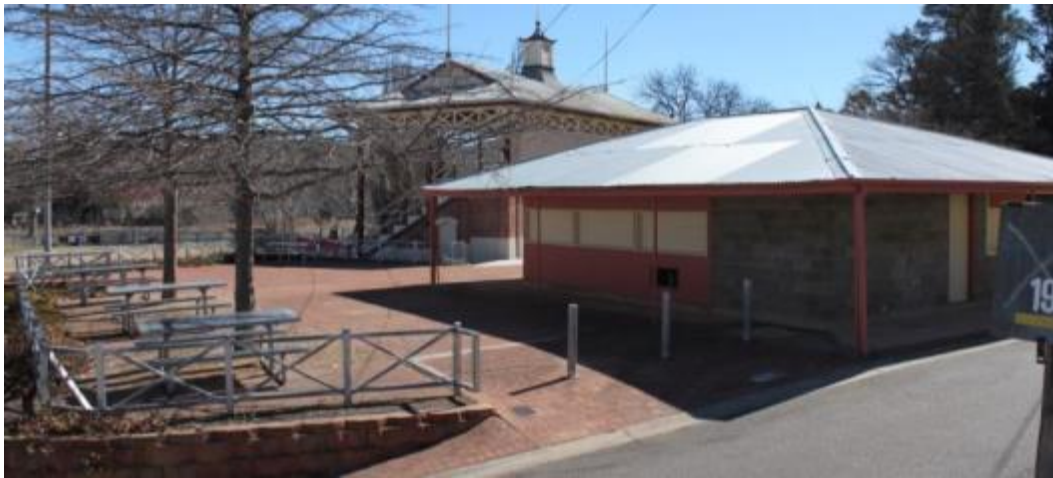
Durable tables and seats under trees on the south west side a short distance from the bar.
The fence defines the space and links visually to the grandstand

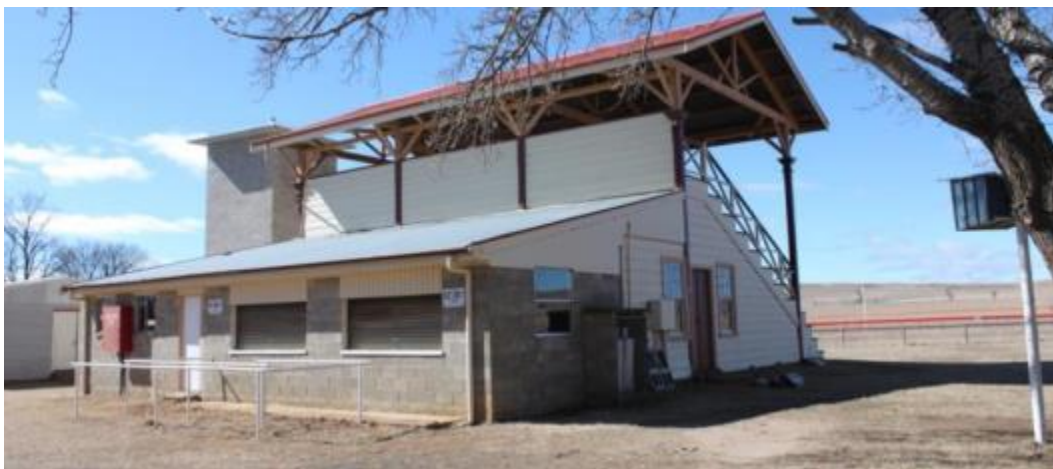
Polo flat has a more pragmatic and less appealing bar complete with queuing rails and fire hydrant built on the back of the its grandstand. The toilets are in a nearby freestanding structure clad with colorbond metal weatherboards.

Polo flat bar

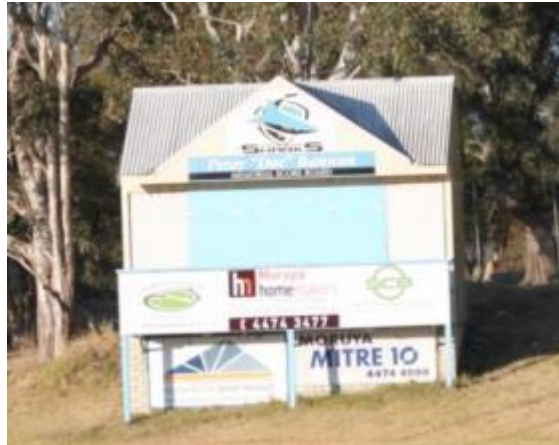
A roof form such as this might be appropriate for the bar.

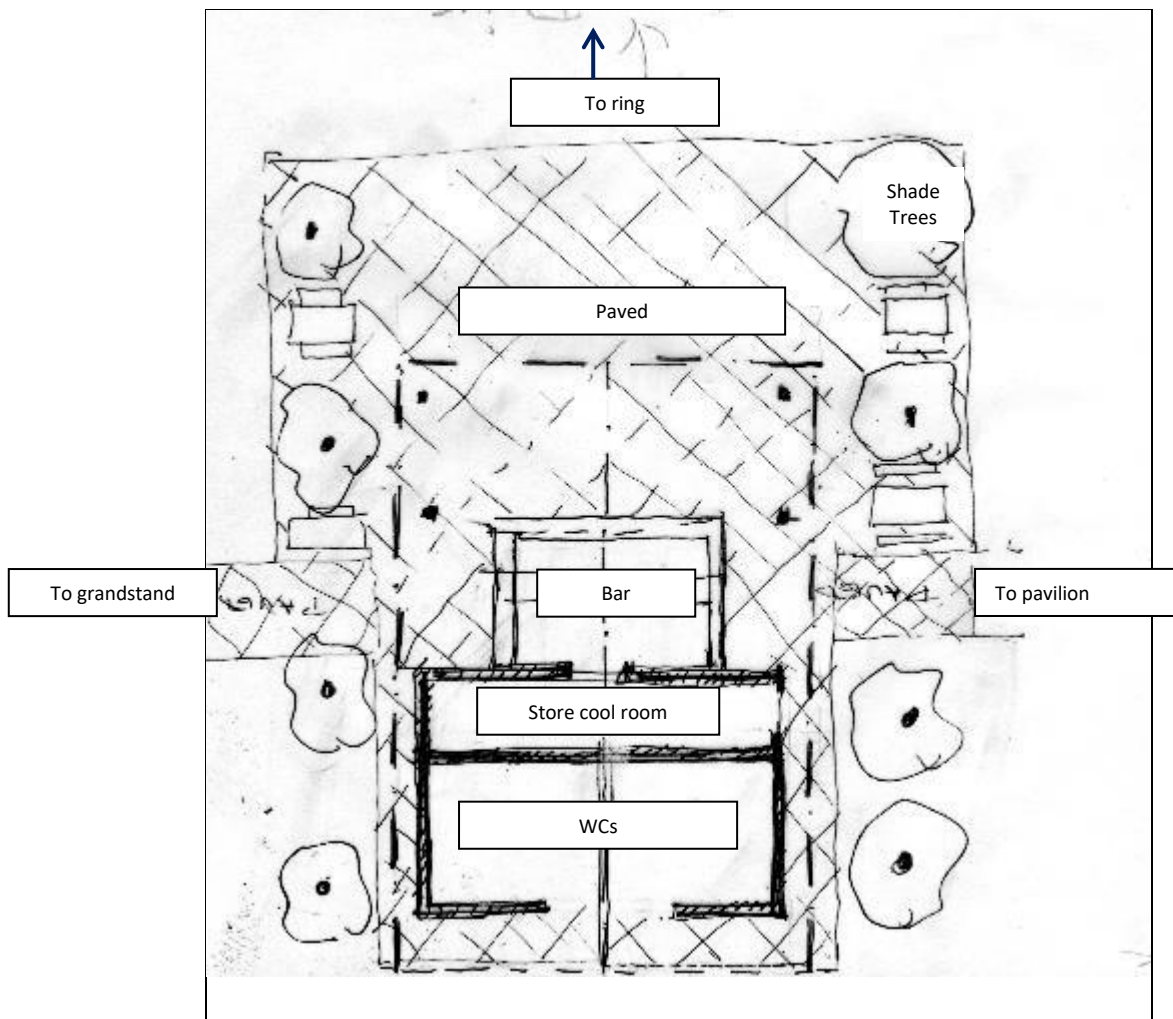
Conceptual layout for bar with WC's behind. North to top of page

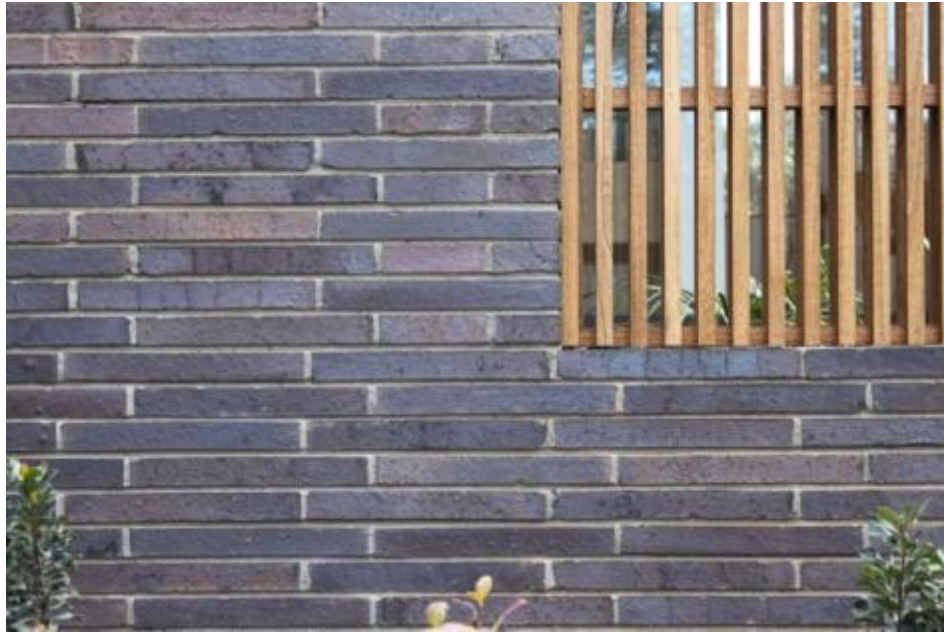
Use of quality face brickwork would be appropriate for the walls of the bar and would fit well with the showground's heritage theme.

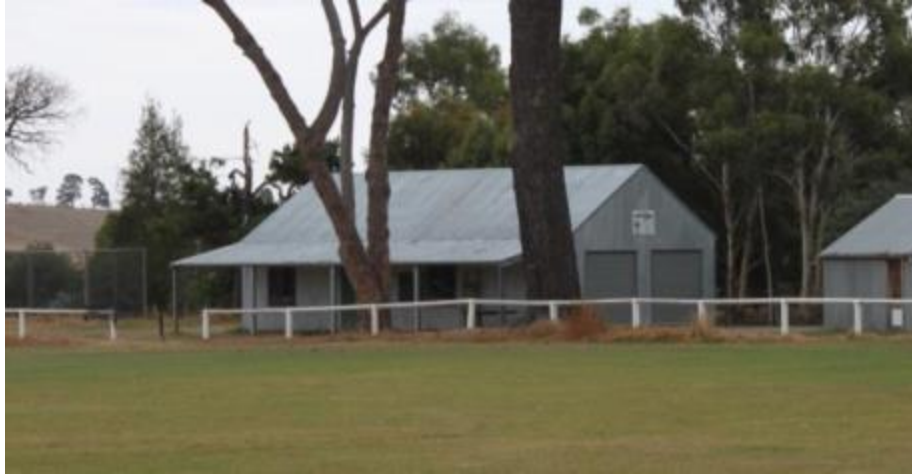
Storage and facility shed at Gundaroo Showground clad with galvanised iron.
This structure has good sympathetic historic character

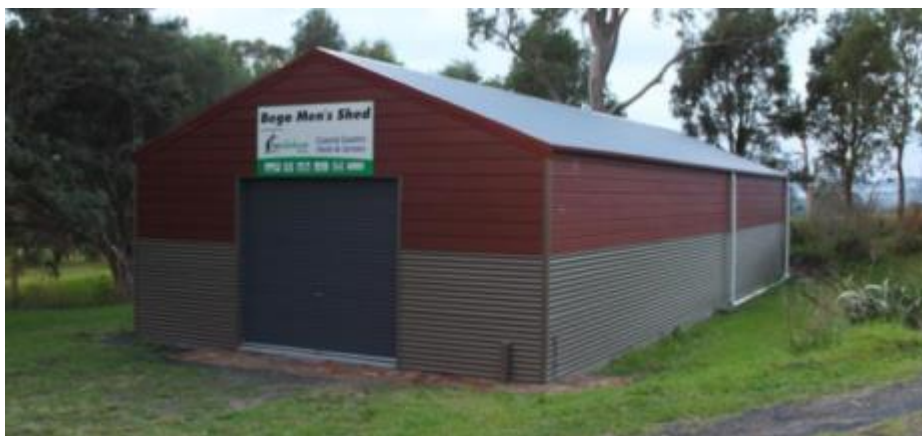
The Bega Men's shed is modern, but fits into its historic context by careful choice of colour and cladding material.

The Bega men's shed uses a combination of corrugated colorbond as a base and fibre cement weatherboards for the upper half of the walls.

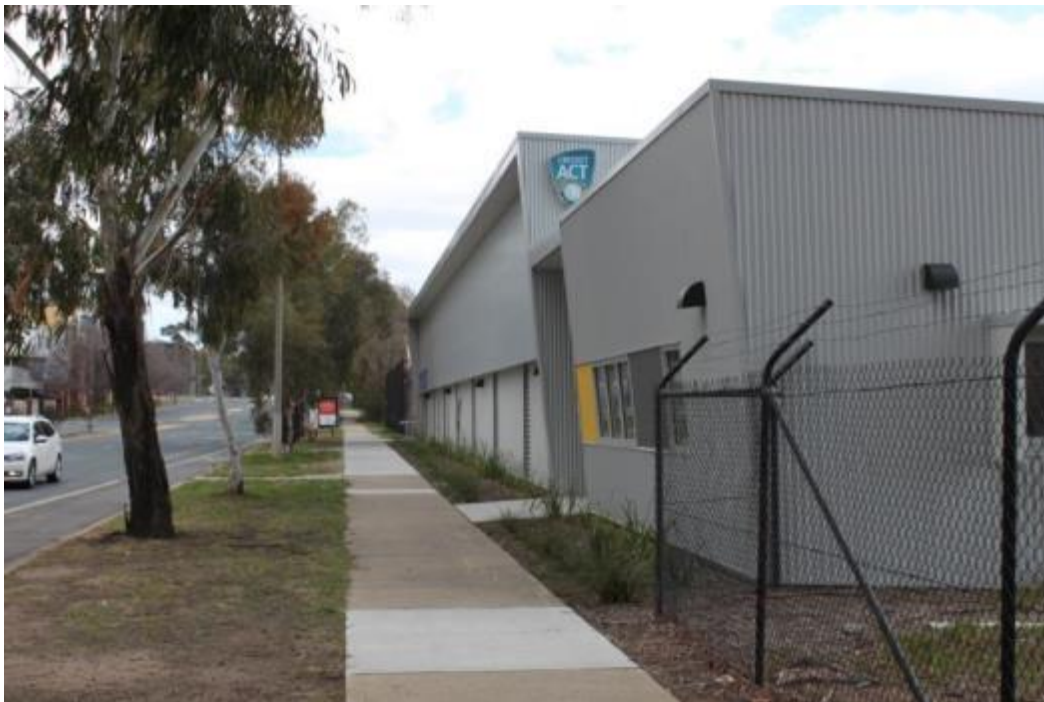
Cricket Australia building / shed at Woden Valley Oval. The fence in front of the shed has been deleted and replaced with low maintenance landscaping. This removes the waste space between the fence and the building and frees up space between the building and oval on the other side.

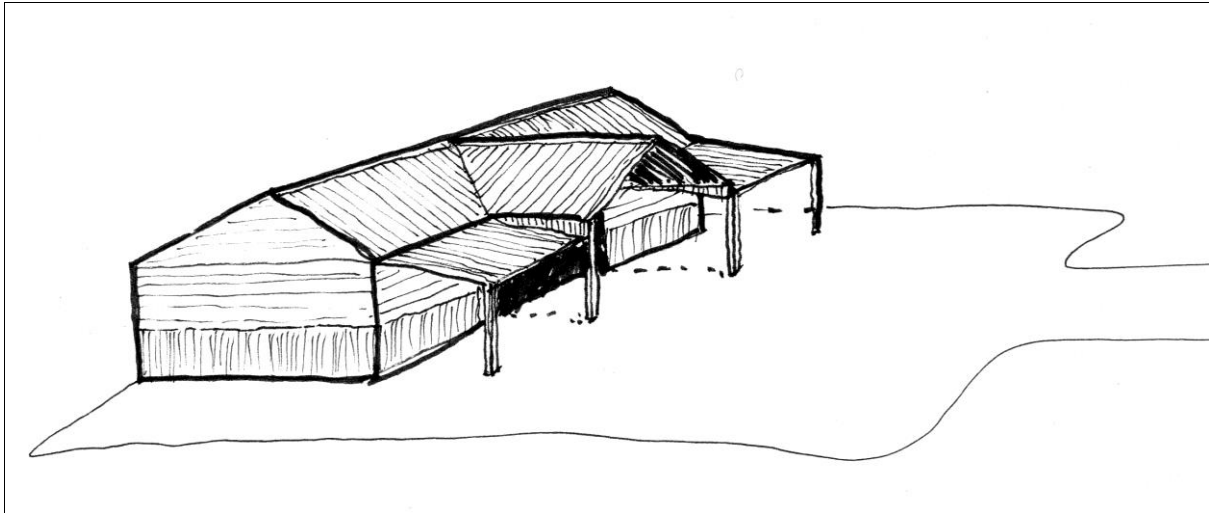
Concept for shared maintenance facility M5 with centre gable facing the oval

37. The building should have a gable roof with pitch matching the other more historic buildings on the site. The wall facing the oval could include an additional gable with high doors and a covered external area. The walls could comprise a combination of materials such as corrugated iron or brick in the lower half with fibre cement weatherboards in the upper portion. The design should seek to have one face along the perimeter boundary

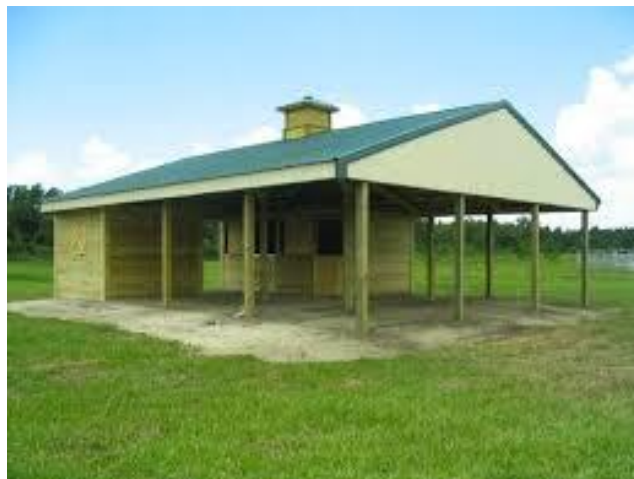
A gable-roofed stall three bays wide with secure spaces in the rear corner.

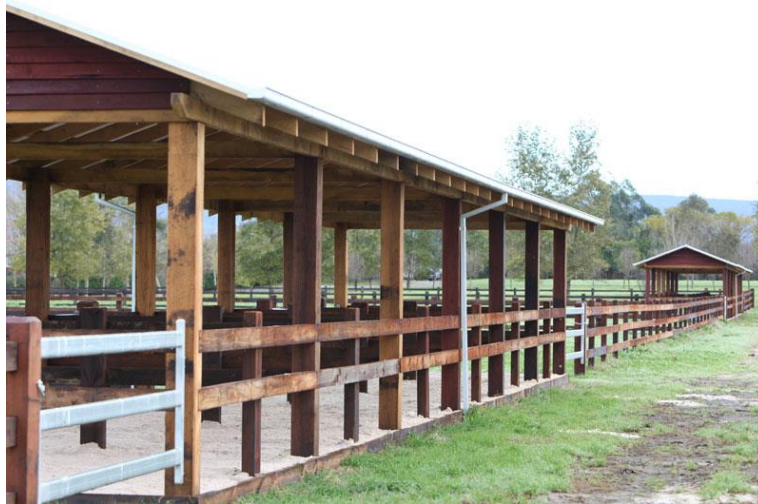
A gabled roof stall constructed from robust and durable timbers with simple but well executed attention to detail. This building style would fit well with Moruya's historic character.

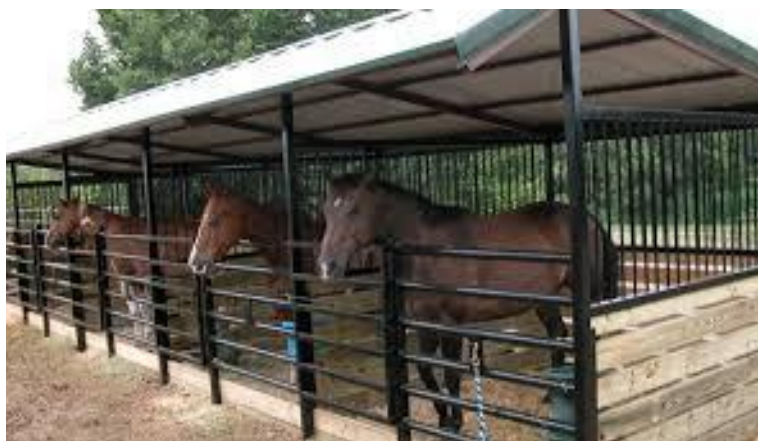
This is a modern set of stalls with powder coated steel frame, timber wall dividers and corrugated metal roof. Note that the roof ridge sits over the front line of posts creating a gable like effect that fits with Moruya Showground's character. The stall could be arranged back to back with a valley gutter between, or with fronts facing across an open walkway as shown below.

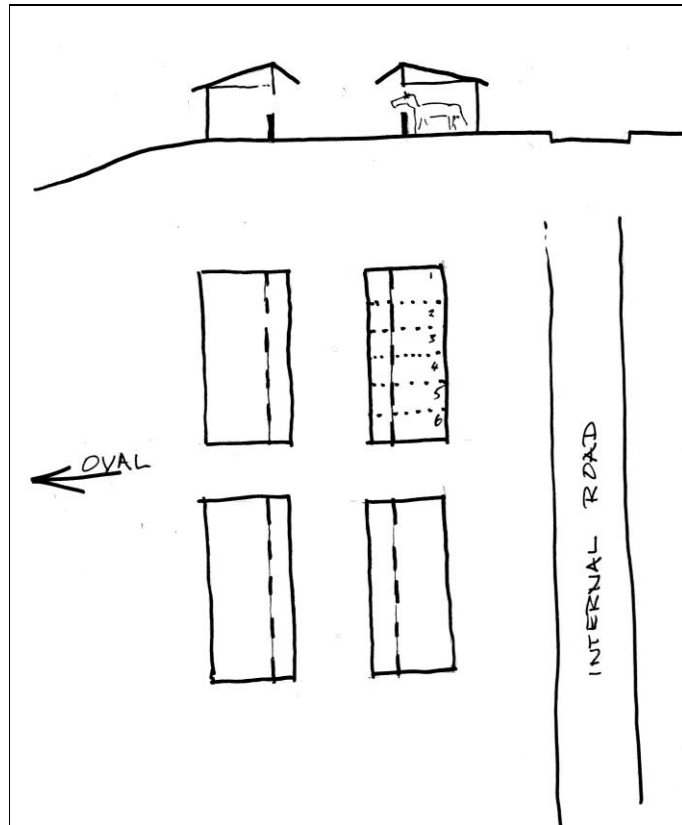
Open stalls facing one another in four banks of six. Solid timber panelling could be added around some stalls to cater for differing needs of horses and owners. Drug testing located under the extended roofline.

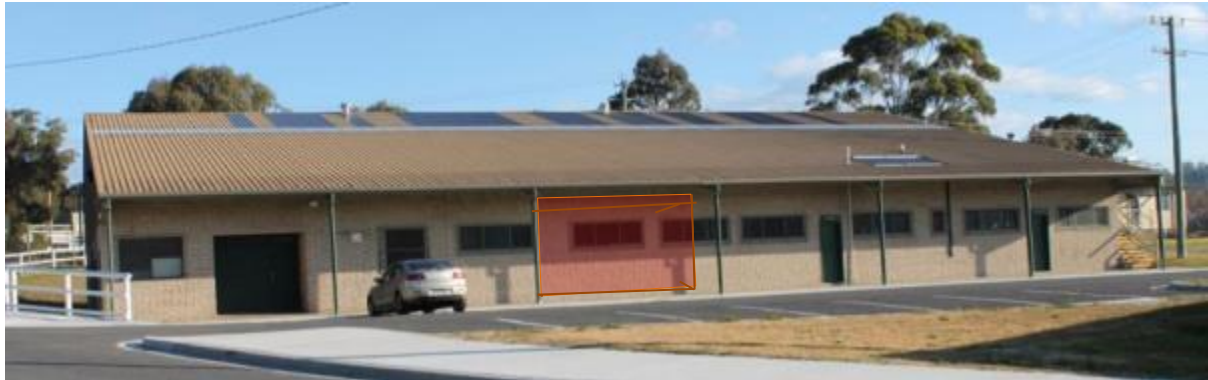
- Open the centre of the wall to create a large welcoming entry foyer.
- Install more attractive security screening to the windows.
- Visually soften the front verandah by adding a secondary beam below the fascia and planting hardy vines/creepers to grow up posts and along the beam. This is a tough building and can handle plants growing on it.

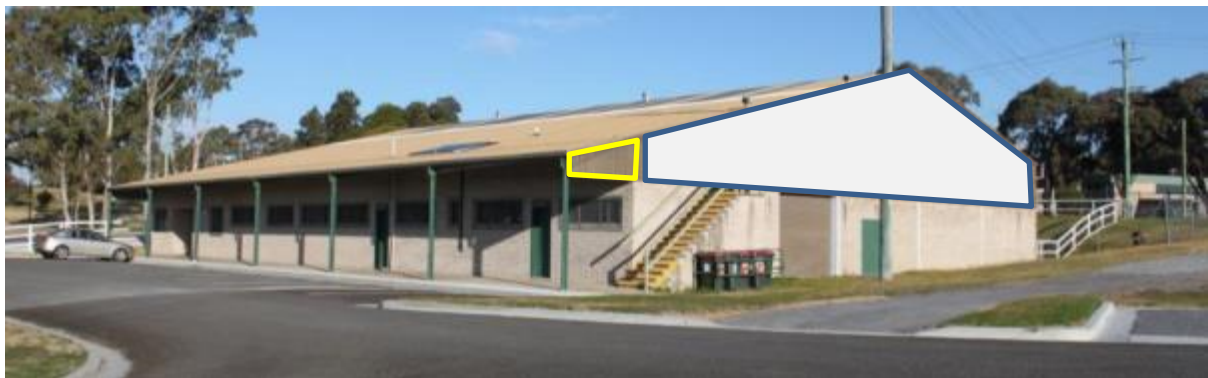
- Delete the end cladding outlined in yellow so the verandah reads more neatly as a skillion.
- Re clad the gable end shown white, on vertical 'Dune' corrugated colourbond to visually lighten the building.
- Grow Virginia creeper or similar climbing vine over the brick wall to mask it with vegetation. Plant small light-weight shrubs in front of the west wall to mask the wall but not interfere with power lines.

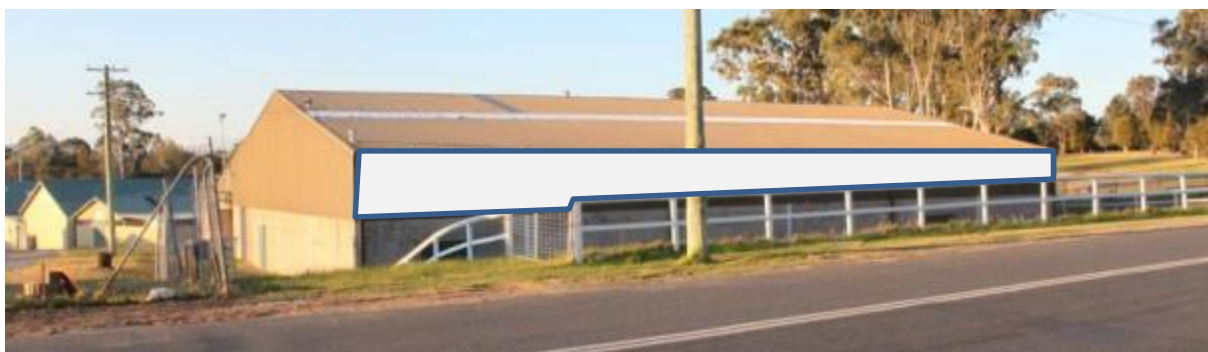
- Reclad the south and east elevations in off-white vertical corrugated colorbond.
