Moruya Showground Design Guidelines

December 2018

Prepared by Pip Giovanelli

Heritage Advisor, Eurobodalla Shire Council

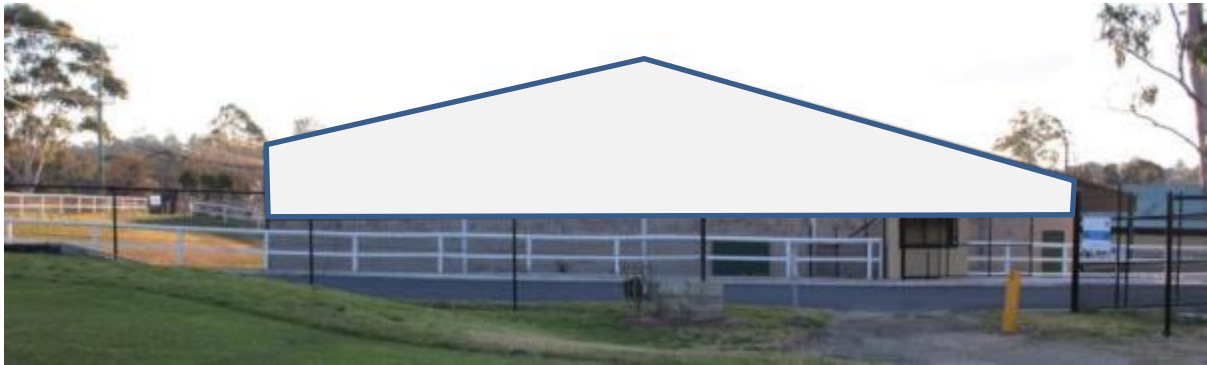
- Reclad end wall and expose front skillion verandah.
- Introduce narrow light weight trees as screen planting between the east wall and entry fence

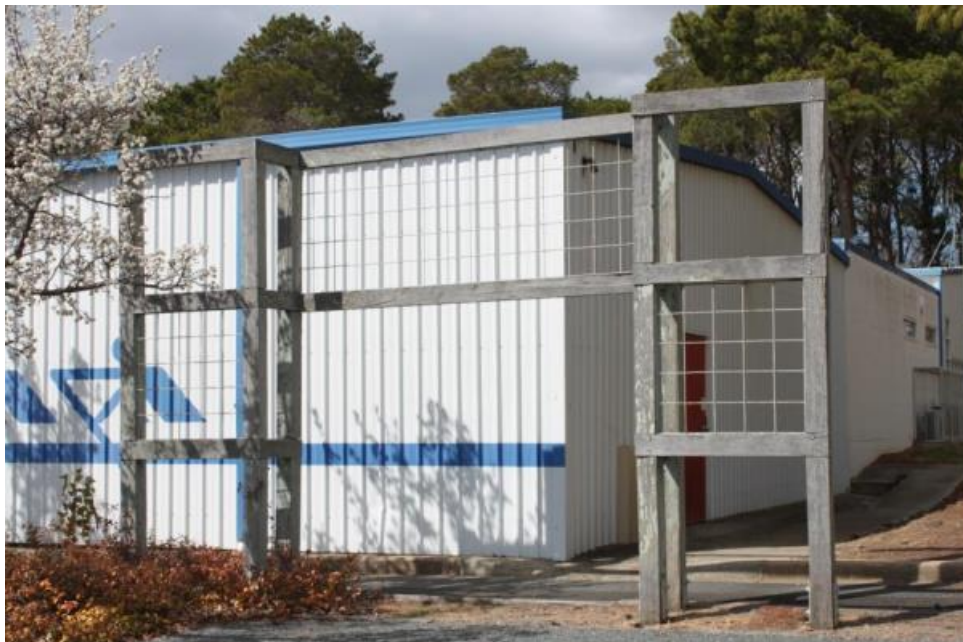
Vegetation climbing frame used to mask building. Climbers (if ever planted) have not been maintained. Even so, the screen aids in breaking up the scale and impact of the shed behind.

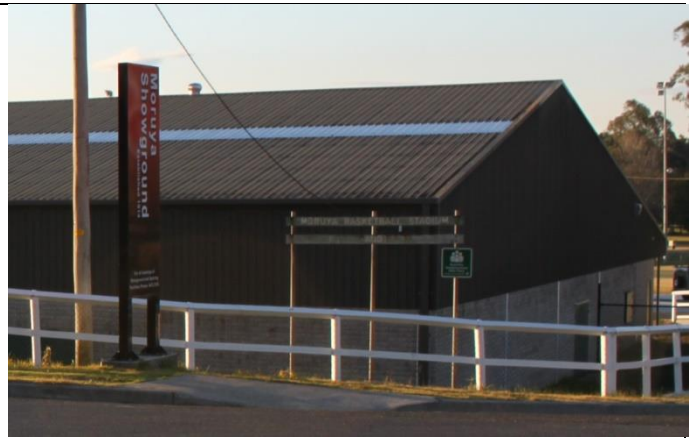
Showground and basketball stadium sign at entry

The current showground sign is no longer considered appropriate. The style, font, text orientation and background colour have little if any relevance to the grounds, their use or history. The basketball sign is almost illegible and suggests a low-grade make-do facility. There is the opportunity to make the sign more relevant and more welcoming. It may also be possible to use the sign to partly screen the stadium.

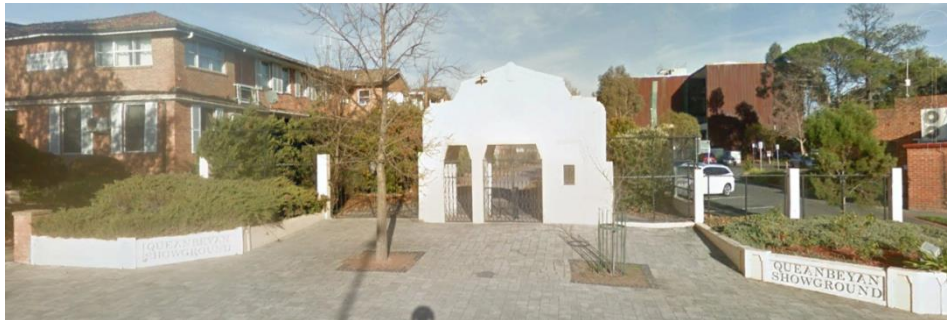
Art Deco gates erected circa 1930s, Lowe St Queanbeyan. Note that the sign incorporated into the edge of the planter bed is not ostentatious but remains clearly legible.

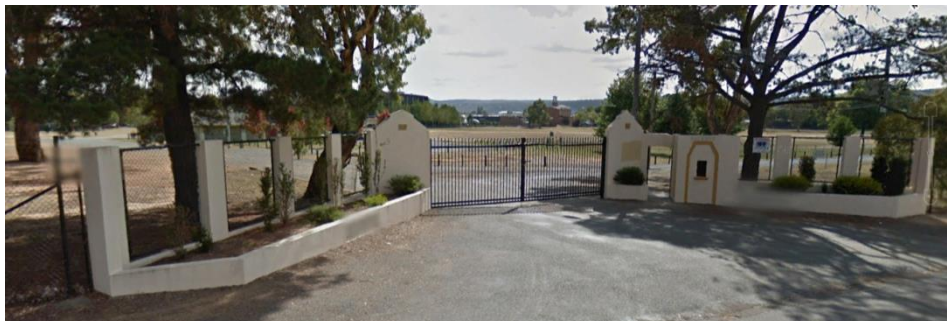
New gates in Farrer Place circa 2010 continue the Art Deco theme.

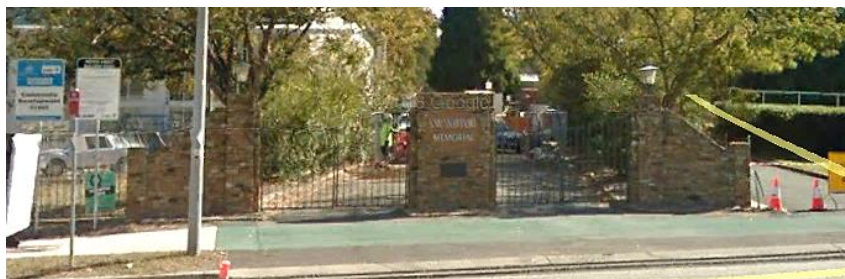
Large vehicle gates in Glebe Place Queanbeyan erected circa 2015 draw on the earlier design.

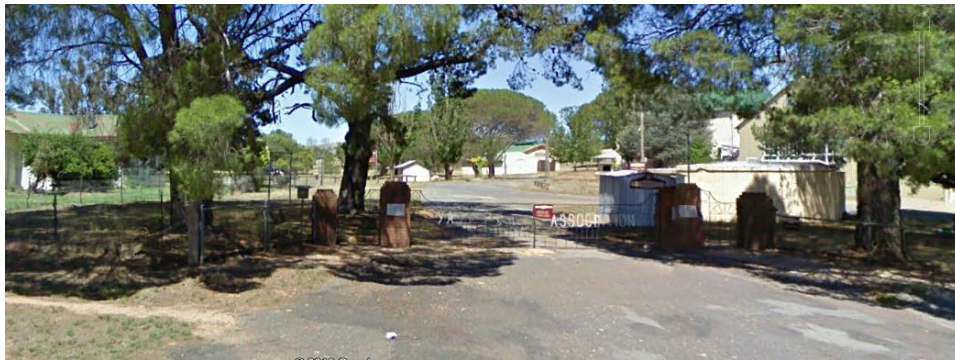
The gates at Yass football oval commemorate a significant member of the community. The entry is enhanced by flanking walls built from the same stone and the landscape's symmetrical layout.
Google image

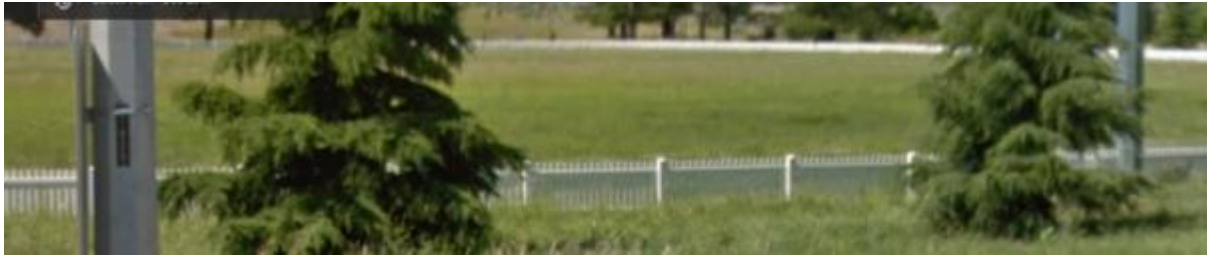
Metal picket fence at Australian Defence Force Academy has a traditional appearance but is low maintenance.
