This Conservation Management Plan (CMP) has been commissioned by Eurobodalla Shire Council (ESC), and forms the basis for conservation of heritage values to be protected during the establishment of new uses of the building.

This Conservation Management Plan (CMP) investigates and establishes the cultural significance of the former Mechanics' Institute, Page Street, Moruya NSW. This summary should be read in conjunction with figures 2 - 5.

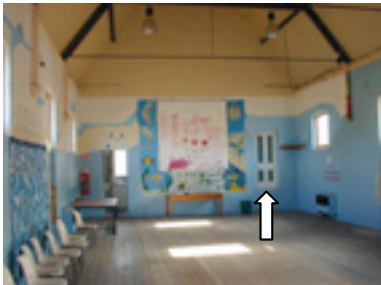
Plate 3

MAIN HALL LOOKING WEST TOWARD  
KITCHEN DOOR (LEFT). THE DOOR  
ON THE RIGHT INDICATES THE  
HEIGHT OF THE FORMER STAGE,  
NOW REMOVED.

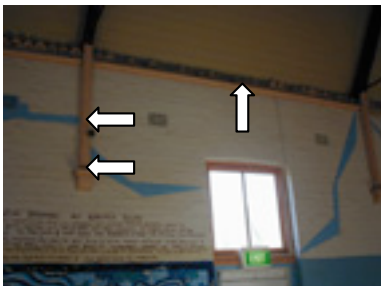
Plate 4

TRANSOM WINDOW DETAIL,  
BOSSES AND CLEATS OF ROOF  
STRUCTURE

NOTE ALSO THE DELICATE  
ACROTERION USED AS A CORNICE.

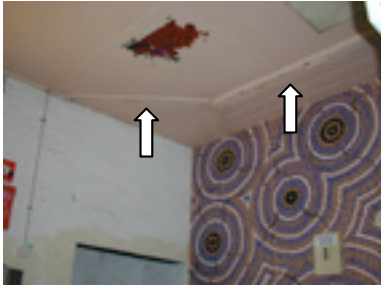
Plate 6

KITCHEN CEILING, LOOKING NORTH-WEST. NOTE THE TRIANGULAR PANELS SHOWING LOCATIONS OF CORNER FIREPLACES, AND THE TOP PLATE OF A FORMER STUD WALL.

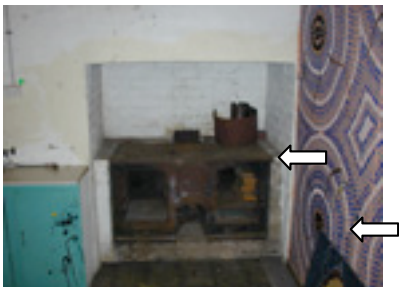
Plate 7

There is a cast-iron cooker in the north west corner, built into a brick breast (plate 7). It is not original. There is a panelled side door, which has been blocked off by the built-in kitchen benchwork. The window sashes have been removed and replaced with glass louvres fitted to the original box frames (plate 8).

CAST IRON COOKER – POSSIBLE ADDED IN THE 1920'S TO ASSIST THE ACTIVITIES OF THE C.W.A.

THE NORTH WALL IS RECENTLY BUILT

- Repair roof vents.
- Repair all barge details and moulding details on east facade.
- Replace non –original wall vents.
- Weatherproof cooking chimney base.

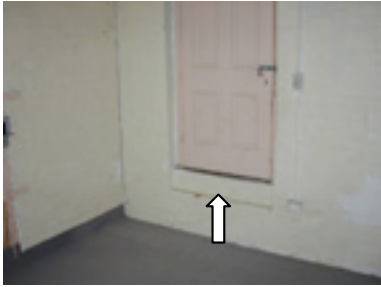
Plate 9

DOOR FROM THE 'GREEN' ROOM TO THE MAIN HALL. ELEVATED TO SUIT THE FORMER STAGE

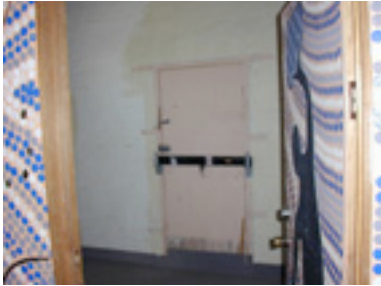
Plate 10

NORTH DOOR OF THE 'GREEN' ROOM HAS BEEN REINFORCED WITH STEEL SHEETING AND SECURITY WORKS

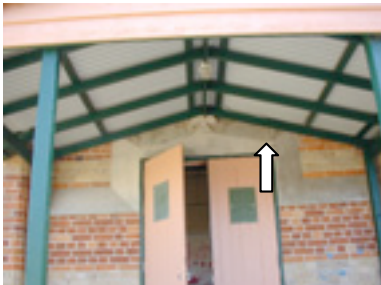
Plate 11

THE PORCH OBSCURES AN APPRECIATION THE DECORATIVE MOULDINGS ON THE OUTSIDE OF THE MAIN ENTRANCE

- Repair and return windows and doors to original appearance, in operable order, and with accurately selected period hardware (interior and exterior)
- Replace the entry porch with a more suitably designed structure. An unroofed terrace may be appropriate for easy access, and less interruption of the façade. The side doors can assume an increased role for access to the hall.

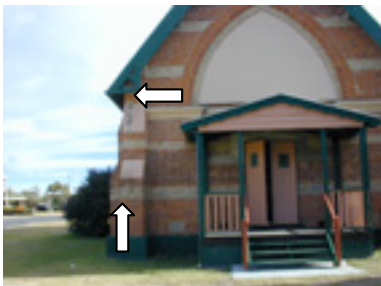
Plate 12

The brickwork expresses headers at every second course, and there are distinctive changes in colour at various levels (plates 12, 13). The bricks are laid with cut-and-struck joints (plate 15). Some wall vents are missing, and have been replaced with purpose-made steel grilles, made of expanded steel (plate 13). Above the door and windows are simple brick-on-end arches.

The eastern wall is the main façade of the building (plates 12, 17). Two foundation stones with "A.D." and "1880" confirm the age of the building. One of these is believed to contain a time capsule.

The roof purlins are express externally, and the bargeboard has quatrefoil and trefoil fretwork (plate 12). Above the door is a rendered band and details partly obscured by the porch roof. There are marks that show the location of missing details, and traces of lime wash that demonstrate the original finishes.

EAST FAÇADE. NOTE BANDING IN BRICKWORK, AND DECORATIVE DETAILS ON BARGEBOARD. THE ARCH, CORNICE AND BUTTRESSES ARE SIMPLE GOTHIC THEMES

THE PORCH IS AN UNCOMPLIMENTARY ADDITION

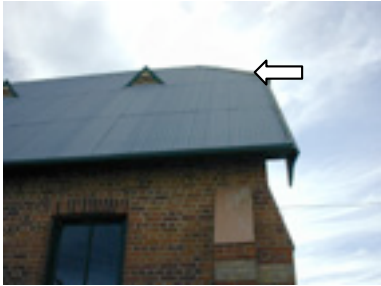
Plate 14

The distinctive jerkinhead can be seen at the eastern end of the roof. The roofing is corrugated iron and the hips are rolled. There is a replacement gutter at the bottom of the jerkinhead. There are four pairs of distinctive gabled vents on the roof (plate 14). Trefoil details are formed by the small valences.

THE ROOF HAS A JERKINHEAD FACING EAST (RIGHT)

THE ROOF VENTS MAY HAVE BEEN ADDED TO VENTILATE THE BUILDING FROM GASLIGHT FUMES

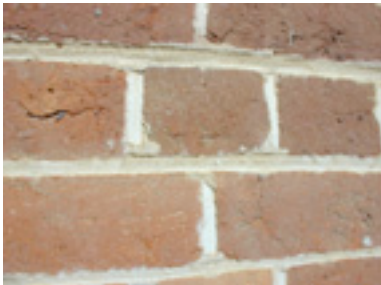
Plate 15

BRICK DETAIL SHOWING 'CUT AND STRUCK' JOINTS

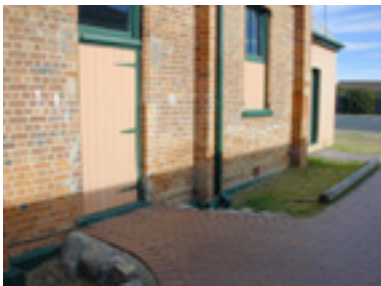
Plate 16

The main threat to the building is the salt damp at the north side. If not corrected, it will result in serious damage to the brickwork, mortar and internal finishes. Decay could also extend to the floor. Some stonework requires re-pointing in order to protect the stone, and prevent weathering.

SIDE DOOR ON NORTH WALL.

THERE ARE SERIOUS SALT DAMP PROBLEMS IN THIS WALL THAT MUST BE ADDRESSED

- Ensure adequacy of stormwater catchment and dispersal.
- Stabilise and repair damaged timber sills, and other deterioration of windows and doors.
- Re-point exposed stone plinth and weathered brickwork.

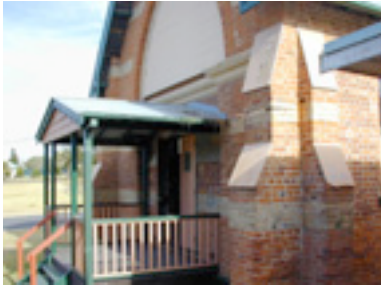
Plate 16

PORCH

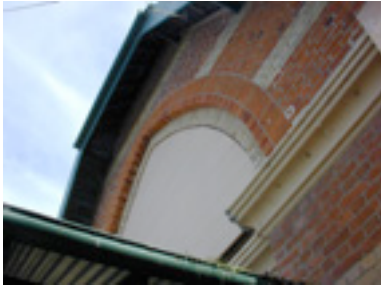
Plate 17

DETAILS ON EAST WALL, INCLUDE  
THE CORNICE, BRICK BANDING  
AND THE SHINGLE BATTENS ABOVE  
THE EAVES
