Tuross River Estuary and Coila Lake: Coastal Management Program

Final

September 2017

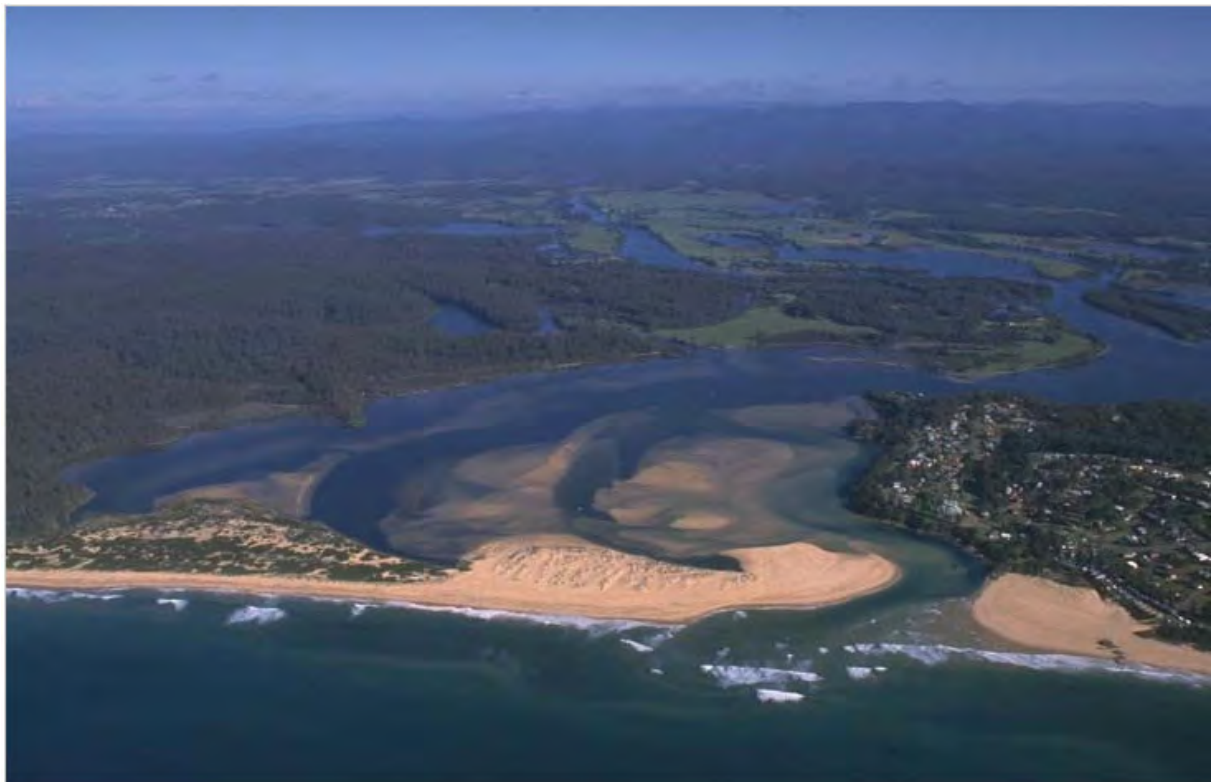
Figure 4: Tuross River Estuary

The Tuross River Estuary has a catchment area of 1,814 km². The upper catchment is steep and mostly forested, whilst much of the land of the Tuross River floodplain and surrounding the estuary itself has been cleared for cropping and grazing. The estuary is a semi-mature wave dominated barrier estuary as classified by Roy *et al.*, (2001) and consists of a complex array of lakes and channels, all formed behind a large coastal sand barrier. Estuarine vegetation in the Tuross River Estuary includes saltmarshes and mangroves in the intertidal zone and seagrass beds in the shallow subtidal areas. The estuary supports a range of wildlife, especially birds and is recognised for its ecological importance. The Tuross River Estuary is a recreational fishing haven and is protected from commercial fishing with no trawling, mesh nets or haul nets allowed.

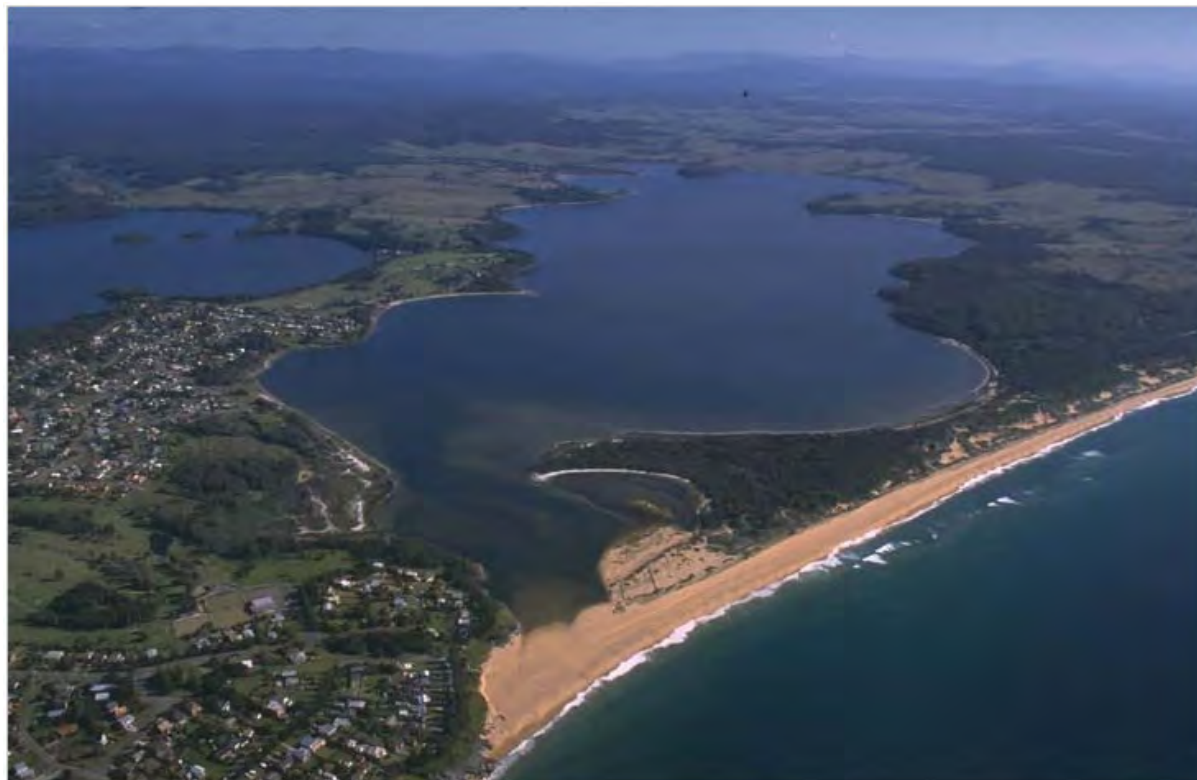
Figure 5: Coila Lake

Coila Lake is a large, young intermittently closed saline coastal lagoon (as classified by Roy *et al.*, 2001) and is located to the immediate north of the Tuross River Estuary and is separated from the ocean by a ridge of land that is about 0.5 to 1km wide. The catchment of Coila Lake is relatively small (47.6 km²) which has resulted in the lake only being open to the ocean intermittently and usually for short periods. Much of the catchment has been cleared for agriculture although Coila Lake itself contains extensive areas of seagrass and is fringed by casuarinas and saltmarsh. The Lake is open to commercial fishing and contains an important habitat for the Greenback prawn.

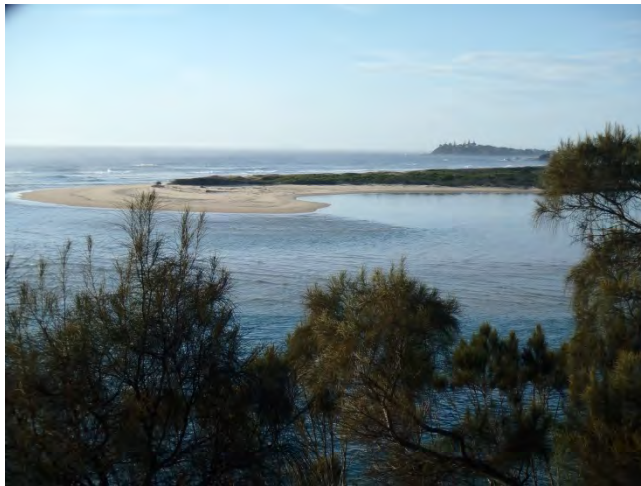
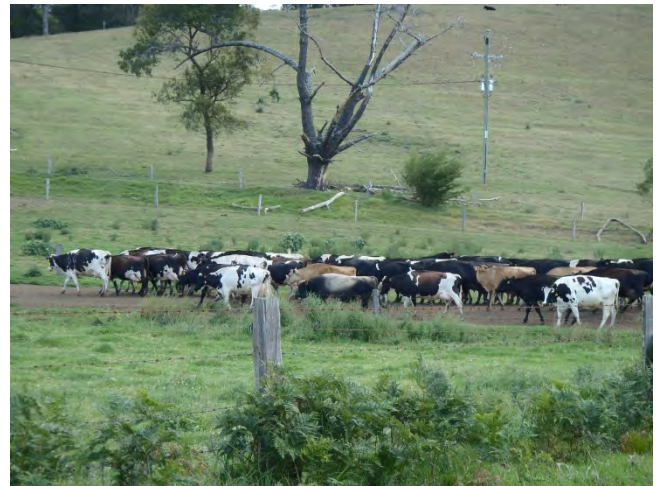
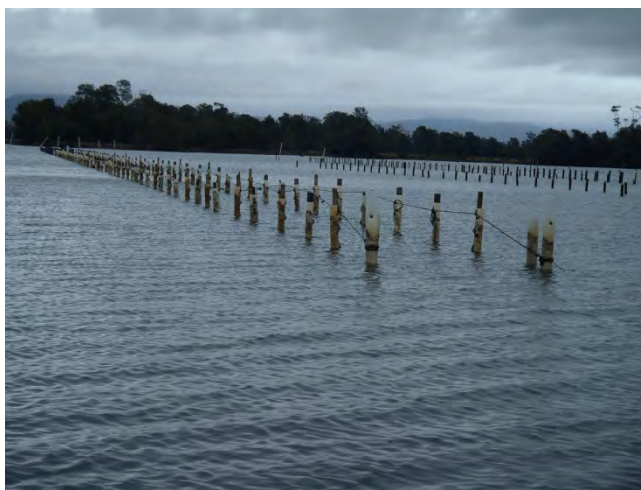
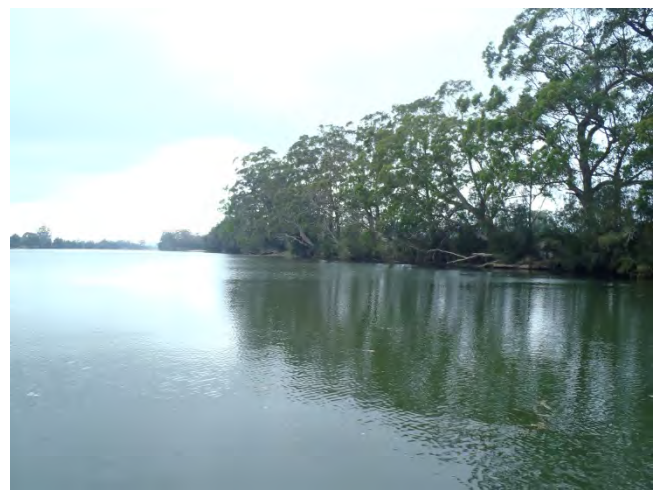
Figure 13: Tuross River Estuary study area

a. Tuross River entrance; b. Agriculture in Tuross River catchment; c. Coopers Island oyster leases; d. Mid-estuary

Tuross River Estuary is a complex waterbody comprised of shallow interconnecting channels and lakes. The entrance has generally remained open but was recorded to have closed during the 19th century and more recently closing during the droughts of 2006 and at the end of 2009. The environmental processes within the overall estuary are influenced by the condition of the entrance. The Tuross River Estuary is a barrier system separated from the ocean by a large coastal sand barrier (dune). The dominant coastal processes push sand northwards along South Tuross Beach and into the Tuross River Estuary entrance. The condition of the Tuross entrance is dependent on the relative balance between the longshore sand transport moving along the beach and the entrance scouring potential of freshwater discharges from large flood events (refer Appendix K - Entrance Management). In dry times, the entrance will be heavily shoaled and tend towards closure, while during wet weather the entrance can be quite large (WBM, 2004).

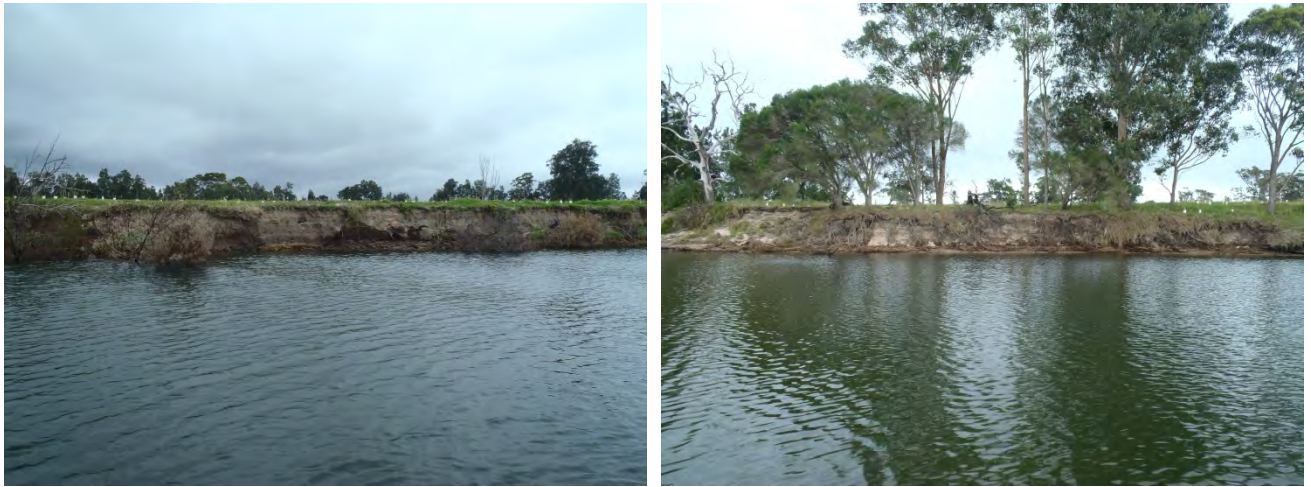
Figure 17: Examples of active bank erosion observed November 2017 along Tuross River main channel

The Water Quality Improvement Plan for the Tuross River Estuary identified the main causes of bank erosion as stock access to the top of bank and/or water's edge with little to no riparian buffer and steep banks with high exposure to main channel flows (refer Section 4.1.1). Bank erosion at sites with limited riparian buffer and steep banks along the Tuross River Estuary main channel are shown in Figure 17.

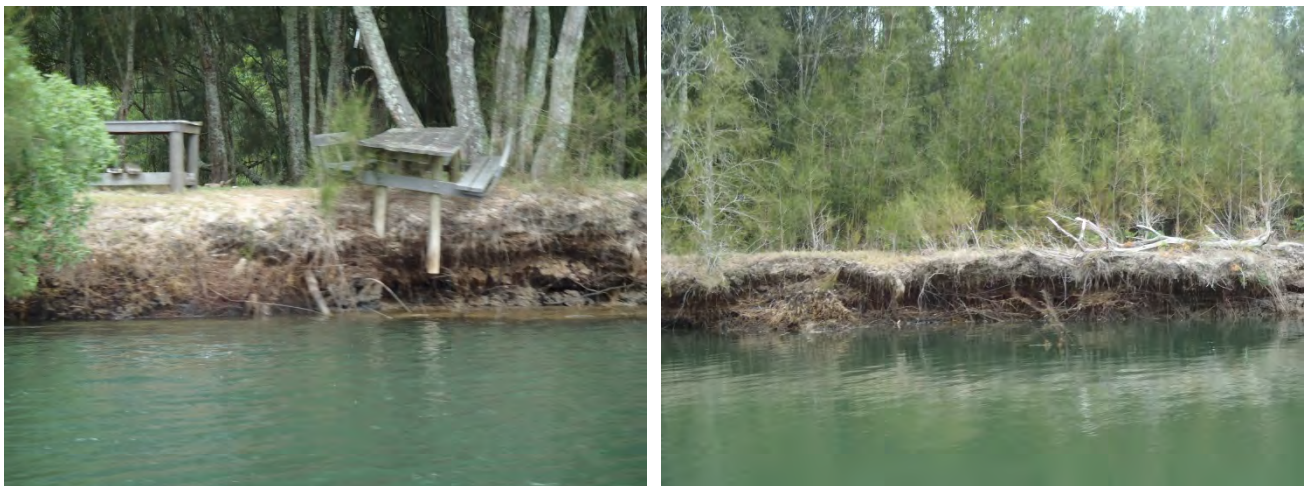
Figure 18: Bank erosion observed November 2017 along Cambathin Island

The risk of significant change in the alignment of the main river channel (avulsion) resulting from erosion of the western banks of Cambathin Island (Figure 18) has been identified previously (Brown and Root, 2001; WBM, 2004) and remains an unresolved issue. The predicted impacts of the breakthrough include loss of estuarine vegetation, the disturbance of fine nutrient rich sediment and areas of high flow within the estuary becoming quiescent.

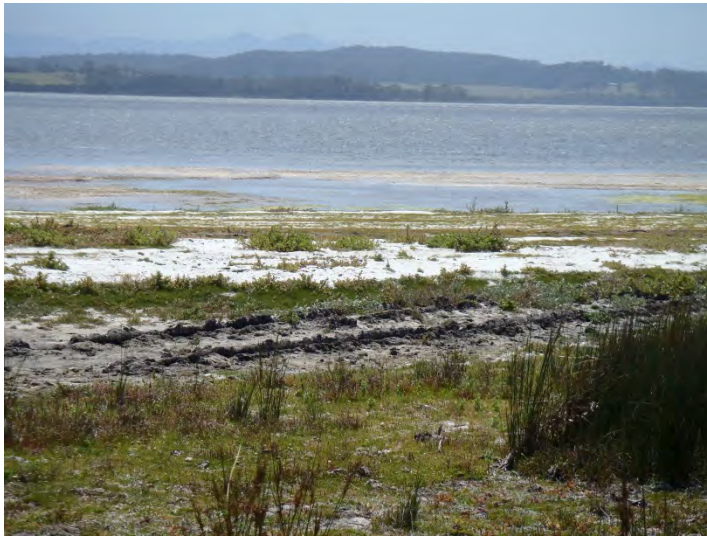
Figure 19: Damage to saltmarsh, Coila Lake

A saltmarsh community located on the south-east shores of Coila Lake (not classified as CMA 1 - coastal wetlands) is currently being impacted by vehicular access. This area is utilised as an informal access to Coila Lake and to Bingie Beach via the bordering dune system. This is having a detrimental impact on the saltmarsh and is a key community concern regarding pedestrian safety, damage to threatened shorebird nests and habitat, damage to dune structure and dune vegetation and illegal clearing of native vegetation, camping, fires and dumped rubbish. The Bingi Dreaming Track, which is of Aboriginal cultural significance, traverses through this areas and is at risk of impact (refer Appendix M). Sea-level rise is also likely to impact this area potentially resulting in decreased saltmarsh coverage as a consequence of 'coastal squeeze' (Section G6.4, Appendix G).

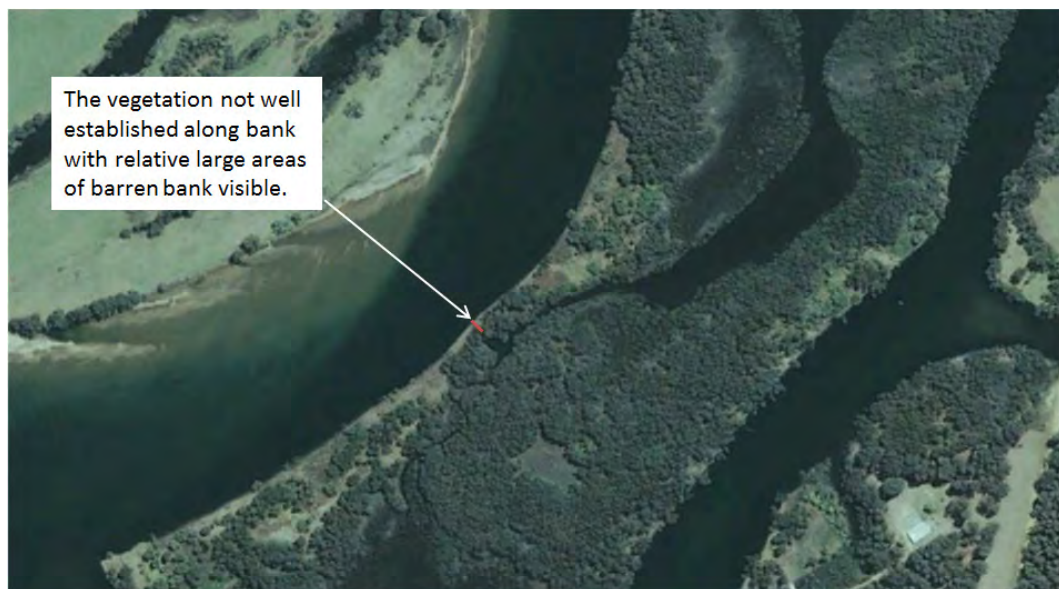
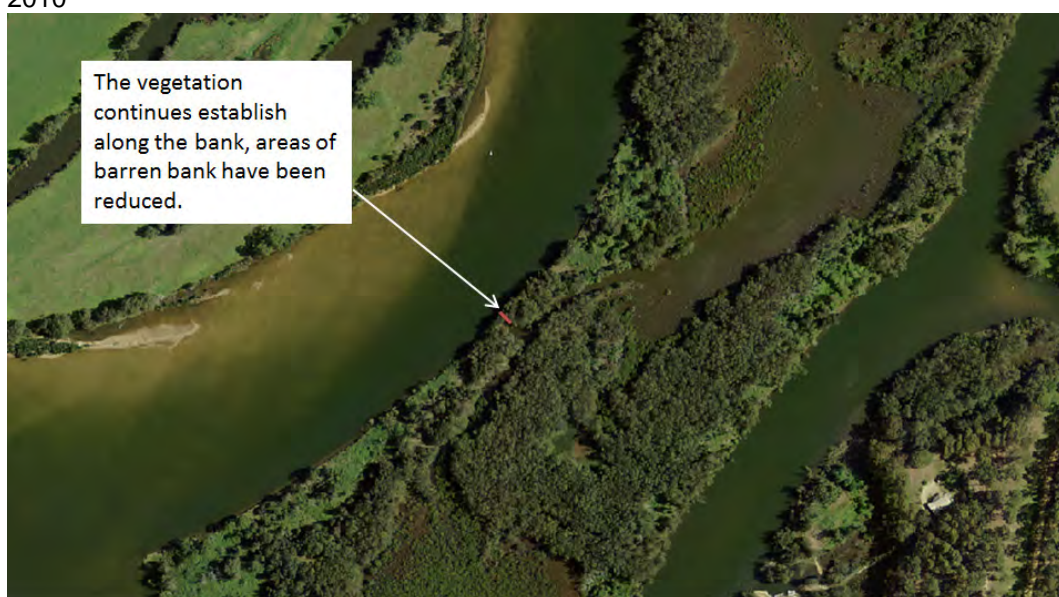
Figure 23: Potential breakthrough location – western foreshore of Cambathin Island

2002 (Google Earth Image)

2014

Stabilisation techniques including rock toe protection and riparian revegetation are estimated to cost \$475,000 (Southeast Engineering and Environmental, 2016). Funding is not currently available for this level of expenditure. As such, it is recommended that the risk of avulsion is further investigated along with an assessment of potential options to address the risk. As the bank becomes narrower, the rehabilitation options become more limited and potentially more costly and this should be considered in the analysis.

There are no recent survey data of this area to determine the current width of the bank, although inspection of current aerial photography in 2010 and 2015 (Figure 23) shows this section of the bank appears to be well vegetated in the most recent aerial photo. However, the canopy is obscuring the view of the bank and it is not possible to determine whether the canopy has grown, or the bank has retreated, or both. Significant on-going erosion has been observed along this foreshore and flooding in June 2016 appears to have exacerbated the undercutting of the banks. Despite the timeframe for avulsion predicted in earlier studies not being realised, the risk of avulsion is still apparent, is increasing with time and is likely to be significantly increased with the occurrence of flood events.

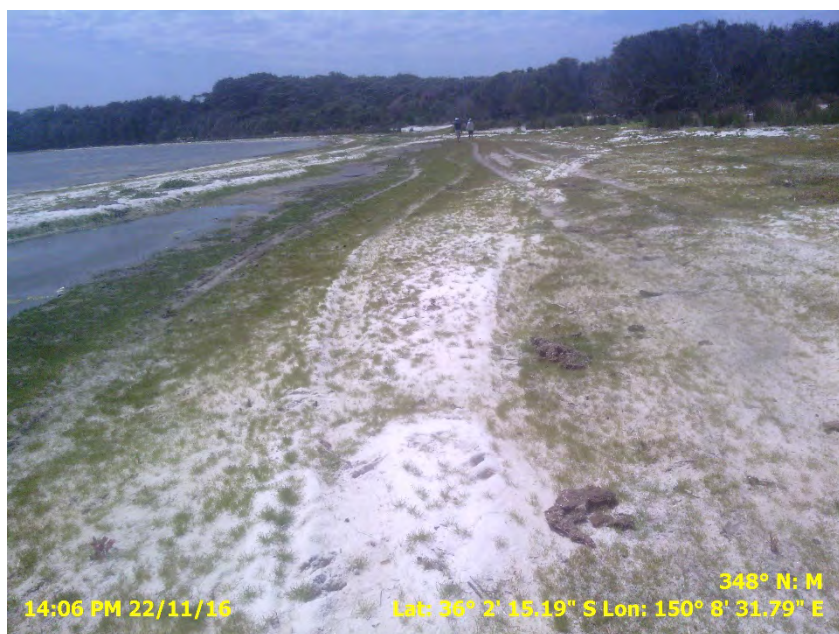
Saltmarsh damage from vehicles. Threatened shorebird nests occur at this location.

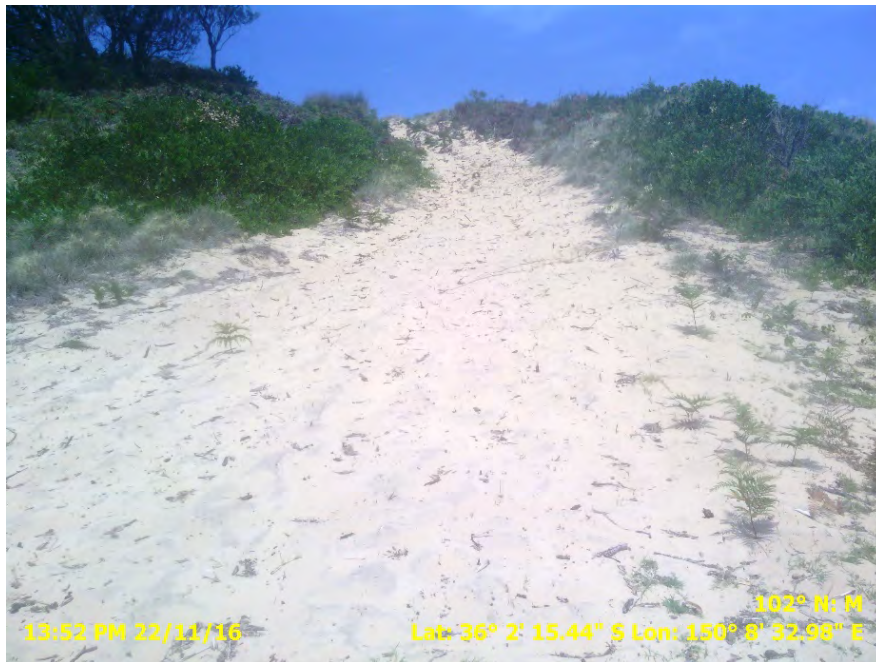
Damage to dune vegetation in sensitive coastal area.

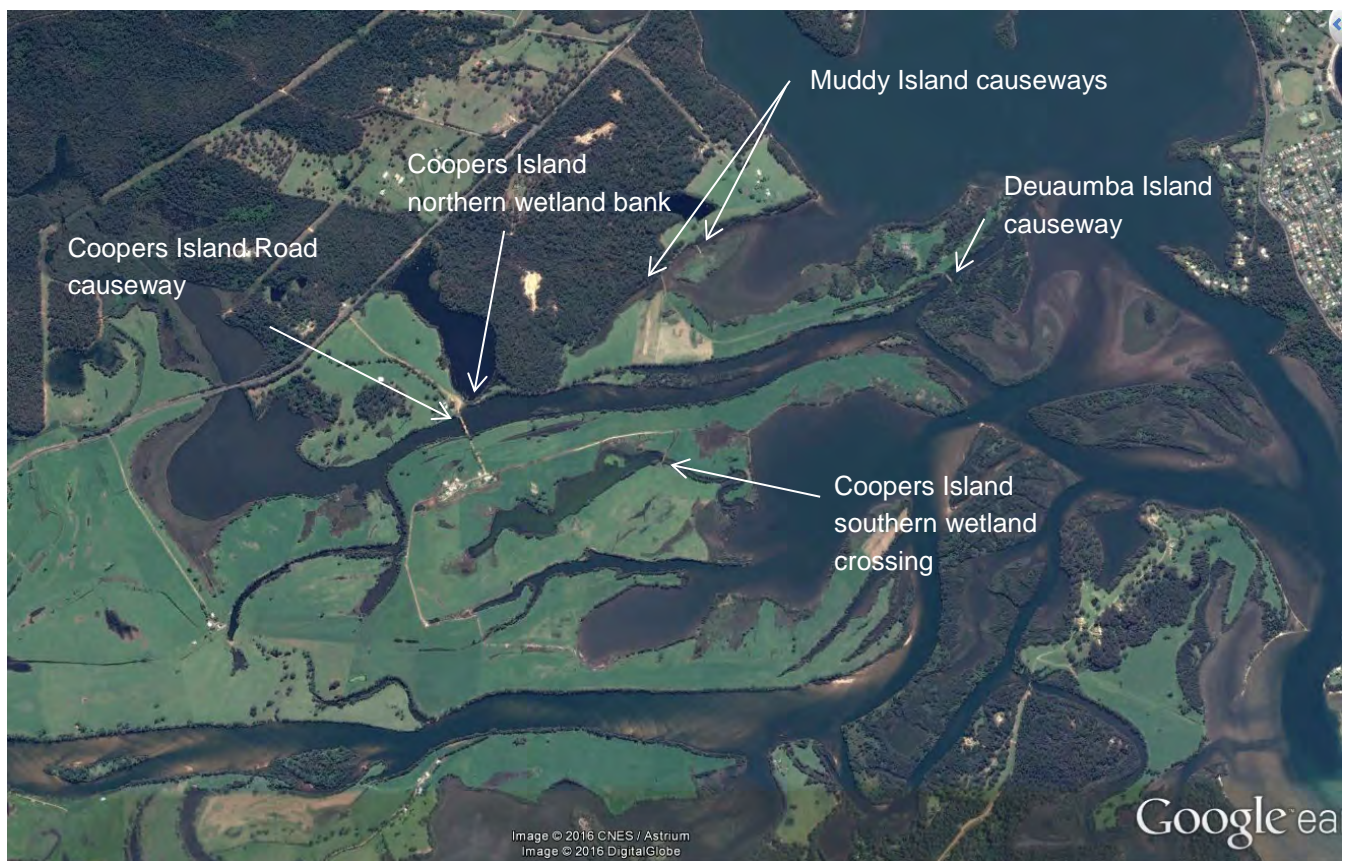
Figure 32: Waterway barriers in the Tuross River Estuary

Any upgrade of these waterway crossings should consider improvements to tidal flow.

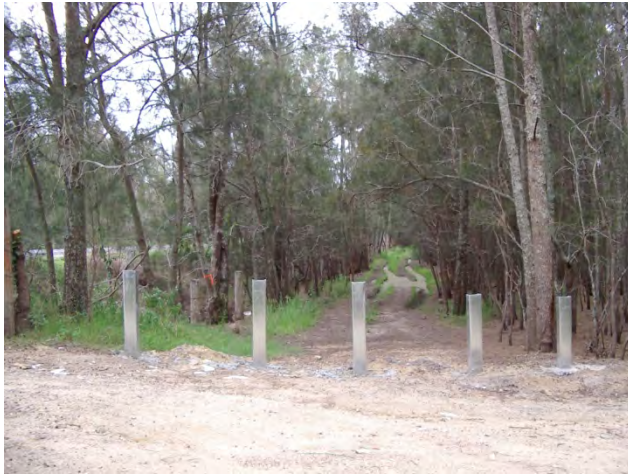
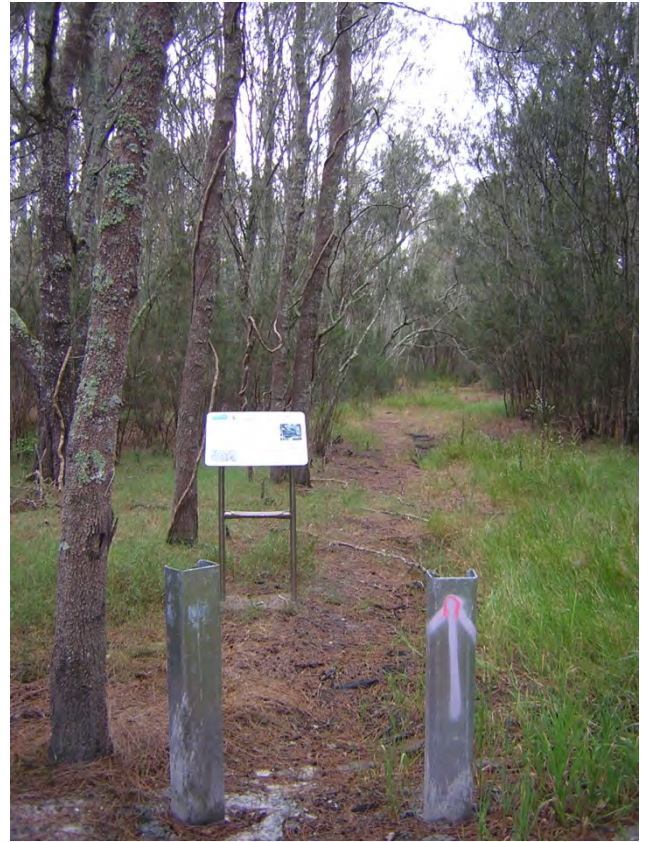
Figure 43: Coila Creek saltmarsh protection: a, b – post barrier; b: educational signage

The Eurobodalla Biodiversity Program implemented measures to prevent vehicular access to saltmarsh along Coila Creek (including the endangered *Wilsonia rotundifolia*). The project included access barriers and educational signage near Princes Highway.

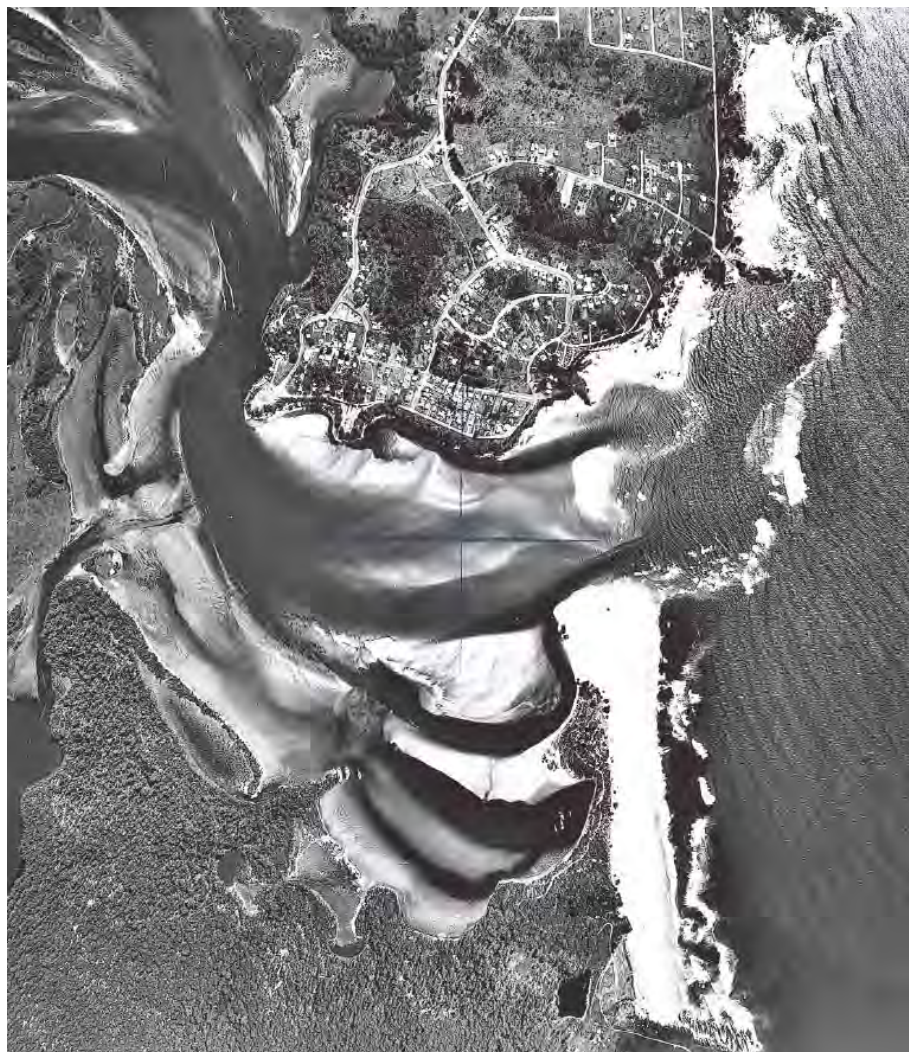
February 1999: Northern channel open with 3 distinct spiral channels. Vegetation extending to ocean.

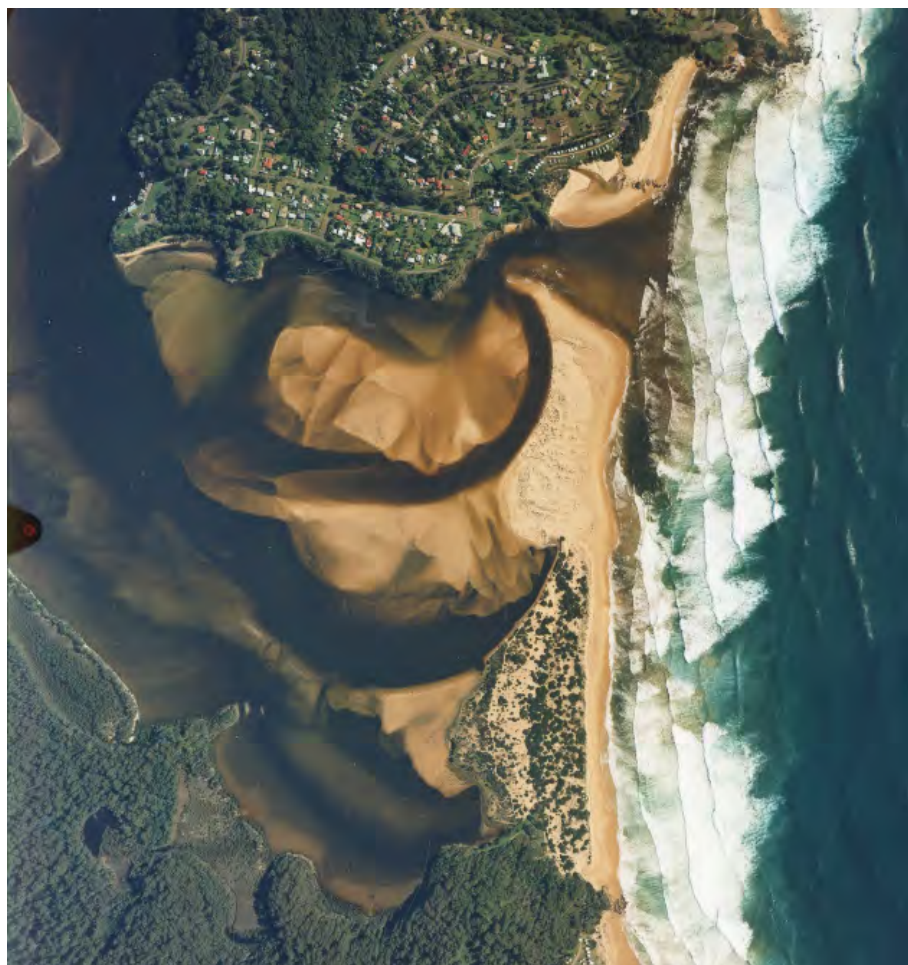
August 2002: northern channel closed and central channel open (entrance migrated to south).

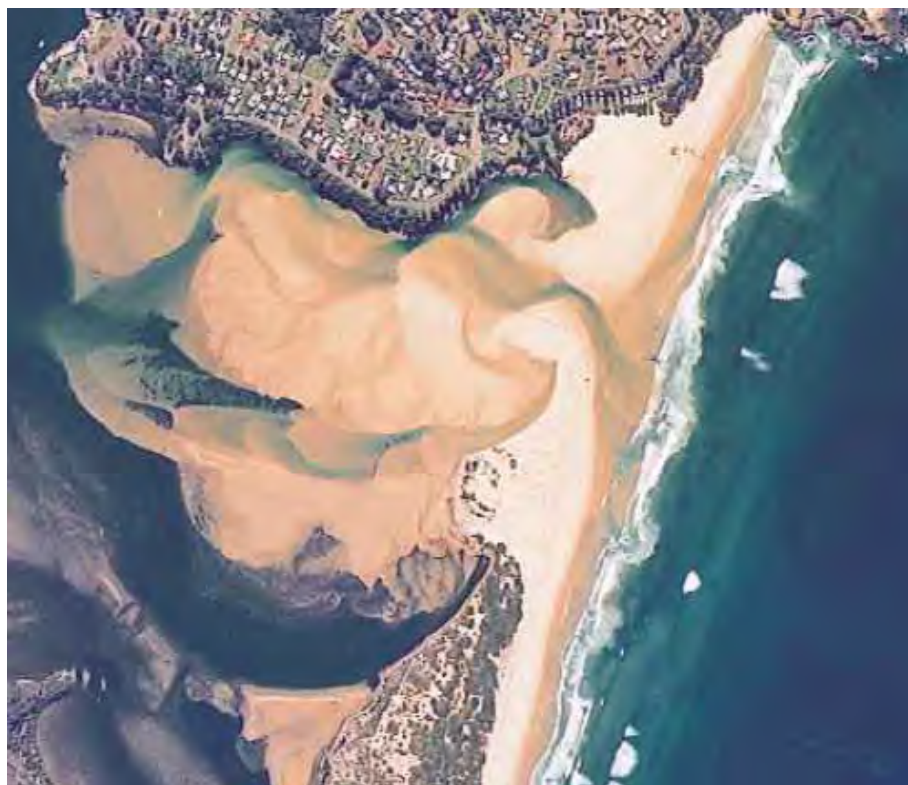
March 2007: Open narrow northern channel with central channel open at same point.

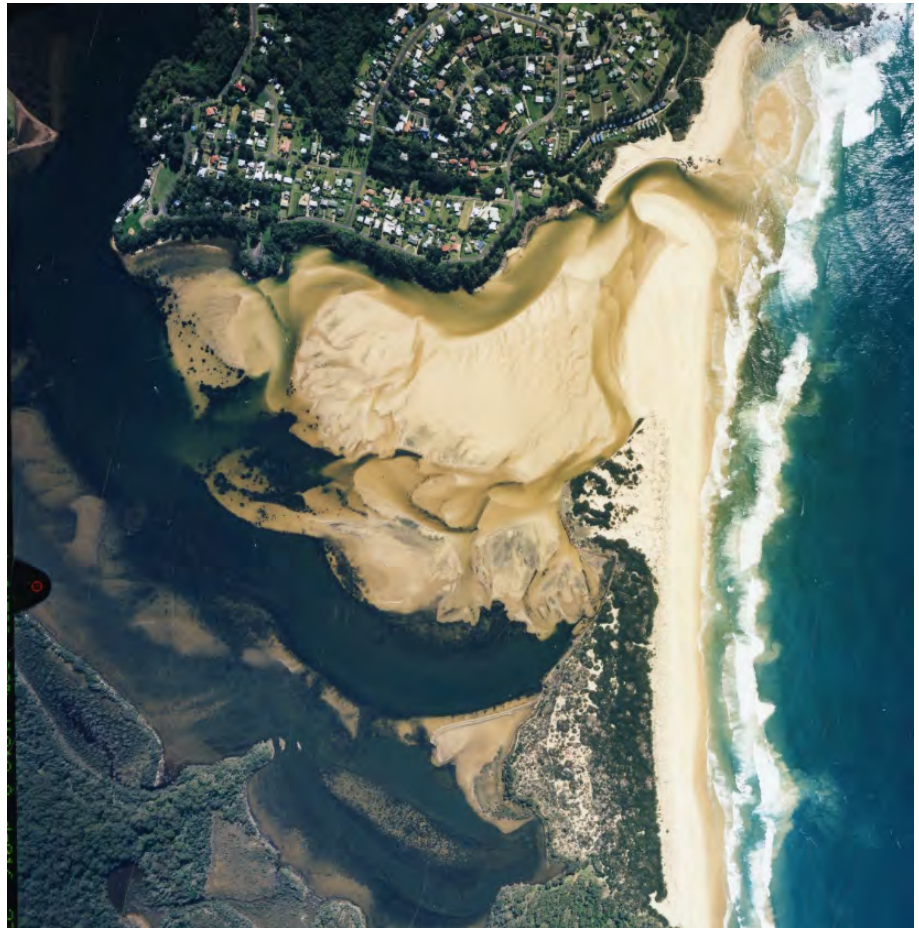
Jan 2016: Most recent aerial photo showing open northern channel and closed southern channels. Dense dune vegetation

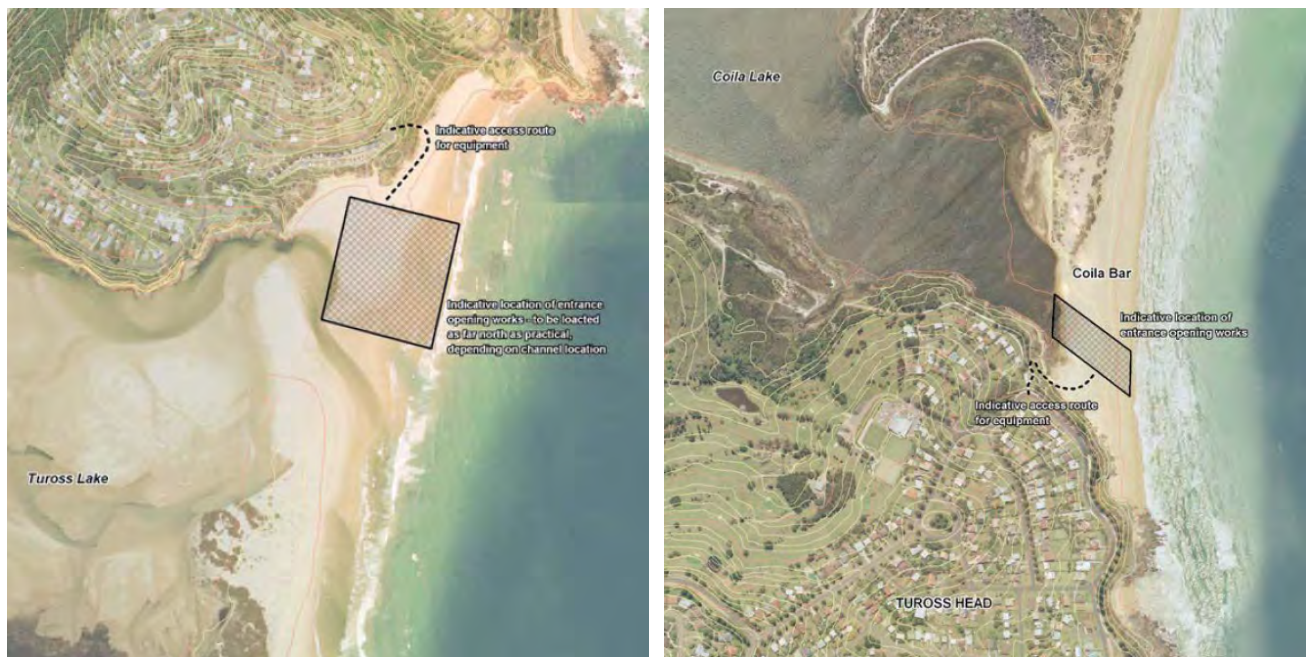
Figure 87: Location of Tuross and Coila Lakes entrance opening works

The location of the entrance opening works is shown in Figure 87.

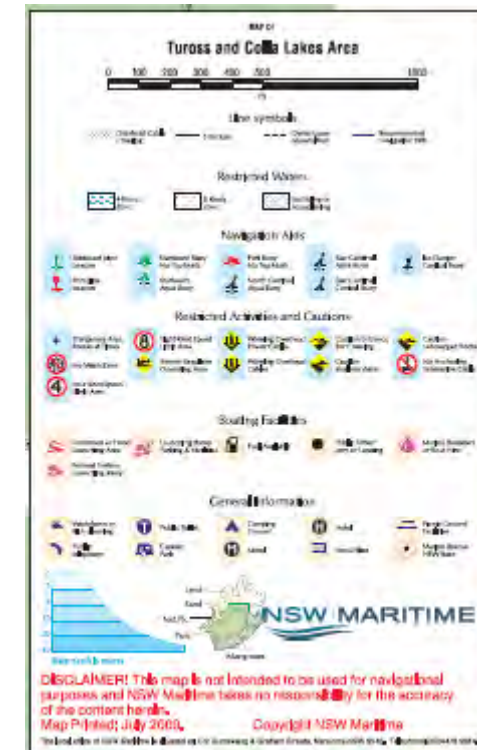
Figure 90: Boating map for Tuross River Estuary

RMS representatives frequently patrol, monitor and assess the navigation channel and location of markers in the Tuross River and Coila Lake with consideration of depth and seagrass extent. RMS manages the placement of navigation aids (buoys, markers etc.) and waterway mapping to assist the boating public (refer Figure 89 and Figure 90).

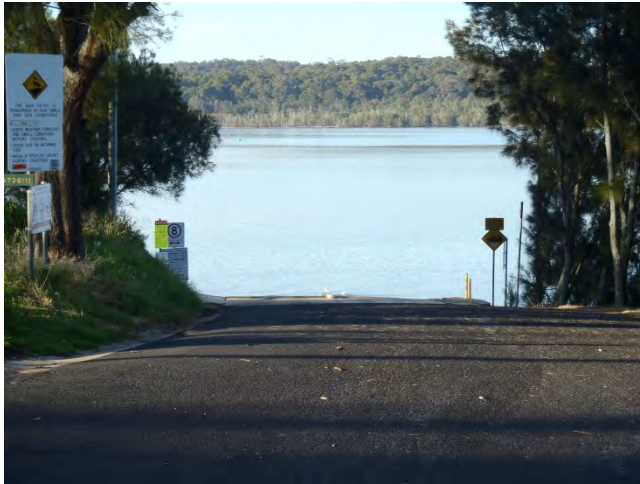
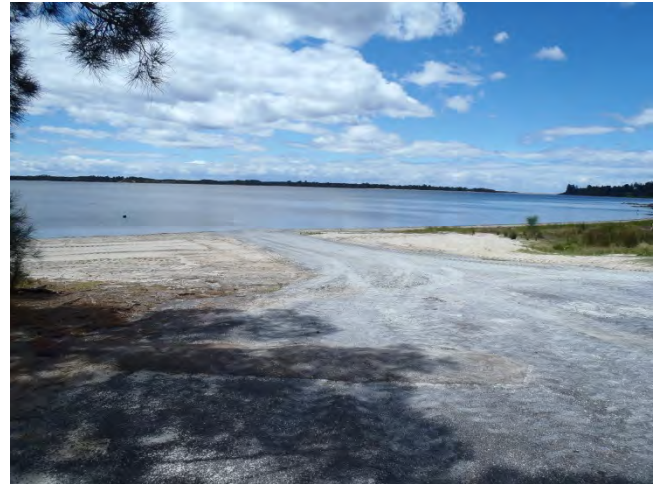
Boat ramps are located at Lavender Bay, Tuross River (concrete), Tuross River Bridge (concrete), Kyla Park, Coila Lake (gravel) and Foam Street, Coila Lake (gravel). The ocean ramp at One Tree Point, Tuross Head has been closed. Commercial jetties exist on the Tuross River for the hire boat businesses and a public jetty is located at Lavender Bay boat ramp.

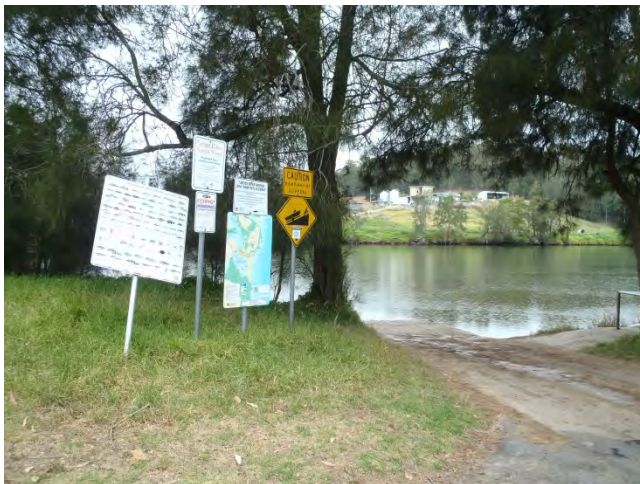
Figure 91: a – Tuross River boat ramp, Lavender Bay; b – Kyla Park, Coila Lake boat ramp; c – Tuross River bridge boat ramp

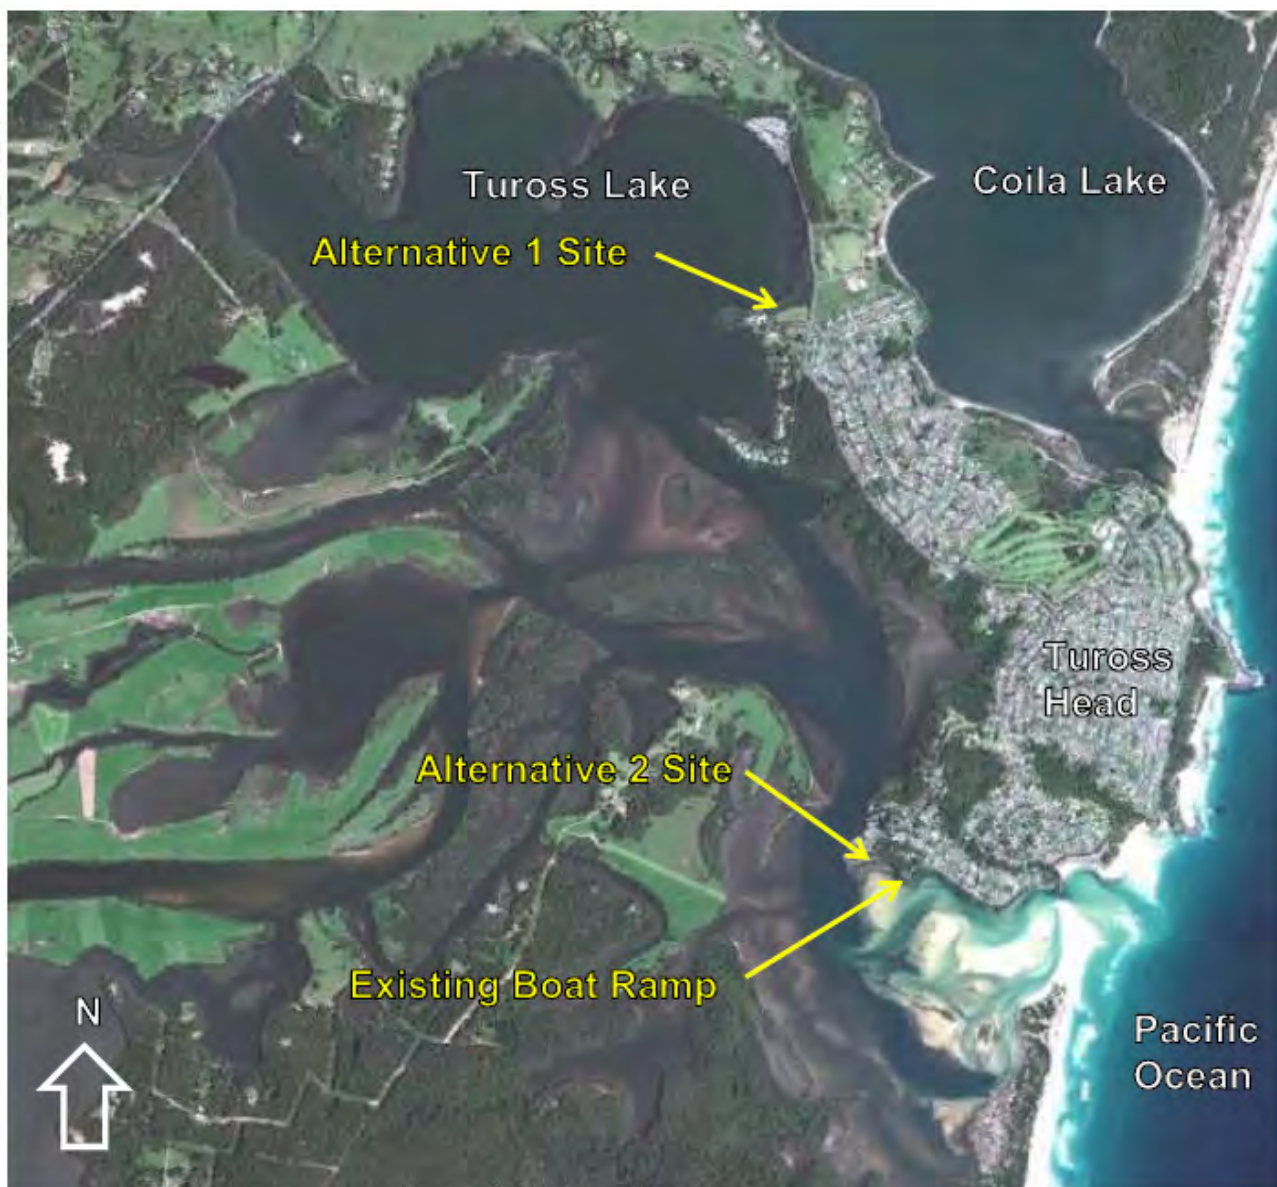
Figure 92: Tuross boat ramp options

- Option A – upgrading the existing boat ramp off Nelson Parade;
- Option B – an alternative boat ramp site on community land adjacent to Hector McWilliam Drive and near Lake Street (Alternative 1 Site);
- Option C – an alternative boat ramp site within Lavender Bay on the southern side of Sandy Point (Alternative 2 Site); and
- Option D – channel maintenance at the existing boat ramp.

The study found that Option B: Alternative Site 1 would be the most beneficial option to pursue as a long term solution to the current problems with water depth and parking capacity at the existing boat ramp. A boat ramp sited on the foreshore of Tuross Lake at this location would provide a reliable water depth for launching whilst also having sufficient areas for car/trailer parking to cater for current demand and as a regional facility

to accommodate future growth in boat ramp usage. Measures to reduce amenity impacts of the Alternative 1 proposal on nearby residents were recommended as part of further design development (Royal Haskoning DHV, 2013).
