## Eurobodalla Southern Storage - Technical Note

<b>Technical Note No.:</b>	<b>ESS-TN-02</b>	<b>Date:</b>	<b>23 June 2017</b>
<b>Title:</b>	<b>Eurobodalla Quarry Geotechnical Investigations</b>		
<b>Project Ref.:</b>	<b>30012127</b>	<b>Rev.:</b>	<b>03</b>
<b>Originator:</b>	<b>SMEC Design Team</b>	<b>Reviewer:</b>	<b>Dave Evans</b>
<b>Discipline:</b>	<b>Storage</b>

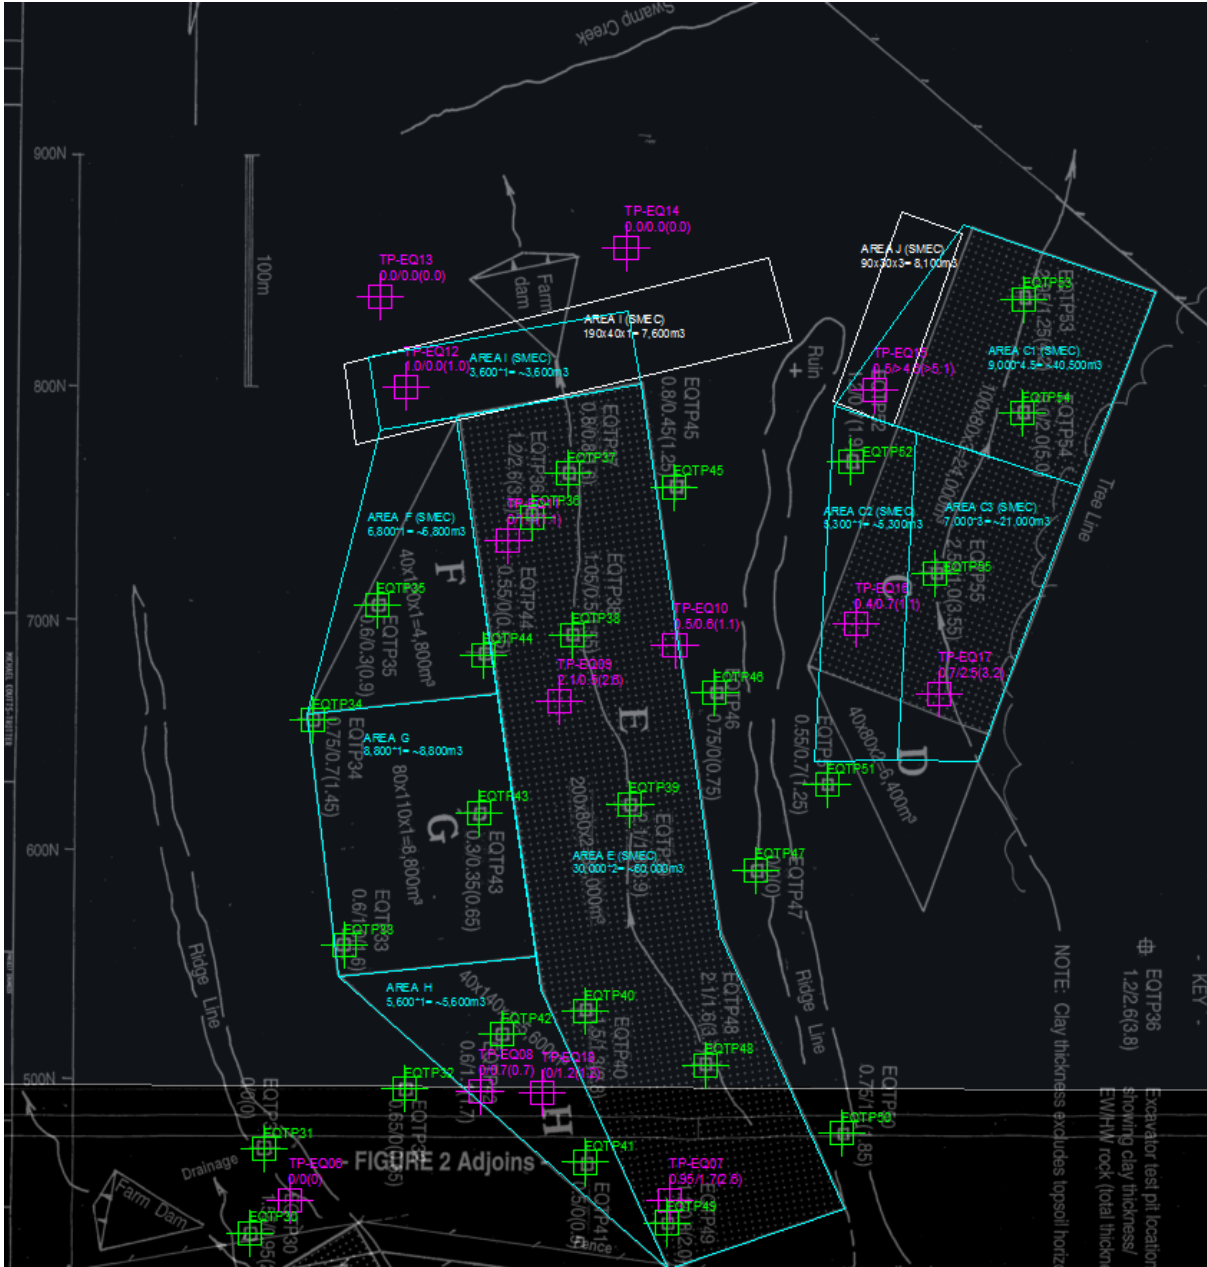
Figure 6: Northern paddock volume estimate – current estimates shown in cyan, current test pits shown in magenta (adapted from DoC 2006a)

Volume estimates have been undertaken by dividing the quarry into areas based on similar depths of potential earthfill. These areas were then multiplied by average thickness of combined residual soil and XW Dolerite (thickness adopted to be on the conservative side) to estimate the volume of potential earthfill. Where possible, the naming convention for areas used to estimate the material volume has been adopted to be consistent with that used in DoC 2006a to enable comparison.

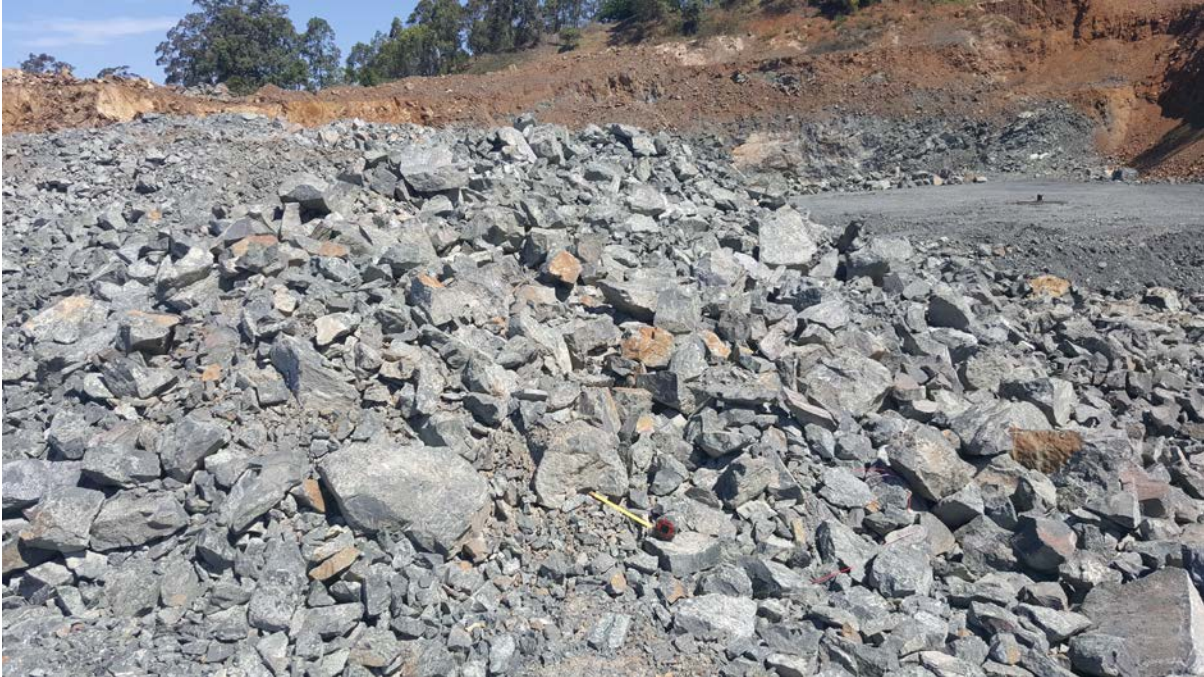
Following a blast undertaken within the pit, the resulting rockfill was observed to be well-graded between approximately 20 mm to 400 mm. This material would likely be suitable for use as rockfill zones for embankment construction with minimal processing, subject to confirmation of suitability from laboratory testing.

*Figure 7: Rockfill stockpile following blast at Eurobodalla Quarry 17/1/17*

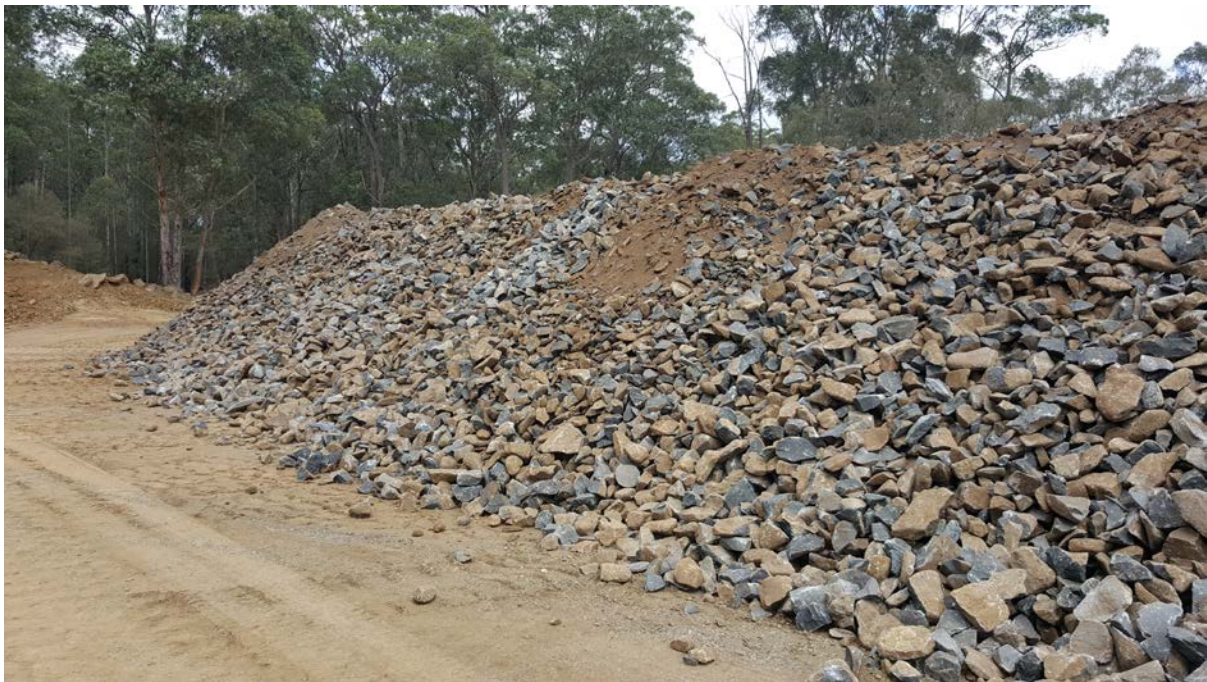
Basalt Quarry supplying aggregates and rockfill products. This material would likely be suitable for use as a coarse filter (Zone 2B) and rockfill zones, subject to confirmation of material properties from laboratory testing. At the time of visiting the plant was producing approximately 200 mm rockfill as shown in Figure 8.

*Figure 8: Rockfill stockpile at Bay Sand and Gravel 20/1/17*
