0.0 INFRASTRUCTURE RECOVERY & RESILIENCE – NATURAL DISASTERS

The purpose of this report is to provide an overview of the extensive work done since the Black Summer bushfires to recover our local road and bridge infrastructure and deliver 'in-perpetuity' improvements to address these specific issues.

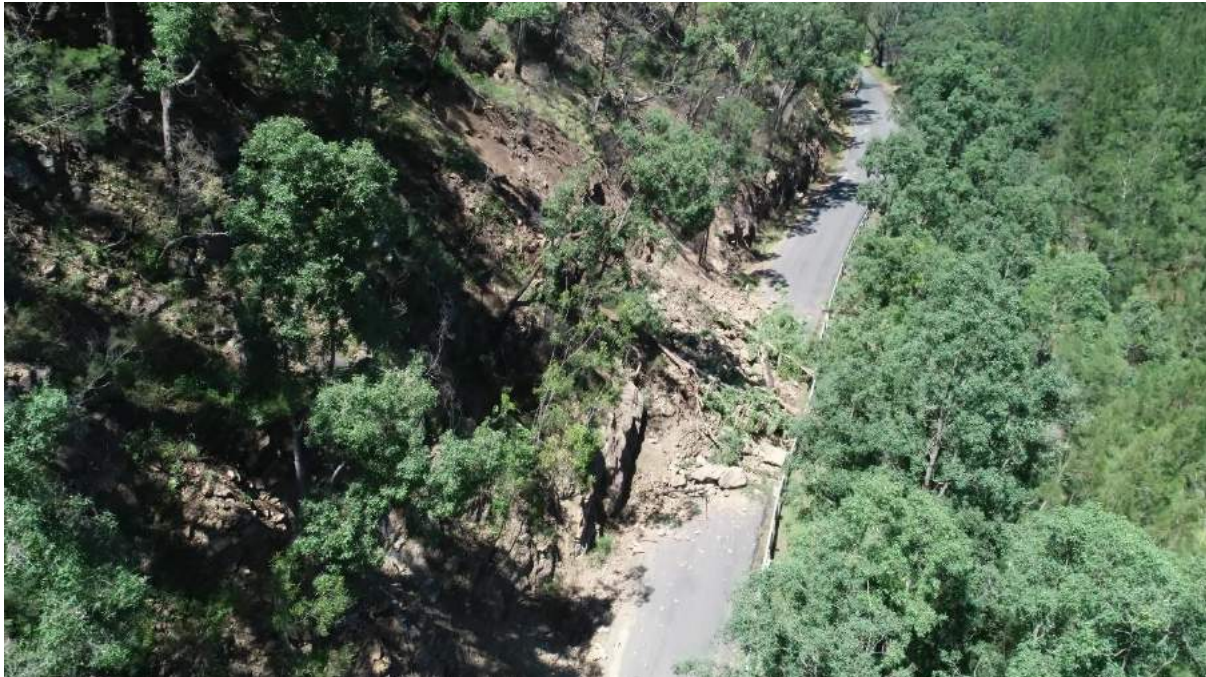
Photo 1 – Araluen Road

Major landslide area at 22km mark with adjoining minor slides either side over an extended length. This section has now been bypassed by a new alternate route over the mountain.

- 22km mark (see photos below) – this landslide closed the existing road. Detailed investigations to repair the existing road compared to a new more resilient alternate route around the site were undertaken. Approval to build the new alternate road was gained in June 2021 and the new road opened to traffic on 10 December 2021. Works are now substantially complete with a new more resilient sealed road provided for the Deua Valley community. Materials won being recycled to provide improved road surfacing elsewhere on Araluen Road under a Fixing Local Roads grant.

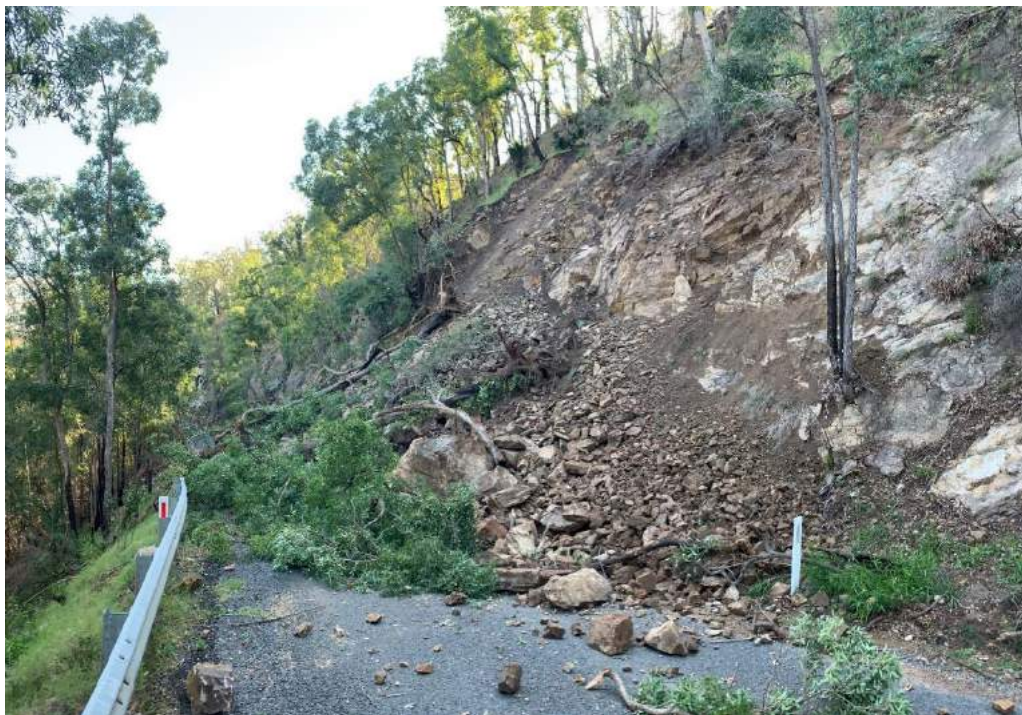
Photo 2 – Araluen Road

Major landslide at the 22km mark extending approximately 30-35m upslope

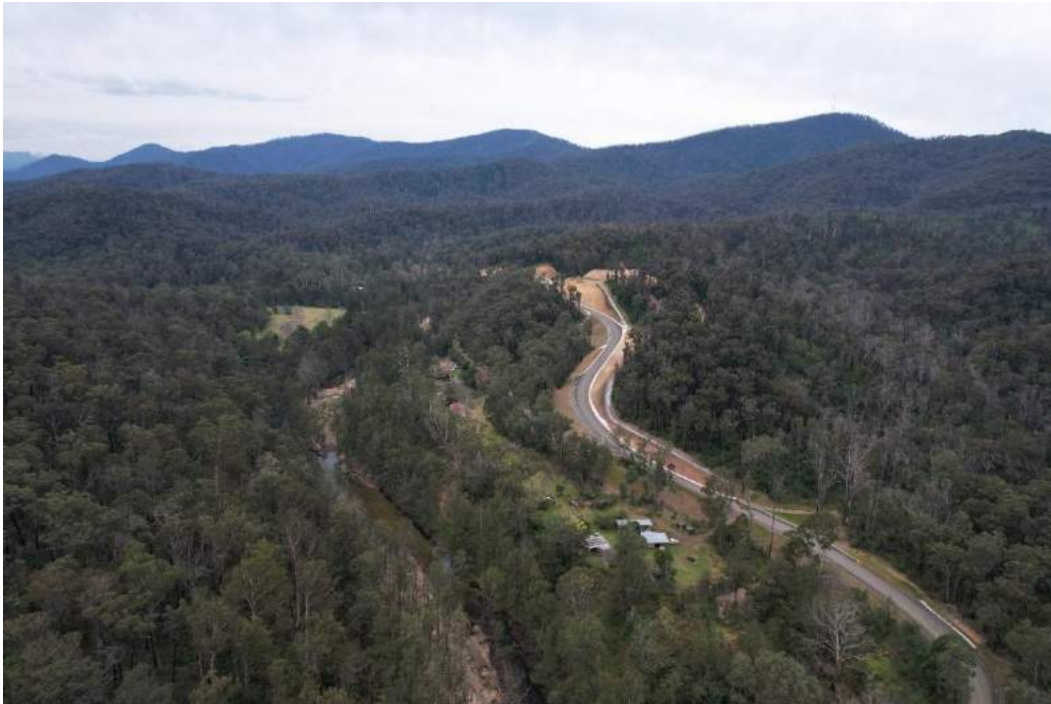
Photo 3 – Araluen Road

22km mark with new alternate road now substantially complete, with Mt Wandera telecommunications tower in the background (peak on top right-hand side)

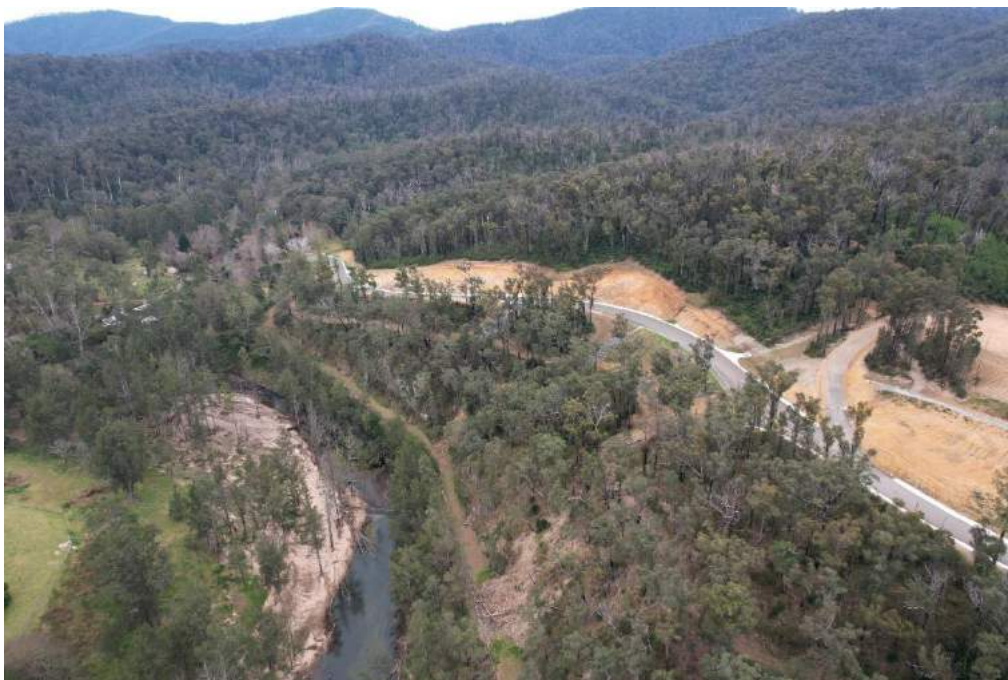
Photo 4 – Araluen Road

22km mark looking north with the old road with landslides in the foreground. Despite the new road being built in mountainous terrain clever design has meant the maximum road grade is only 12.5% vertical grade. The old road and tracks have been restored. Only minor drainage and restoration work remains to be completed.

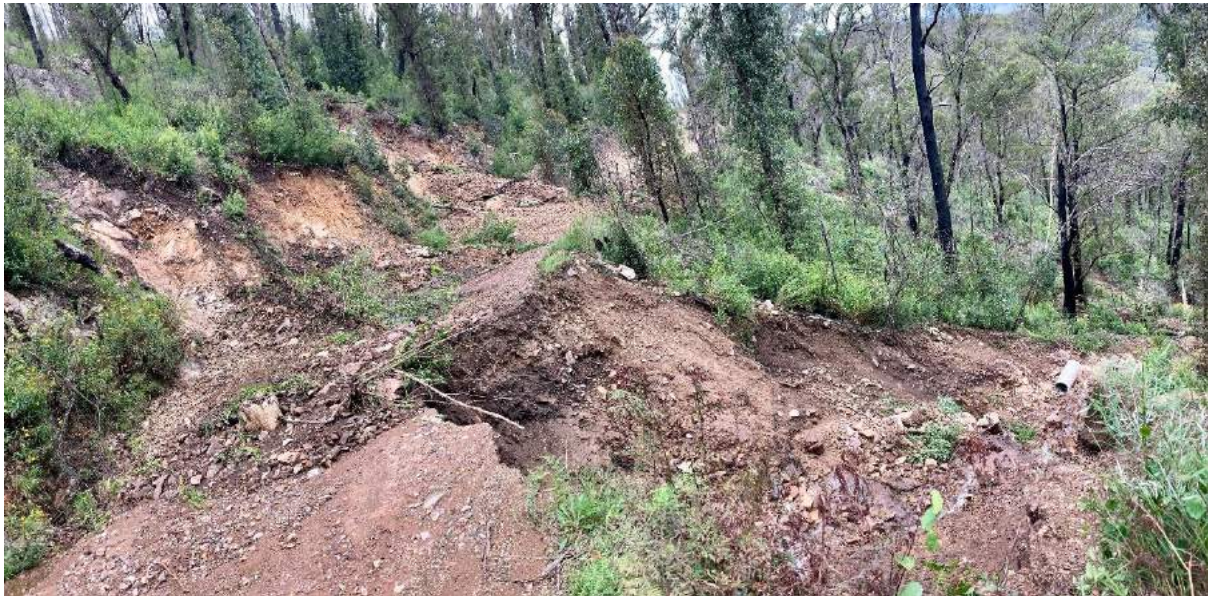
Photo 5 – Mt Wandera Trig Road

This was the alternate access for Deua Valley residents via Mt Wandera until it collapsed in the natural disaster flood on 10 December 2021. Council's works were sufficiently advanced at the 22km mark on Araluen Road to allow it to be opened to resident-only traffic.

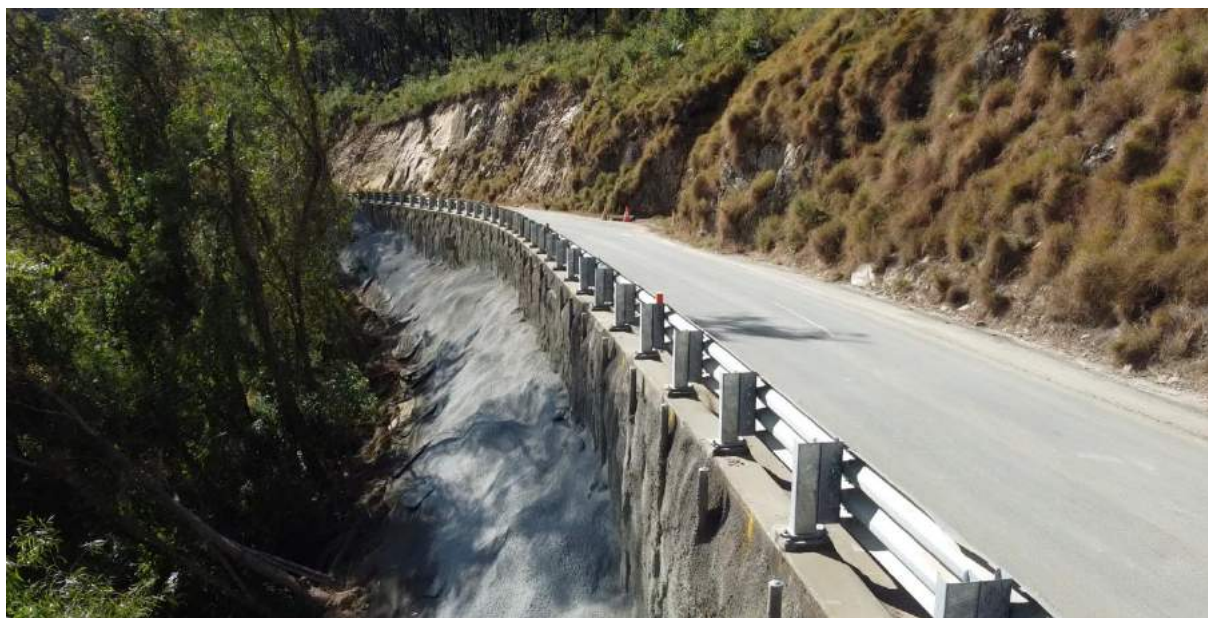
Photo 6 - Araluen Road

Slope instability developed below the existing foam block wall at the 18km mark requiring urgent soil nailing works to stabilize the natural slope

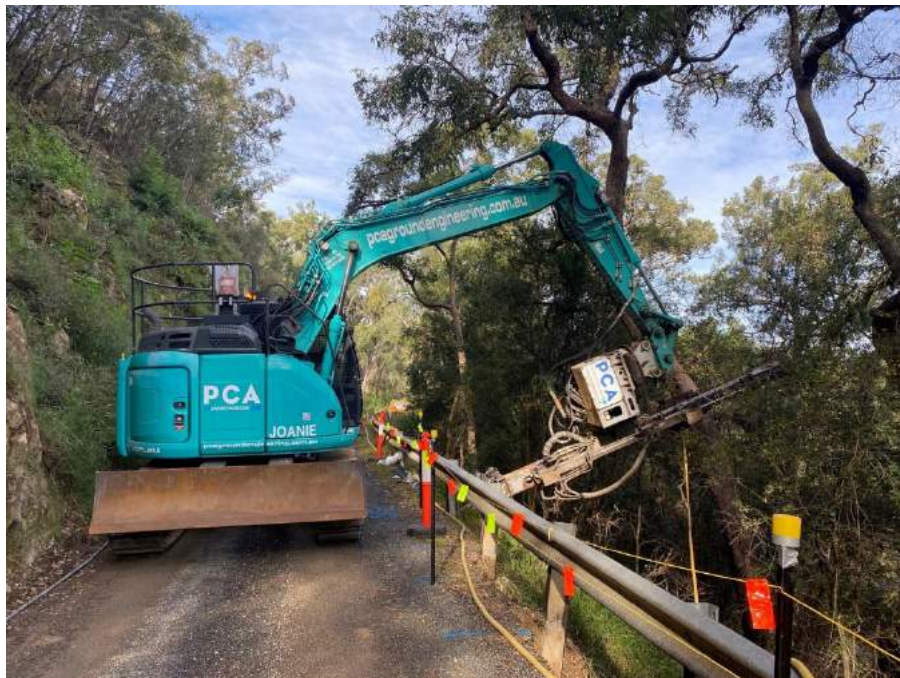
Photo 7 – Araluen Road

19km mark is just one example of the sites requiring extensive geotechnical stabilisation in a constrained location. The soil nailing work was extended using other grant funds beyond the work able to be funded under NDRRA whilst crews were on-site, facilitating a more resilient outcome for the community

- 18km site – geofoam wall underpinned and embankment stabilisation extended 40m. Substantially complete.
- 19km site – urgent stabilisation in narrow cutting March 2021. Damage increased in March 2022 with stabilisation works complete August 2022. Additional LRCIP grant funding provided to extend treatment area. Substantially complete.

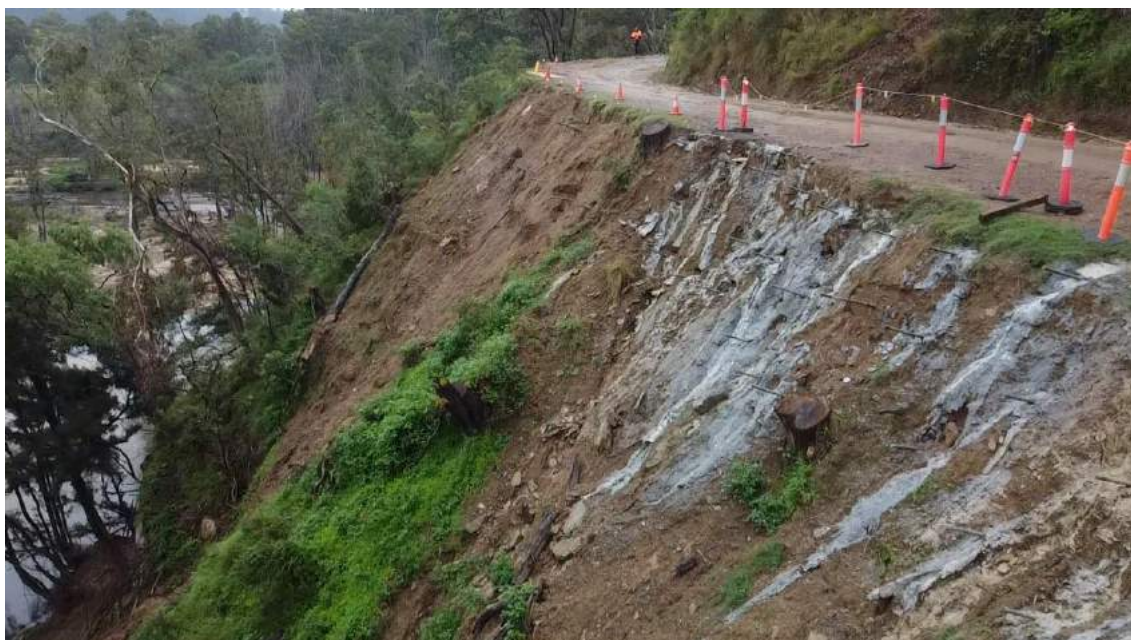
Photo 8 Araluen Road

Many of the sites that suffered landslide or instability were in extremely steep terrain and required specialized geotechnical solutions to stabilize the existing side slopes. This photo shows the soil nailing work being progressed.

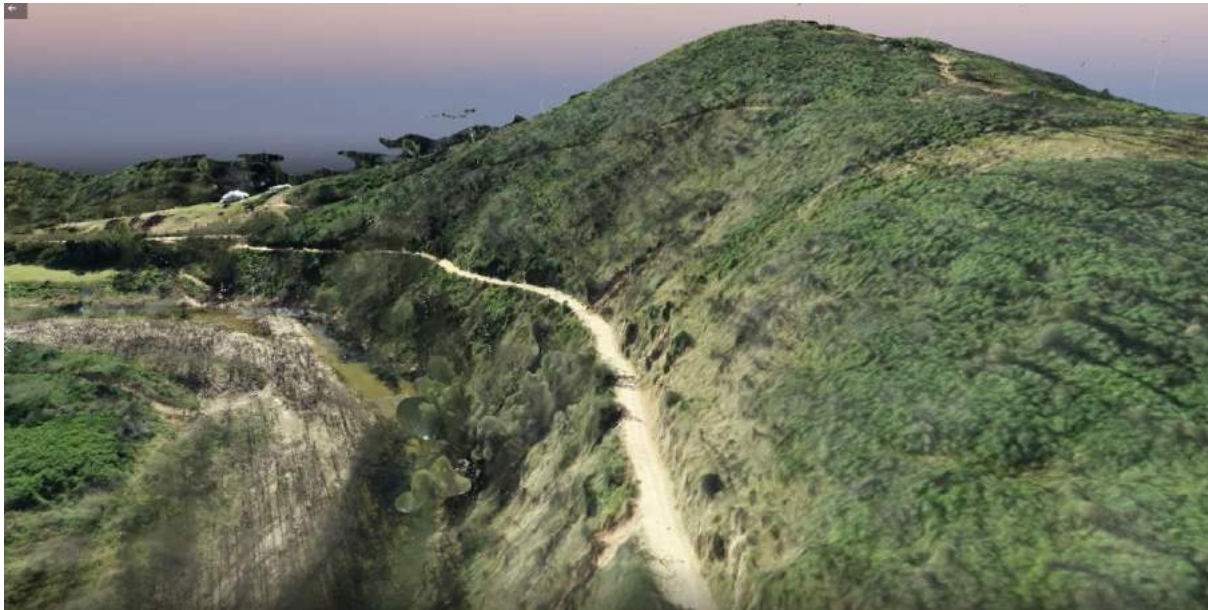
Photo 9 Araluen Road

The major landslides at the 43km mark occurred in extremely steep terrain closing the road indefinitely. This 3-D animation was created by Council's in-house teams using drone survey technology to assist assessment of recovery options.

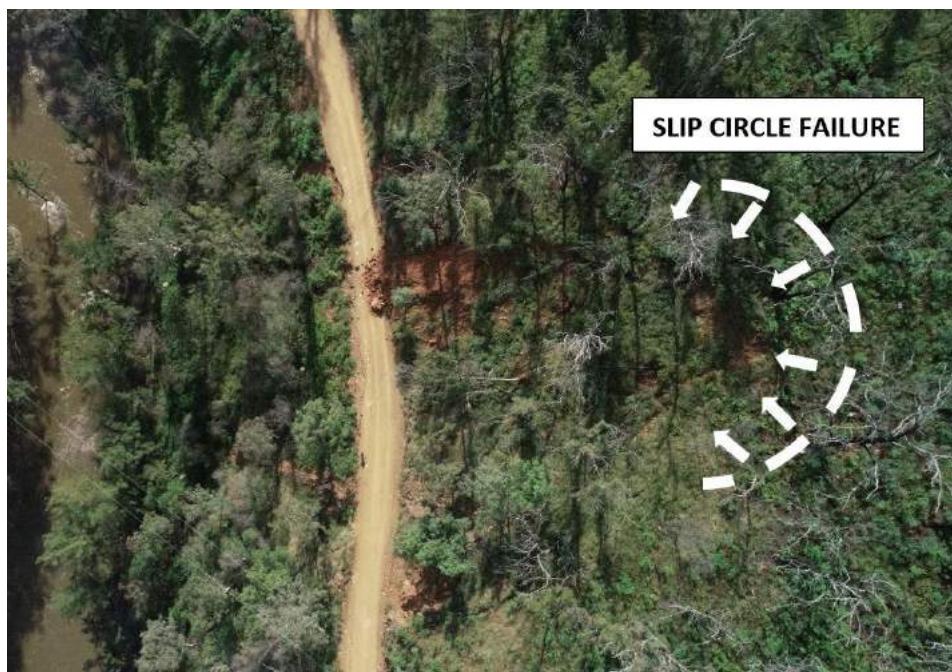
Photo 10 – Araluen Road

Drone technology allowed identification of a major landslide developing 35-40m above the landslides visible at road level. Detailed geotechnical investigations followed to develop solutions to recover the roadway and contracts have now been awarded to allow works to proceed over 2022-23 to treat the failed sections.

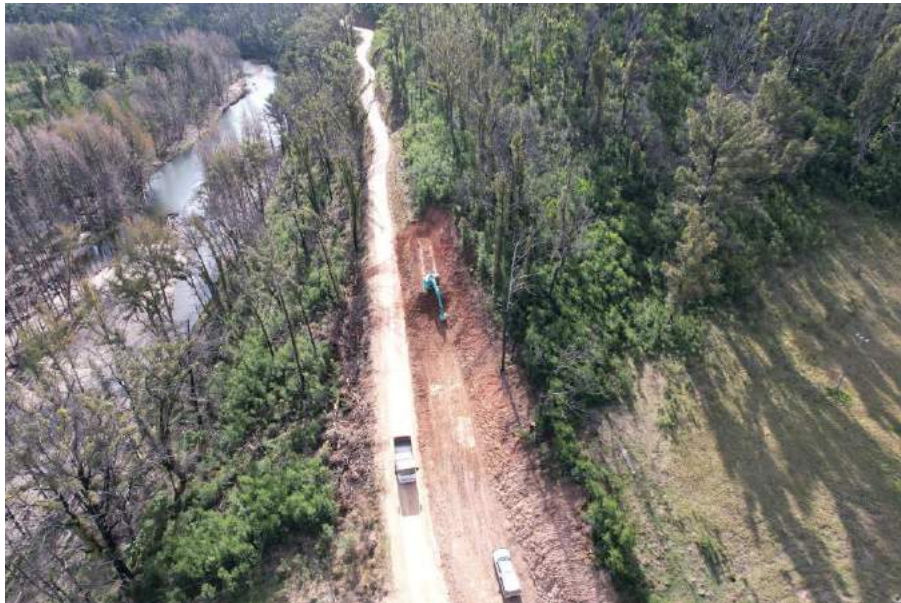
Photo 11 – Araluen Road Merricumbene

Additional grant funding was sourced to allow commencement of resilience works to mitigate the risk of further road collapse into the Deua River. A further stage is funded and planned for 2022-23. Additional grant funding will need to be sourced to continue this work.

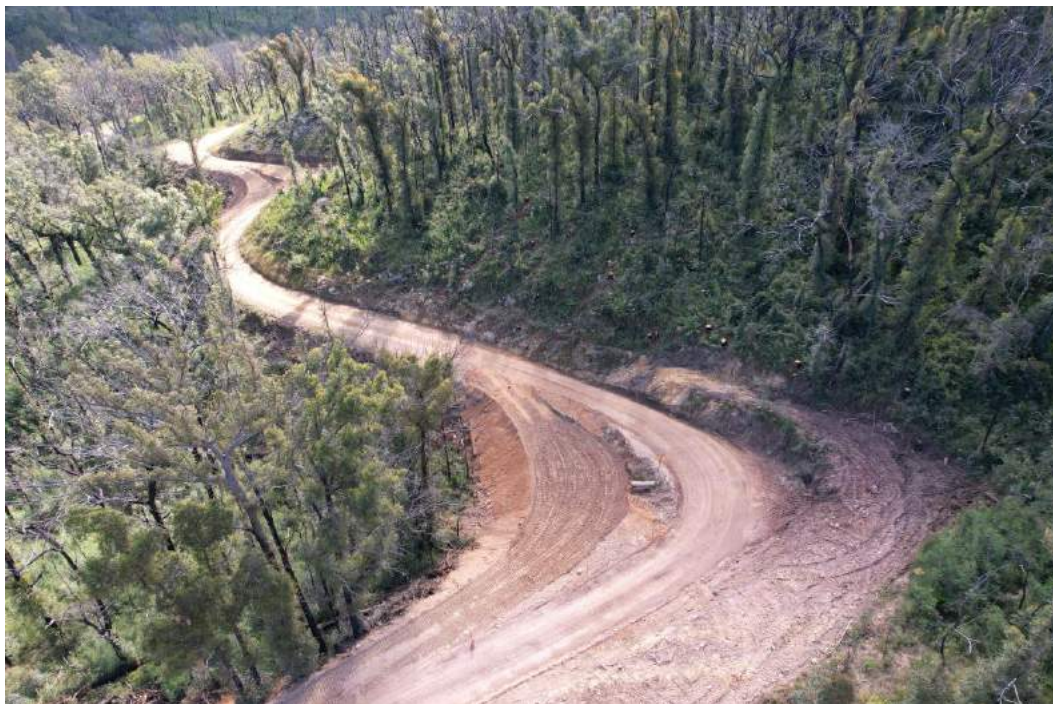
Photo 12 – Araluen Road Merricumbene

Additional grant funding was directed to allow re-use of materials won from resilience works to stabilize existing batters and widen corners to allow safer travel along Araluen Road

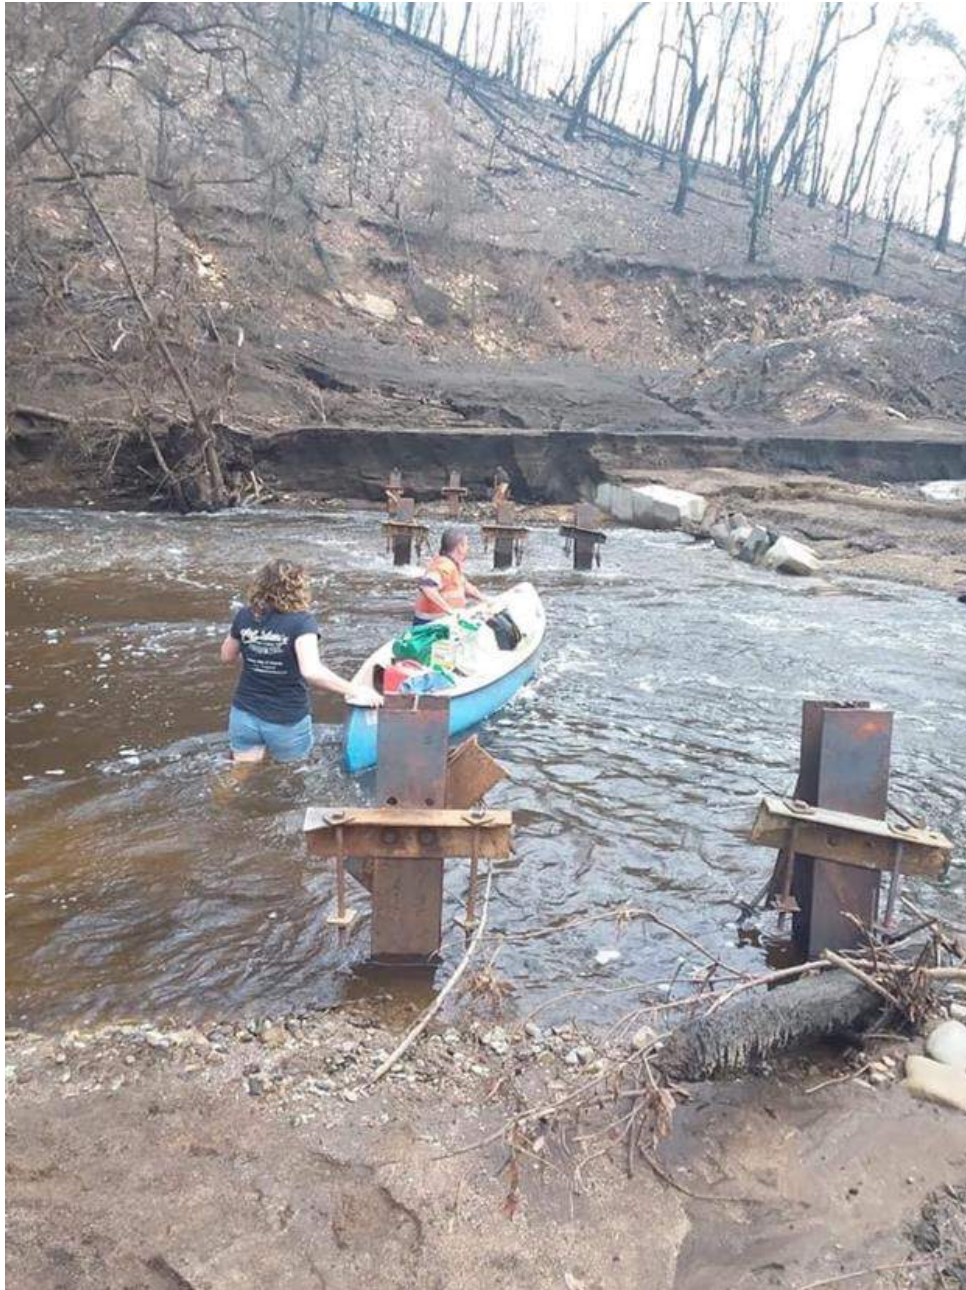
Photo 13 – significant challenges face rural farmers and residents when critical infrastructure is lost. Belimbla bridge was destroyed on 31 December 2019. Temporary structures suffered repeated damage during subsequent repeat flood events

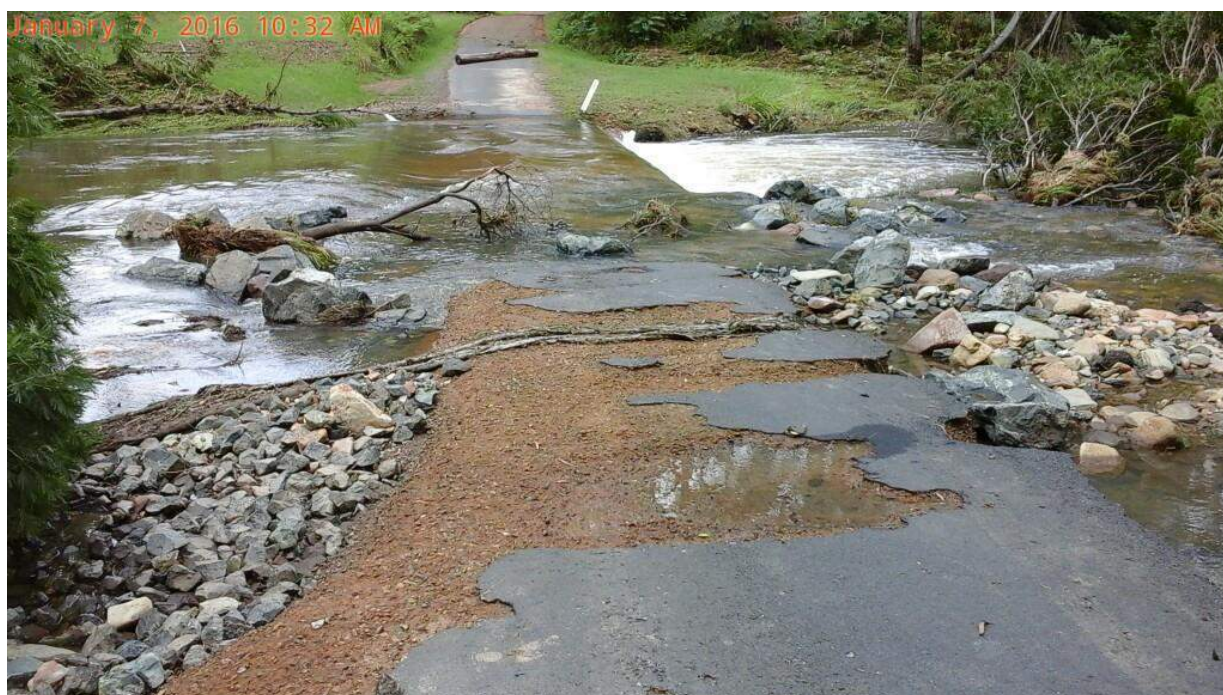
Photo 14 – Northern Gulph Creek Causeway, Eurobodalla Road, Nerrigundah

This structure has been washed out at both ends repeatedly and will be replaced with a bridge with similar flood capacity to the bridge into Nerrigundah over Gulph Creek. This will provide vastly improved access to local residents and for Essential Energy to access the main powerline into Nerrigundah. The bridge components have been procured with installation scheduled for 2023, subject to confirmation of grant funding.

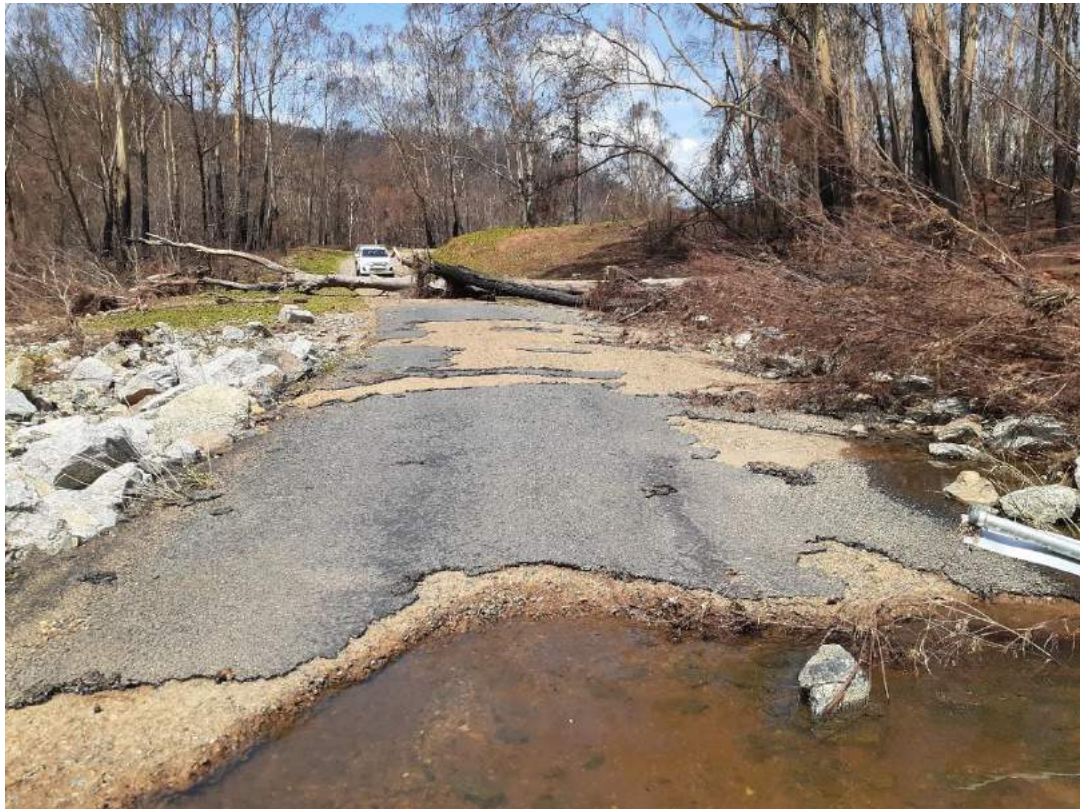
This structure is located in a very wide section of Gulph Creek and would be a large exercise to replace with a bridge structure. The causeway will therefore be repaired in the interim and extended concrete approaches provided to mitigate loss of the roadway. This work is scheduled for 2023.

**Photo 15 – part of the southern causeway Gulph Creek Eurobodalla Road, Nerrigundah.
This photo highlights the devastating impact of both
the bushfires followed by a natural disaster flood event.**

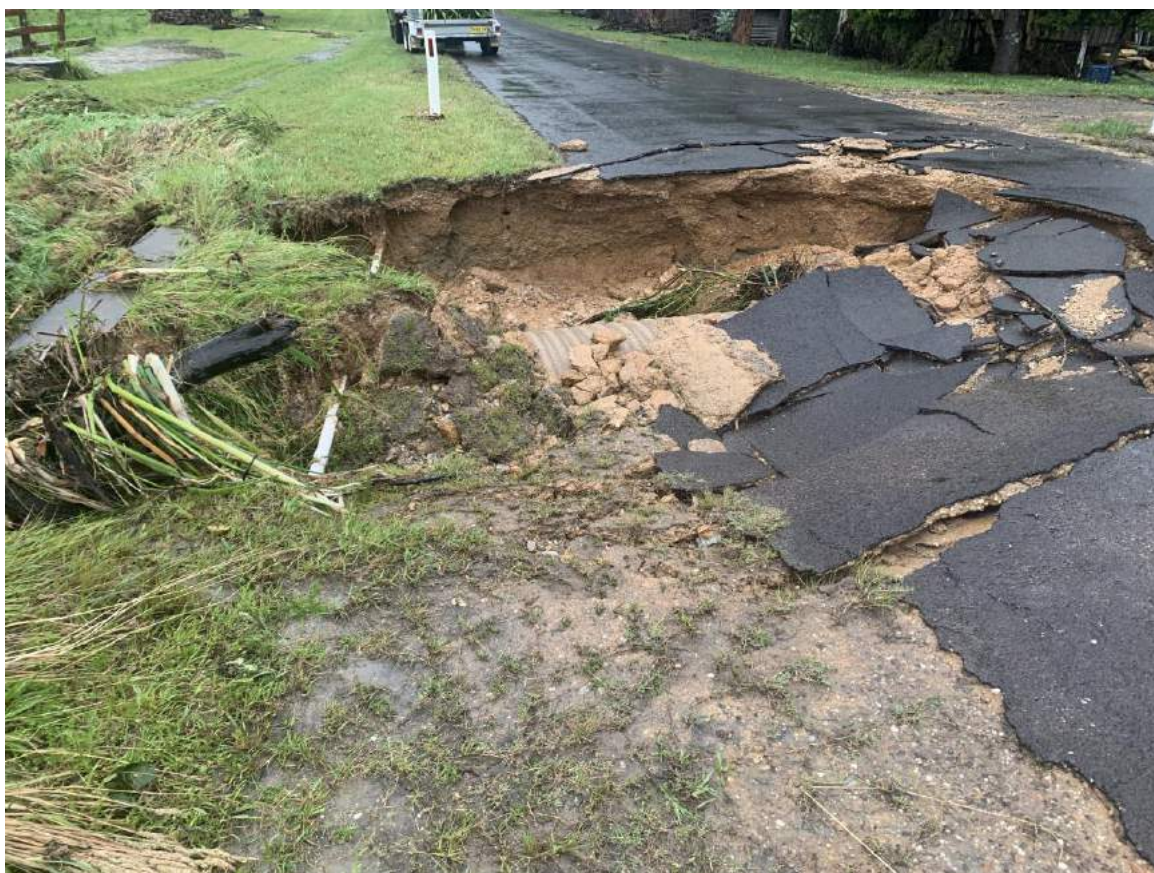
This structure was significantly damaged in the December 2021 flood, resulting in collapse of the road. Single lane access was quickly re-established that same night and a temporary repair affected shortly thereafter. Design solutions will be investigated during 2022-23 and funding sources identified.

Photo 16 Veitch Street, Mogo – culvert crossing December 2022 was restored that evening and re-opened to provide resident access. Major renewal/replacement will be required in the short term.

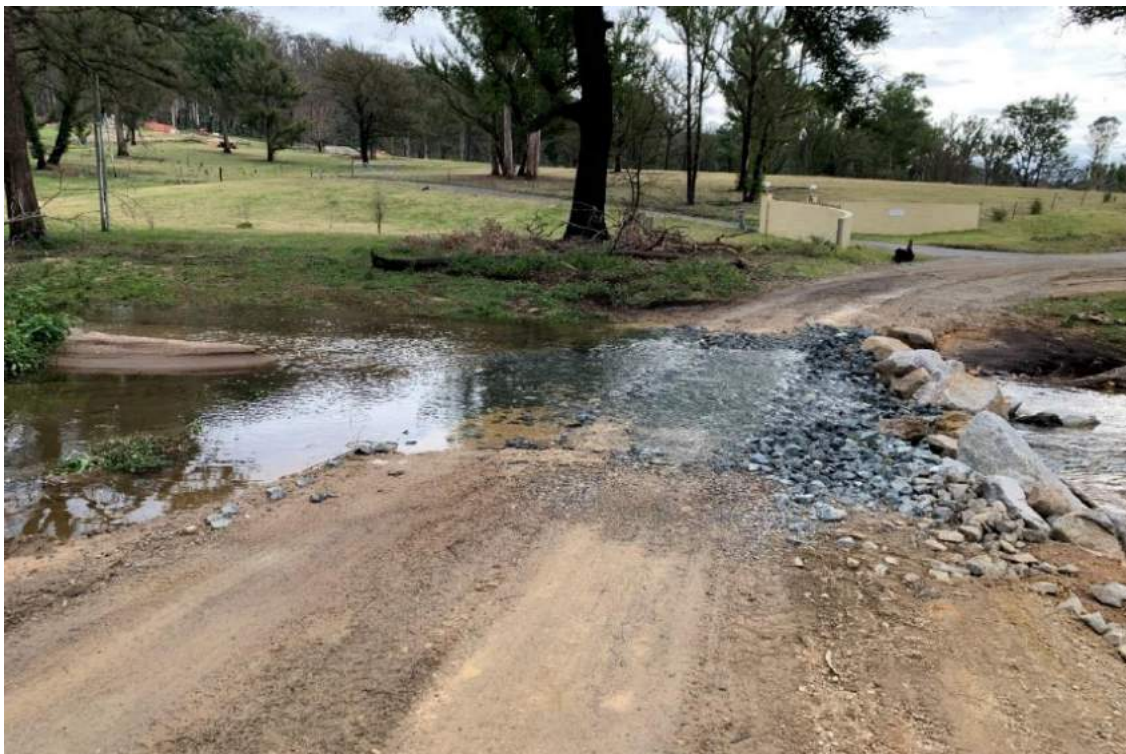
This piped causeway has been washed out in multiple events cutting access to rural residents and resulting in the loss of the road embankment and pavement materials into the nearby receiving waterways. This structure will be replaced with a bridge to improve resilience and overcome the challenges of repeat loss of the roadway. This work is scheduled to be undertaken in late 2023.

Photo 17 - Nelligen Creek Road causeway has been repeatedly washed away

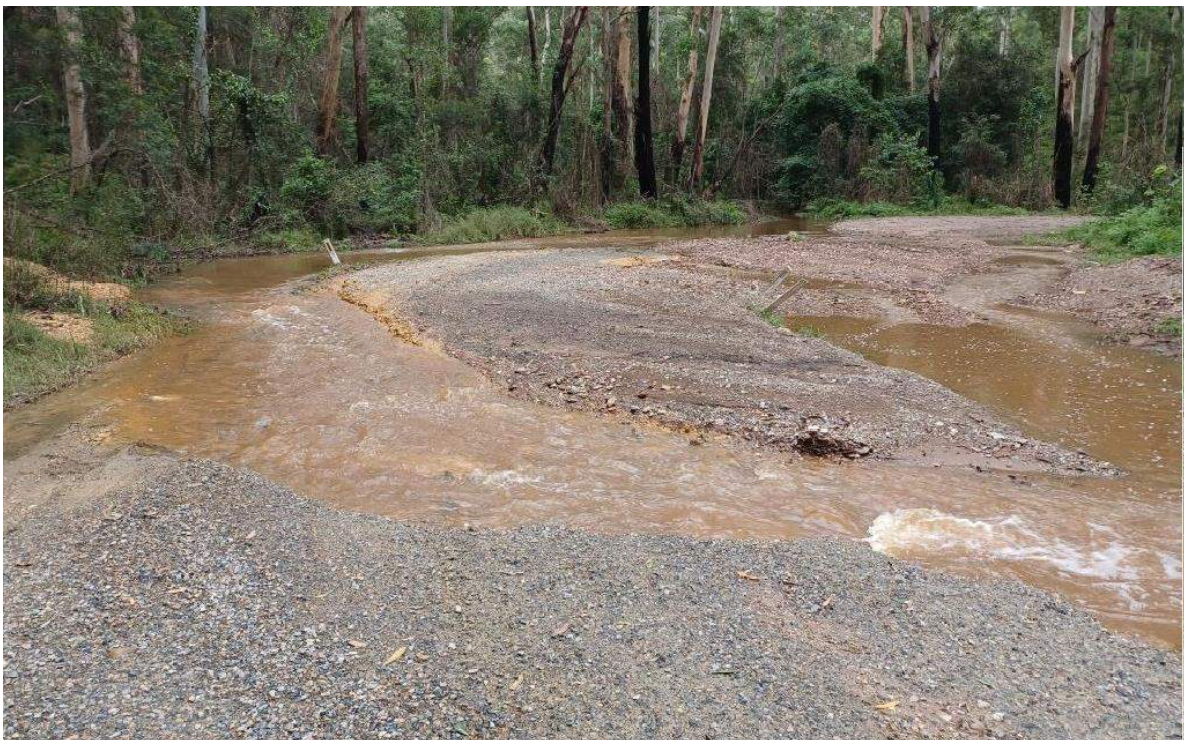
Photo 18 – River Road, Nelligen suffers regular flood damage

It is proposed to pursue grant funding to allow the NDRRA funding to be topped up to allow installation of a major culvert structure at this site. The road would also be lifted to mitigate flooding and the loss of the roadway to improve access for residents and environmental outcomes.

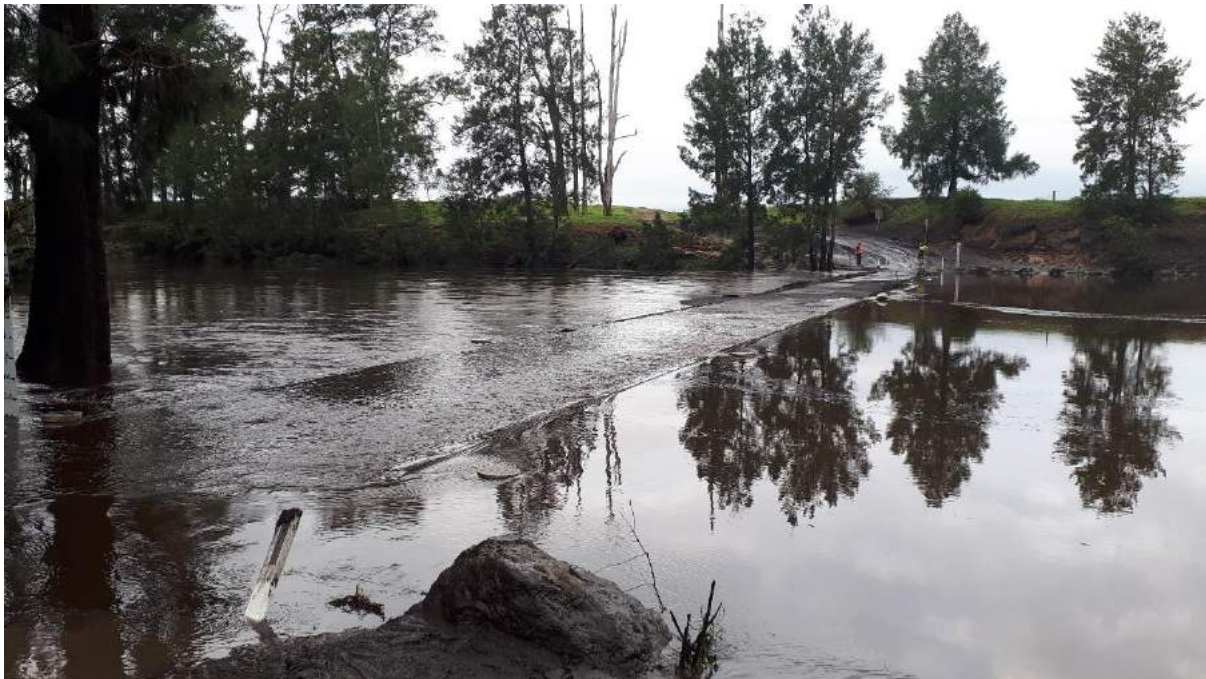
Photo 19 – Silo Farm bridge on Comerang Forest Road, Bodalla goes underwater regularly isolating dairy farmers from milk transport. Typical scene when decisions need to be made about the safety of re-opening the bridge to milk tankers and farm vehicles.

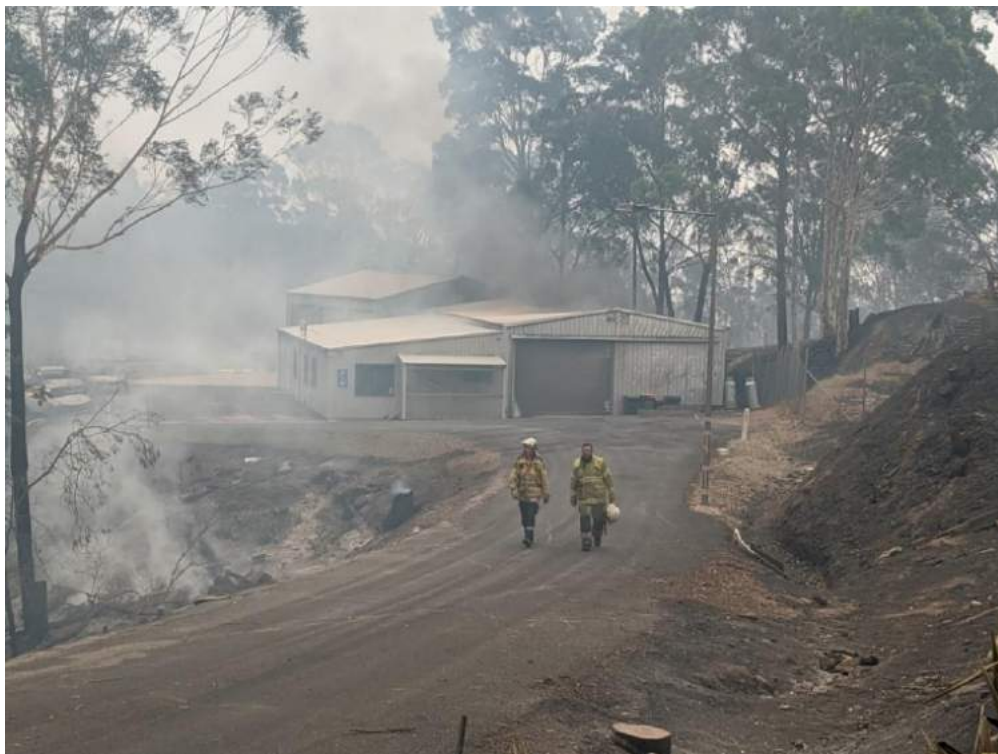
Photo 20 – Batemans Bay SES

Ember attack from the bushfires resulted in the existing SES building near Batemans Bay depot being destroyed on 31 December 2019. Much of the equipment had been relocated from the sheds before the bushfire hit.

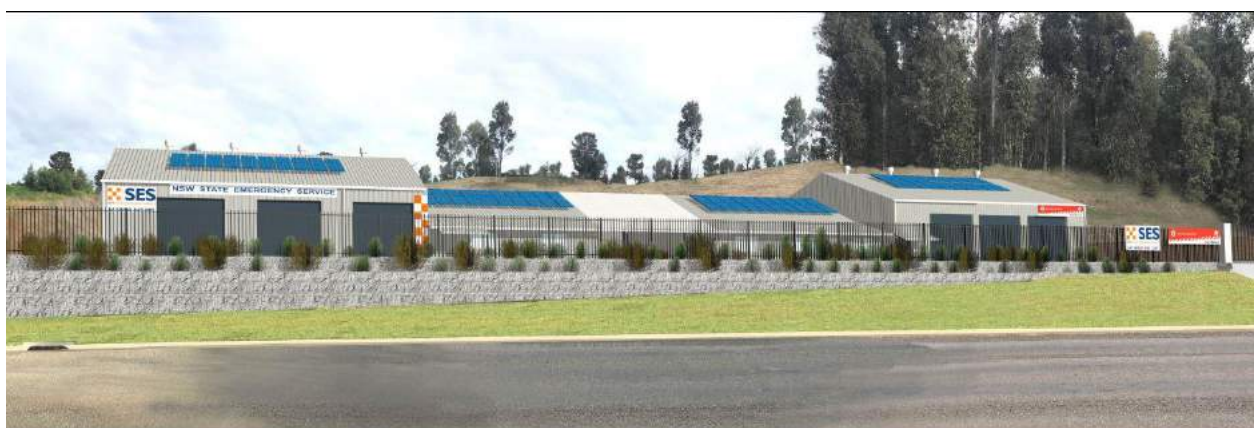
Figure 3 – Design for collocated SES and RFS stations, Surf Beach

The new stations will be located immediately adjacent to the NSW Ambulance station.

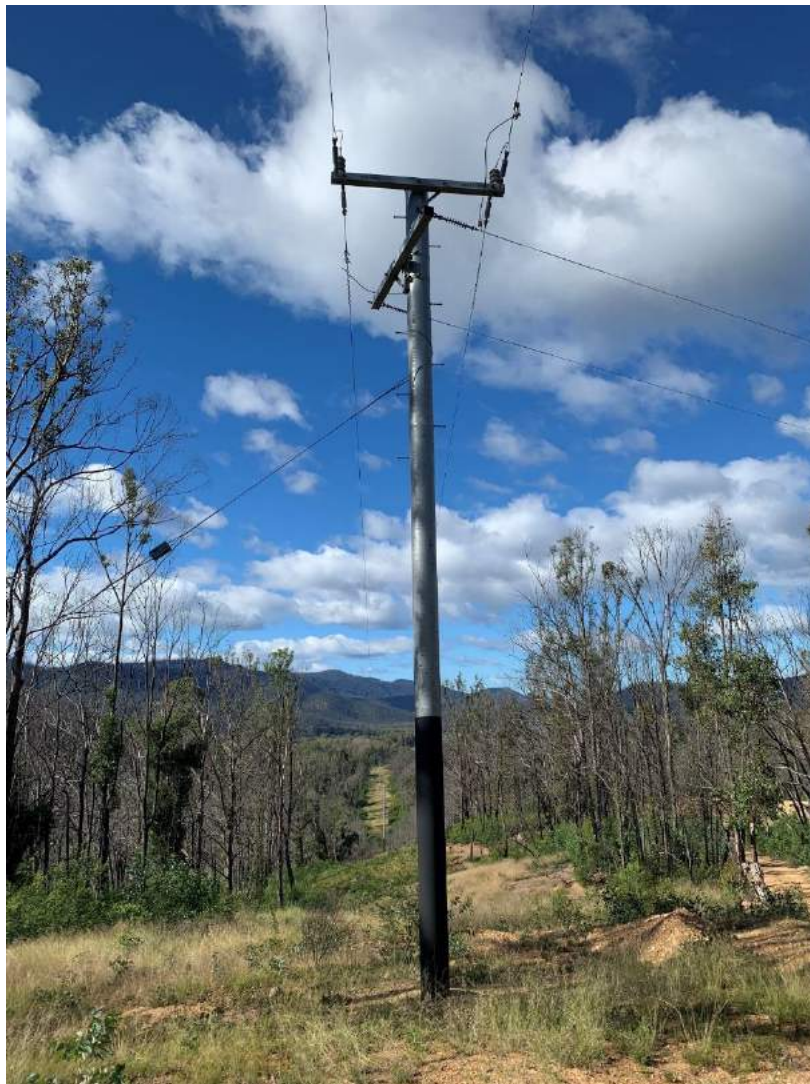
**Photo 22 – resilient power poles survived the intense bushfire at Merricumbene.
Broader application would significantly improve the resilience of the power supply network.**

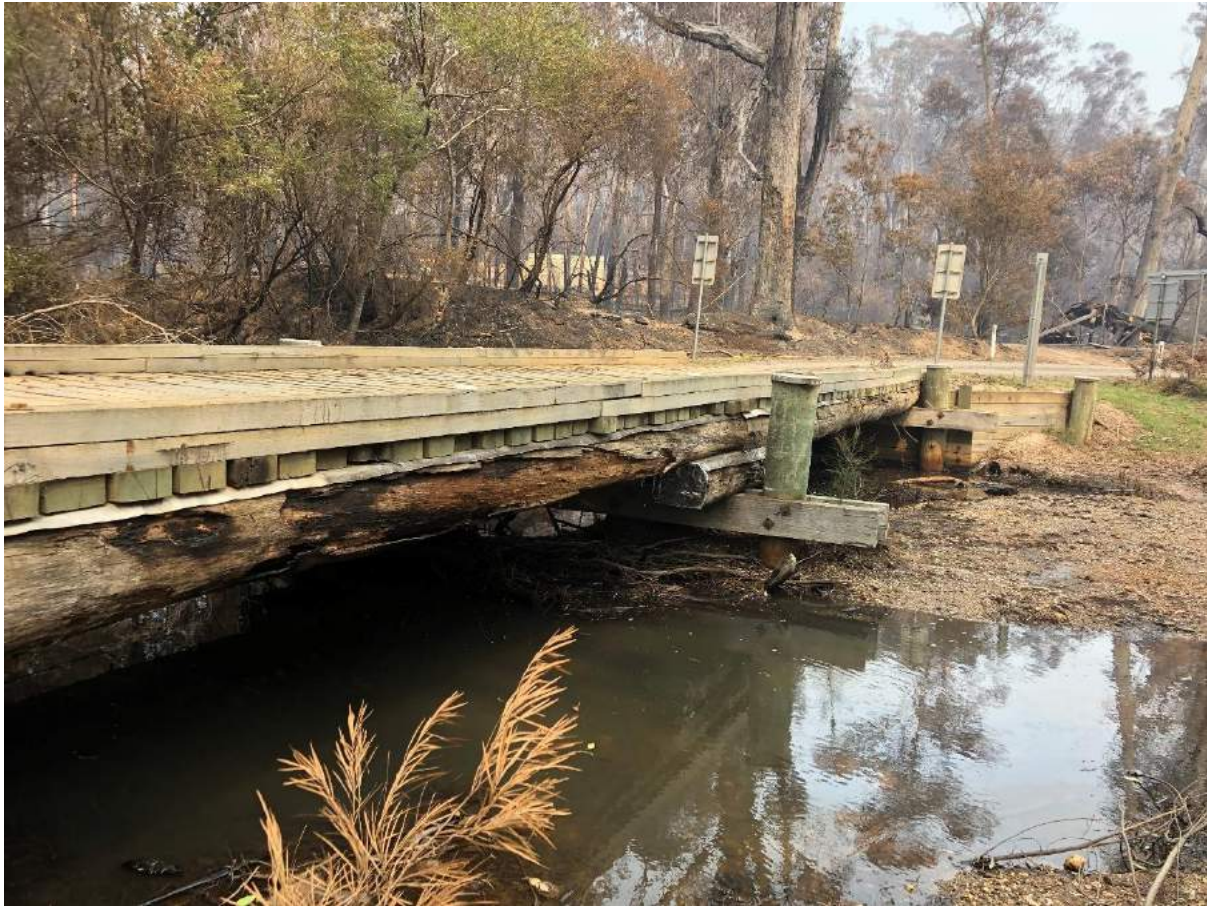
Photo A.1 Clarksons Bridge Wagonga Scenic Drive Narooma

This bridge was damaged in the bushfire and quickly assessed and repaired with new decking.

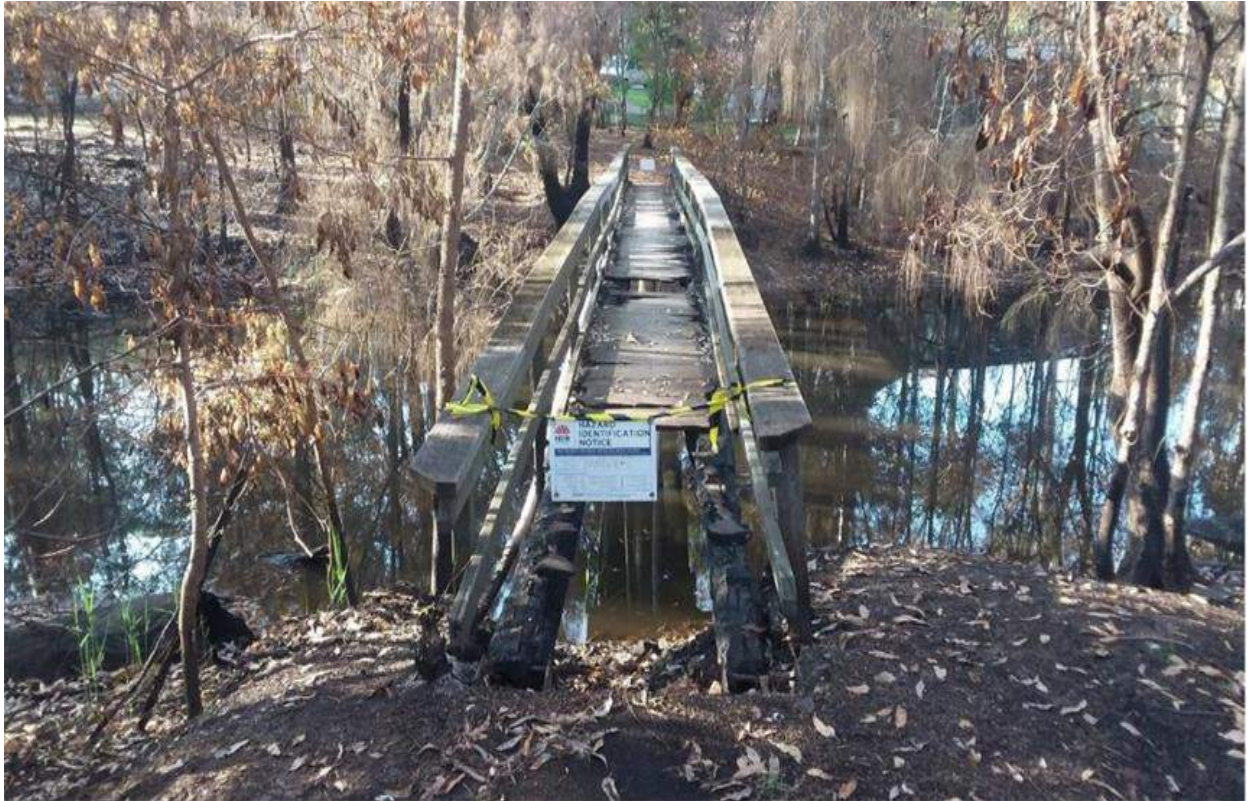
Photo A.2 Rosedale footbridge post the 2019-20 bushfires

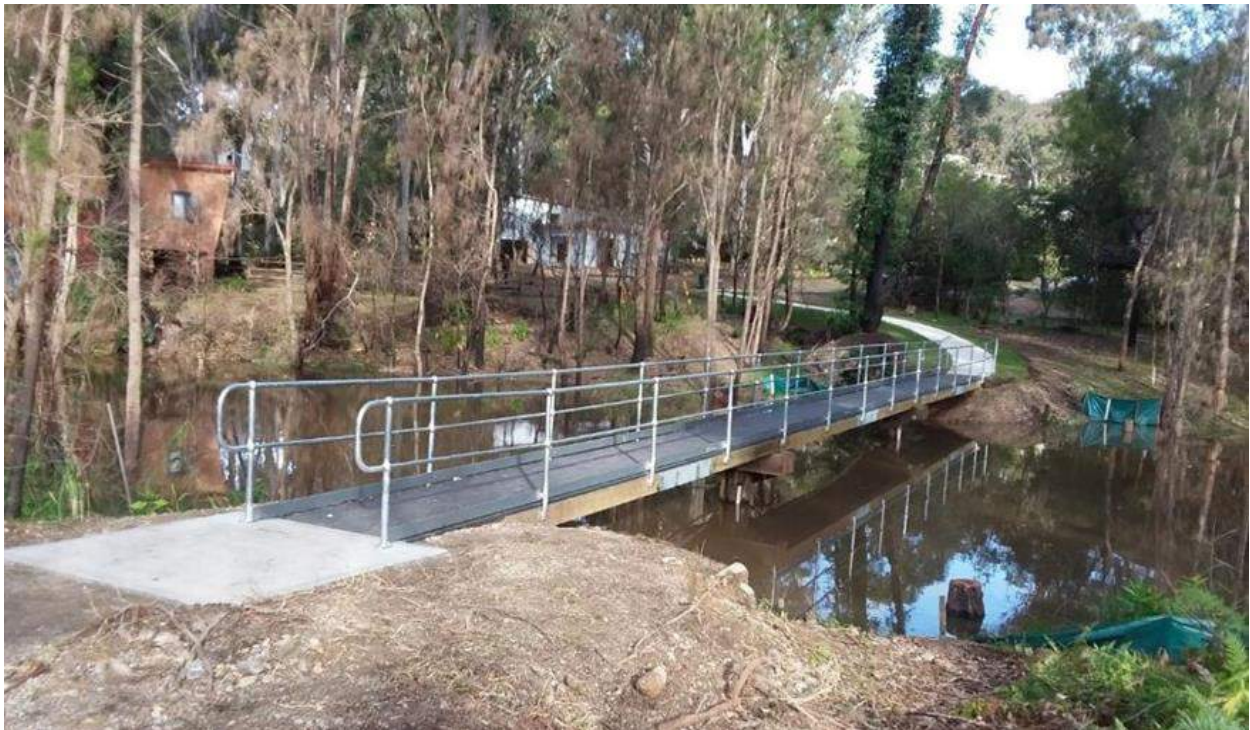
Photo A.3 Rosedale footbridge was replaced with a composite structure, in keeping with the surrounds, to reconnect the heavily impacted North and South Rosedale villages

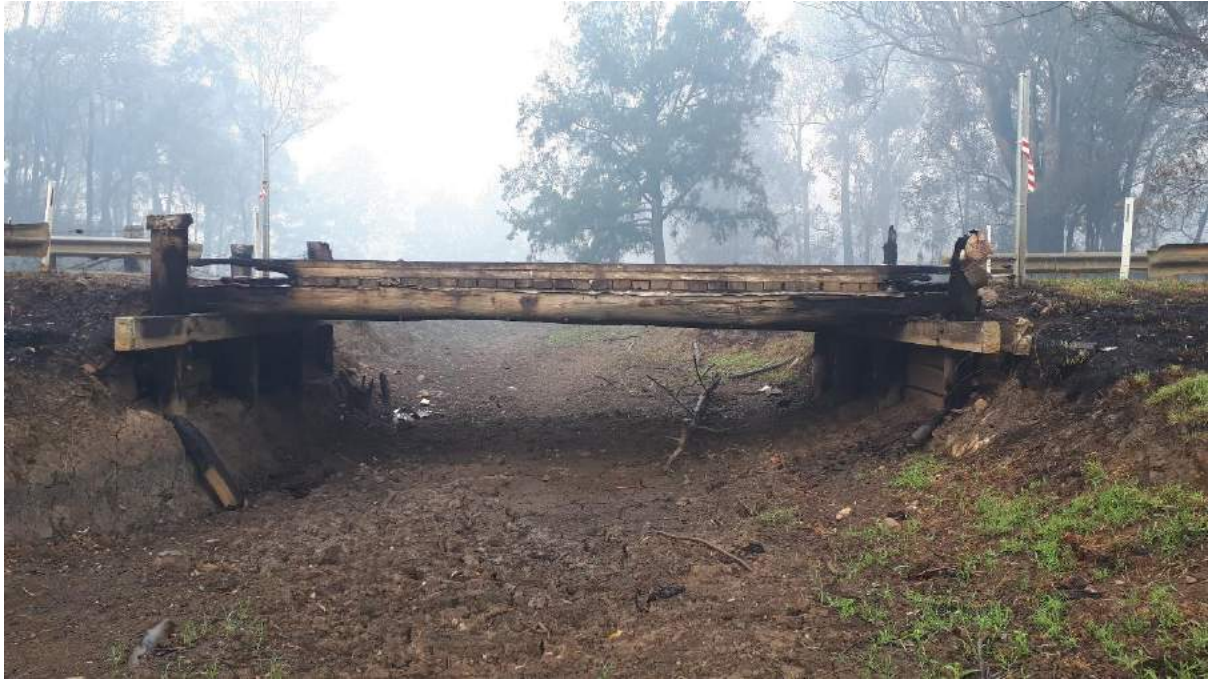
Photo A.4 Cheese Factory bridge – normally ‘permanently’ wet waterways were dry completely when the bushfires hit on 31 December 2019.
