0.0 INFRASTRUCTURE RECOVERY & RESILIENCE – NATURAL DISASTERS

The purpose of this report is to provide an overview of the extensive work done since the Black Summer bushfires to recover our local road and bridge infrastructure and deliver 'in-perpetuity' improvements to address these specific issues.

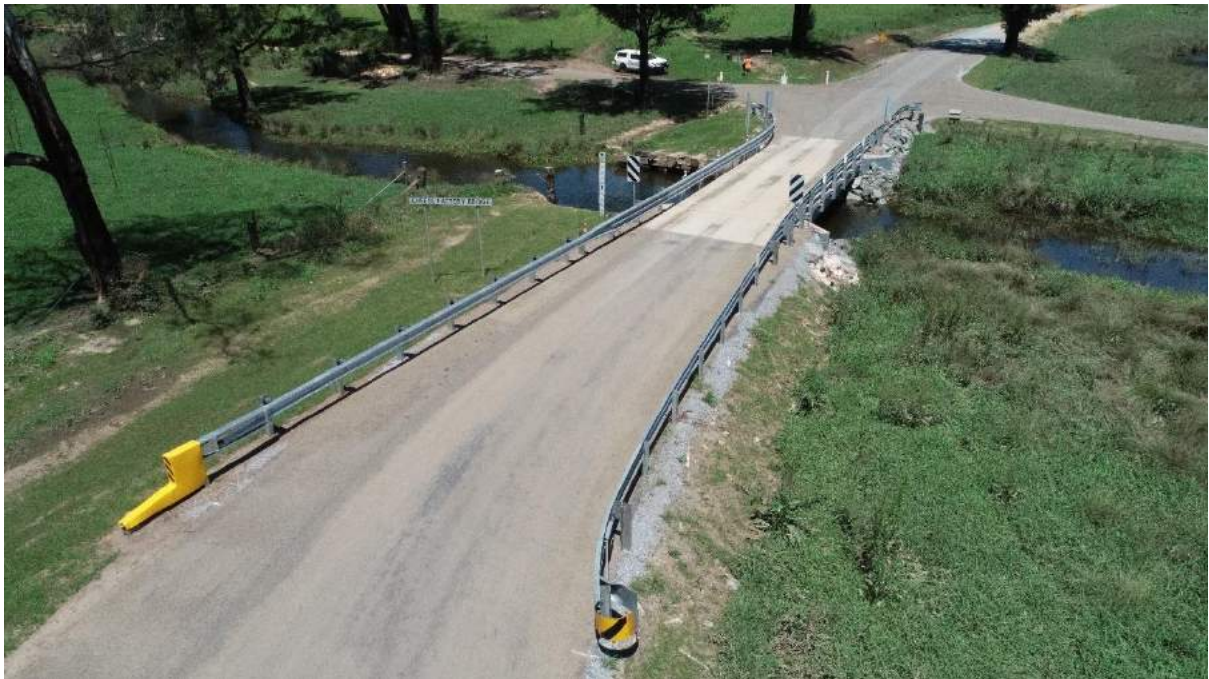
Photo A.5 – Cheese Factory bridge was replaced with a new concrete bridge

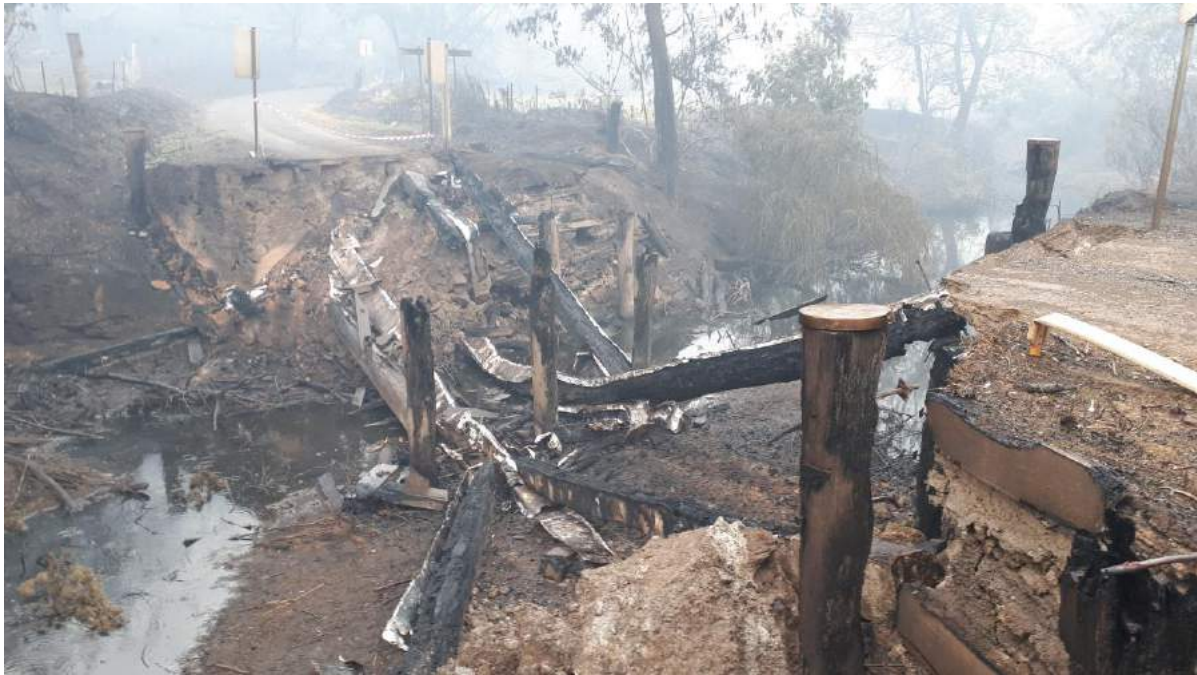
Photo A.6 – Reedy Creek bridge was completely destroyed during the bushfires requiring multiple temporary crossing structures to be built and rebuilt due to flooding damage prior to completion of the new concrete bridge

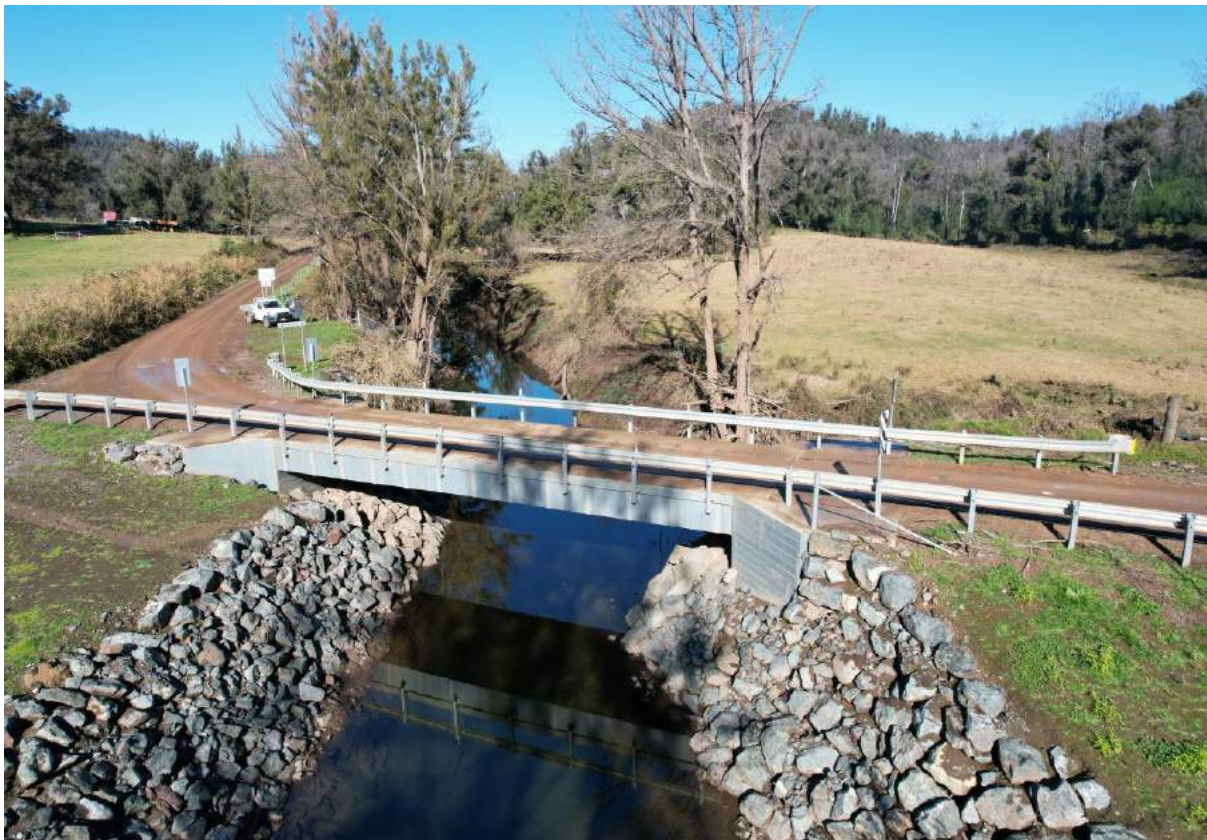
Photo A.7 – Reedy Creek bridge – a new concrete bridge is now in place and the approaches have since been sealed to reduce sediment loads into nearby waterways and better care for the new bridge

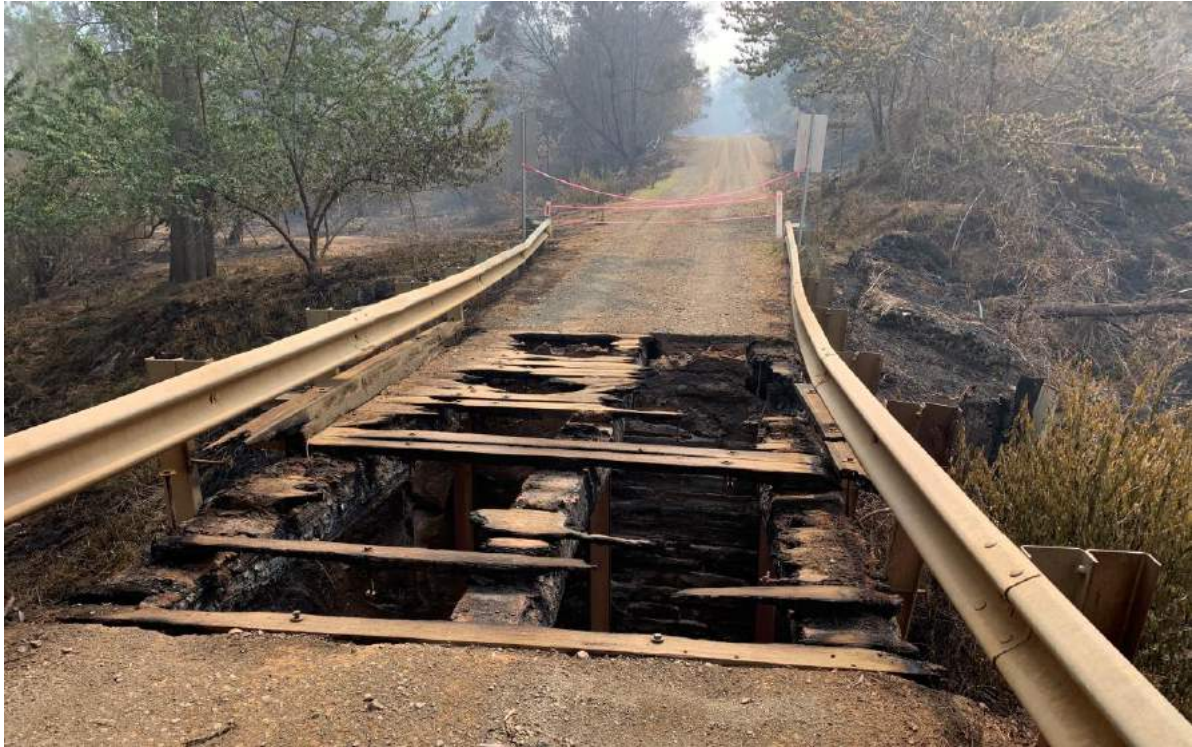
Photo A.8 Peach Tree bridge – destroyed during the 2019-20 bushfires on 31 December 2019

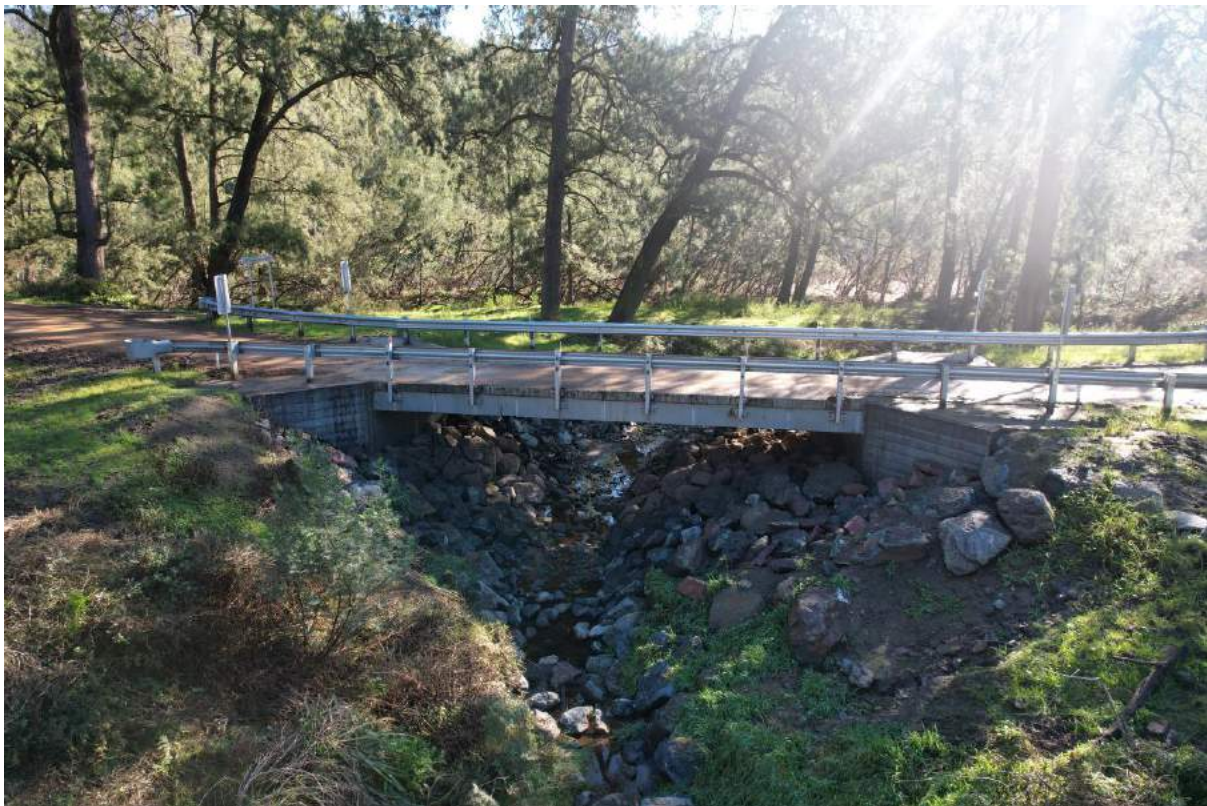
Photo A.9 – Peach Tree bridge – a new concrete bridge is now in place with sealed approaches

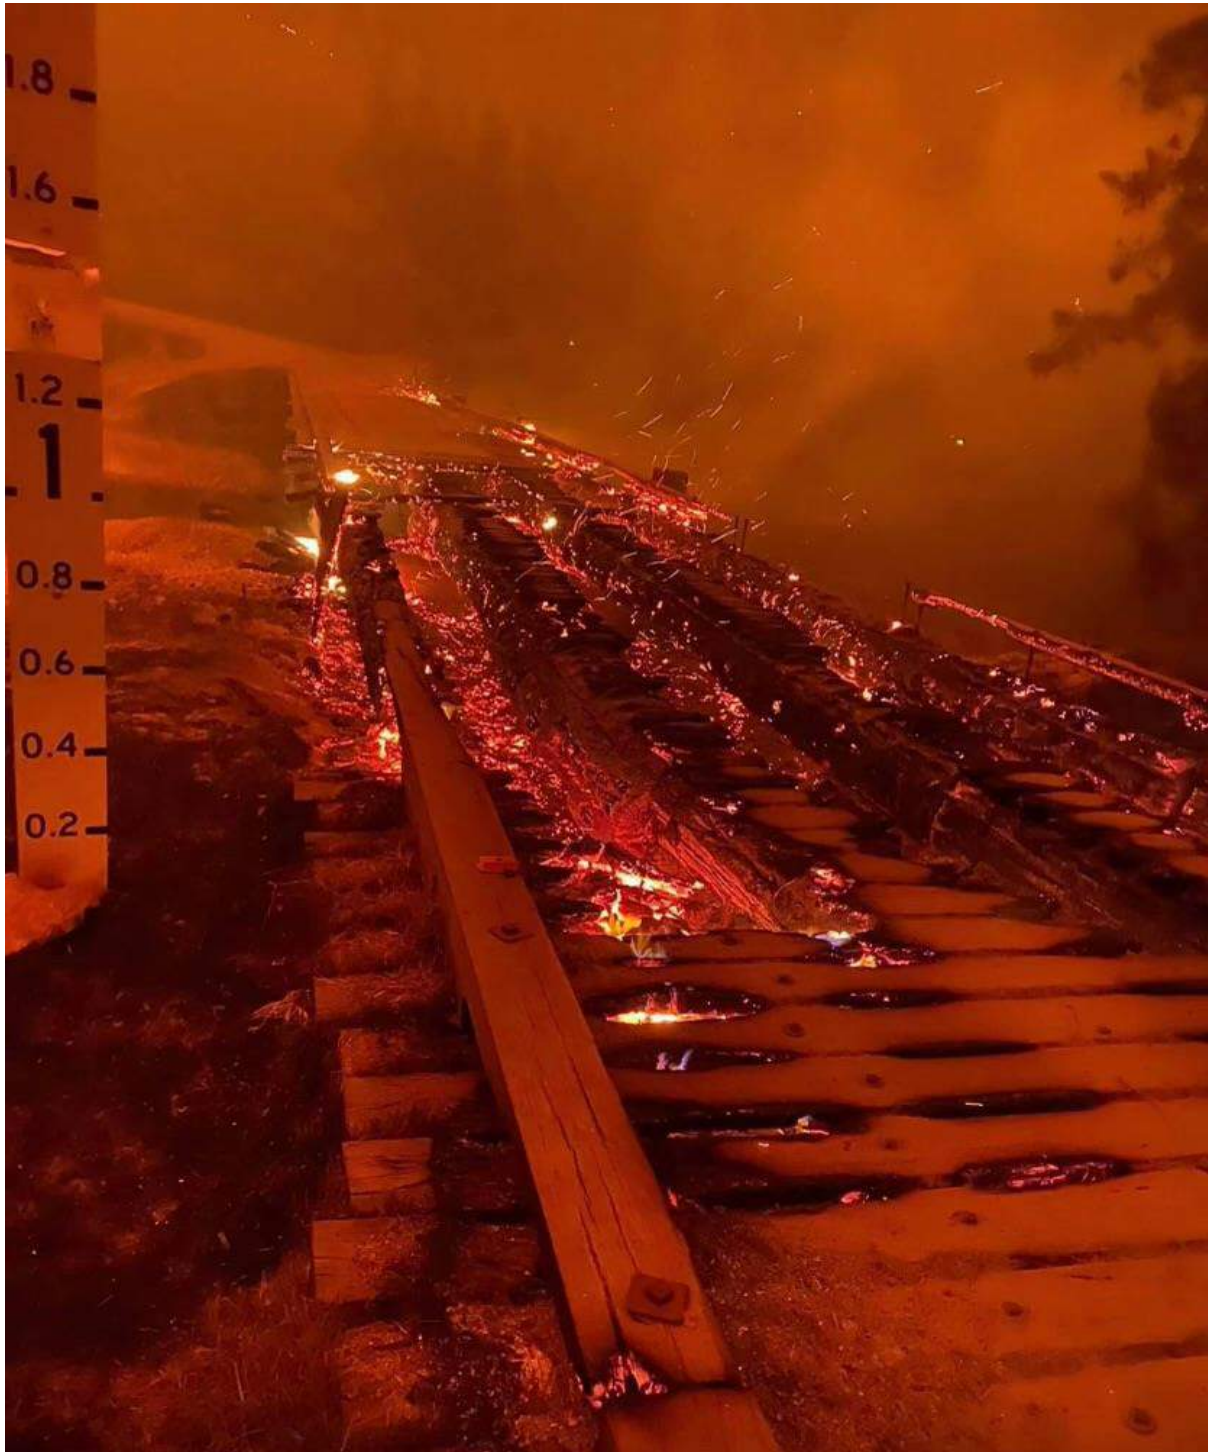
Photo A.10 – Murphys bridge 31 December 2019 during the bushfires
(photo courtesy of local residents).

Council crews cut the girders on this deck on the same day to save a portion of the bridge timber.

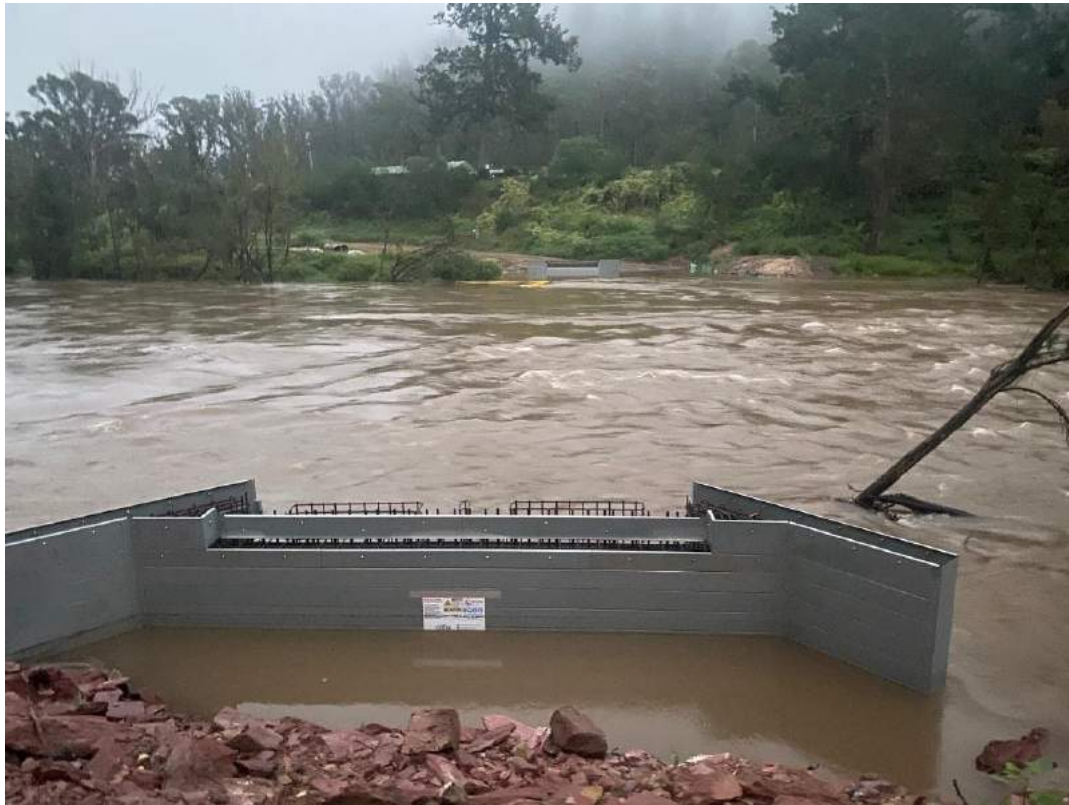
Photo A.11 – Murphys bridge Eurobodalla Road Cadgee was the largest of the bushfire affected bridges to be replaced. Regular flooding of the Tuross River kept the contractor off-site, increasing the time required to replace the bridge making reconnection of the community during recovery more difficult. Alternate transport routes were maintained throughout despite many challenges with flood damage (loss of pavement, landslides and slope instability).

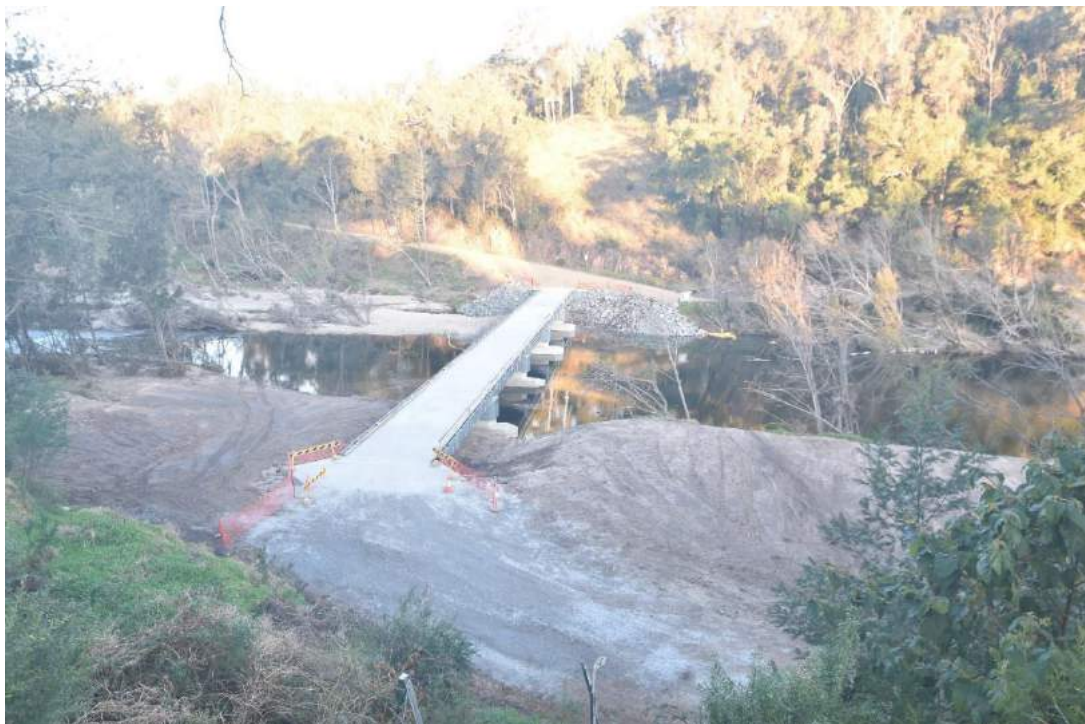
Photo A.12 – Murphys bridge Eurobodalla Road Cadgee – new 68.5m long concrete bridge re-opened to local traffic and school buses on 25 August 2022. Further work is to be undertaken on the bridge approaches for larger vehicles

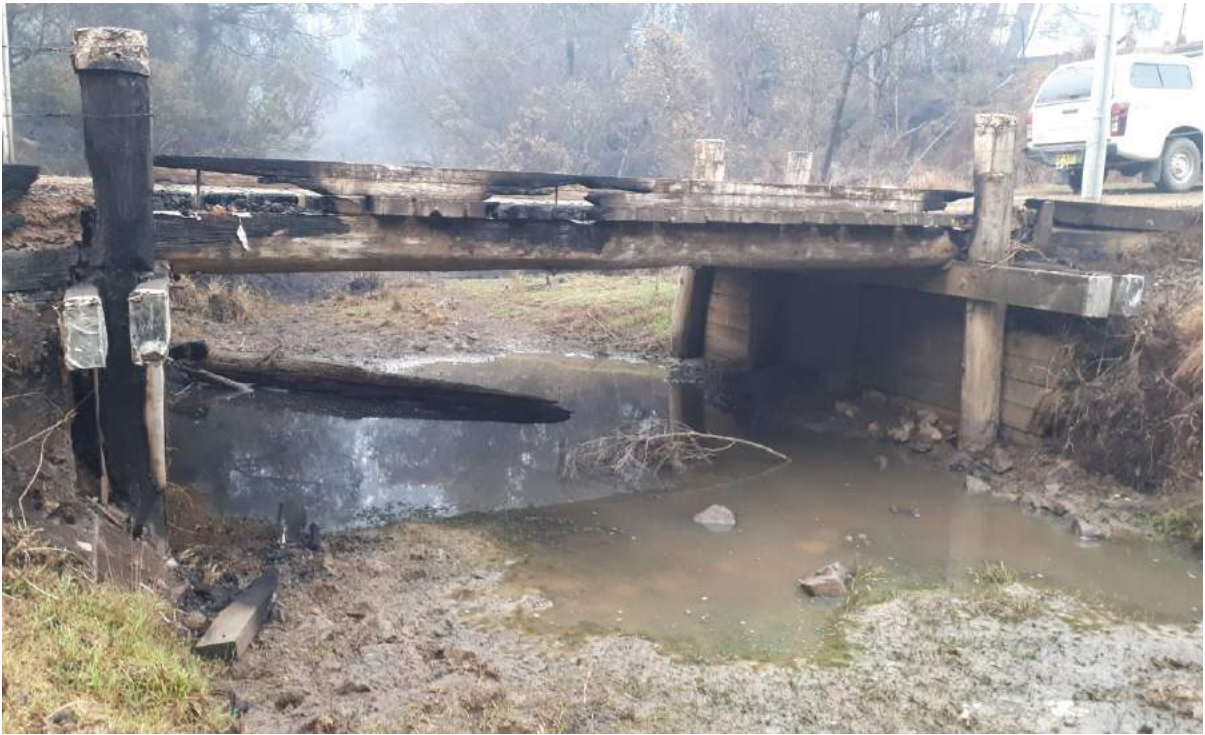
Photo A.13 – Sinclairs bridge

The bridge was temporarily repaired to allow traffic to continue use until replacement could be arranged

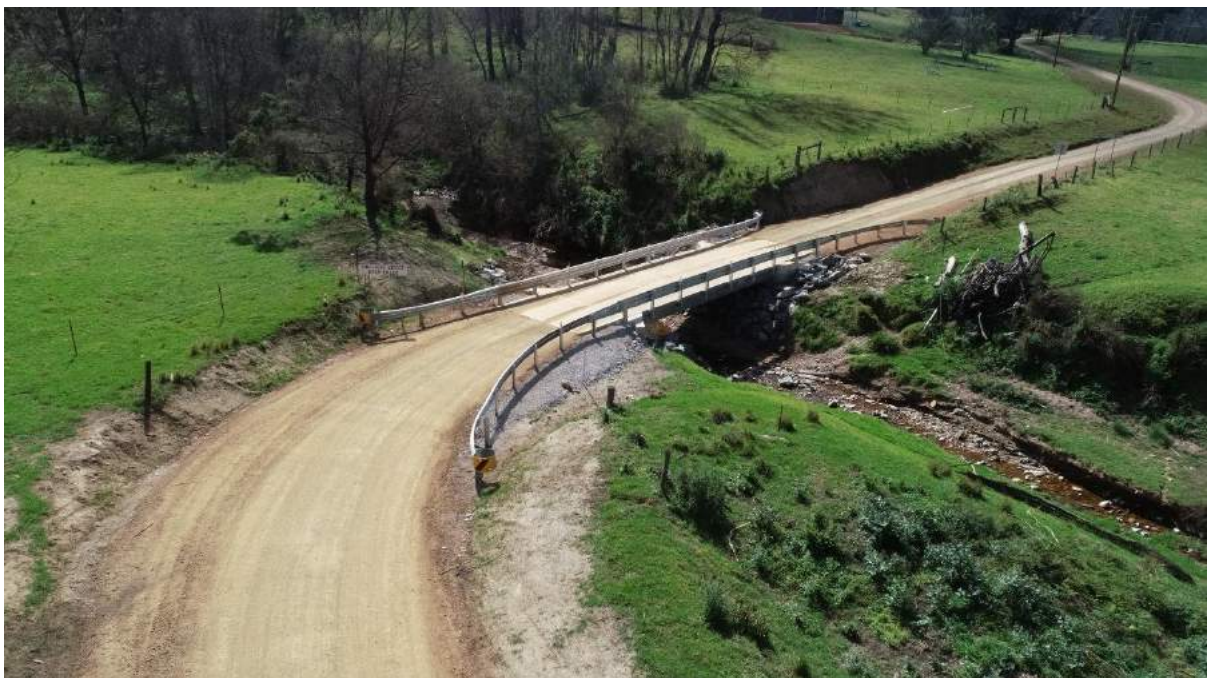
Photo A.14 – Sinclairs bridge

New concrete bridge in place. The road approaches will be sealed in late 2022 including linking the seal at Cadgee bridge to Sinclairs bridge

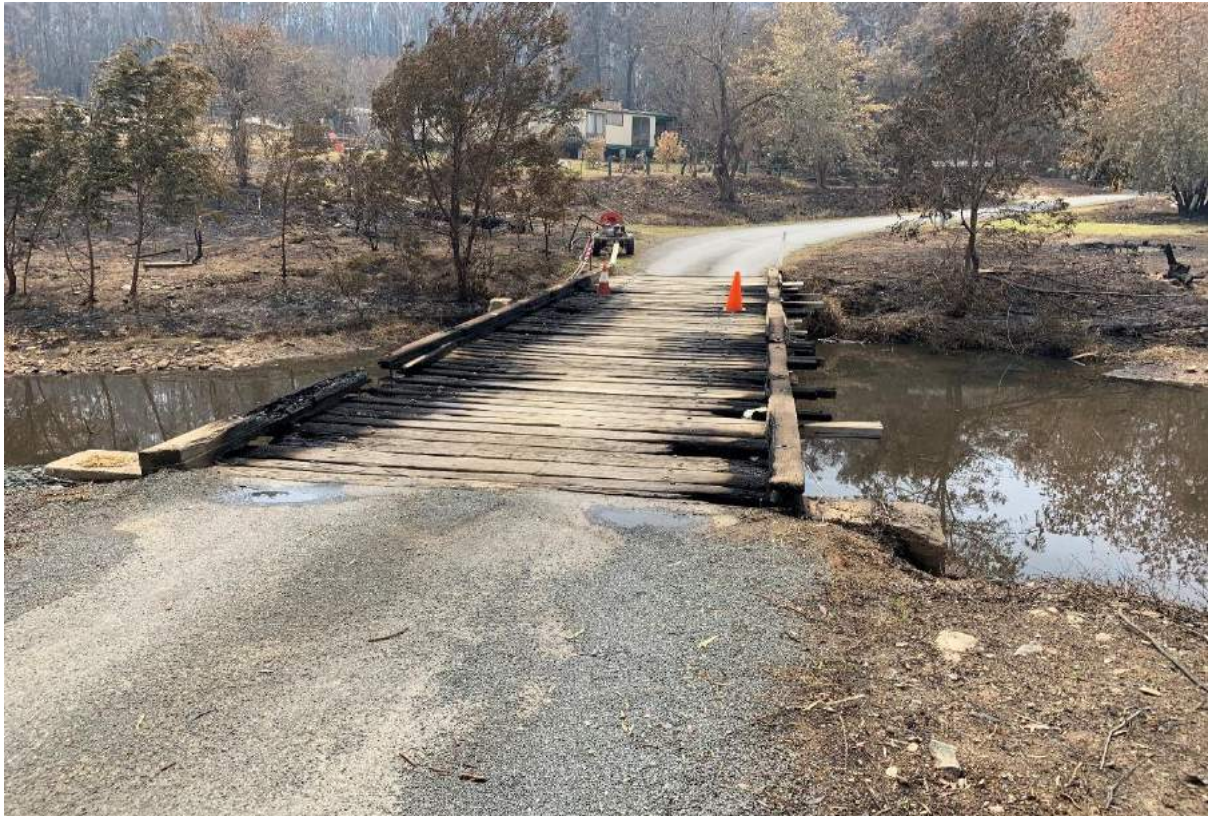
Photo A.15 – Gulph Creek bridge

The bridge suffered significant damage during the bushfires. Temporary repairs were undertaken to keep local traffic able to access Nerrigundah village

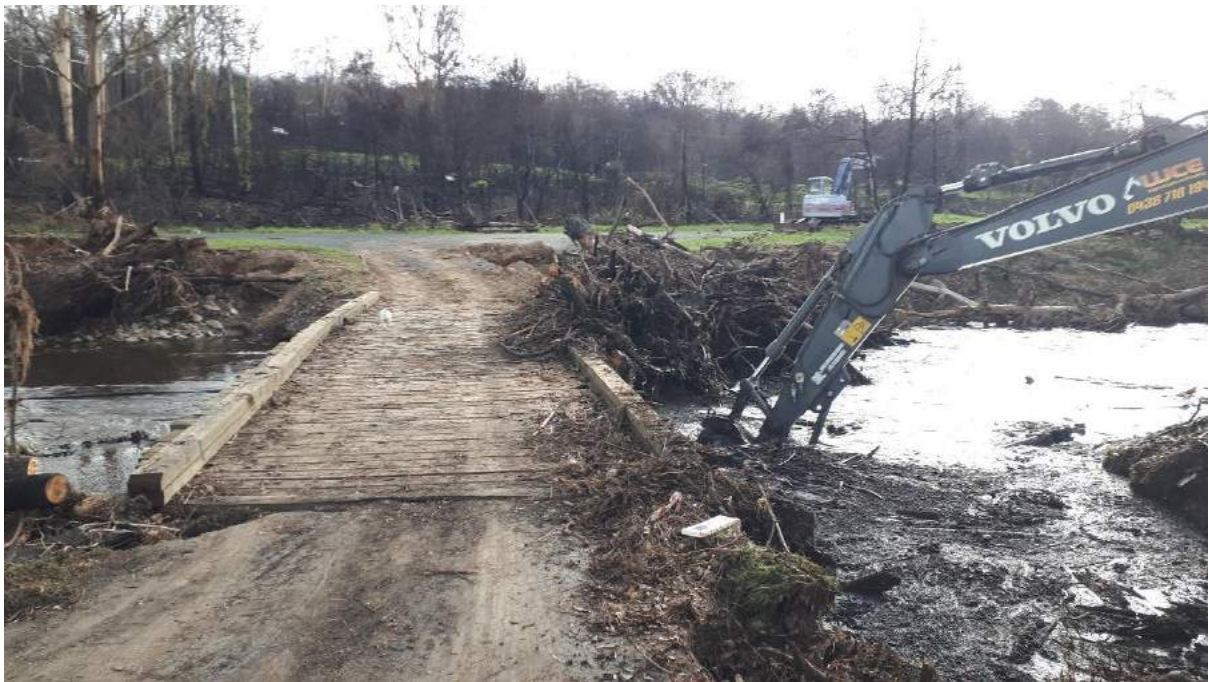
Photo A.16 – Gulph Creek bridge

Following the bushfires, floods washed huge volumes for burnt timber and debris onto the temporary structure. This was removed, mulched and provided to Forestry NSW for environmental restoration work as part of the recovery effort.

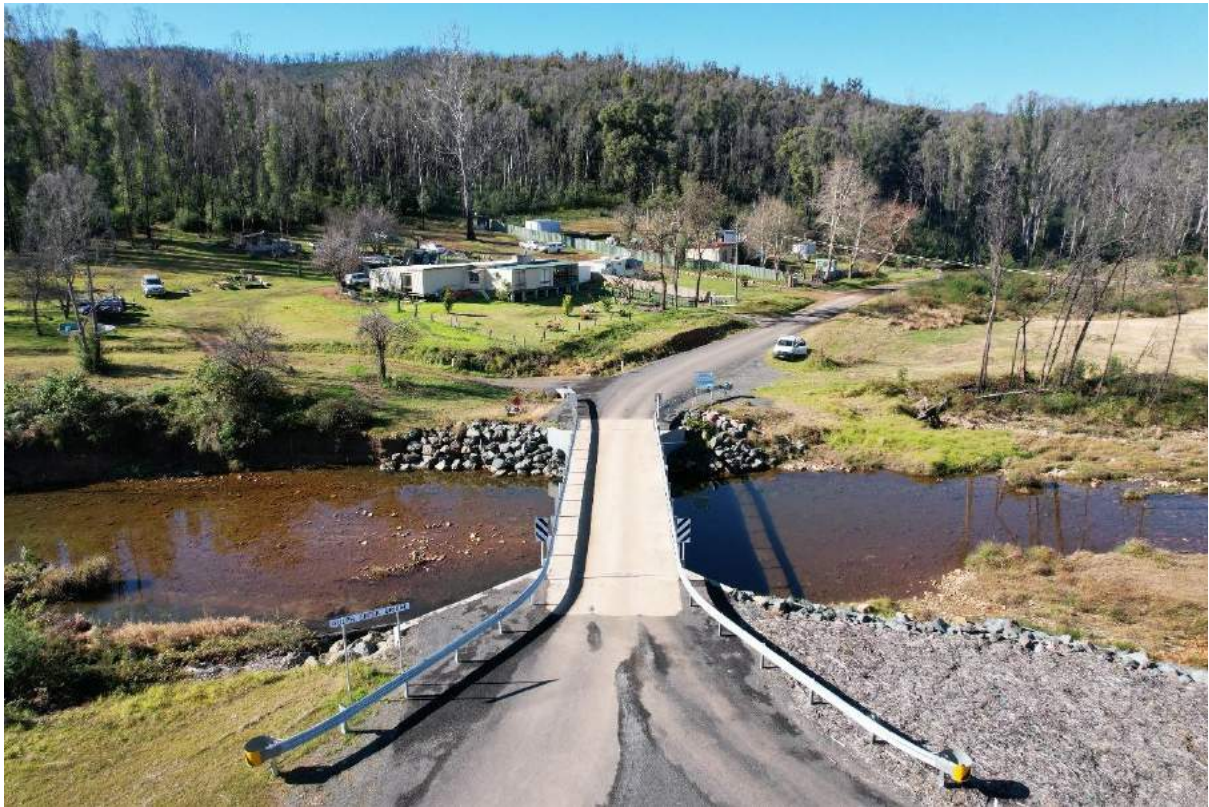
Photo A.17 – Gulph Creek bridge

The completed concrete bridge. This was the first 18.5m long single span Inquik bridge installed in Australia.

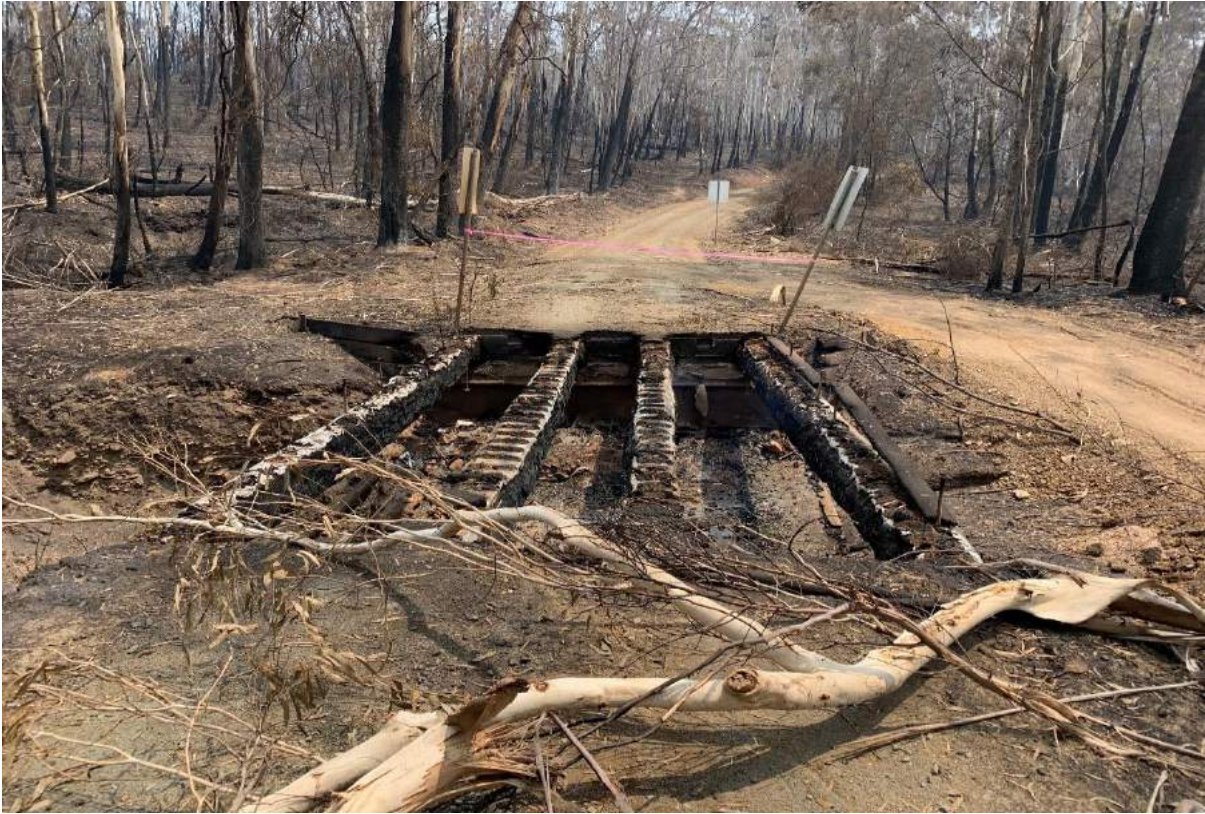
Photo A.19 – Comans bridge

The timber bridge was completely destroyed in the bushfires.

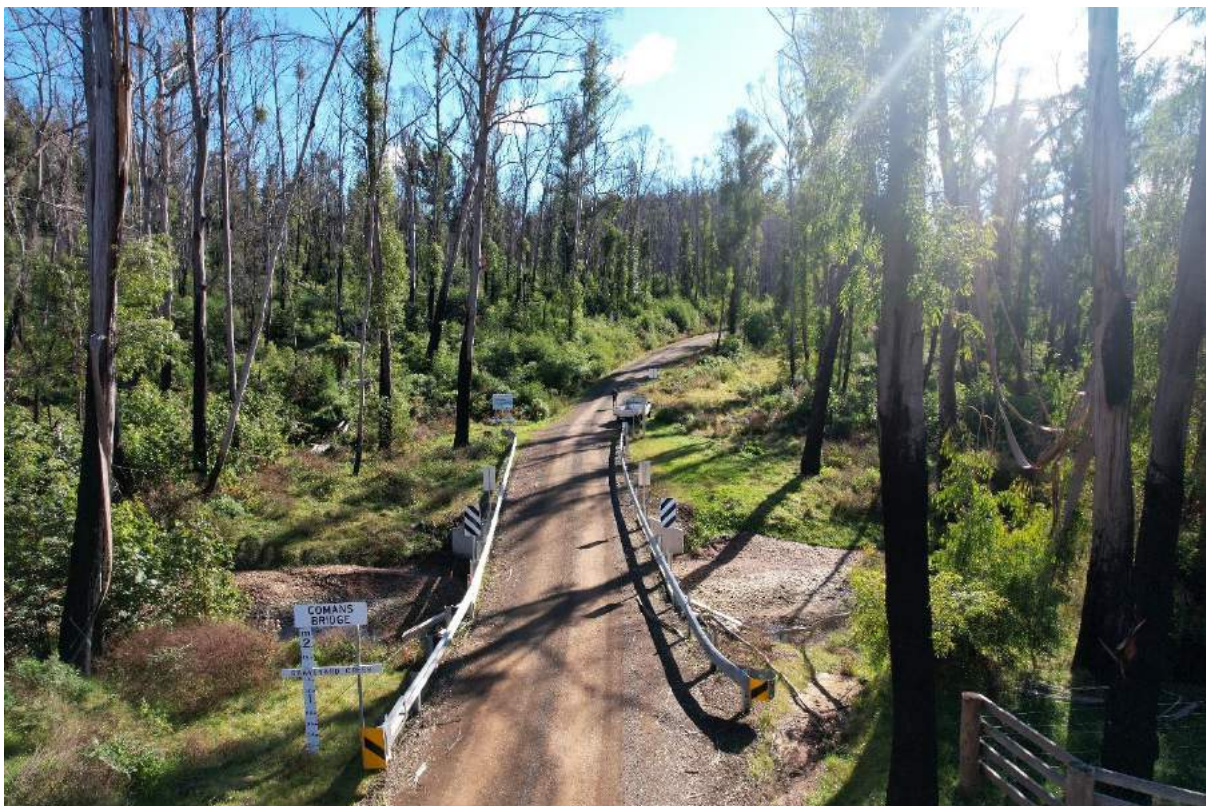
Photo A.20 – Comans bridge

The timber bridge was replaced by multiple concrete box culverts

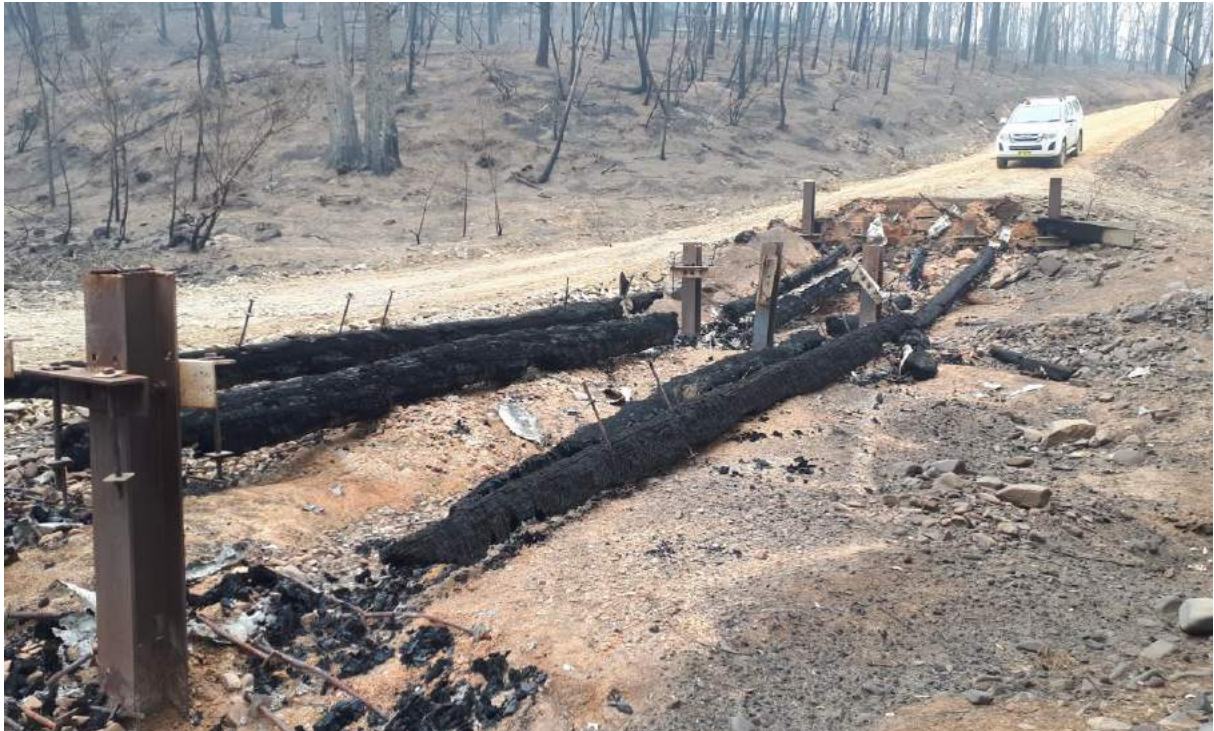
Photo A.21 – Belimbla bridge

Normally a flowing creek, the river was dry when the 2019-20 bushfire burnt the timber bridge.

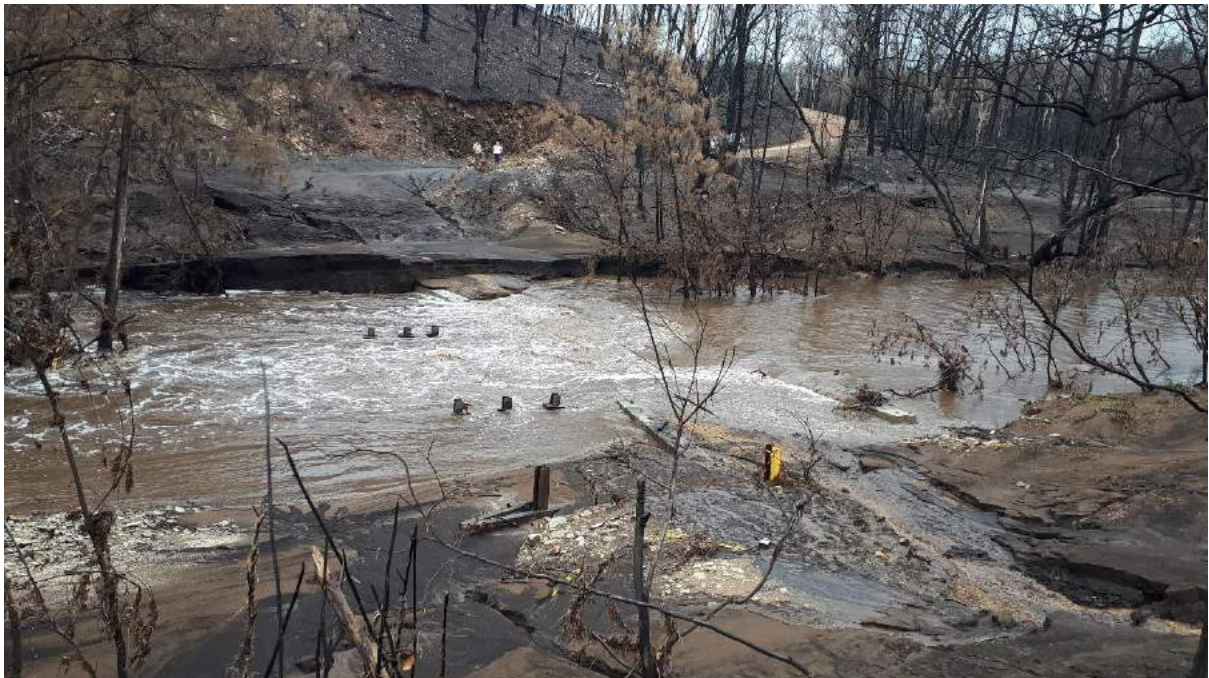
Photo A.22 – Belimbla bridge

The February 2020 and subsequent floods washed temporary access arrangements away and resulted in huge quantities of ash, sediment and timber being washed into Belimbla Creek and the immediately adjoining Tuross River

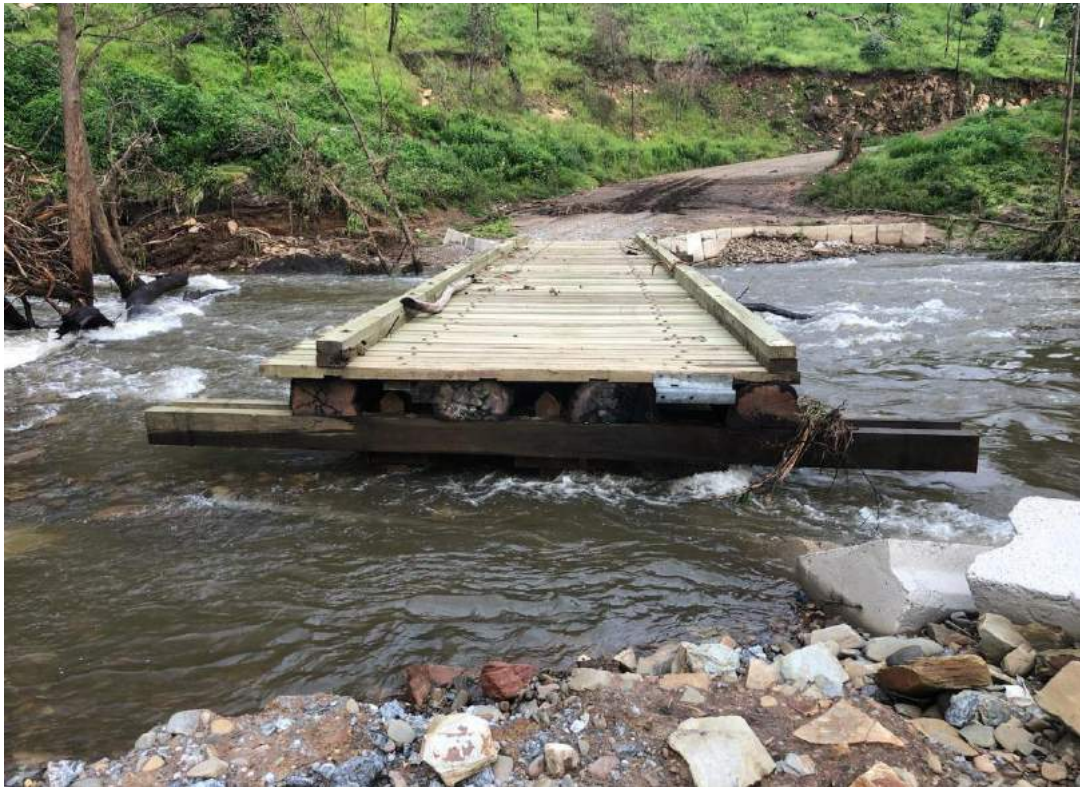
Photo A.23 – Belimbla bridge

Smaller temporary timber bridge structures were installed to provide access.
Repeat floods made retention of access to Belowra challenging

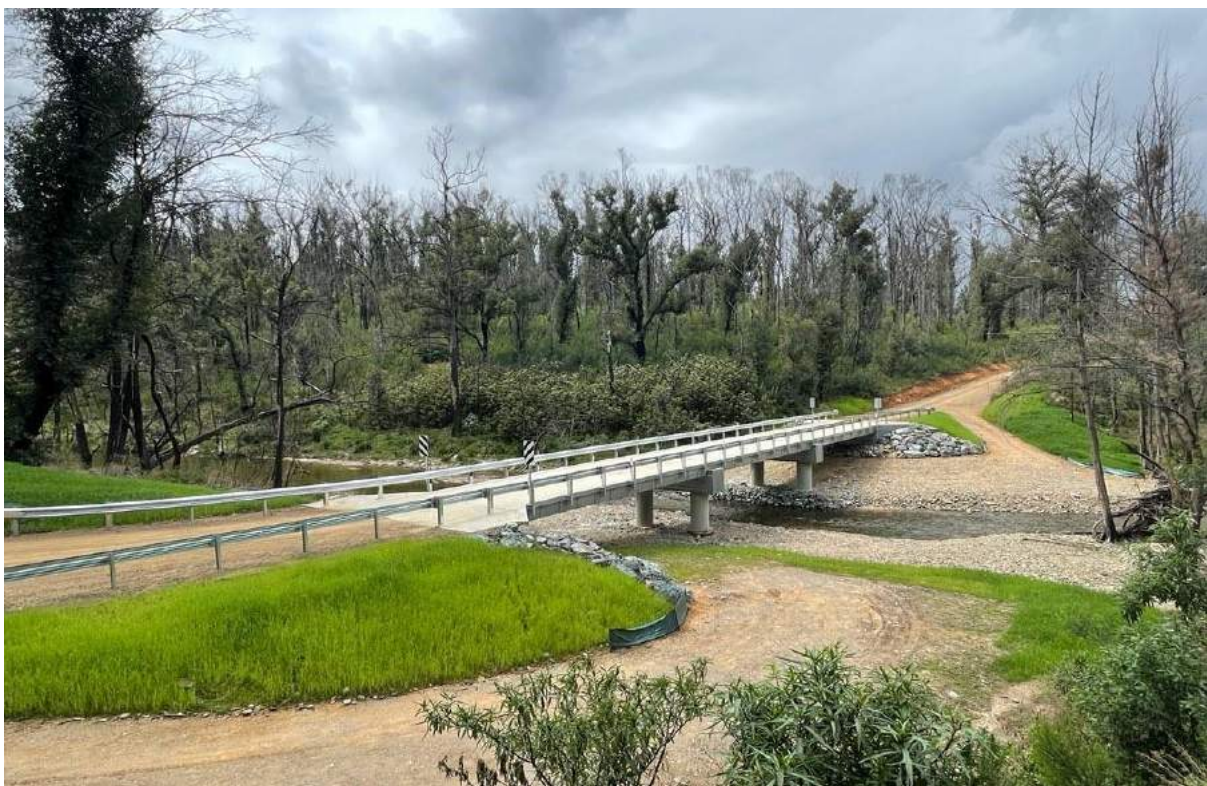
Photo A.24 – Belimbla bridge

The new concrete bridge now in place

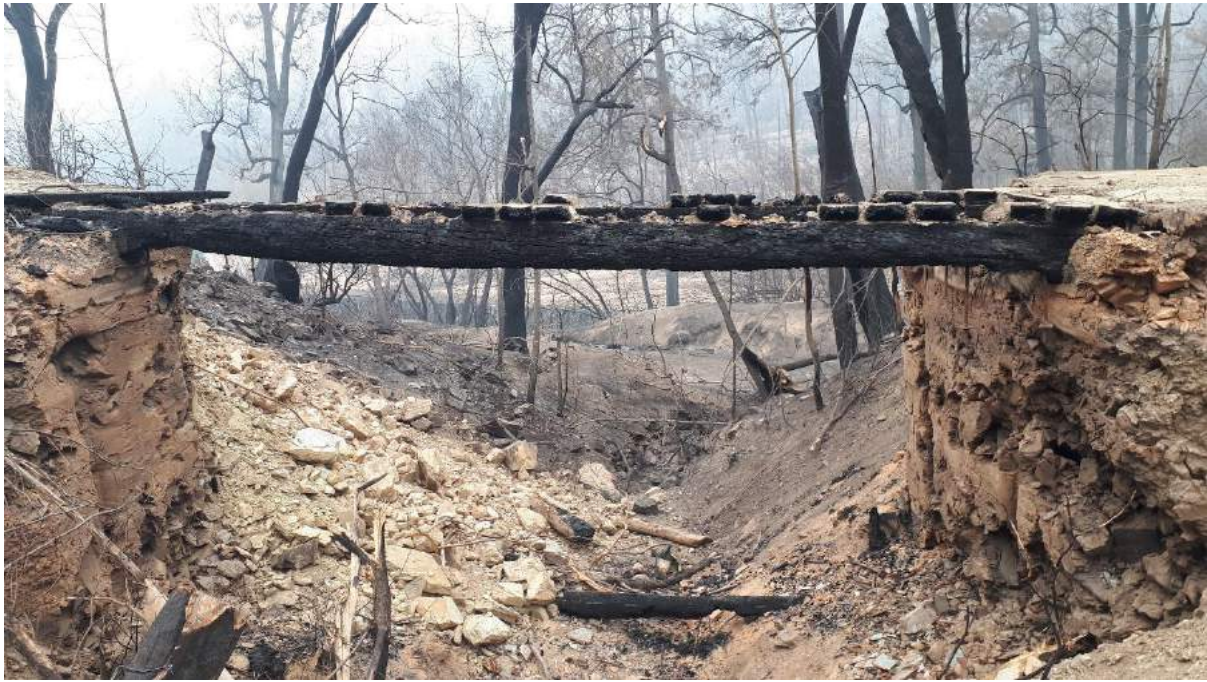
Photo A.25 – Sitters Ditch bridge
The bridge was destroyed on 31 December 2019

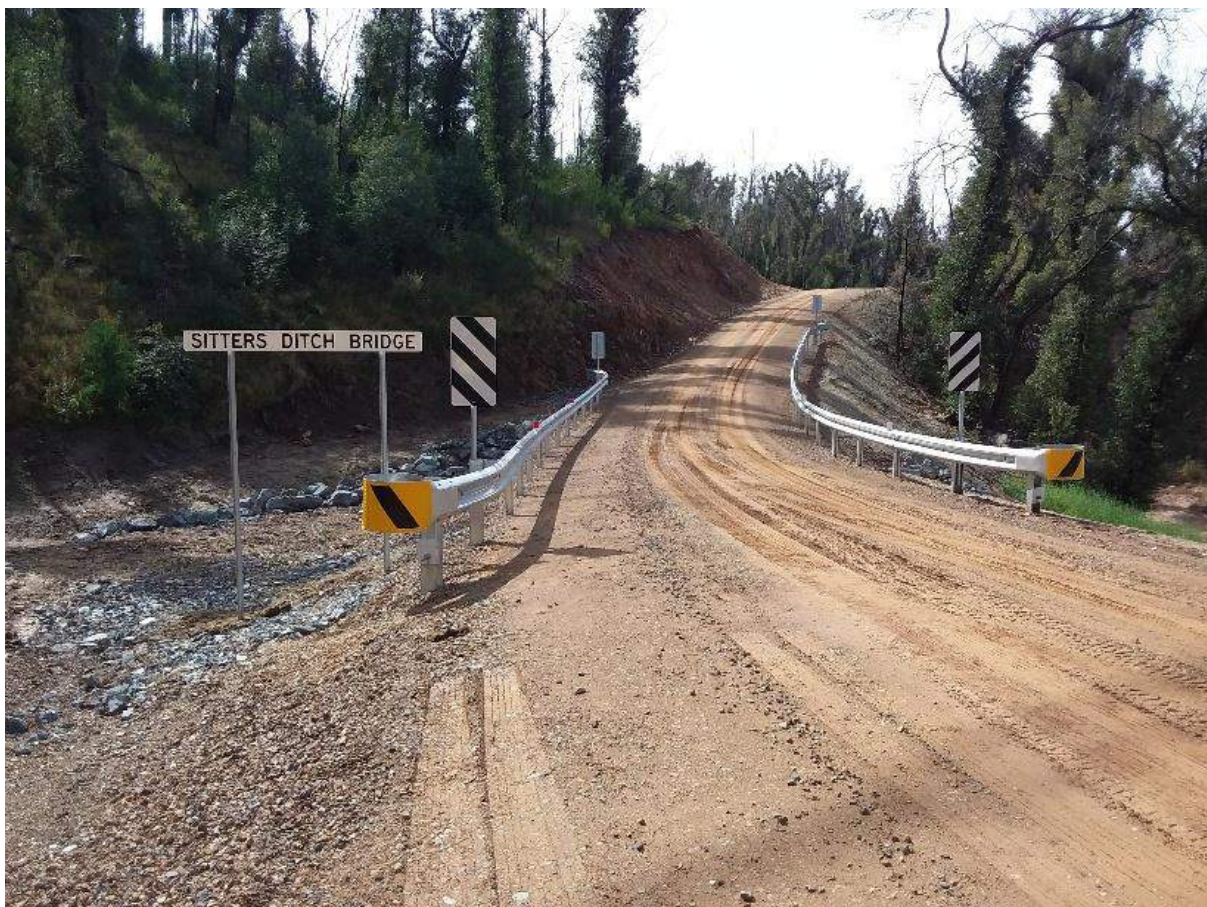
Photo A.26 – Sitters Ditch bridge
The bridge was replaced with a multiple cell concrete culvert

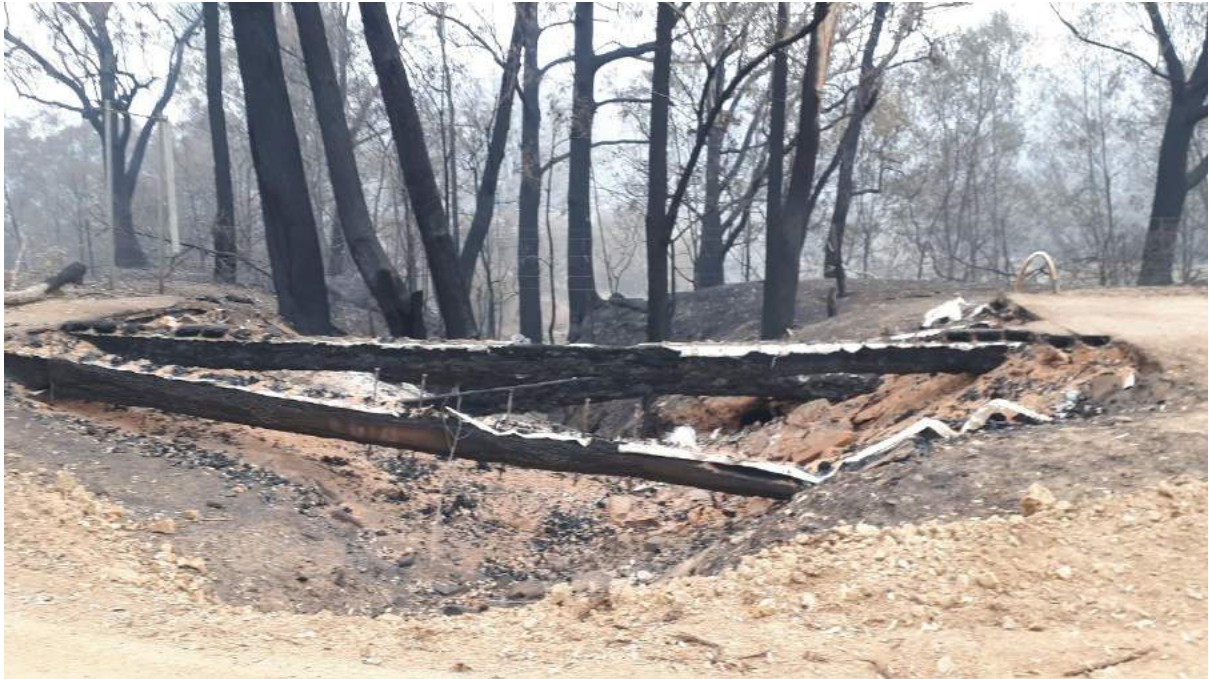
Photo A.27 – Four Gums bridge
The bridge was destroyed on 31 December 2019

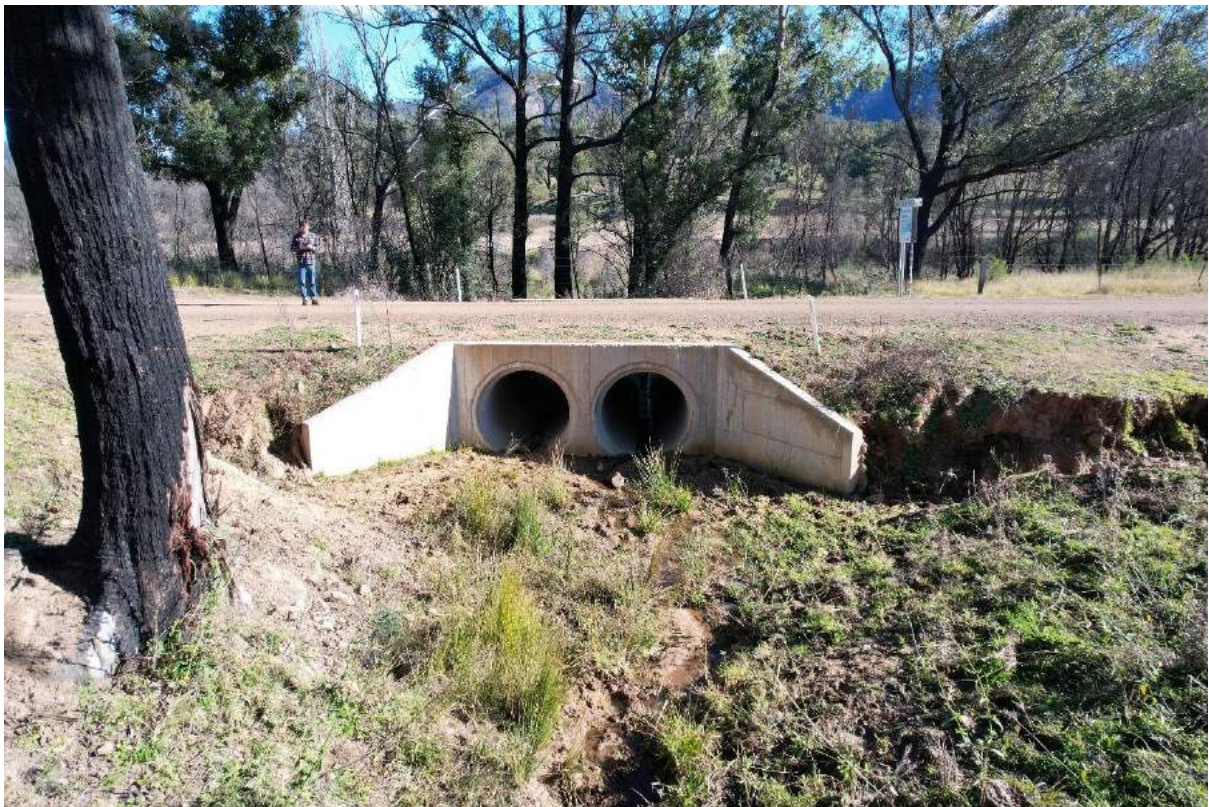
Photo A.28 – Four Gums bridge
The bridge was replaced with a multiple cell concrete culvert
