0.0 INFRASTRUCTURE RECOVERY & RESILIENCE – NATURAL DISASTERS

The purpose of this report is to provide an overview of the extensive work done since the Black Summer bushfires to recover our local road and bridge infrastructure and deliver 'in-perpetuity' improvements to address these specific issues.

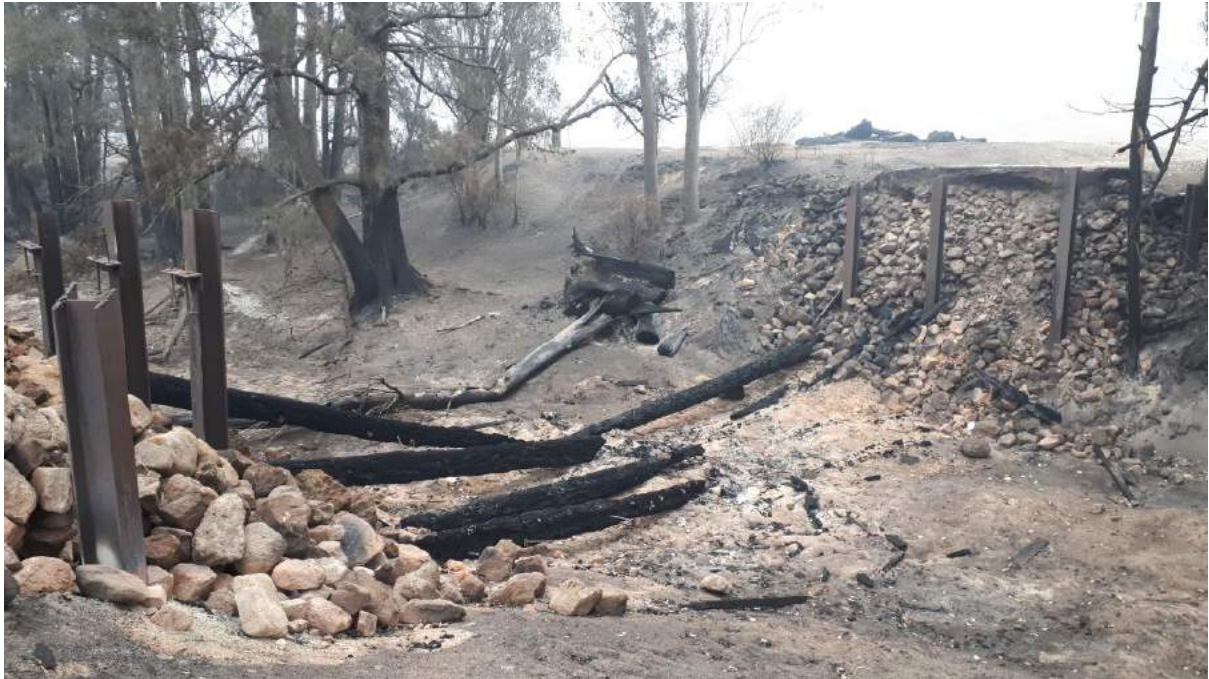
Photo A.29 – Belowra bridge
The bridge was burnt on 31 December 2019

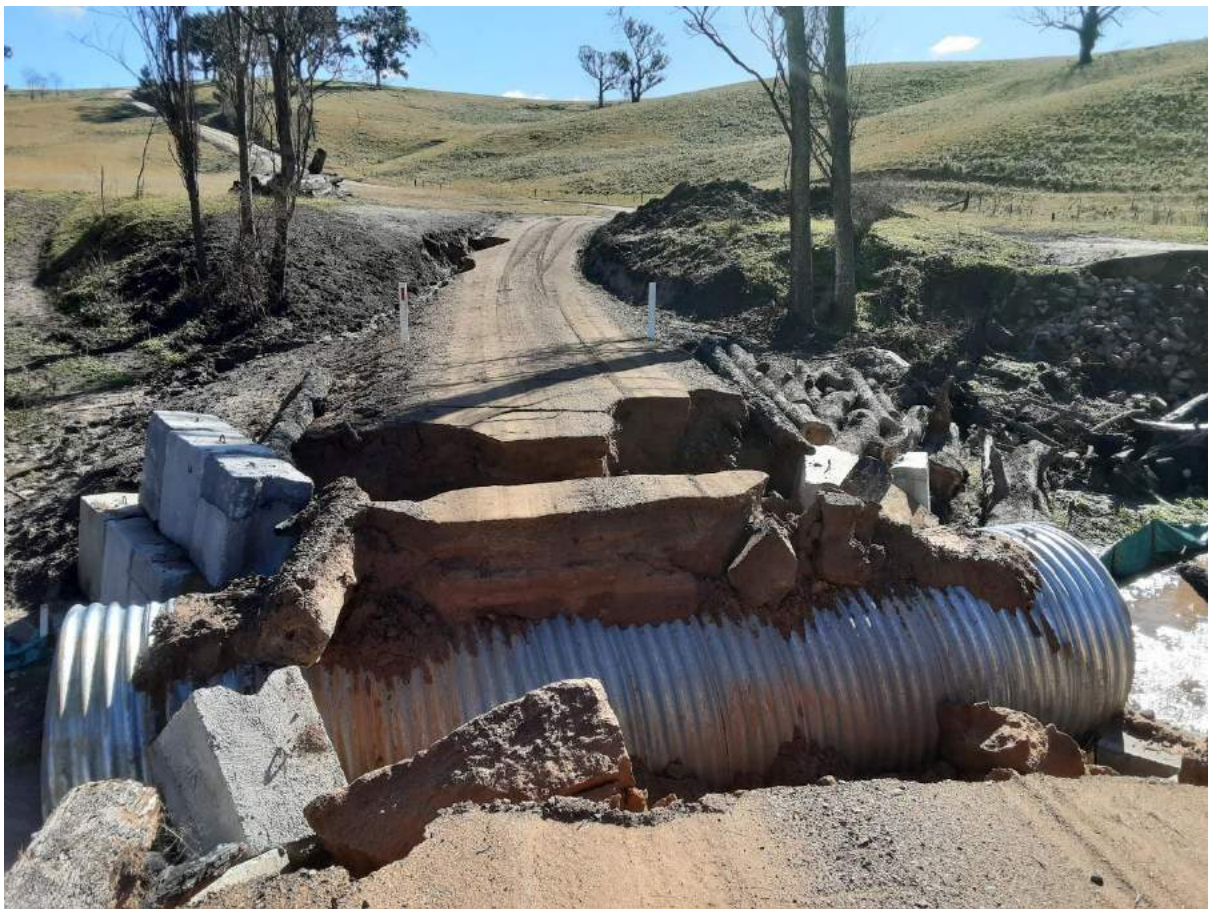
Photo A.30 – Belowra bridge
Temporary access structures were repeatedly damaged by subsequent flood events

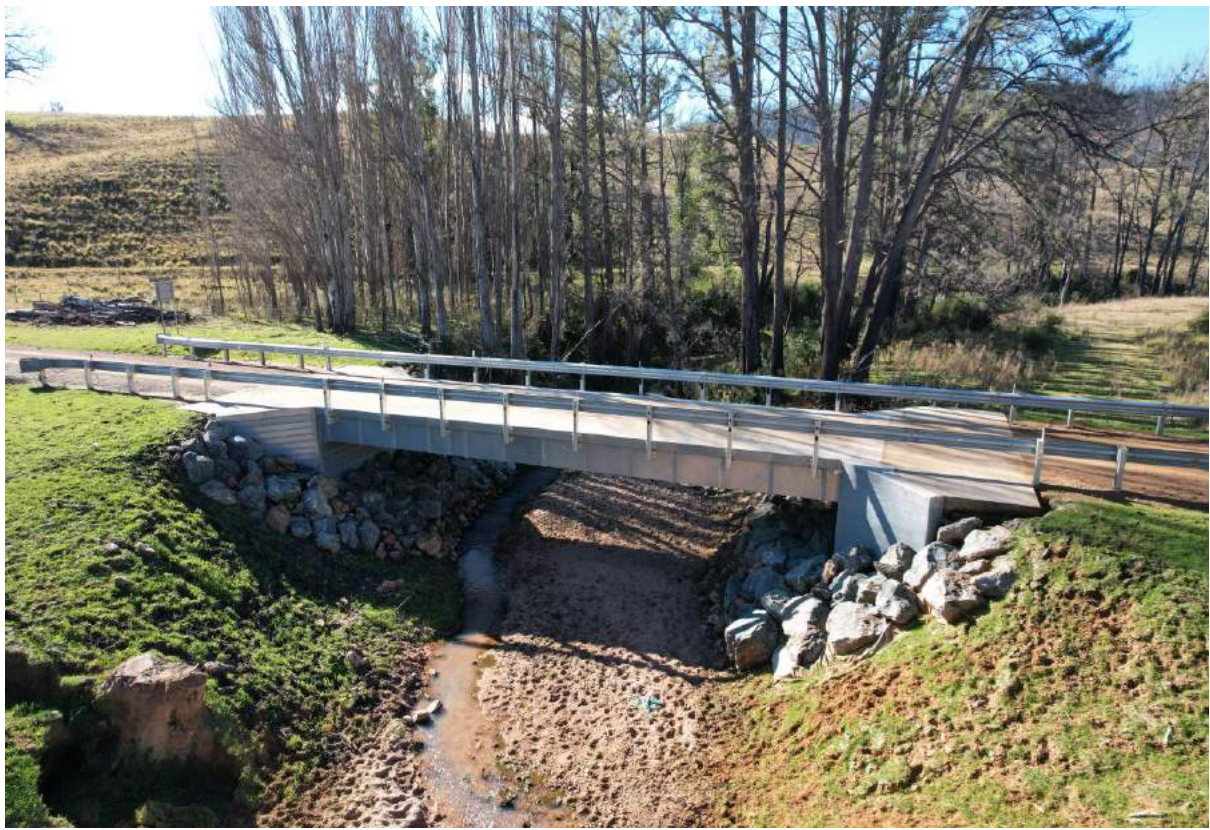
Photo A.31 – Belowra bridge

The new concrete bridge is now in place providing a resilience solution for the future

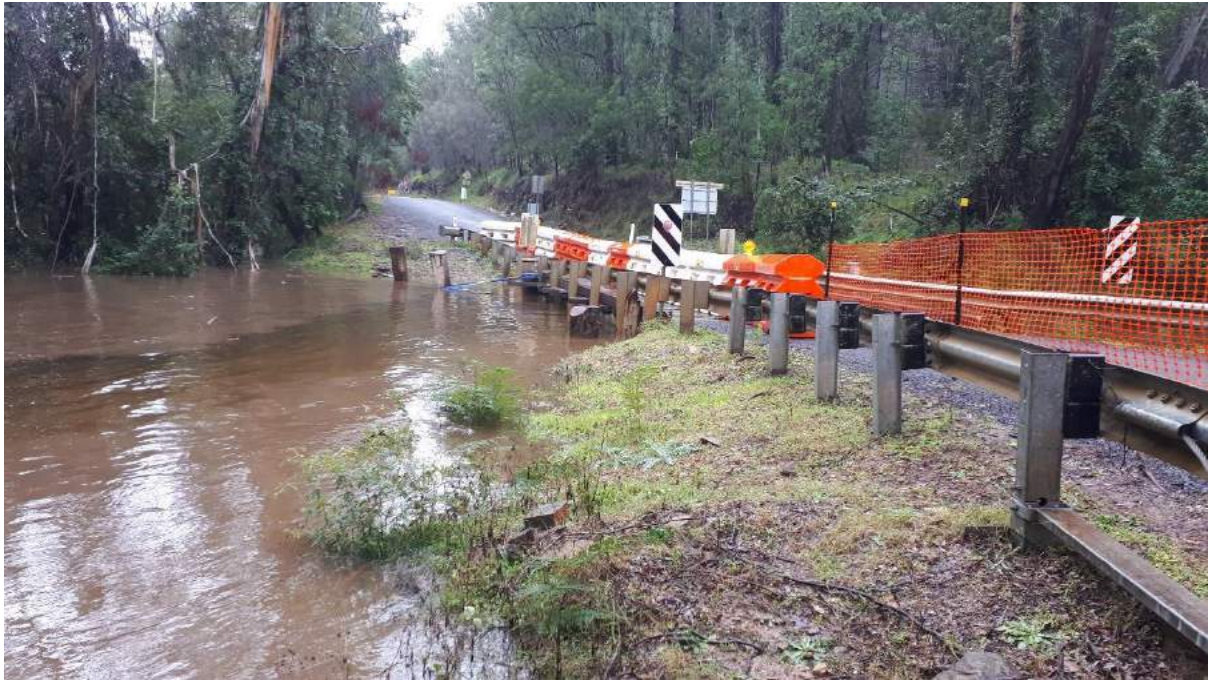
Photo A.32 – Bradburys bridge

The existing timber bridge suffered significant damage in the July 2020 floods following the bushfires.

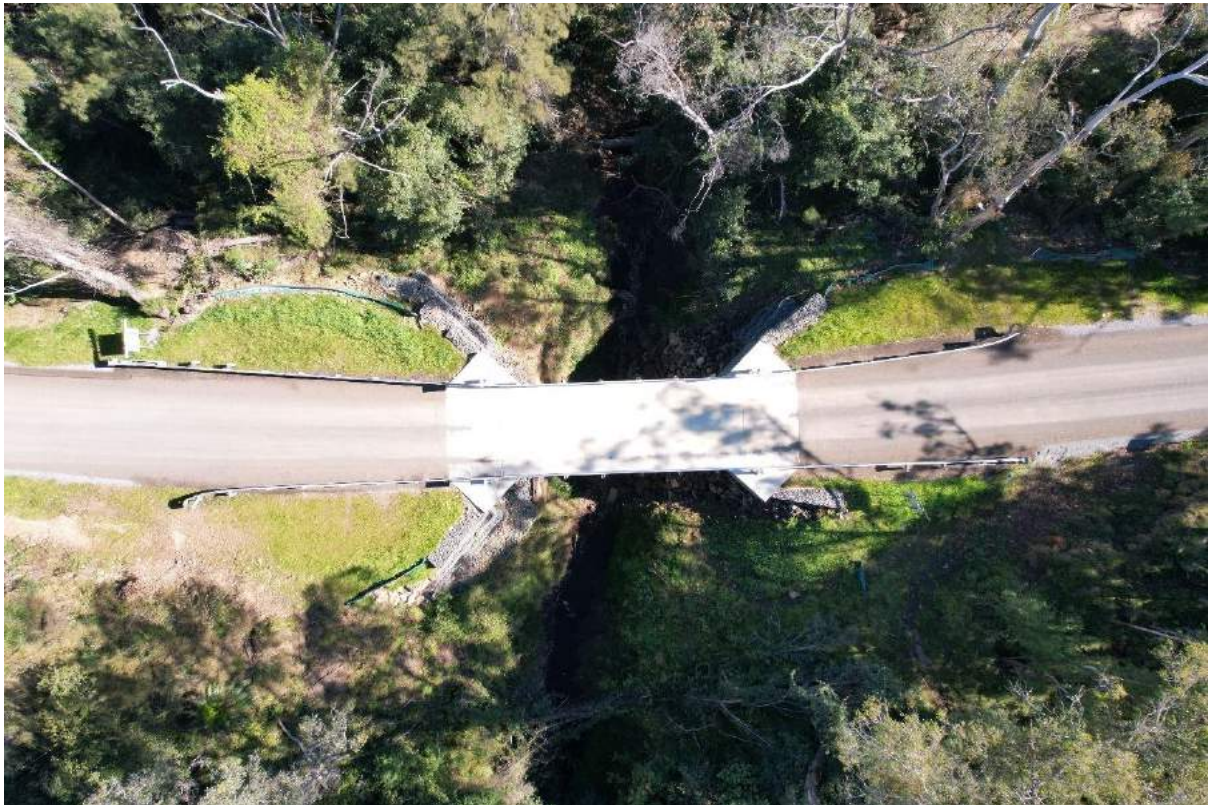
Photo A.33 – Bradburys bridge

A new concrete bridge has been provided.

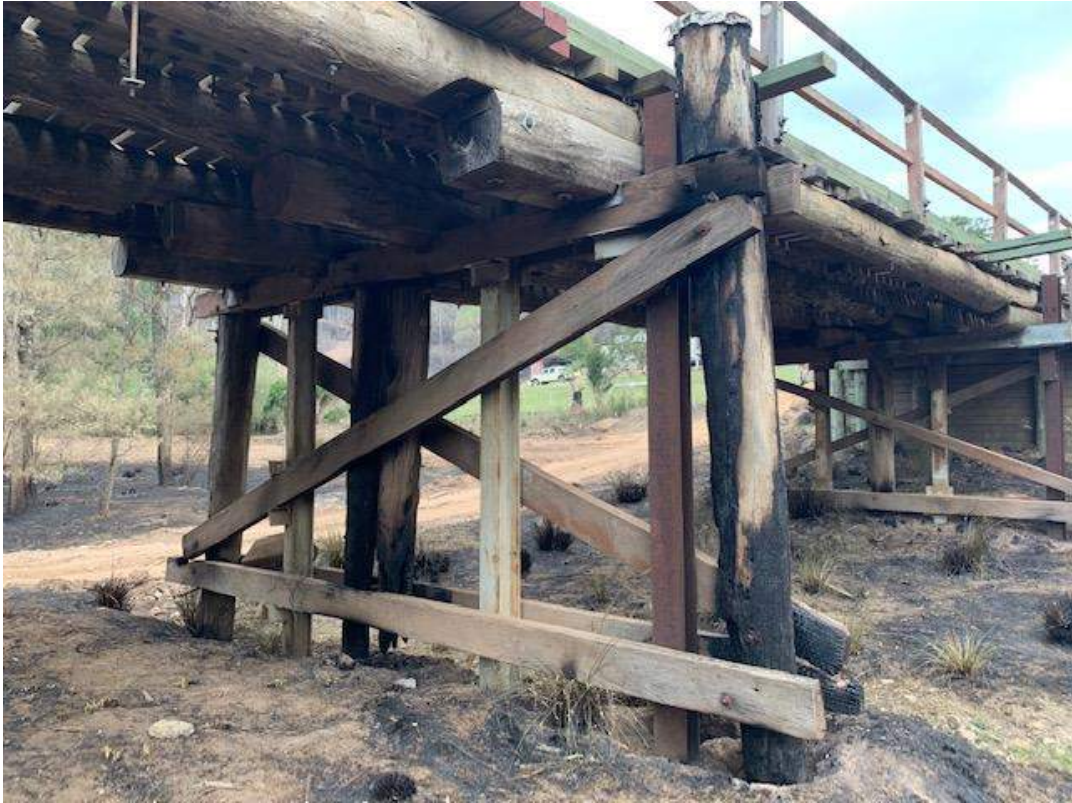
Photo A.34 – McGregors Creek bridge

The bushfires caused significant damage to the bridge in January 2020

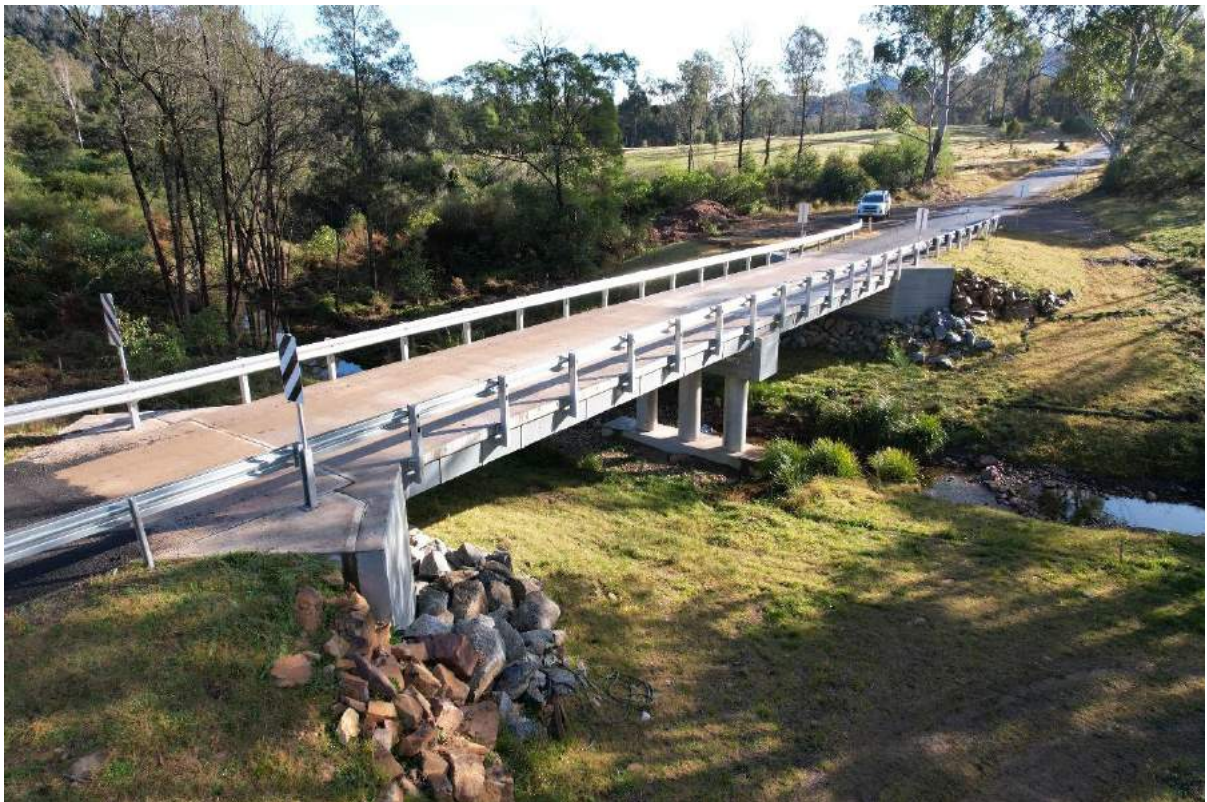
Photo A.35 – McGregors Creek bridge

A new concrete bridge has been provided

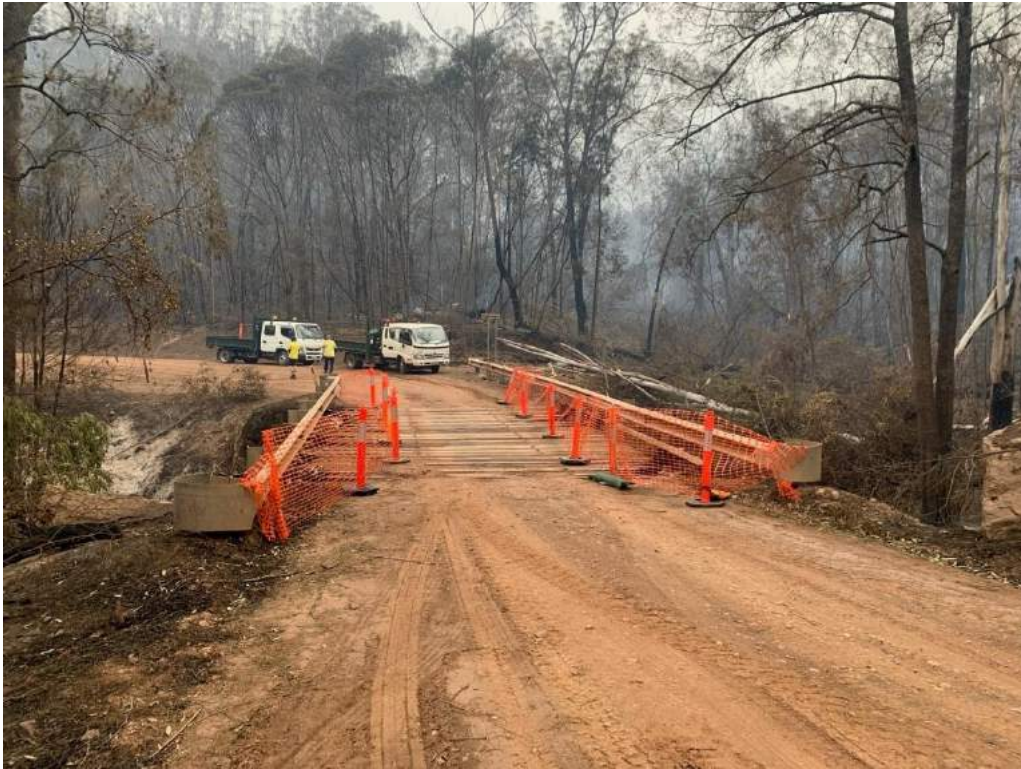
Photo A.36 – Kennys Creek bridge

The timber bridge suffered extensive damage in the January 2020 bushfires. Temporary repairs were provided to maintain access until the new bridge was completed.

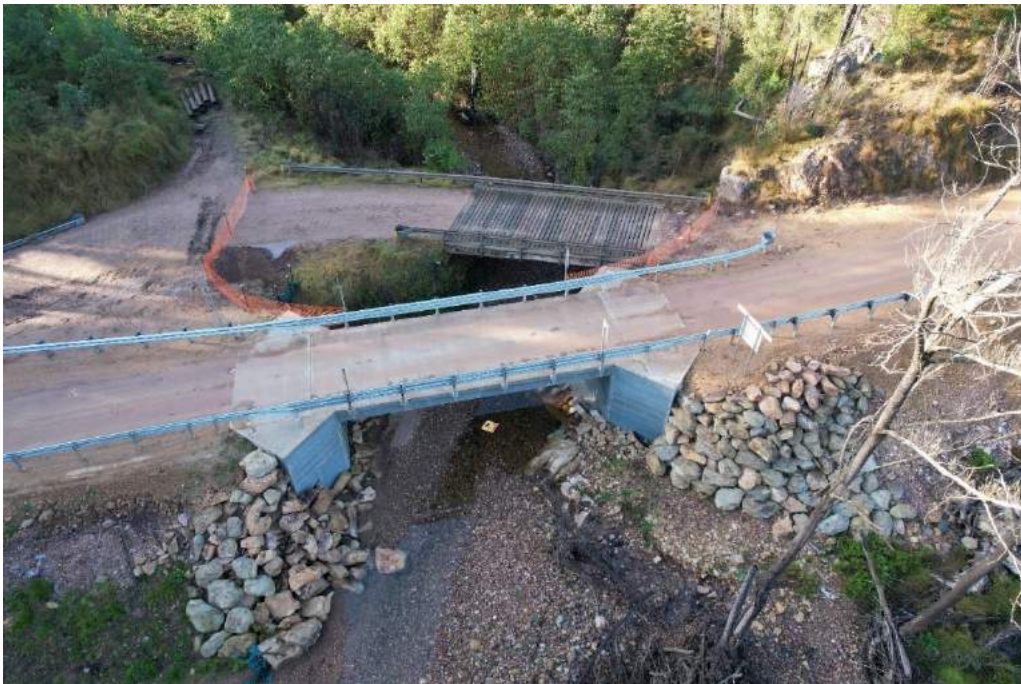
Photo A.37 – Kennys Creek bridge

A new concrete bridge has been provided and open to traffic. Works are still required to remove the old bridge and restore the site

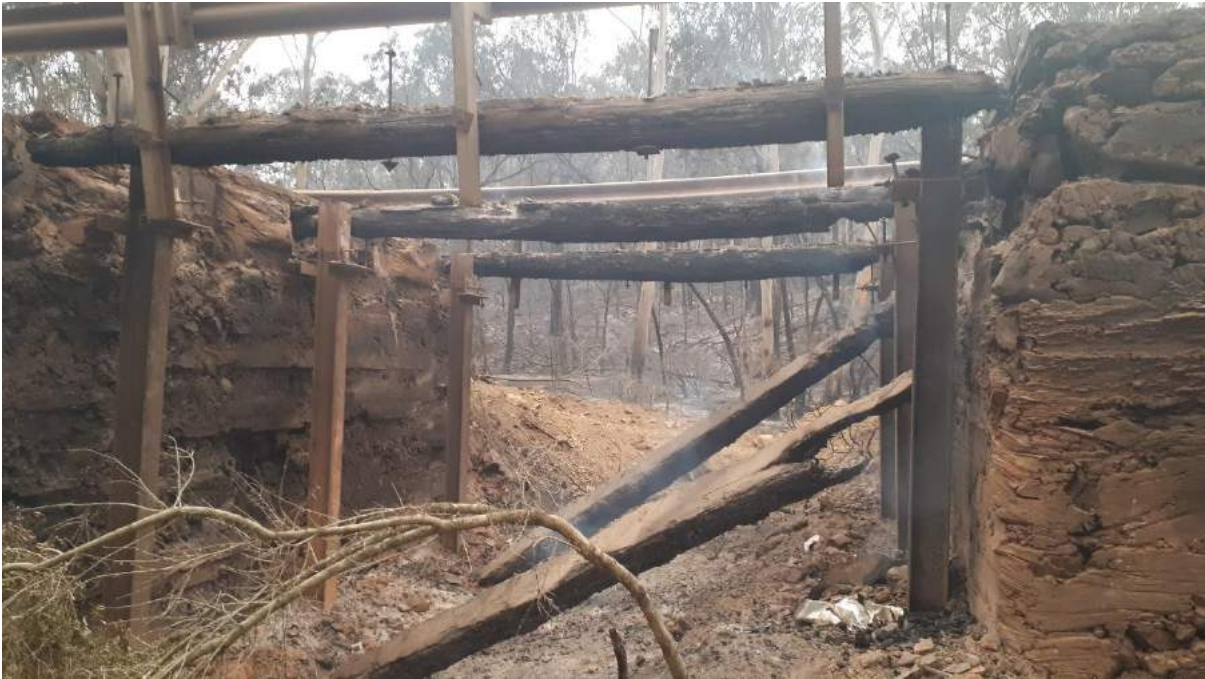
Photo A.38 – Pigeon Gully bridge

The timber bridge was burnt during the January 2020 bushfires

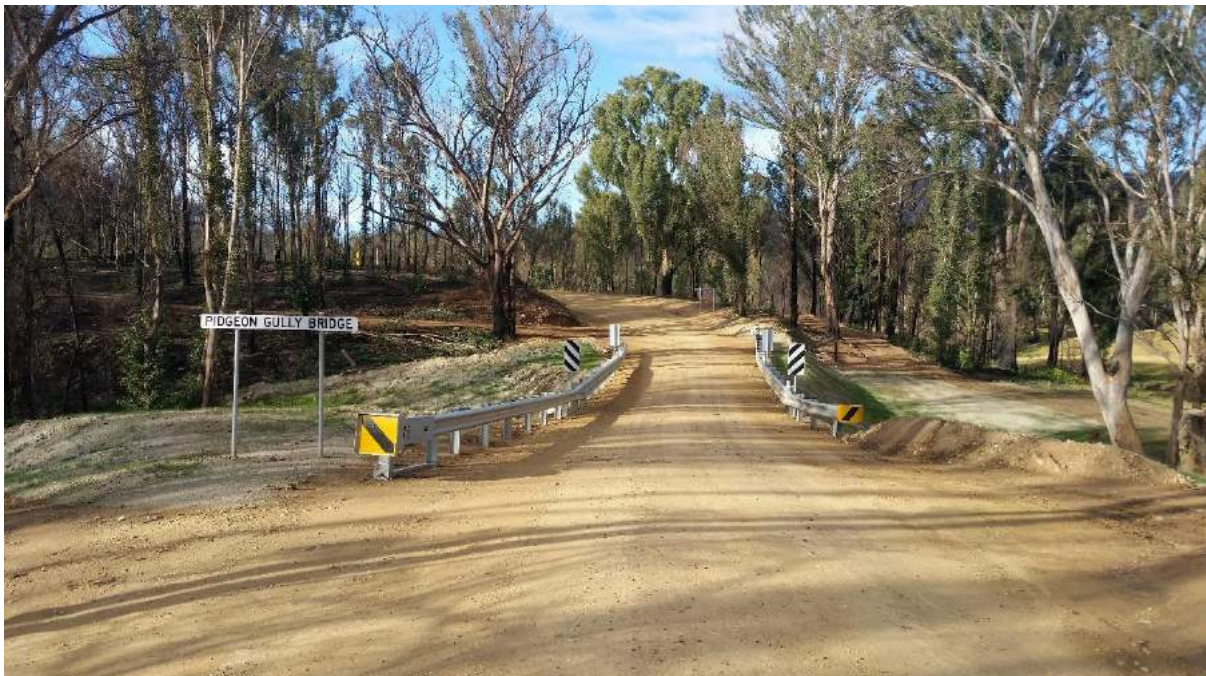
Photo A.39 – Pigeon Gully bridge

A new multi-cell concrete box culvert was installed to replace the bridge. The box culverts were available locally from Transport for NSW which facilitated a faster outcome at this site

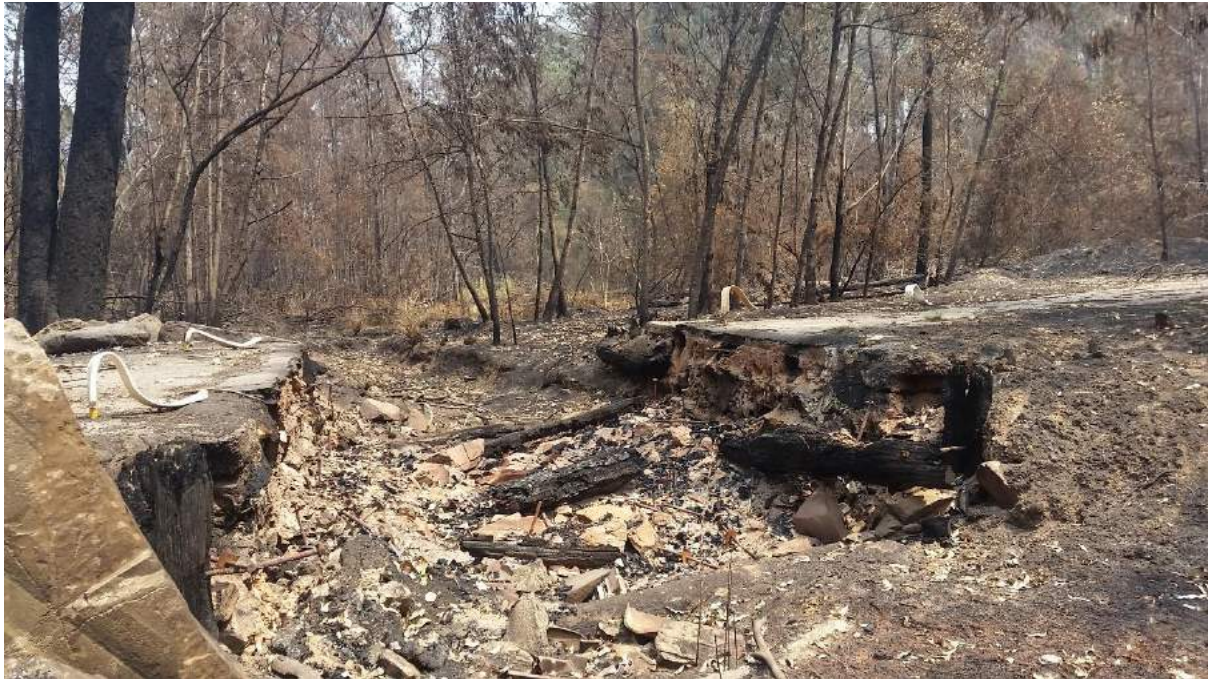
Photo A.40 – Old Tomakin Road bridge

The timber bridge was burnt on 31 December 2019

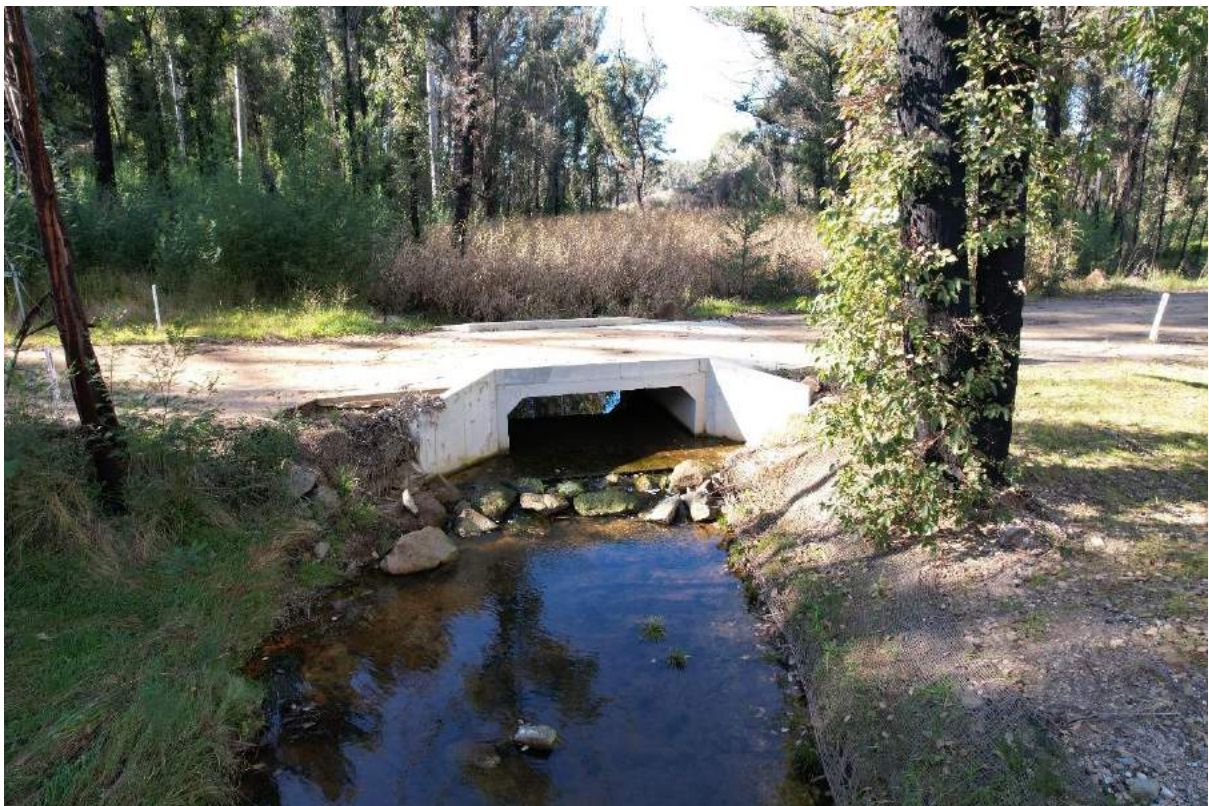
Photo A.41 – Old Tomakin Road bridge

The bridge was replaced with a concrete box culvert

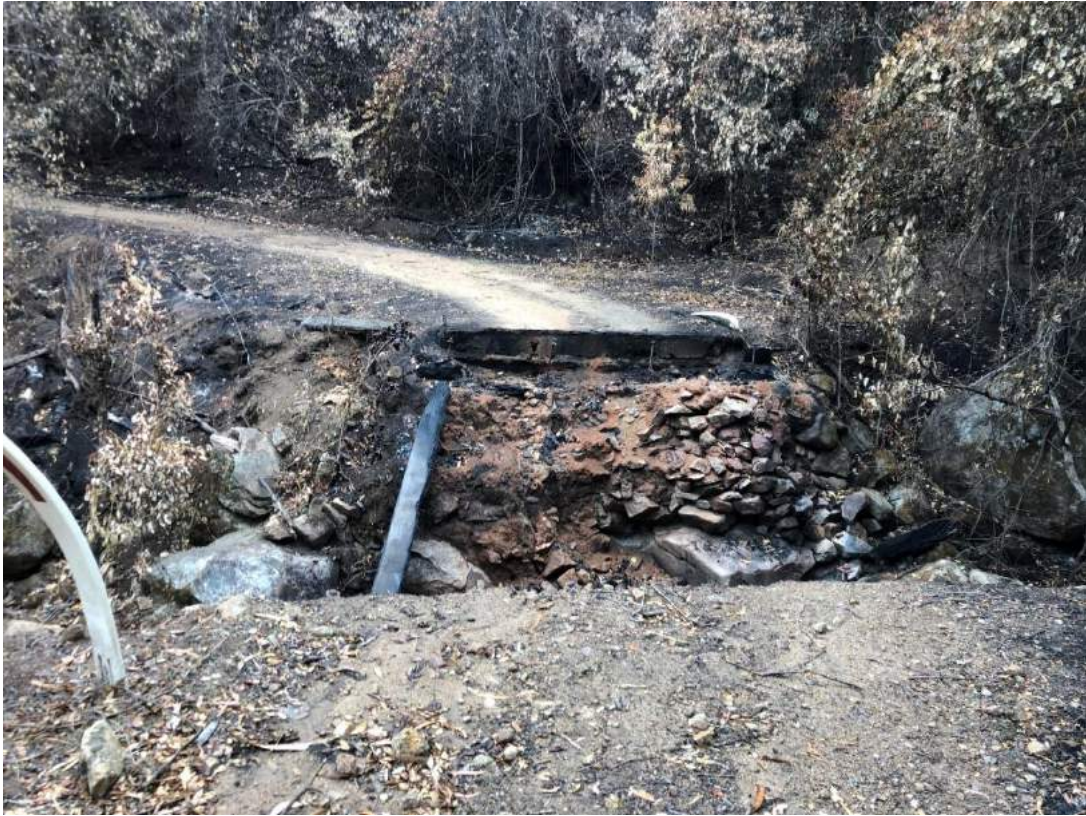
Photo A.42 – Old Bolaro bridge

The bridge was burnt on 31 December 2019

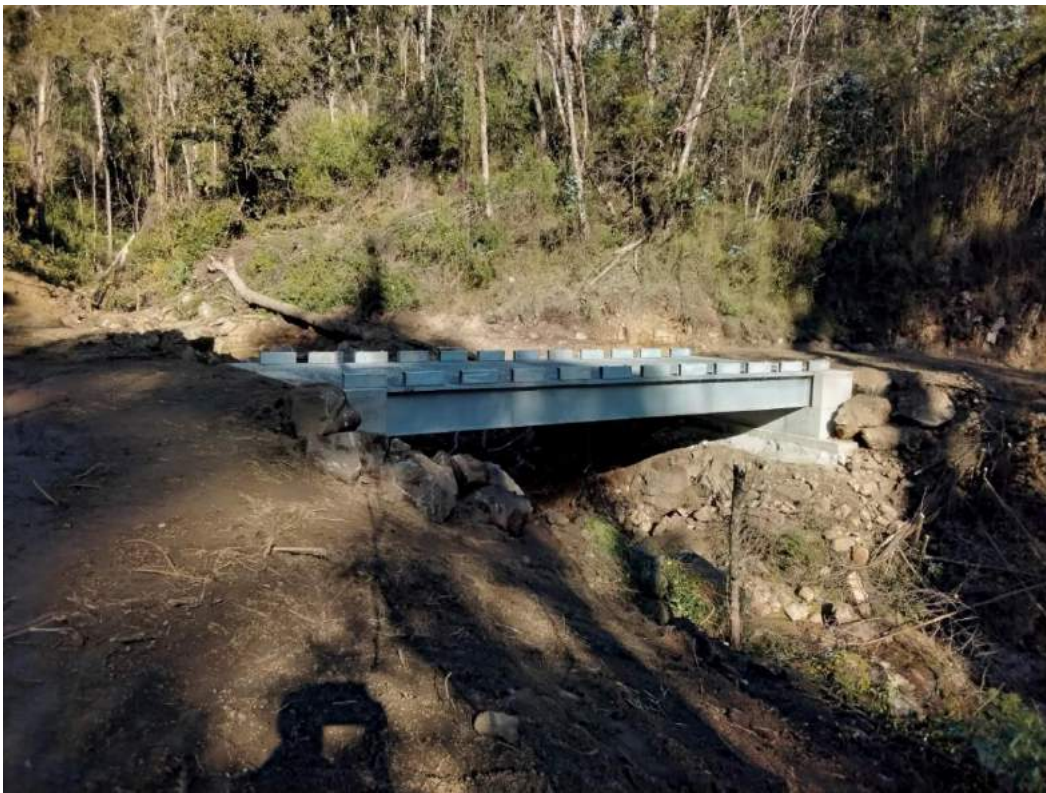
Photo A.43 – Old Bolaro bridge

This site was difficult to access so the bridge was designed as a composite steel and concrete bridge structure. The concrete for the bridge had to be hand mixed on-site with the work completed by Council's crews.
