## **Appendix B**

Conceptual Sediment Transport Model – Batemans Bay

# Inner Batemans Bay Conceptual Sediment Transport Model

Eurobodalla Open Coast Coastal Management Program - Stage 2: Vulnerability Assessments

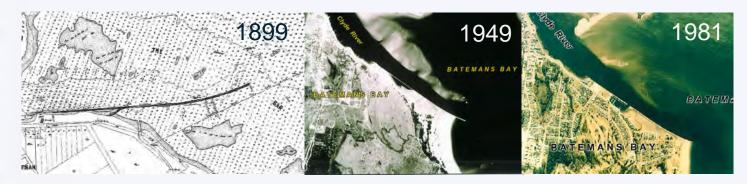
- History
  - 1899 to 1905 Training wall constructed (low crested)
  - circa 1950s/60s Training wall upgraded (~+2mAHD crest)
  - 1991 Extension of training wall
  - Significant accretion has occurred (~8,000m³ /year since 1942)
- Sediment Transport
  - Accretion due to construction of training wall and subsequent upgrade and extension
  - Training wall (both pre- and post- upgrade) was an effective trap of bed load sediment transport (the principal mechanism of sediment transport/morphological change since 1900)
  - Longshore sediment movement of fluvially supplied sediments to the north, minor bypassing of training wall back into the shoal

Original training wall

Upgraded training wall

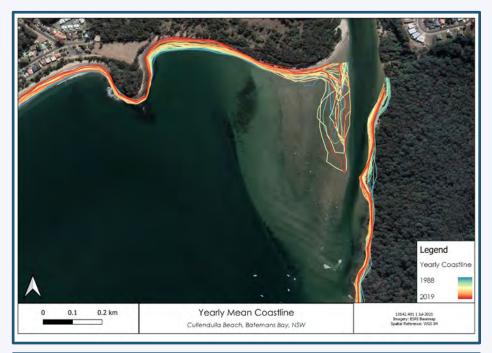
- History
  - Embayed by Square Head and Hawk's Nest Head.
  - Chenier Plains to the rear (variably spaced a function of the variable rate of falling sea level over ~6000 yrs).
  - Significant flood delta (Square Head Shoal) from Cullendulla Creek fed by flood flows/runoff. Protected from incident waves.
  - Limited human interference.
- Sediment Transport
  - Eastern longshore transport.
  - Ongoing recession at the western end (90 m between 1942 to 2018) following end to seaward progression of the beach ridge system after stable/rising sea levels over the last ~1000 years.
  - No direct mechanism of fluvial sediment from Cullendulla Creek to reach the adjacent shoreline to the west.

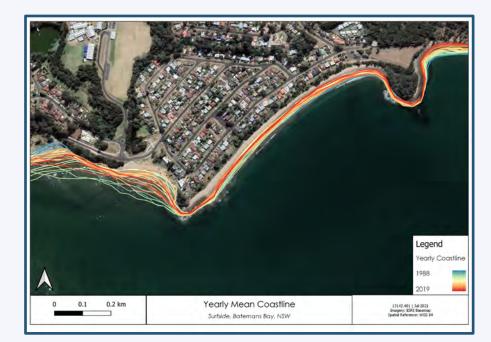
- History
  - Surfside development, circa 1940s
  - Sand nourishment at Northern End (1996) ~12,000m³
- Low to negligible net longshore transport (shoreline in alignment with incident waves)
- Limited transfer of sand to/from Cullendulla Beach
- Onshore transport likely from nearshore bars (when configuration allows)
- Otherwise marginal SW transport (Nth to Sth)
- Generally dynamically stable
  - Marginal recession trend at northern end
  - Marginal accretion trend at southern end

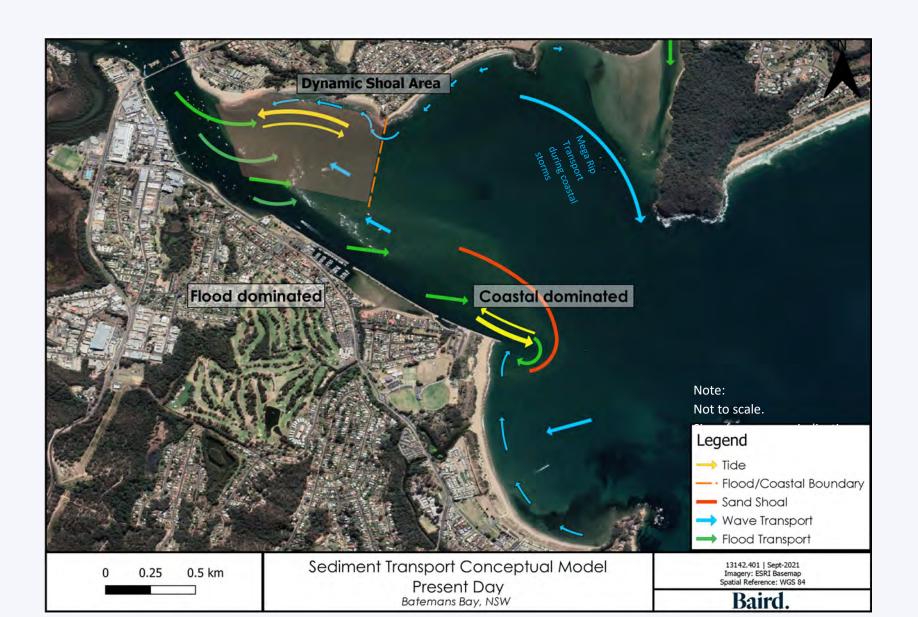
## **Sediment Transport Concept Models – Present Day**
