CONSERVATION MANAGEMENT PLAN

POLLOCK'S GENERAL STORE NERRIGUNDAH NSW

Location: 6 – 8 Gulph Street, Nerrigundah NSW

Date: June 2011

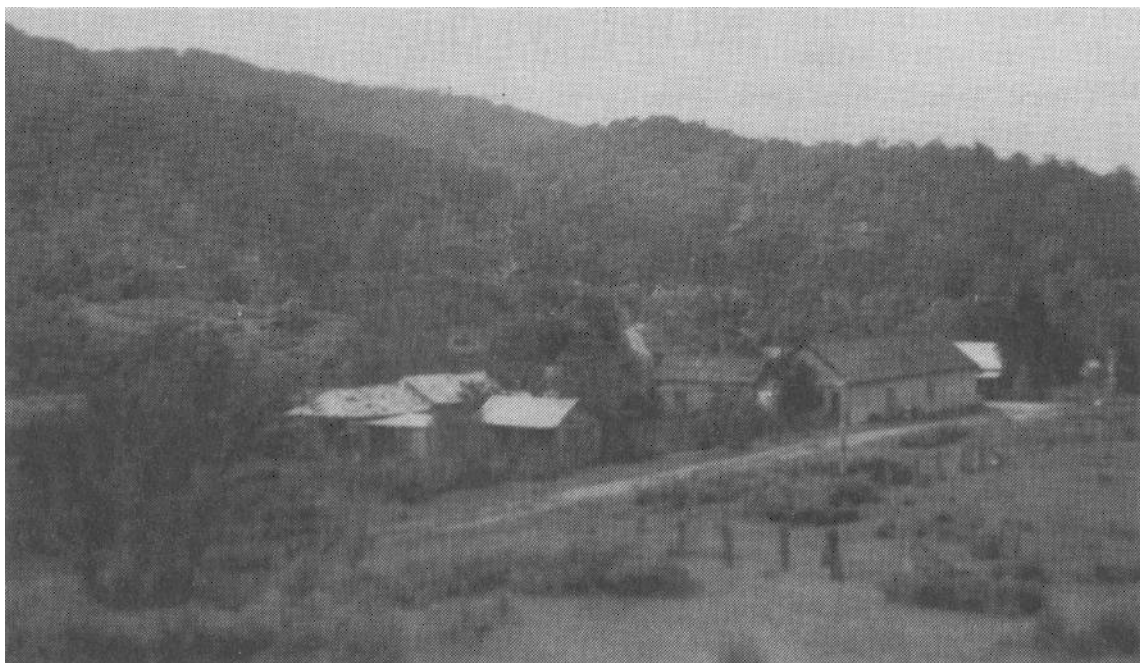
The corridor that ran between the store and residence was blocked by the construction of a chimney when the kitchen was moved from an outer building into the rear of the residence. An elderly local informant, Ka Rooke, recalls looking through the passage of the residence and seeing the pots and pans of the kitchen in a small separated building to the rear. The building had a bullnosed awning that faced the bullnosed rear verandah of the house. The small gabled structure in the image may therefore be the former kitchen building.

The image is also helpful in that it demonstrates that a timber window was inserted into the western façade along Moruya Street sometime after the 1950's and certainly after 1966 when the image at the bottom of this page was taken. The BP sign on the building's side appears again, as a remnant smudge in the paintwork, in the image on the following page. This indicates that the horizontal sash window was inserted into the built fabric in the 1970's.

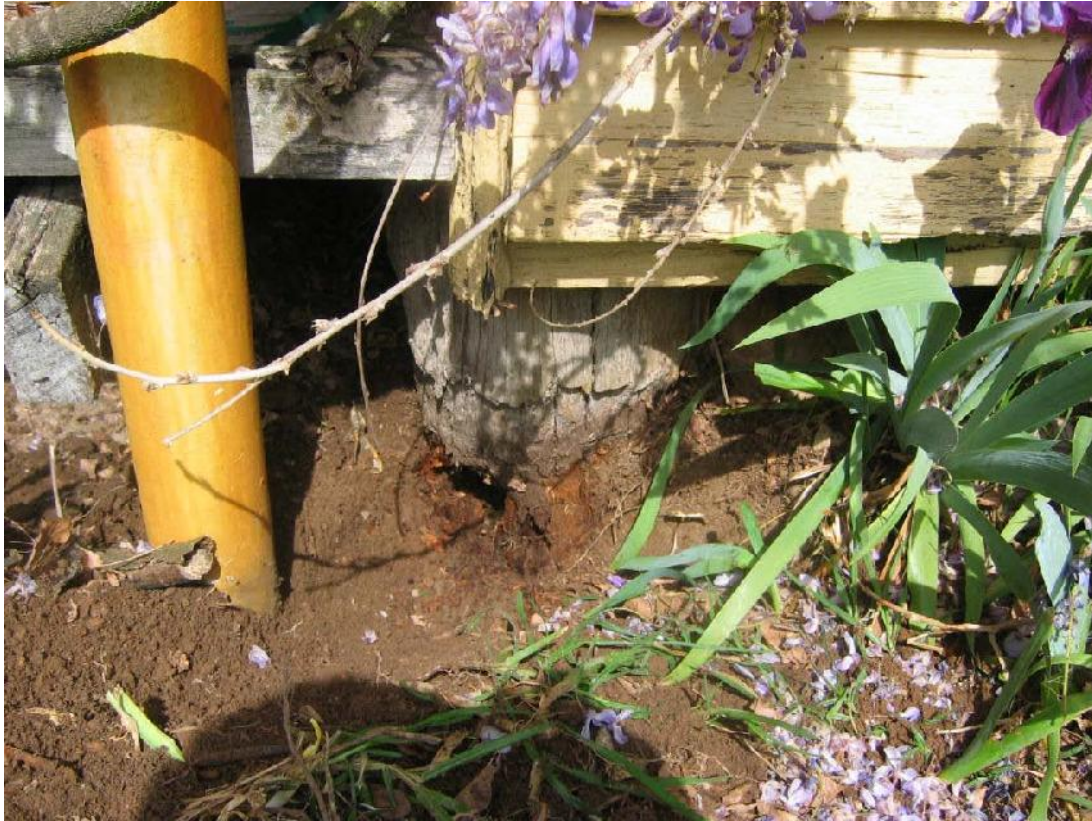
The deteriorated condition of the hardwood piers is demonstrated in these images. Inadequate support provided by the piers resulted in subsidence, the sub-floor structure being, in some cases, left suspended, and twisting of the frame. Undamaged roof framing provided the necessary structural integrity, holding the building together and limiting further structural damage. Roughly laid stone landscaping, shown below the damaged piers, contributes to the retention of on-site moisture and its uneven surface is a hazard to safe travel.

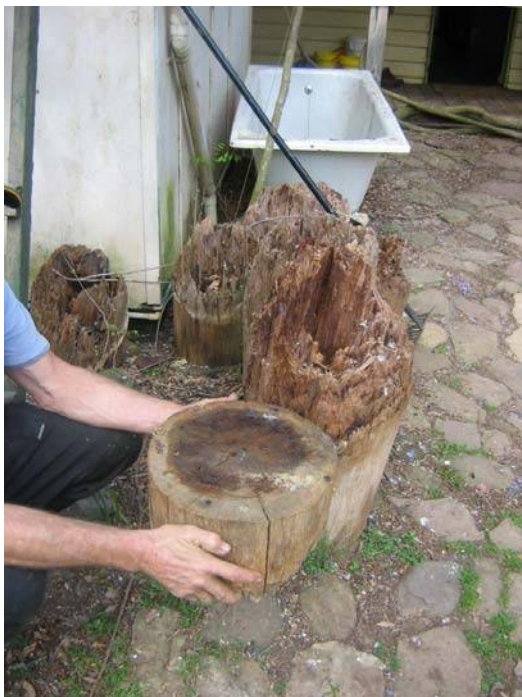
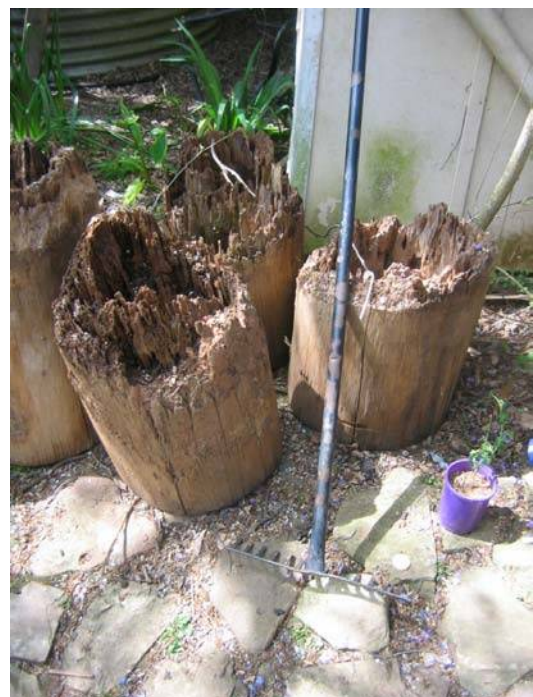
Evidence of termite damage to studs

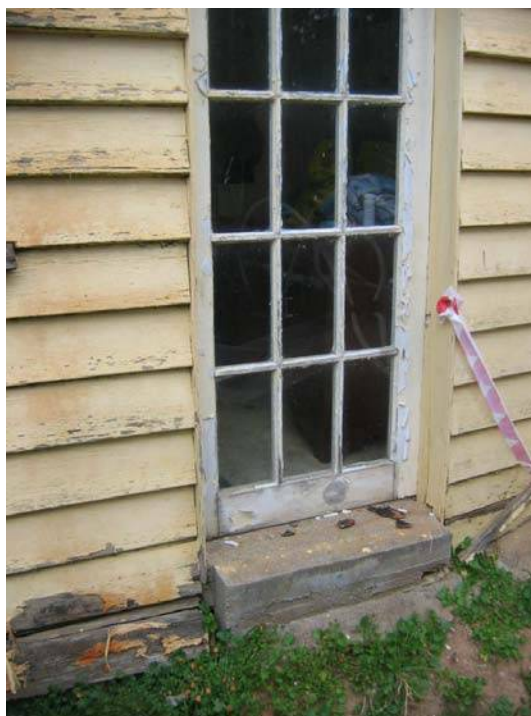
Poor amenity at door threshold

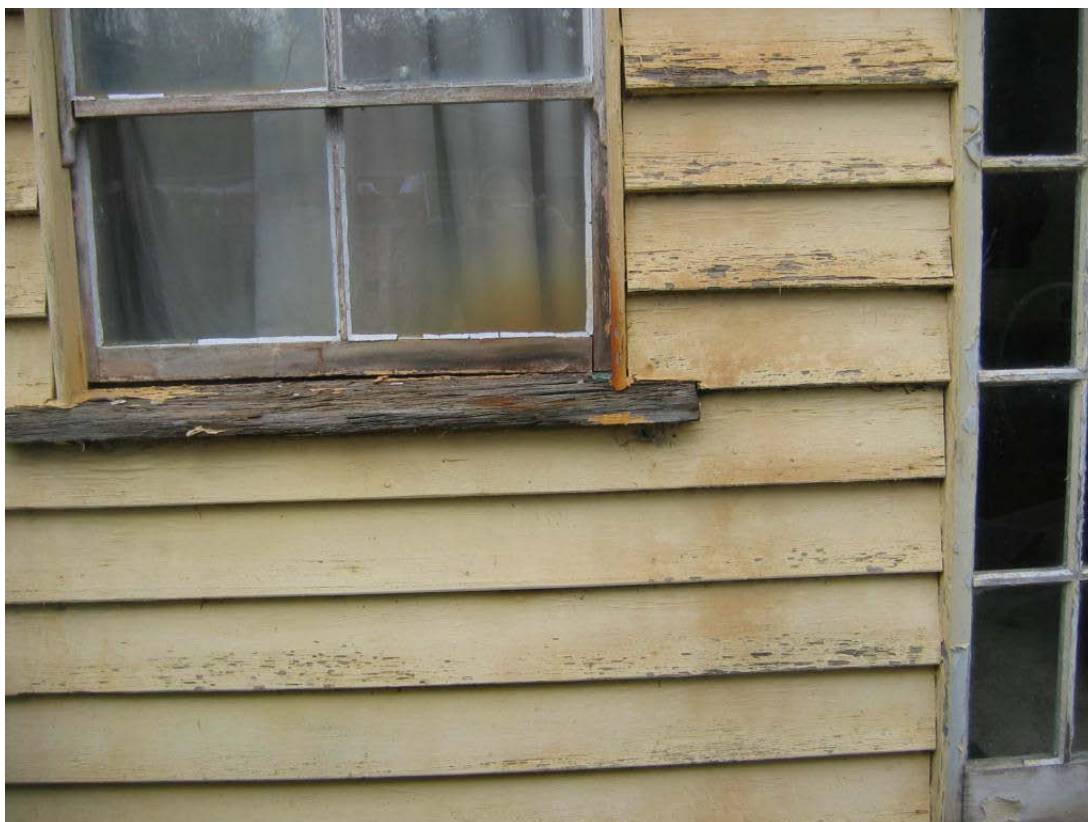
Image below shows deteriorated window, sill and surface protection for wooden and glazed elements.

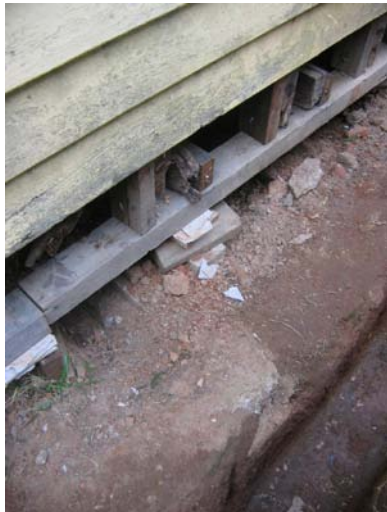
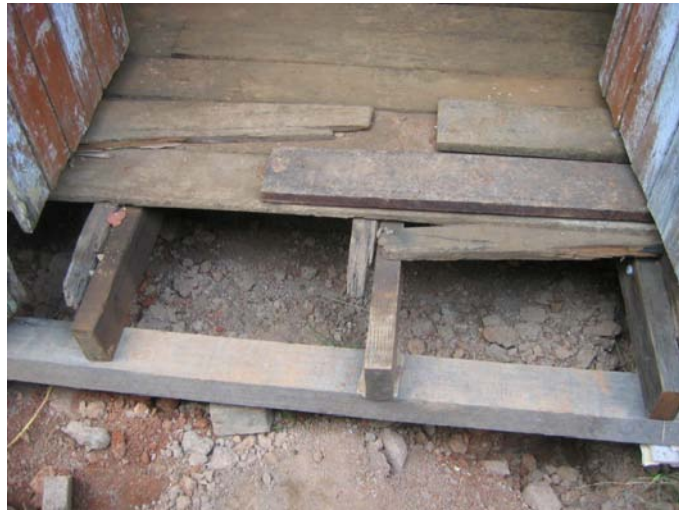
The close proximity of the bearer/bottom plate to the ground is shown above. The image below demonstrates that floor level in the most westerly area of the store is situated below the level of the street, which is located at the base of the paling fence.

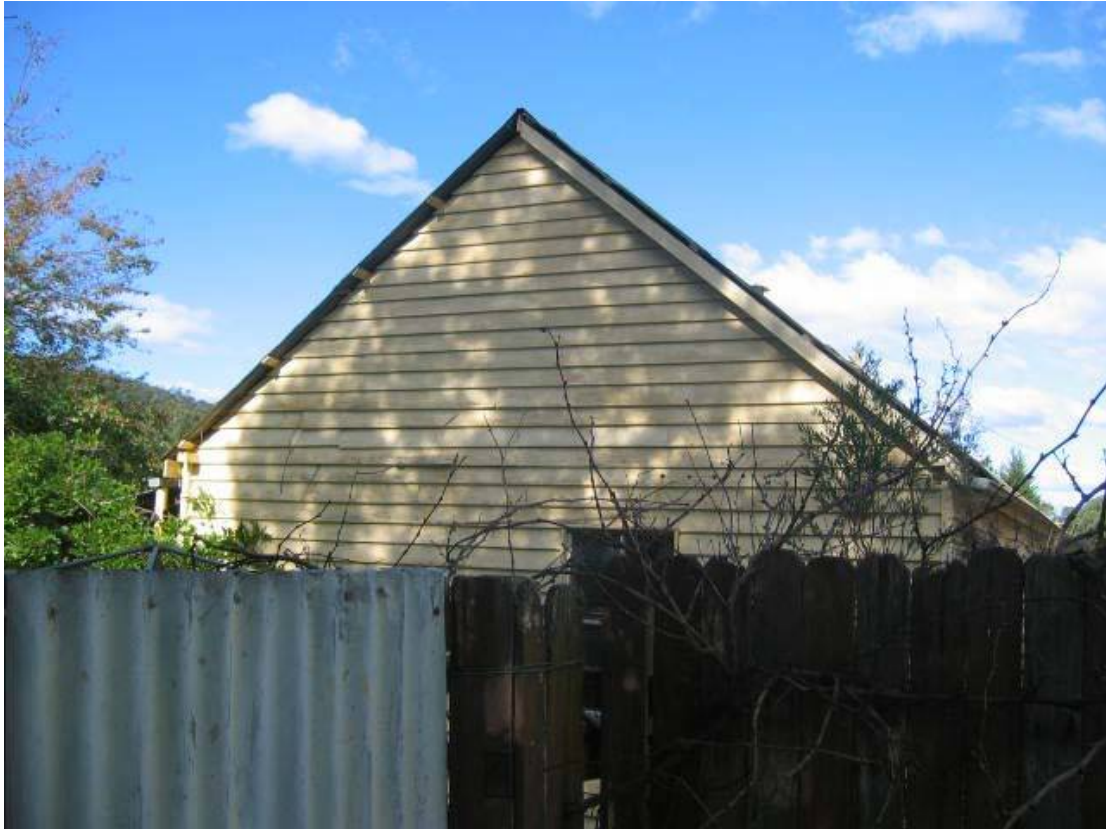
Missing barge board and roof capping to western gable.
Missing base element to decorative barge at eastern front verandah entrance
and unsympathetic placement of TV antenna

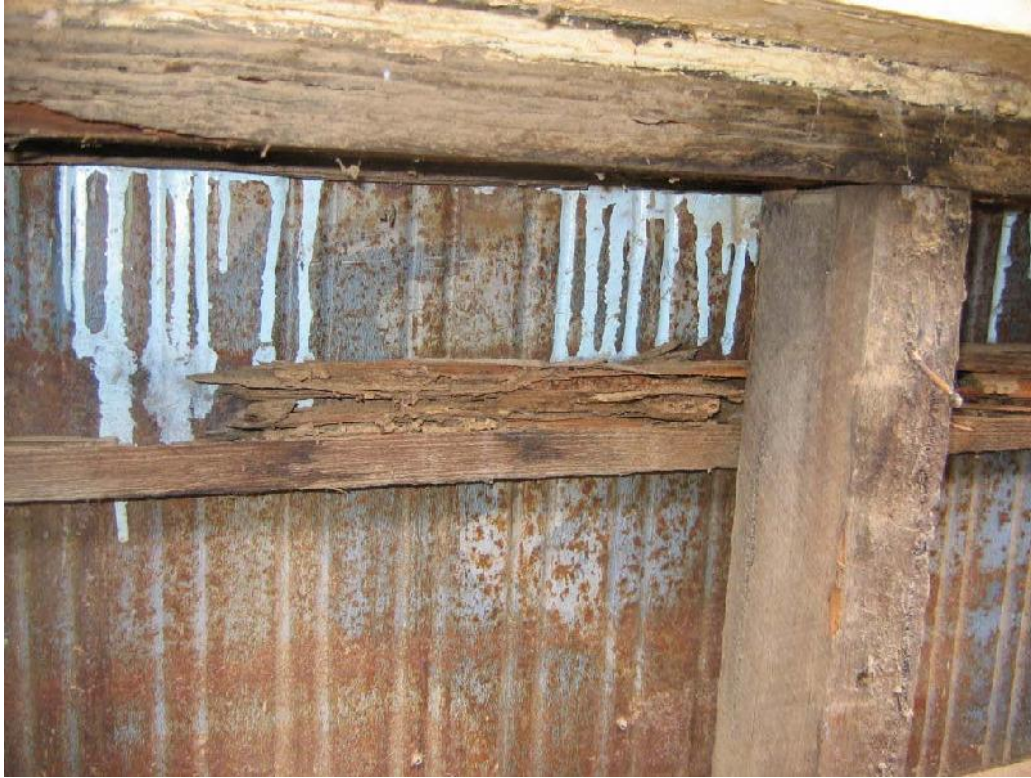
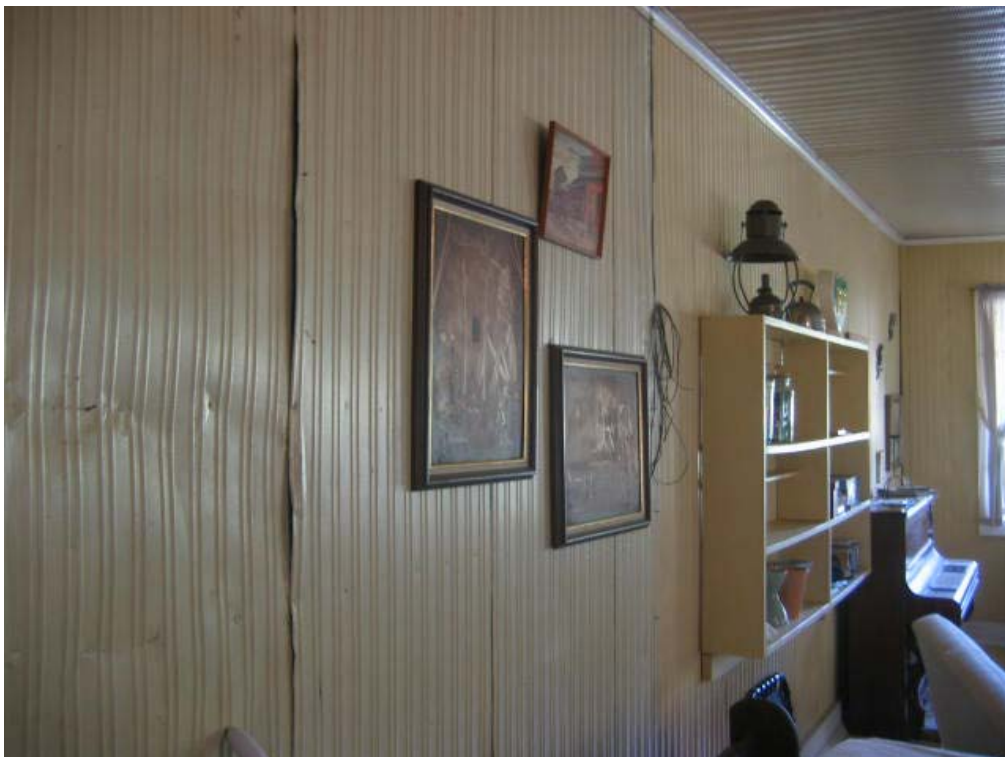
Penetrating damp, rising damp in the fireplace, and termites have combined to cause considerable damage to the structure. This has impacted on the condition of the largely intact, original pressed metal lining and on the internal amenity that the building provides. Damage to the interior lining and evidence of termite infestation of wall battens to which lining is affixed are shown below.

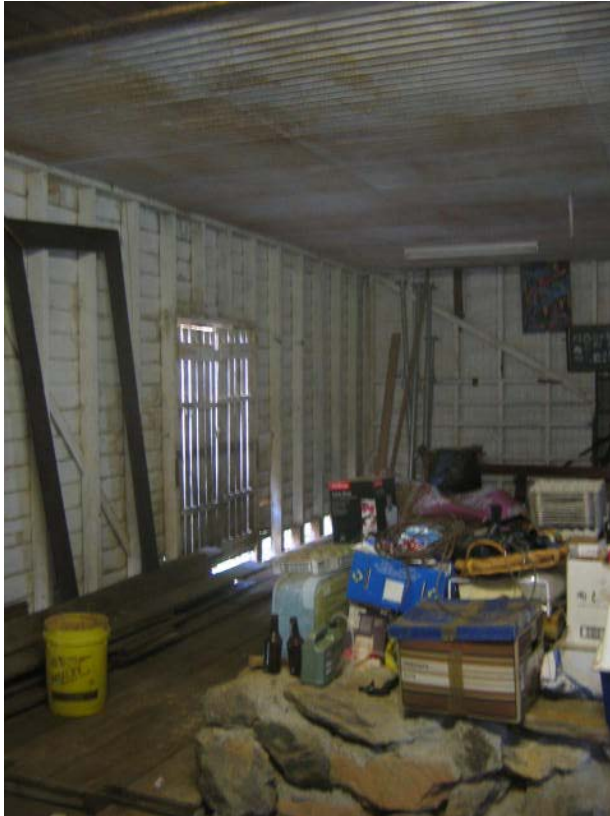
This photo, from the preliminary site visit in May 2010, shows the internal finishes at that time. Both studs and external lining were painted, the room was unlined and it lacked any form of insulation. The internal amenity it provided was therefore limited by this factor. The image also indicates the poor quality of the stonework in the central structure, which also suggests that it was built at a relatively recent time. This structure impedes the free flow of circulation, which is also an argument against it being an original element within the produce store, and it constitutes an unsightly and unsympathetic element in the space. The picket style barn doors are also considered unlikely to be

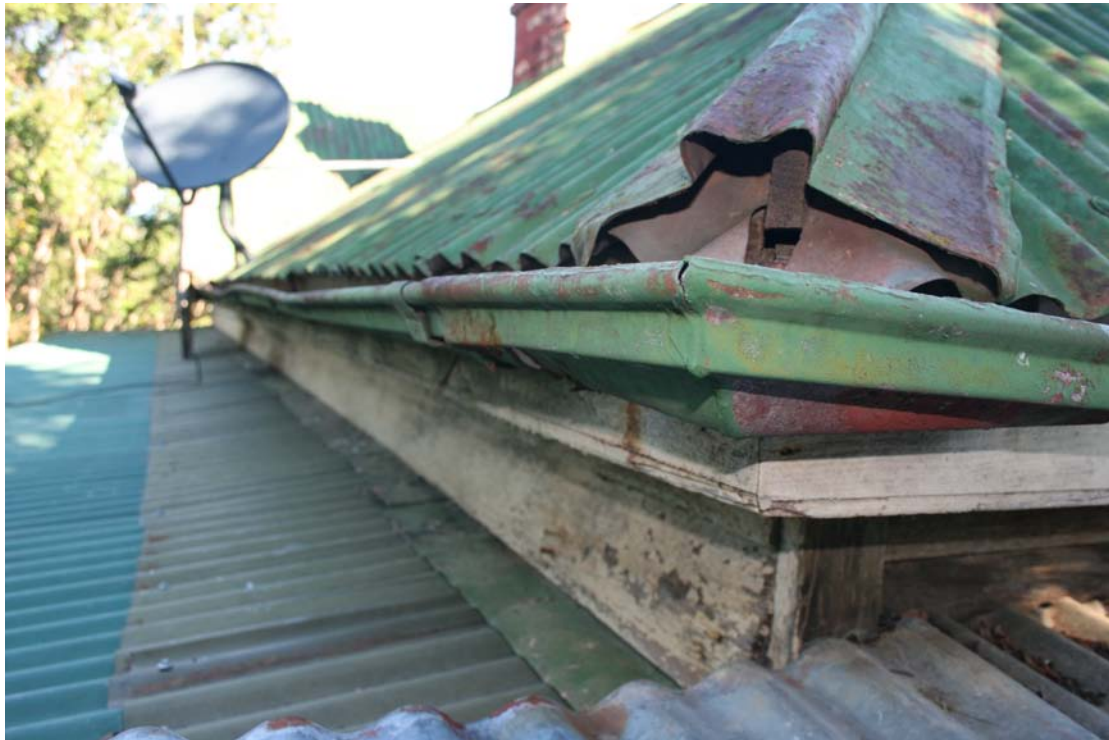
Images show deteriorated gutter, timber elements and corrugated valley tray.

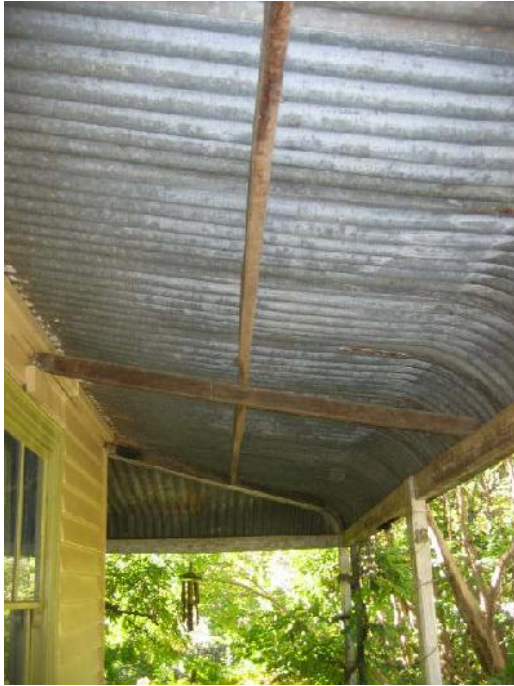
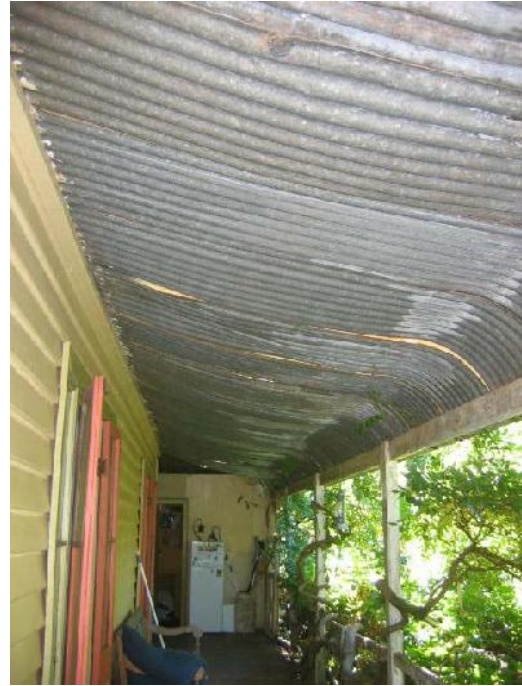
Images of bull-nosed verandah as seen from below. In general, the fabric still performs its protective function adequately, but some sheets need to be replaced, with new galvanized iron bull-nosed sheets, especially those along the eastern verandah as shown above right.

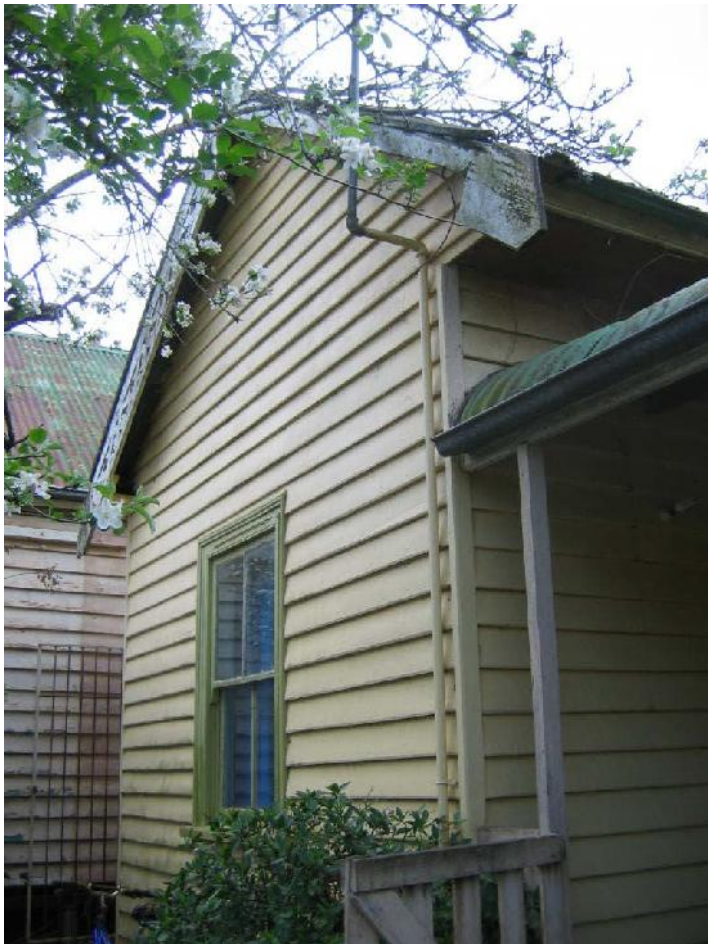
Missing decorative gable element to front bedroom.

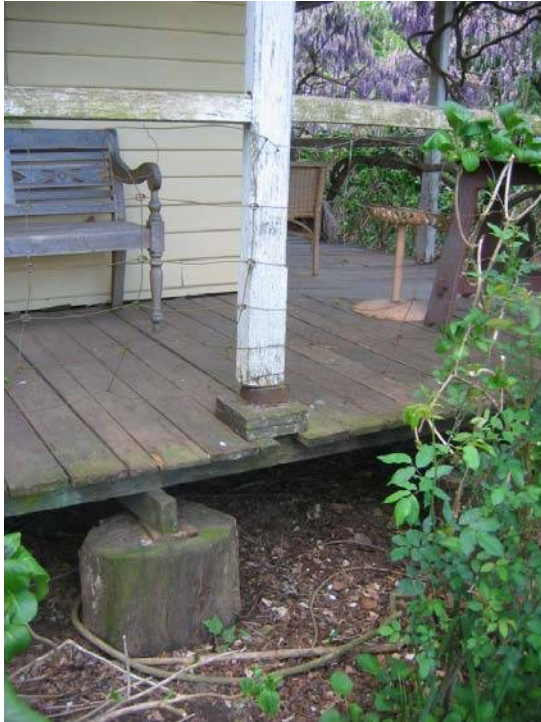
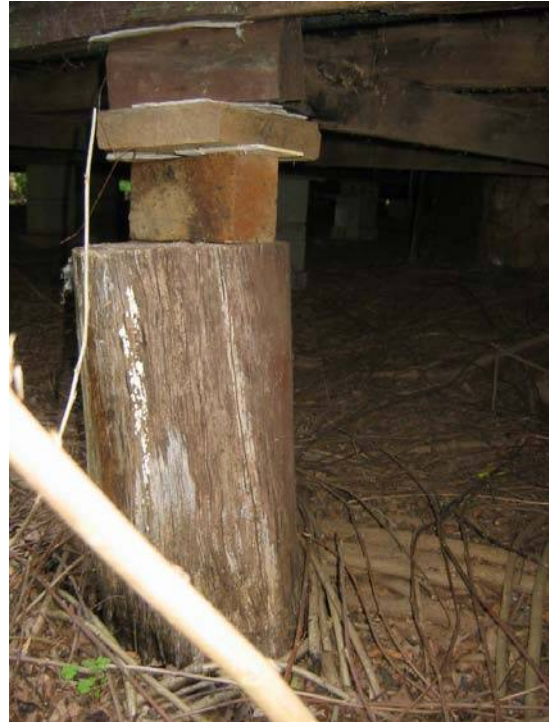
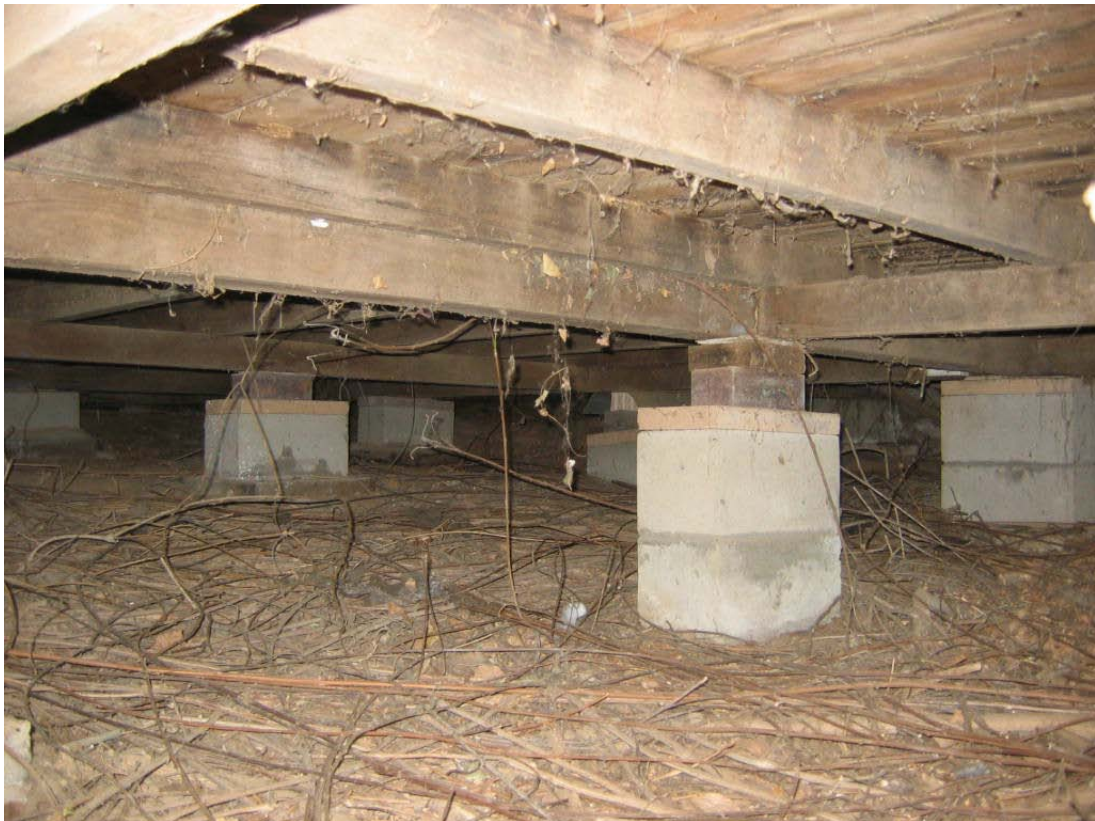
The deteriorated condition and ad hoc fabric substitution of the residence's piers is shown above and below. Ant caps are generally absent and attention will need to be directed towards the close proximity of the ground below the kitchen and former dining room area, where the verandah boards are almost contacting the ground.

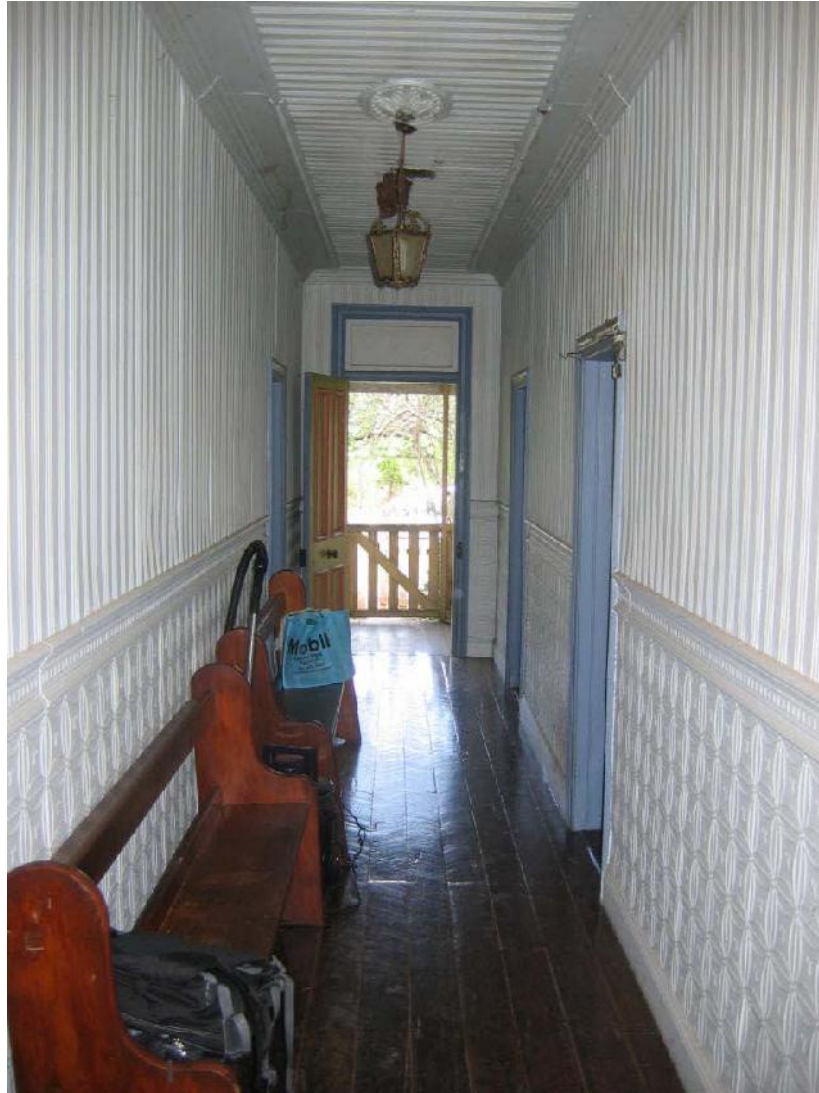
This single storey building was originally composed of three modest bedrooms, a centrally located passageway that provided access to the front and rear verandahs and to all rooms, and two larger rooms that provided the more public functions of Parlour and Dining Room. Direct access to the eastern verandah was available from these rooms.

The walls and ceiling of the residence are lined throughout with pressed metal, the sheet patterns and expressed moulding being of finer detail and variety than that which is within the store. The pressed metal lining of the original parlour, dining room and bedrooms is a distinctive feature of the residence and its conservation is important to the future of the building.

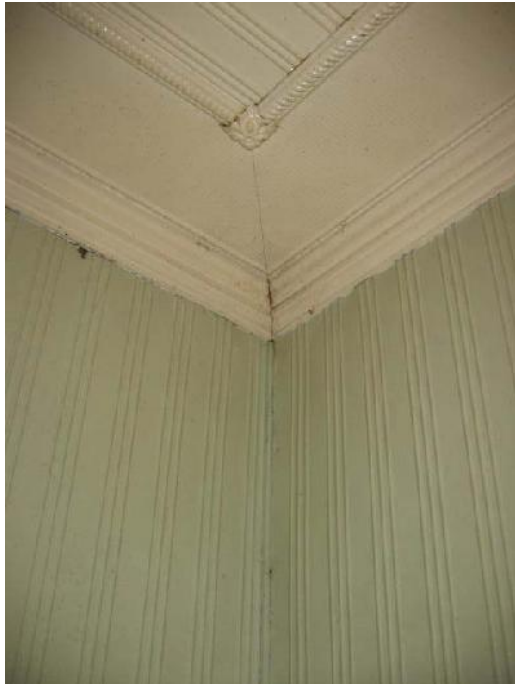
Residential tri-line pattern

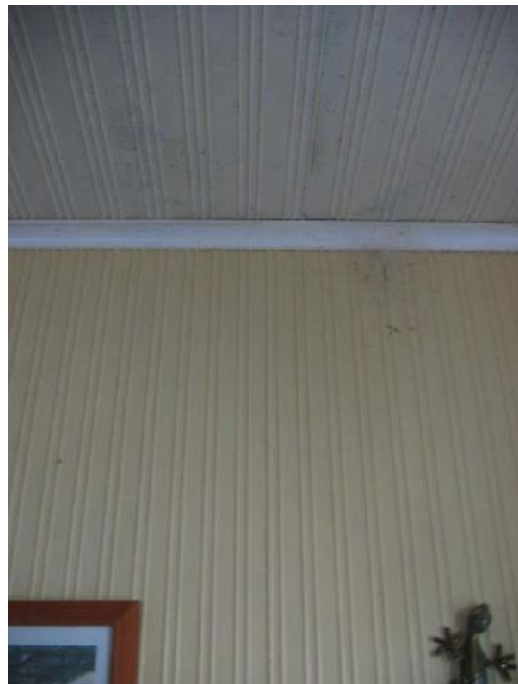
Dual-line pattern in store

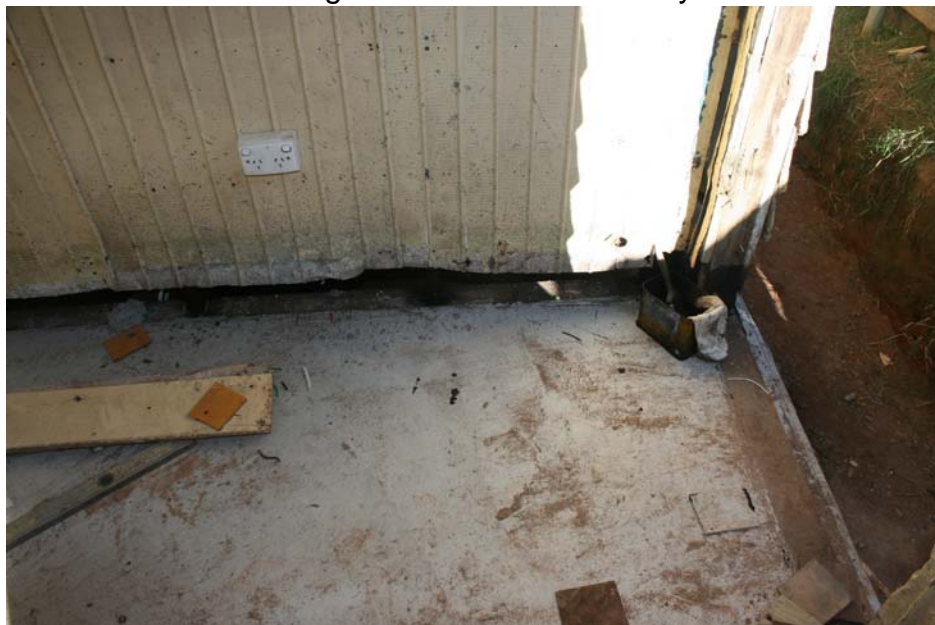
Single-line in former butchery

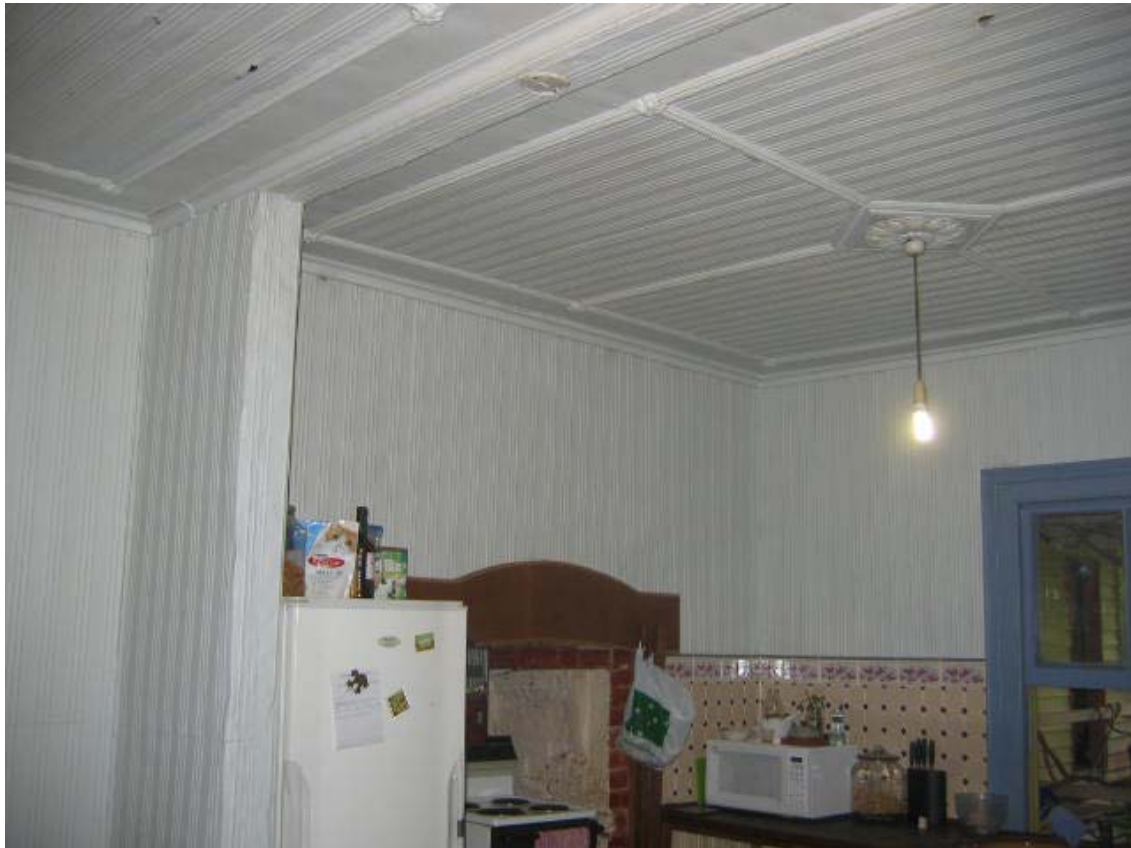
Unsympathetic changes to the internal appearance of the residence are within the kitchen area where most of an original bedroom wall has been removed to enlarge the space, the pressed metal lining having being bent and nailed around the stud at the opening. The recent adaptation of constructing an access passageway through to the store was not built to an adequate standard and this also constitutes an unsympathetic element.

View of the opening that was formed when the rear bedroom was adapted to become a kitchen.

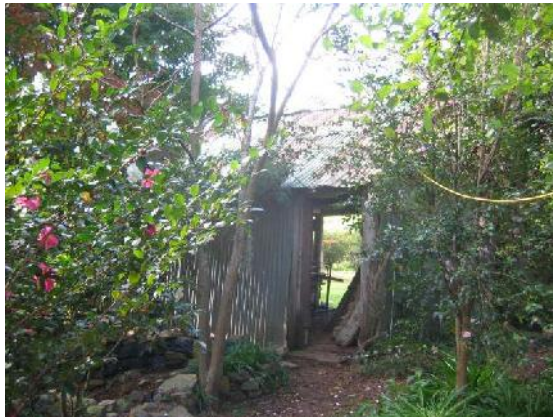
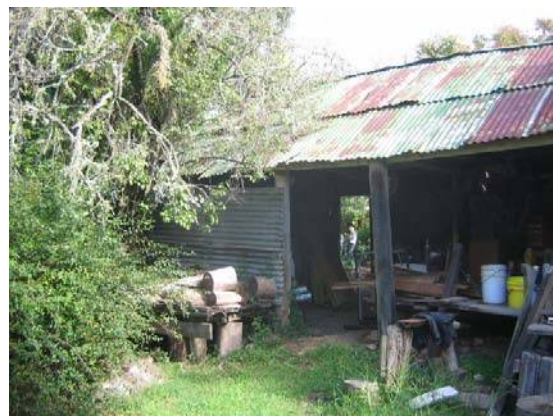
The image of the rear of the property shown on page 25 gives some indication of the extent of buildings that formerly existed in proximity to the store and residence. Much of this urban fabric has been removed over the years. However the property still contains a shed, a remnant building that contributes to the charm of the current setting and to an ability to understand the evolving story of the property.
