4 MUMMUGA LAKE ISSUES AND ACTIONS

Map 5: CM SEPP Coastal Management Areas for Mummuga Lake
CMP for Eurobodalla Estuaries
GIS file: Z:\GIS\workspace\Projects\Project\K250N\CM_Area\mummuga\cm\CoastalManagementAreas\99m.aprx

Map 1: Management Actions for Mummuga Lake estuary
CMP for Eurobodalla Estuaries

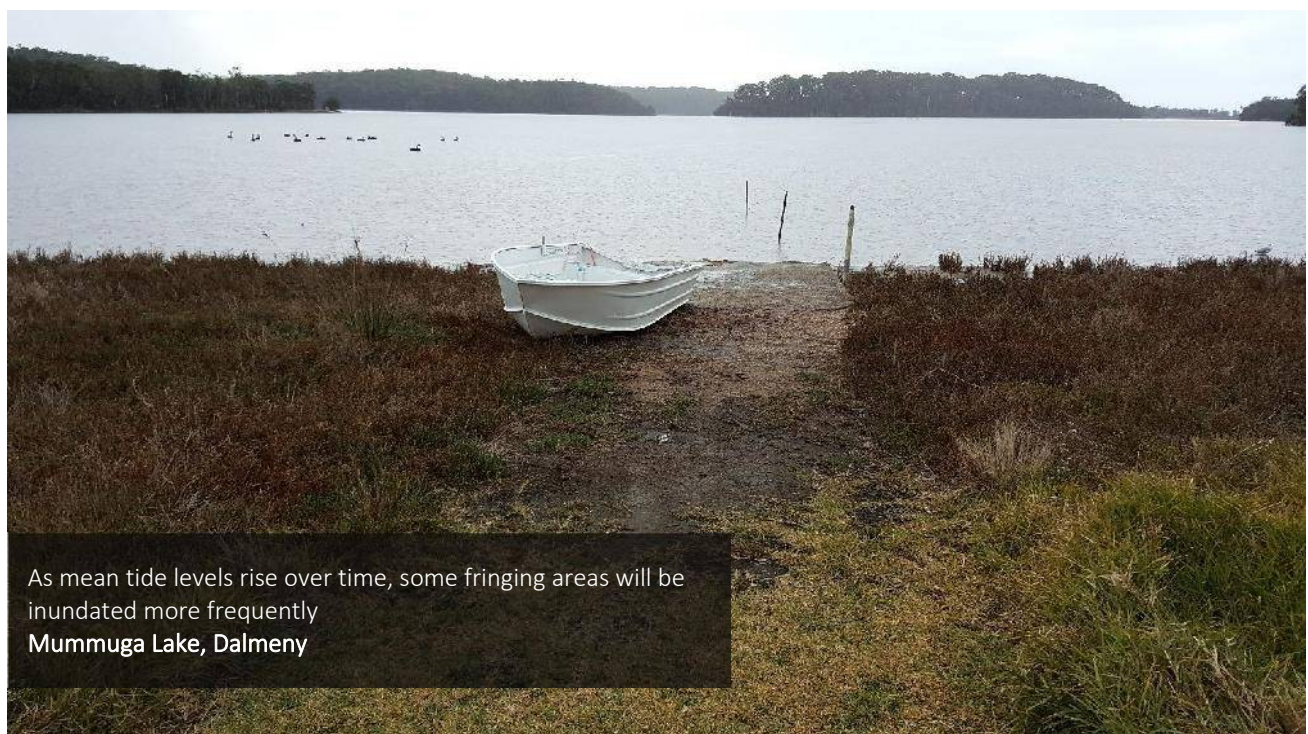
Note that some key issues occur in multiple areas. Locations indicated on map are representative locations.

CM SEPP coastal wetlands mapping does not match full extent of wetlands

Overfishing within Mummuga Lake

Damage/erosion exacerbated by informal access around the entrance and Mummuga Headland

Poor condition of boat ramp and car park

Management of saltmarsh / damage from vehicular access

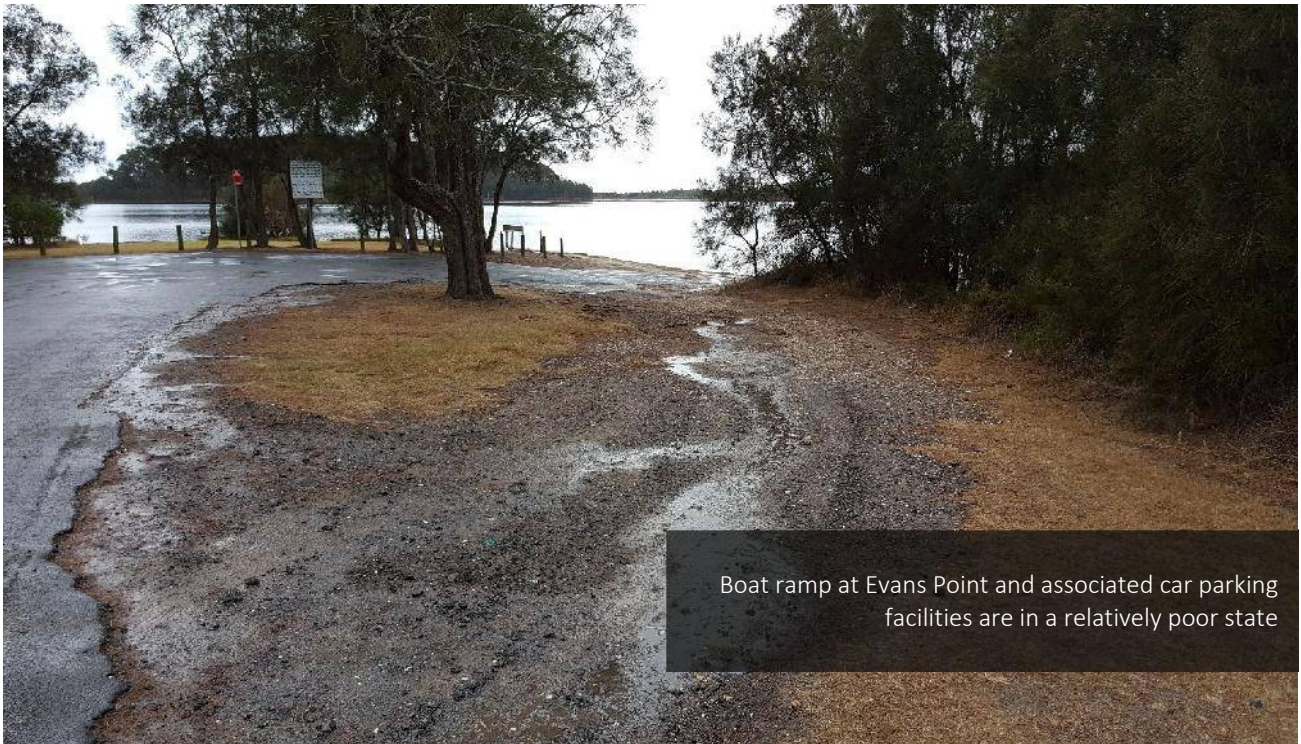
General concerns were expressed by some in the community that there is a lack of access to the lake for boating, resulting in informal access at several locations and damage to foreshores. Certainly, the boat ramp at Attunga St (Evans Point) is in relatively poor condition and the overall facility does not lend itself to intensive use. Runoff from the road here is poorly managed and erosion of sediment from informal parking and unsealed manoeuvring areas would be contributing some sediment to the Lake.

However, discussions with Council staff and TfNSW have indicated that this boat ramp is unlikely to be a priority for upgrade soon. We note that both Council and TfNSW are in the process of reviewing maritime facilities in the Eurobodalla Shire.

The situation should continue to be monitored by the Estuarine Management Advisory Committee (see Action EM5). While no action is proposed under this Program, Council may consider taking steps to reduce the impact of informal parking at the site, potentially paving some areas to facilitate boat turning at the facility.

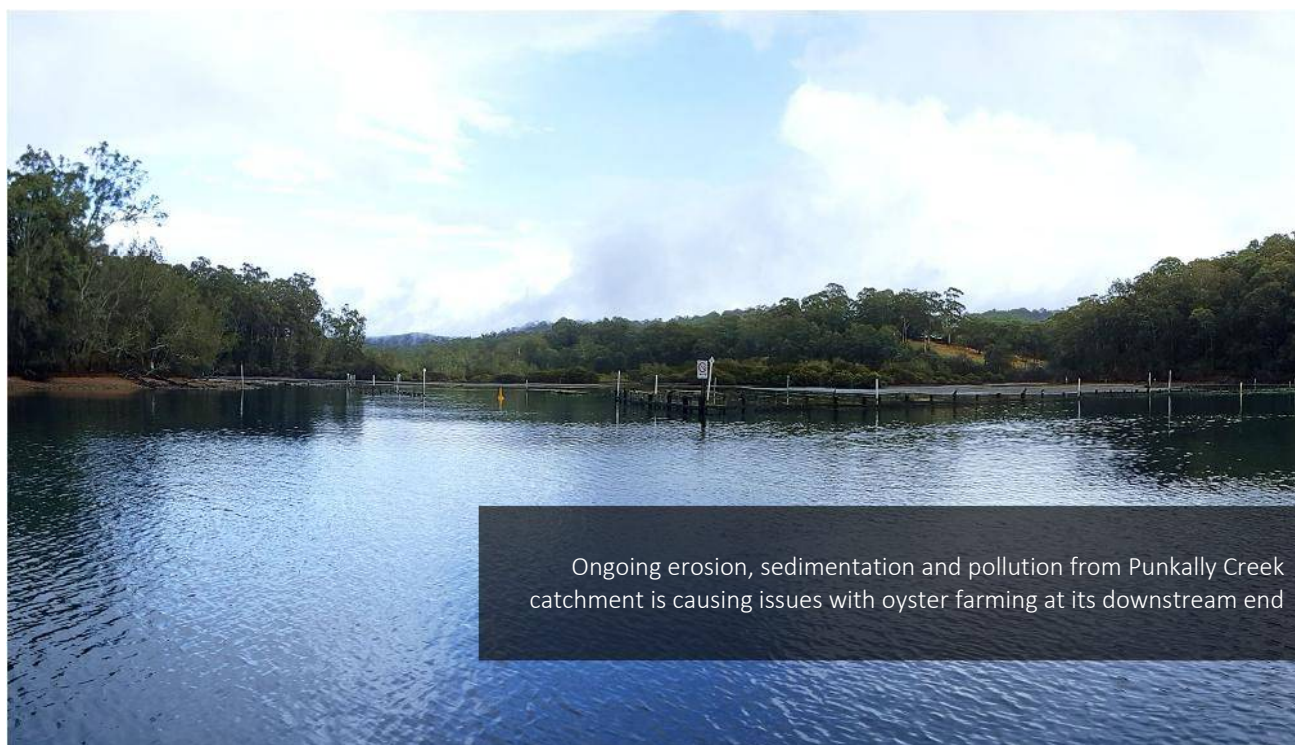
Ongoing erosion, sedimentation and pollution from Punkally Creek catchment is causing issues with oyster farming at its downstream end

While it is understood that the sediment load flowing down the creek is high, and that some sources have suggested intermittent faecal pollution of the waters, the exact nature of any faecal pollution and the main causes of erosion and sedimentation are not well understood.

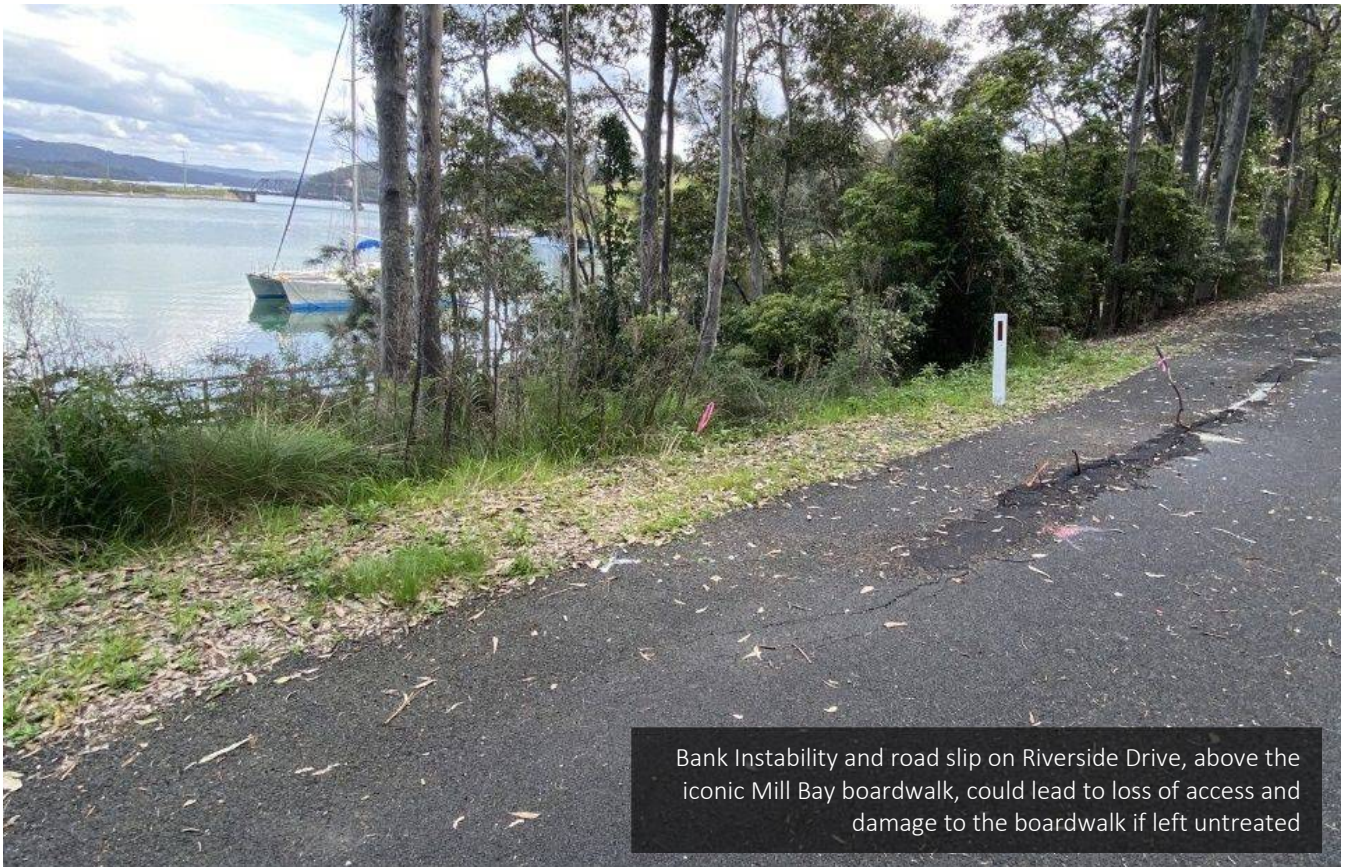
Location 1. Centenary Drive above the iconic Mill Bay boardwalk on the northern shoreline of Wagonga Inlet has become increasingly unstable. Following storm events in early 2021, the road partly collapsed, and one lane was closed. This presents a significant access limitation to Bar Beach and boat ramps, including the only ramp in Wagonga Inlet with boat trailer parking. Without bank stabilisation works, the condition of this road is likely to worsen, and the road may collapse. Damage and potential closure of the Mill Bay boardwalk, a very popular walking and bicycle route, could result.

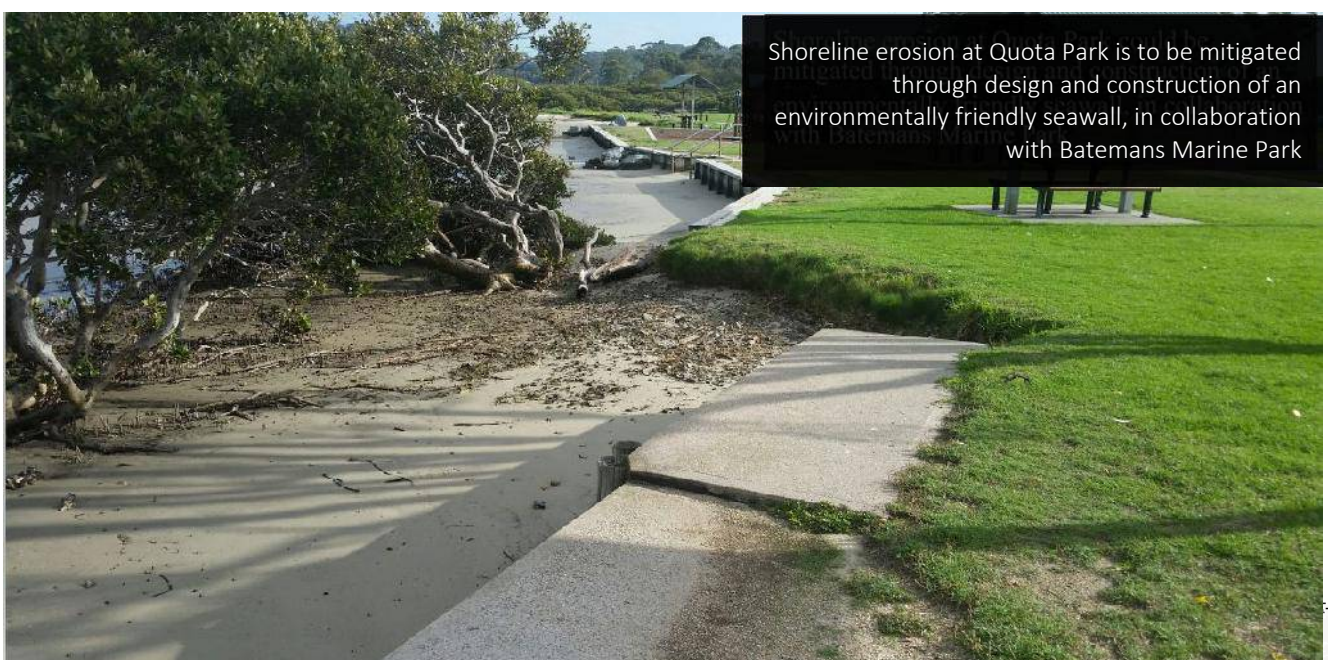
Location 2. A low-lying revetment protects the foreshore of Quota Park, Narooma from erosion. A short (few metres long) gap between revetment walls near public amenities adjacent to the southern end of the car park exists to the rear of a small mangrove stand, and shoreline erosion has occurred here. It is proposed to fill this gap using an environmentally friendly solution consistent with DPE EHG guidelines, designed in collaboration with Batemans Marine Park.
