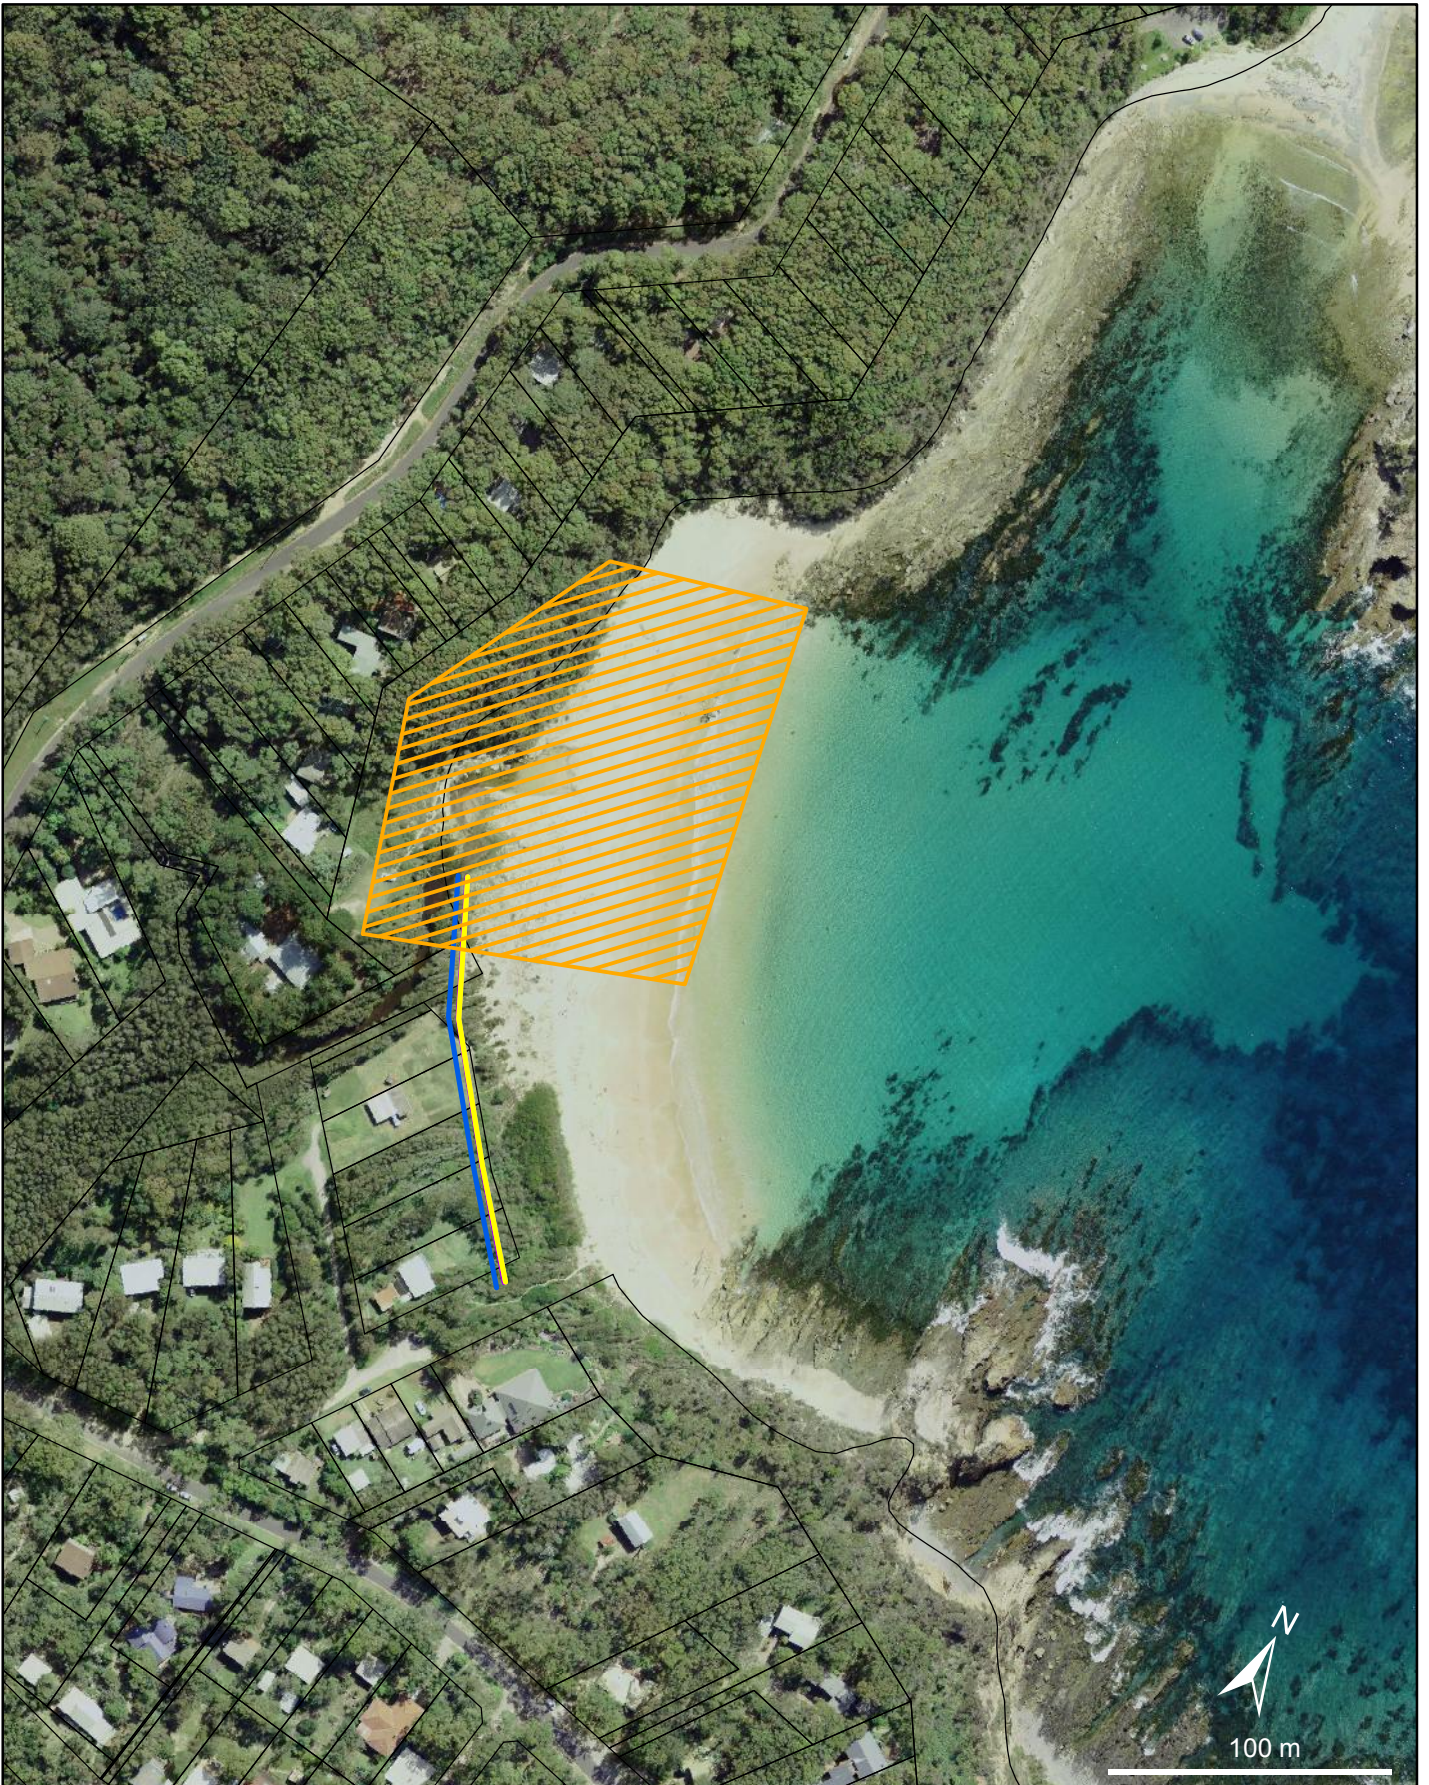
Figure I.17

Note 1: Landward movement of the shoreline could be limited by the presence of bedrock.

Note 2: The shoreline could potentially move landward of the hazard lines in the watercourse entrance instability region due to lowering of the beach profile from entrance scouring.

Guerilla Bay (south)

Deterministic erosion/recession hazard lines

Watercourse instability region

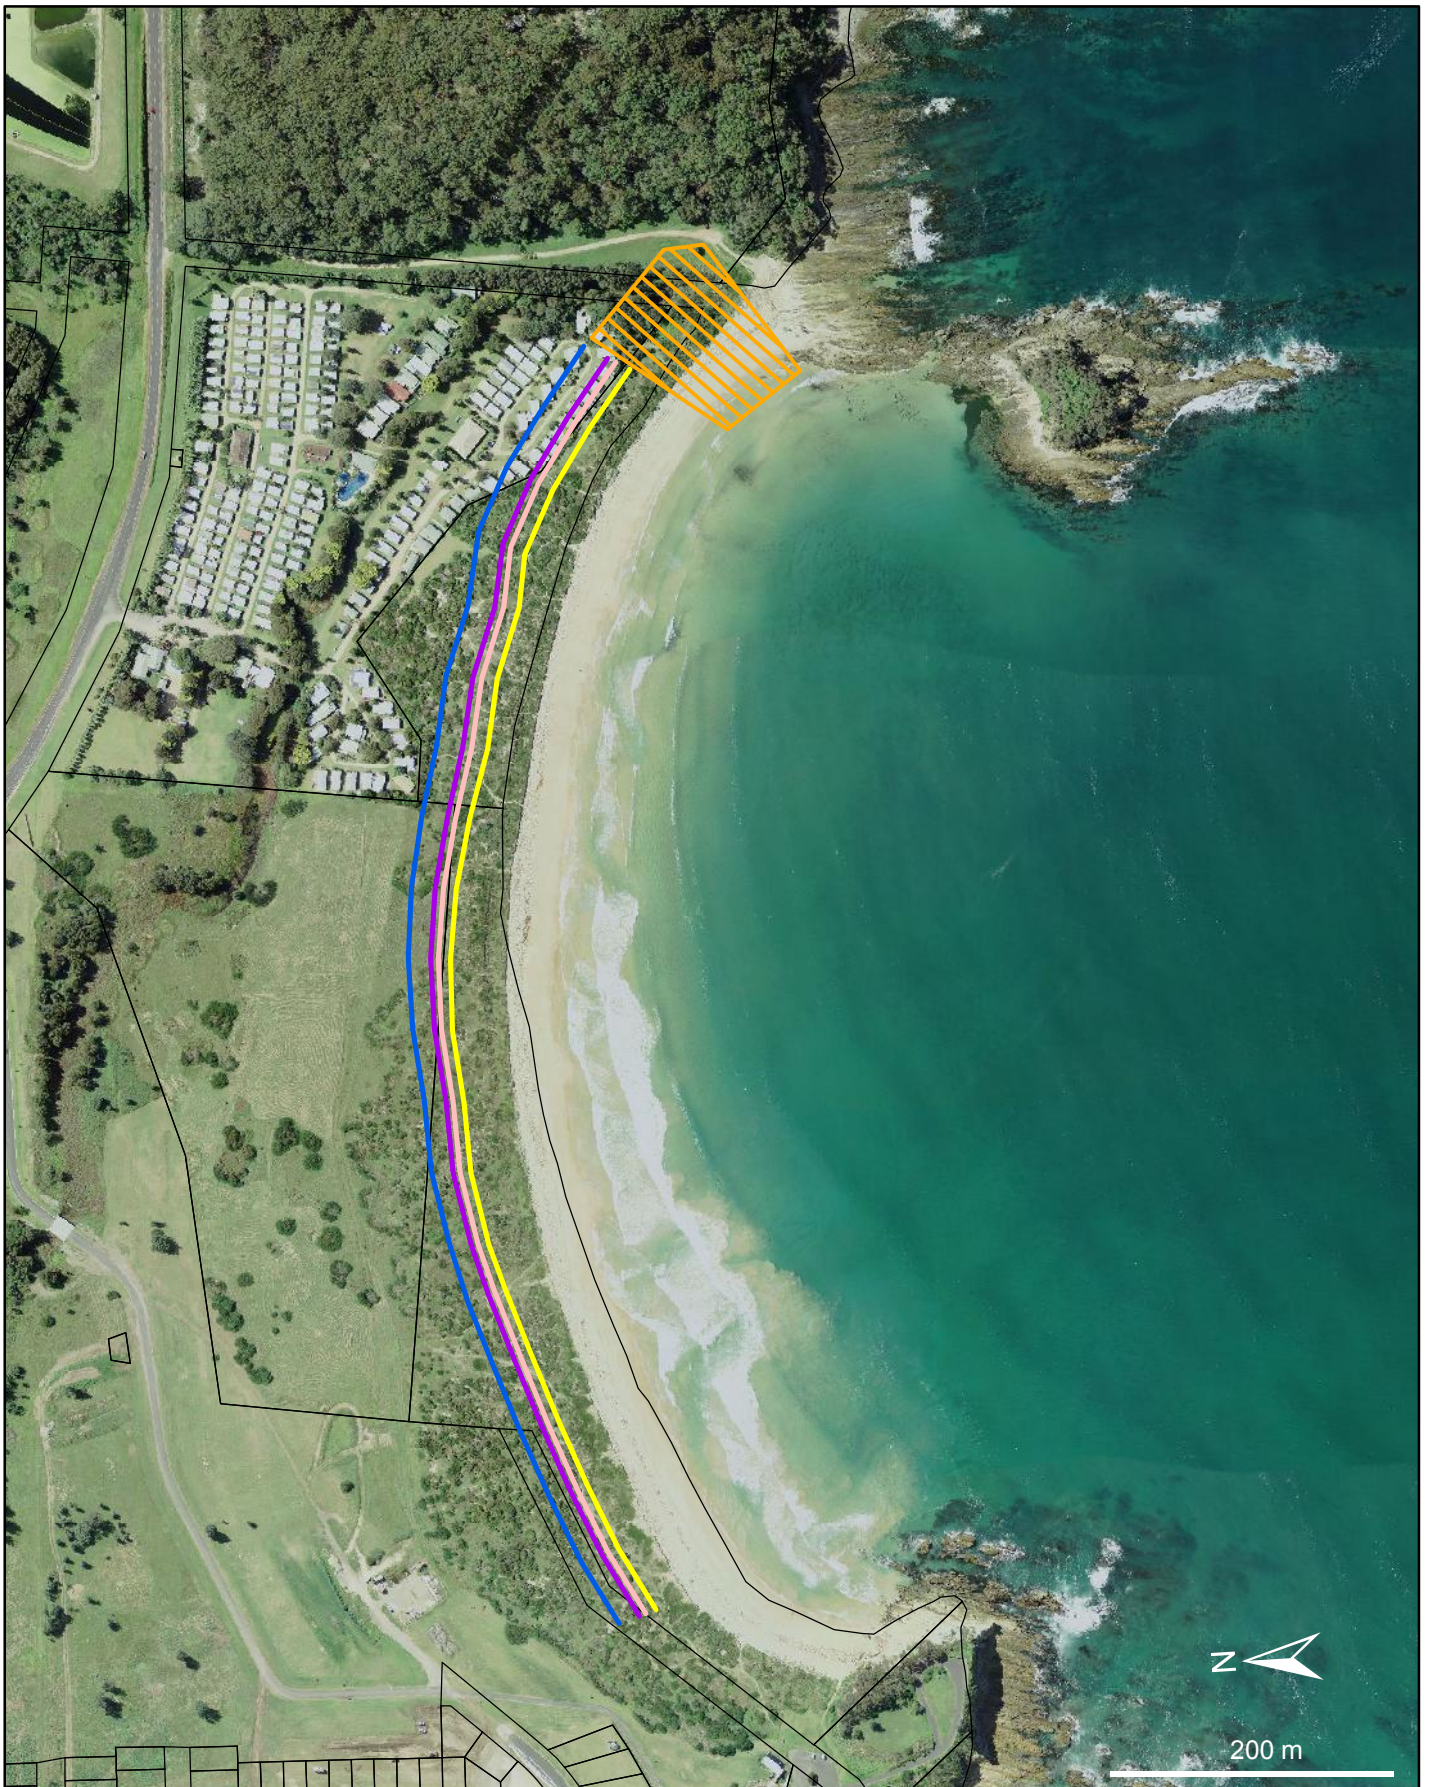
Figure I.18

Note 1: Landward movement of the shoreline could be limited by the presence of bedrock.

Note 2: The shoreline could potentially move landward of the hazard lines in the watercourse entrance instability region due to lowering of the beach profile from entrance scouring.

Note 3: Hazard lines do not extend to the western end of the beach as this is the limit of available photogrammetry.

Barlings Beach

Deterministic erosion/recession hazard lines

- 2017
- 2050
- 2065
- 2100

Watercourse instability region

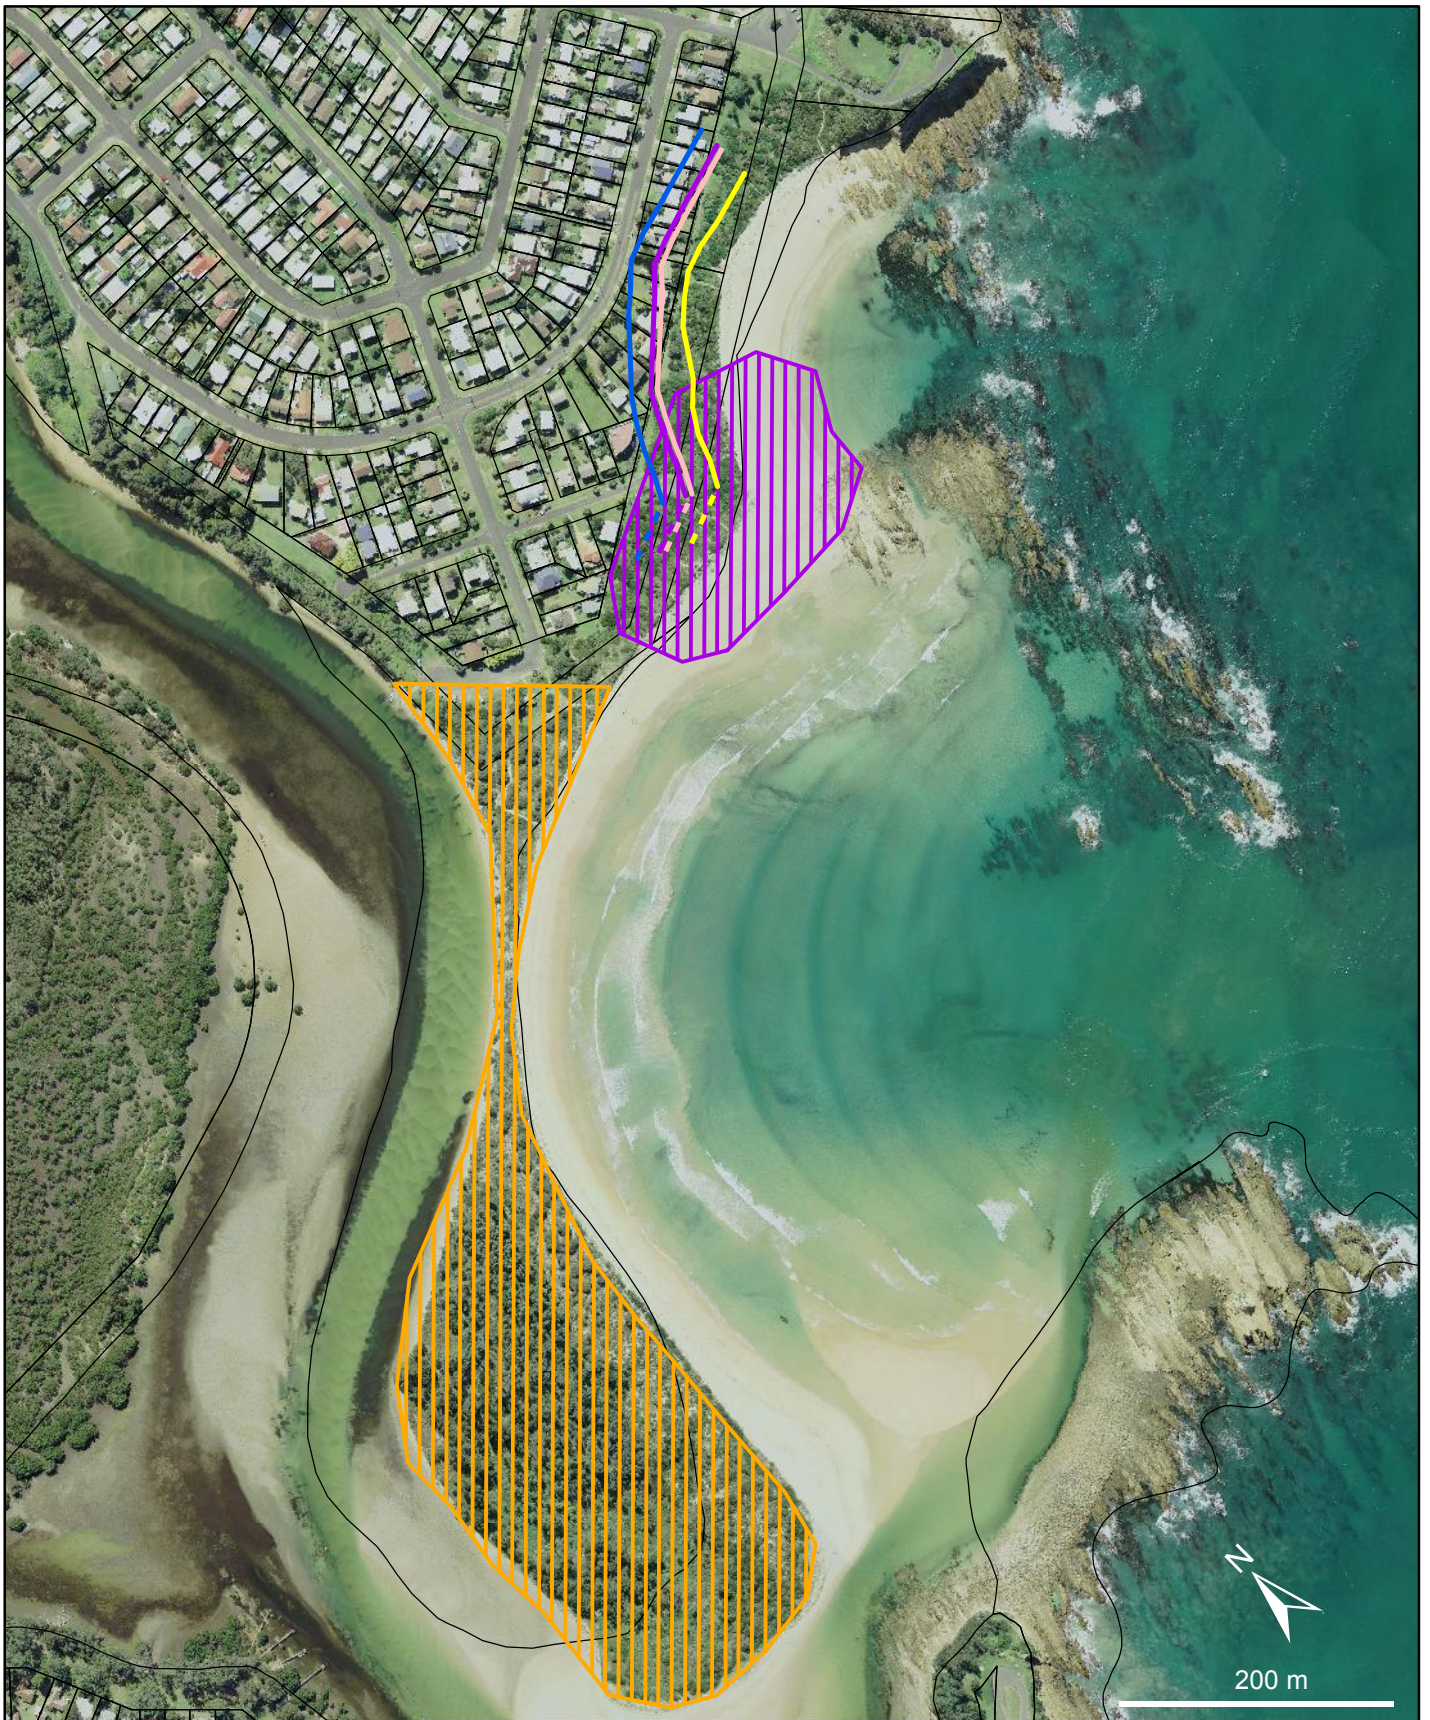
Figure I.19

Note 1: Landward movement of the shoreline could be limited by the presence of bedrock.
 Note 2: The watercourse entrance instability region is potentially subject to breakthrough from the Tomaga River and modified sand transport processes.
 Note 3: Potential for salient loss cannot be fully quantified with contemporary desktop engineering techniques. The shoreline could potentially move landward of the hazard lines in this region due to sea level rise or other coastal processes.

Tomakin Cove
 5% encounter probability
 Probabilistic erosion/recession hazard lines
