FIGURE 11
HYDRAULIC MODEL CALIBRATION
TIDAL - MAY 2012 EVENT
STAGE HYDROGRAPH

FIGURE 16A
PEAK FLOOD LEVEL PROFILES
CANDLAGAN CREEK

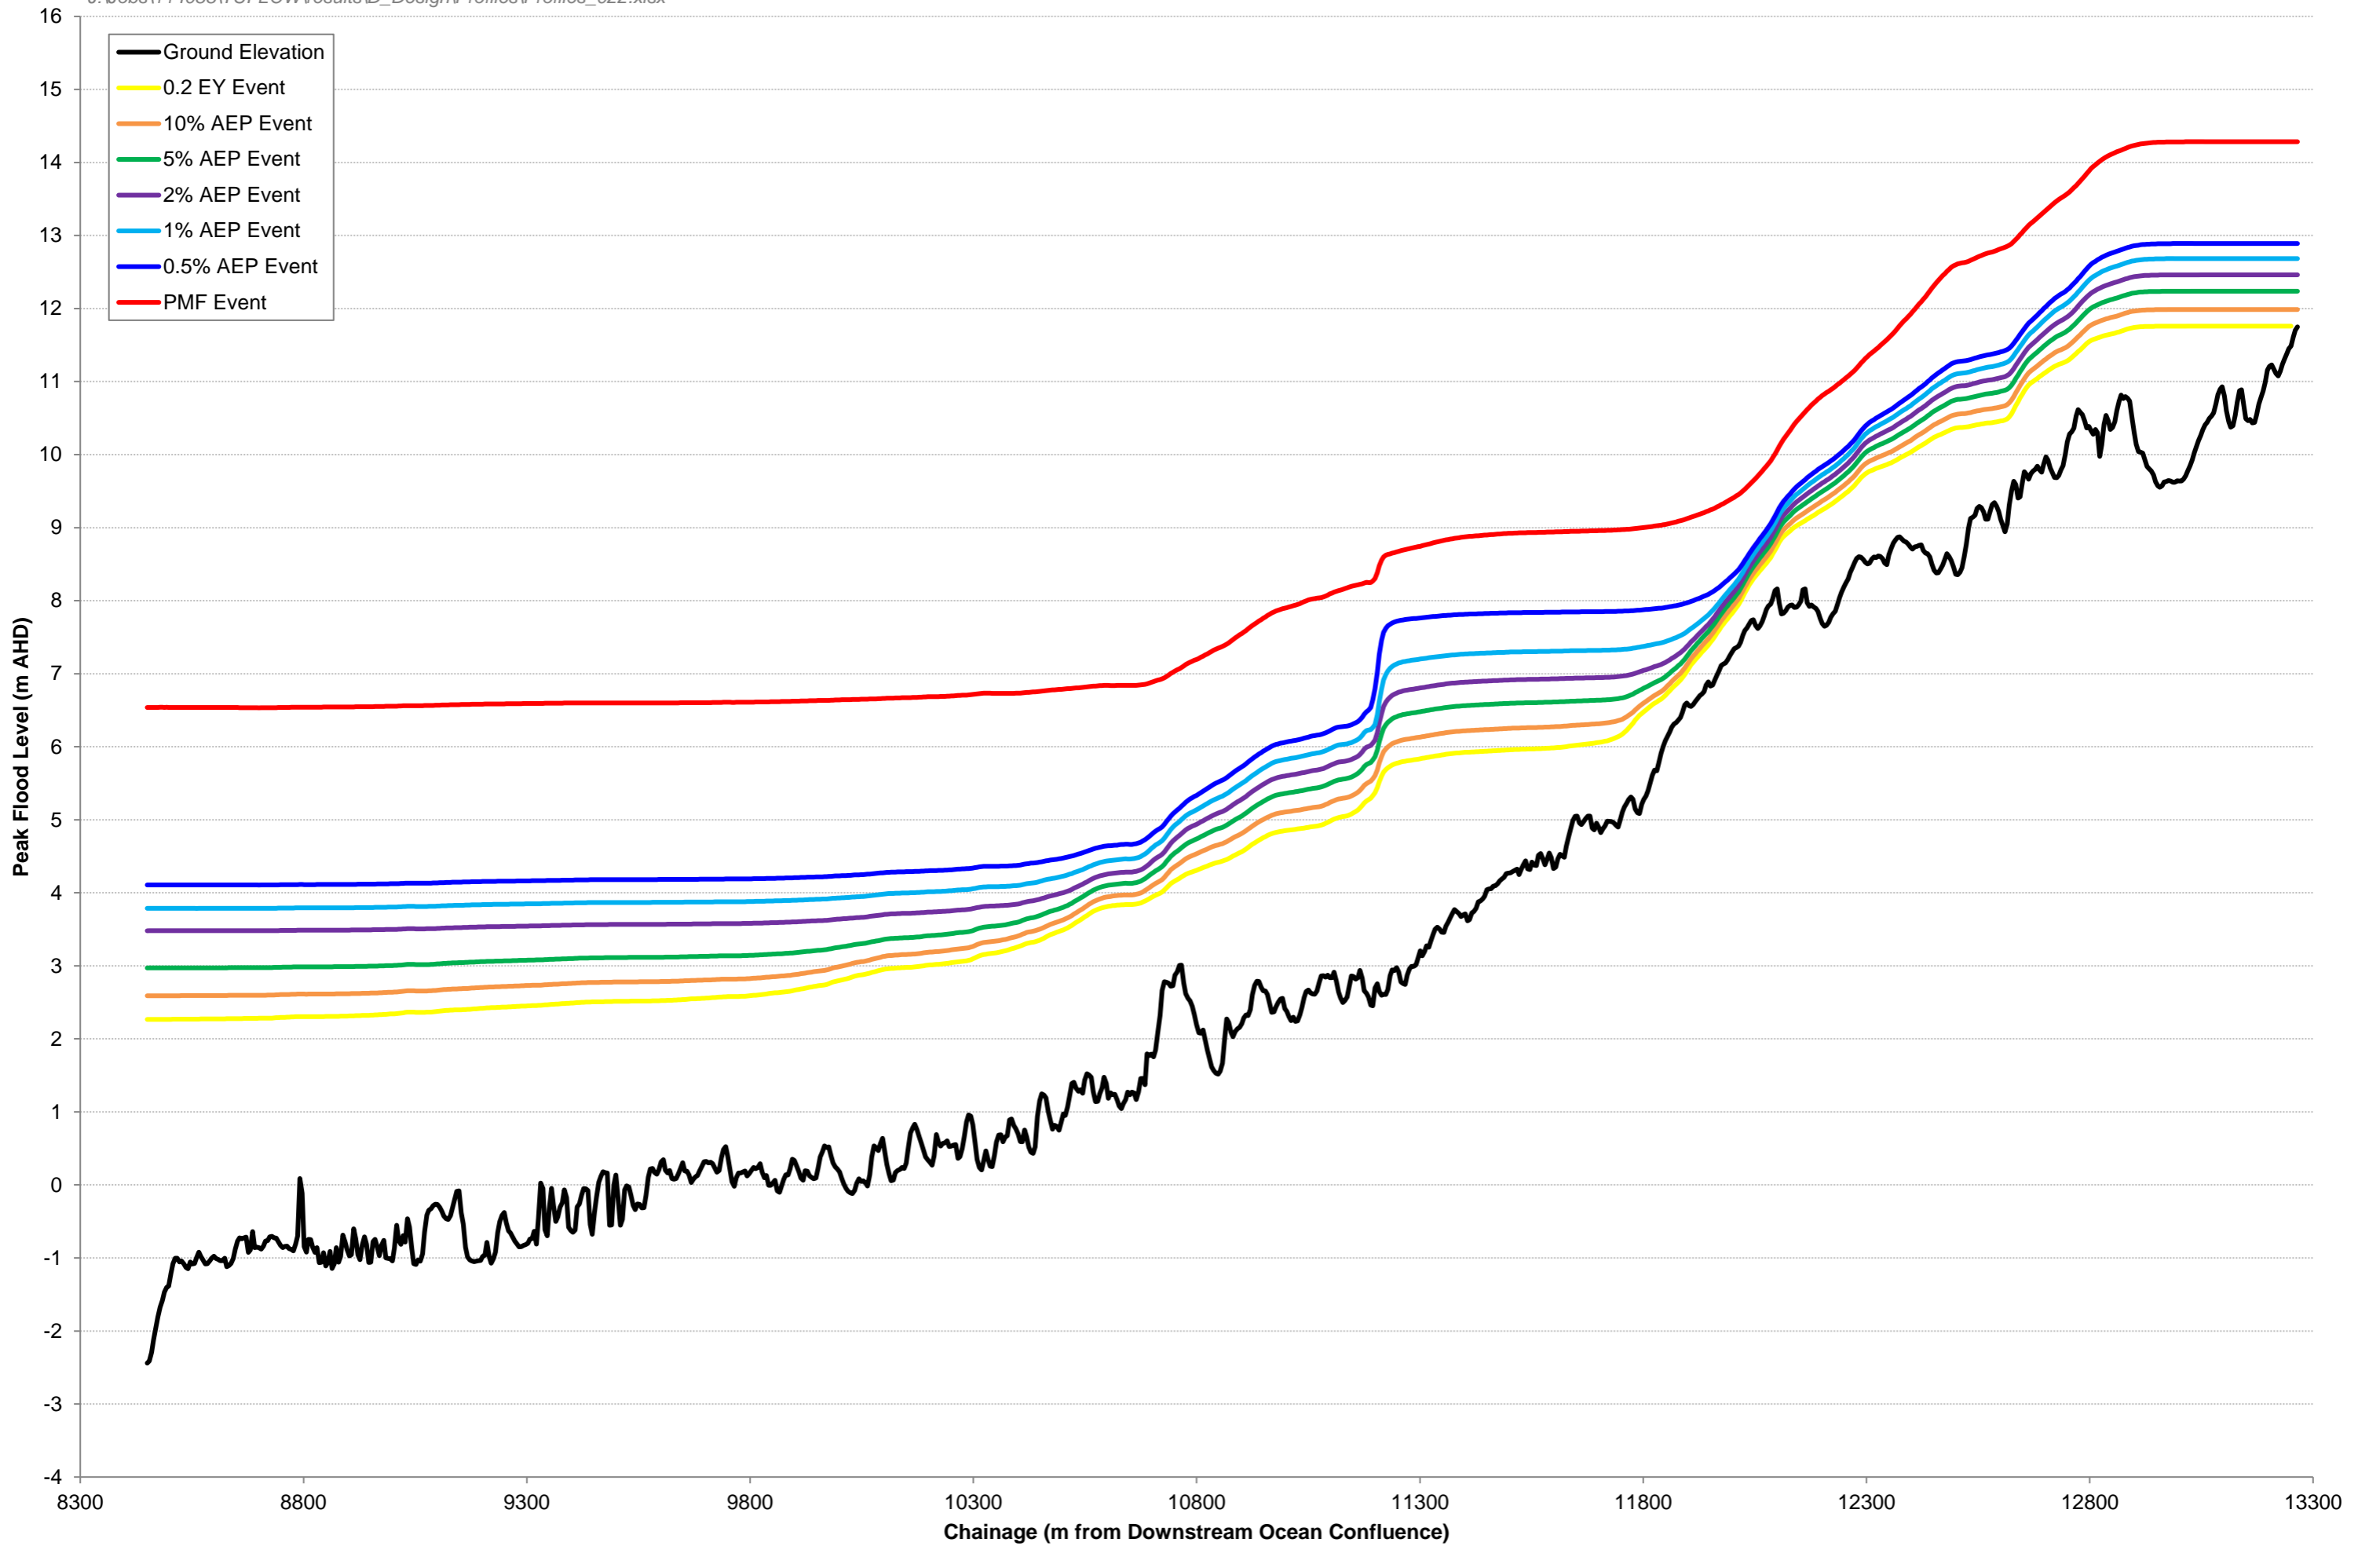
FIGURE 16C
PEAK FLOOD LEVEL PROFILES
JEREMADRA CREEK

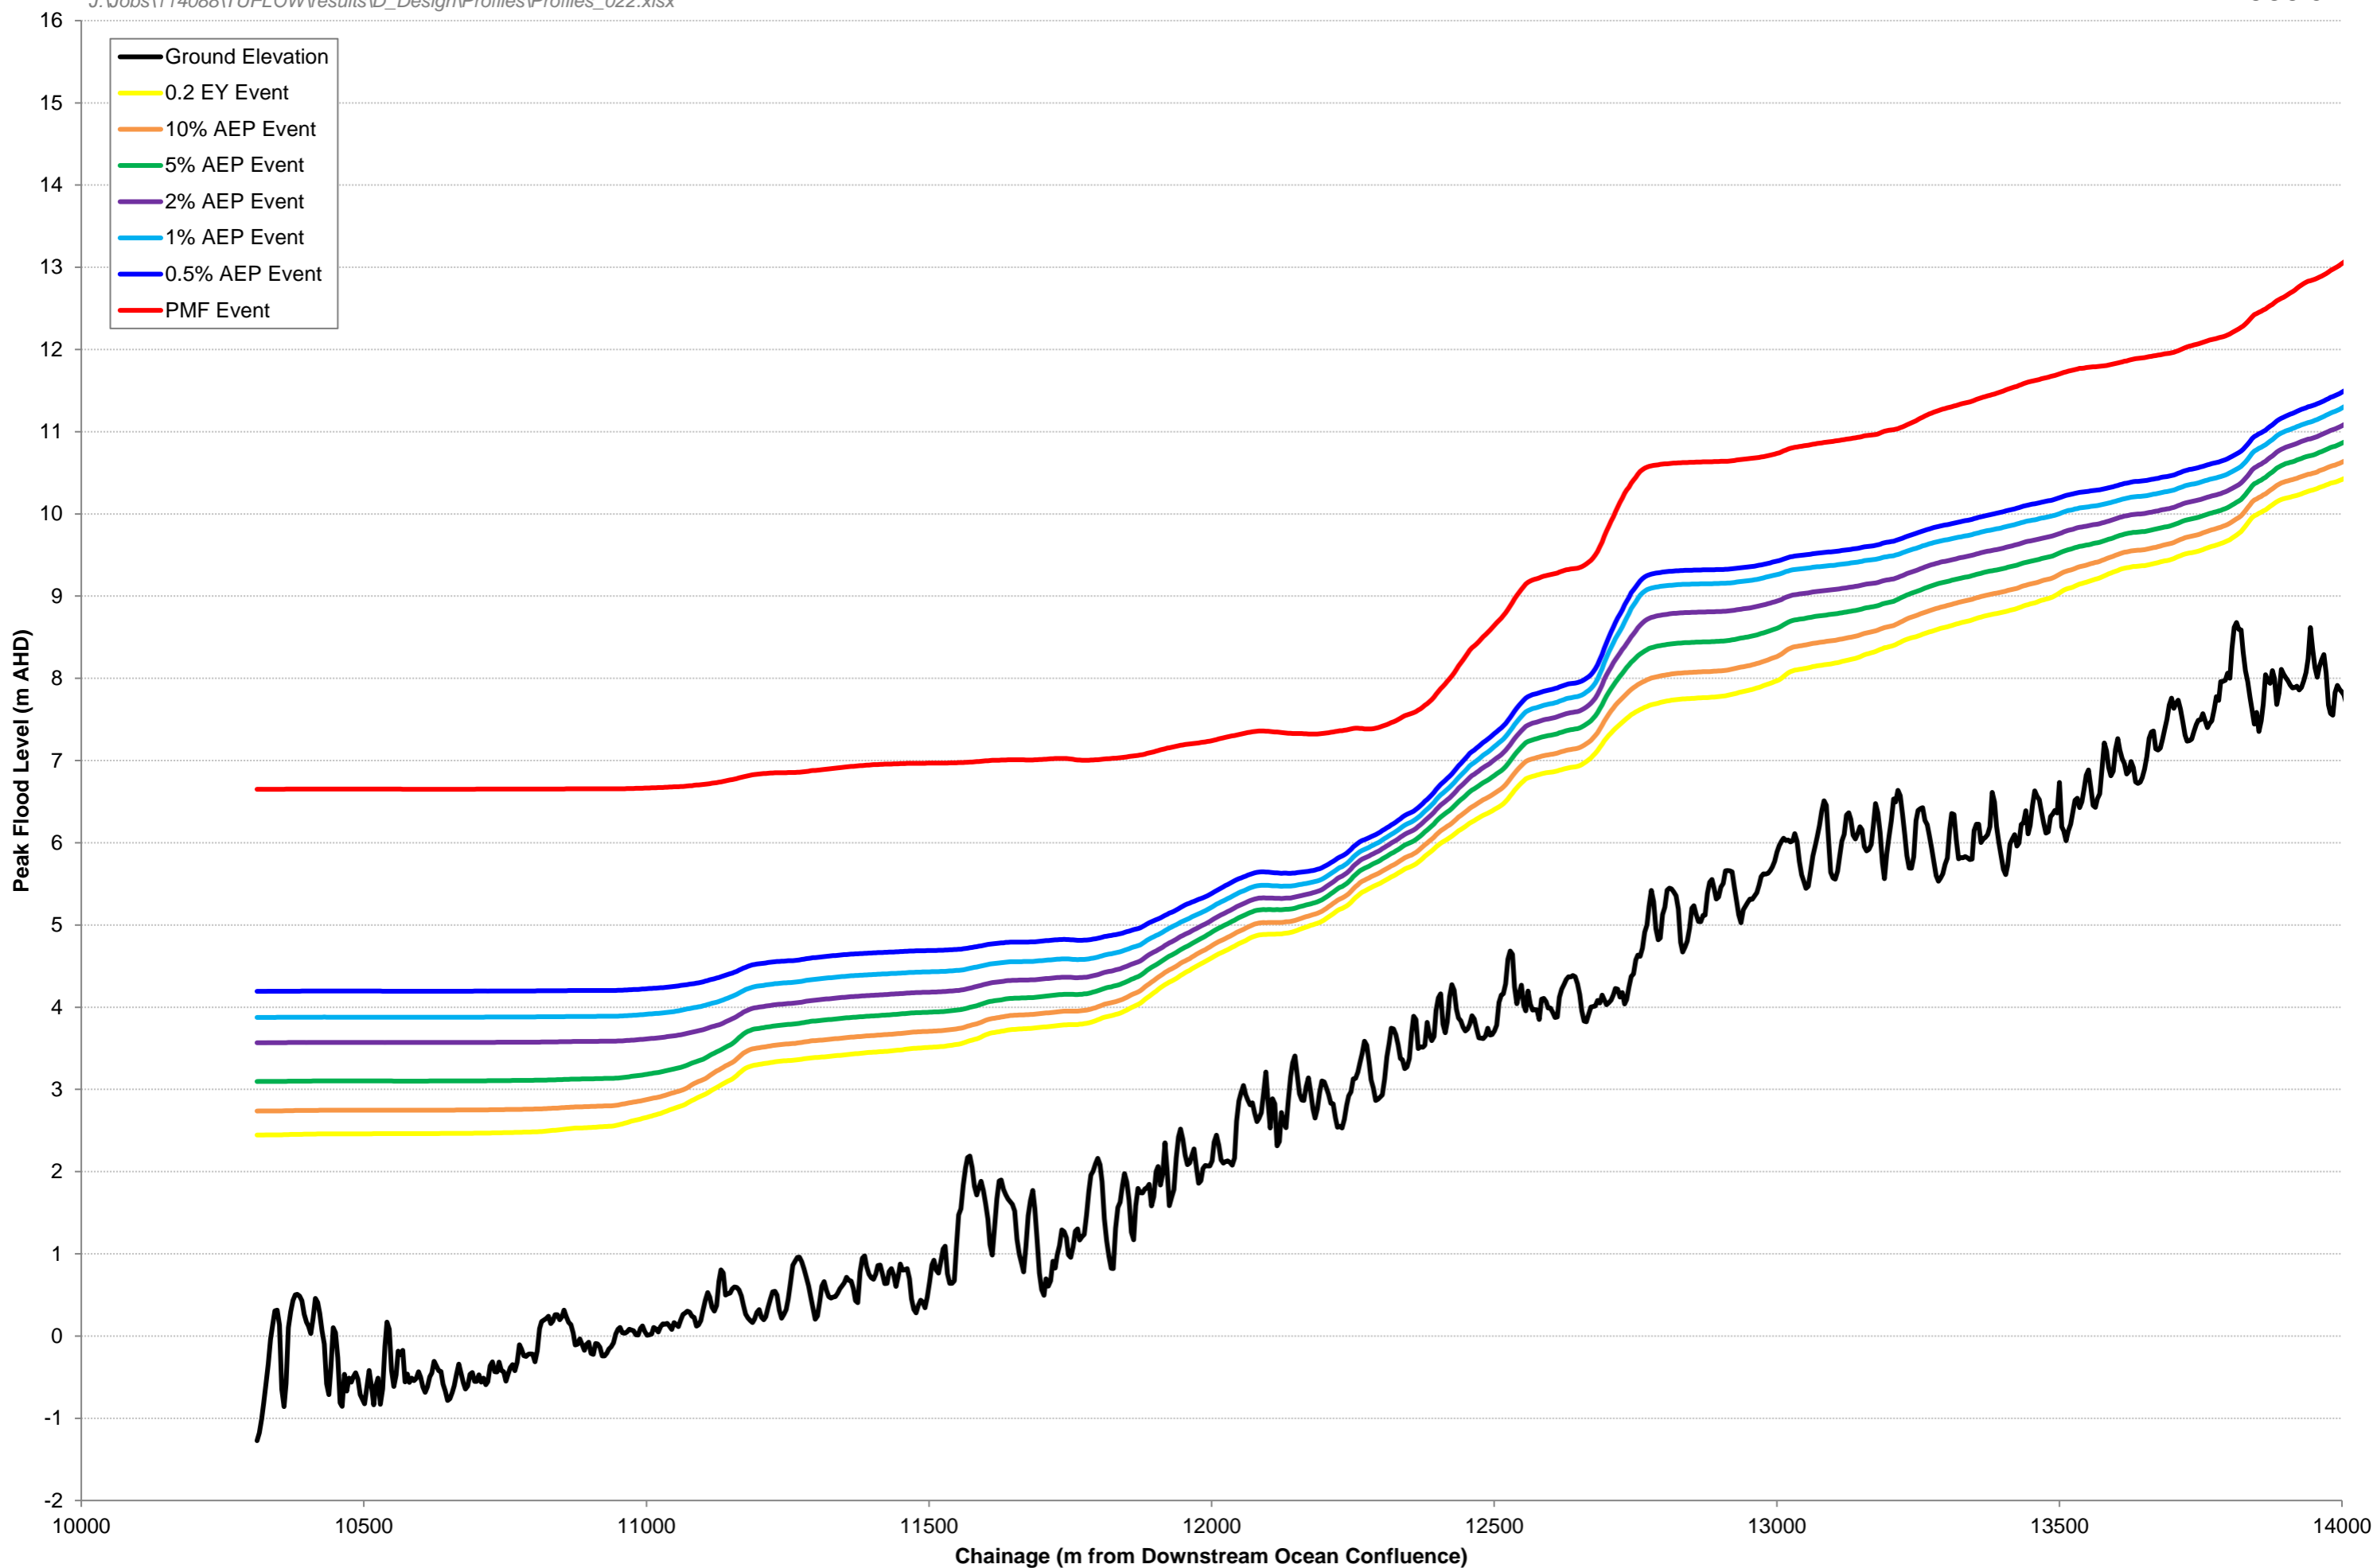
FIGURE 16D
PEAK FLOOD LEVEL PROFILES
MOGO CREEK

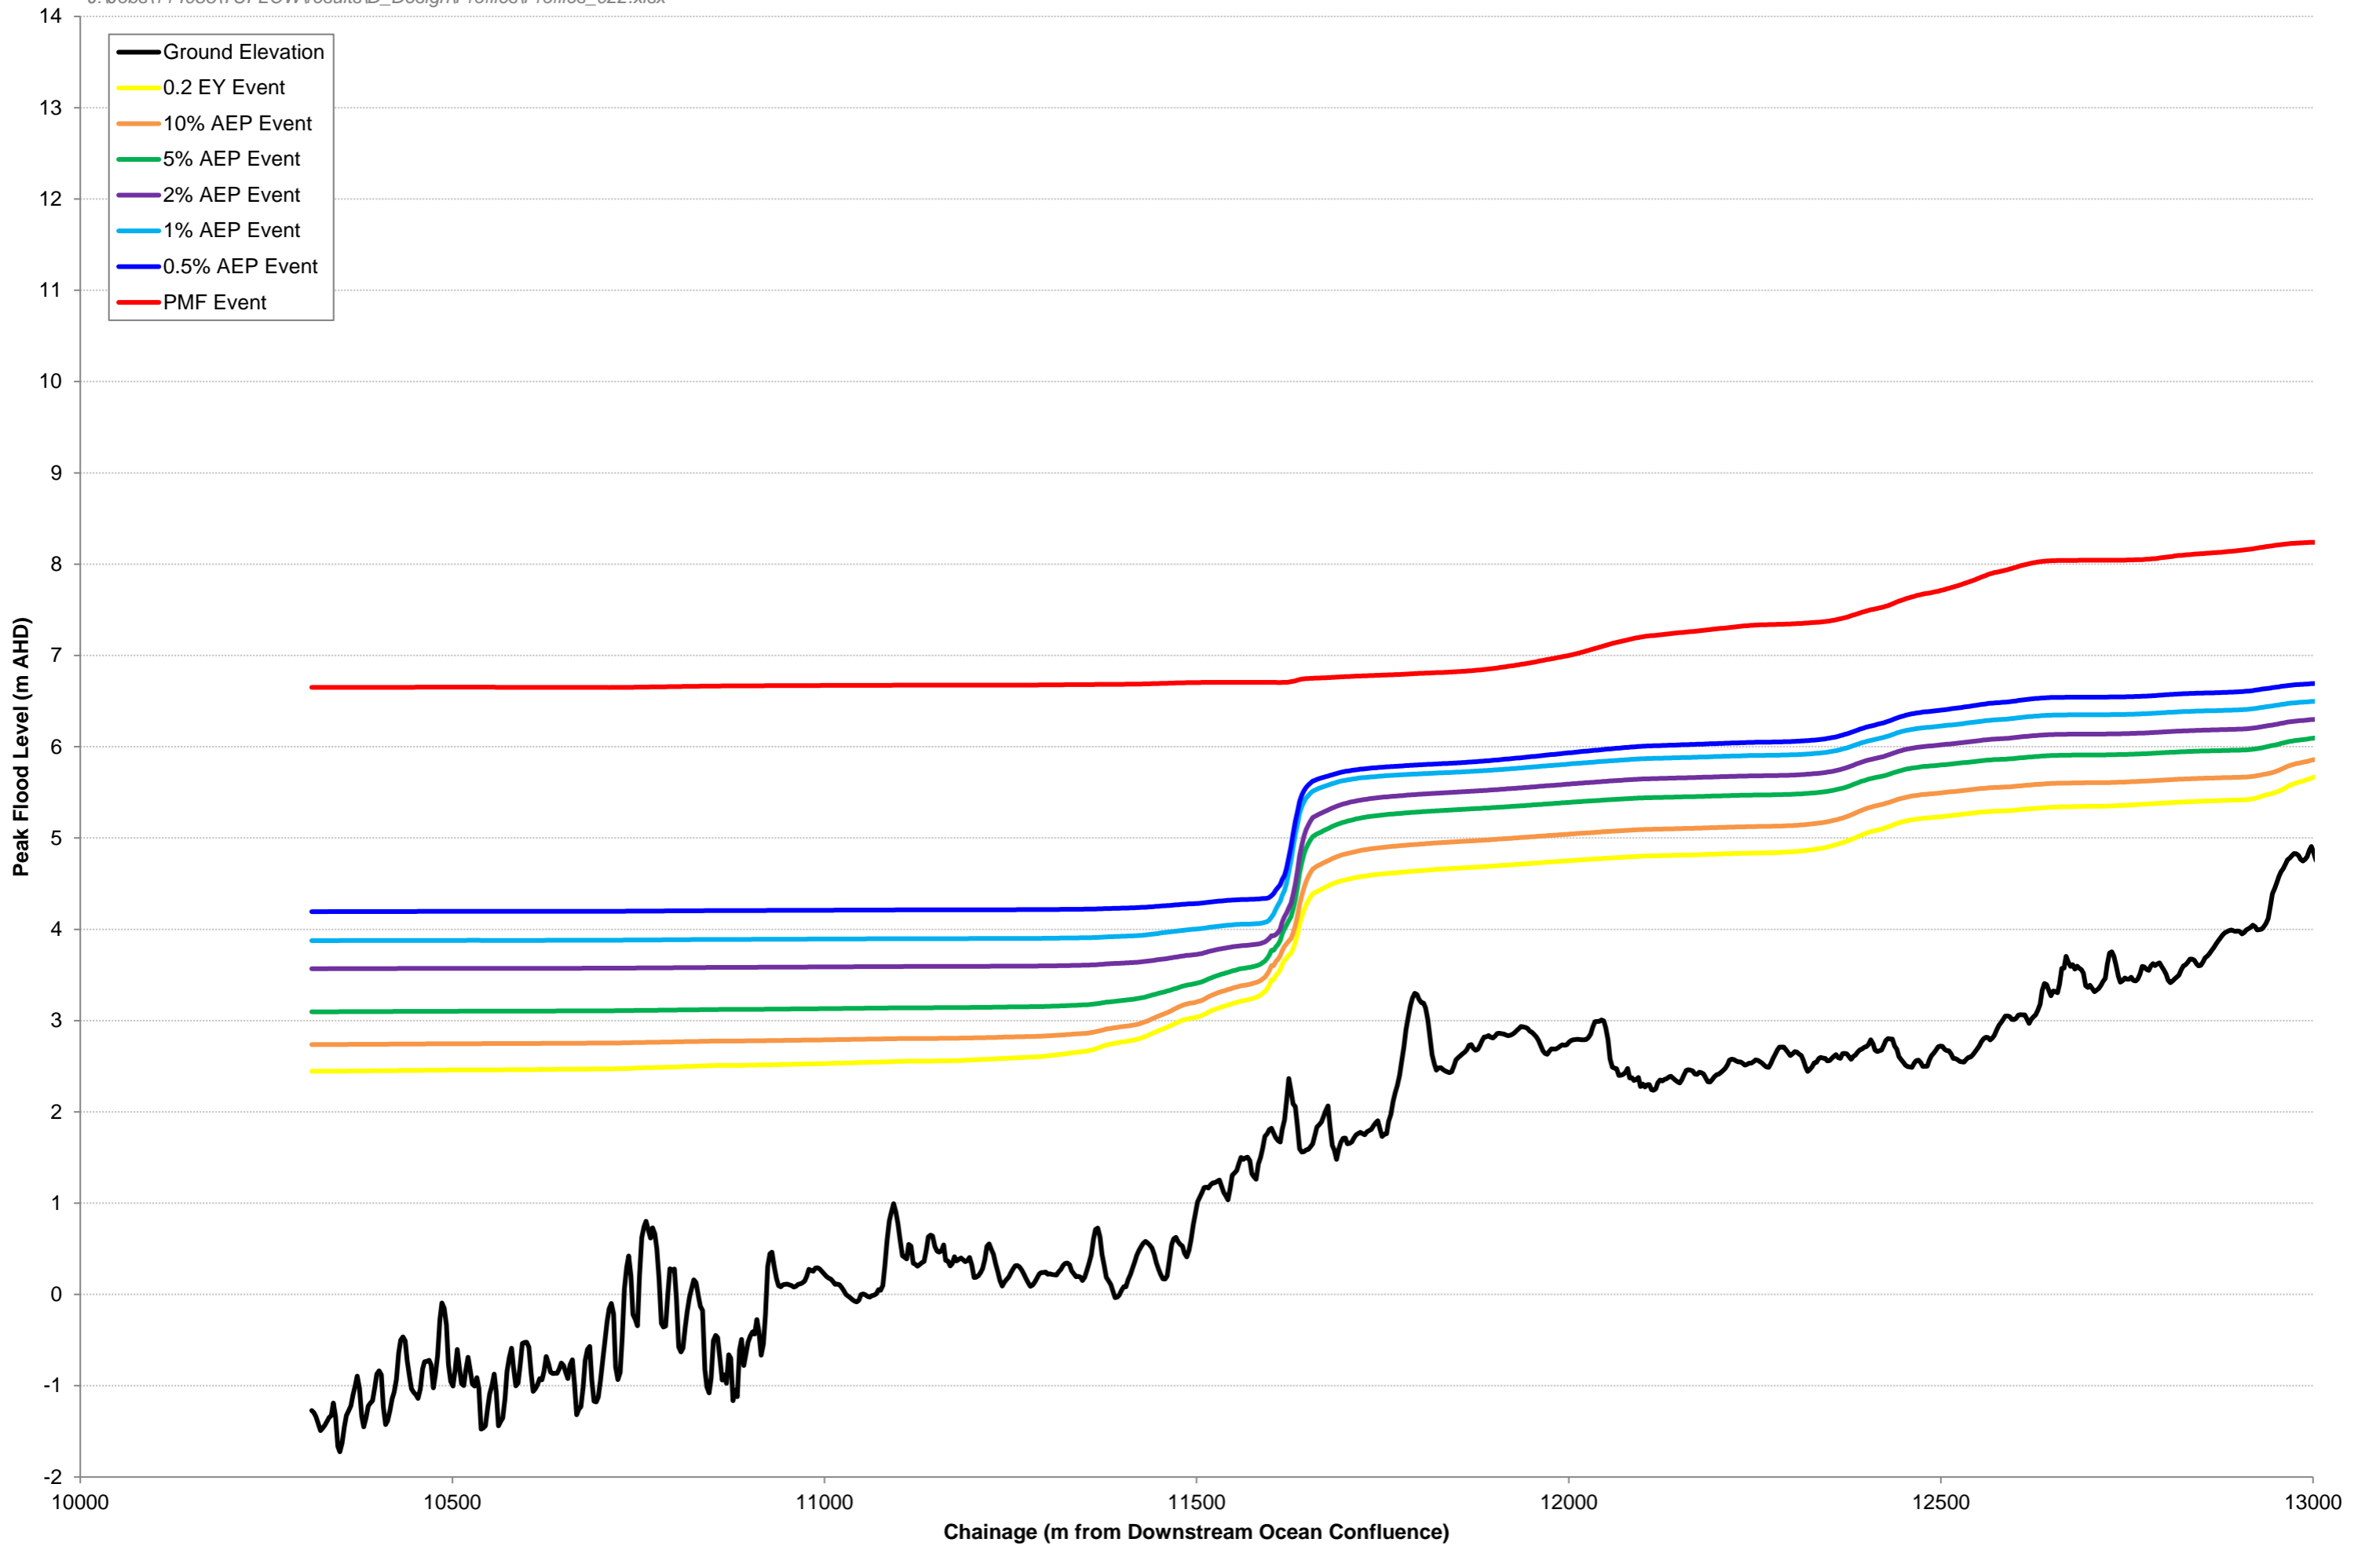
FIGURE 16E
PEAK FLOOD LEVEL PROFILES
DUNNS CREEK
