# Report for Bay Pavilions

## Energy Audit

Eurobodalla Shire Council

13 July 2023

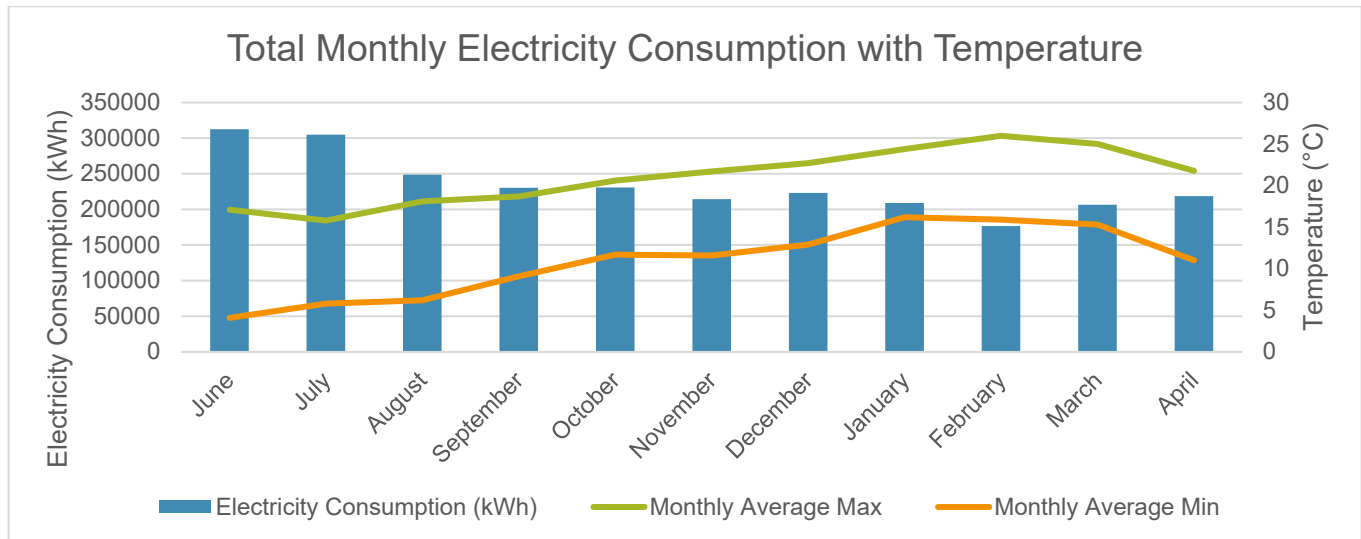
Figure 2 Total Monthly Electricity Consumption with Temperature

Figure 2 shows the total electricity consumption for each month of available data, compared with the average maximum and minimum temperatures of each month. A pattern of seasonal variation is somewhat apparent with higher electricity consumption in the winter months and lower consumption in the summer. This higher electricity consumption in colder months is likely to be associated with pool HVAC systems which constitutes a major energy consumer as it operates 24/7 to maintain warm indoor temperatures and providing heating of the incoming outdoor air ventilation.

It can however be noted that despite seasonal variation in temperature, electricity consumption remains consistently high even in warmer months, indicating that the major sources of energy consumption are not entirely dependent on external temperature.

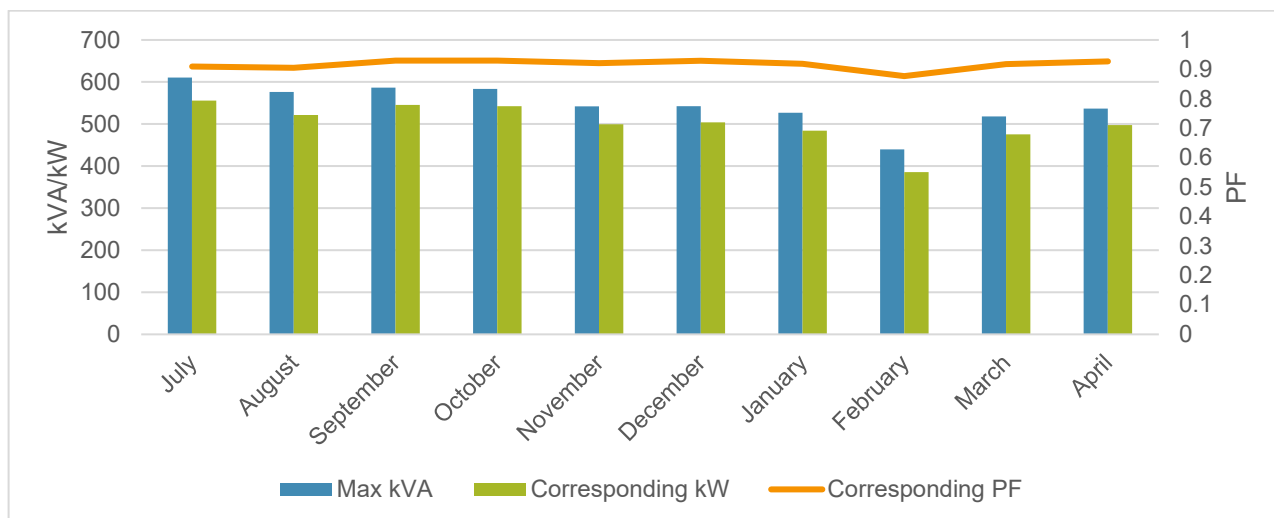
Figure 9 Monthly Max kVA and corresponding kW and PF

Figure 9 shows the maximum kVA per month, with the corresponding kW and power factor. Maximum demand appears to show a similar trend to electricity consumption, being higher in winter than summer. The corresponding power factor for each month's maximum demand remains high, with values ranging from 0.87 to 0.93. A power factor over 0.99 is

considered ideal as it means electricity bills will only charge for the true power drawn by the building. Power factor correction systems can ensure high power factor, which will provide some reduction in energy costs through reducing maximum demand charges.

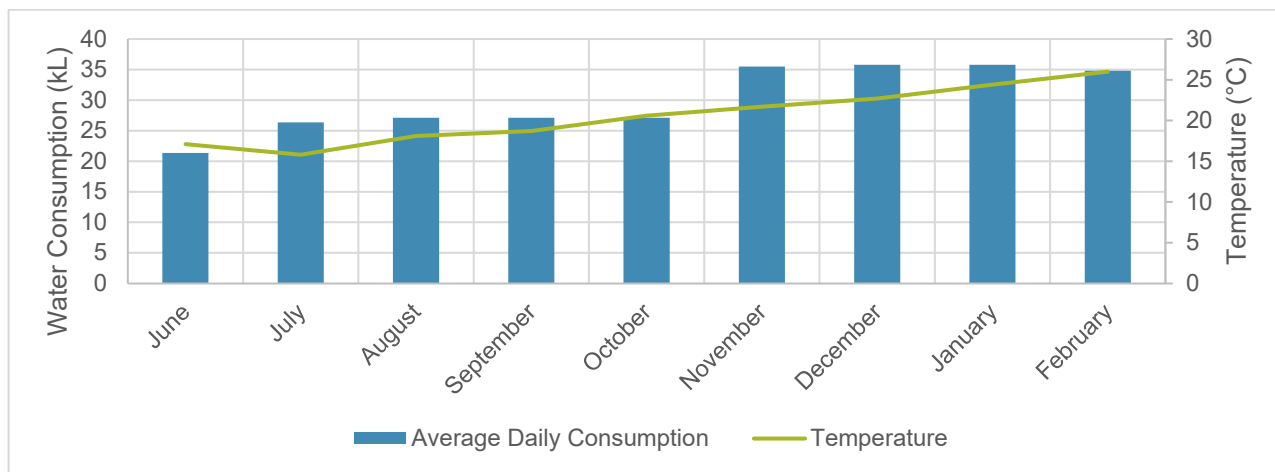
Figure 11 Total Monthly Water Consumption with Monthly Average Temperature

Figure 11 illustrates the water consumption of each month for which water billing has been made available. As water is billed approximately quarterly, water consumption is approximated to be split across each period evenly. This shows

that water consumption has increased over the operational period of the building. This is attributed to outdoor pool use being higher in warmer months and evaporation in pool and irrigation applications being higher when temperatures are warmer. Improving upon energy efficiency at Bay Pavilions may also result in reducing water demand which may result in further savings.

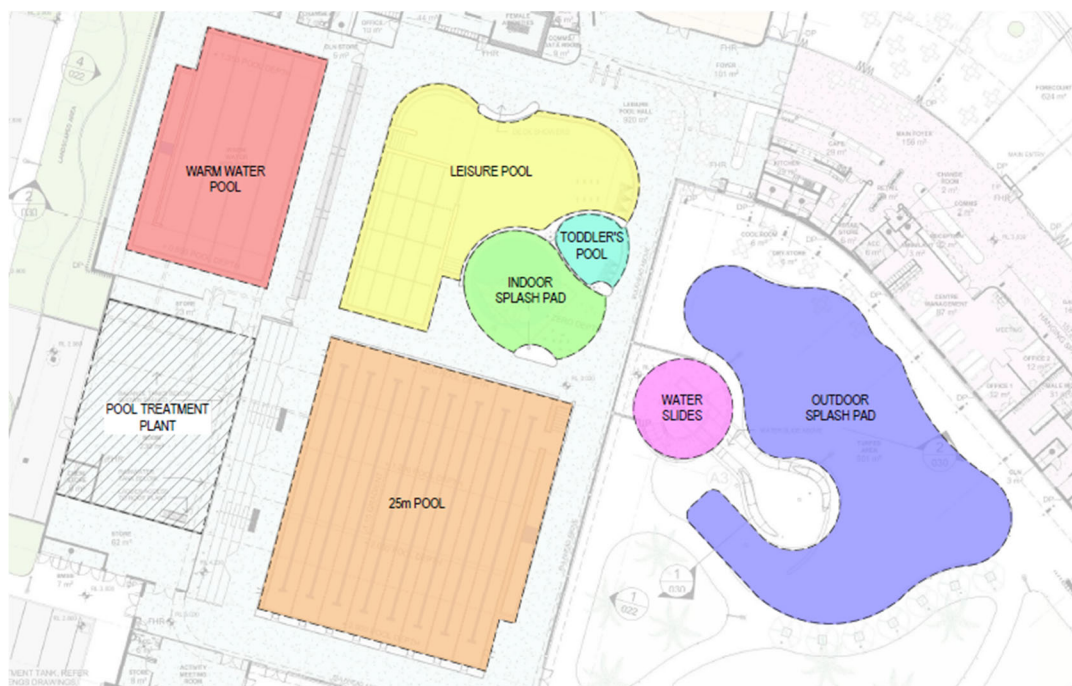
**Figure 14 Pool water systems**

All pool water treatment plant is located within a dedicated plant room, as shown in Figure 14.

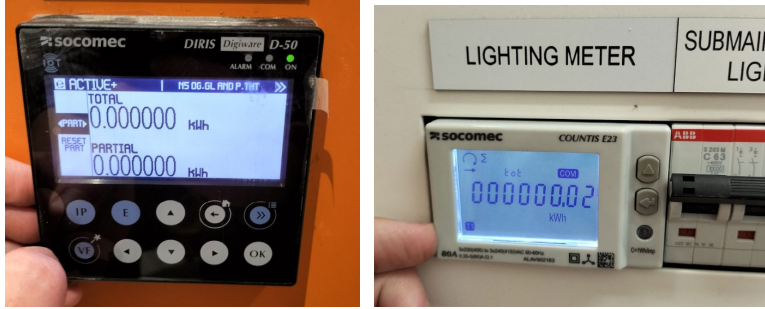
2.2 Error reading on physical meter: “No data available! No response from device.”

- MSSB-0R.01
- DB-0G.GL.POOL
- DB-0G EXT
- GPU

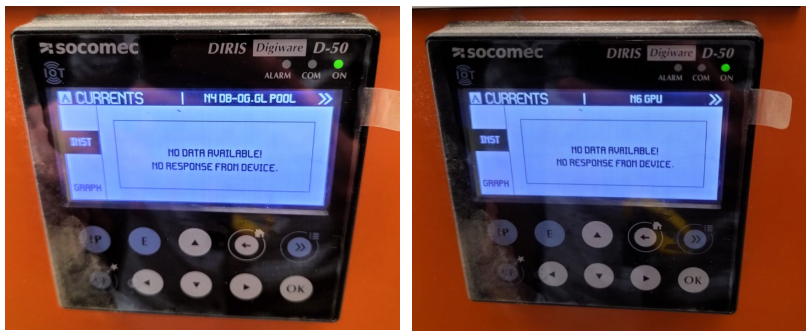
2.3 Zero-value readings on BMS electricity meter summary page:

- Gym Lighting
- Centre Management Lighting
- Bar Lighting
- Theatre Lighting
- DB\_0G\_L&P
- DB\_0G\_GL\_Pool
- MSSB-0R.01

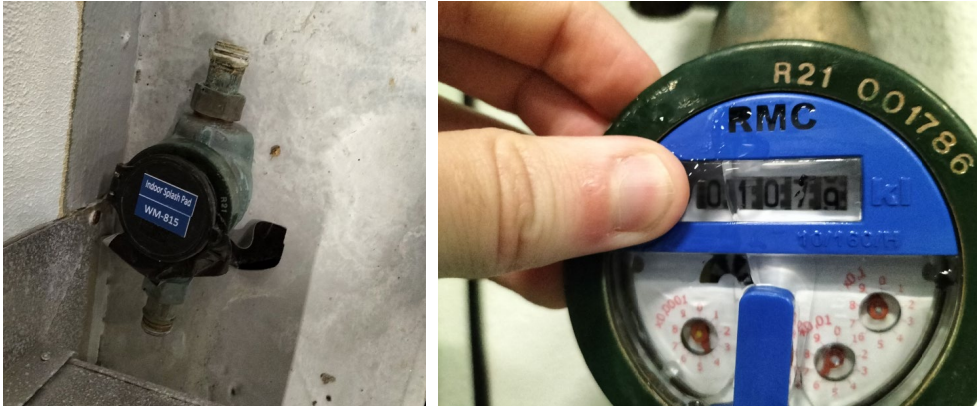
2.6	Water metering data on BMS generally does not match with physical meter readings and billing water meter.
2.7	<p>Water meters physically damaged or not installed.</p> <ul style="list-style-type: none"> <li>- Slides water meter (WM-816) is cracked and leaking.</li> <li>- Indoor splash pad water meter (WM-815) has been removed and currently sitting on floor.</li> </ul>

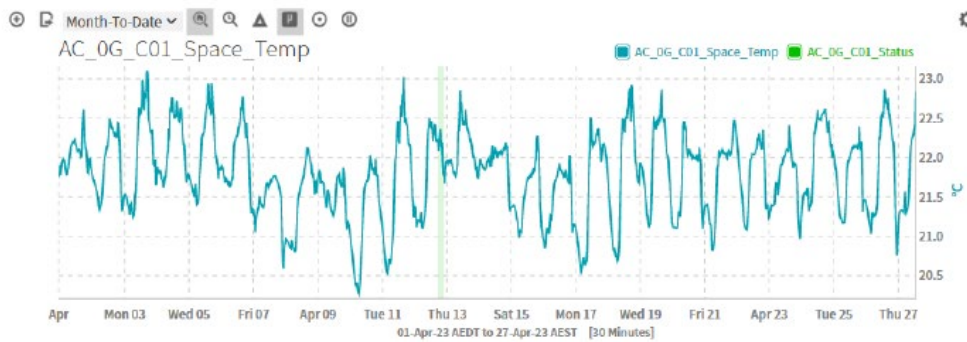
TRENDS LOGS NOT LABELLED / NO LEGEND
