# TUROSS RIVER ESTUARY

## Water Quality Report Card 2017-18

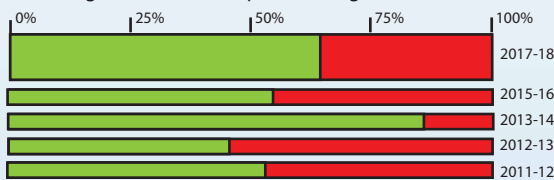
### Chlorophyll a Indicator

Percentage number of samples within guideline values

**Chlorophyll a** is a measure of the microscopic algae biomass in the water and is an important indicator of water quality. Having the right amount of microscopic algae is extremely important, as it is a major food source for many species. Excessive input of nutrients from catchment runoff (urban stormwater, agricultural runoff, and sewage overflows) can increase chlorophyll a levels however, leading to algal blooms and detrimental effects on estuarine plants and animals. To the left **Green** indicates the percentage of samples that lie within the acceptable NSW Monitoring, Evaluation and Reporting guideline values.

(\*Note: Chlorophyll-a guideline trigger values were updated in 2019)

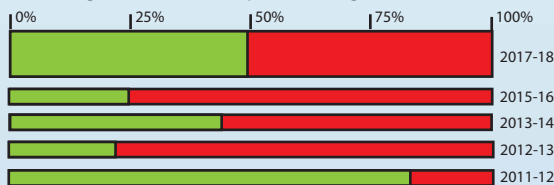
### Turbidity Indicator

Percentage number of samples within guideline values

**Turbidity** is a measure of light scattered by suspended particles such as sediment, algae and dissolved material in the water which affect its colour or murkiness. Turbidity can increase from sediments transported in catchment runoff (particularly after heavy rainfall), shoreline erosion and increased microscopic algae. Having low turbidity levels in the estuary is important for the growth and survival of seagrasses, fish and other organisms. To the left **Green** indicates the percentage of samples that lie within the NSW Monitoring, Evaluation and Reporting guideline values.

(\*Note: Turbidity guideline trigger values were updated in 2019)

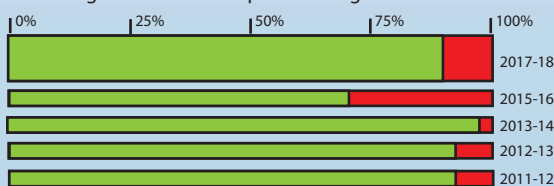
### pH Indicator

Percentage number of samples within guideline values

**pH** also provides an indicator of water quality, and is a measure of the acidity or alkalinity of the water on a scale from 0 (extremely acidic) to 7 (neutral), through to 14 (extremely alkaline). Water with extremely high or low pH is lethal, and a pH below 4 or above 10 will kill most fish and invertebrates. Although pH naturally fluctuates within an estuary, pollutants from urban runoff and agriculture such as fertilisers will have a major impact. The disturbance of acid sulphate soils can also lead to acid runoff into the estuary and harmful low pH conditions. To the left **Green** indicates the percentage of samples that lie within the acceptable ANZECC Water Quality guideline values.

(\*Note: pH guideline trigger values were updated in 2019)
