MORUYA/DEUA ESTUARINE PROCESSES STUDY

November 2003

Document Number	AC.2002.J021.0311.R01
Document Title	Moruya/Deua Estuarine Processes Study
Client	Eurobodalla Shire Council
Job Number	AC.2002.J021
Job Title	Moruya Estuary Process and Management Study
Copy Number	1

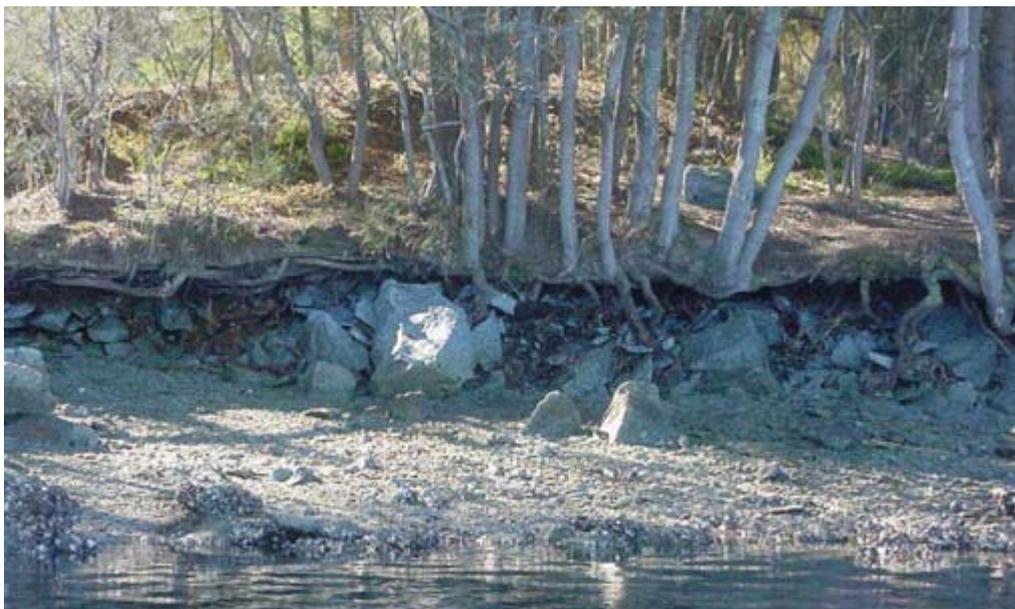
In any meandering river channel, flow velocities are unevenly distributed across the river cross-section so that higher velocities at outer banks of bends lead to higher rates of erosion in these areas. The Moruya Estuary should not be an exception to this general rule, although the results of hydrodynamics modelling for the once in one and once in 20 year floods do not show large differences in velocities between inside and outside bank locations at bends. This agrees with the field observations that bank erosion was occurring on both the inside and outside of bends.

Figure 5.6: Natural bank erosion near The Anchorage.

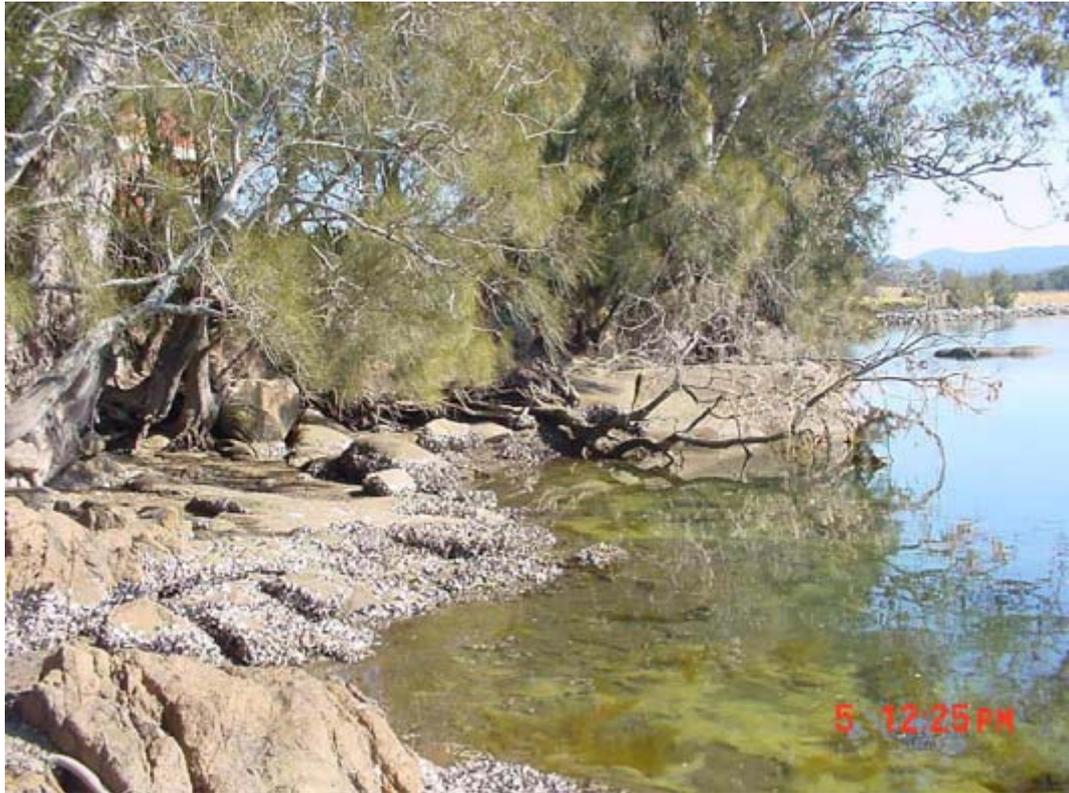
Figure 5.10: Natural granite outcrops.

Natural granite outcrops limit the extent of bank retreat, although the sandy soils above them are vulnerable to erosion if they are exposed in the river banks.
