Draft Final Report

Eurobodalla Shire Coastal Hazards Scoping Study

October 2010

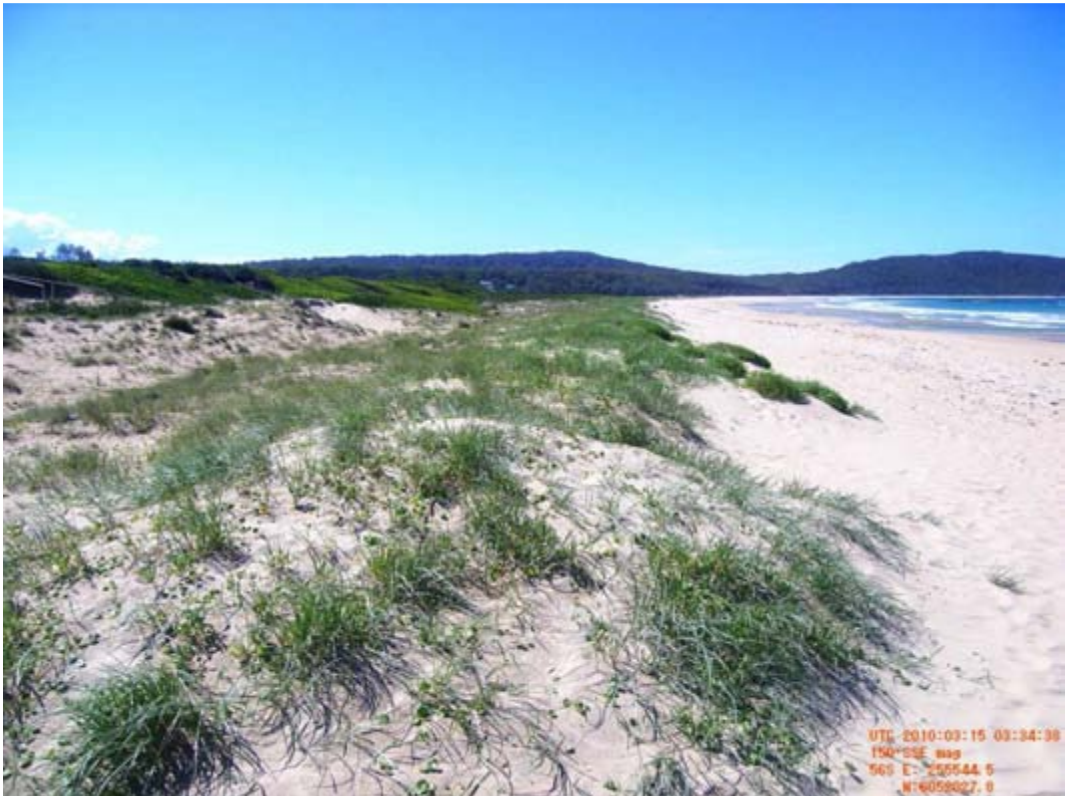
The dune of South Durras Beach near the lake entrance is healthy with a full dune and foredune and a good succession of vegetation (Figure 3.1). The access road is located behind the dune and is not at immediate risk. The beach is fully exposed to an open ocean wave climate. Offshore reef and Wasp Island provide some sheltering. There is no development present on the dune. Some evidence of an old scarp is noticeable within the dune area. The beach is composed of fine grained sand and has a relatively flat gradient. The beach accessways are uncontrolled and fencing should be considered to prevent damage to the dune from foot traffic. The southern end of the beach is very narrow and a creek outlet creates a gully. However nothing is at risk except a boat ramp covered with sand (Figure 3.2). There is some evidence of tyre tracks and the sandy part of the beach is used as a turning area. The flooding of the creek due to elevated tailwater level may impact a couple of low-lying houses.

*Figure 3.1 – Healthy dune at South Durras near Durras Lake entrance
(March 15th 2010)*

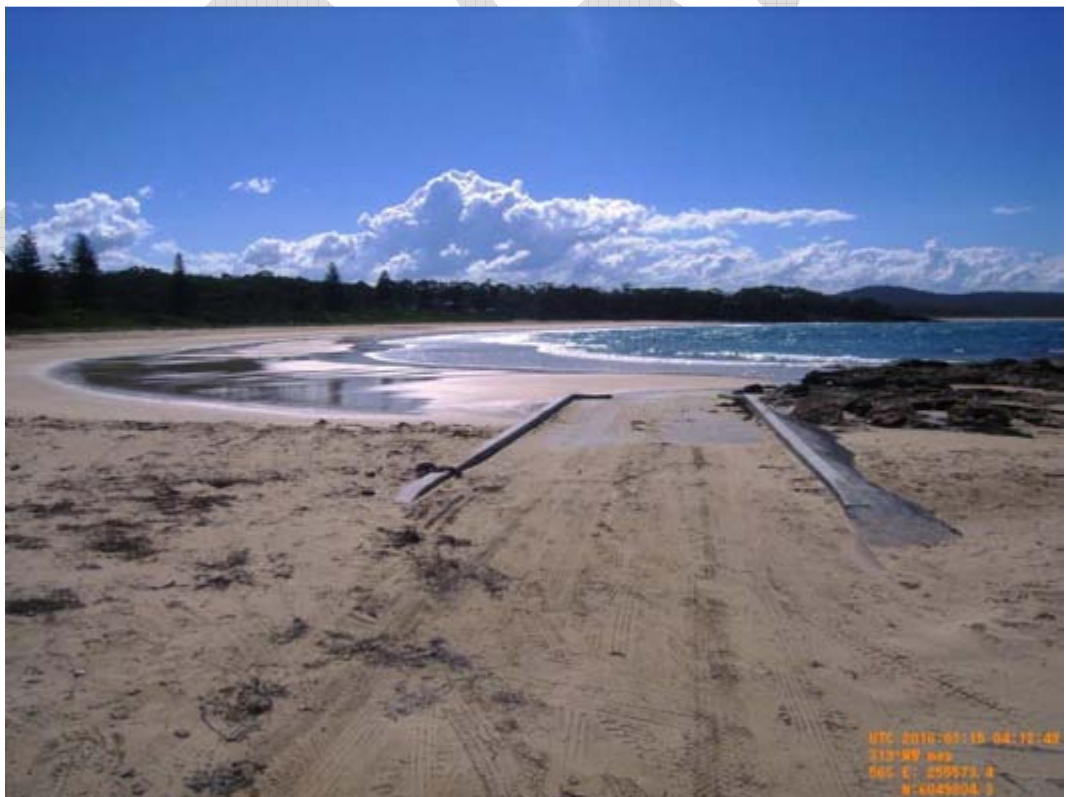
*Figure 3.2 – Boat ramp at the southern end of South Durras northern beach
(March 15th 2010)*

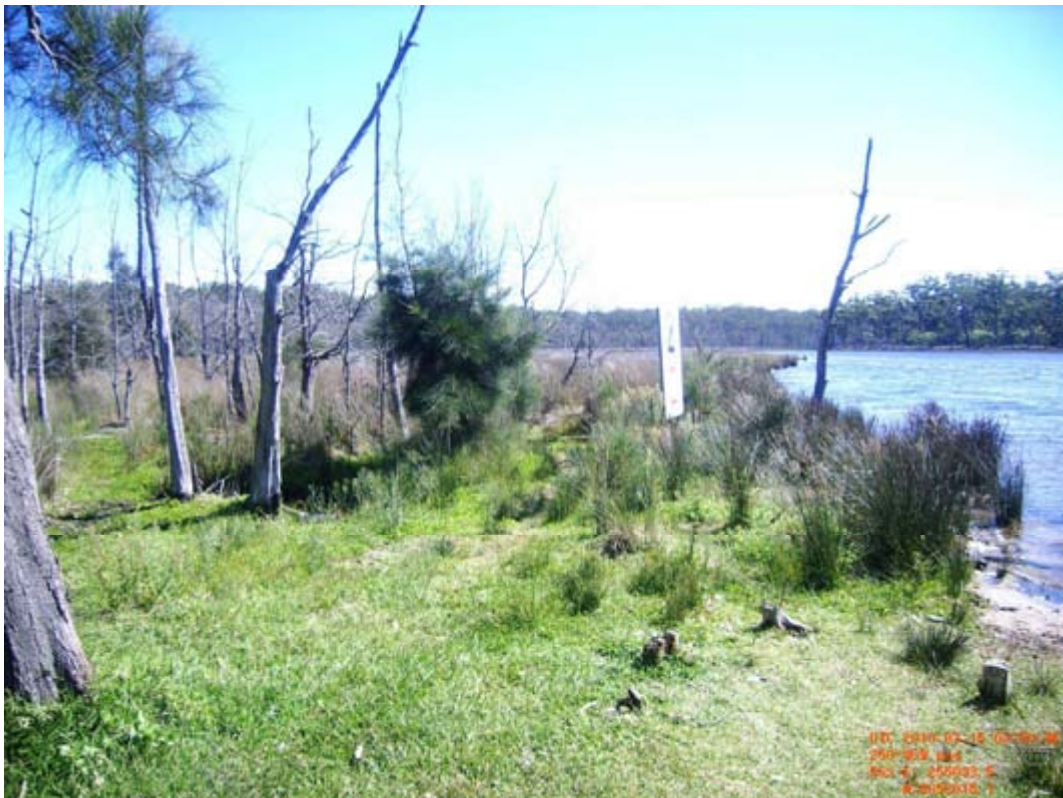
The caravan park is located behind the dune and is at least three metres above the lake level. The flooding risk is therefore very low. Saltmarshes were observed between the low-lying houses located along Lakeside Drive and the lake entrance channel (Figure 3.3). This shows that this area is flooded regularly and the low-lying dwellings might become at risk from inundation in the future due to sea level rise.

*Figure 3.3 – Saltmarshes between Lakeside Drive and Durras Lake
(March 15th 2010)*

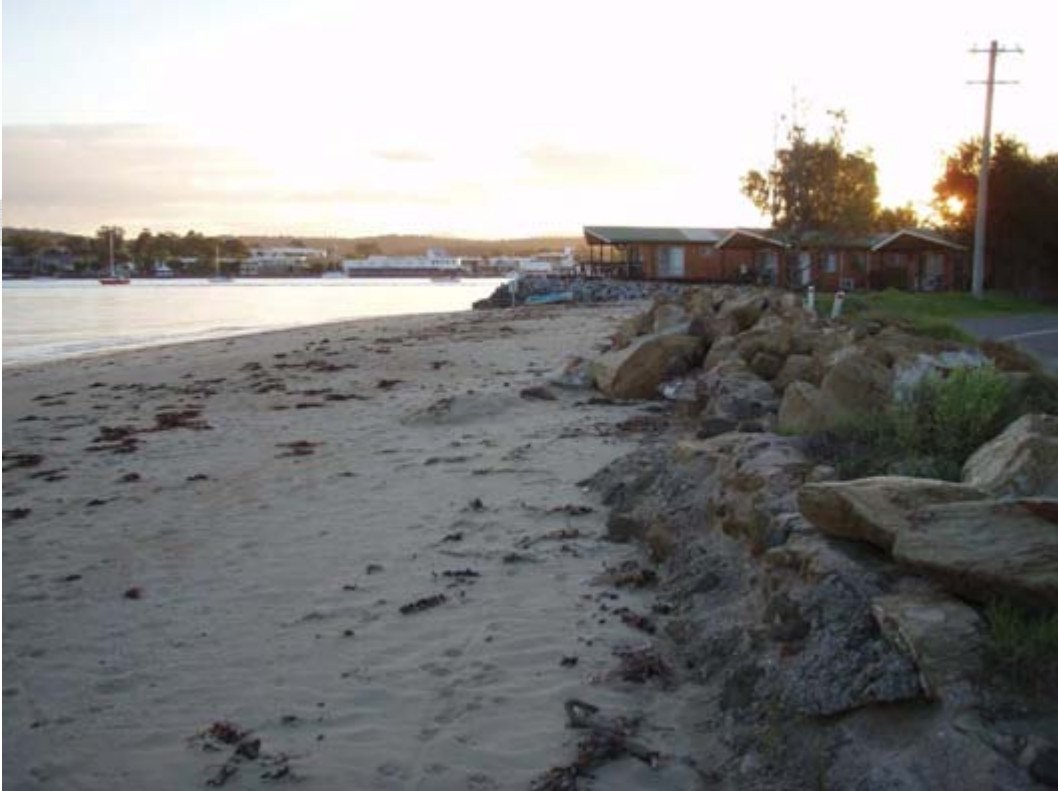
The beach is actively eroding with a visible scarp and exposed vegetation (Figure 3.19). There is a seawall protecting the road and Easts Riverside Holiday Park (Figure 3.20) and a small groyne has been illegally built at the eastern end. Some properties are very low lying. Wave exposure through Batemans Bay is high and there is a direct impact of offshore swell, particularly at high tide.

*Figure 3.20 – Seawall along the road and the holiday park
(March 15th 2010)*

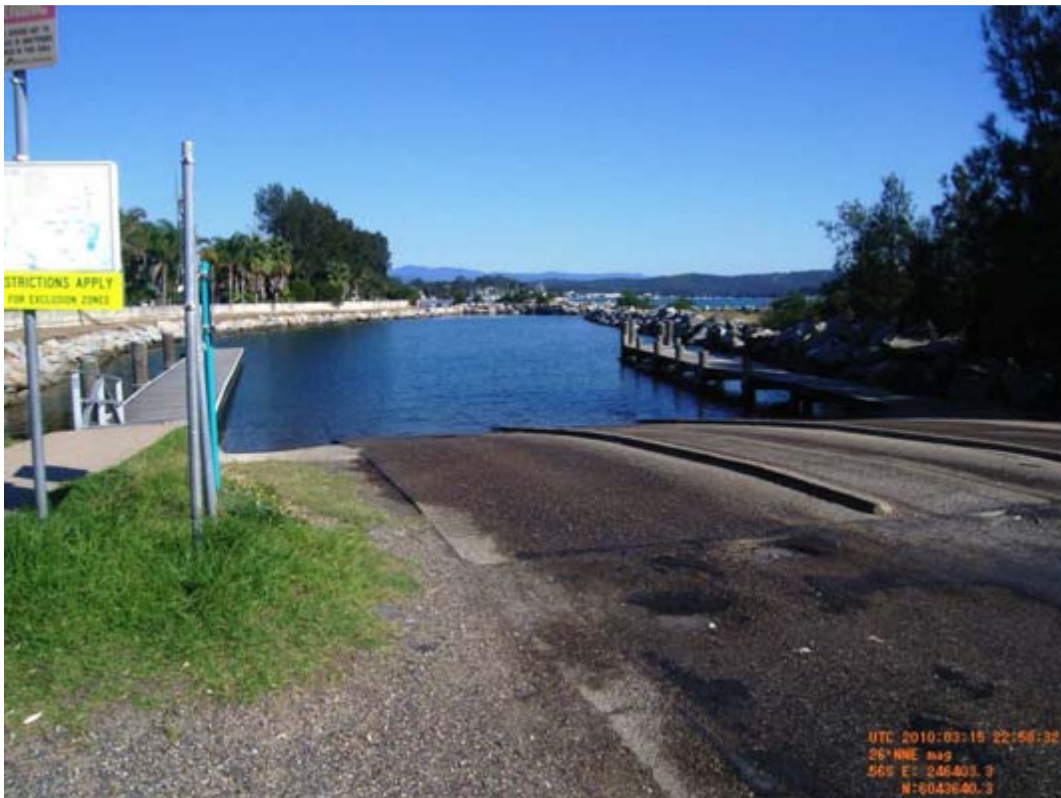
The seawall all along the harbour (from Batemans Bay CBD to Hanging Rock) is in fairly good condition (Figure 3.21). CBD shops located along the water have elevated floor levels. Houses inside the marina near Hanging Rock are very low and protected by different types of seawalls in varying condition. Some housing has no protection (Figure 3.22). A lot of sand is present within the marina. Hanging Rock boat ramp is in good condition (Figure 3.23). The area is protected from waves with waves breaking on offshore shoals (Figure 3.24).

*Figure 3.23 – Hanging Rock boat ramp
(March 16th 2010)*

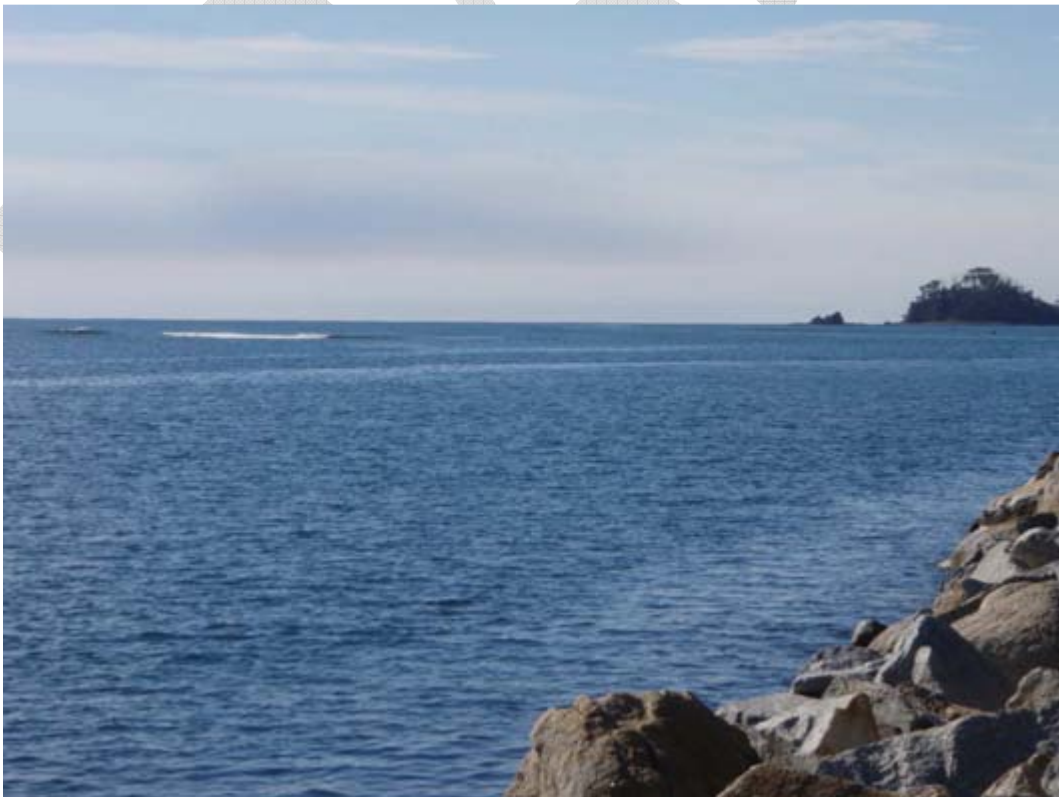
*Figure 3.24 – Waves breaking on offshore shoals at Batemans Bay
(March 16th 2010)*
