Appendix B: Location Summaries

B.1 Durras and Cookies Beaches

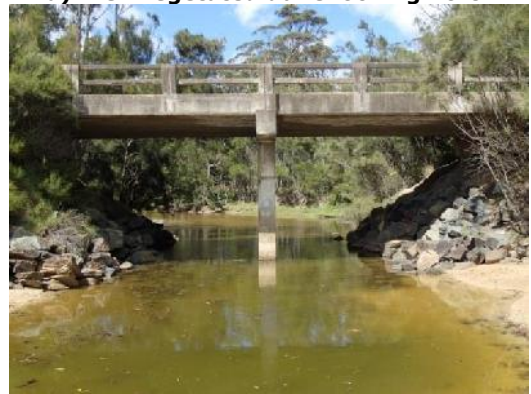
The foredune continues to the southern rocks where a small creek (Durras Lake) crosses the beach. The entrance to the creek is controlled by the Durras Road bridge and existing scour protection for the concrete abutments. Scour protection on the northern side of the entrance is composed of granite rock primary armour with an approximate size of 0.5 m. No secondary armour or geotextile underlayer was observed on the structure. There is a natural wall of rock along the southern side of the creek.

f) Durras Road bridge at southern end

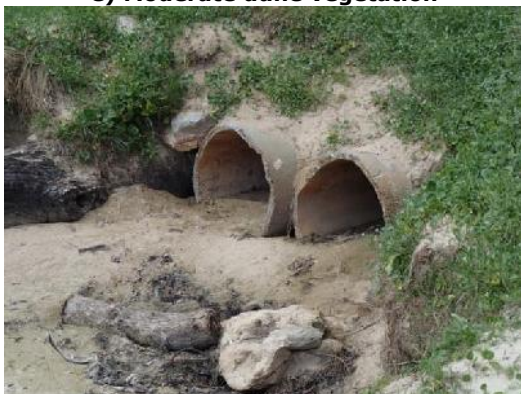
g) Stormwater outlets at the southern end

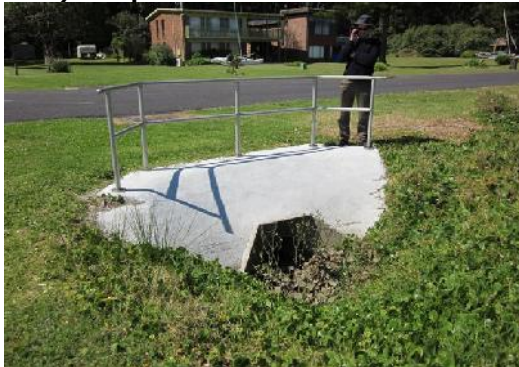
c) Stormwater Outlet 1

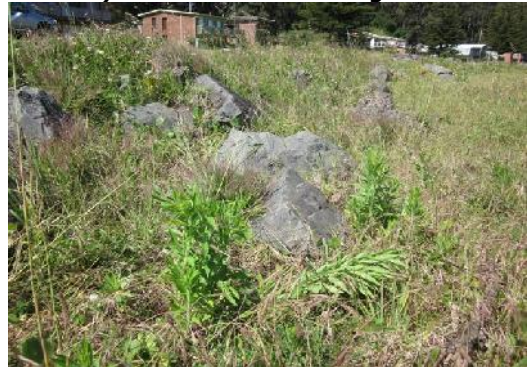
d) Partially buried rock revetment wall

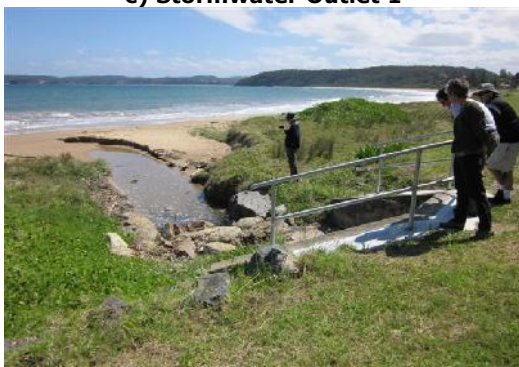
e) Stormwater Outlet 2

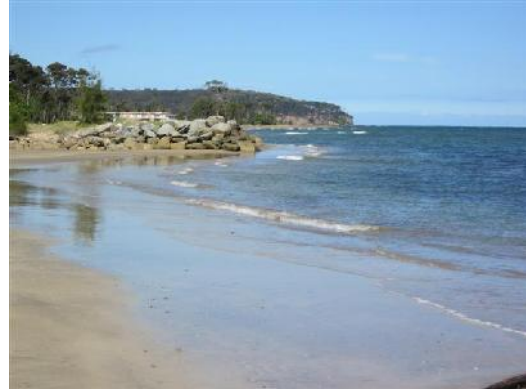
b) Unapproved groyne

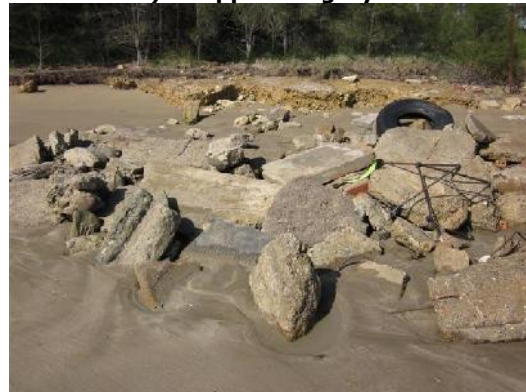
d) Building waste used as groyne armour

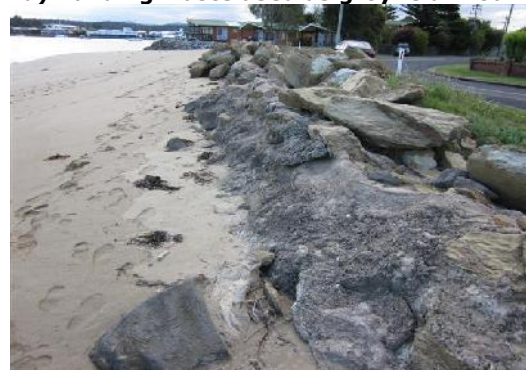
f) Wall armour is grouted together

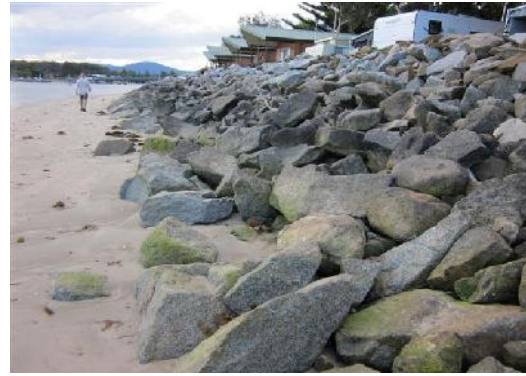
c) Rock wall armour properties are mixed

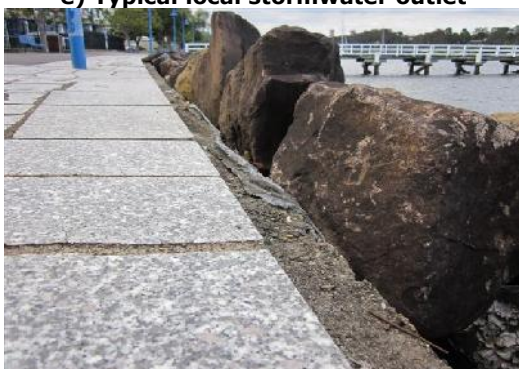
Overall, the condition of the rock revetment wall around the CBD is considered to be reasonable. However, WRL recommends that ongoing monitoring of the condition of the wall be undertaken by ESC according to coastal engineering guidelines (USACE, 2006). At the western end of the CBD (up to the second wharf), the revetment is mainly composed of granite with an approximate size of 0.4 m. In this region, the armour appears to have recently been topped up. The structure slope in this region is relatively steep at approximately 1V:1.2H. There is a change in armour between the second wharf and the third wharf (Innes Boatshed), with at least two different types of rock (granite and another unknown material) used on the revetment. The granite has an approximate size of 0.3 m and the unknown rock type has a size of 0.9 m. The structure slope in this region is relatively flat at approximately 1V:2.0H. It should be noted that directly under the Innes Boatshed there is no rock revetment. Instead, the rock wall temporarily discontinues and is replaced by a vertical concrete besser block wall. Some pavers in the footpath were noted to be settling in this area, probably due to undermining or loss of fill through the wall. East of the third wharf (Innes Boatshed) the armour was mainly composed of granite with an approximate size of 0.4 m and a structure slope of 1V:2.0H. A geotextile filter was generally evident under the armour along the full length of the revetment.

g) Geotextile underlayer visible

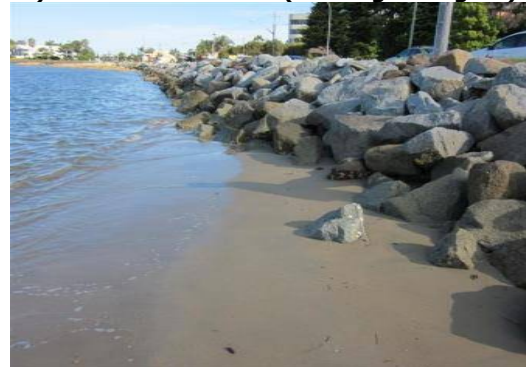
d) Revetment rock armour type 2 of 2

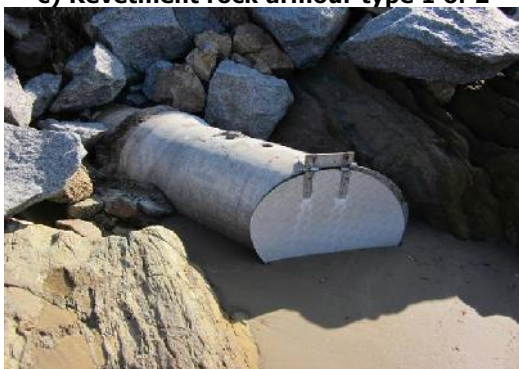
b) Stormwater outlet (blocked floodgate)

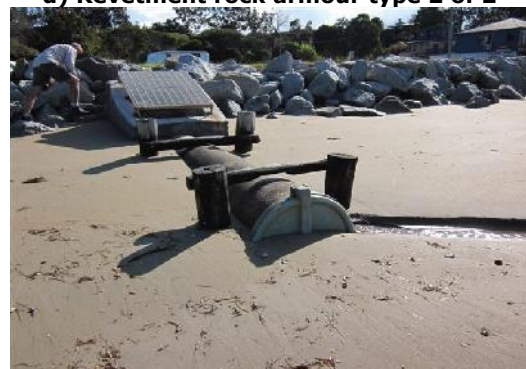
f) Stormwater outlet (blocked floodgate)

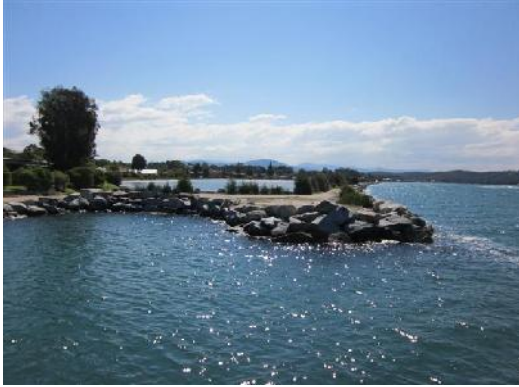
a) View of boat harbour looking west

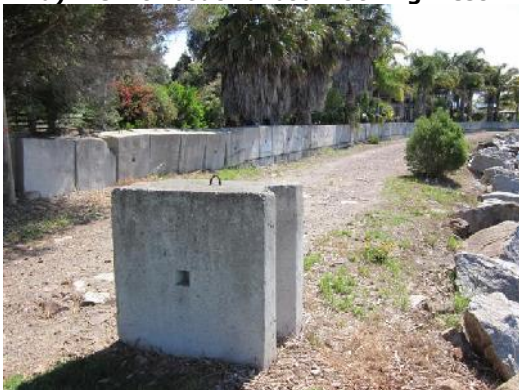
c) Concrete cube wall seaward of development

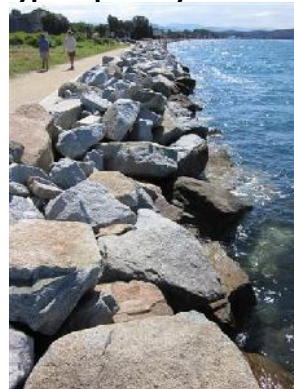
f) View of rock training wall looking west

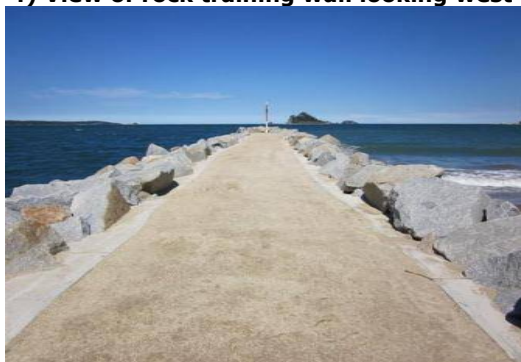
h) Eastern end of rock training wall

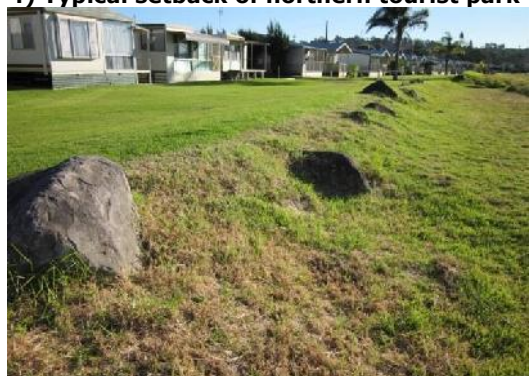
In addition to sand accumulation due to the presence of the training wall, sand dredged from the Clyde River (ebb tide) bar has repeatedly been placed at the northern and centre thirds of Corrigans Beach over many years. Buildings in the northernmost caravan park are set back further from the shoreline than those in the southern caravan park. The foreshore of the southern caravan park is protected by a rock revetment wall. The condition of this wall is unknown and was predominantly buried at the time of the inspection (1 November 2011). Since construction details are unavailable, the alongshore extent of the seawall in Figure B-29 is approximate only.

h) Predominantly buried rock revetment wall

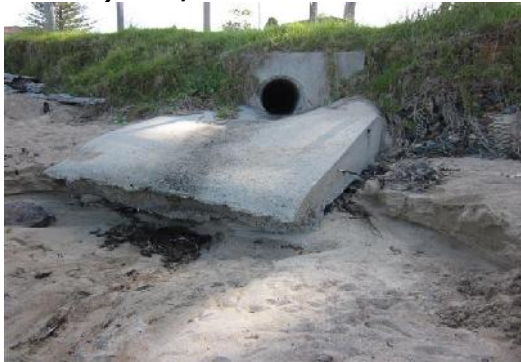
c) Stormwater outlet

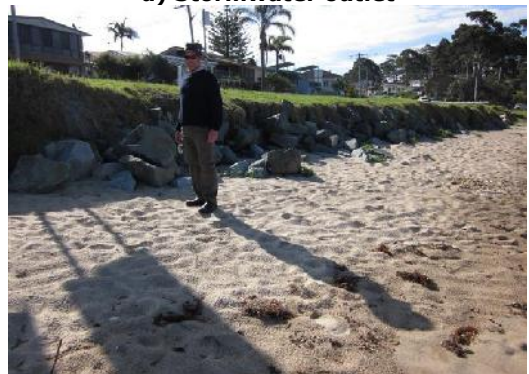
Overall, the condition of the seawall along the northern part of Caseys Beach is considered to be poor and requires immediate action and ongoing monitoring by ESC. The reader is referred to WRL's detailed condition assessment and design advice report for this seawall (Blacka and Coghlan, 2016).

f) Northern end of rock revetment wall

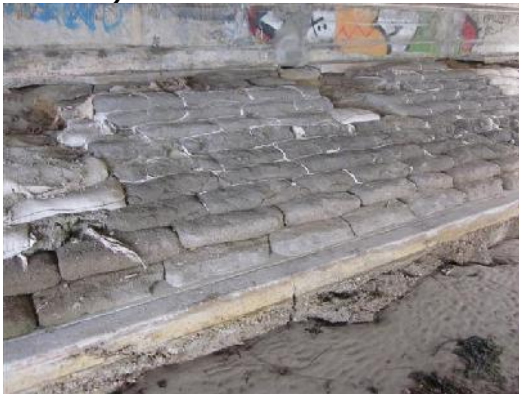
c) Scour protection at bridge abutments

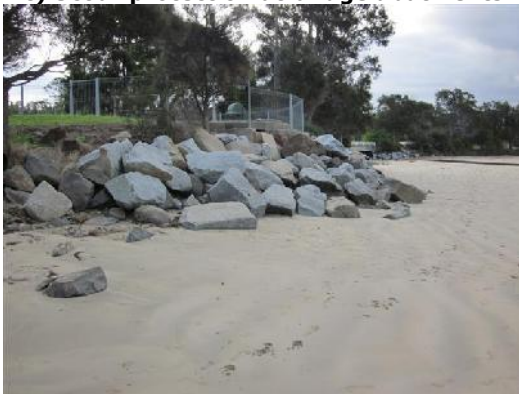
Since WRL's original site inspection on 31 October 2011, WRL also prepared a detailed condition assessment and design advice report for the seawall along the southern part of Caseys Beach which protects the sewage pumping station (Coghlan and Drummond, 2013). In April 2017, upgrade works on this seawall section were completed.

e) Sewage pumping station

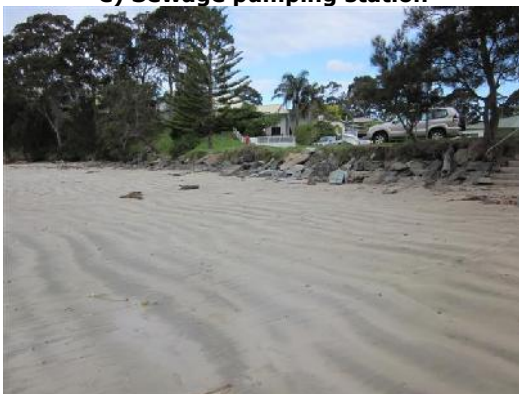
g) Southern end of rock revetment wall

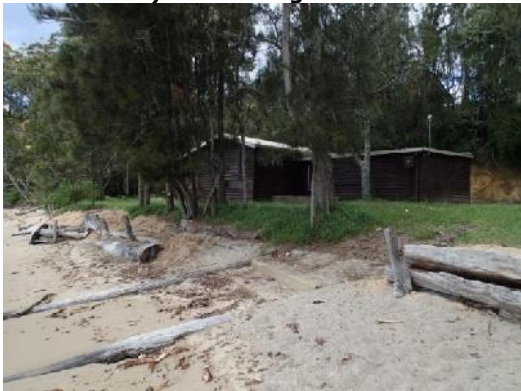
e) Wooden retaining wall at southern end

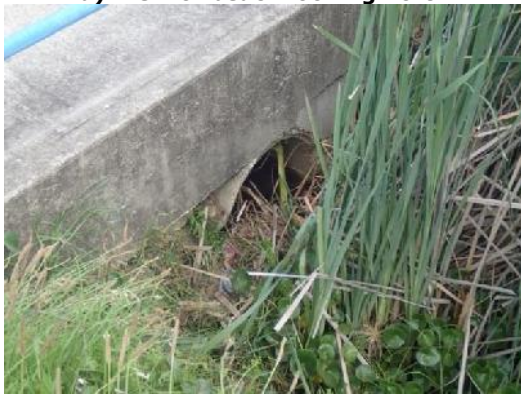
c) Blocked stormwater pit at southern end

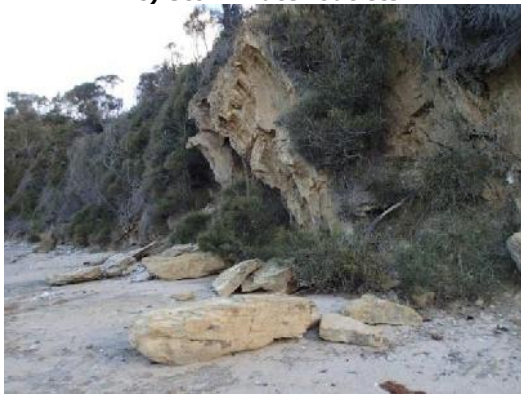
A large, healthy dune is located landward of the beach. Guerilla Bay can be accessed via a small car park off Ocean Street. Houses at the northern and southern ends of the beach are located on rock cliffs. At the time of the site inspection, recent undercutting of the cliff was observed at the southern end. There are several properties with varying degrees of development located at low elevations in close proximity to the beach. A summary of sand sample analysis is shown in Figure B-42.

e) Backing rocky bluffs with rockfall

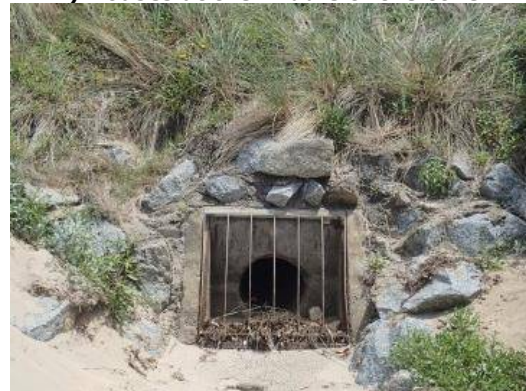
h) Stormwater outlet

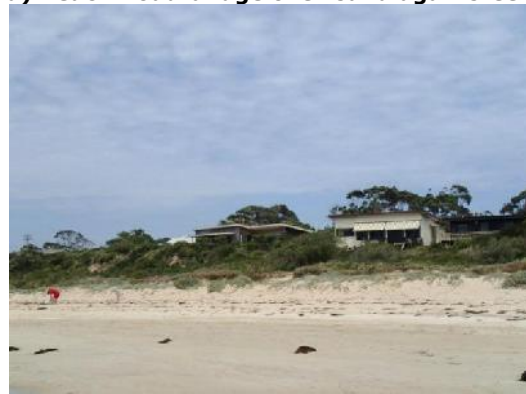
A healthy, vegetated dune exists along the entire beach with several formal beach access points along Coronation Drive. This foredune provides a buffer between the beach and the road. Houses landward of Coronation Drive appear to be located well landward of the active beach. However, five houses at the northern end of the beach and on the southern side of Candlagan Creek are located in close proximity to the beach. These houses sit on the crest of the sand dune with limited sand stores and vegetation on the seaward side.

f) Houses at the northern end

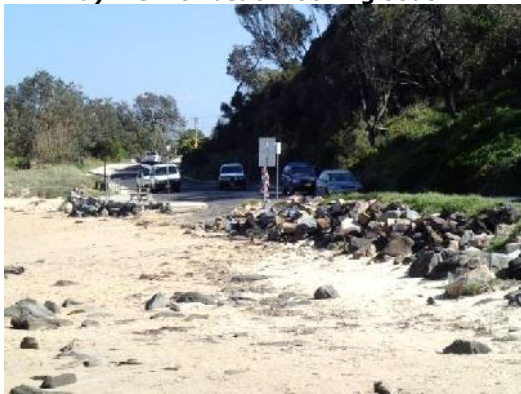
There are two coastal structures at either end of Bengello Beach. At the northern end of the beach, a small revetment protects the car park situated just off Heath Street. The revetment structure is composed of granite rock primary armour with an approximate size of 0.5 m, with no underlayer or secondary rock visible. The structure slope of the revetment wall is approximately 1.0V:1.5H. At the southern end of the beach, the northern training wall of the Moruya River interrupts littoral sand transport. The northern training wall has a pedestrian footpath along its entire length and has primary armour on both sides consisting of granite rock with an approximate size of 1.0 m, a geotextile underlayer and secondary rock armour. A summary of sand sample analysis is shown in Figure B-55.

c) Boat ramp and rock revetment
