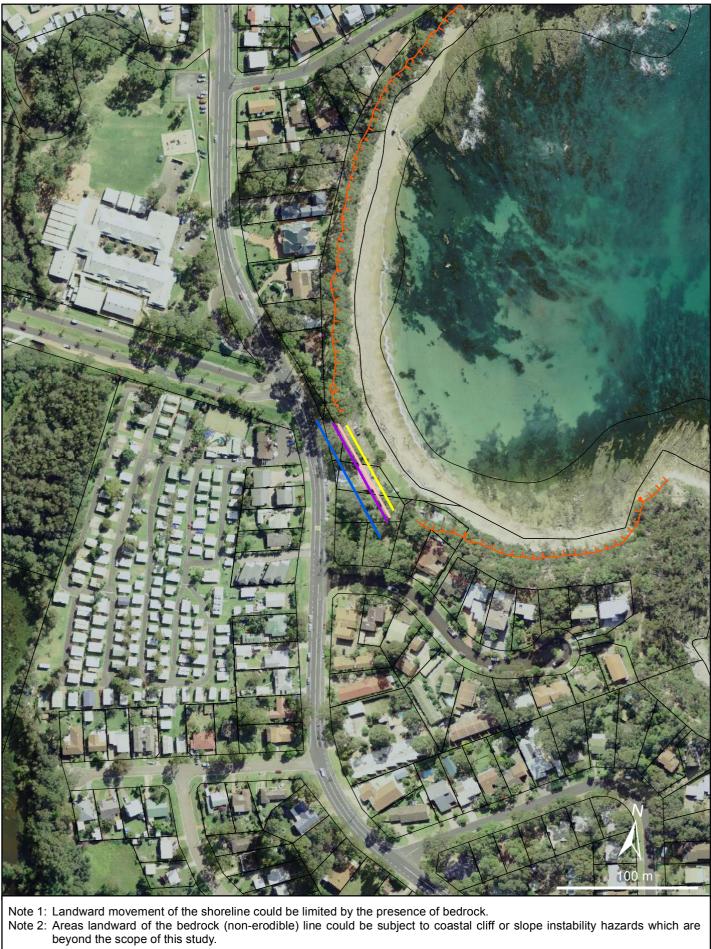
2017		
Sunshine Bay 2050	Bedrock (no	on-erodible)
Deterministic erosion/recession hazard lines — 2065		
2100		Figure I.12

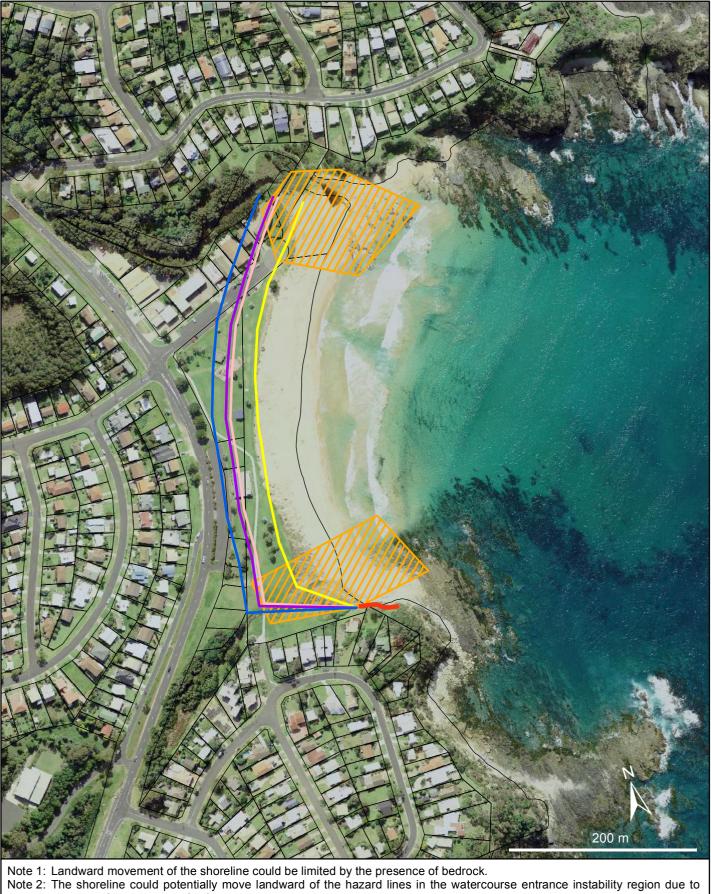
lowering of the beach profile from entrance scouring. Note 3: The shape of hazard lines not located at the seawall is hypothetical only and requires further detailed assessment beyond the scope of this study.

Malua Bay existing seawall	2017	Watercours	se instability region
5% encounter probability	2050	Seawall	
. ,	2065	ocawaii	
Probabilistic erosion/recession hazard lines	2100		Figure I.13

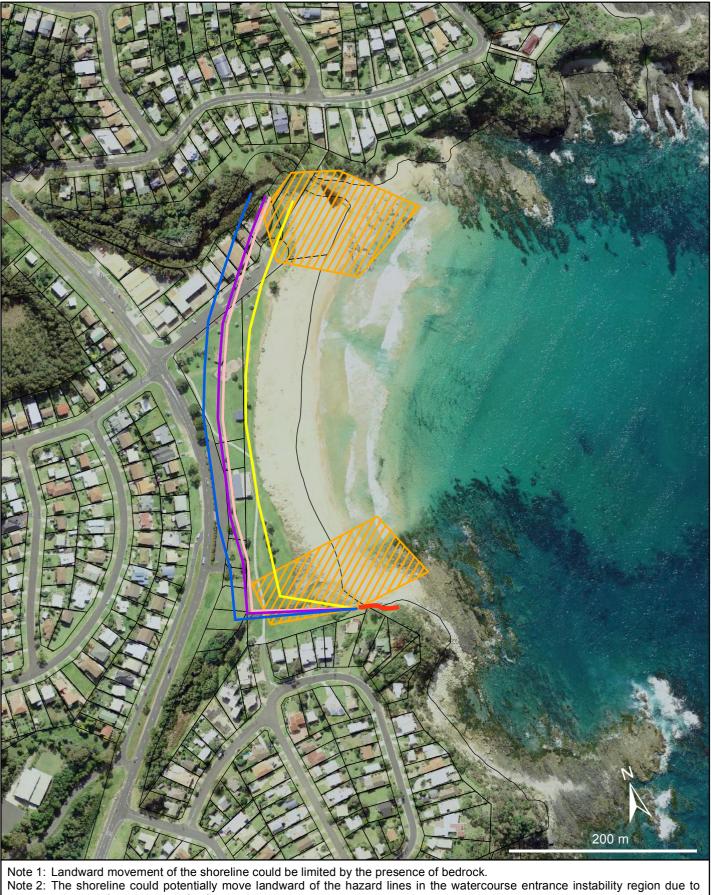
lowering of the beach profile from entrance scouring. Note 3: The shape of hazard lines not located at the seawall is hypothetical only and requires further detailed assessment beyond the scope of this study.

Malua Bay existing seawall	2017	Watercours	se instability region
1% encounter probability	2050	Seawall	
	2065	Countain	
Probabilistic erosion/recession hazard lines	2100		Figure I.14

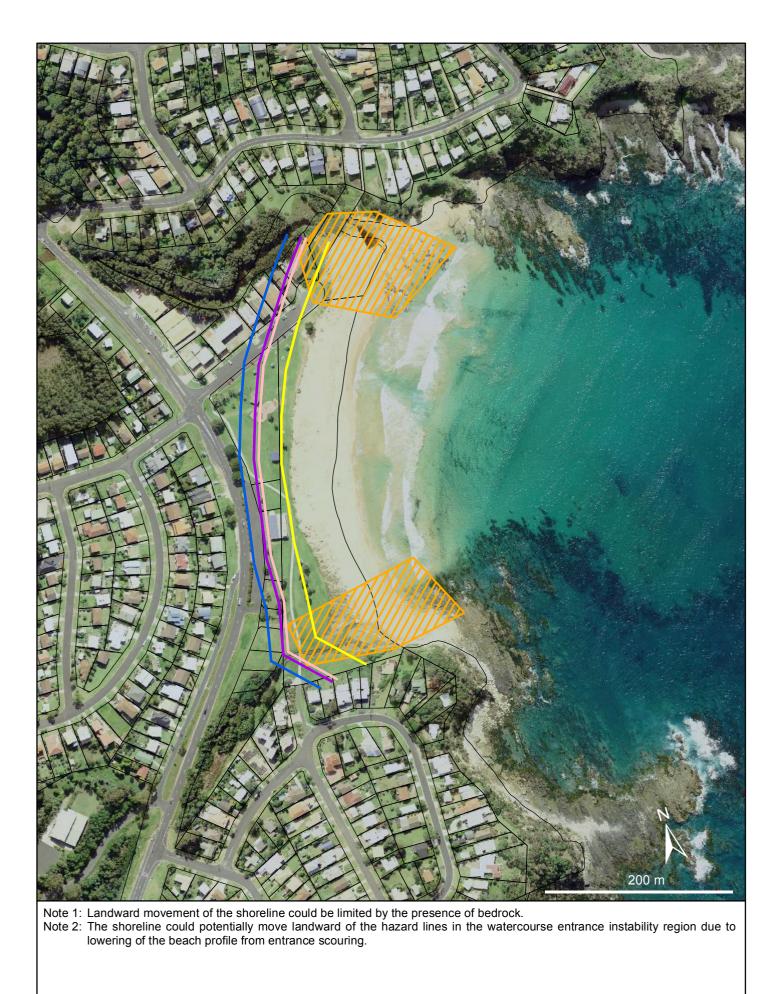
Malua Bay no seawall	2017	Watercours	e instability region
1% encounter probability	2050		
	2065		
Probabilistic erosion/recession hazard lines	2100		Figure I.16

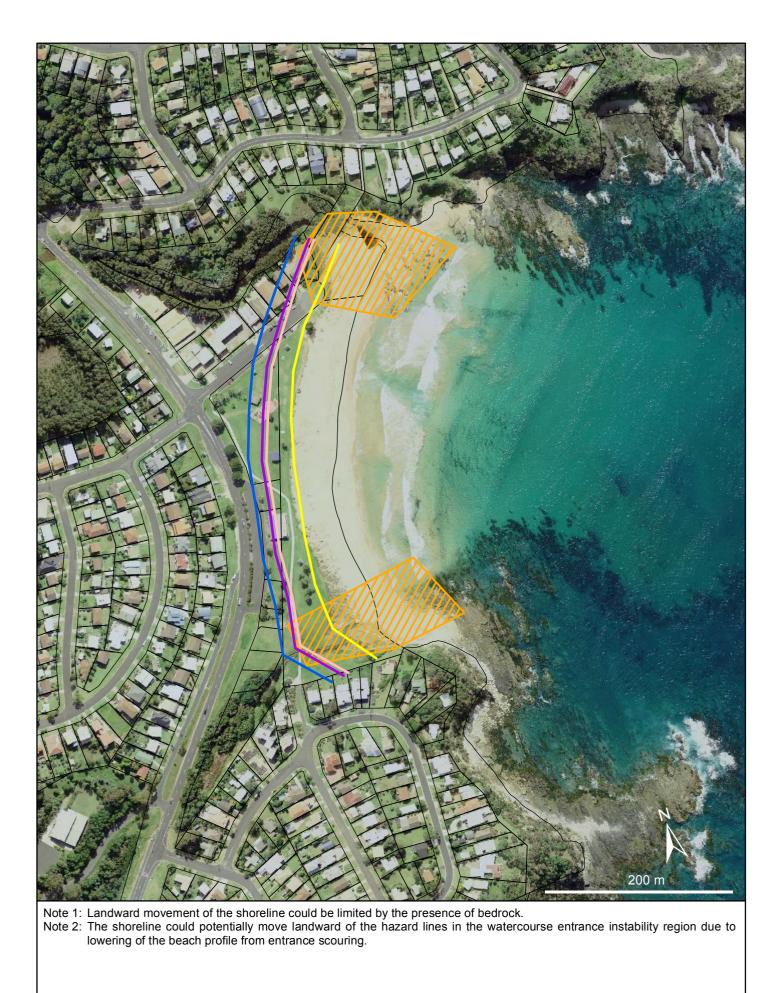
Malua Bay no seawall	2017	Watercours	se instability region
5% encounter probability	2050		
	2065		
	2100		Figure I.15
