#### Inner Batemans Bay Conceptual Sediment Transport Model

Eurobodalla Open Coast Coastal Management Program - Stage 2: Vulnerability Assessments

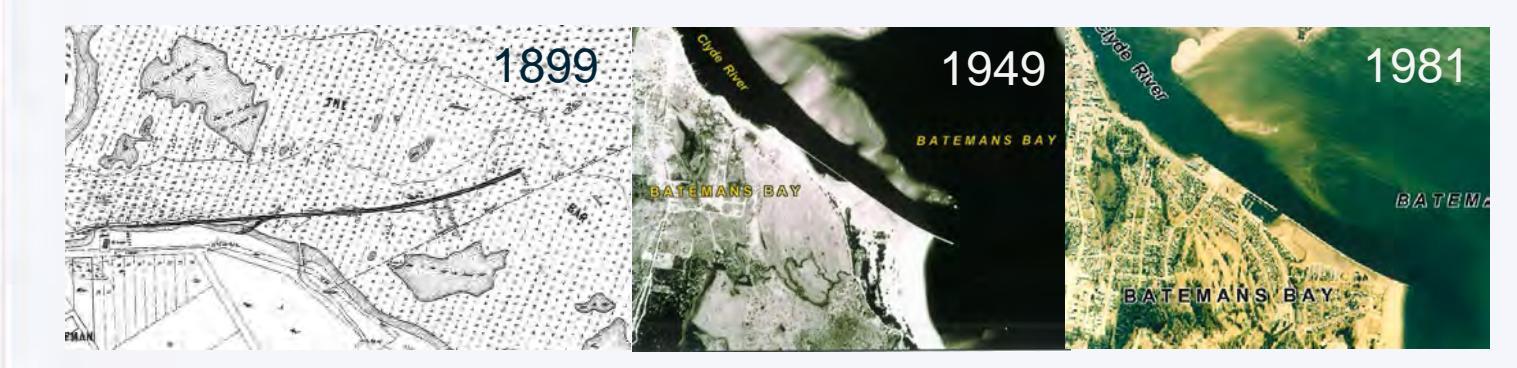
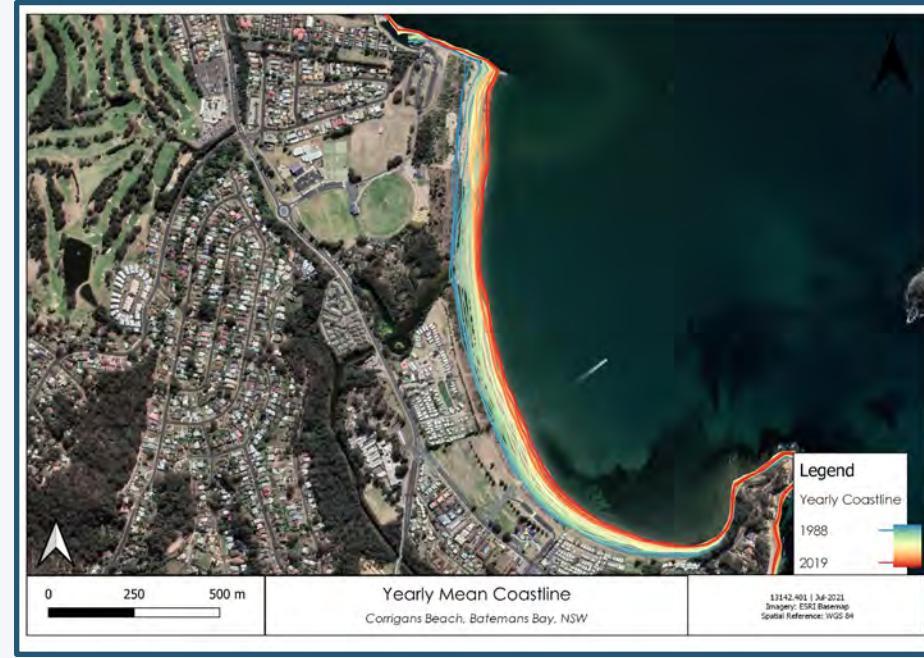
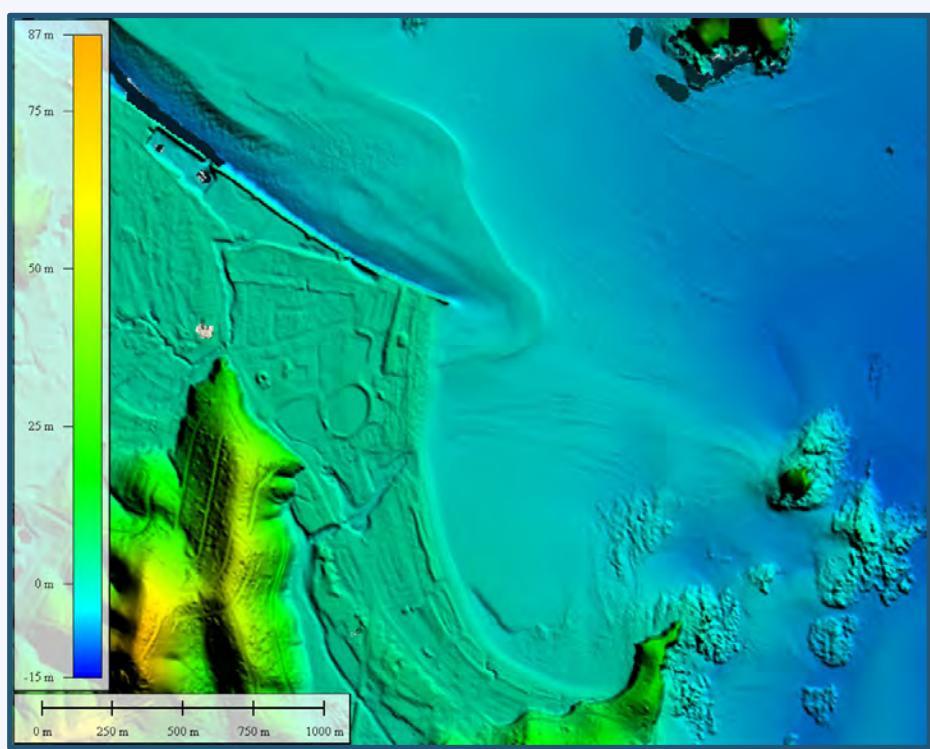
# **Corrigans Beach**

- 1899 to 1905 Training wall constructed
- 1991 Extension of training wall
- Significant accretion has occurred (~8,000m<sup>3</sup> / year since 1942)
- Sediment Transport
  - Accretion due to construction of training wall and subsequent extension
  - Longshore sediment movement of fluvially supplied sediments to the north, minor bypassing of training wall back into the shoal

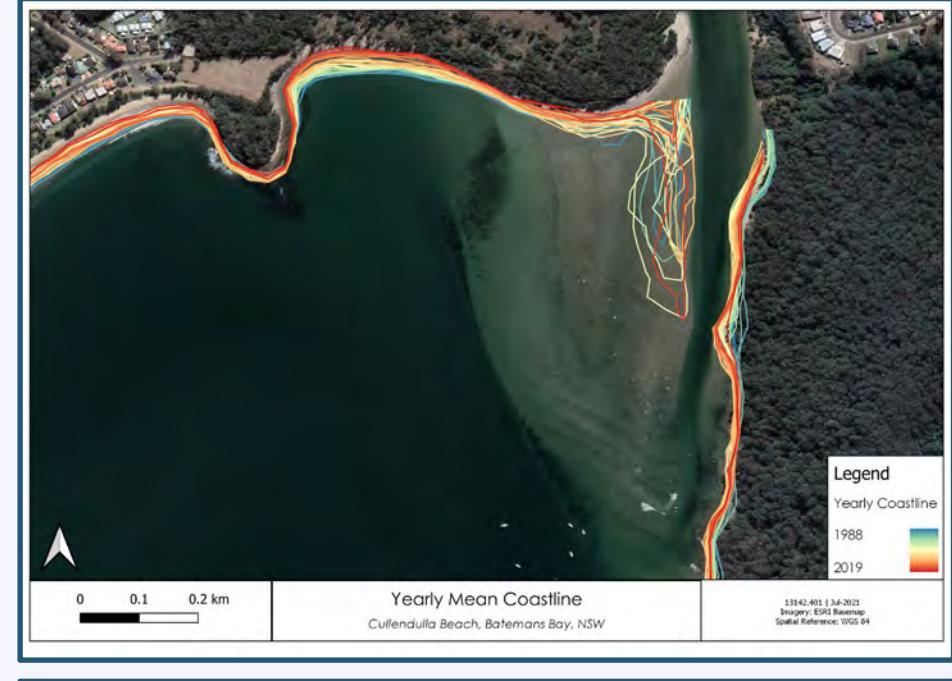
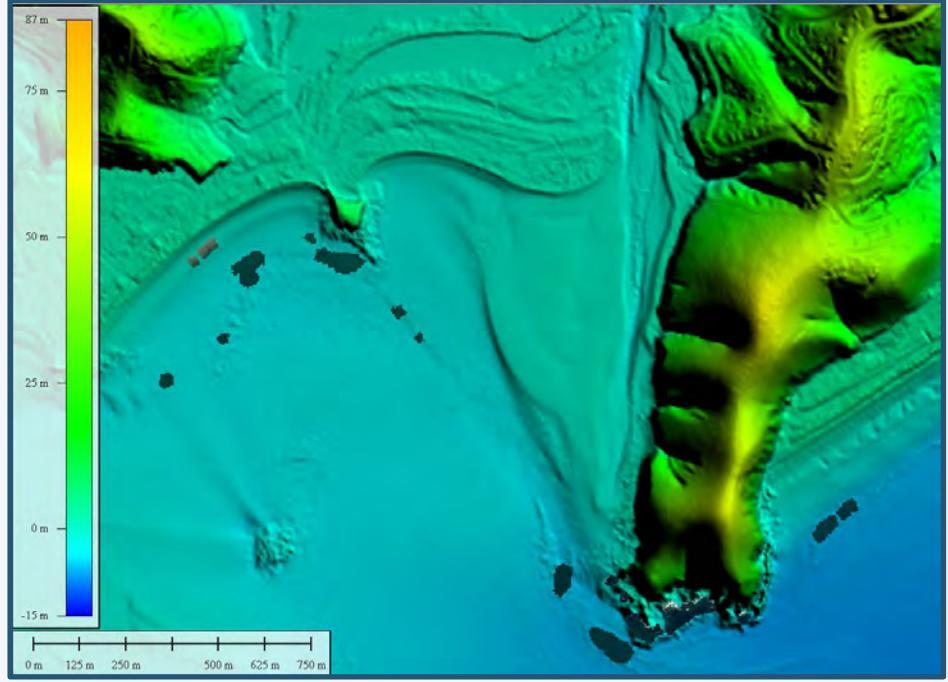
# **Cullendulla Beach**

- Embayed by Square Head and Hawk's Nest Head.
- Chenier Plains to the rear (variably spaced a function of the variable rate of falling sea level over ~6000 yrs).
- Significant flood delta (Square Head Shoal) from Cullendulla Creek fed by flood flows/runoff. Protected from incident waves.
- Limited human interference.
- Sediment Transport
  - Eastern longshore transport.
  - Ongoing recession at the western end (90 m between 1942 to 2018) following end to seaward progression of the beach ridge system after stable/rising sea levels over the last ~1000 years.
  - No direct mechanism of fluvial sediment from Cullendulla Creek to reach the adjacent shoreline to the west.

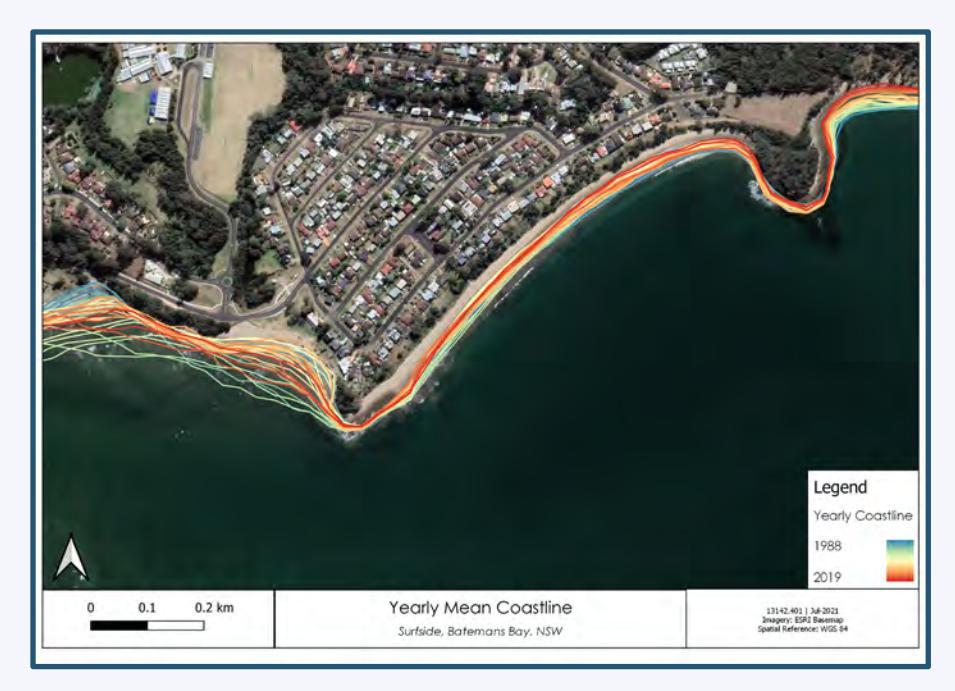
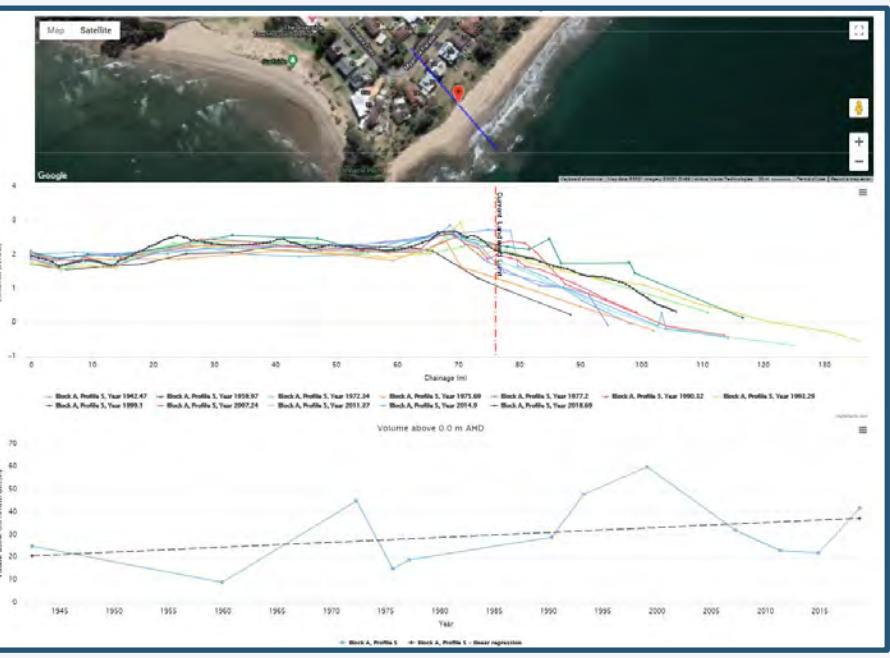
# **Surfside East**

- History
  - Surfside development, circa 1940s
  - Sand nourishment at Northern End (1996) ~12,000m<sup>3</sup>
- Low to negligible net longshore transport (shoreline in alignment with incident waves)
- Limited transfer of sand to/from Cullendulla Beach
- Onshore transport likely from nearshore bars (when configuration allows)
- Otherwise marginal SW transport (Nth to Sth)
- Generally dynamically stable
  - Marginal recession trend at northern end
  - Marginal accretion trend at southern end

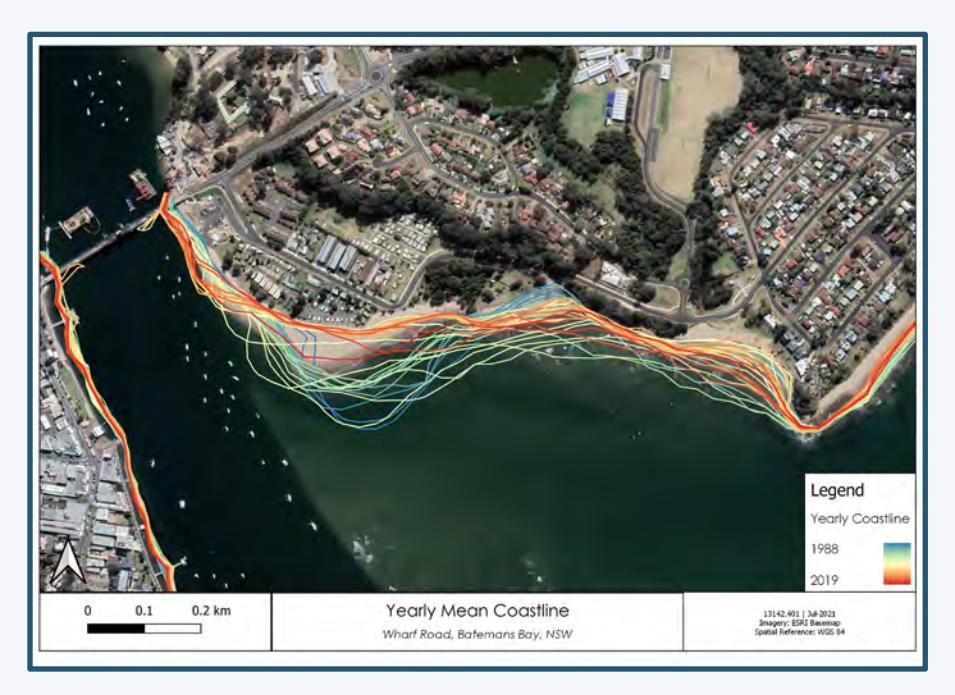
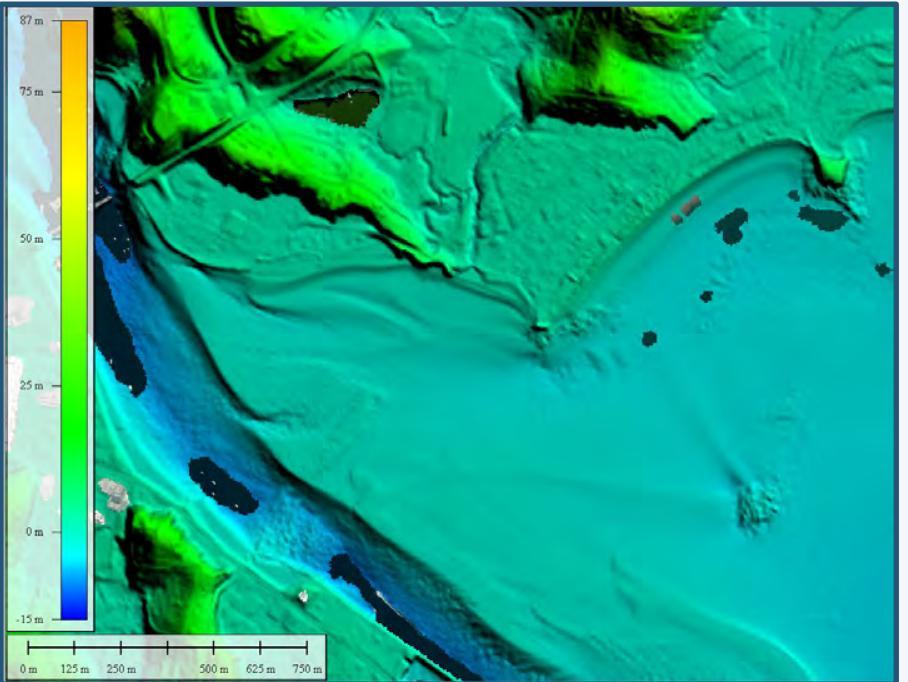
### Surfside West / Wharf Road

- Surfside West History
  - Natural creek line channelized with culvert at western end (circa 1950s)
  - Dynamic fluctuating shoreline
- Wharf Road History
  - Located along a 400 m stretch of active coastline with considerable instability.
  - Residential allotments created in the 1800s during an accreted phase has meant that many allotments are now below the high water mark.
  - A seawall was constructed in the 1960s/1970s at the North West end.

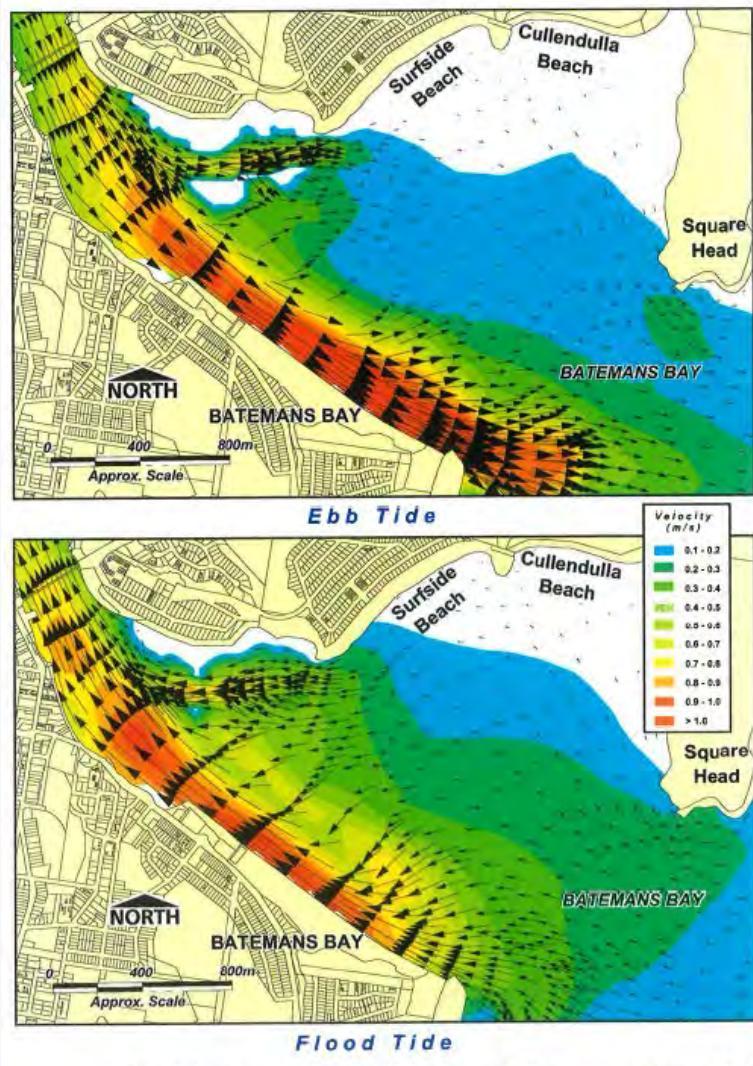
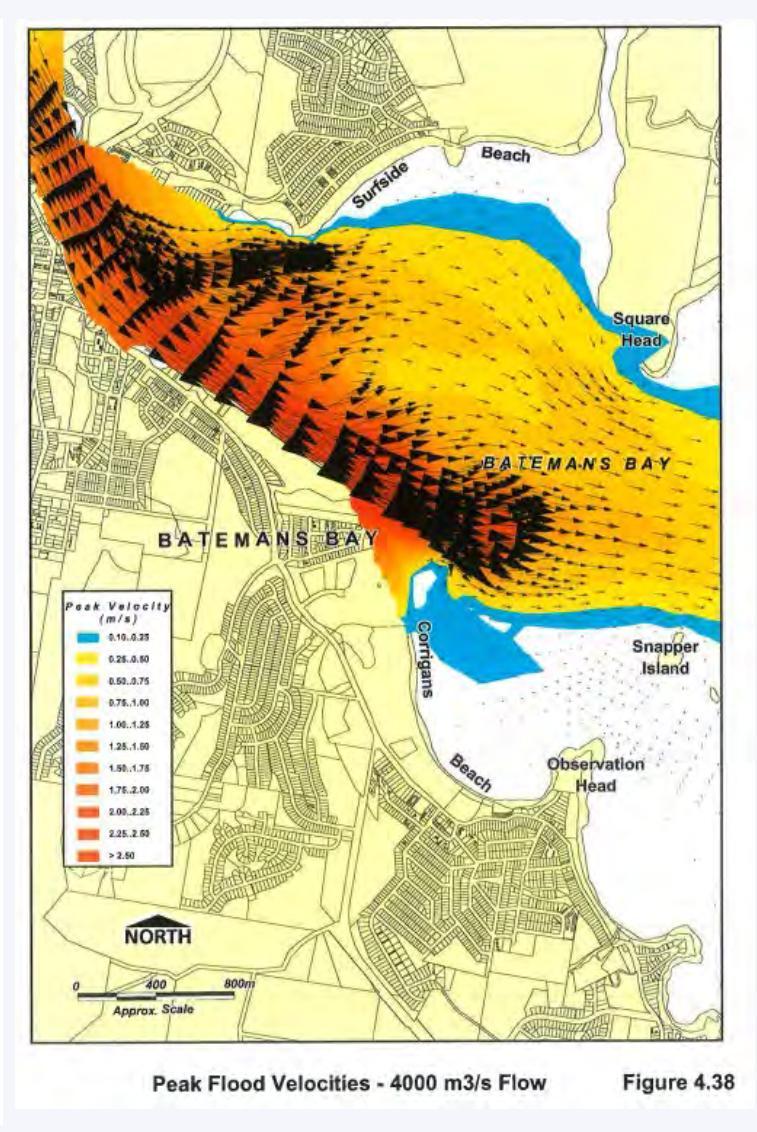
Figure 4.37

- Tidal flows generate currents across Wharf Road/Surfside in excess of 0.5m/s (dependent on shoal configuration)
- Would hinder onshore transport of sediment from nearshore shoals when present

- Flood flows generate currents across Wharf Road/Surfside in excess of 2m/s
- Will drive significant sediment transport through area
- Flow structure dependent on shoal configuration prior to flood and flood magnitude

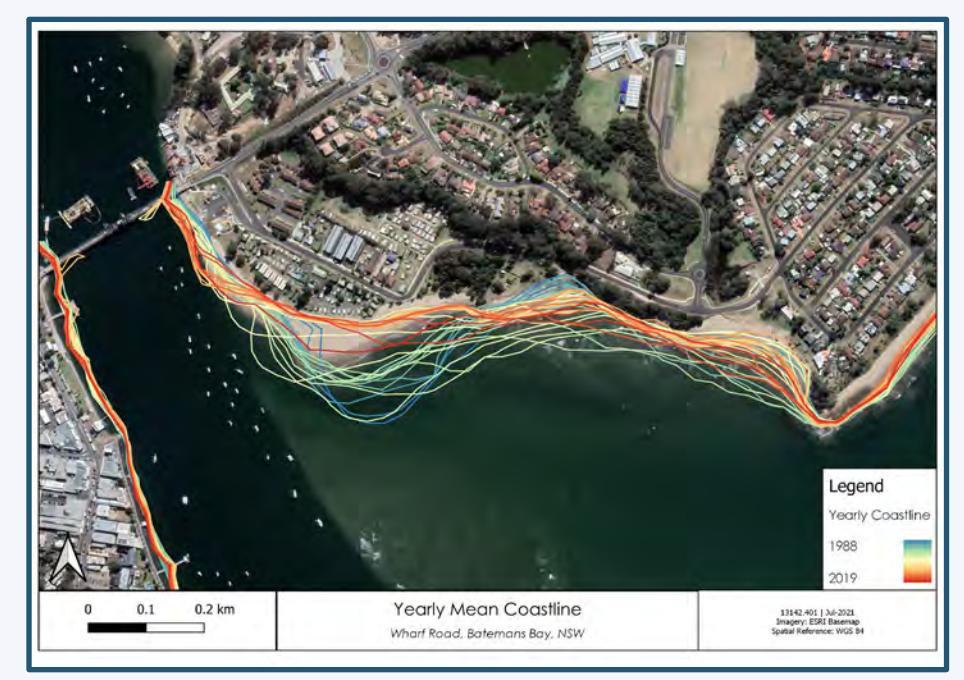
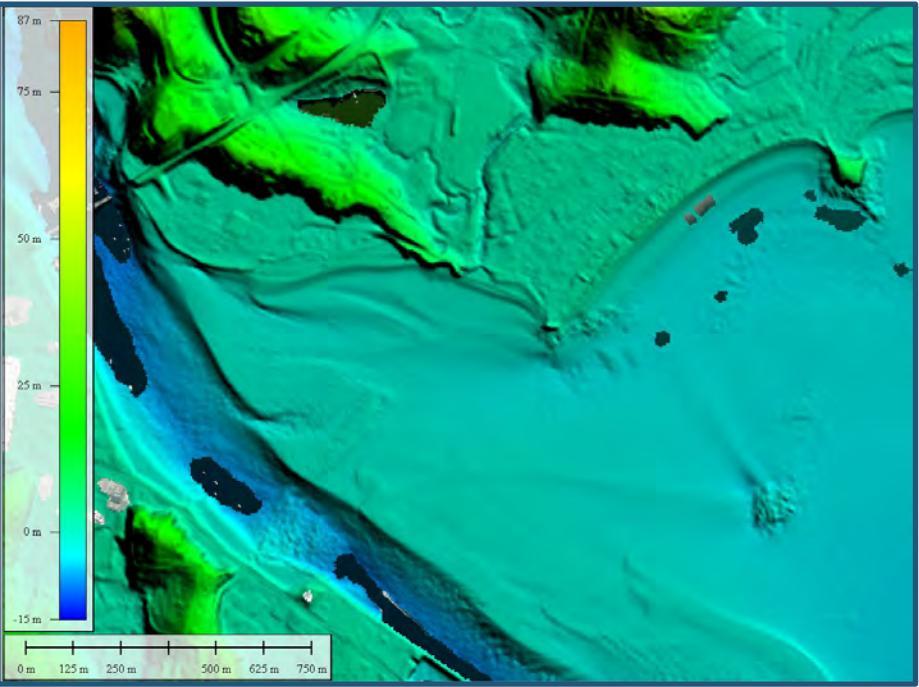
# Wharf Road

- Clyde River flood events are the major influence on re-working the Wharf Road beach and shoal, with large flows close to the beach and across the shoals leading to scour
- Wave induced transport during ambient and elevated offshore swell, which replenish Wharf Rd shoreline from the shoal (over time)
- Longshore transport is to the west along the beach, predominantly from wave driven currents and a flood tide inequality (flood > ebb currents).
