Appendix C

Long List of Options and Feasibility
Assessment

Appendix D

Appendix E

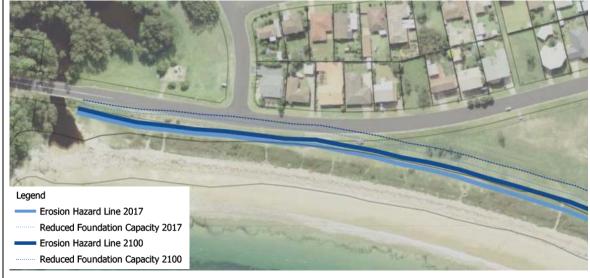
Figure 1 Maloneys Beach Erosion Extents

The Stage 2 Coastal Hazards Assessment determined that Northcove Road was at risk of coastal erosion impacting the road at both the 2017 and 2100 100-year ARI extents (**Figure 1**). While not identified as being within the direct erosion zone currently, the road runs through the zone of reduce foundation capacity and is therefore at risk of being structurally undermined following a large storm event.

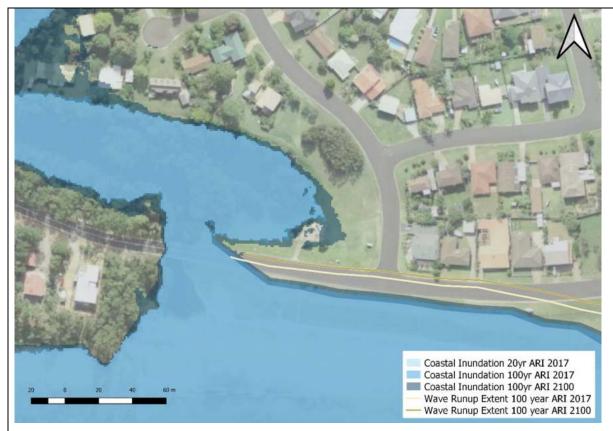
Figure 2 Maloneys Beach Inundation at 20-year ARI

Northcove Road and bridge at the western end of Maloneys Beach can also be inundated at both the 20-year and 100-year ARI, with the potential to cause access issues during severe coastal events. This is due to both coastal inundation, and coincident catchment flooding landwards of Northcove Road, and also wave run-up and overtopping of the roadway (**Figure 2**).

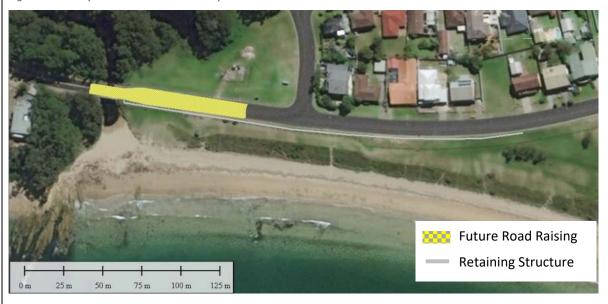
Figure 3 Alignment and extent of Road Raising and retaining structure at Maloneys Beach

To address these risks, road raising of a 100m-120m section of Northcove Road along with a vertical retaining structure with a wave return barrier at its crest has been conceptually designed to protect the public road from erosion and wave damages and to maintain continuous access to Maloneys Beach during severe coastal storms, as shown in **Figure 3**.

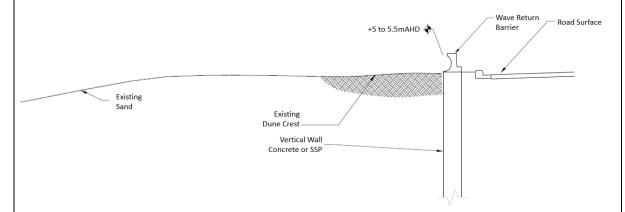
Figure 4 Typical section of a retaining structure with a wave return barrier at the crest

The costed option comprises a sheet pile retaining wall of 5m embedment with a concrete wave return barrier of 1.2m height (Just East of Bridge) reducing in height to the east along the alignment of the wall. The image below provides an indication of the structure form (sheet pile with concrete capping beam), noting that following construction it would buried within the dune and not be at risk of exposure due to coastal erosion from 100year ARI event both now and at 2100.

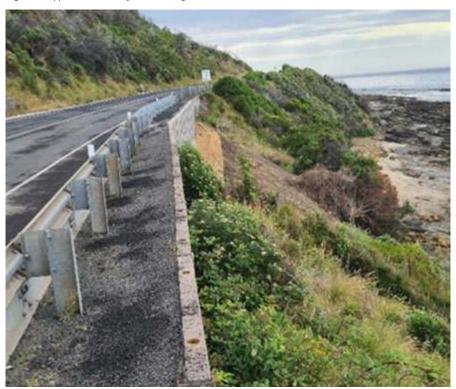
Figure 5 Example of Reinforced concrete wall for stabilisation of a section of the Great Ocean Road, Vic

concrete panels (as shown in **Figure 5**) or driven sheet pile (as shown in **Figure 6**) and would require approximately 5m embedment below the desired crest level, which could be reduced if ground anchoring was adopted. Based on current estimates the retaining wall would not be directly exposed to coastal hazards and hence scour protection is not required. The structure crest would be at a level consistent with the existing road surface (+5 to +5.5mAHD at eastern end) and would comprise a wave return barrier of varying height (example shown in **Figure 7**).

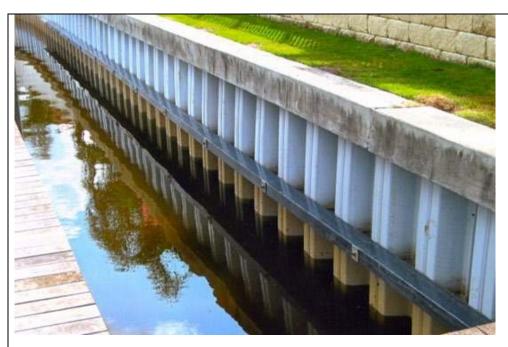
Figure 6 Example of sheet pile wall with concrete capping beam and anchoring

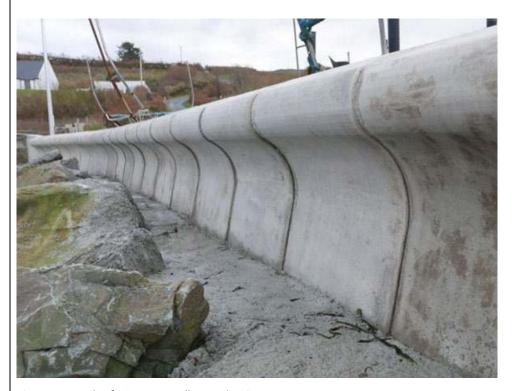
Figure 7 Example of a concrete wall return barrier

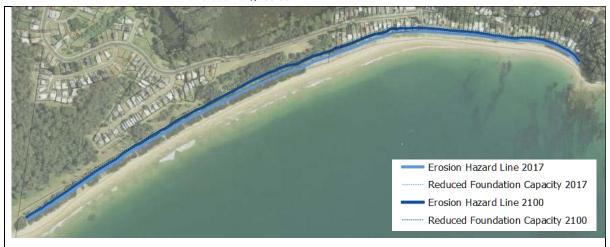
Figure 1 Long Beach Erosion Risk

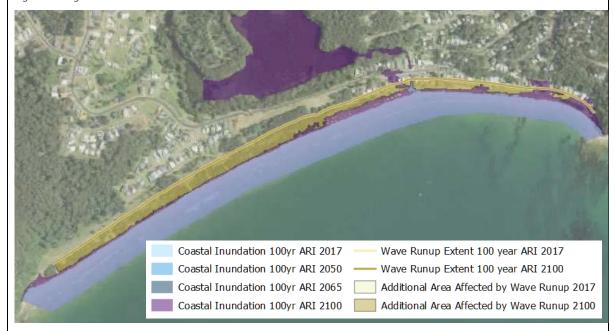
Figure 2 100yr ARI Coastal Inundation Risk

The 100yr coastal inundation risk is shown in **Figure 2**. Further details are provided in the Stage 2 CMP Report (Rhelm, 2022).

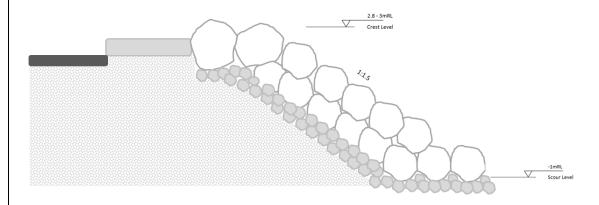
Figure 3 A typical cross section for low crested rock revetment at Long Beach

A typical section for a revetment design is provided below and would remain buried below the dune system under normal beach conditions. The structure crest would be at a level consistent with the existing road surface (+2.8 to +3.2mAHD).

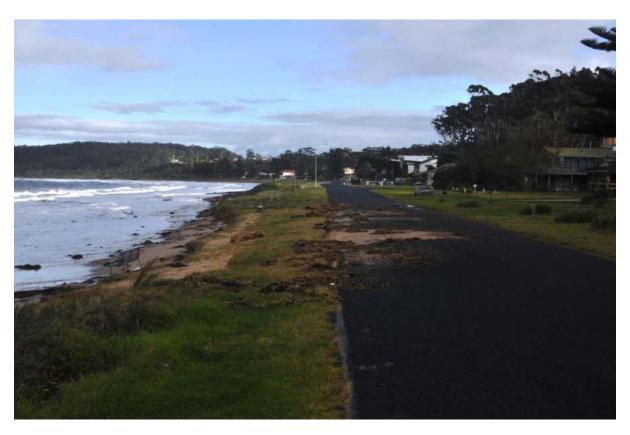
Overtopping of Bay Road, Long Beach, 6 June 2012 (Mr Lindsay Usher) – from WRL, 2017

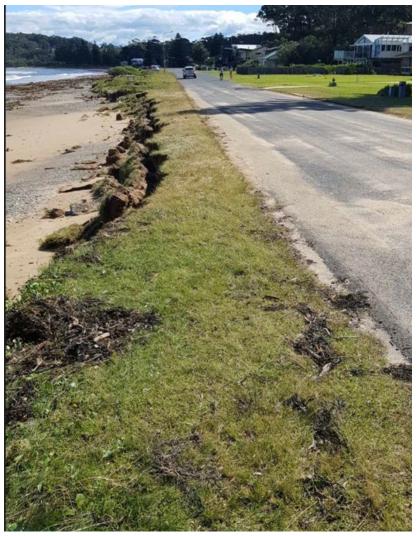
Overtopping of Bay Road, Long Beach, 4th April 2022 (Mr Cameron Whiting ESC)

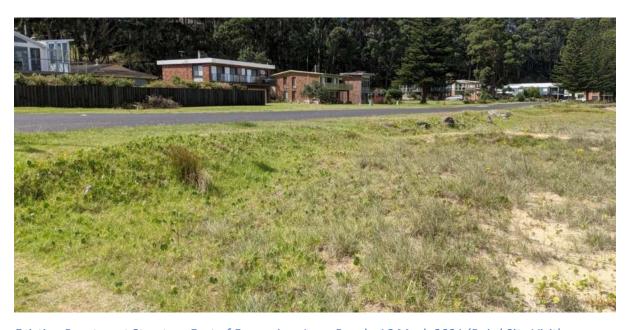
Existing Revetment Structure East of Fauna Ave, Long Beach, 16 Mach 2021 (Baird Site Visit)

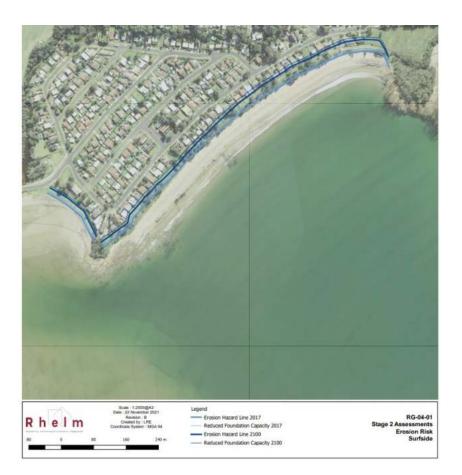
Figure 1 Surfside Erosion Hazard Lines for 2017 and 2100 planning periods

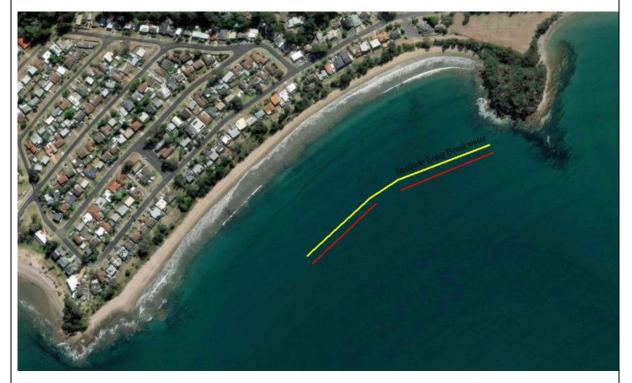
Figure 2 Surfside Offshore Breakwaters, with two potential configurations

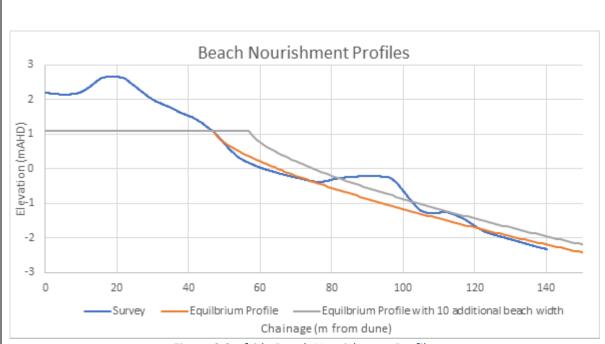
Figure 3 Surfside Beach Nourishment Profiles

For beach nourishment, the sub-aerial beach condition should be assessed, with a sufficient beach width of at least 30 m at the northern end. If beach width is less than 30 m, sediment should be placed according to the equilibrium profile shown in **Figure 3**. If beach width is greater than 30 m, target nourishment of the dune to achieve a target crest level of 2.55 mAHD (2050 100-year ARI Still Water Level, WRL (2017)), and 3.04 mAHD towards 2100 (2100 100-year ARI Still Water Level, SWL (2017)).

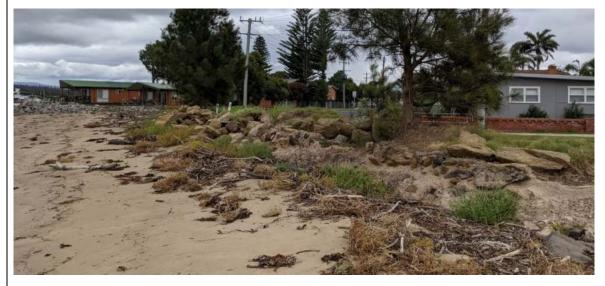
Figure 1. Site Photo of Wharf Road Corner and ad hoc rock protection (Site Visit: 16 March 2021)

The corner of Wharf Road at North Batemans Bay was identified as being at extreme risk of coastal erosion and asset failure under existing conditions due its proximity to the existing shoreline. There currently exists a form of coastal protection along the road corner with quarry stones having been placed in an ad hoc manner (see Site Photo below). During site visits, an inspection of the area concluded that the structural integrity of the rock protection could not be relied upon, and the road and sewer is at risk of damage under extreme coastal conditions.

Both the existing protection (see **Figure 1**) and from the unapproved structure to the east (see **Figure 5**) would be removed and armour stones could be reused as material for the new structure.

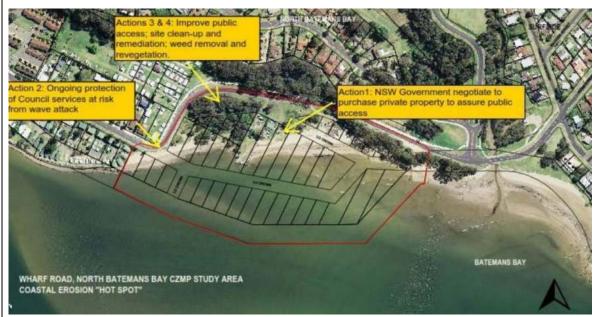
Figure 2. The properties identified for voluntary acquisition by the NSW State Government, as identified in the Wharf Road CZMP

The option firstly requires that acquisition of the properties identified in the certified Wharf Road CZMP (action CH1_M in this CMP) is taken up by the landholders which is currently underway, and the beach area is returned to public open space.

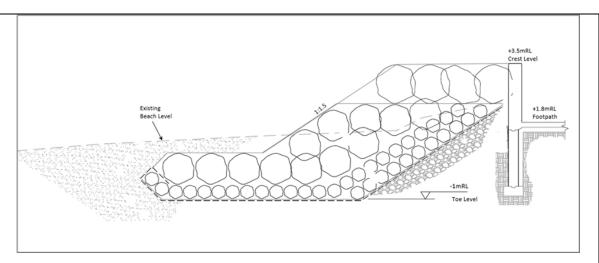
Figure 3. Typical Cross Section of Seawall Concept at Wharf Road Corner.

The proposed design and cost estimates are for the coastal hazard protection purpose of the seawall only. Additional public benefits could be incorporated at the detailed design stage, such as viewing platforms, beach access and other amenity details.

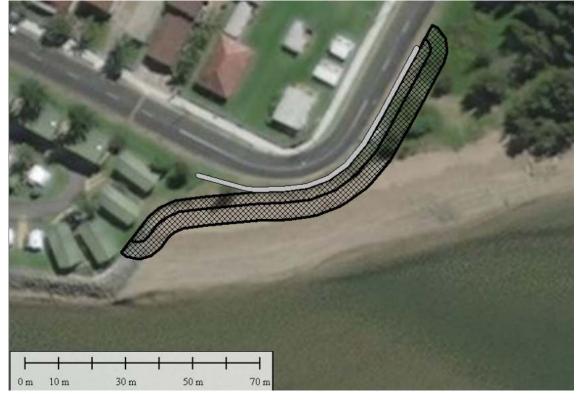
Figure 4. Alignment and footprint of Seawall Concept at Wharf Road Corner.

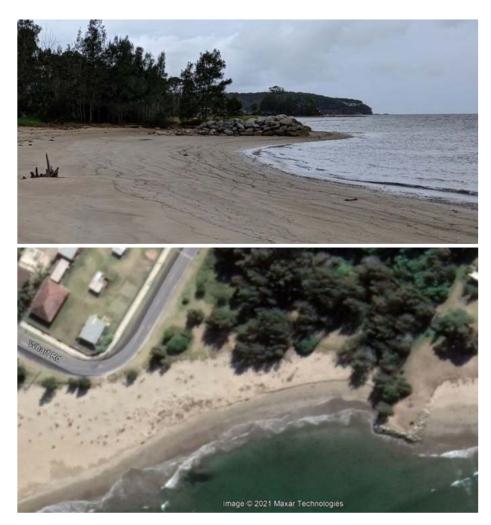
Figure 5. Photo and location of unapproved coastal protection structure at the Wharf Road subdivision.

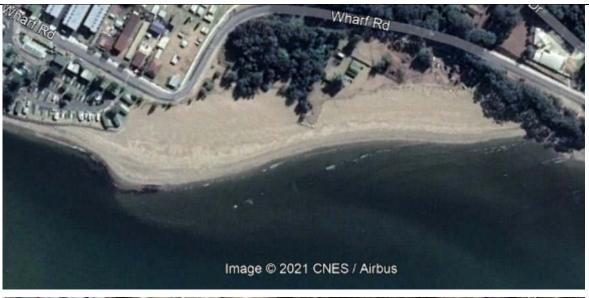
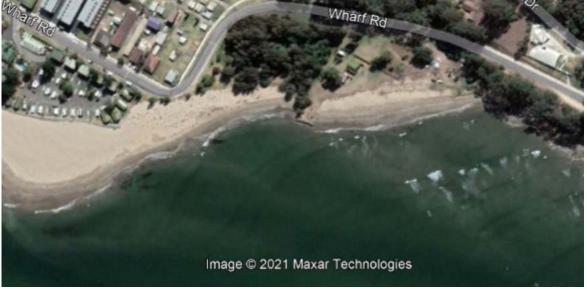
Figure 6. Shoreline positions in September 2018 accreted state (top) and September 2019 receded state (bottom).

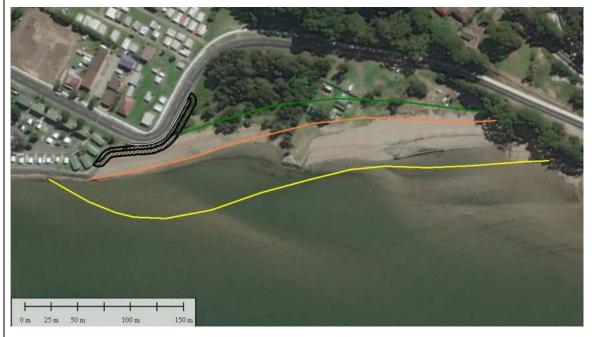
Figure 7. Shoreline positions following removal of the unapproved coastal protection structure. Green is permanent vegetation line. Orange is the receded shoreline alignment. Yellow is the accreted shoreline position.

In an accreted condition, the removal of the unapproved structure will not have an influence on the shoreline position, however in times of a more receded shoreline, a modified shoreline alignment would be expected. An assessment of the future vegetation line and shoreline positions without the presence of the unapproved structure is presented in **Figure 7**.

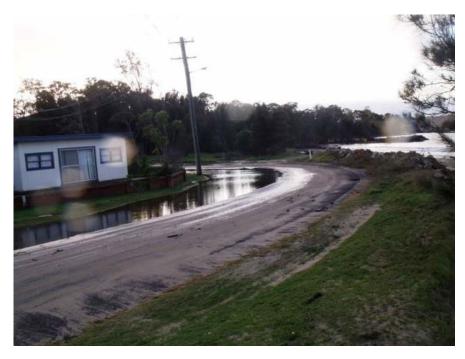
Inundation at Wharf Road, 6 June 2012 (Mr Dick Crompton) from WRL, 2017

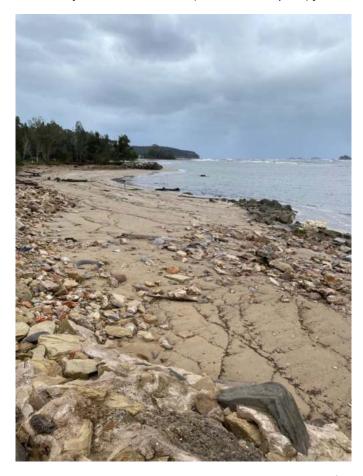
Debris strewn across the beach from the dilapidated seawall, Wharf Road, 4^{th} April 2022 (Mr Cameron Whiting, ESC)

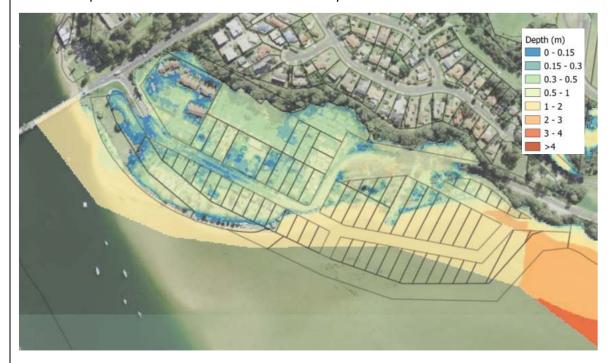
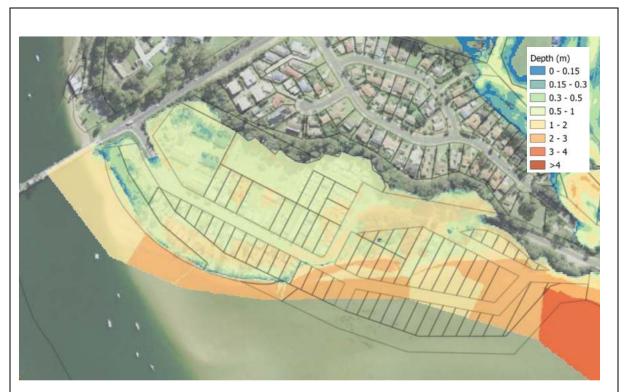
Figure 1. 100year ARI Coastal Inundation Depth across Wharf Road area. Top: Present Day. Bottom: 2100.

The low-lying areas of North Batemans Bay along Wharf Road have been identified as being at risk of coastal inundation under a present day 100yrARI coastal water level, with inundation depth exceeding 1m in some areas. Inundation depth maps for the present day and including projected sea level rise out to 2100 are presented in **Figure 1**. Options to address the existing and future risk of coastal inundation across the wider area have been considered. Given the topography of the area, inundation protection will require a mix of structures to produce a continuous elevated barrier to repel coastal inundation from Batemans Bay.

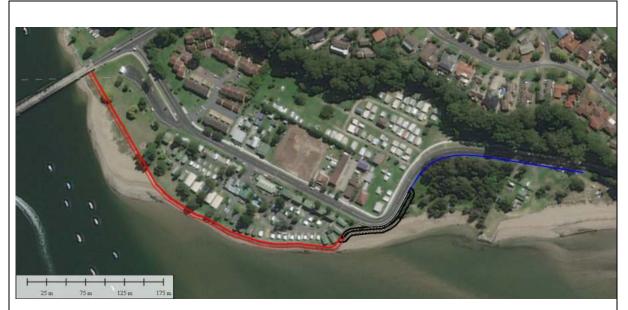
Figure 2 Alignment and extent of Stage 2 Inundation Protection of Wharf Road (Red: Raising of Seawall, Blue: Vertical SSP).

The alignment and extent of structures is presented in **Figure 2**. The flood protection would be constructed to a level that will prevent coastal still water inundation up to the year 2100 (for 100-year ARI immunity – crest level ~3mAHD) and will tie into the Stage 1 protection works (Option CH1_Ka). Wave overtopping of the holiday park would be reduced by the seawall raising, however would not be a targeted outcome of the works as this would reduce the amenity of the holiday park foreshore.

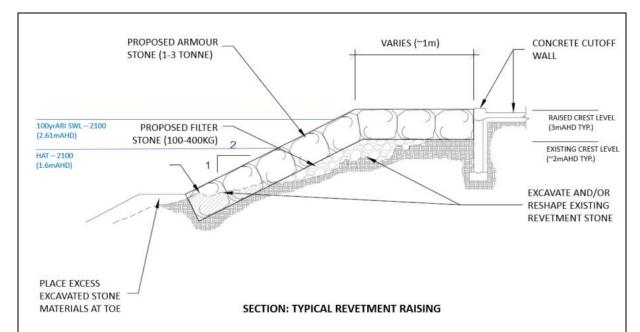
Figure 3 Typical cross section for raising of the Seawall fronting the Easts Riverside Holiday Park

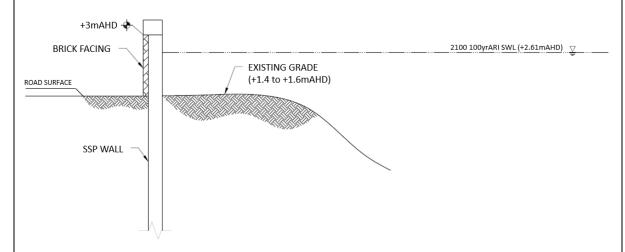
Figure 4 Typical cross section for SSP Wall along Wharf Road

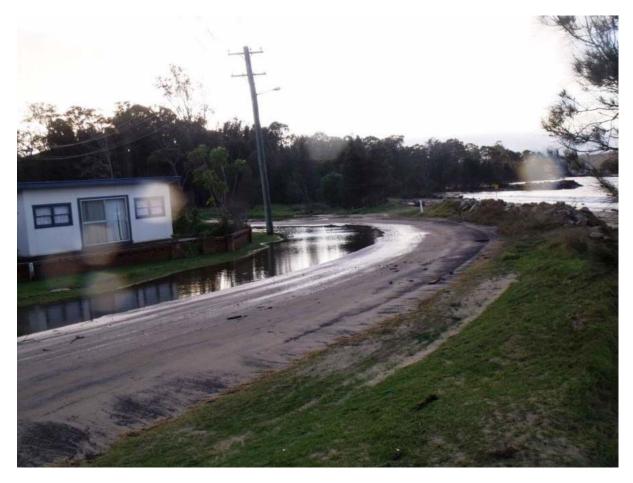
Inundation at Wharf Road, 6 June 2012 (Mr Dick Crompton) from WRL, 2017

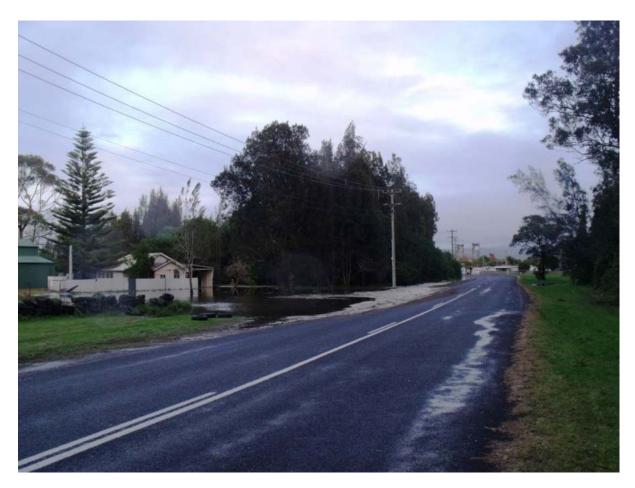
Inundation at Wharf Road, 6 June 2012 (Mr Dick Crompton) from WRL, 2017

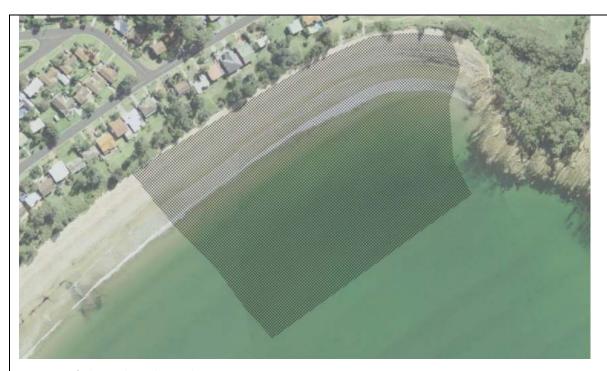
Figure 1 Surfside Beach Sand Nourishment

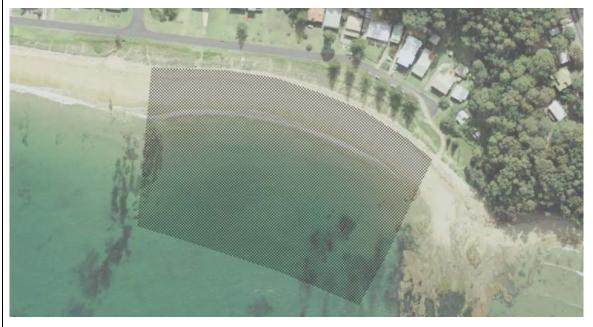
Figure 2 Long Beach Sand Nourishment

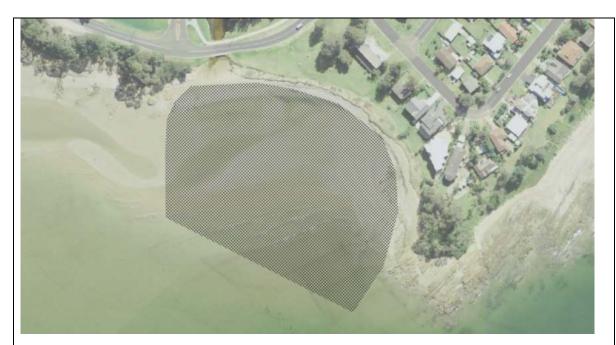
Figure 3 Surfside Beach West (Dog Beach / Mceods Beach) Nourishment

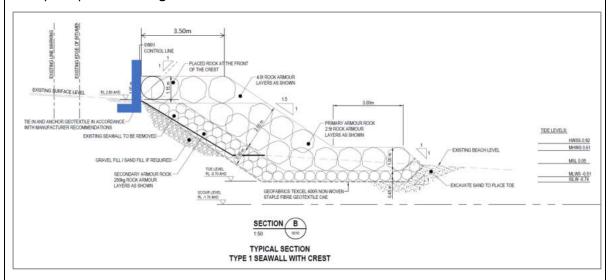
Figure 1 Seawall with Crest Typical Section

To manage the risk of future wave overtopping a modification of the seawall design will be required. A possible modification to the seawall design is presented in **Figure 1** below and incorporates a vertical wall directly behind the structure crest. A similar wave return barrier example is provided in **Figure 2**.

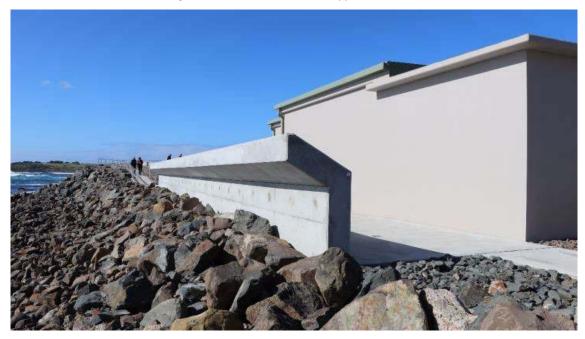
Figure 2 Example of wave return barrier, Port Kembla (from MHL, 2021)

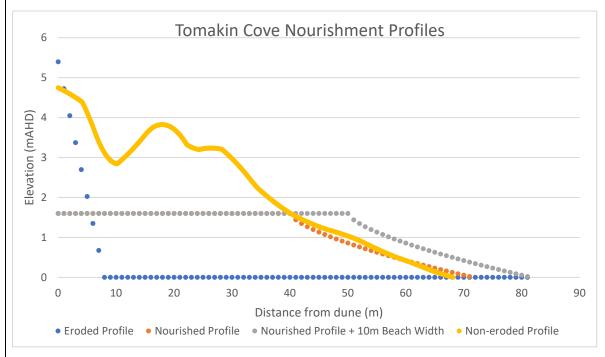
Figure 1 Beach Nourishment Profiles for Tomakin Cove

• Based on a beach length of 250 m, an approximate total nourishment volume requirement is 22,500 m³. At a cost/m³ of \$5, the capital costs of placement are ~\$115,000

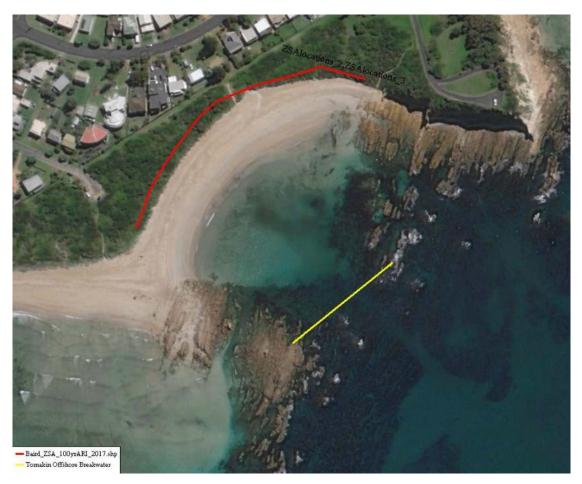
Figure 1 Tomakin Cove Offshore Breakwater Potential Location

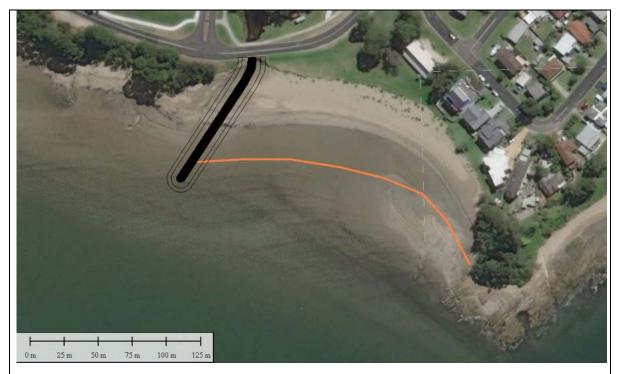
Figure 1. Indicative alignment of a culvert extension/groyne structure (black) at Macleod's beach with anticipated shoreline response (orange)

Figure 1 provides an indicative alignment of the structure, with an anticipated shoreline response. The structure would be approximately 90m long with its toe located below 0mAHD.

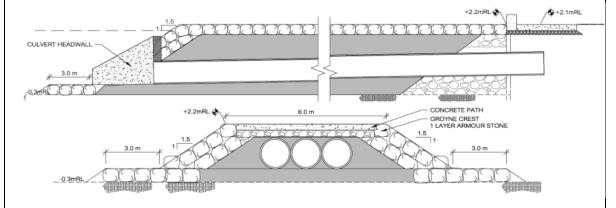
Figure 2. Indicative cross sections of a culvert extension/groyne structure at Macleod's beach

Figure 2 provides indicative cross sections along the groyne length and width and includes double armour stone layers across the structure slopes and crest, and a single armour layer around the toe to act as scour protection. The structure crest would be constructed at ~2.2mAHD, with a concrete path integrated to allow public access, tying in with the level of Wharf Road across the existing outlets, and allow suitable fall between the existing outlet inverts and the new outlet position. A flood gate could be added to the seaward end to reduce the ingress of elevated coastal water levels (subject to sediment dynamics at the outlet).

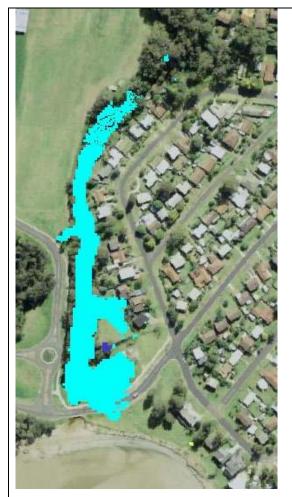
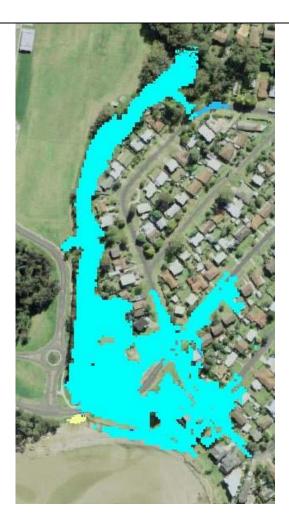
Figure 2 - Flood Impacts 5% AEP

Preliminary flood modelling has been undertaken to assess the impacts of the proposed culvert extension. Modelling was undertaken for the 5% AEP and 1% AEP events. Results shown in **Figures 2 and 3**. For the full length culvert, minor upstream increases were observed in both AEP events. In the 1% AEP, the increases impacted properties between the creek and the eastern arm of Timbara Crescent.

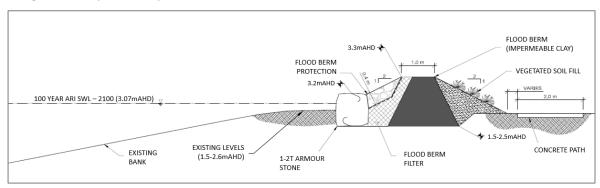
A concept design for a Coastal Inundation Levee is presented in the cross-section figure below. The levee effectively consists of an impermeable core with armouring on the flood prone side and a vegetated slope on the protected side.

The horizontal footprint of the Coastal Inundation Levee will be dependent on crest level targeted and existing ground level. Existing ground levels along the first stage of levee vary between 1.5 and 2mAHD, such that a Coastal Inundation Levee with height of 0.5-1m and width (at the base) of 3 to 5m would be required to achieve a crest level of +2.5mAHD. Increasing the crest height to +3.3mAHD (above the 2100 100year ARI ocean flood level) would require a levee height of 1.3 to 1.8m with a width of up to 8m.

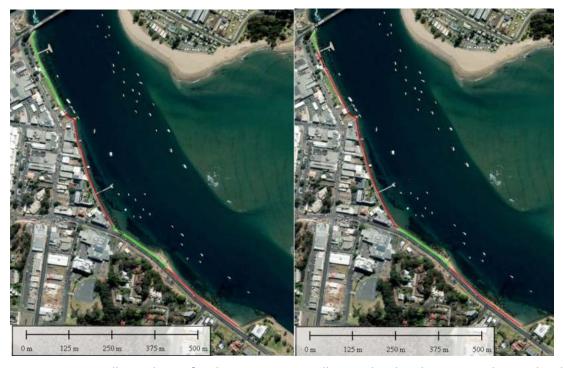
Figure 1 CBD Seawall Inundation for the 100year ARI still water level under present day sea levels.

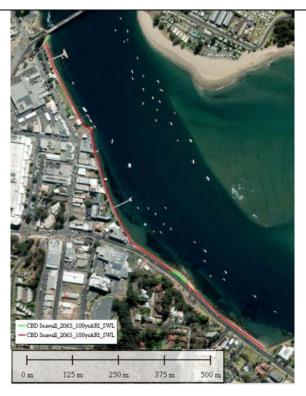
Figure 2 CBD Seawall Inundation for the 100year ARI still water level at 2065 (red = existing seawall crest submerged)

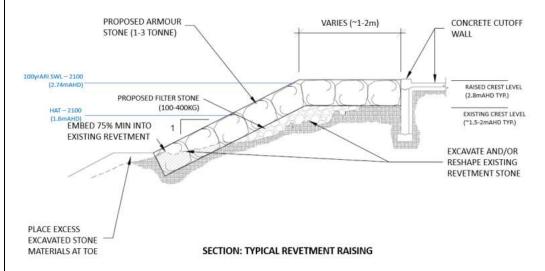
Figure 3 Typical cross section for raising of the CBD

A proposed seawall raising option has been designed that would leverage off the existing seawall as a foundation but increase the crest level to +3.0mAHD, above the 100-year ARI Storm Tide level in 2100. A typical section for the seawall raising design is presented in Figure 3, and includes construction of a 1-2m wide crest and 1 in 2 seawall slope that keys into the existing seawall armour layer. At the back of the crest of the raised seawall a concrete cut-off wall would reduce the permeability of structure and neatly tie the seawall into the promenade behind.

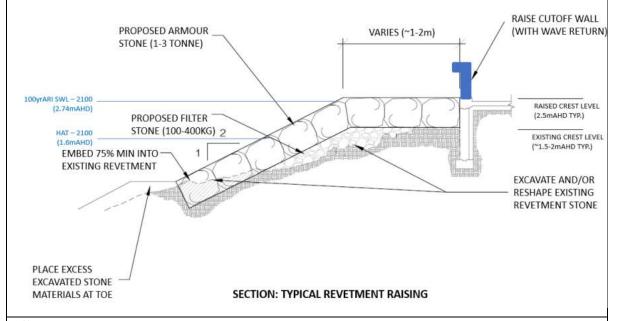
A possible modification to the seawall design is presented in the Figure below and incorporates a vertical wall directly behind the structure crest (as an extension to the vertical cut-off wall). The vertical wall could include a wave return lip to further reduce an overtopping risk. Further overtopping calculations indicate a vertical wall of 0.5m in height (above the seawall crest) would reduce overtopping risk to within acceptable levels out to the year 2100.

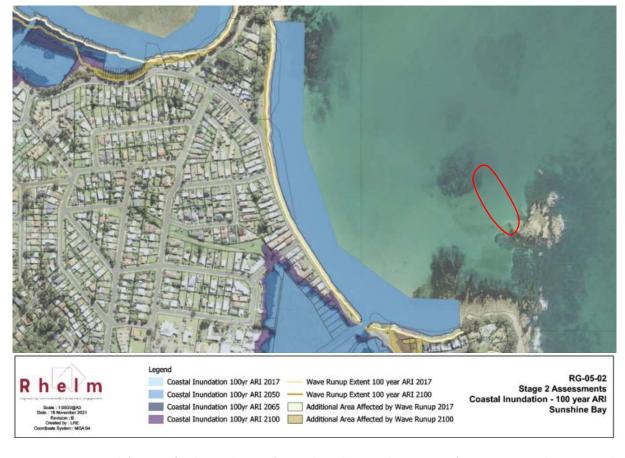
Figure 1 Caseys Beach (as part of wider Sunshine Bay) coastal inundation and wave runup for 2017 to 2100 planning period at 100-year ARI. Red circle indicates approximate position of a proposed wave dissipation breakwater
