Eurobodalla Open Coast Coastal Management Program

Stage 2: Vulnerability Assessments

Eurobodalla Shire Council

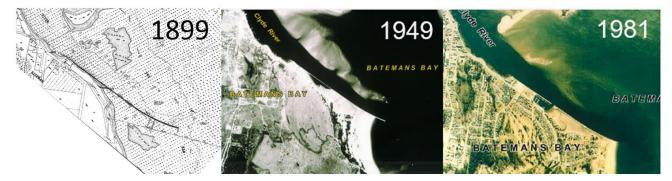
Figure 6-1 shows a snapshot of navigation chart and aerial imagery between 1899 and 1981 that demonstrates the rapid accretion of land behind the training wall.

Figure 6-1 Rapid accretion of land behind the training wall at Corrigans Beach

Significant and rapid accretion of the Southern Shoreline was observed following construction of the 1,300m long training wall along the CBD (completed 1905), with an additional extension having been constructed in 1991 (of ~150m in length).

The sediment accretion at Corrigans Beach is driven by northward longshore transport (driven by waves) that is trapped on the southern side of the training wall. The supply of sediment to this compartment appears to be predominantly from the ebb tide shoal at the end of the Clyde River channel with the sediment being predominantly lithic sands of fluvial origin with only minor marine sand content (WBM, 2000).

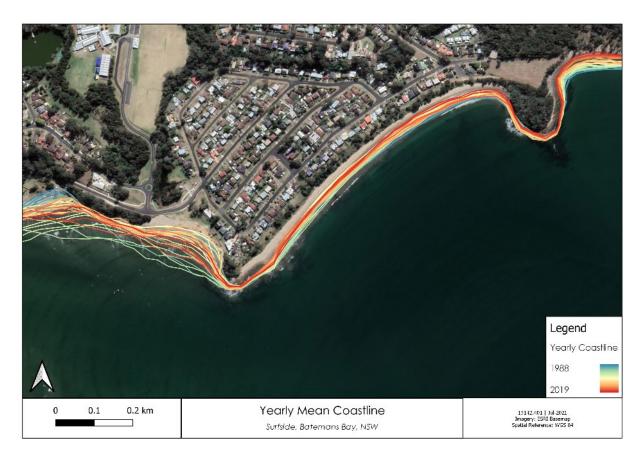
The yearly mean shoreline position is shown in **Figure 6-3** along Surfside Beach between 1988 and 2019, indicating a relatively stable shoreline position.

Figure 6-3 Yearly Mean Shoreline Position (approximately 0mMSL)- Surside Beach

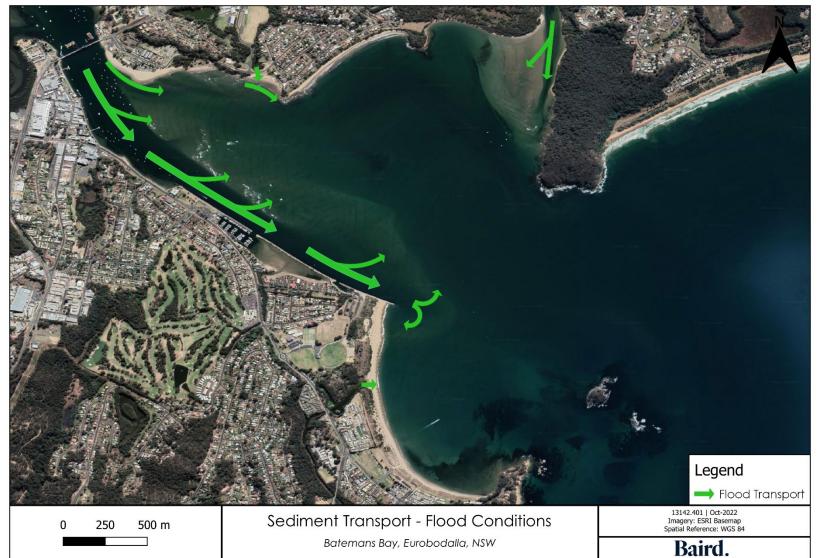
Figure 6-9 Conceptual sediment transport model of inner Batemans Bay under catchment flood conditions

- Ambient conditions (Figure 6-7), where sediment transport is dominated by waves (average) and tidal currents.
- Coastal Storm conditions (Figure 6-8), where sediment transport is dominated by larger waves and elevated water levels (causing shoreline erosion) and storm induced circulations (e.g. rips).
- Catchment Flood conditions (Figure 6-9), where sediment transport is dominated by significant flows out of the Clyde River, Creeks and ICOLL entrances.
