# Toilet Strategy

2023-2028

Eurobodalla  
Shire Council

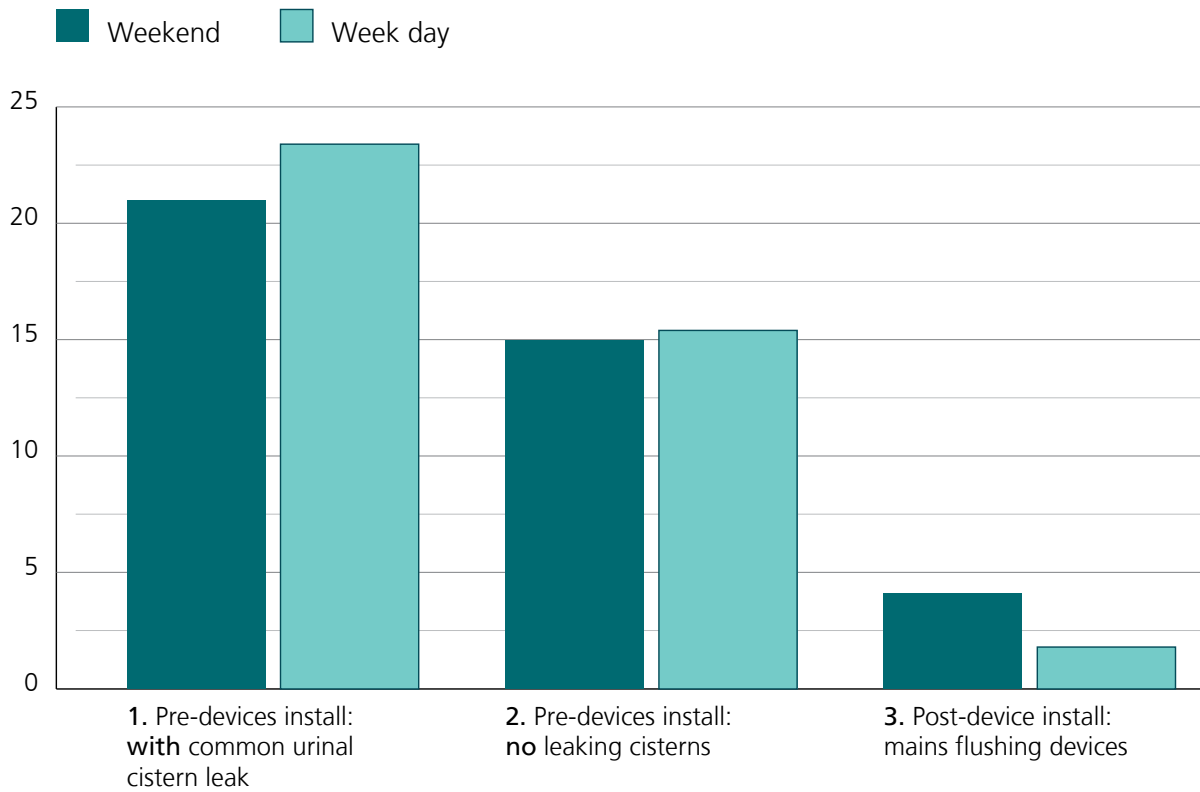
**Graph 1: Daily water consumption**

A data logger that was installed in February 2019 has provided accurate real-time data on the impact of the project. Installation of mains flushing devices and taps took place in early May. The reduction in water consumption and financial savings is evident in the *consumption on week day and weekends before and after device install* list and graph 1.

Three different daily consumption records:

1. Urinal cistern leak
2. No leaking cisterns
3. Post-device install of Mains flushing devices.

### Consumption on week day and weekends before and after device install

#### 1. Pre-device install: With common urinal cistern leak

#### 2. Pre-device install: No leaking cisterns

#### 3. Post-device install: Mains flushing devices

The project cost around \$17,300 and water consumption data to date indicates it will save between \$5,000-\$7,000 annually, giving this project a very reasonable 2.4 to 3.5 year payback, as indicated in Table 3.

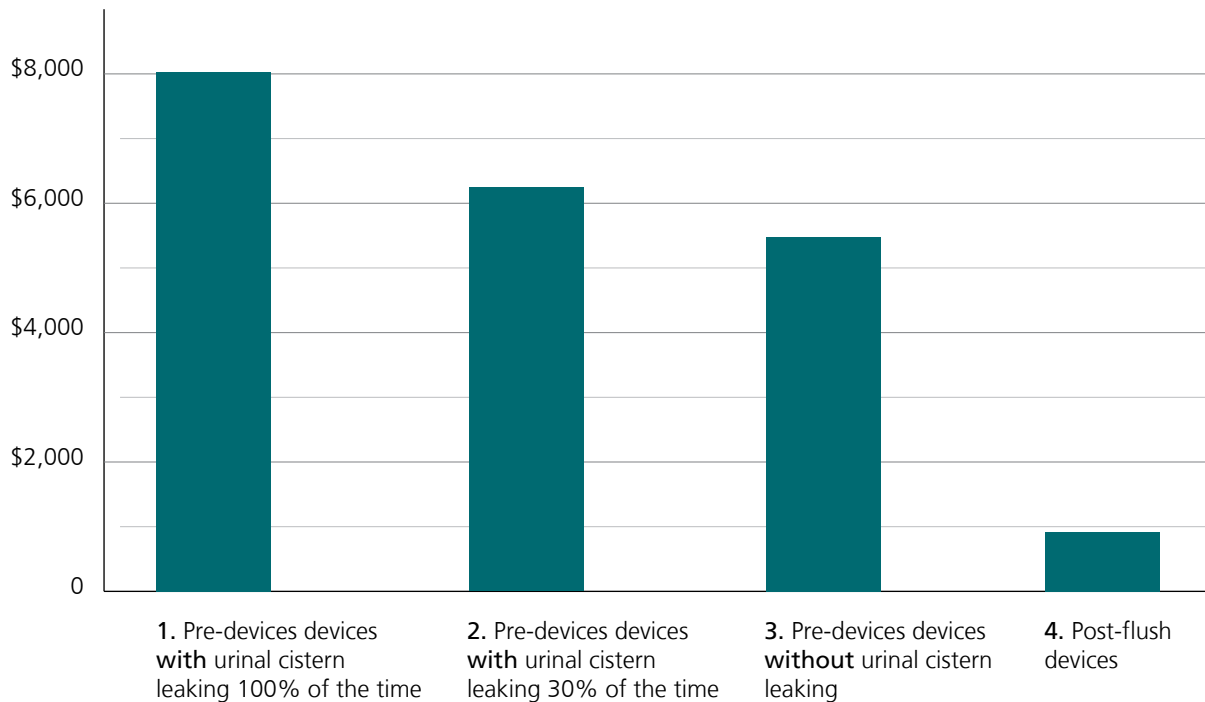
**Graphic 2: Annual water consumption costs**

**Table 3: Daily and annual running costs before and after device installation**

Consumption cost	1. Pre-devices with urinal cistern leaking 100% of the time	2. Pre-devices with urinal cistern leaking 30% of the time	3. Pre-devices without urinal cistern leak	4 Post-flush devices
Daily cost	\$22	\$17	\$15	\$3
Estimated annual cost	\$8,030*	\$6,242	\$5,475	\$913

**Table 4: Annual savings and payback**

Scenario	Annual water savings	Payback
Compared to when there are no cistern leaks	\$4,563	3.8
Compared to when there is ONE cistern leak 30% of the time	\$5,329	3.2
Compared to when there is ONE cistern leak 100% of the time	\$7,118	2.4

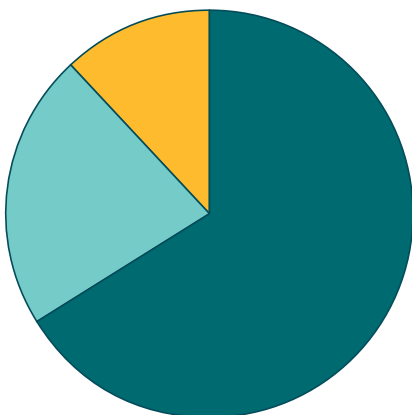
**Graph 3: External condition**

- 67% good
- 22% fair
- 12% poor

The external condition of 67% of public toilets was good with 33% requiring maintenance or an upgrade.

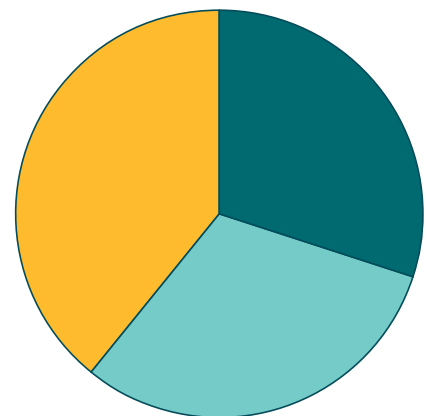
**Graph 4: Internal condition**

- 30% good
- 31% fair
- 39% poor

The internal condition of 30% of the public toilets was good and 70% requiring maintenance or an upgrade.

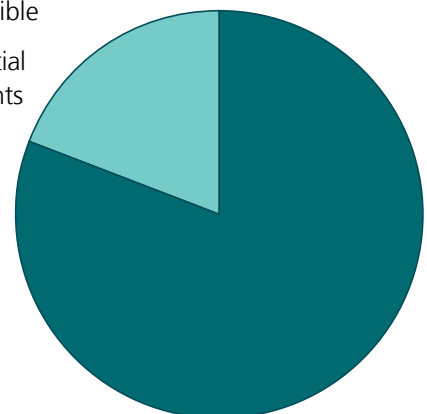
**Graph 6: Accessible locations**

- 81% accessible
- 19% potential improvements

81% of toilet locations have accessible toilet options to cater for the needs of people with a disability. While this is a positive result, further ancillary work needs to be undertaken to ensure that there is access to the facilities, in the form of accessible parking and/or accessible pathways, and additional amenities to enable increased community participation (Actions 10 and 16).

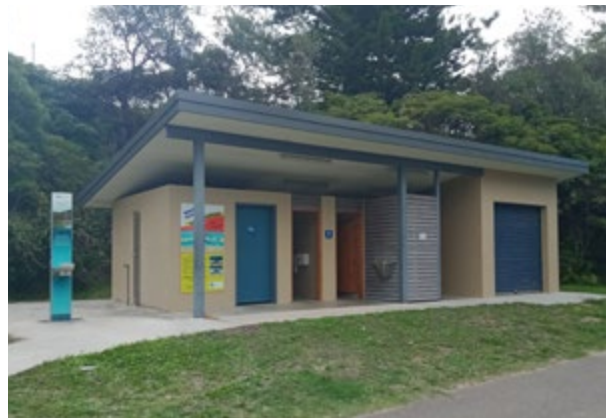
## One Tree Beach – Tuross Head

- Located near One Tree beach South.
- Access via a concrete path from the nearby sealed parking area. Facilities include an external shower, accessible toilet, 2 female cubicles, one male cubicle and urinal.
- Good lighting and ventilation.

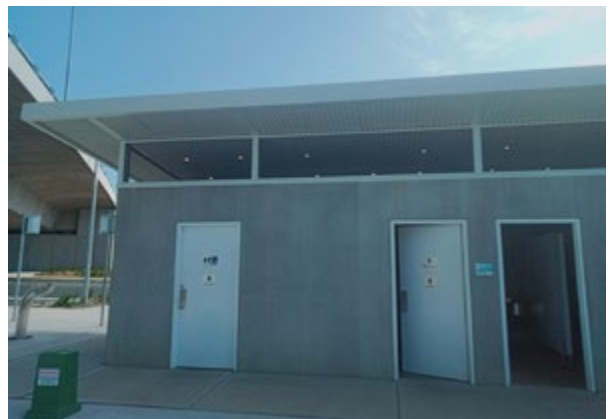
## Lions Park - Batemans Bay

- Located west of the bridge on Clyde Street.
- Near the jetty, playground, shops and Clyde river.
- Modern concrete design with natural light and good ventilation.
- Ample carparking adjacent and path. Accessible toilet with baby change table, 2 female cubicles and 2 male cubicles.

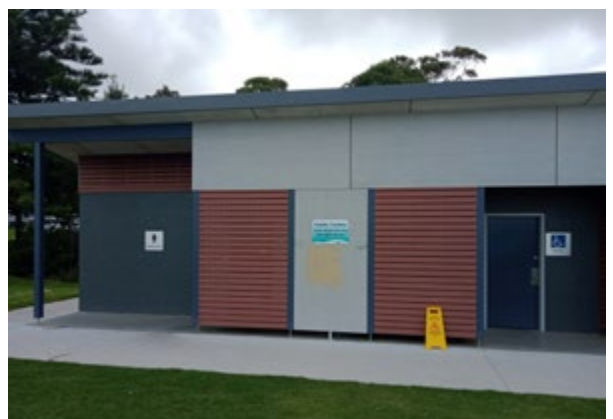
## Surf Beach Reserve – Surf Beach

- Easy access from Beach Road, close to the beach, playground, sealed parking and the Surf Beach café.
- The 4 female cubicles and 3 male cubicles have shelves and door hooks for convenience and an undercover bench seat outside each of the female and male toilets.
- The design is modern, well ventilated with good lighting.
- This is complemented with two external showers.
