FIGURE E7A  
28TH JANUARY 1999 EVENT  
PEAK FLOOD DEPTH  
WAGONGA INLET

FIGURE E7B  
28TH JANUARY 1999 EVENT  
PEAK FLOOD DEPTH  
NAROOMA FLAT

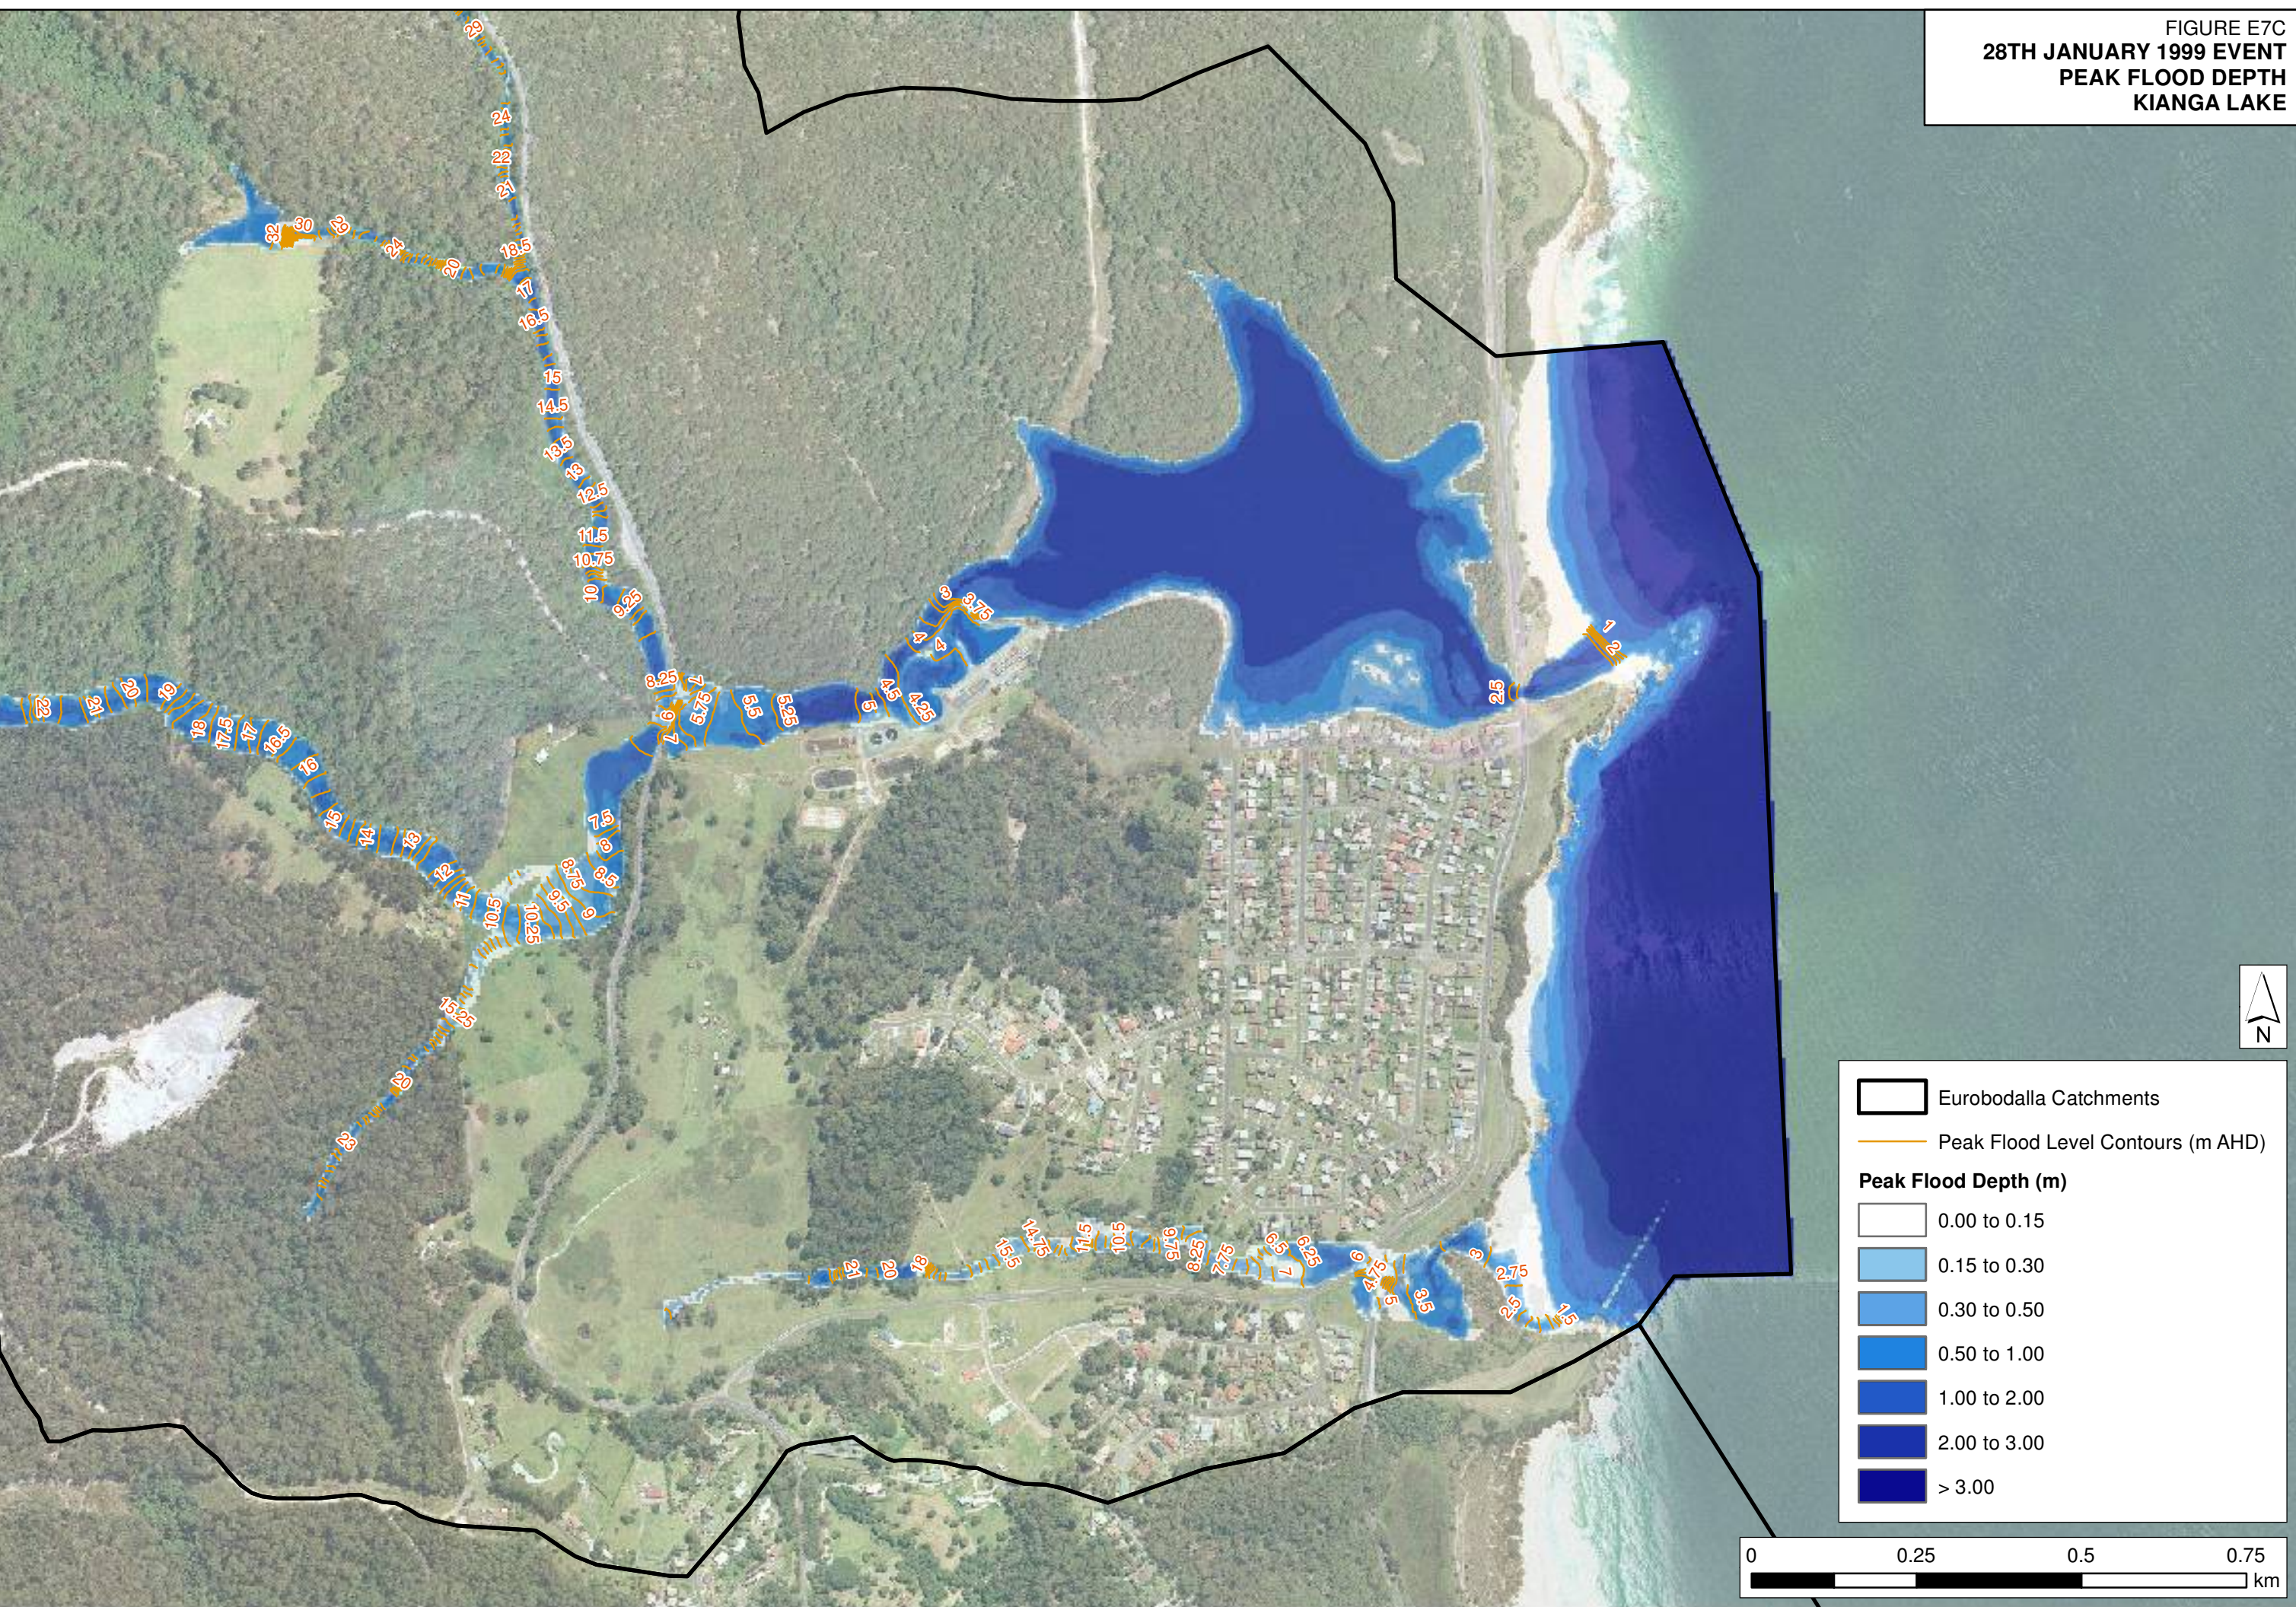
FIGURE E7C  
28TH JANUARY 1999 EVENT  
PEAK FLOOD DEPTH  
KIANGA LAKE

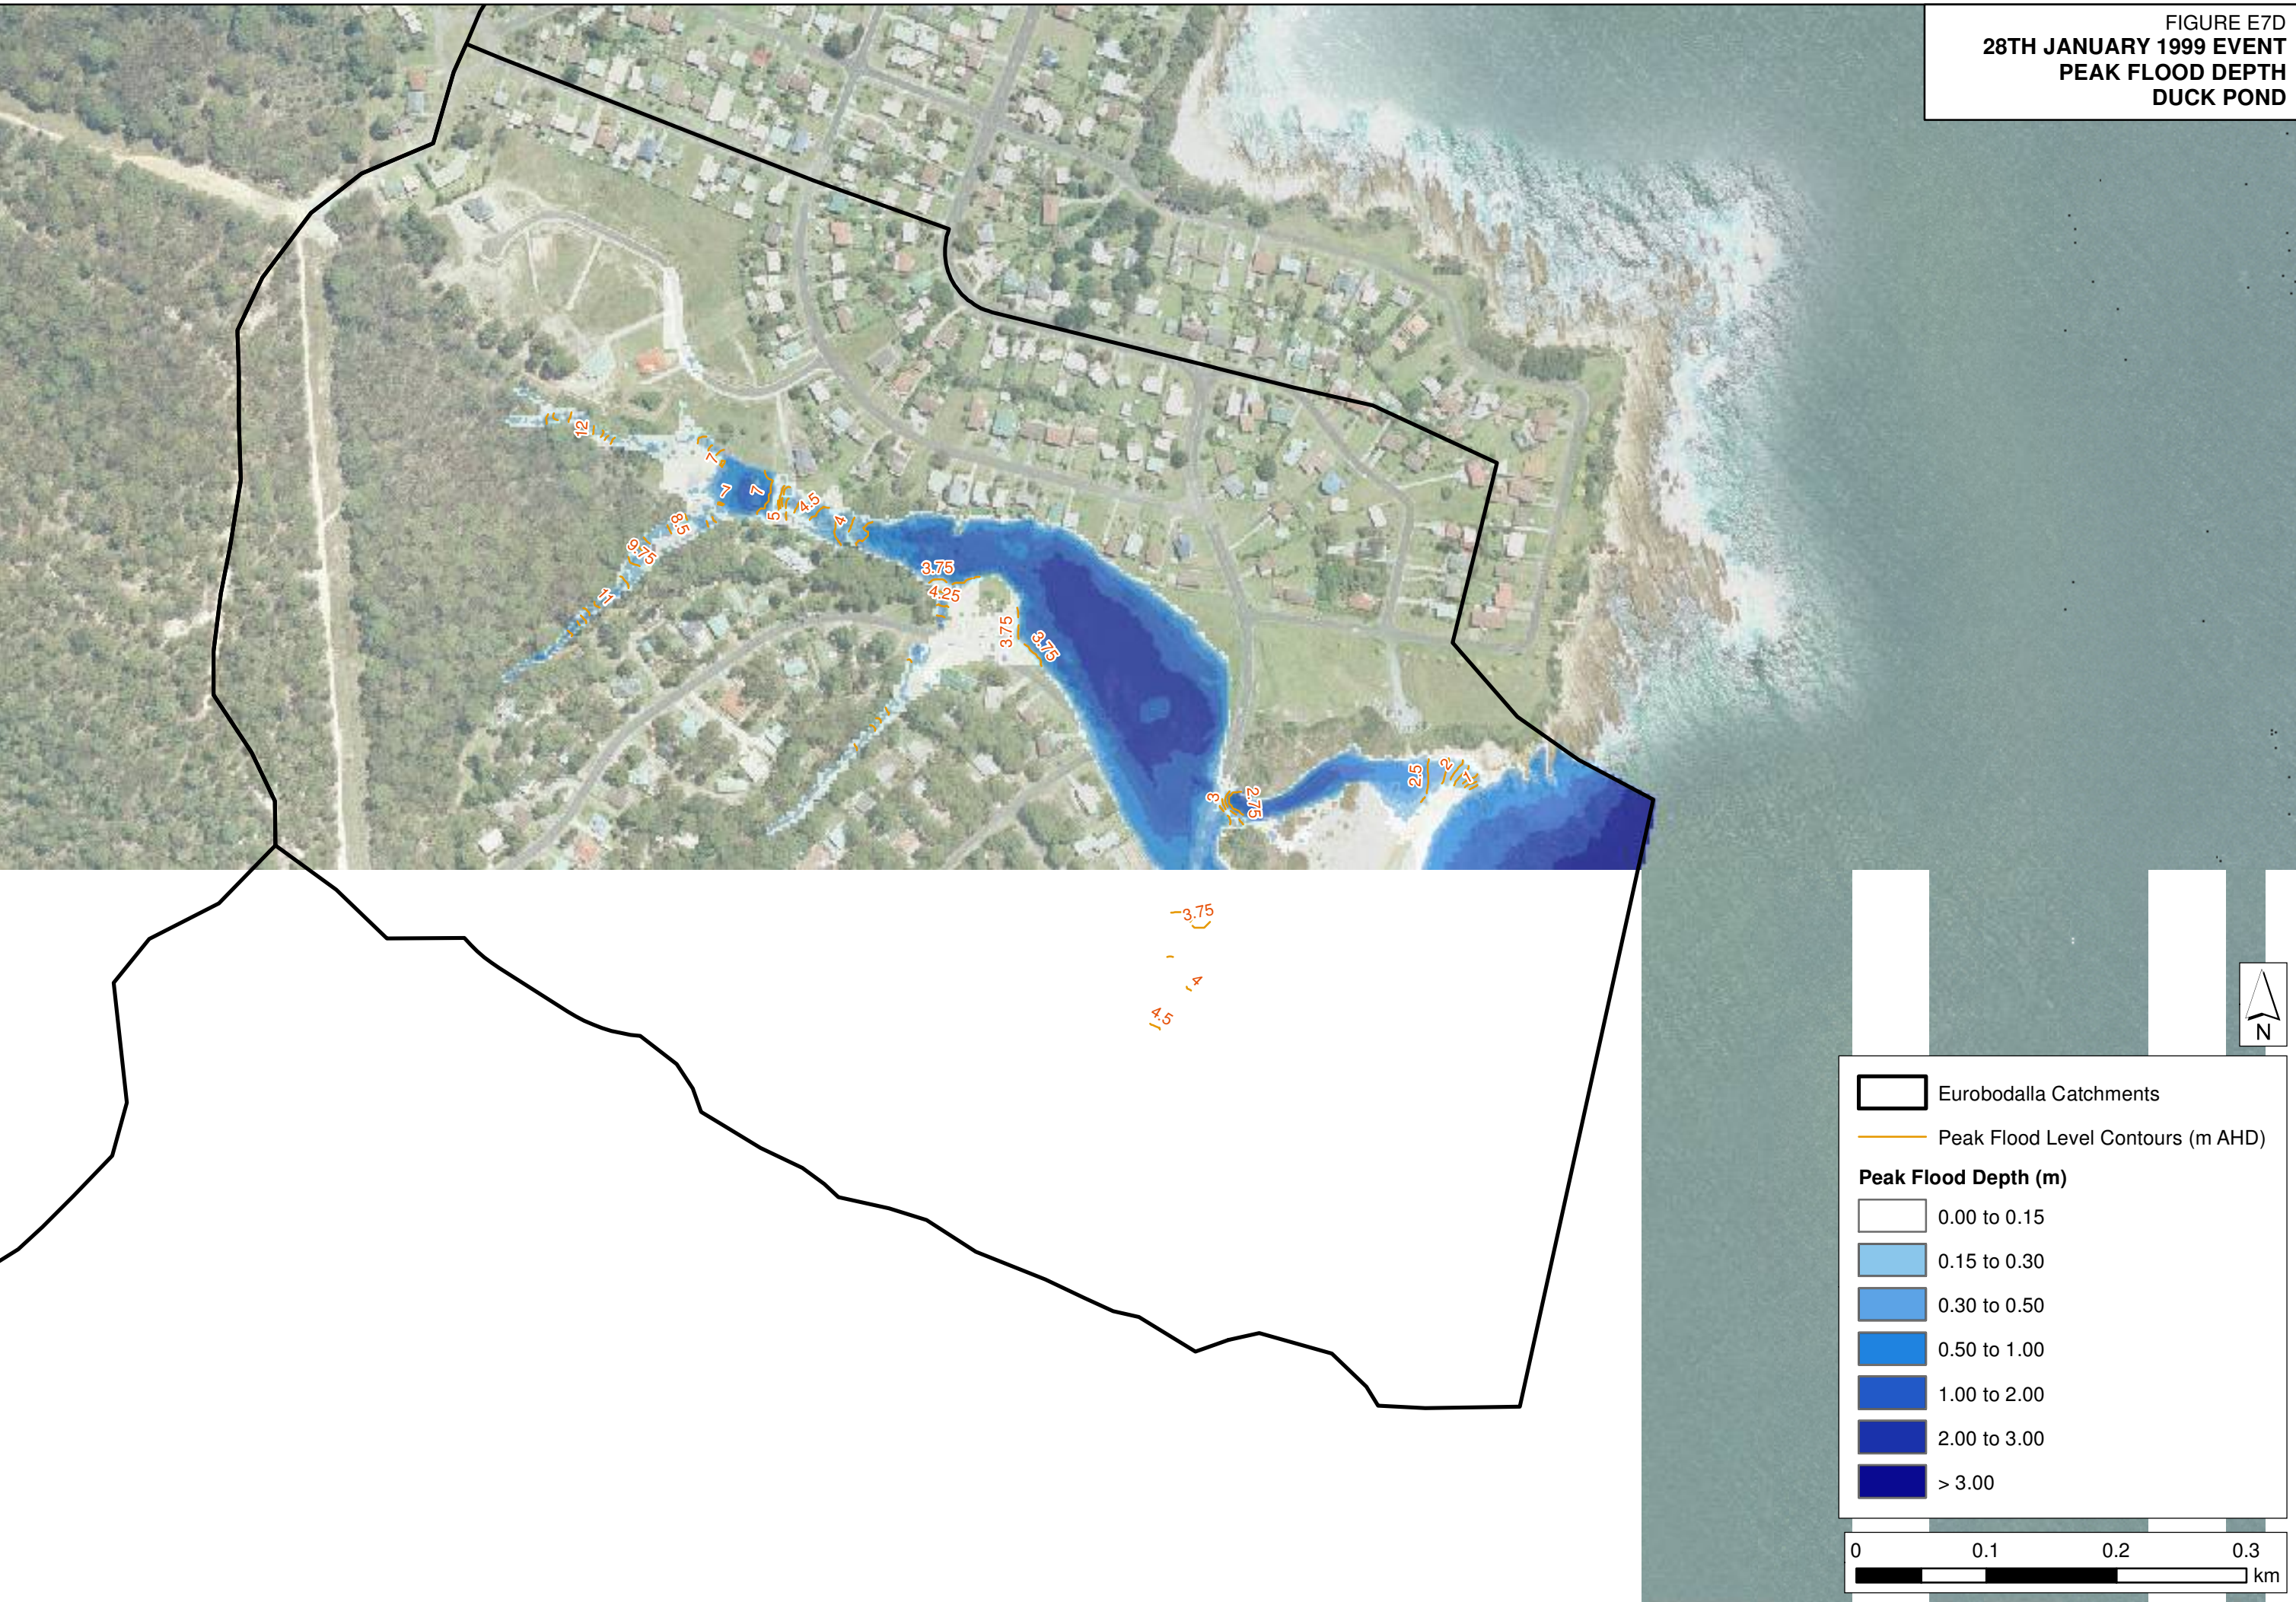
FIGURE E7D  
28TH JANUARY 1999 EVENT  
PEAK FLOOD DEPTH  
DUCK POND

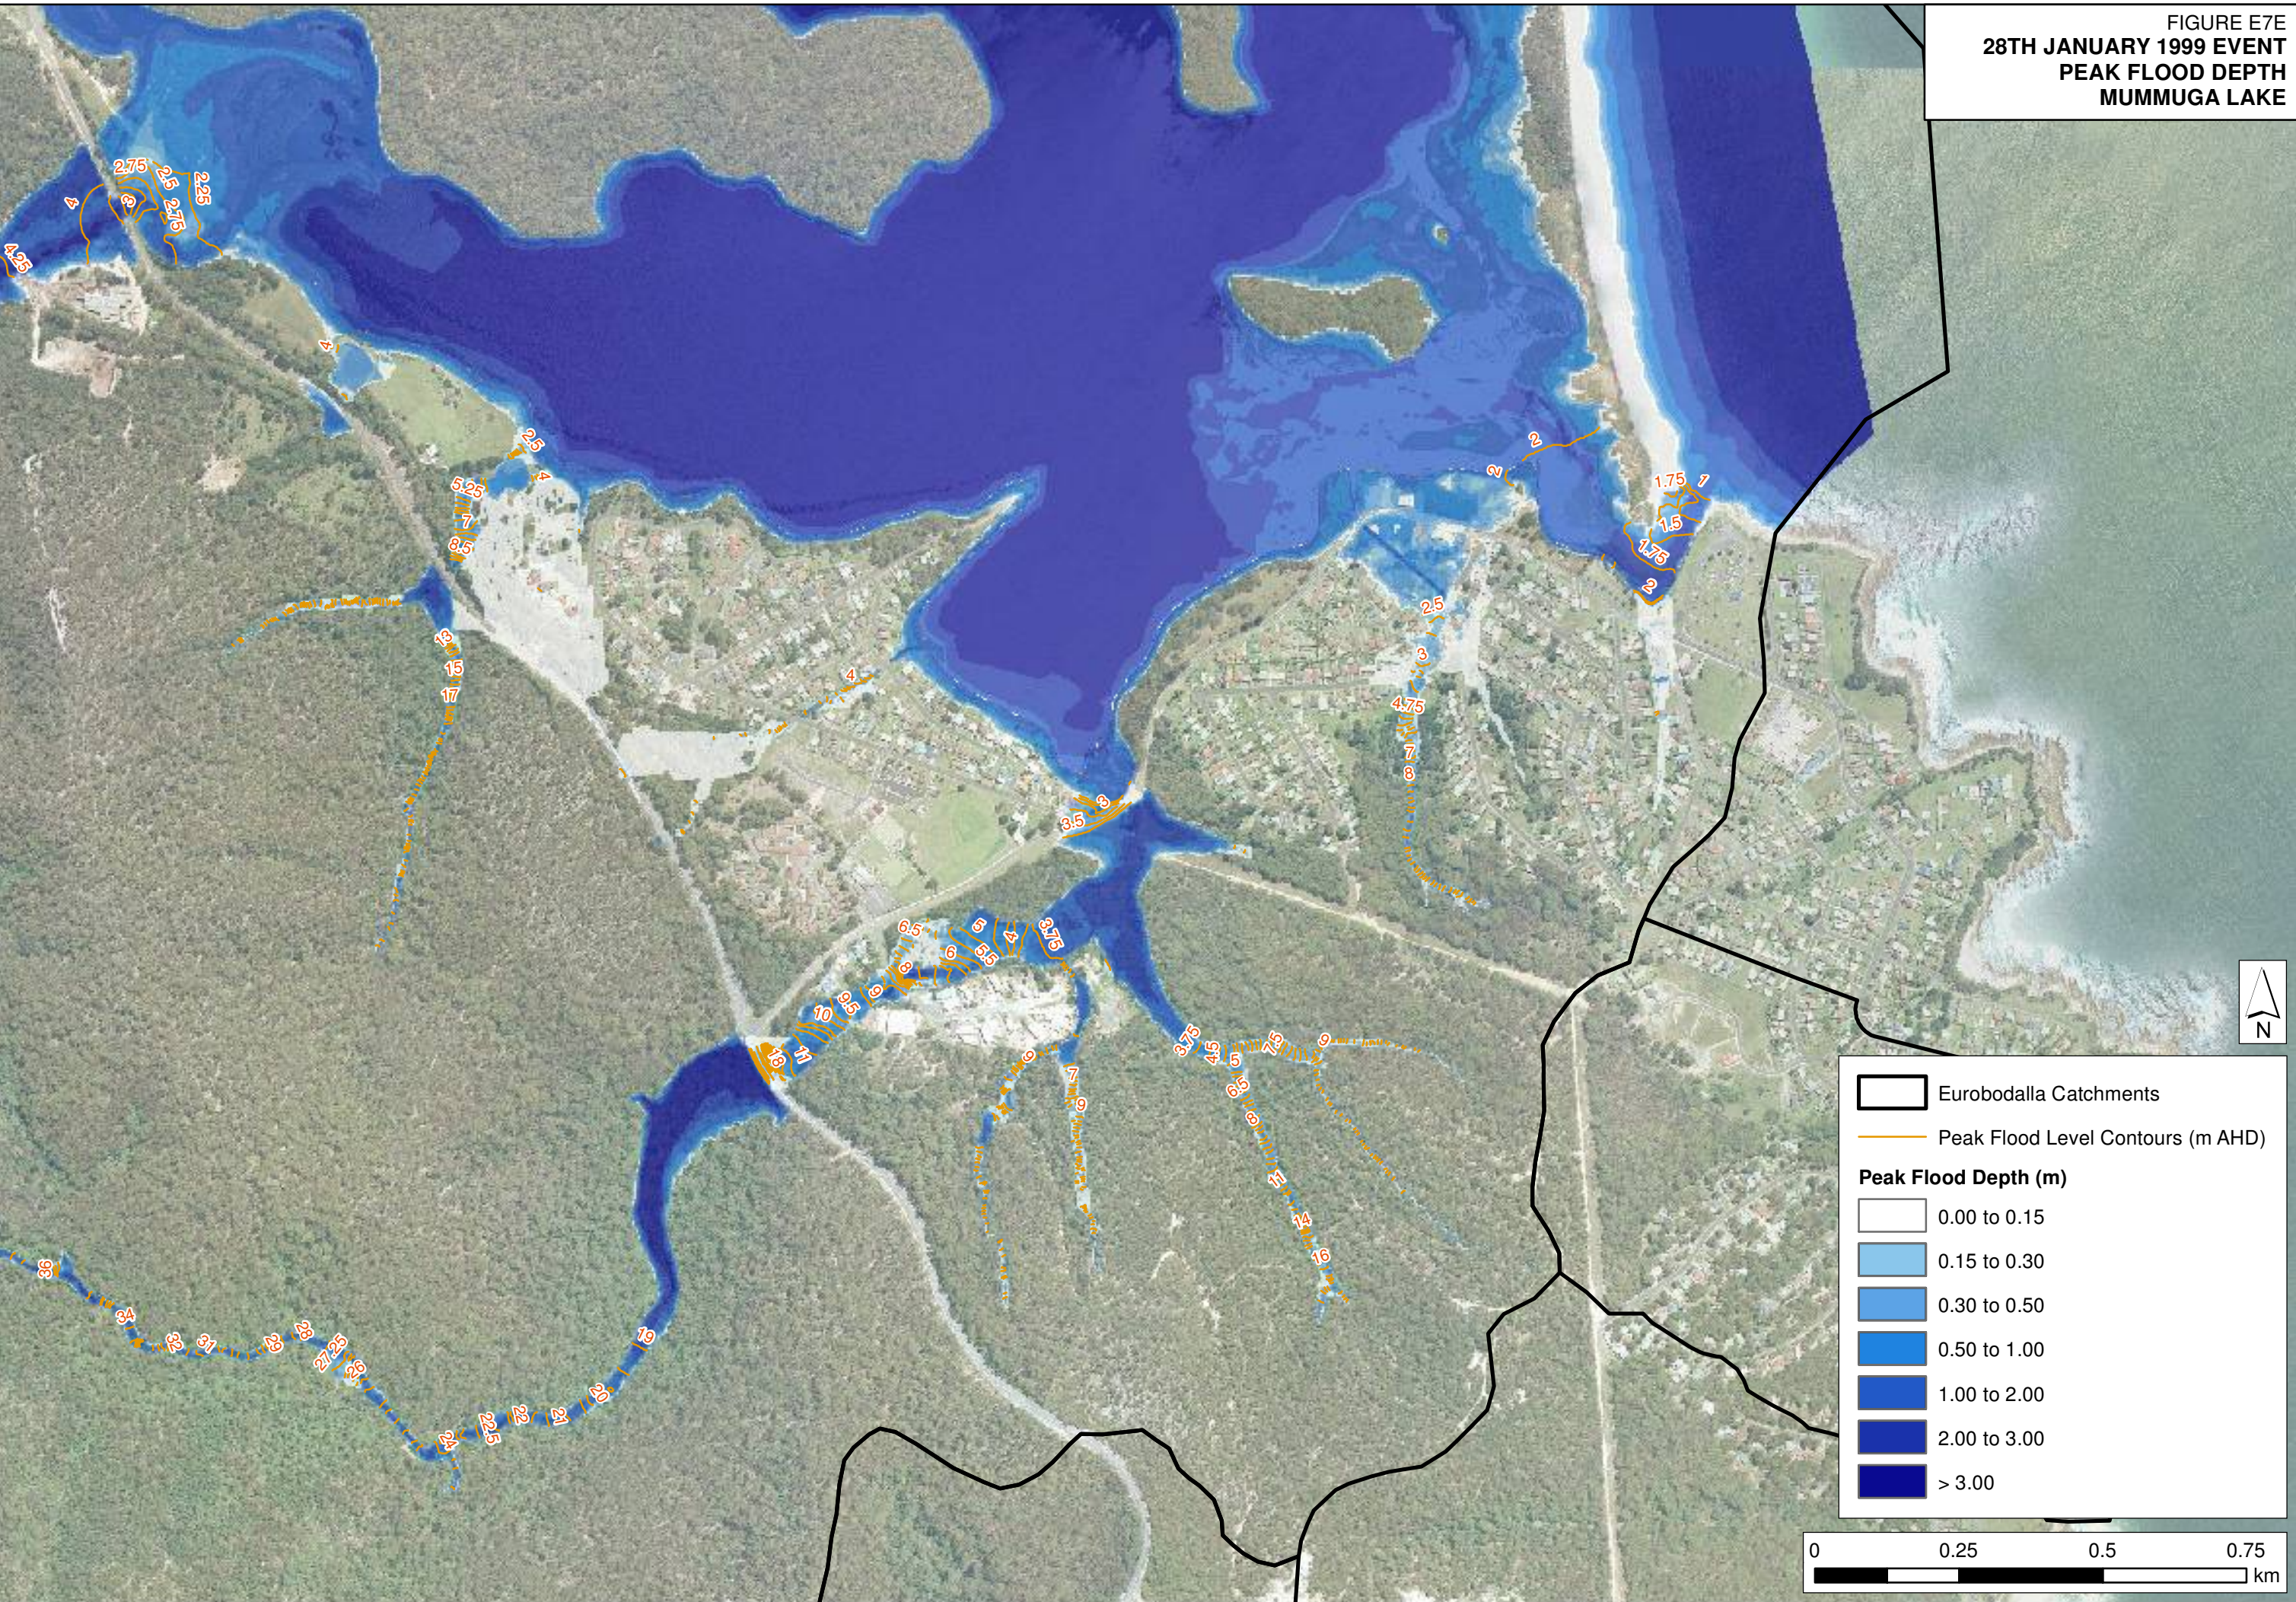
FIGURE E7E  
28TH JANUARY 1999 EVENT  
PEAK FLOOD DEPTH  
MUMMUGA LAKE

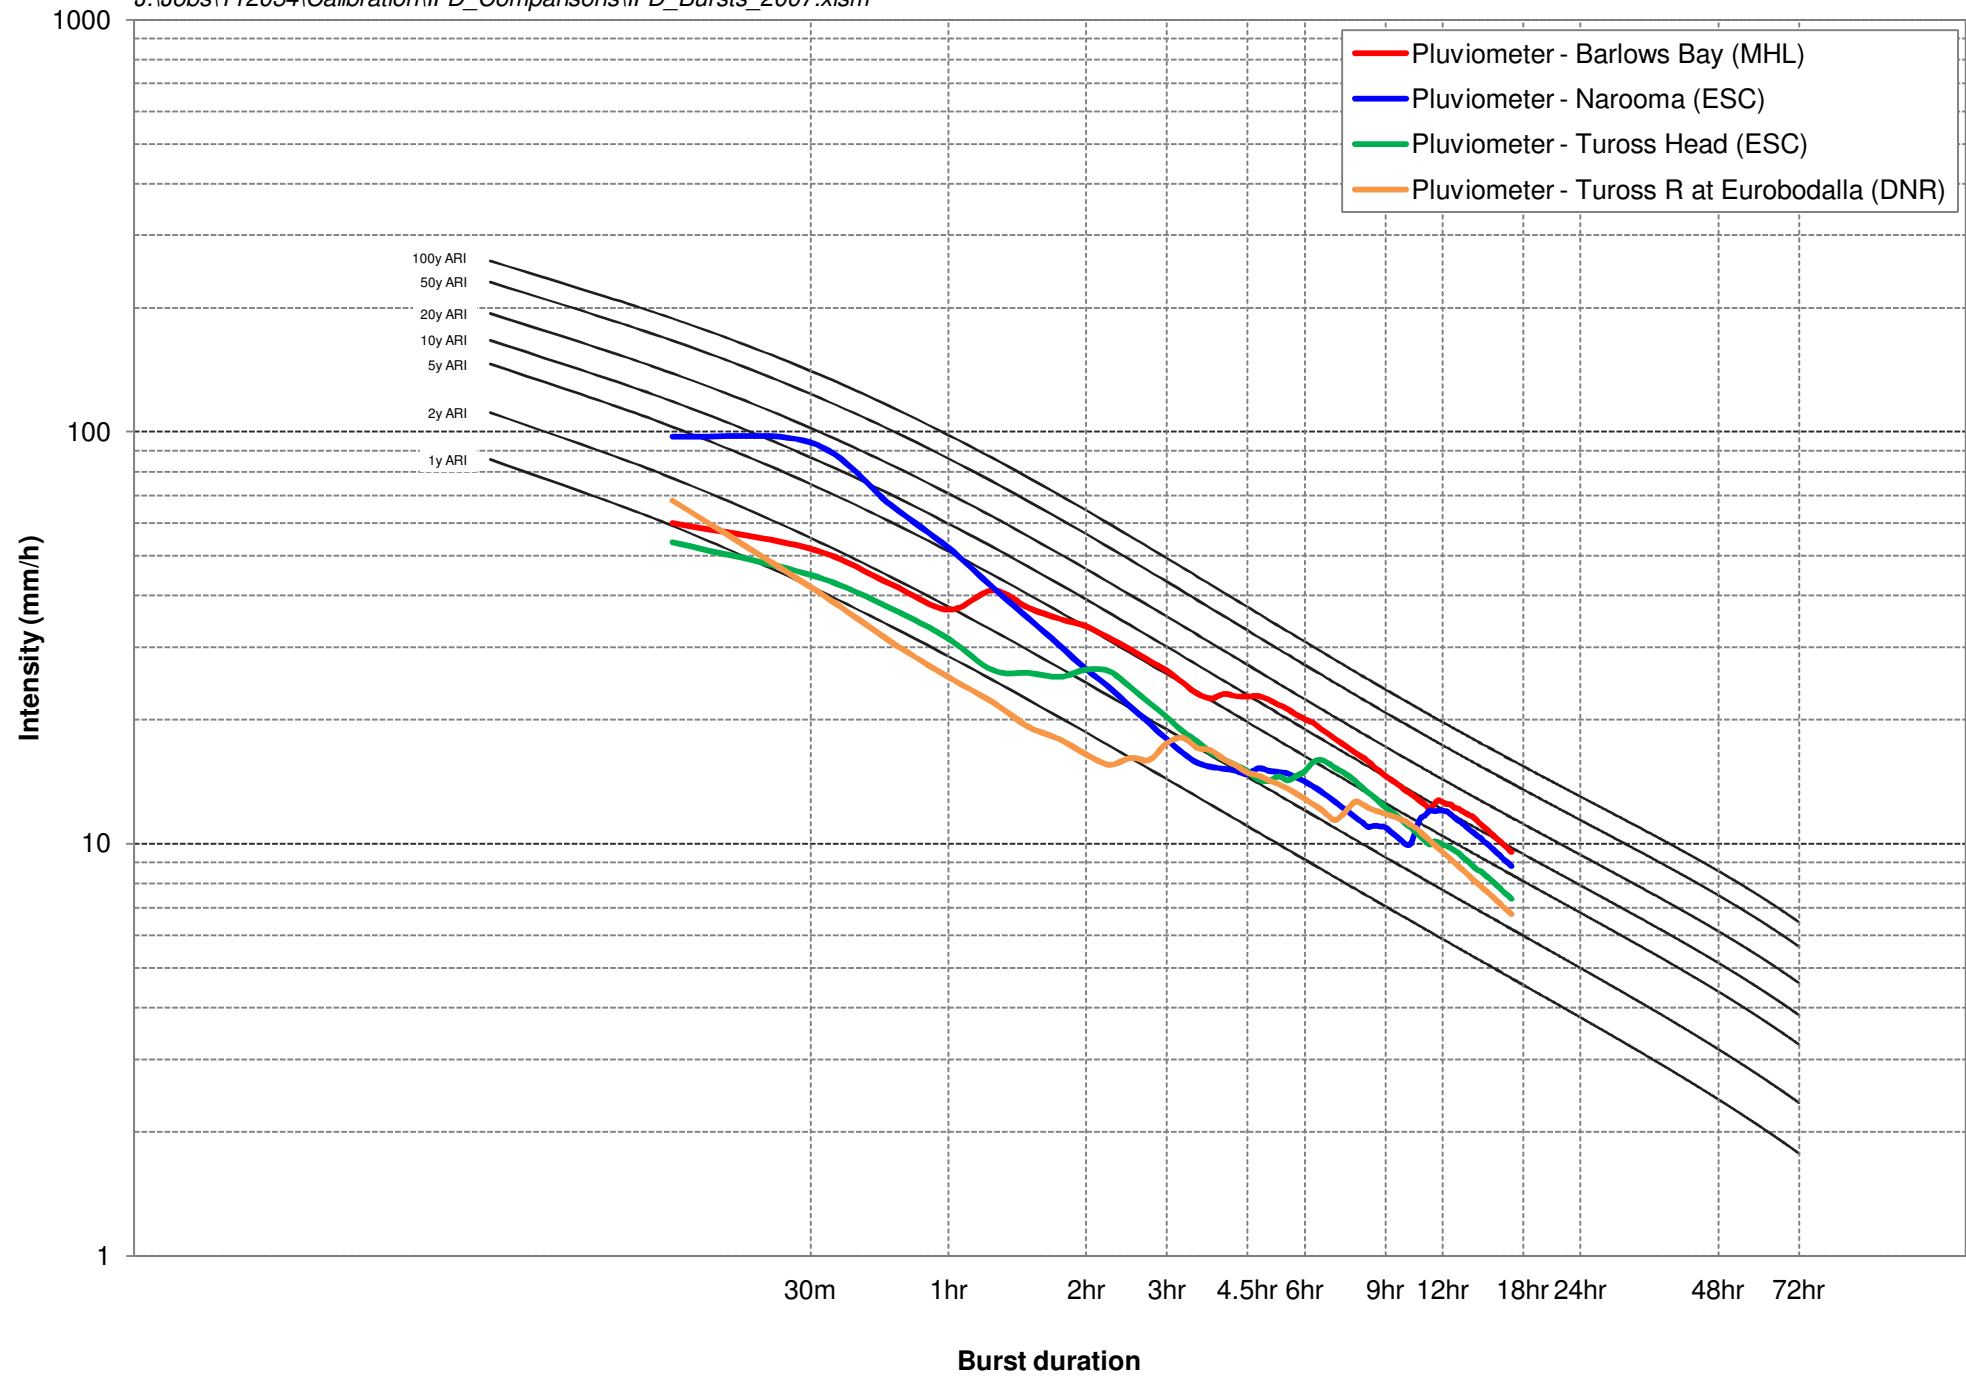
FIGURE E8  
11TH FEBRUARY 2007 EVENT  
IFD DATA

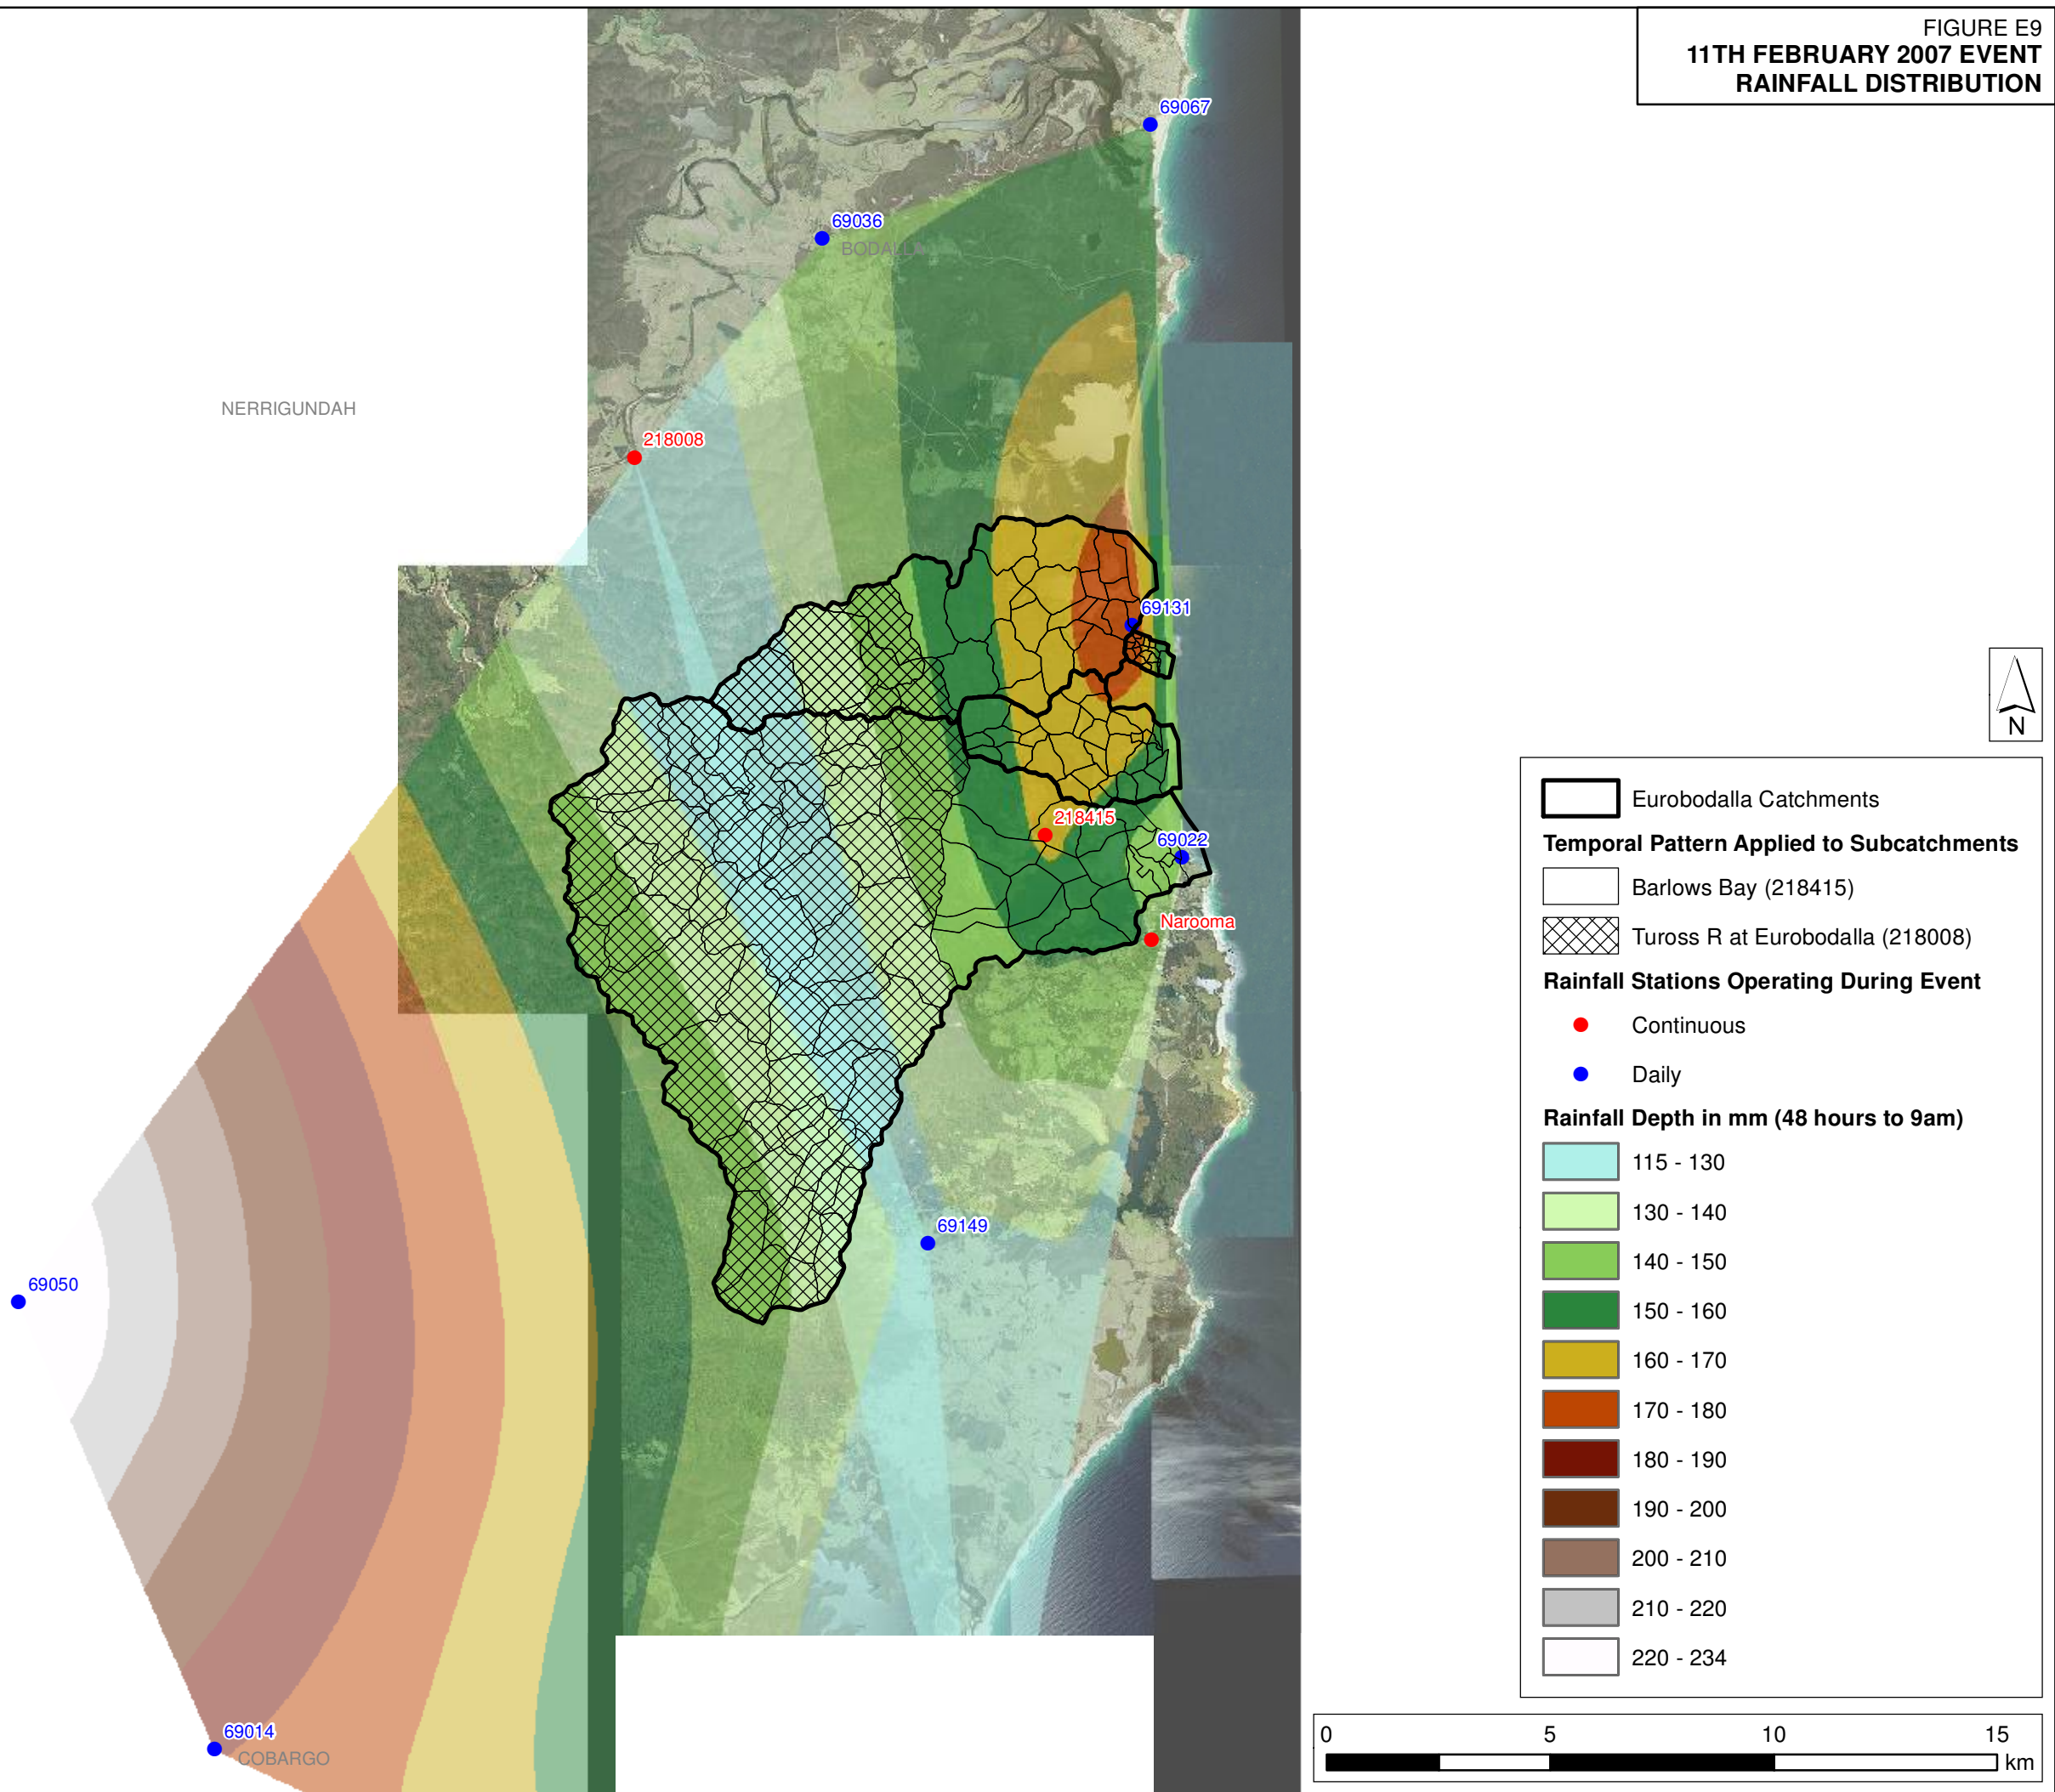
FIGURE E9  
11TH FEBRUARY 2007 EVENT  
RAINFALL DISTRIBUTION

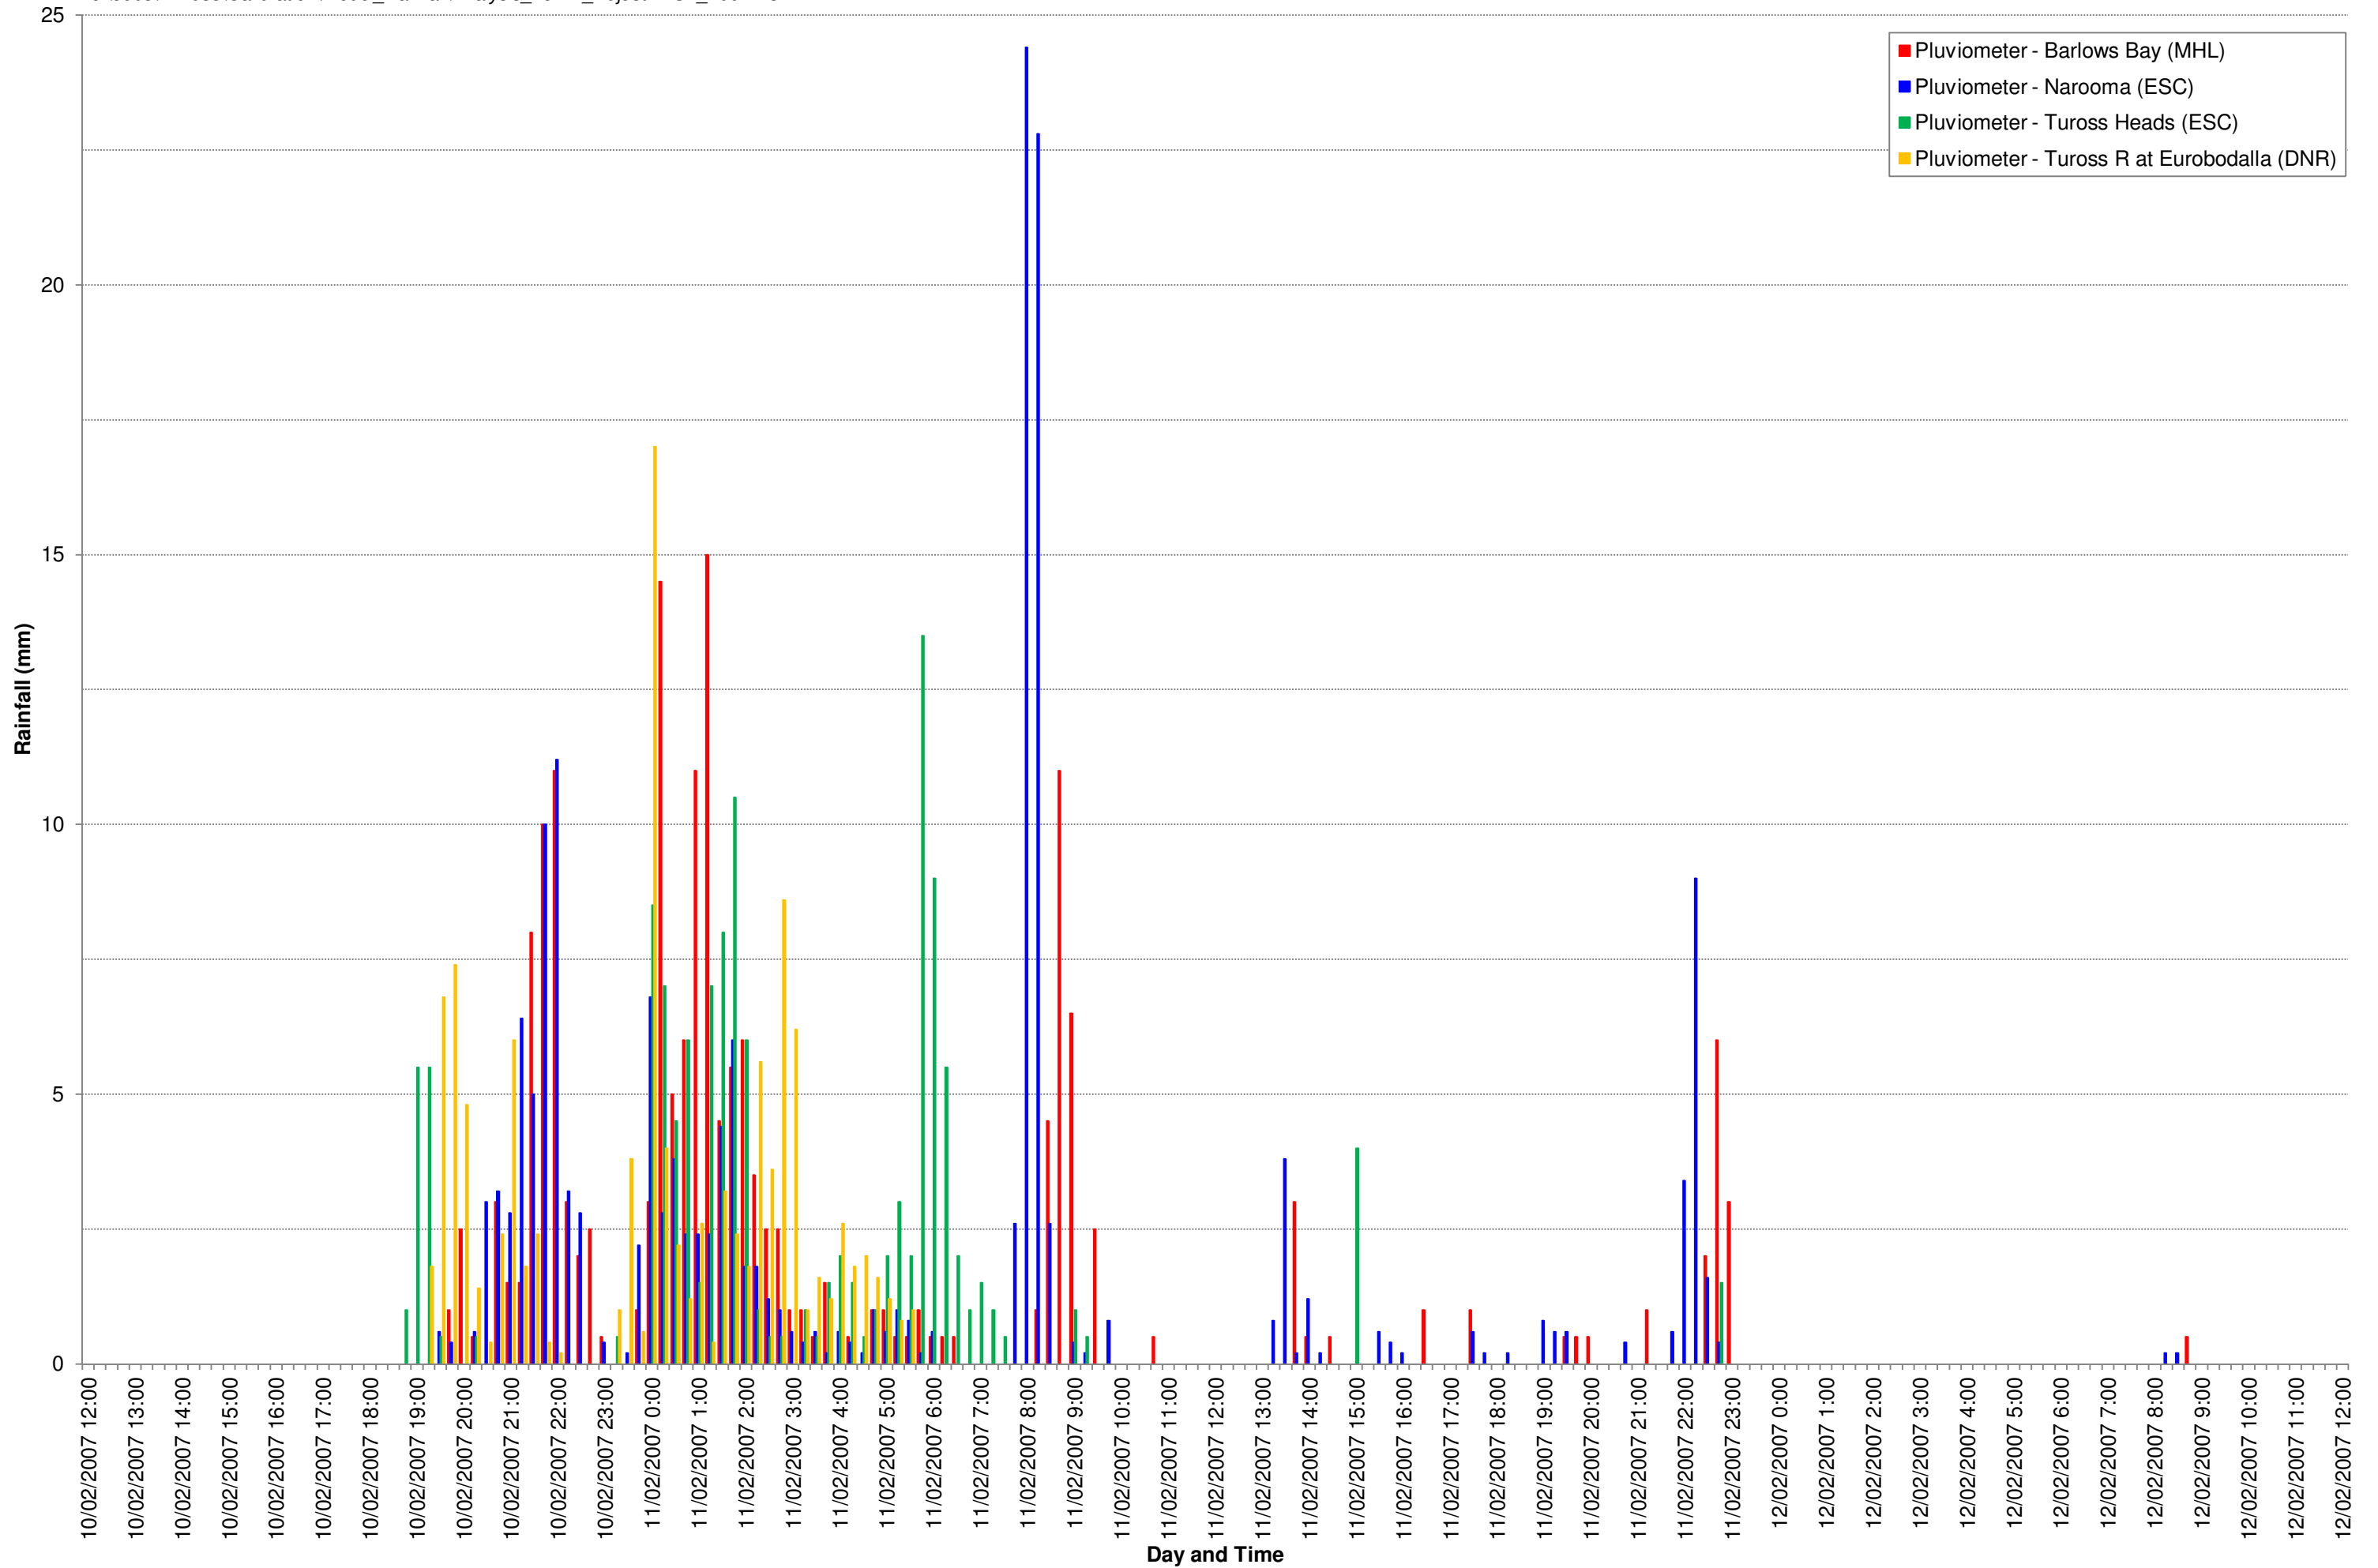
FIGURE E10  
11TH FEBRUARY 2007 EVENT  
RAINFALL HYETOGRAPH COMPARISON
