FIGURE E7A  
28TH JANUARY 1999 EVENT  
PEAK FLOOD DEPTH  
WAGONGA INLET

FIGURE E7B  
28TH JANUARY 1999 EVENT  
PEAK FLOOD DEPTH  
NAROOMA FLAT

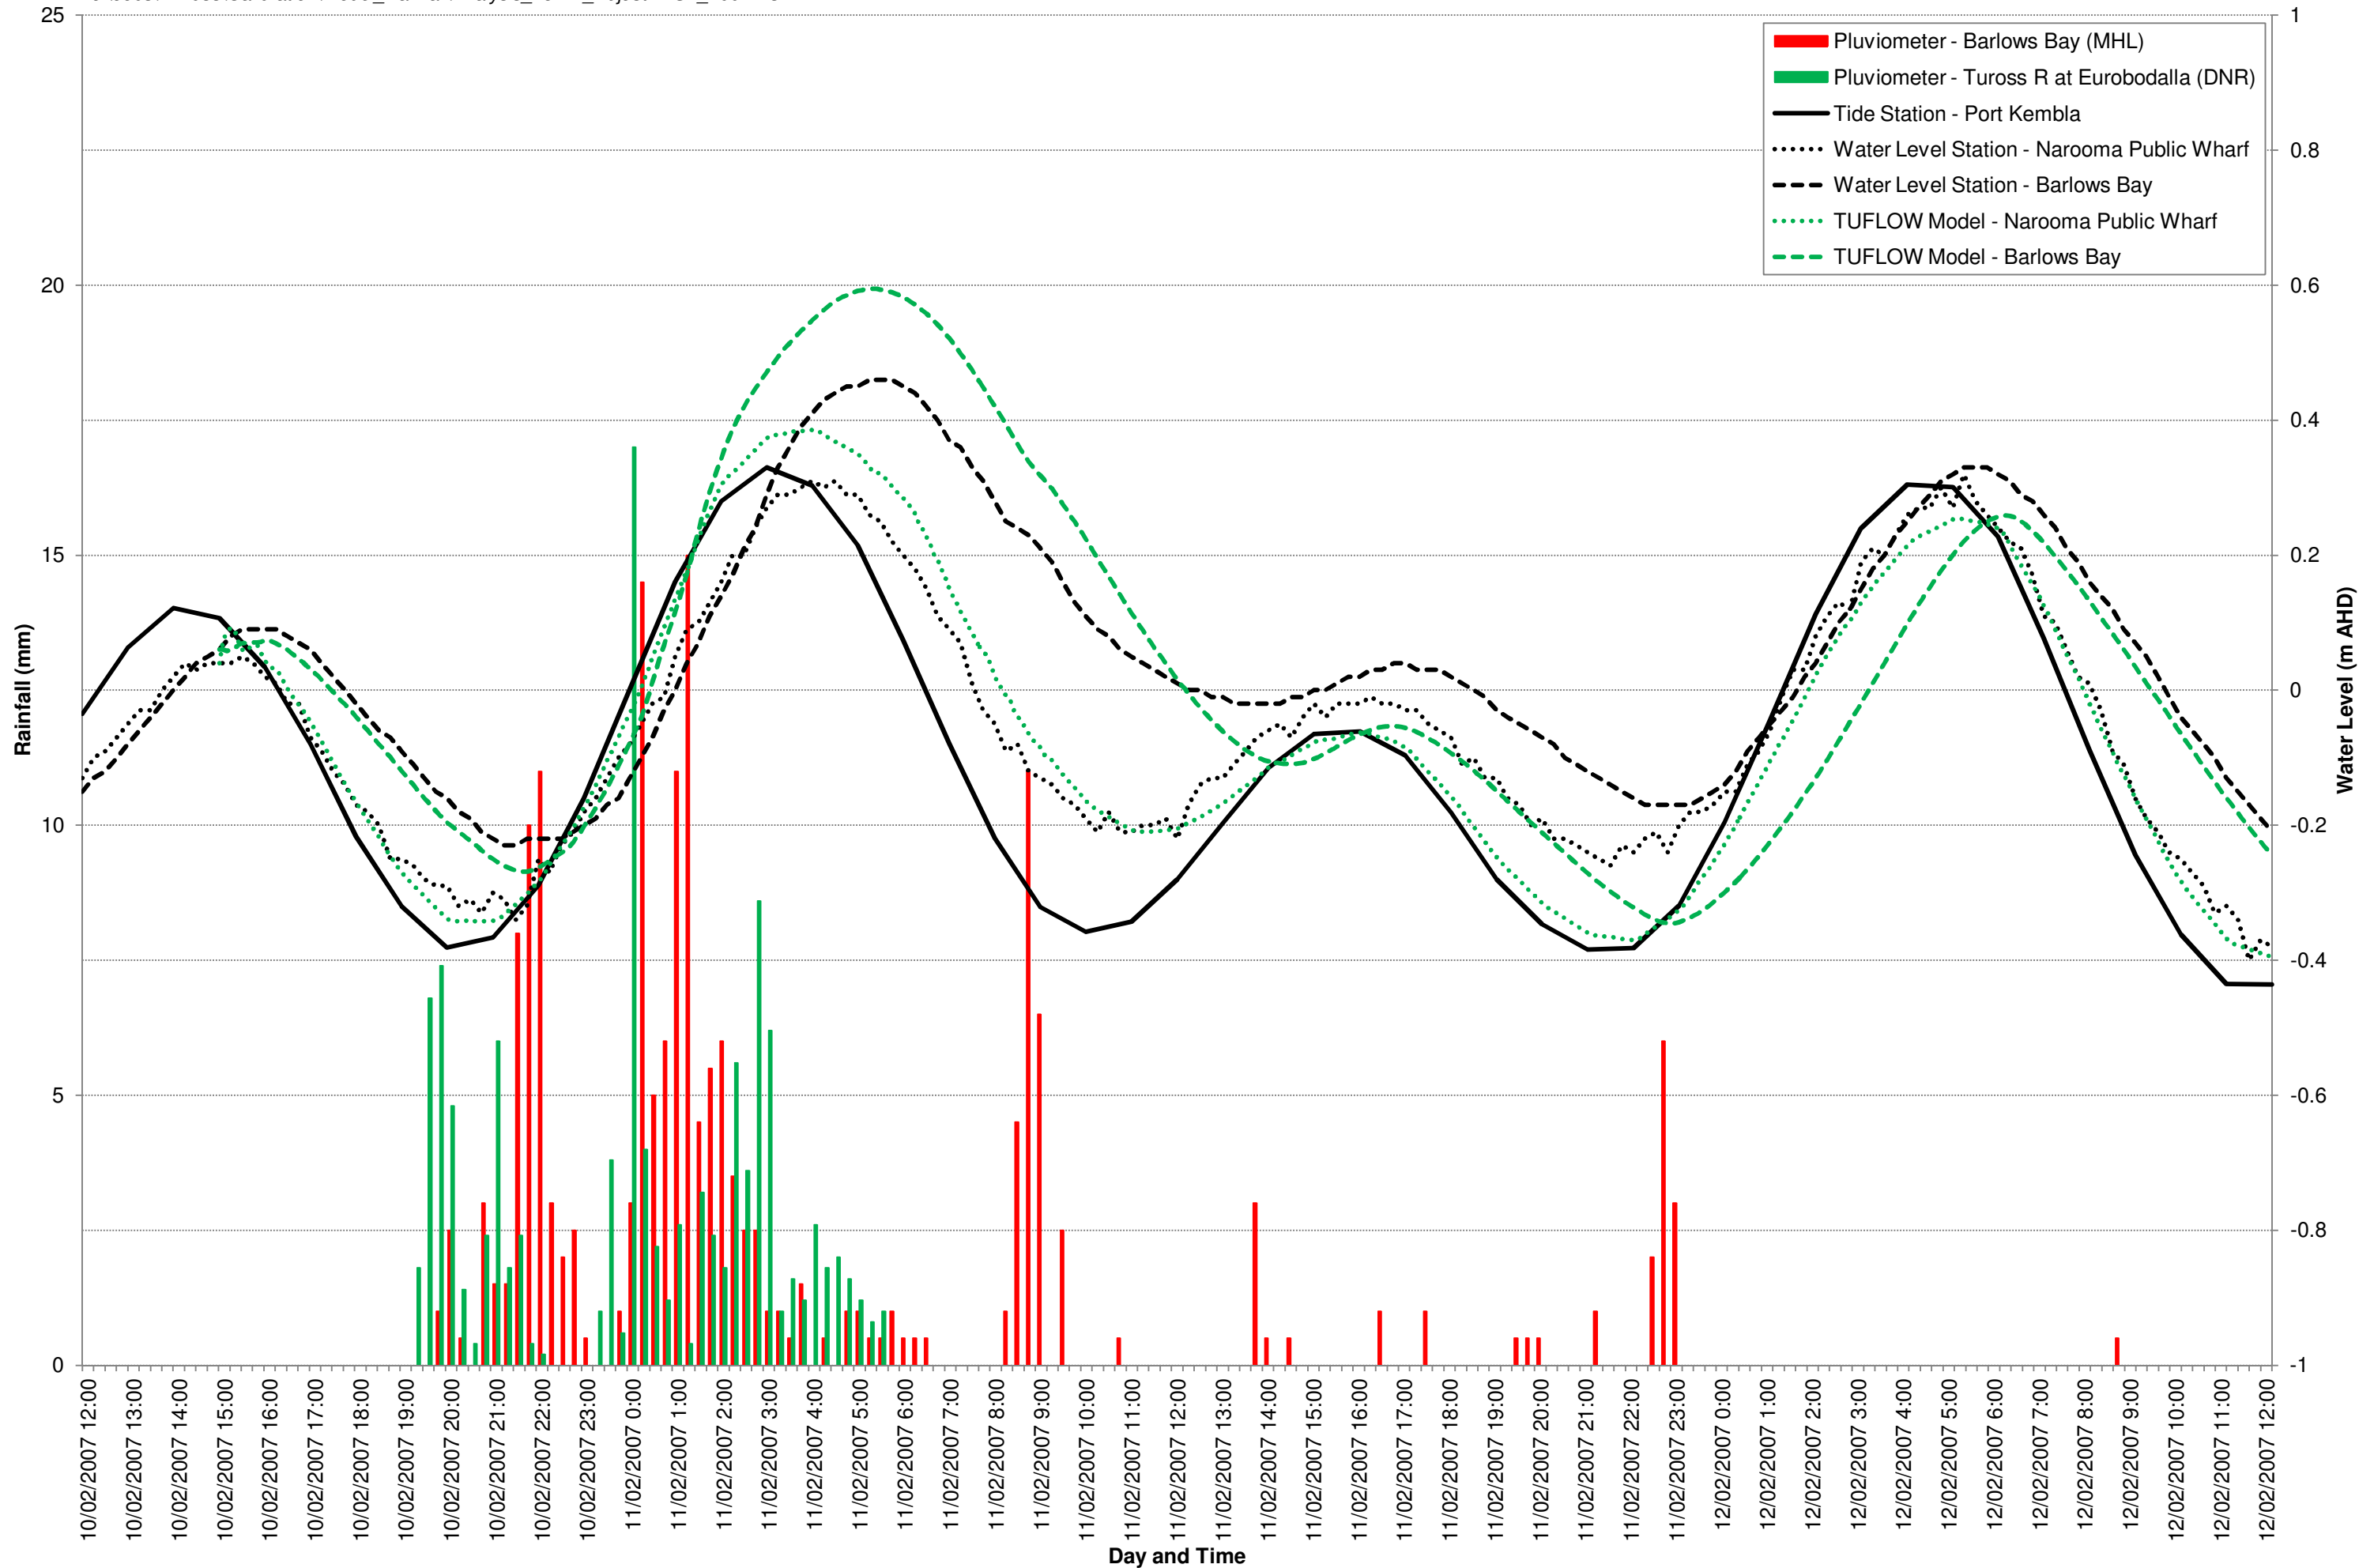
FIGURE E11  
11TH FEBRUARY 2007 EVENT  
STAGE HYDROGRAPHS

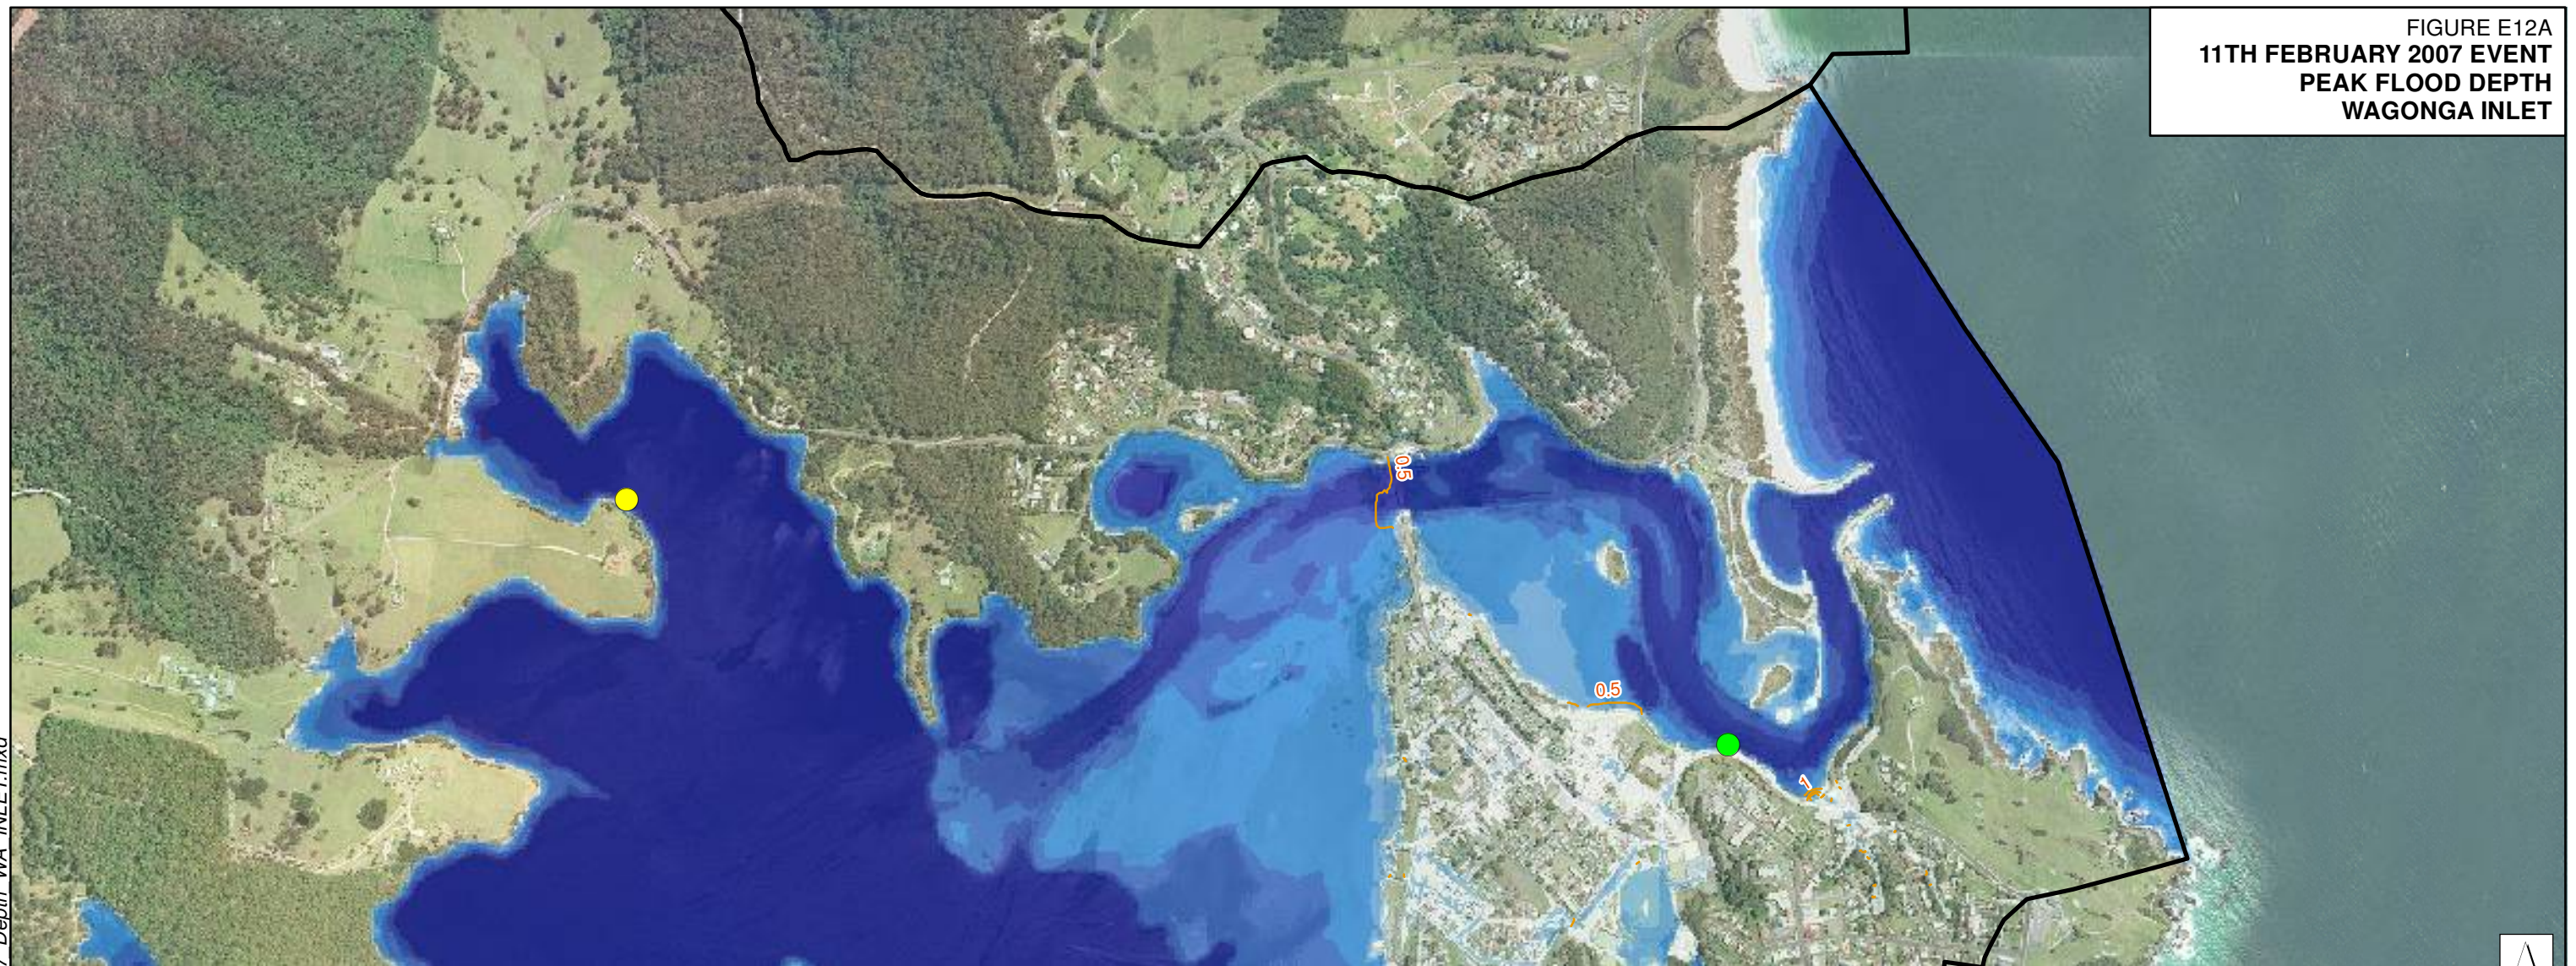
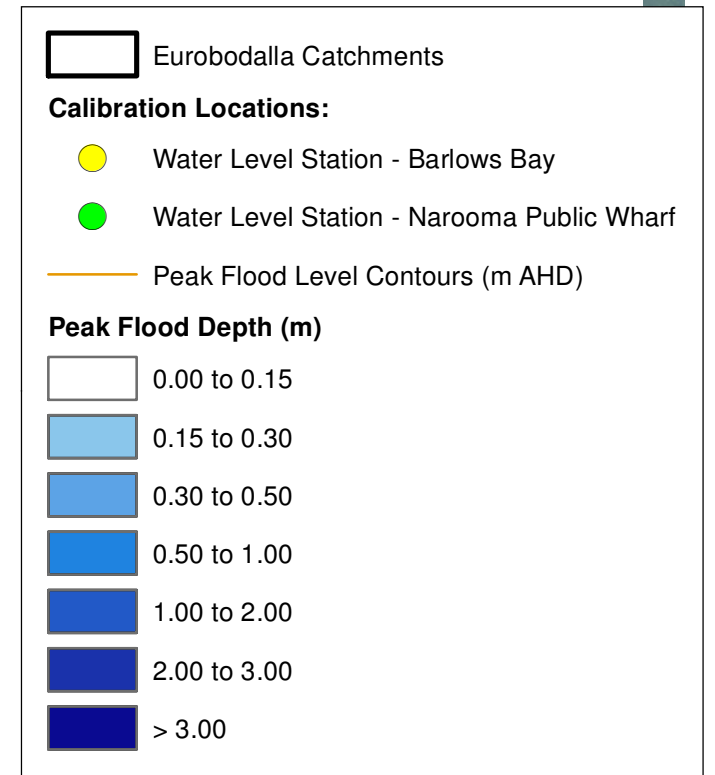
FIGURE E12A  
11TH FEBRUARY 2007 EVENT  
PEAK FLOOD DEPTH  
WAGONGA INLET

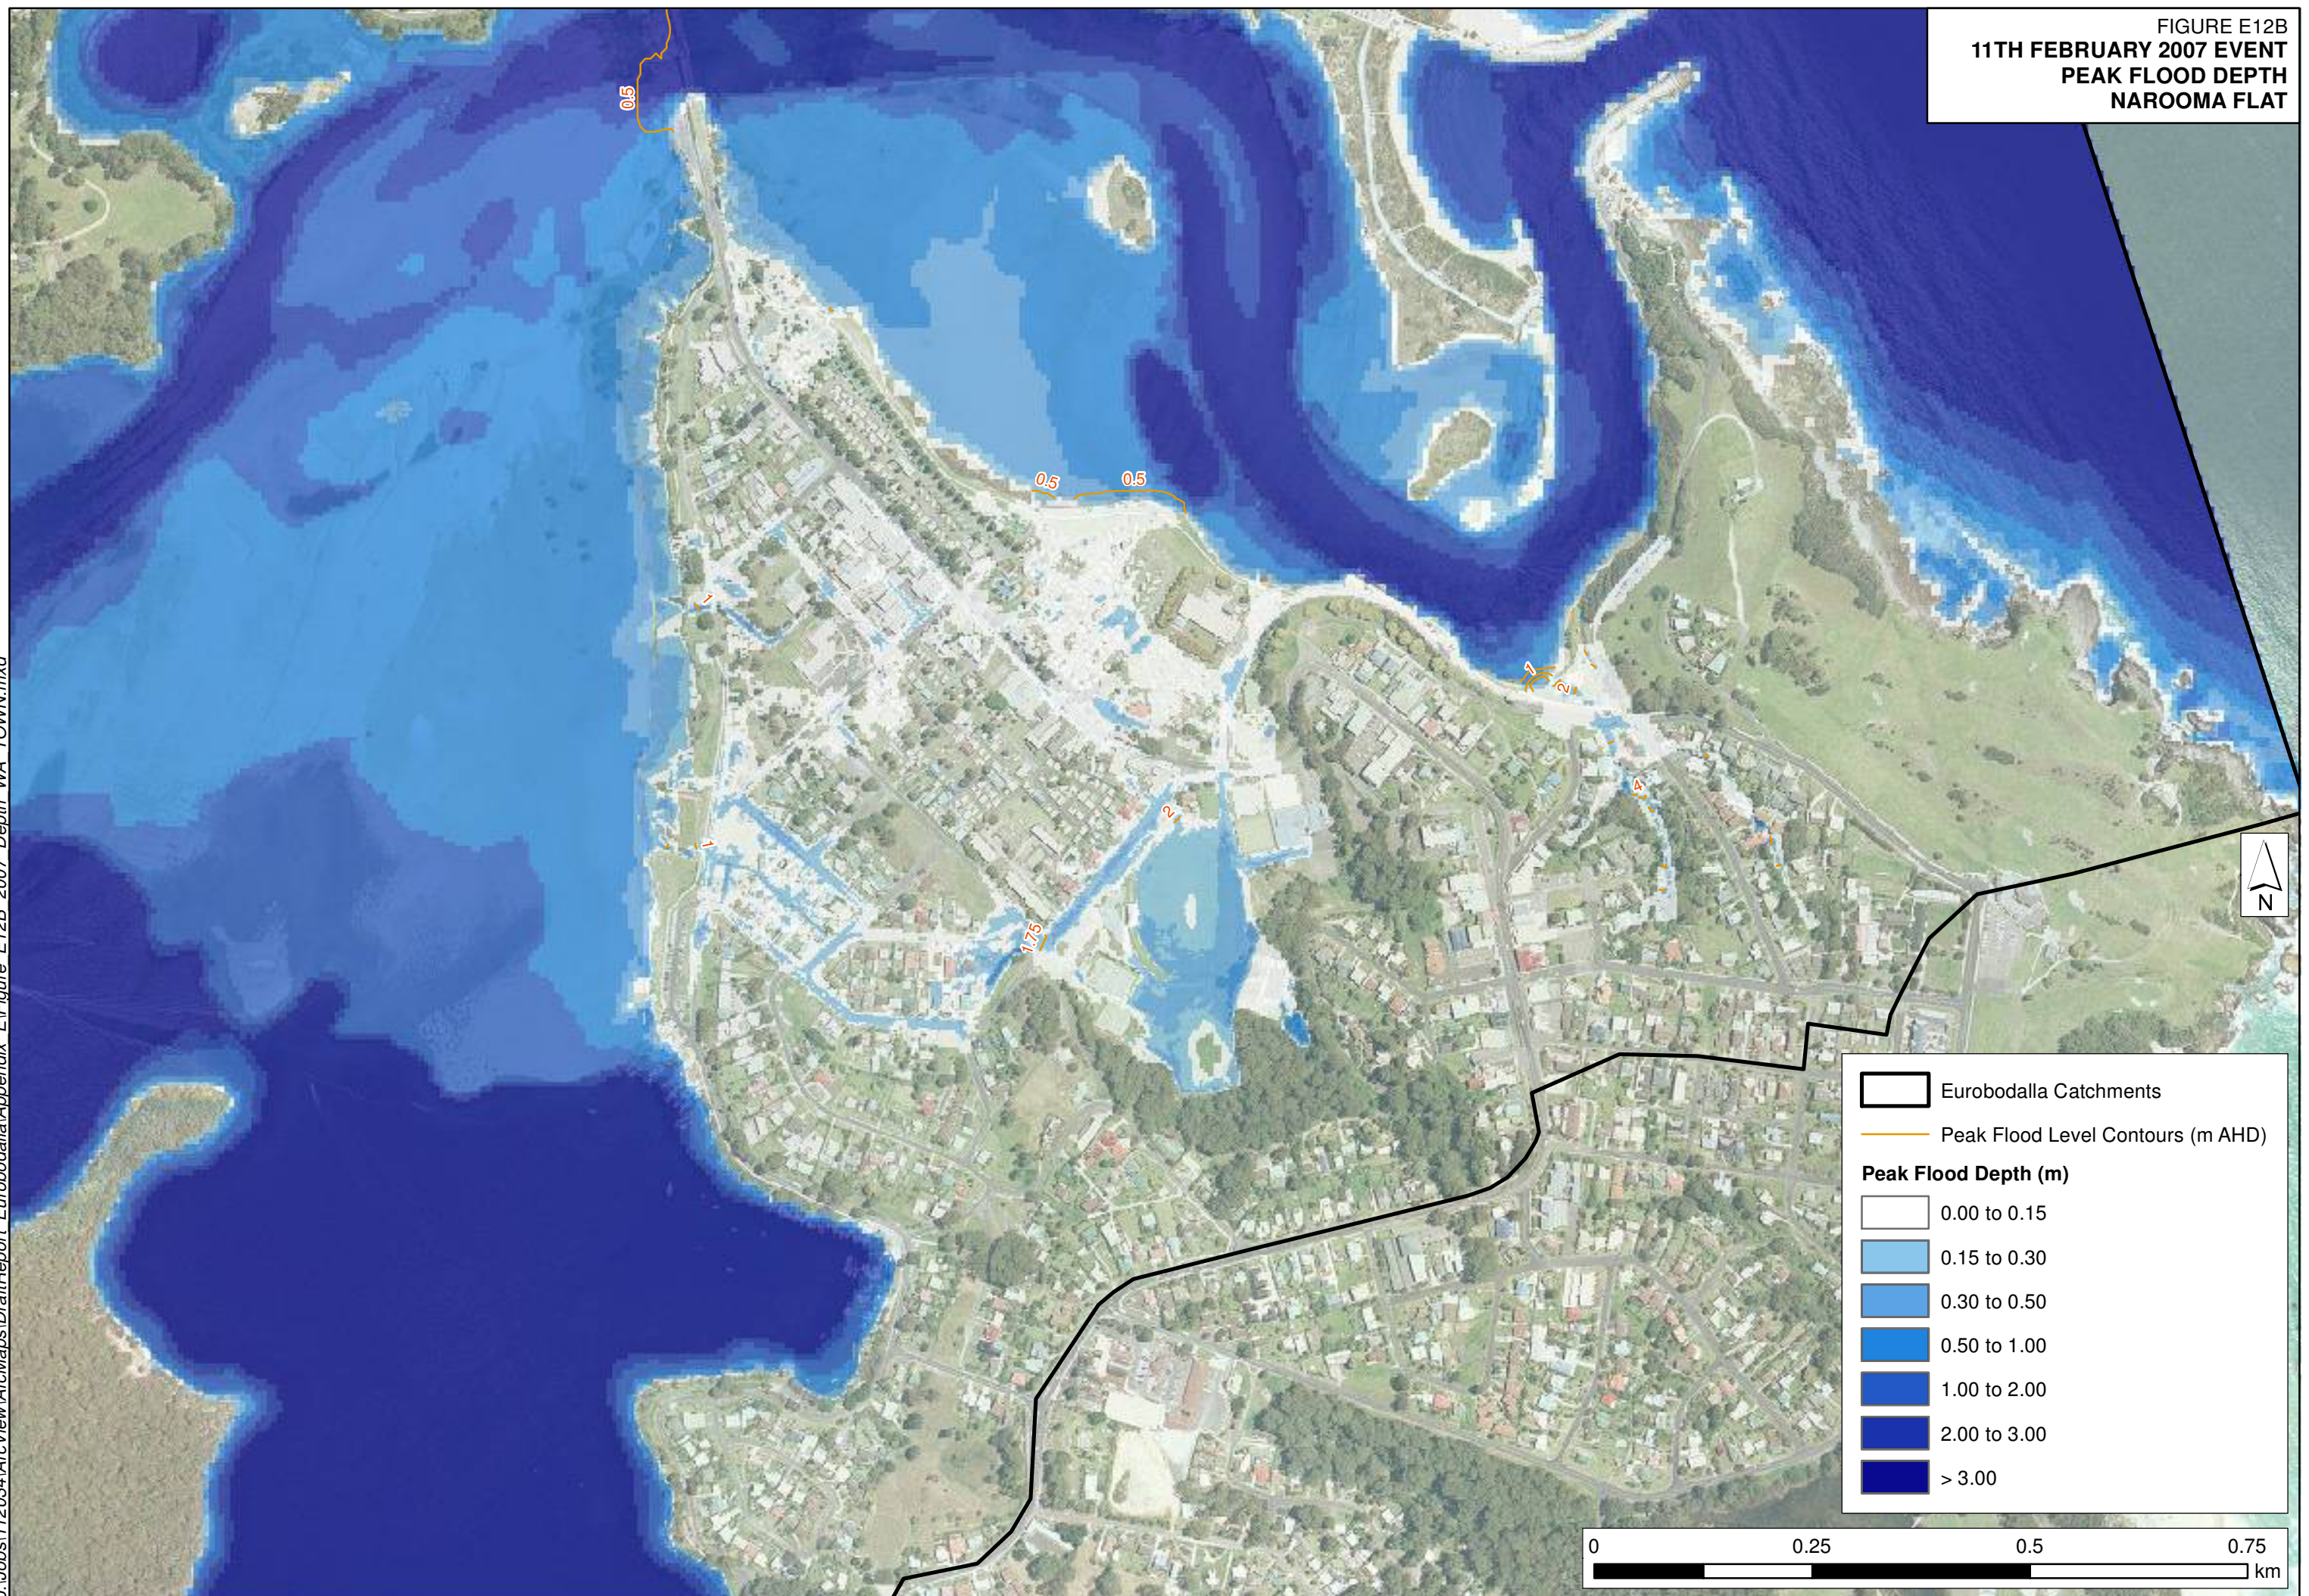
FIGURE E12B  
11TH FEBRUARY 2007 EVENT  
PEAK FLOOD DEPTH  
NAROOMA FLAT

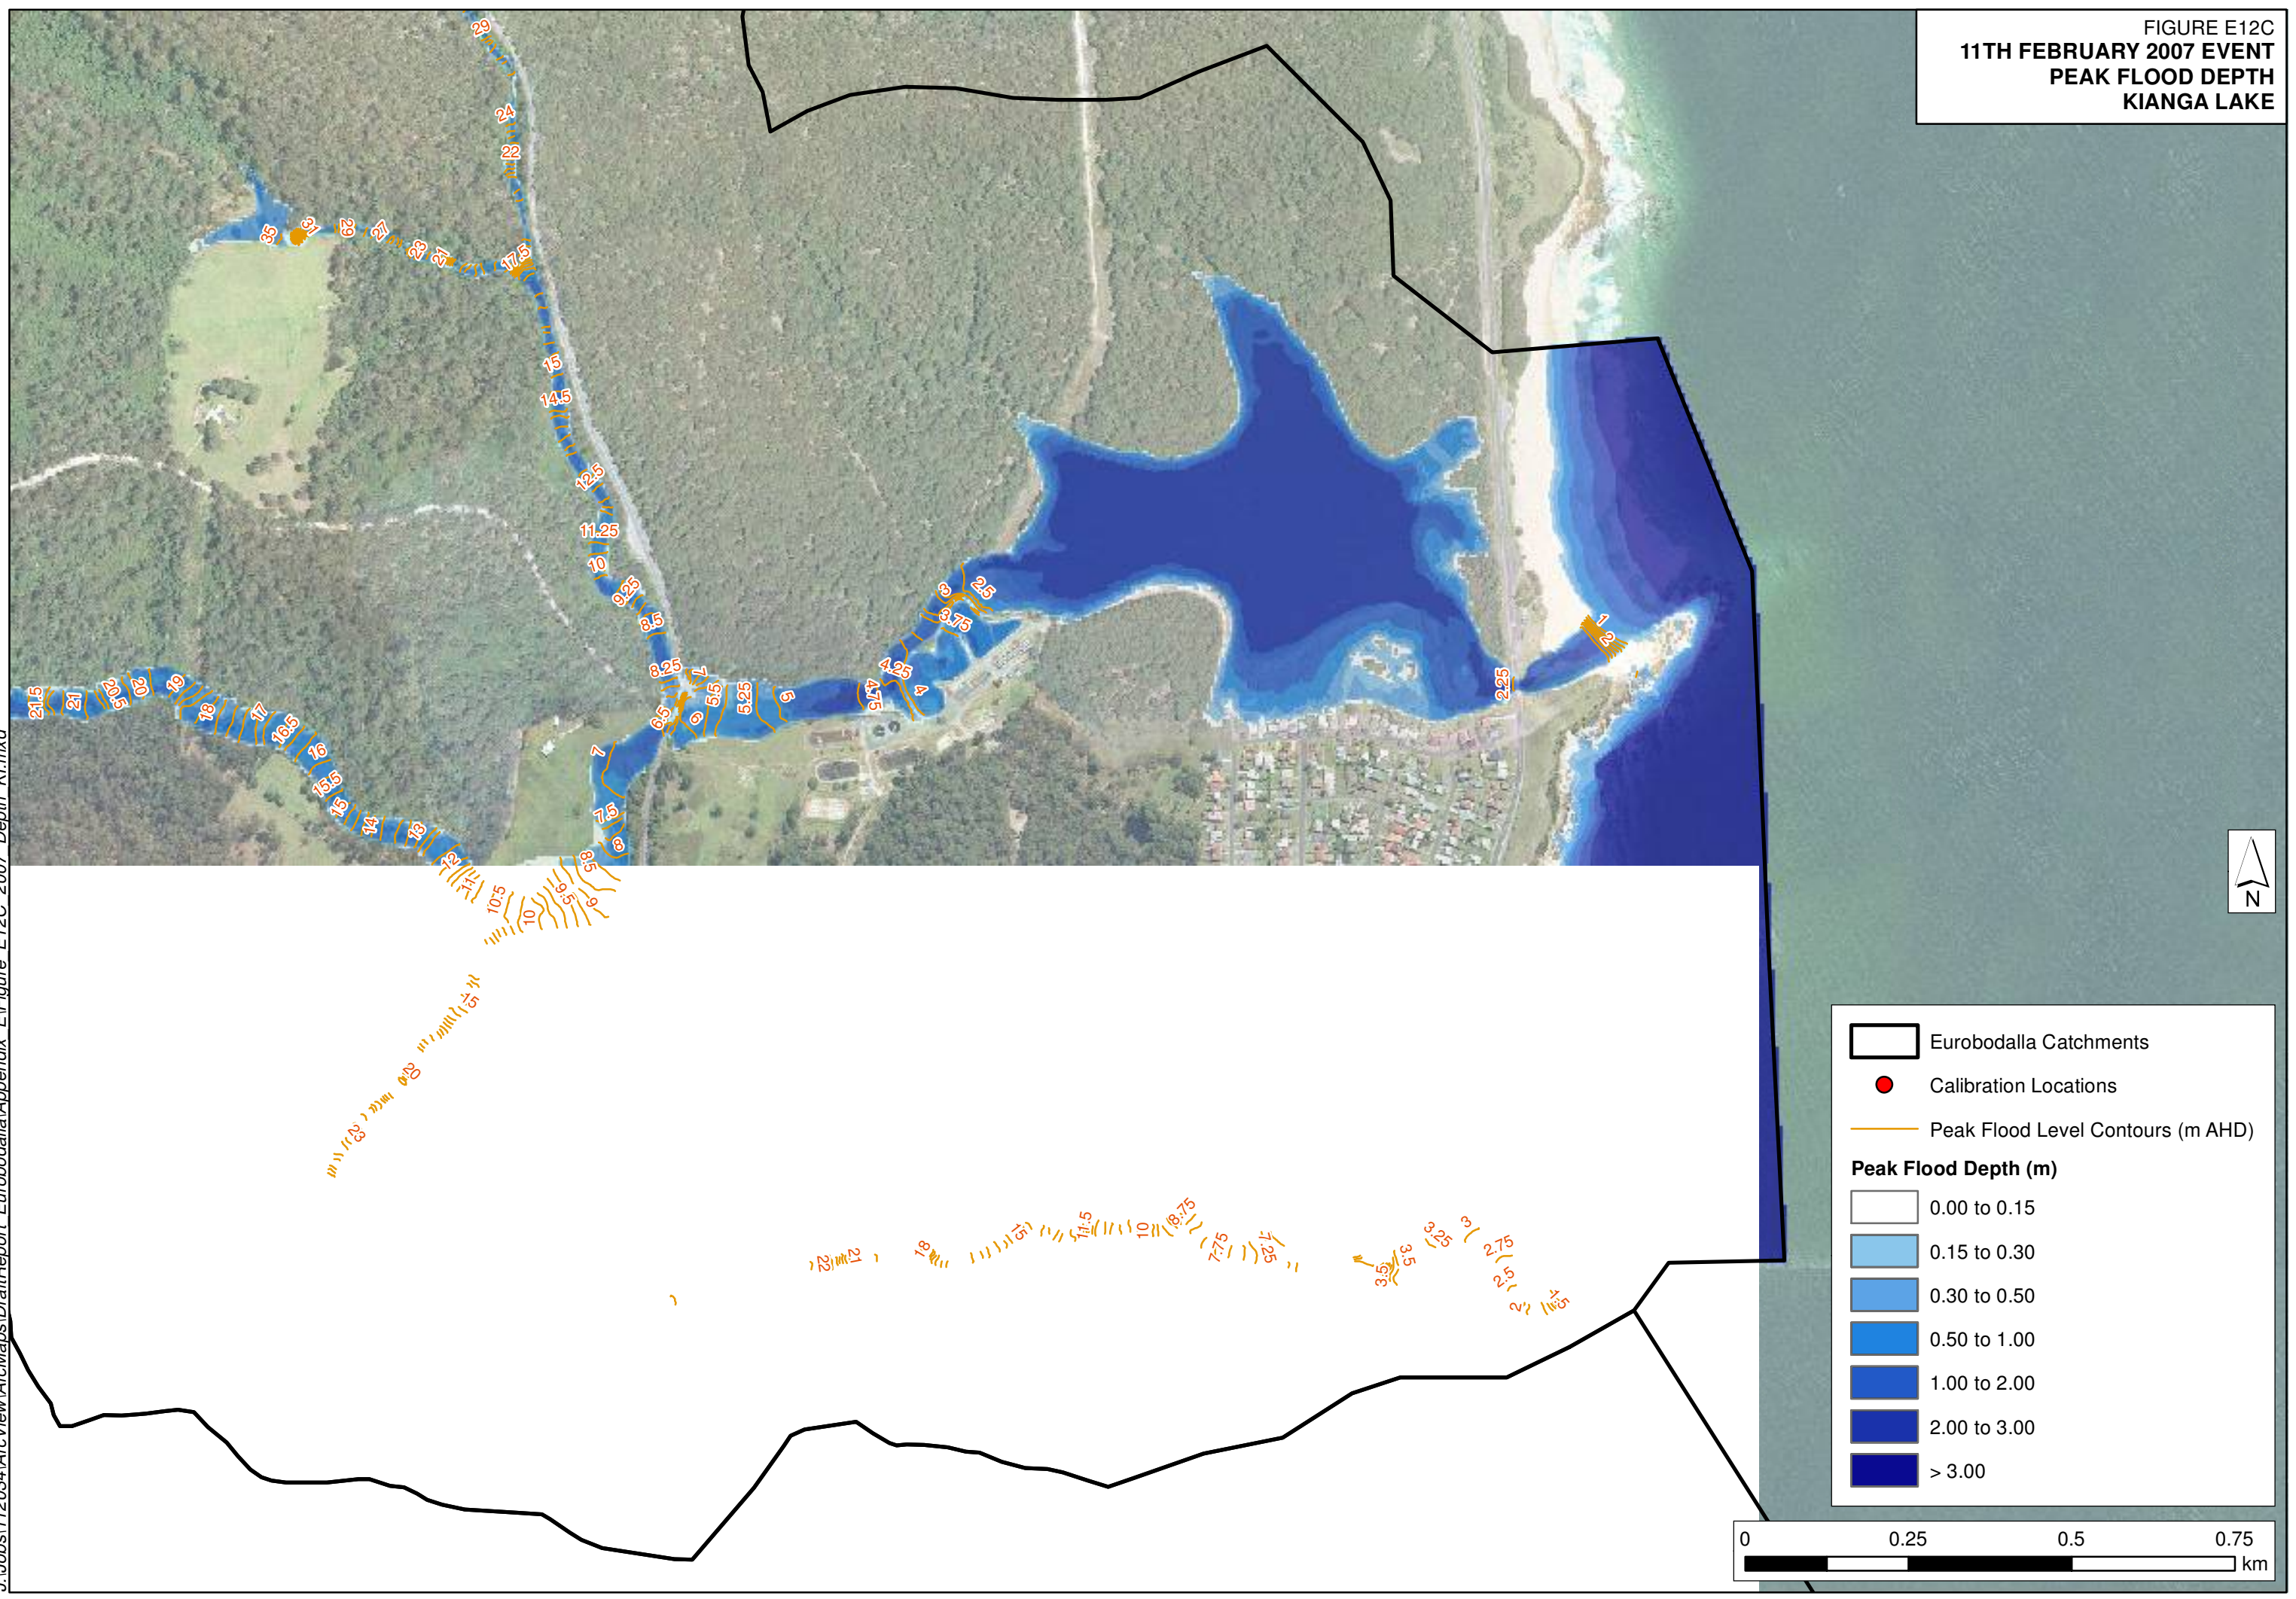
FIGURE E12C  
11TH FEBRUARY 2007 EVENT  
PEAK FLOOD DEPTH  
KIANGA LAKE

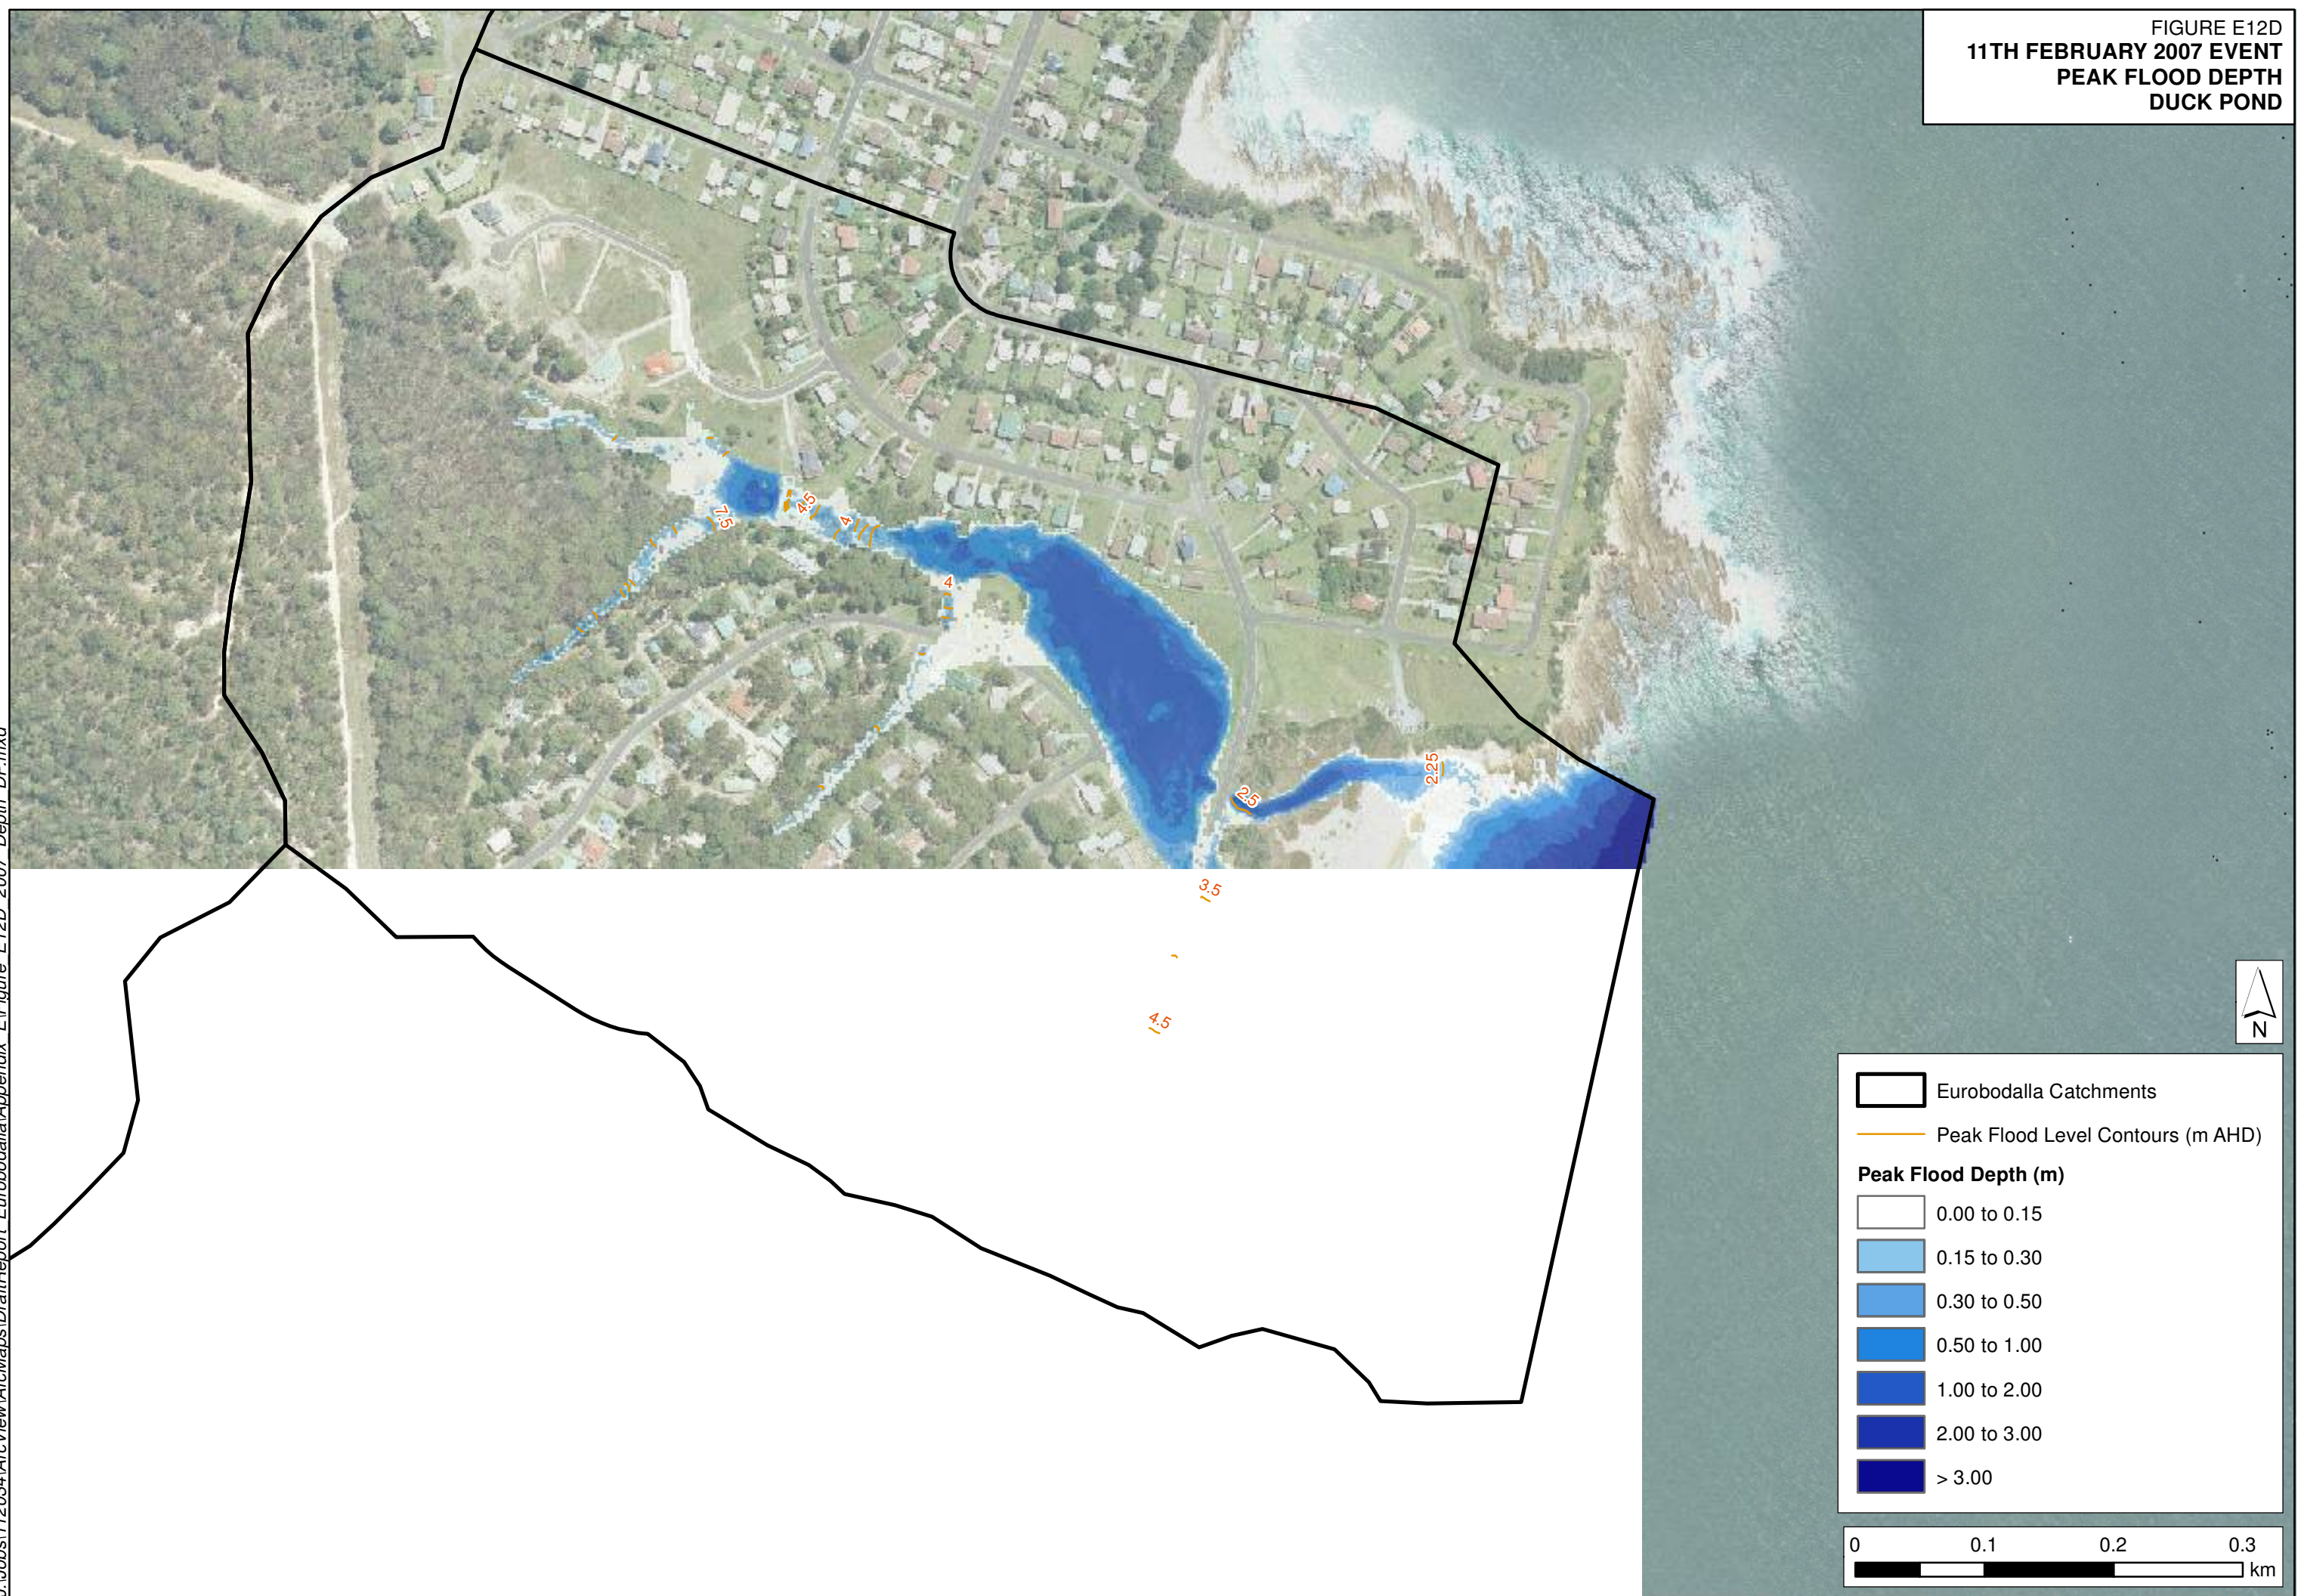
FIGURE E12D  
11TH FEBRUARY 2007 EVENT  
PEAK FLOOD DEPTH  
DUCK POND

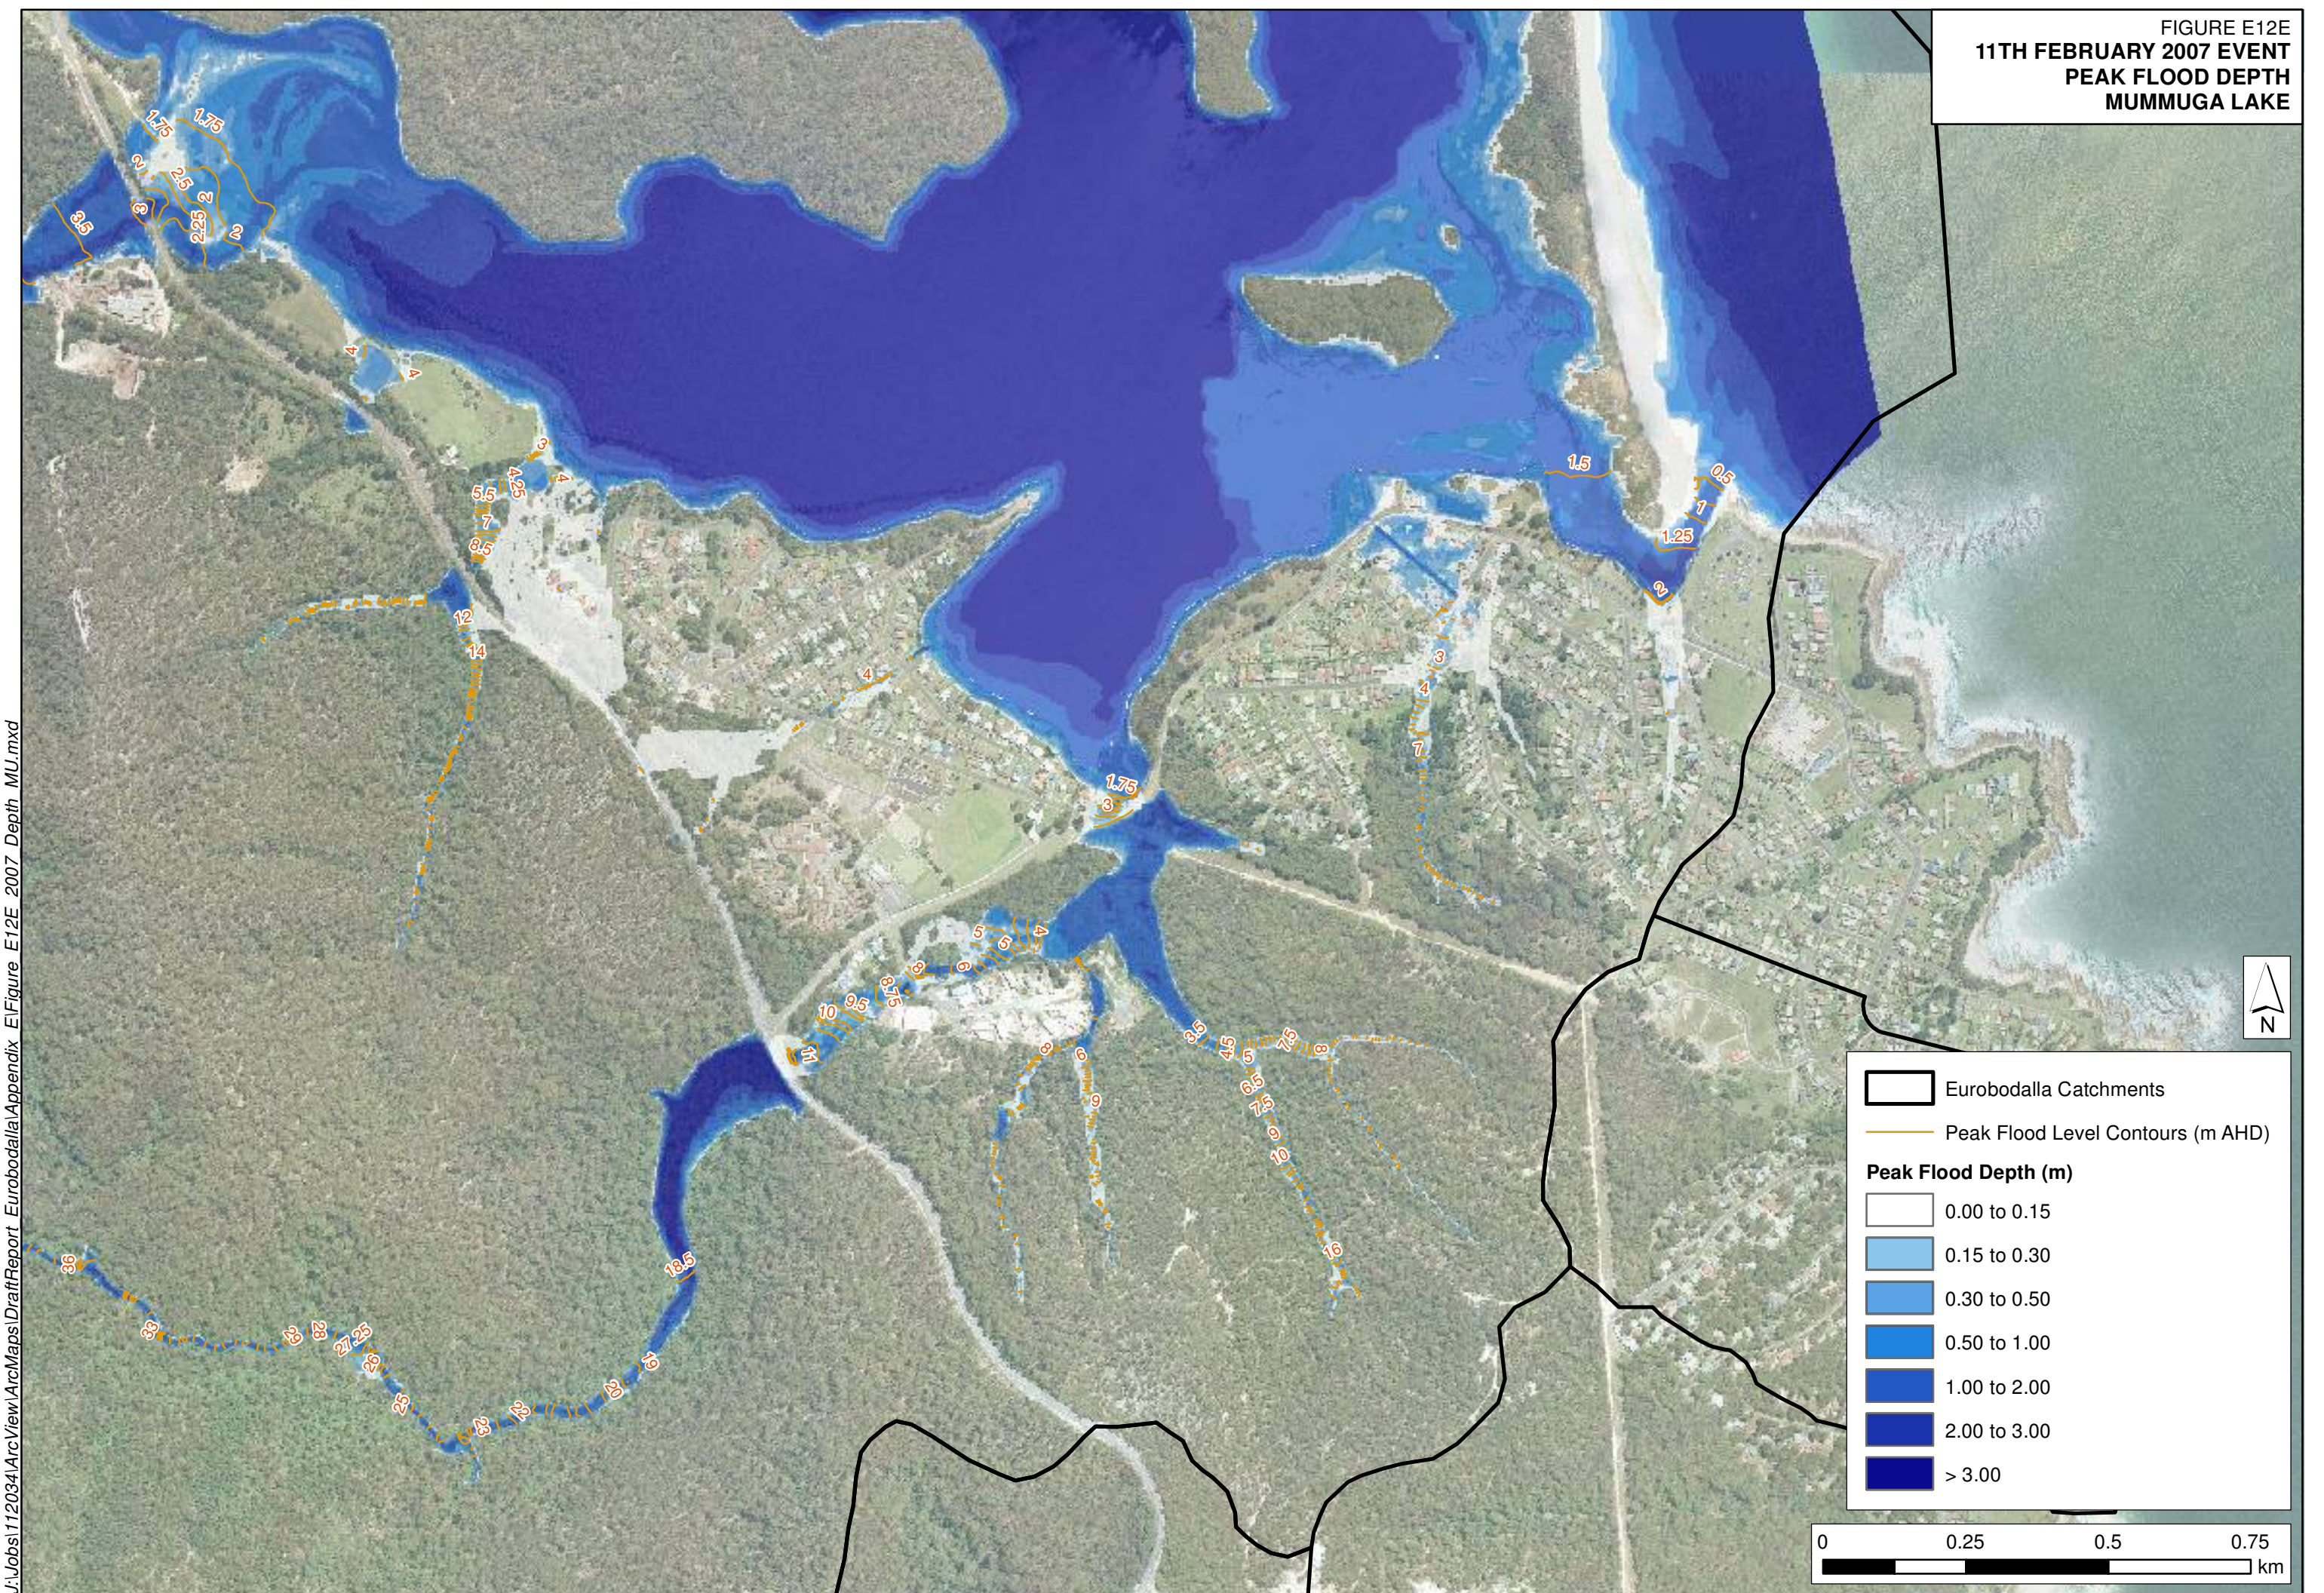
FIGURE E12E  
11TH FEBRUARY 2007 EVENT  
PEAK FLOOD DEPTH  
MUMMUGA LAKE
