FIGURE E7A  
28TH JANUARY 1999 EVENT  
PEAK FLOOD DEPTH  
WAGONGA INLET

FIGURE E7B  
28TH JANUARY 1999 EVENT  
PEAK FLOOD DEPTH  
NAROOMA FLAT

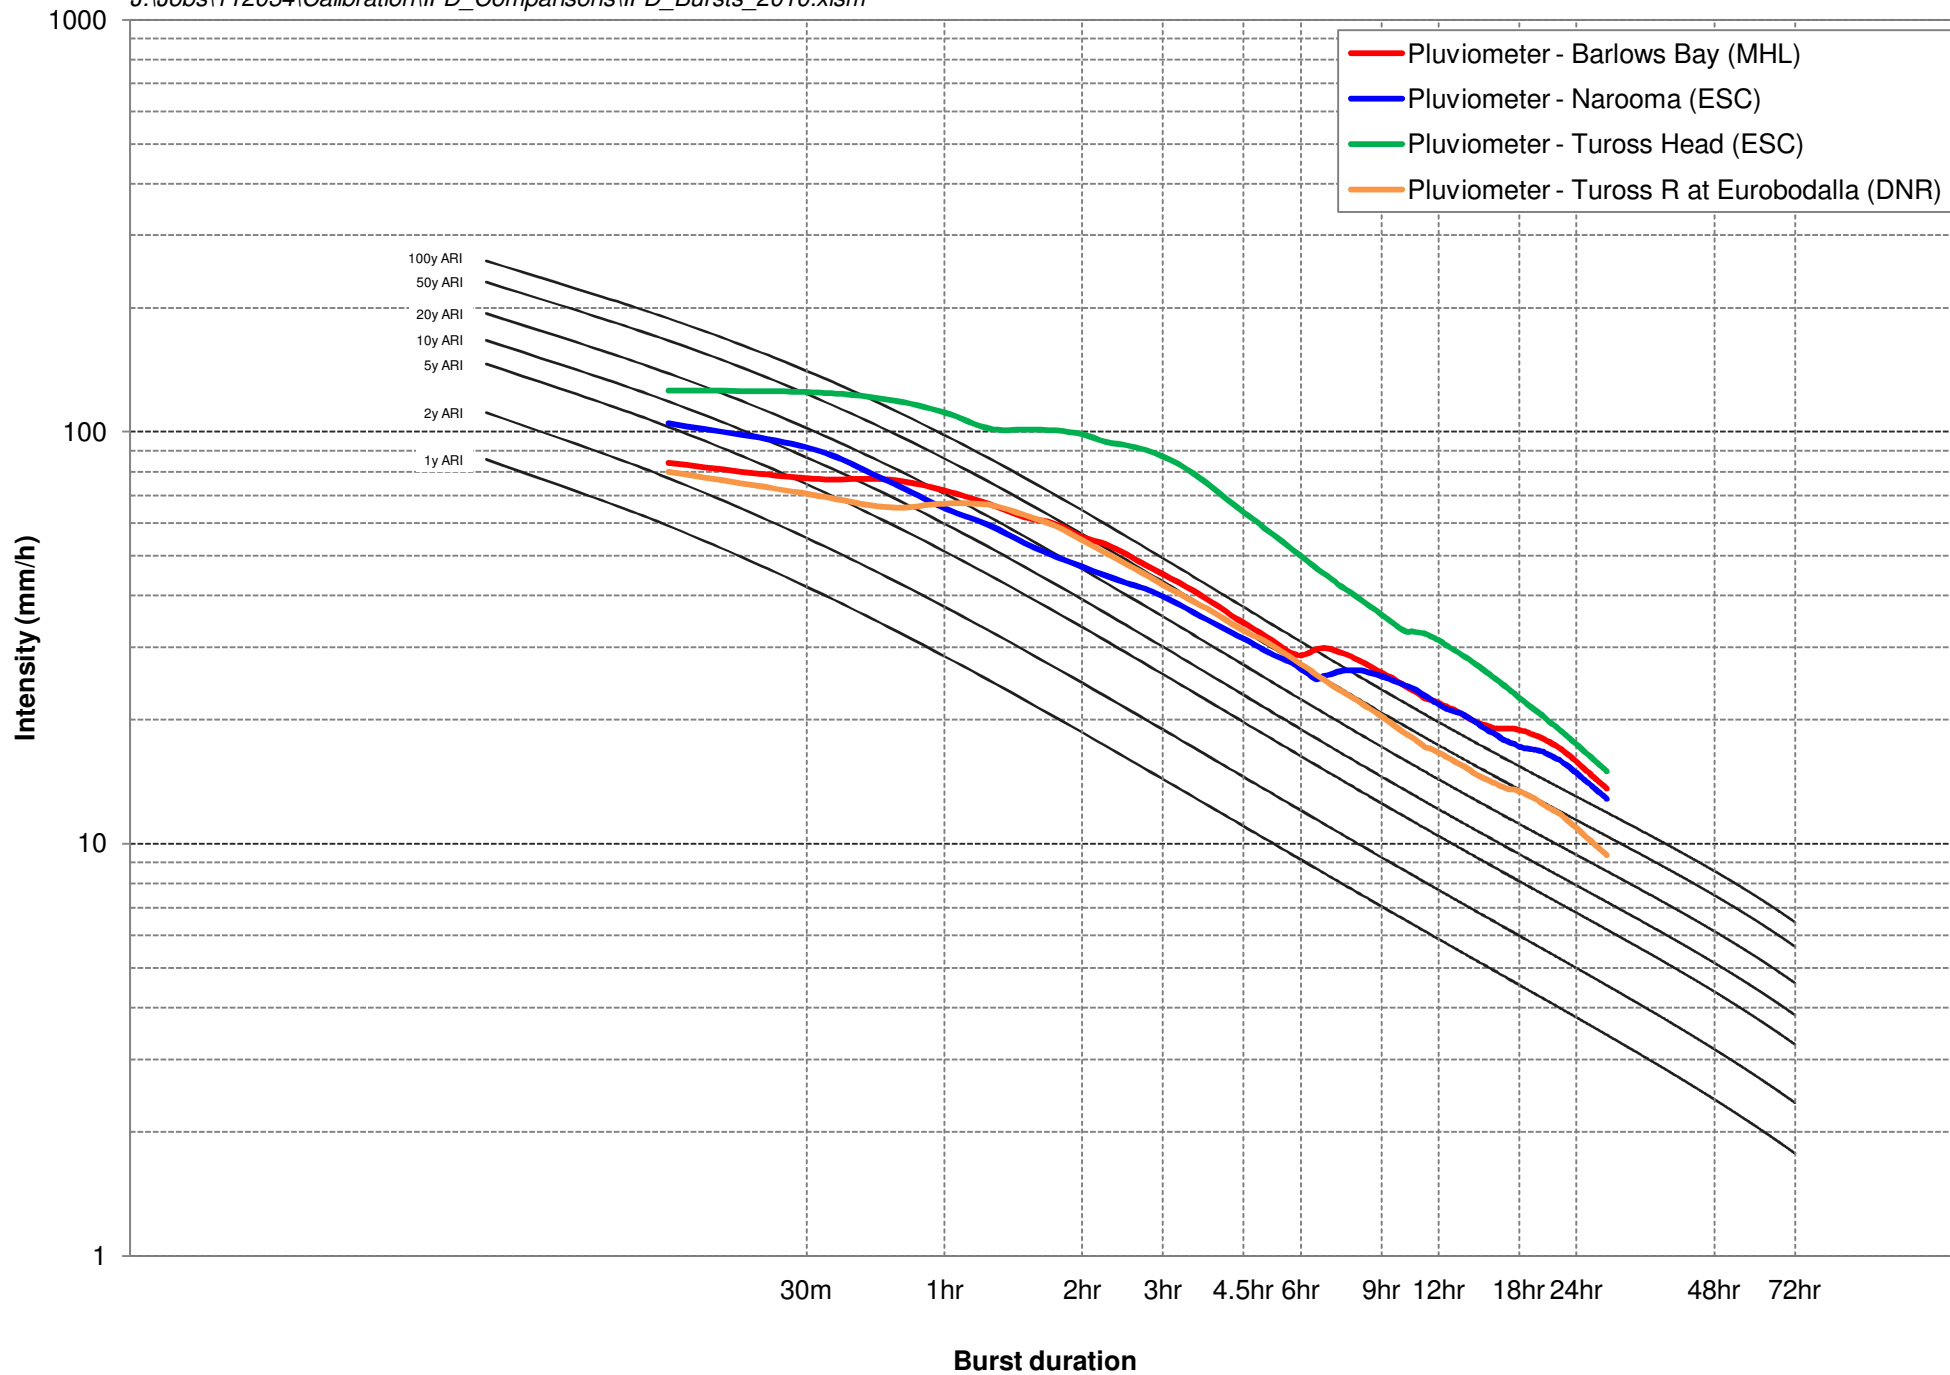
FIGURE E13  
15TH FEBRUARY 2010 EVENT  
IFD DATA

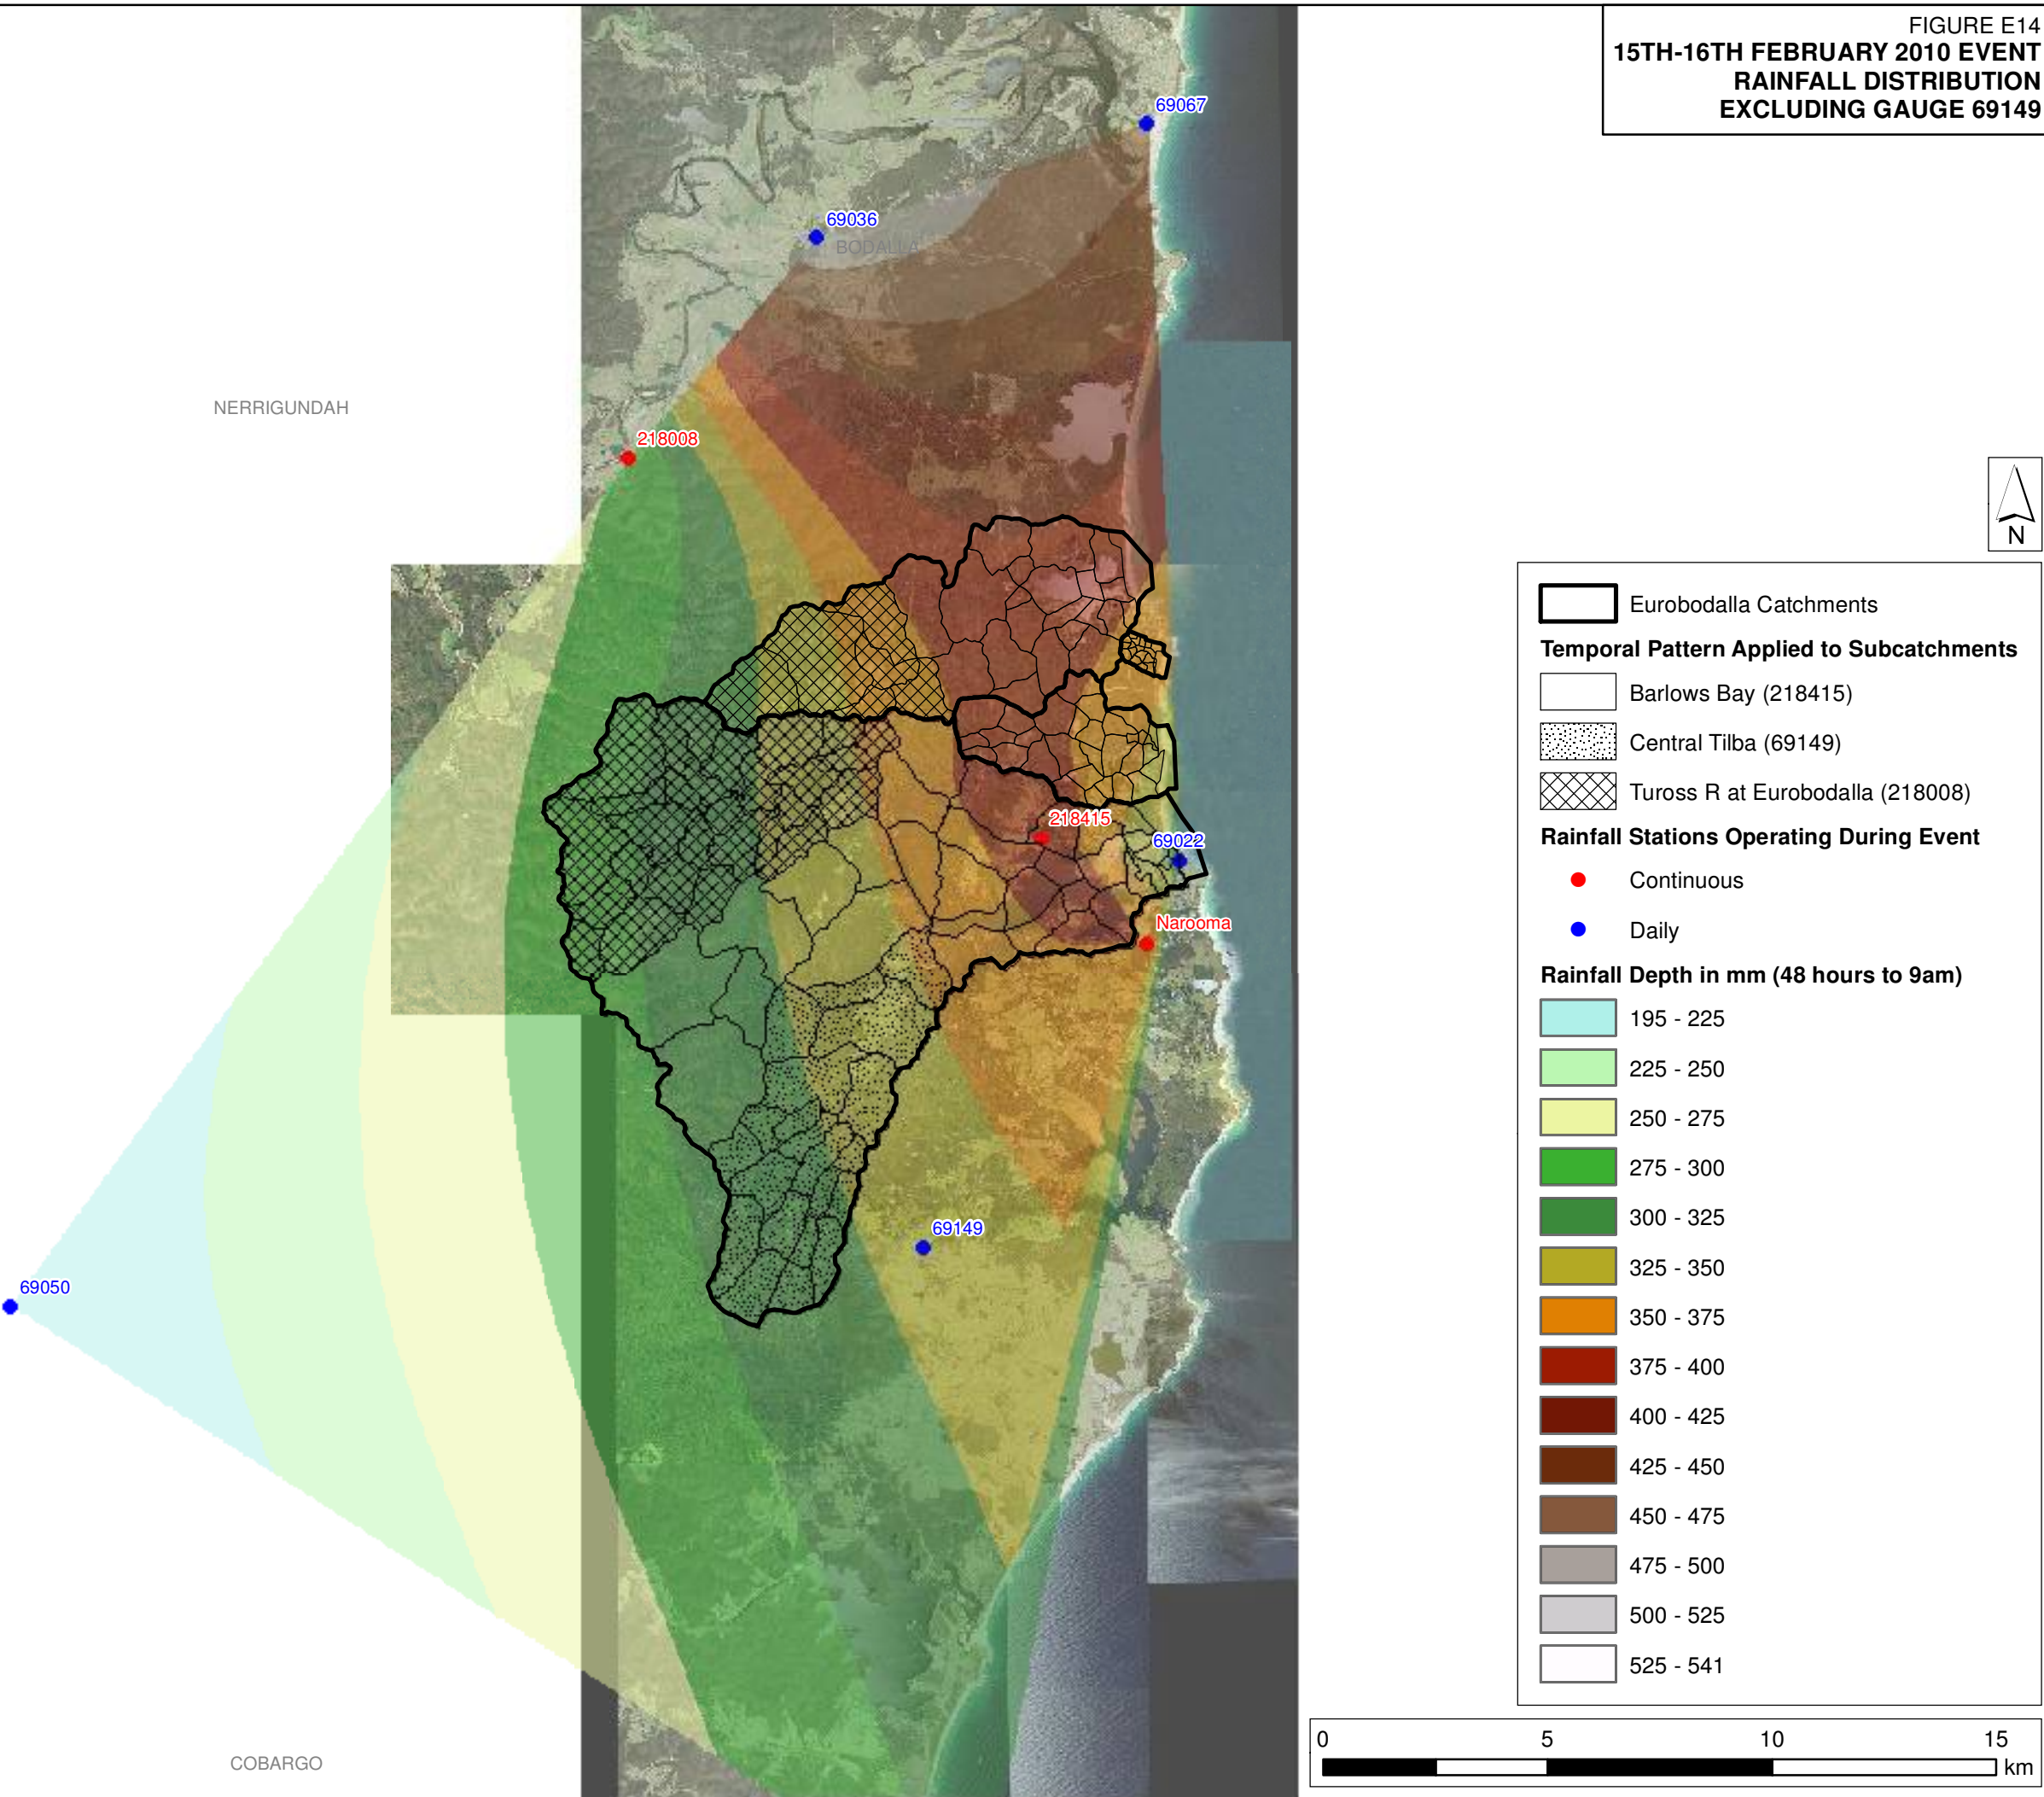
FIGURE E14  
15TH-16TH FEBRUARY 2010 EVENT  
RAINFALL DISTRIBUTION  
EXCLUDING GAUGE 69149

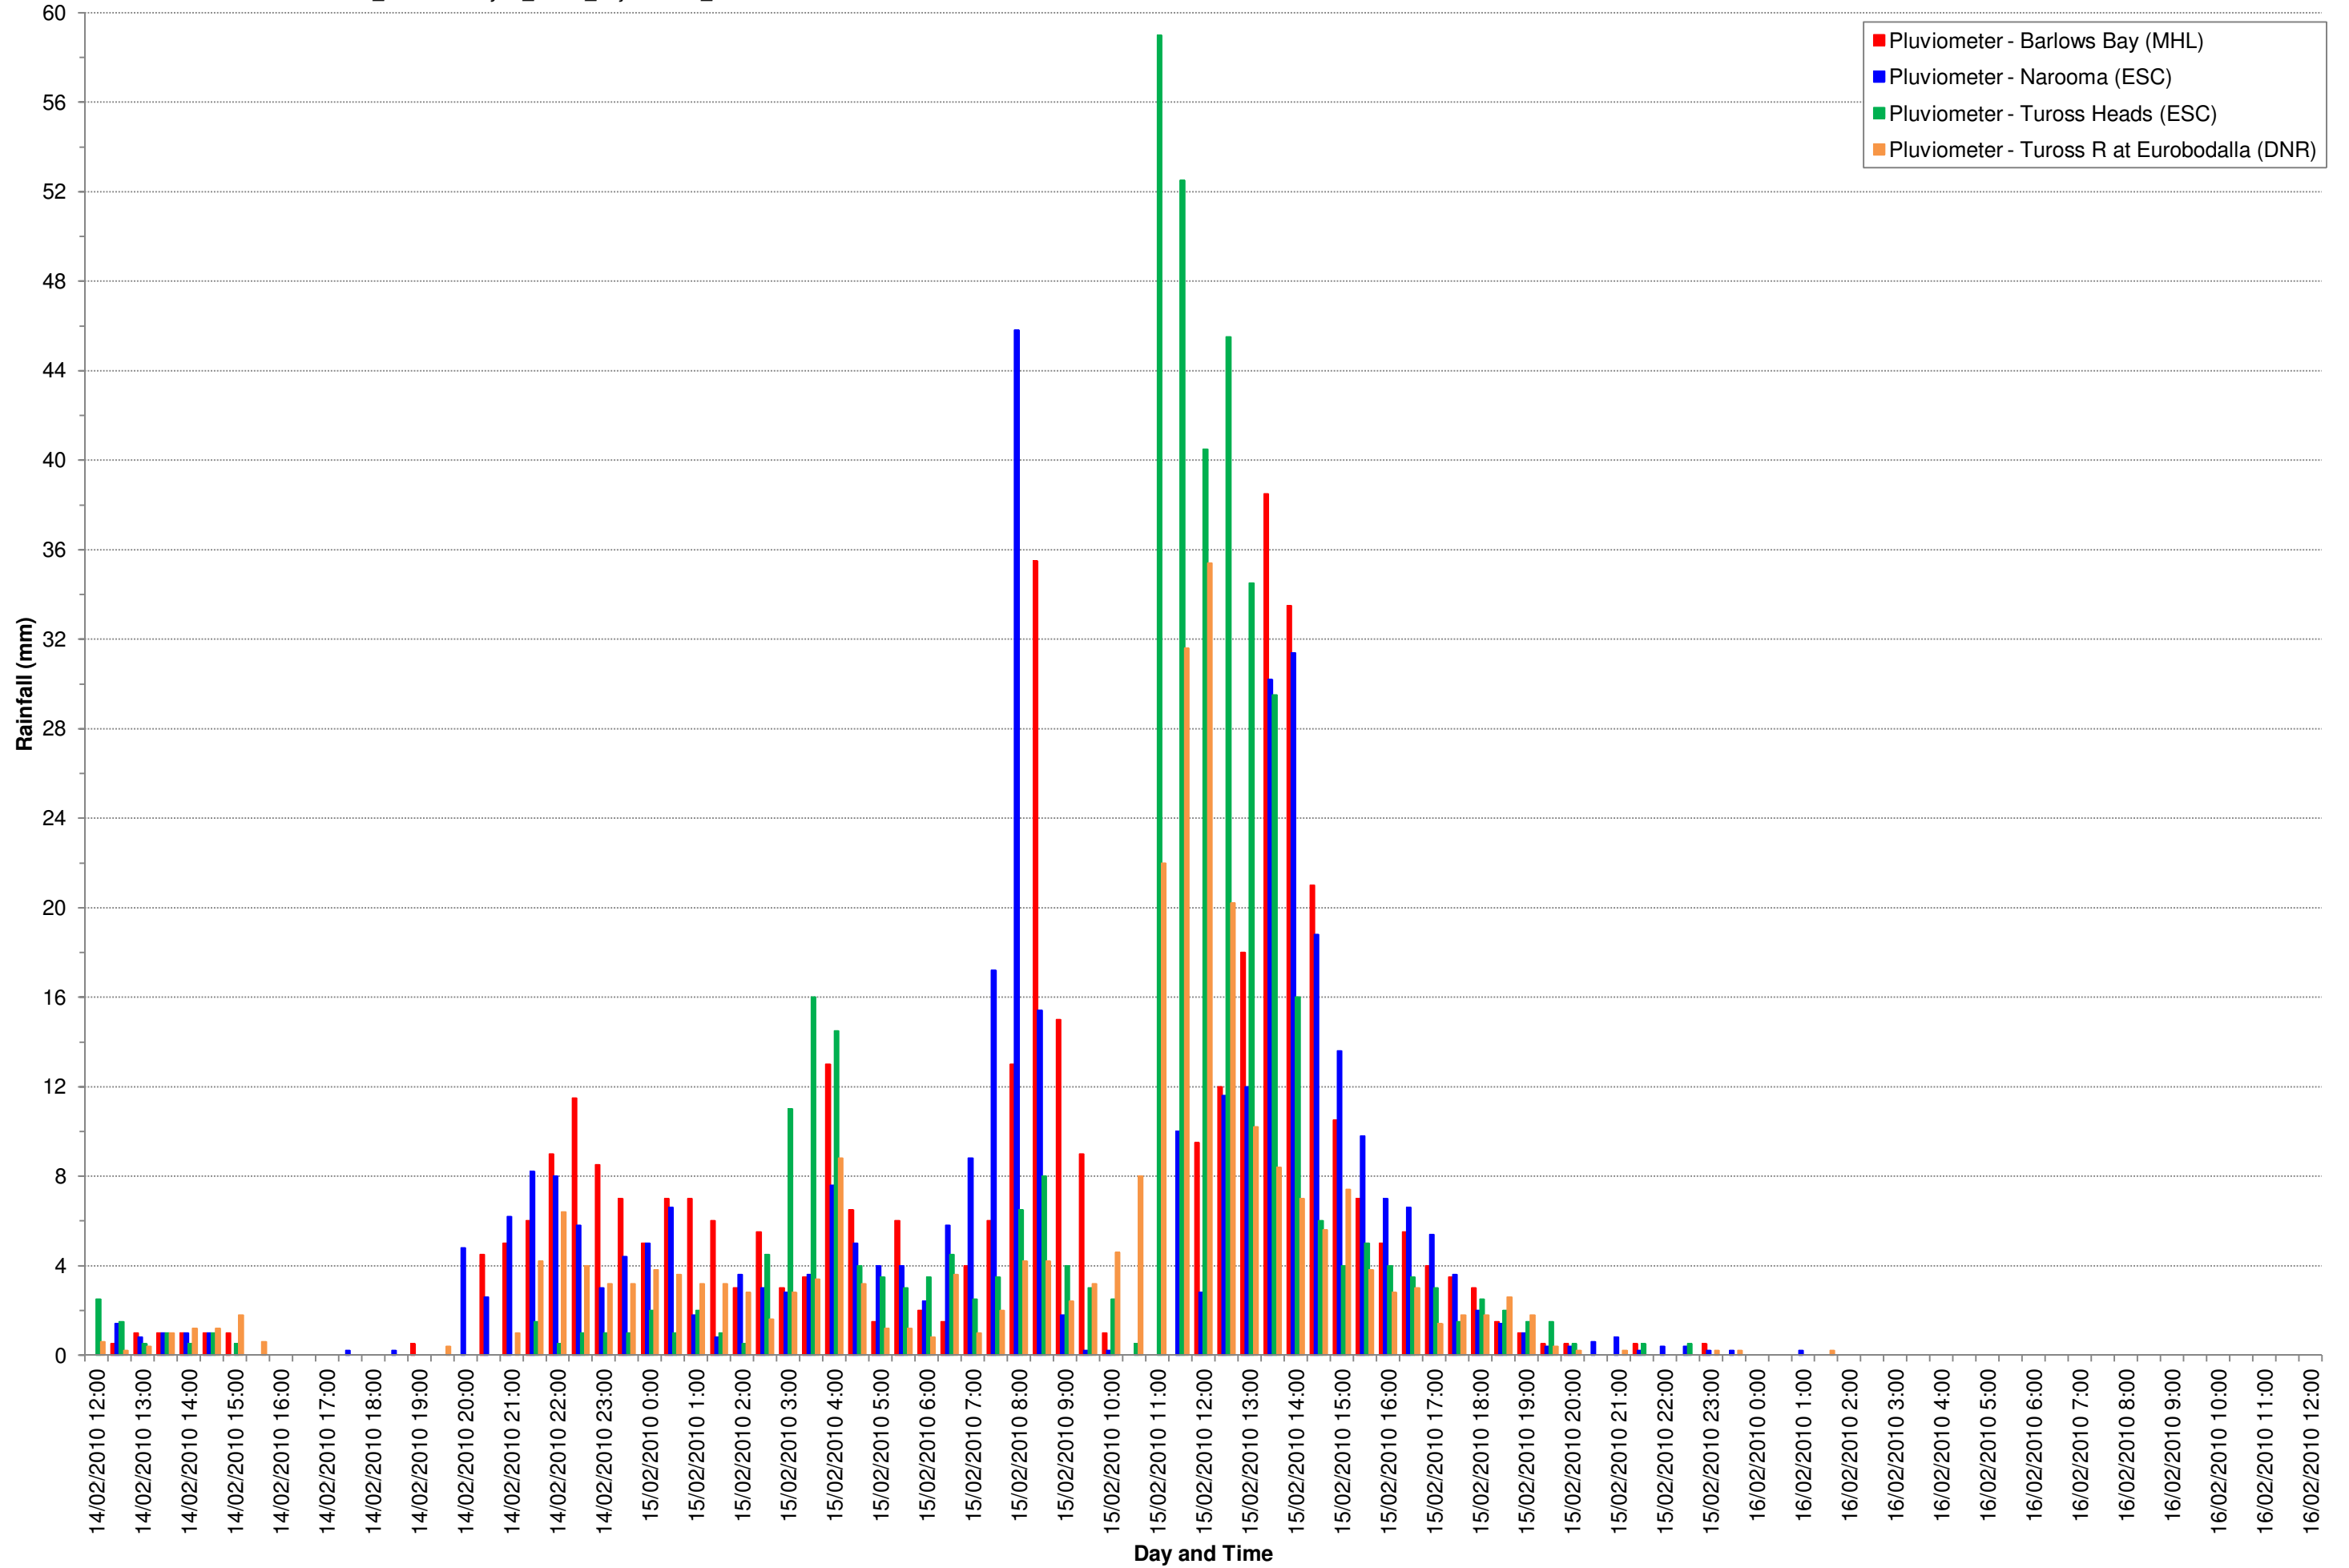
FIGURE E15  
15TH FEBRUARY 2010 EVENT  
RAINFALL HYETOGRAPH COMPARISON

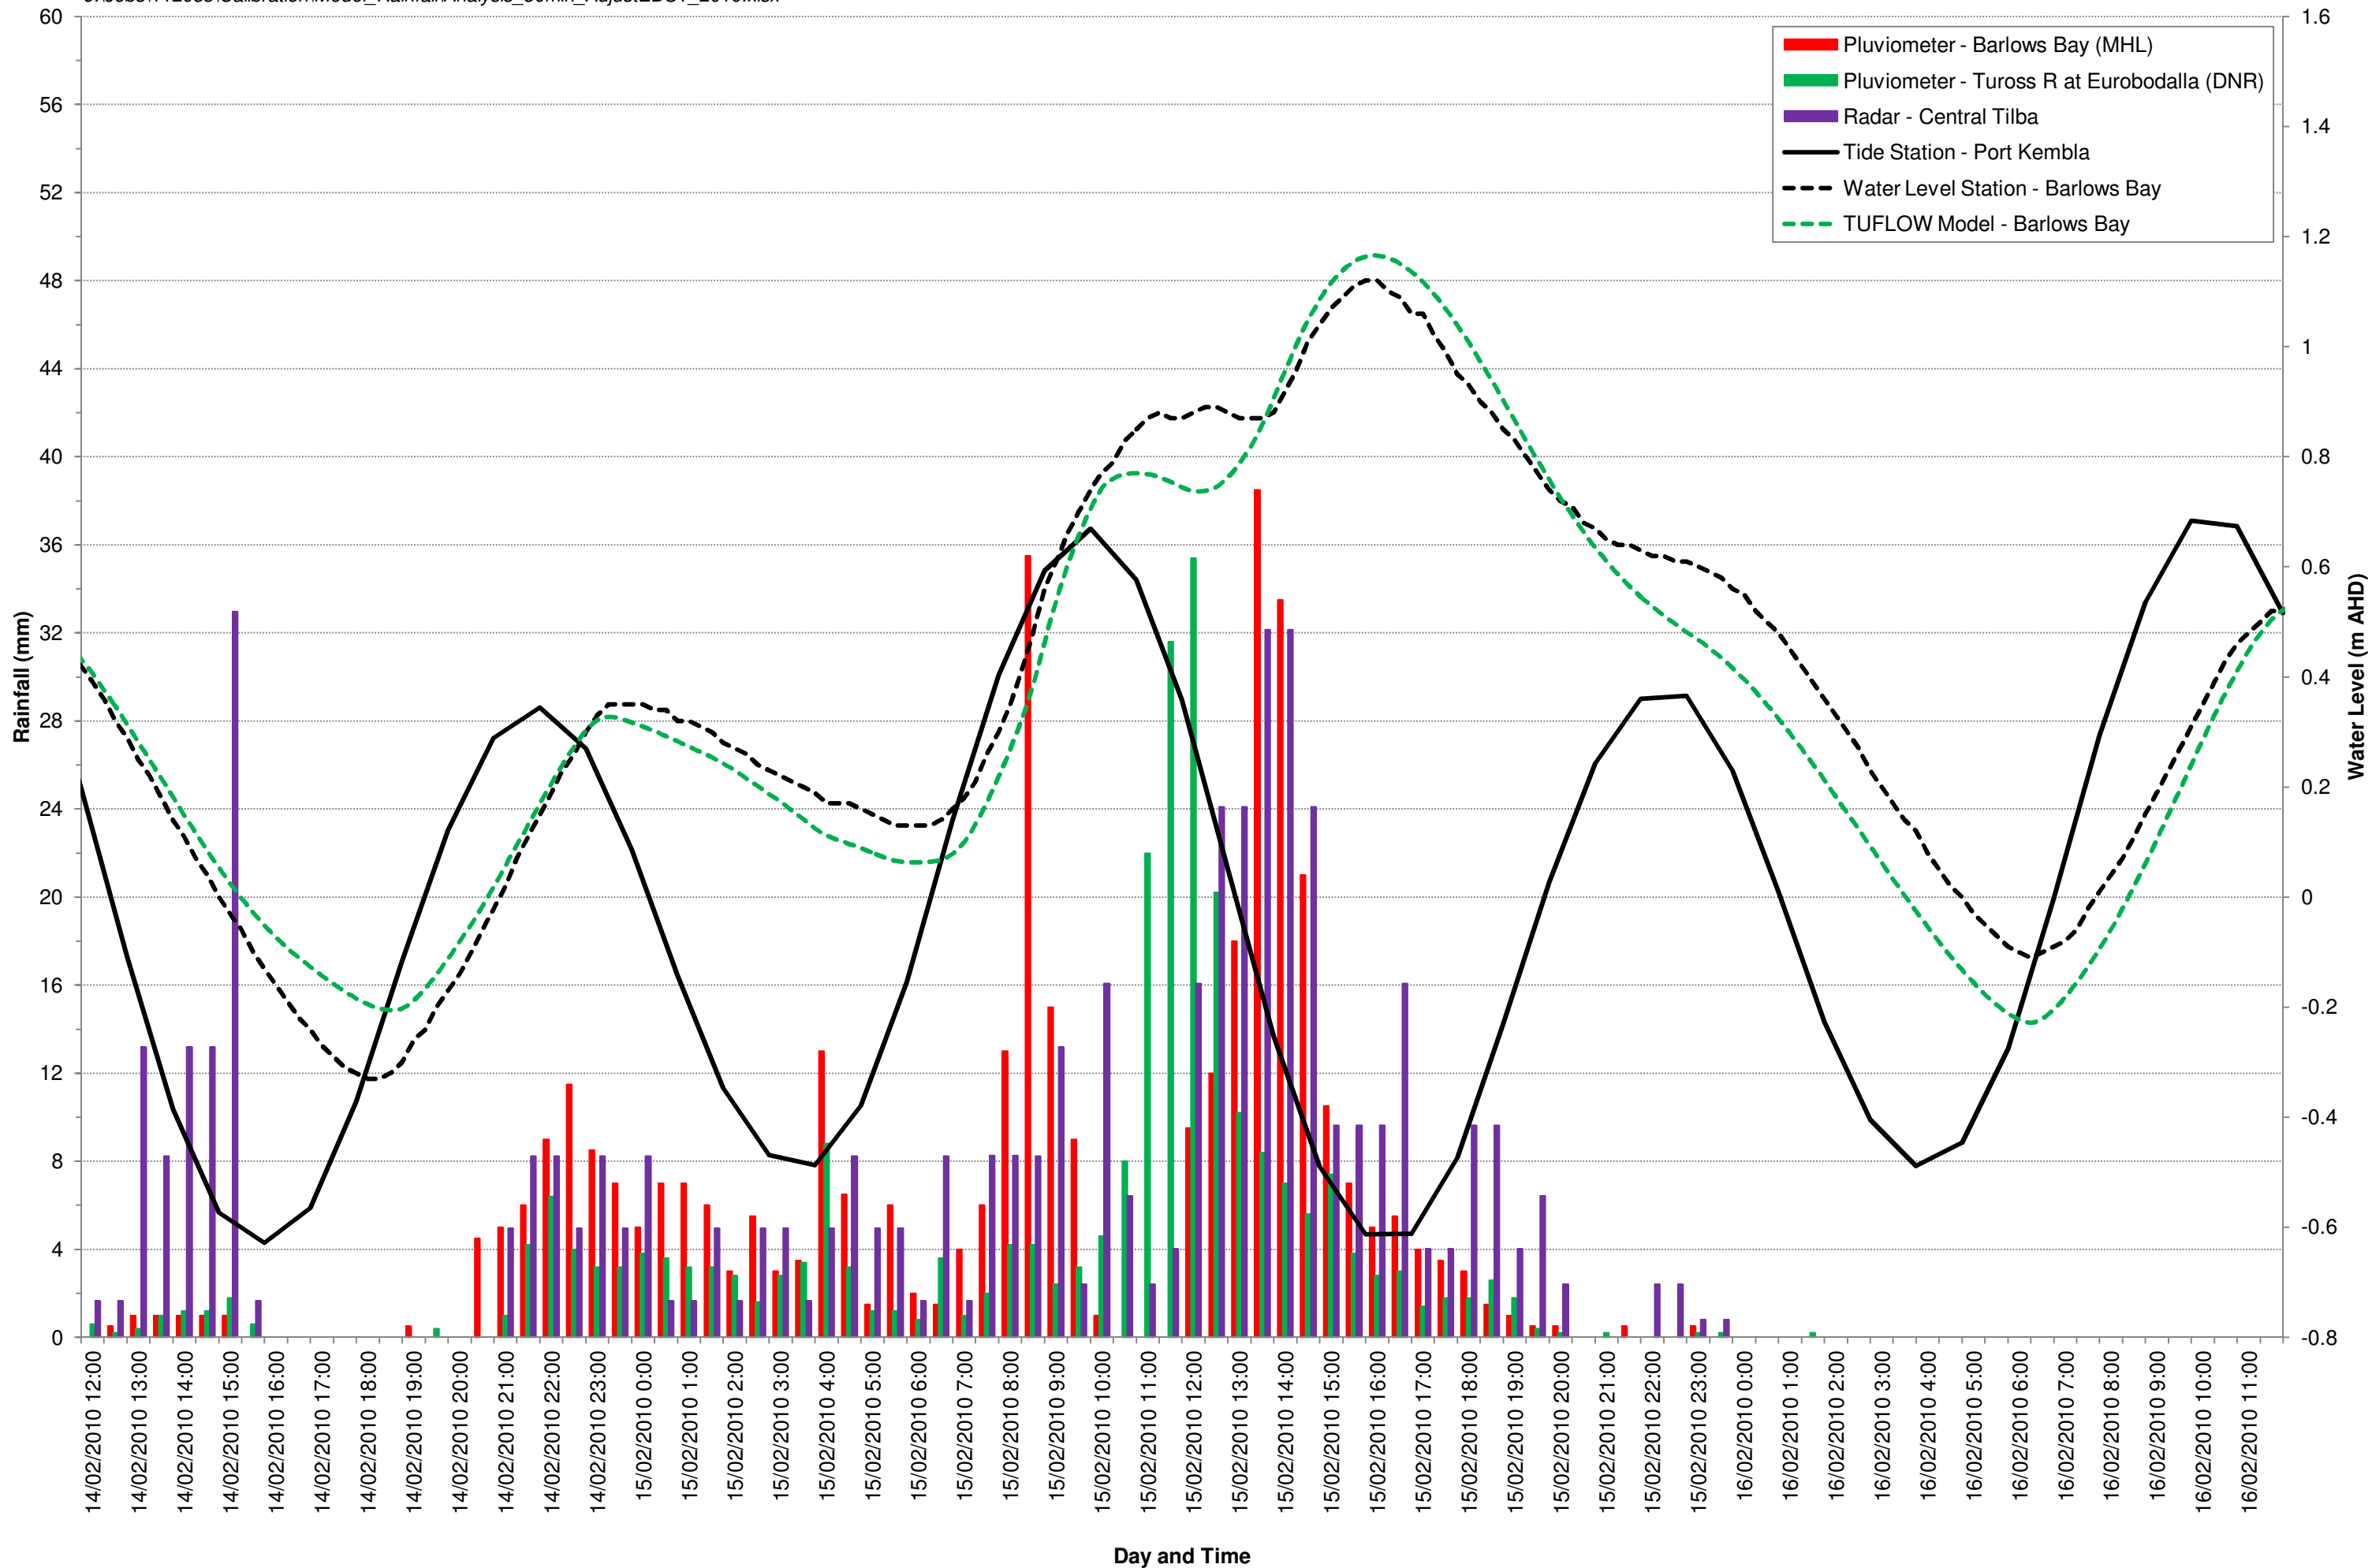
FIGURE E16  
15TH FEBRUARY 2010 EVENT  
STAGE HYDROGRAPHS

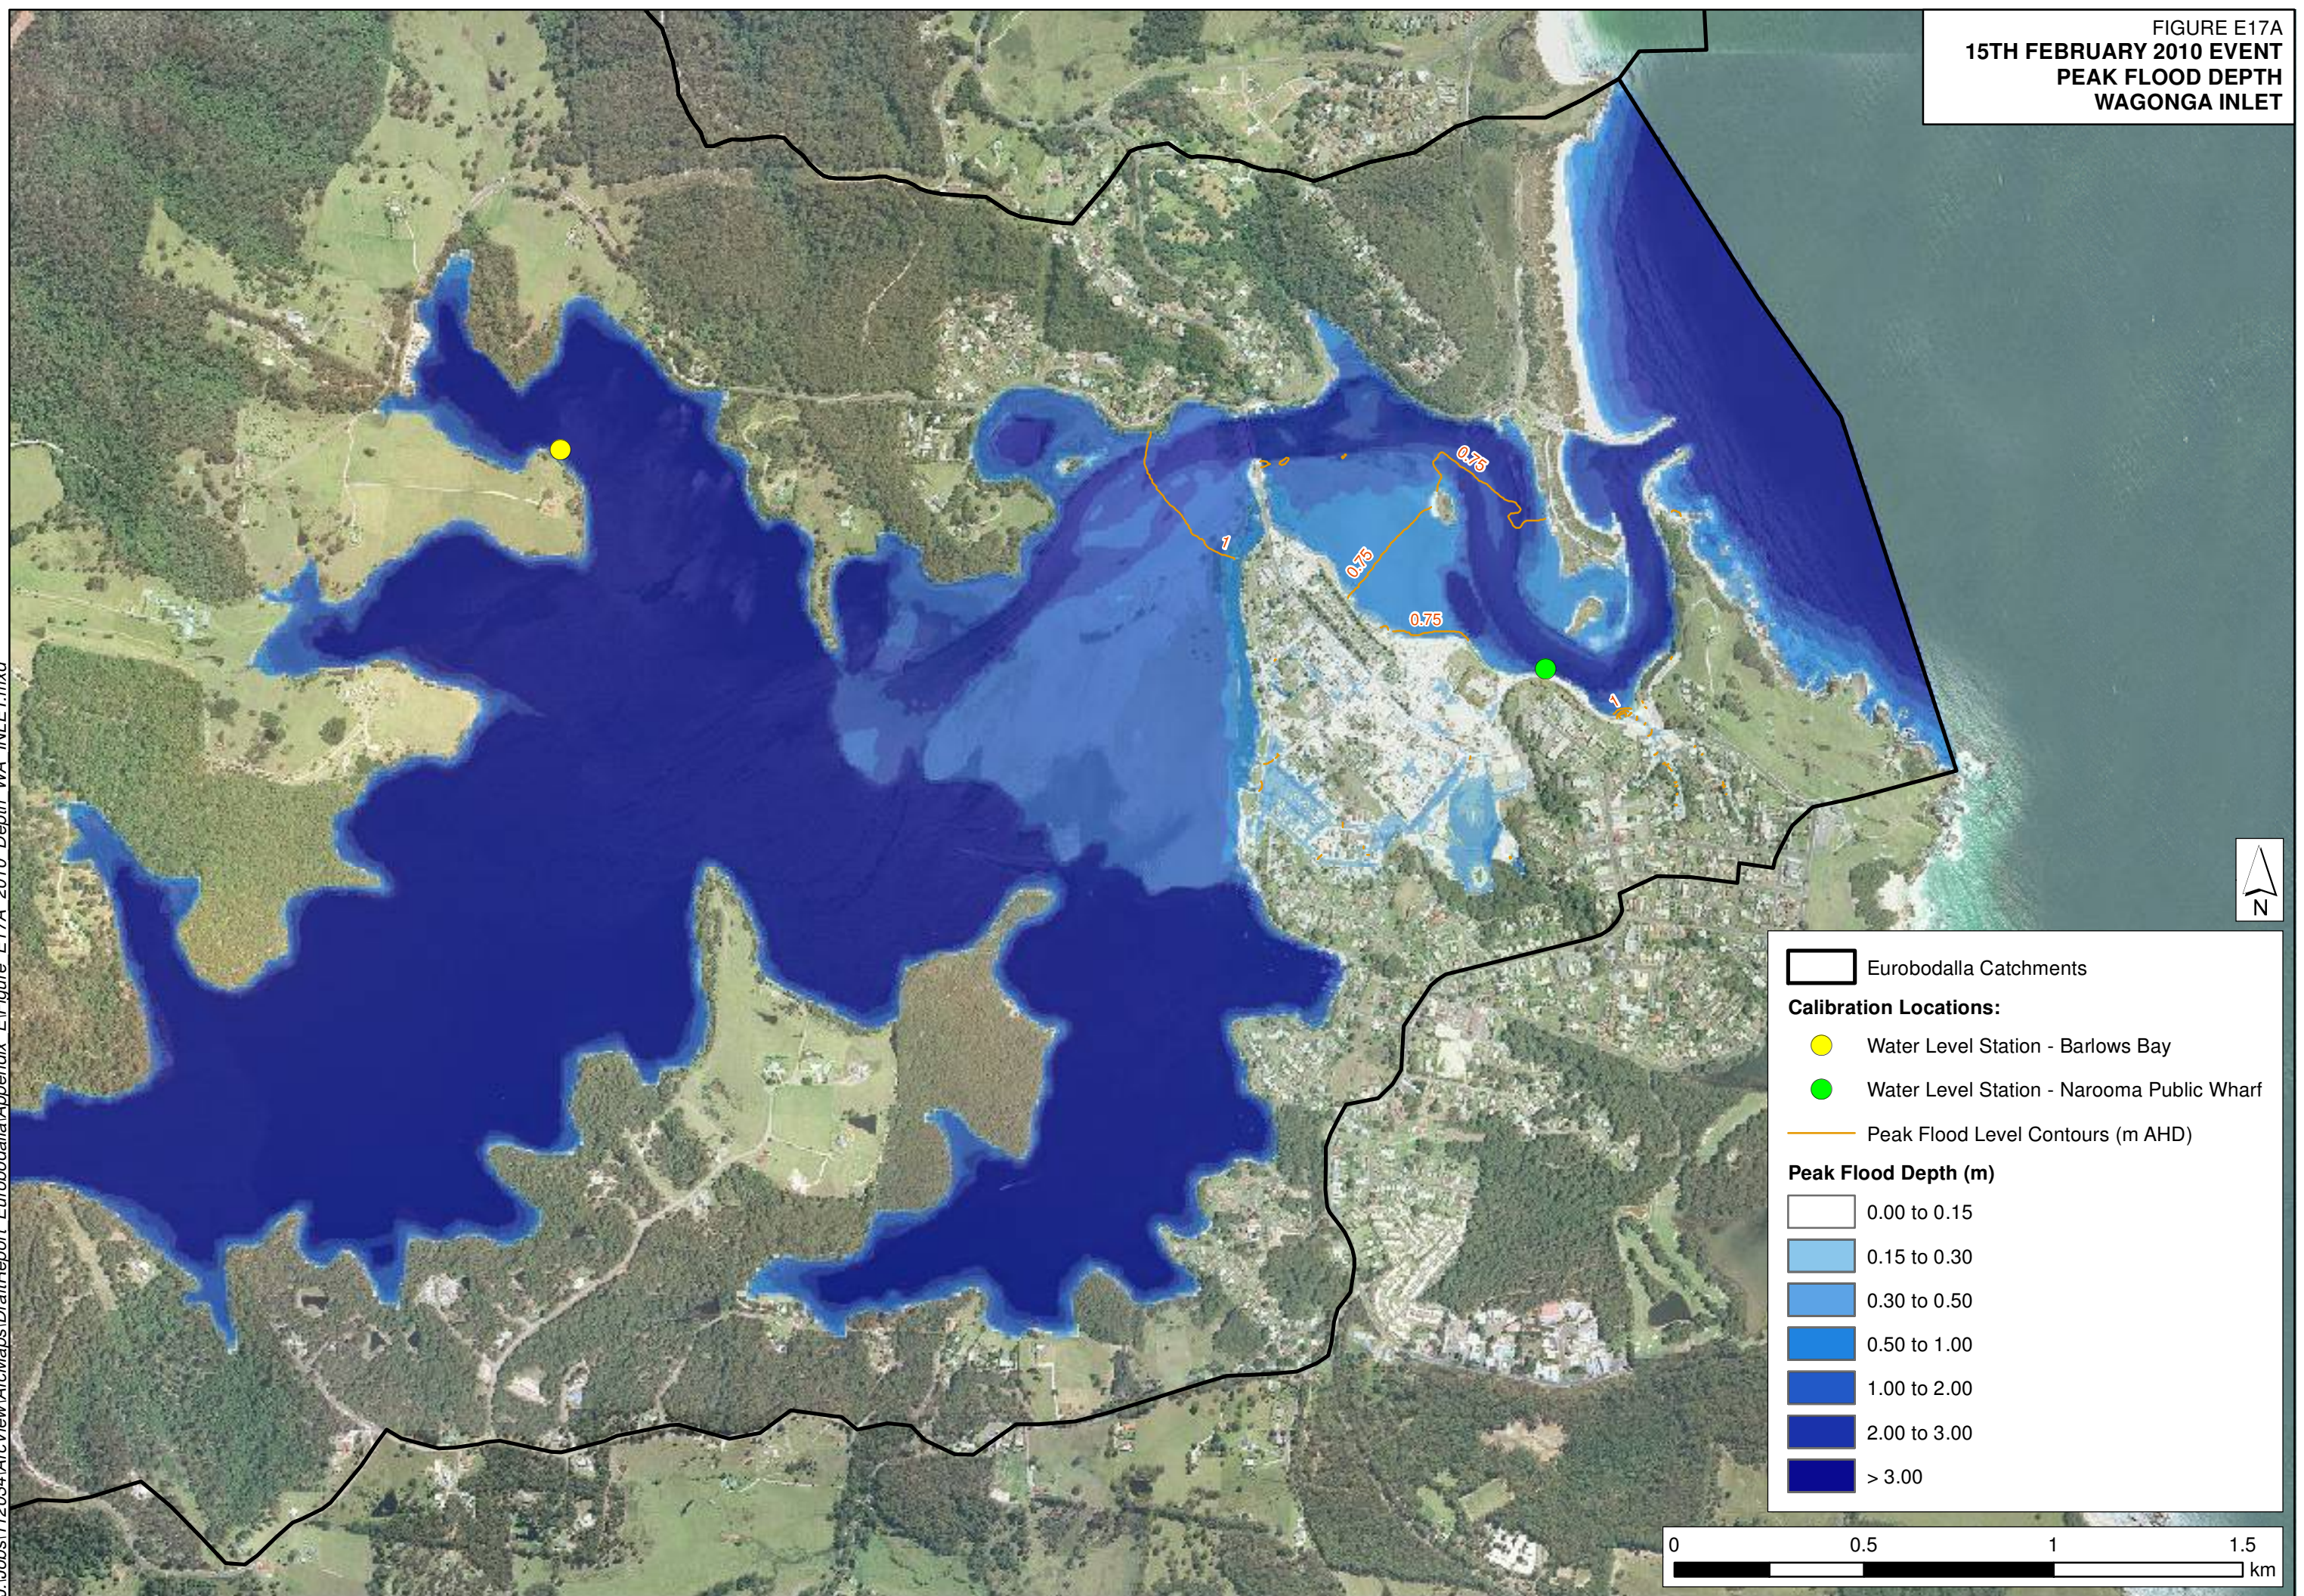
FIGURE E17A  
15TH FEBRUARY 2010 EVENT  
PEAK FLOOD DEPTH  
WAGONGA INLET

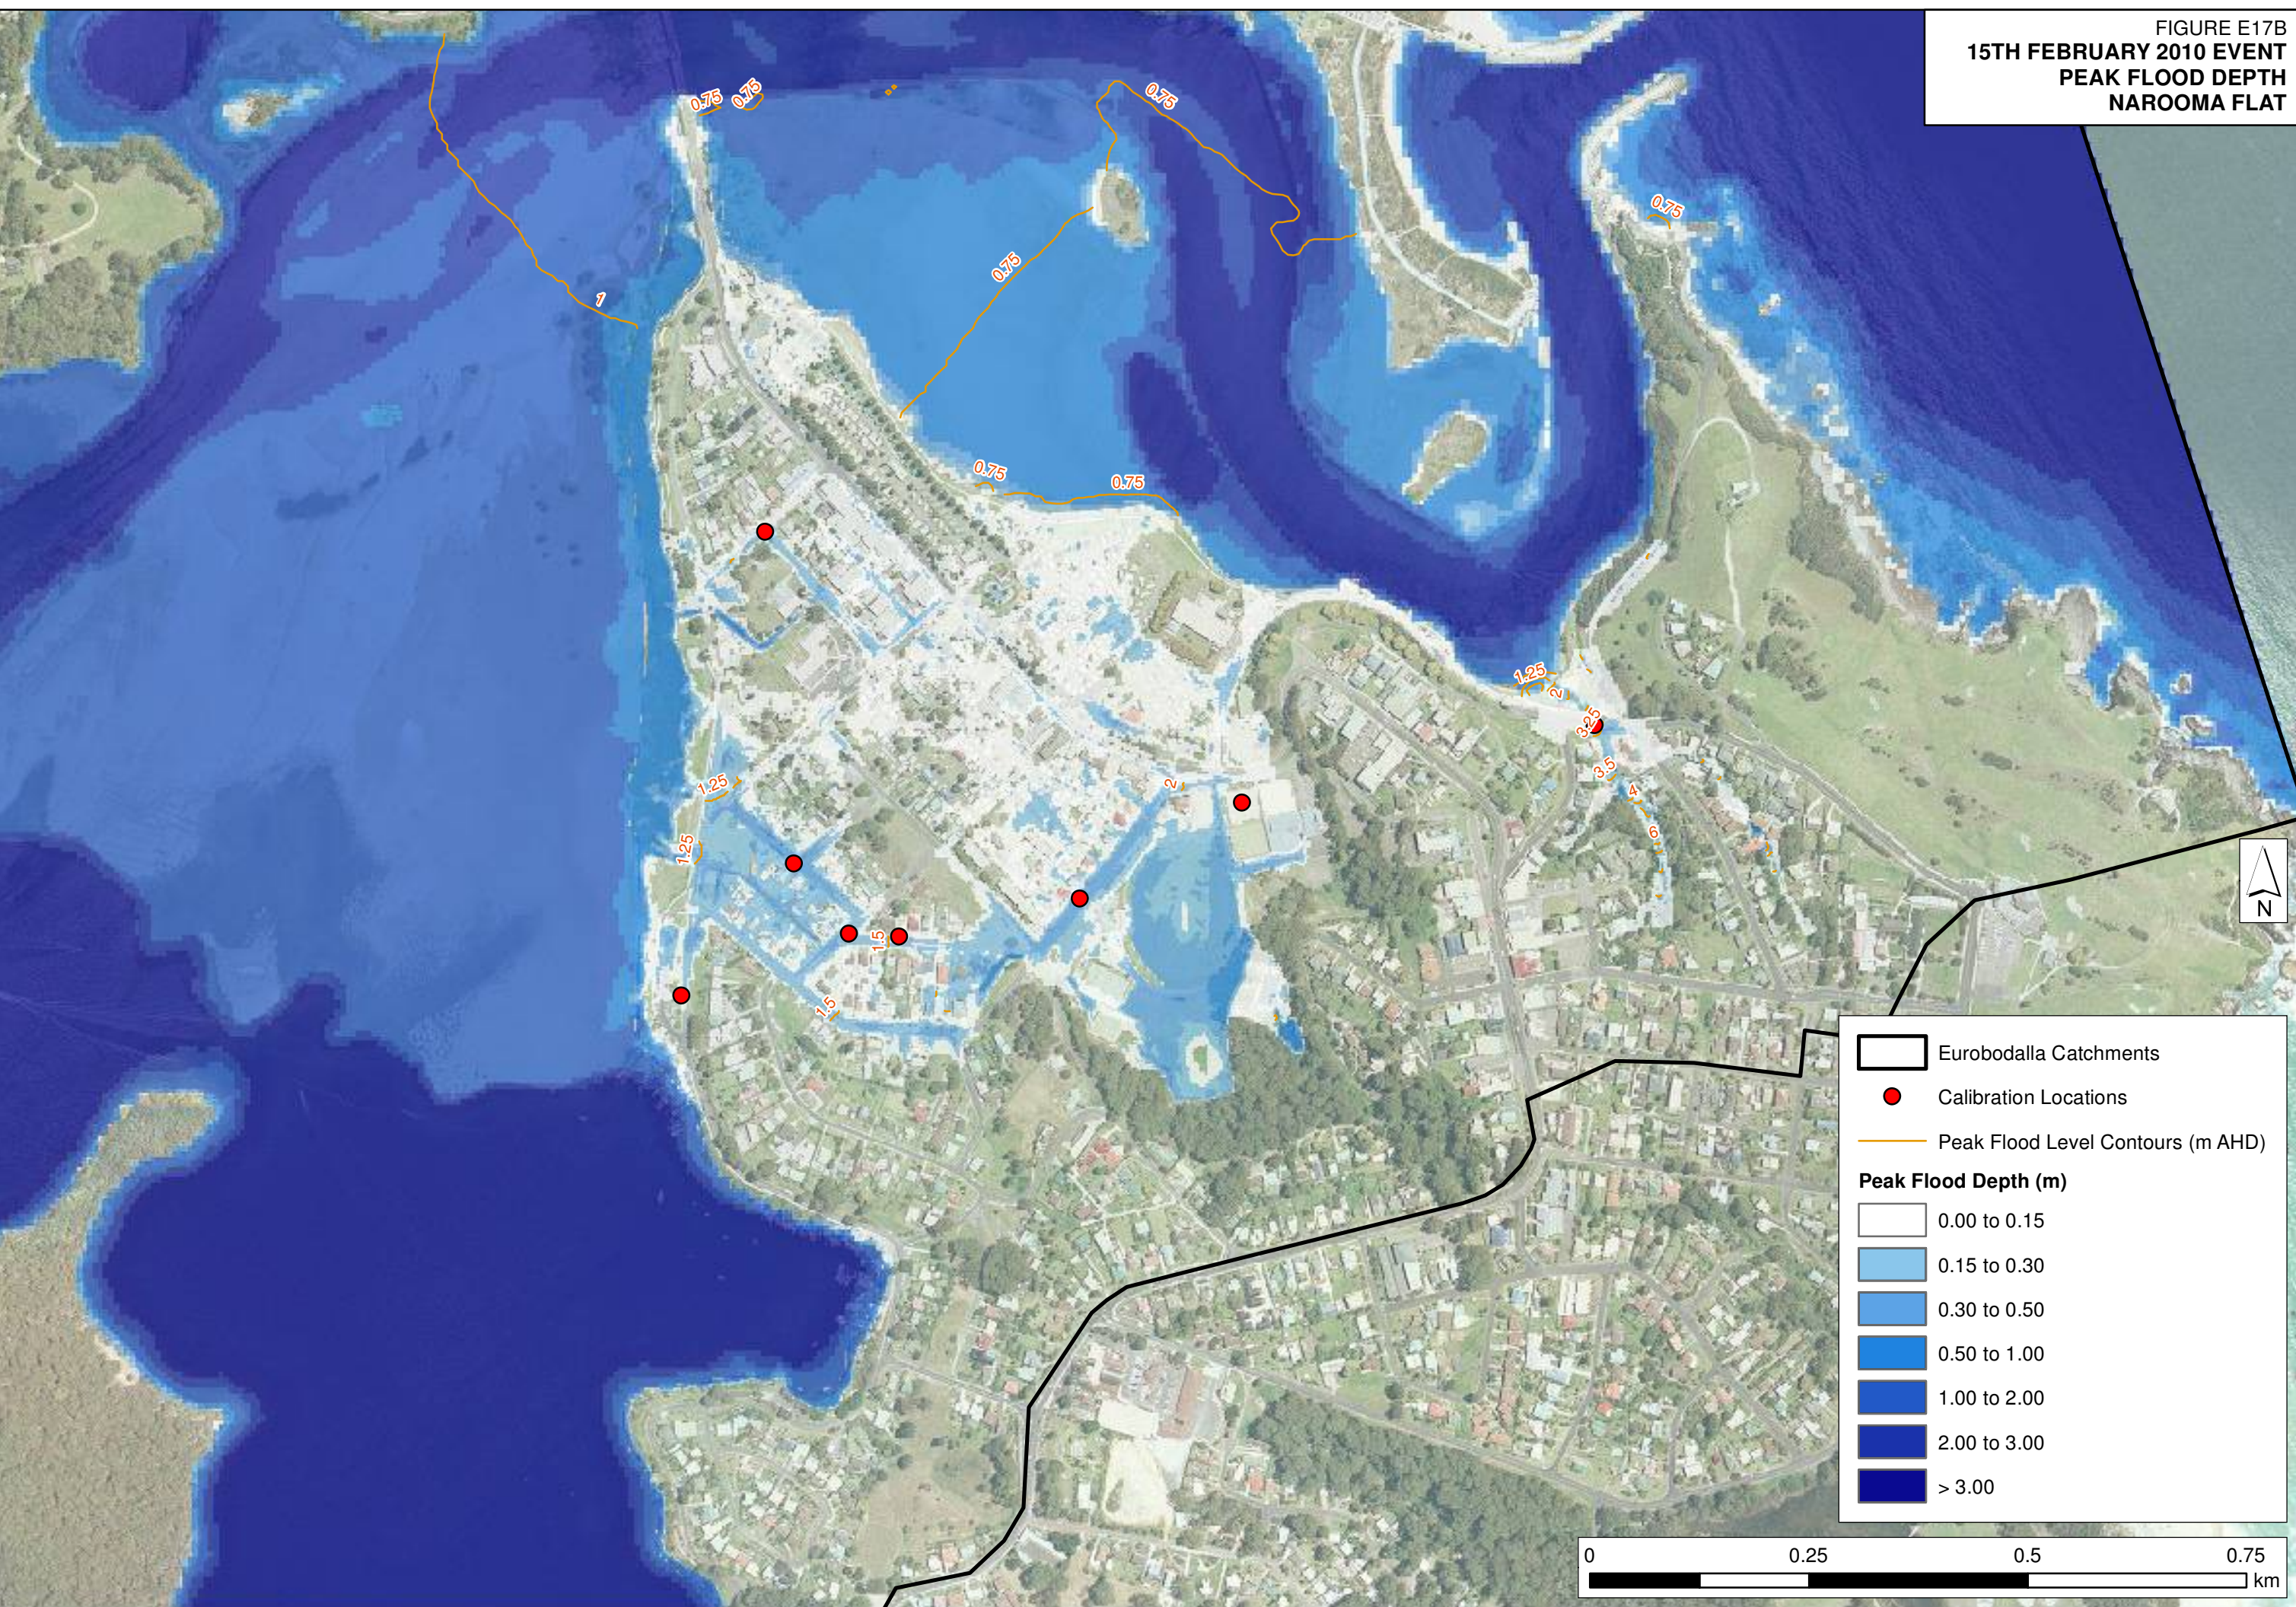
FIGURE E17B  
15TH FEBRUARY 2010 EVENT  
PEAK FLOOD DEPTH  
NAROOMA FLAT
