FIGURE E7A  
28TH JANUARY 1999 EVENT  
PEAK FLOOD DEPTH  
WAGONGA INLET

FIGURE E7B  
28TH JANUARY 1999 EVENT  
PEAK FLOOD DEPTH  
NAROOMA FLAT

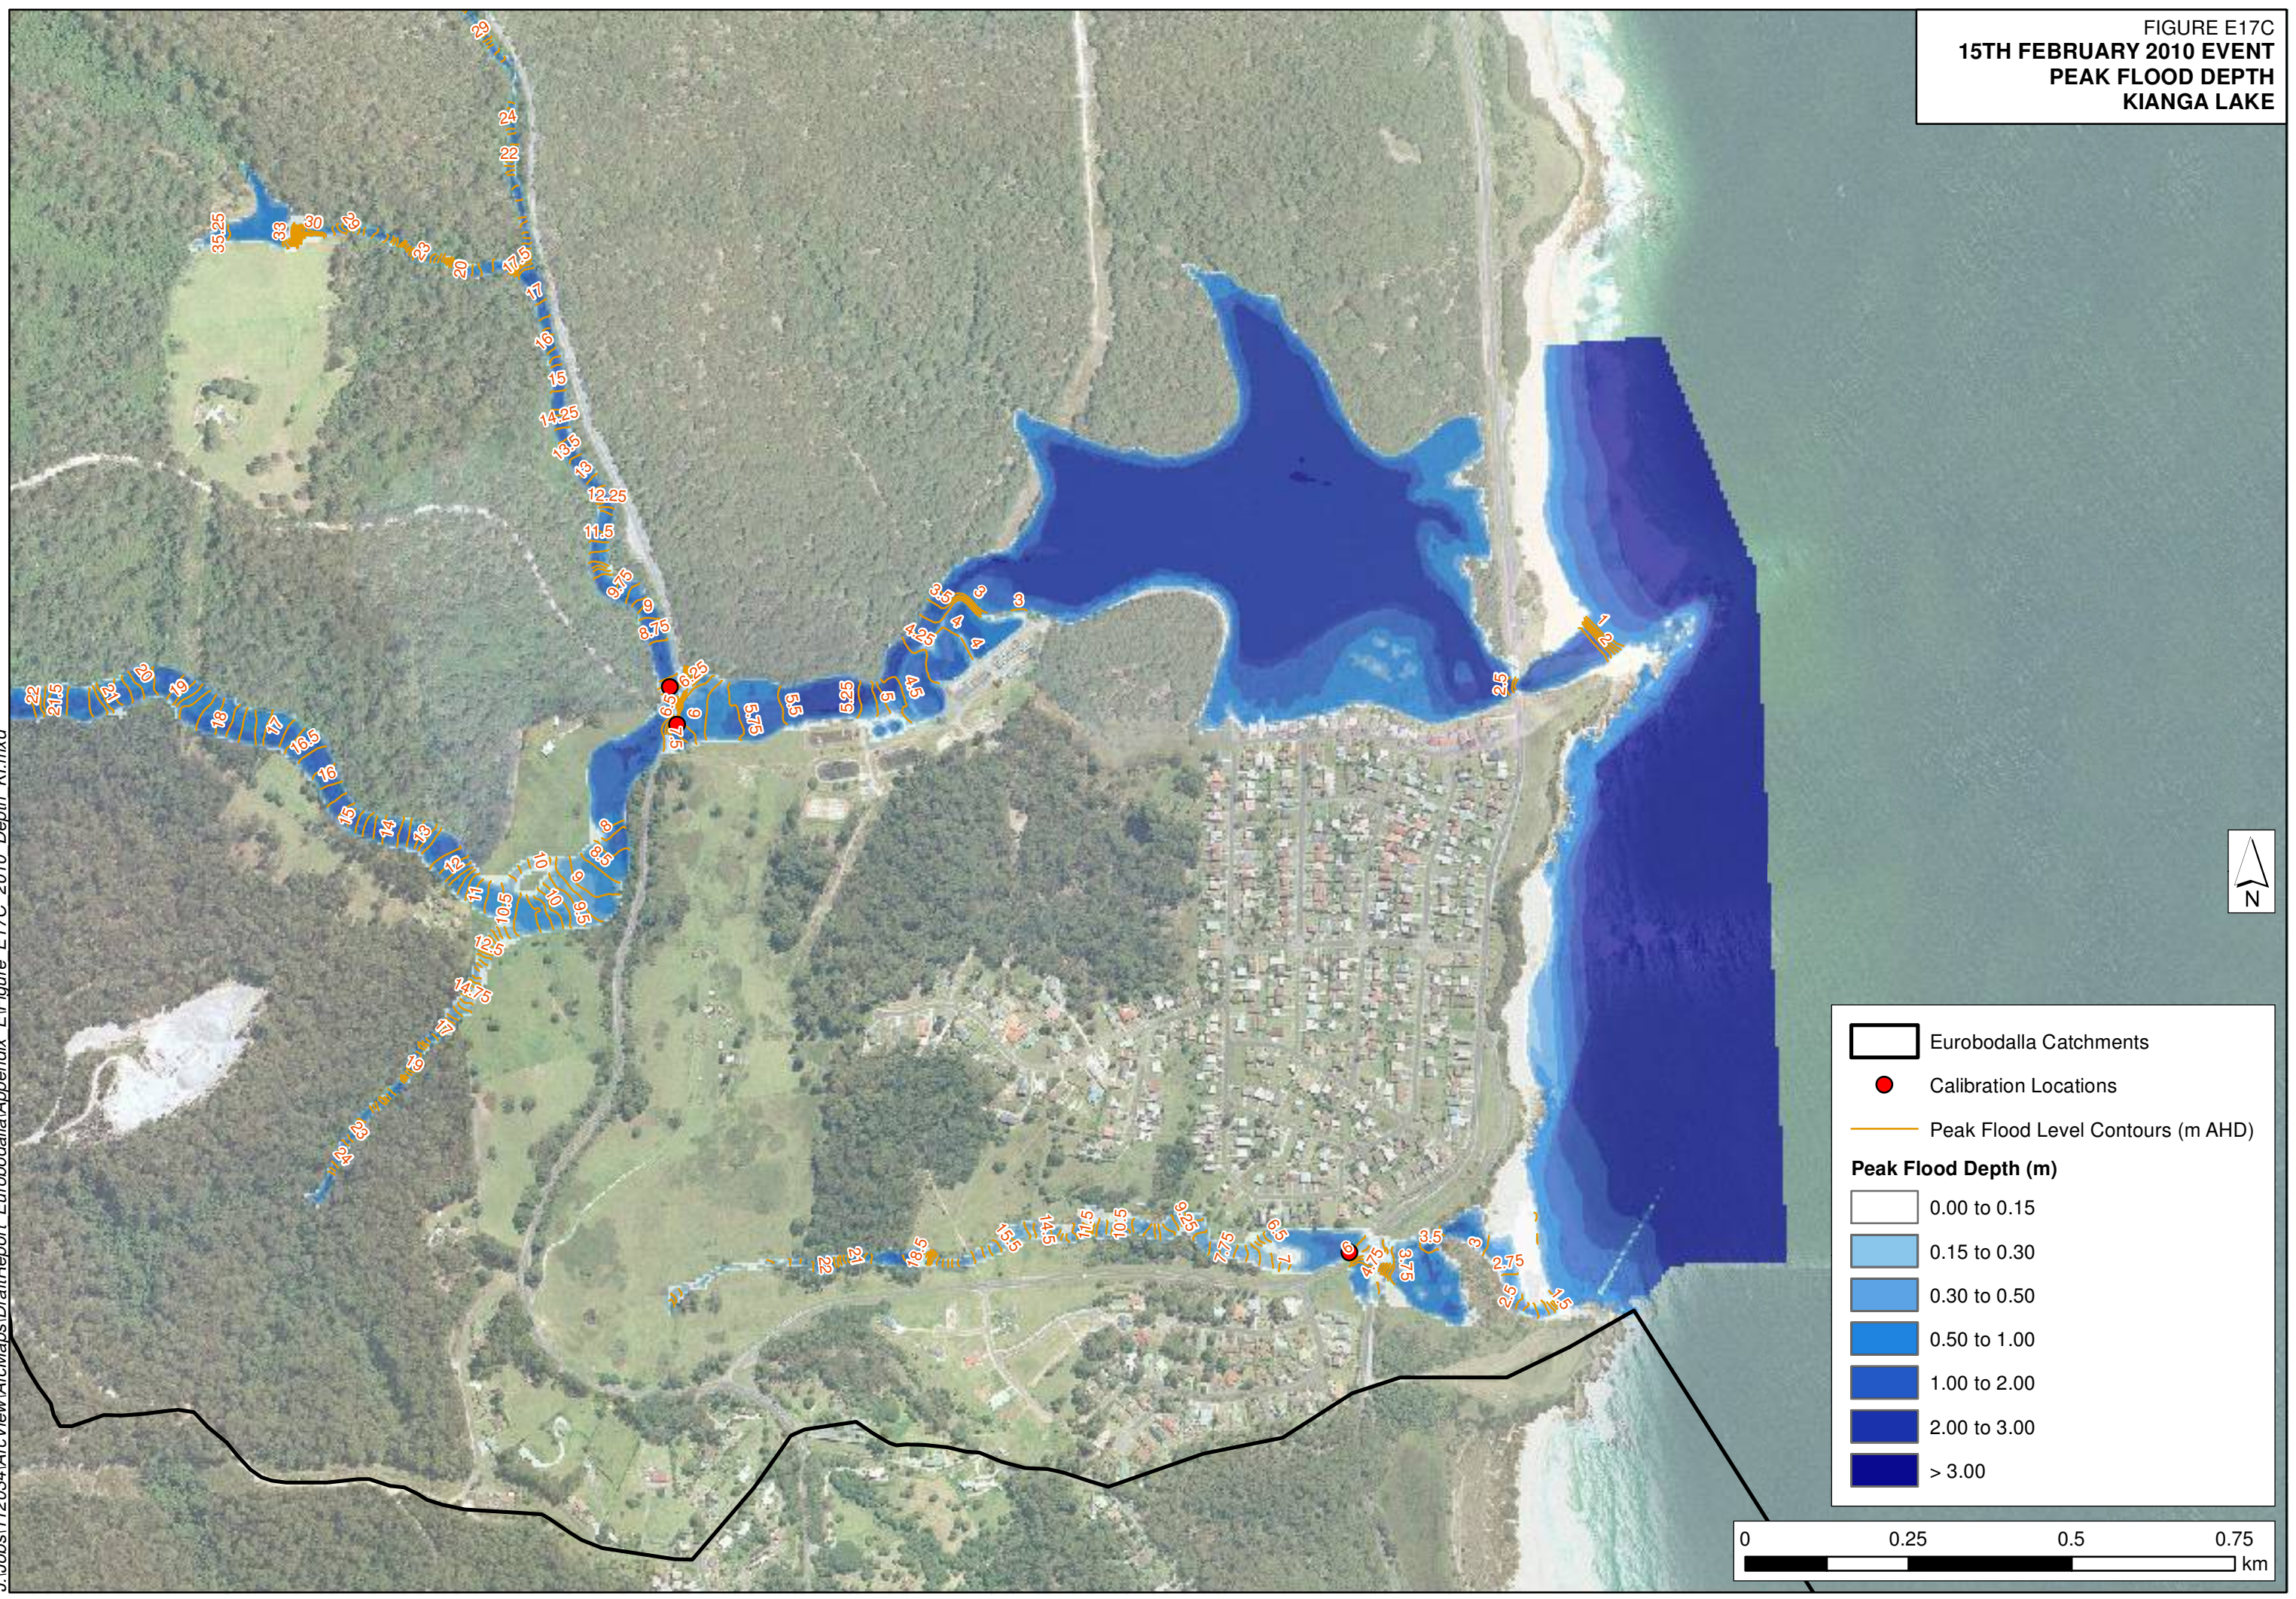
FIGURE E17C  
15TH FEBRUARY 2010 EVENT  
PEAK FLOOD DEPTH  
KIANGA LAKE

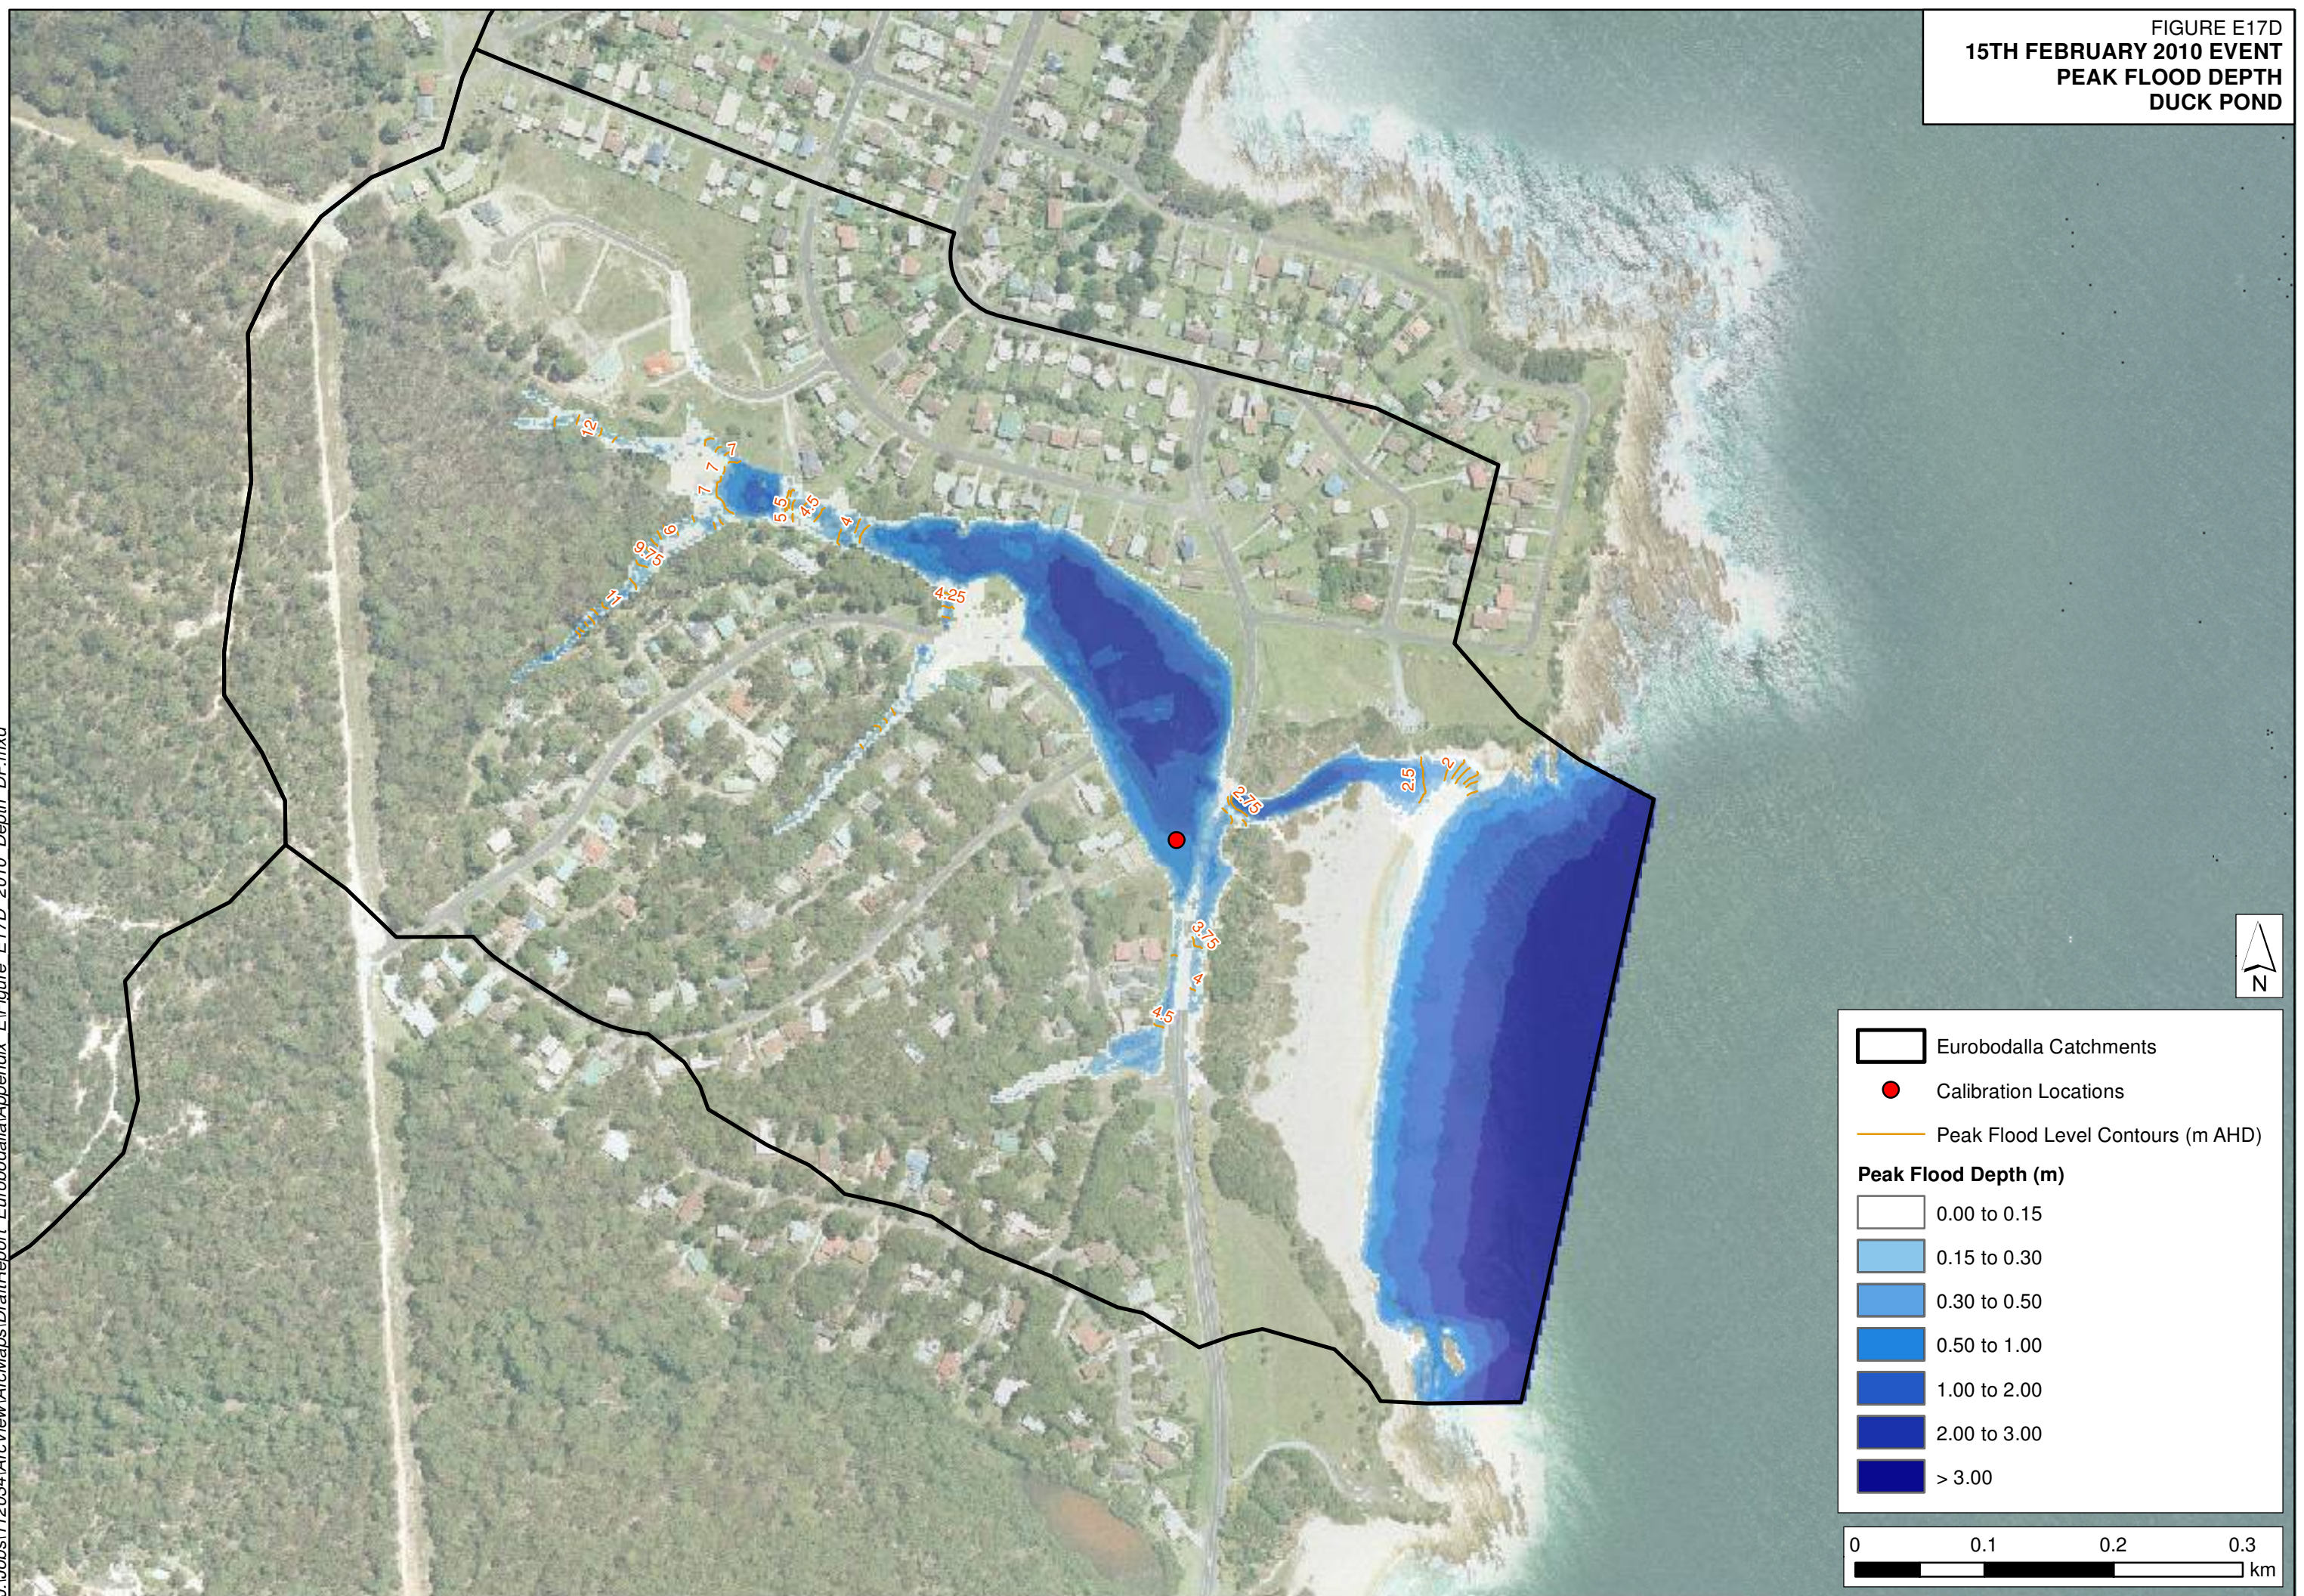
FIGURE E17D  
15TH FEBRUARY 2010 EVENT  
PEAK FLOOD DEPTH  
DUCK POND

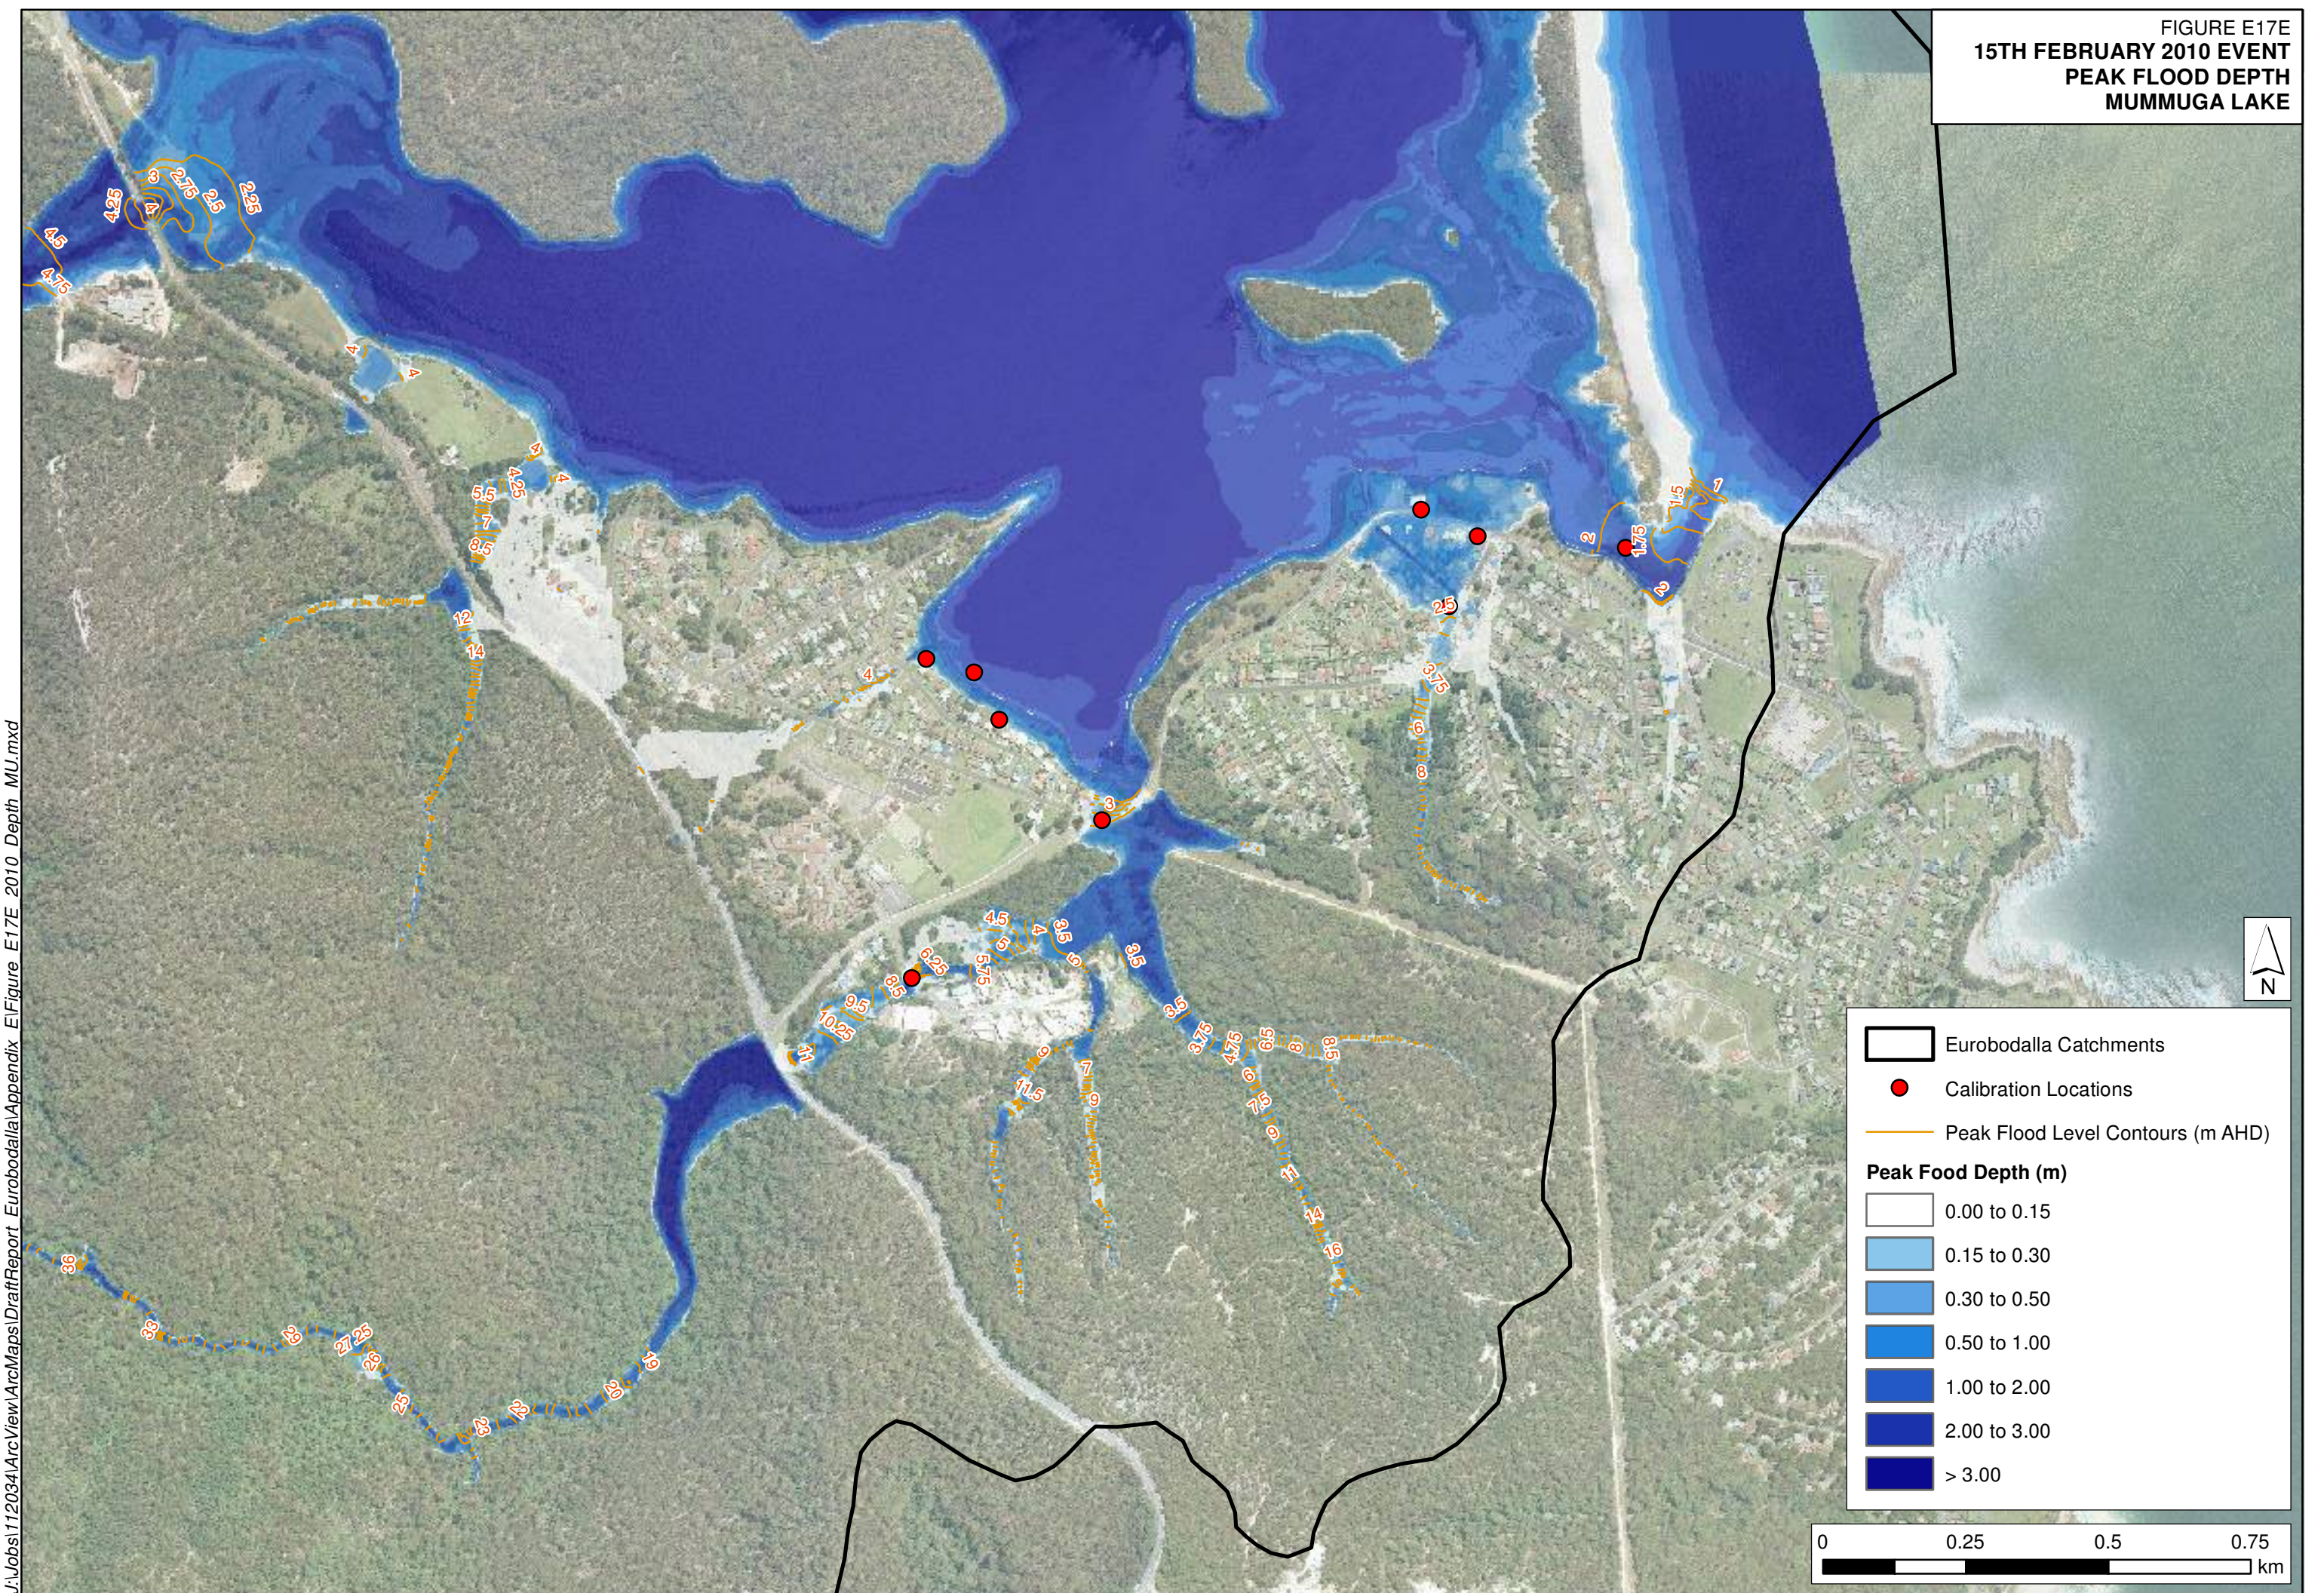
FIGURE E17E  
15TH FEBRUARY 2010 EVENT  
PEAK FLOOD DEPTH  
MUMMUGA LAKE

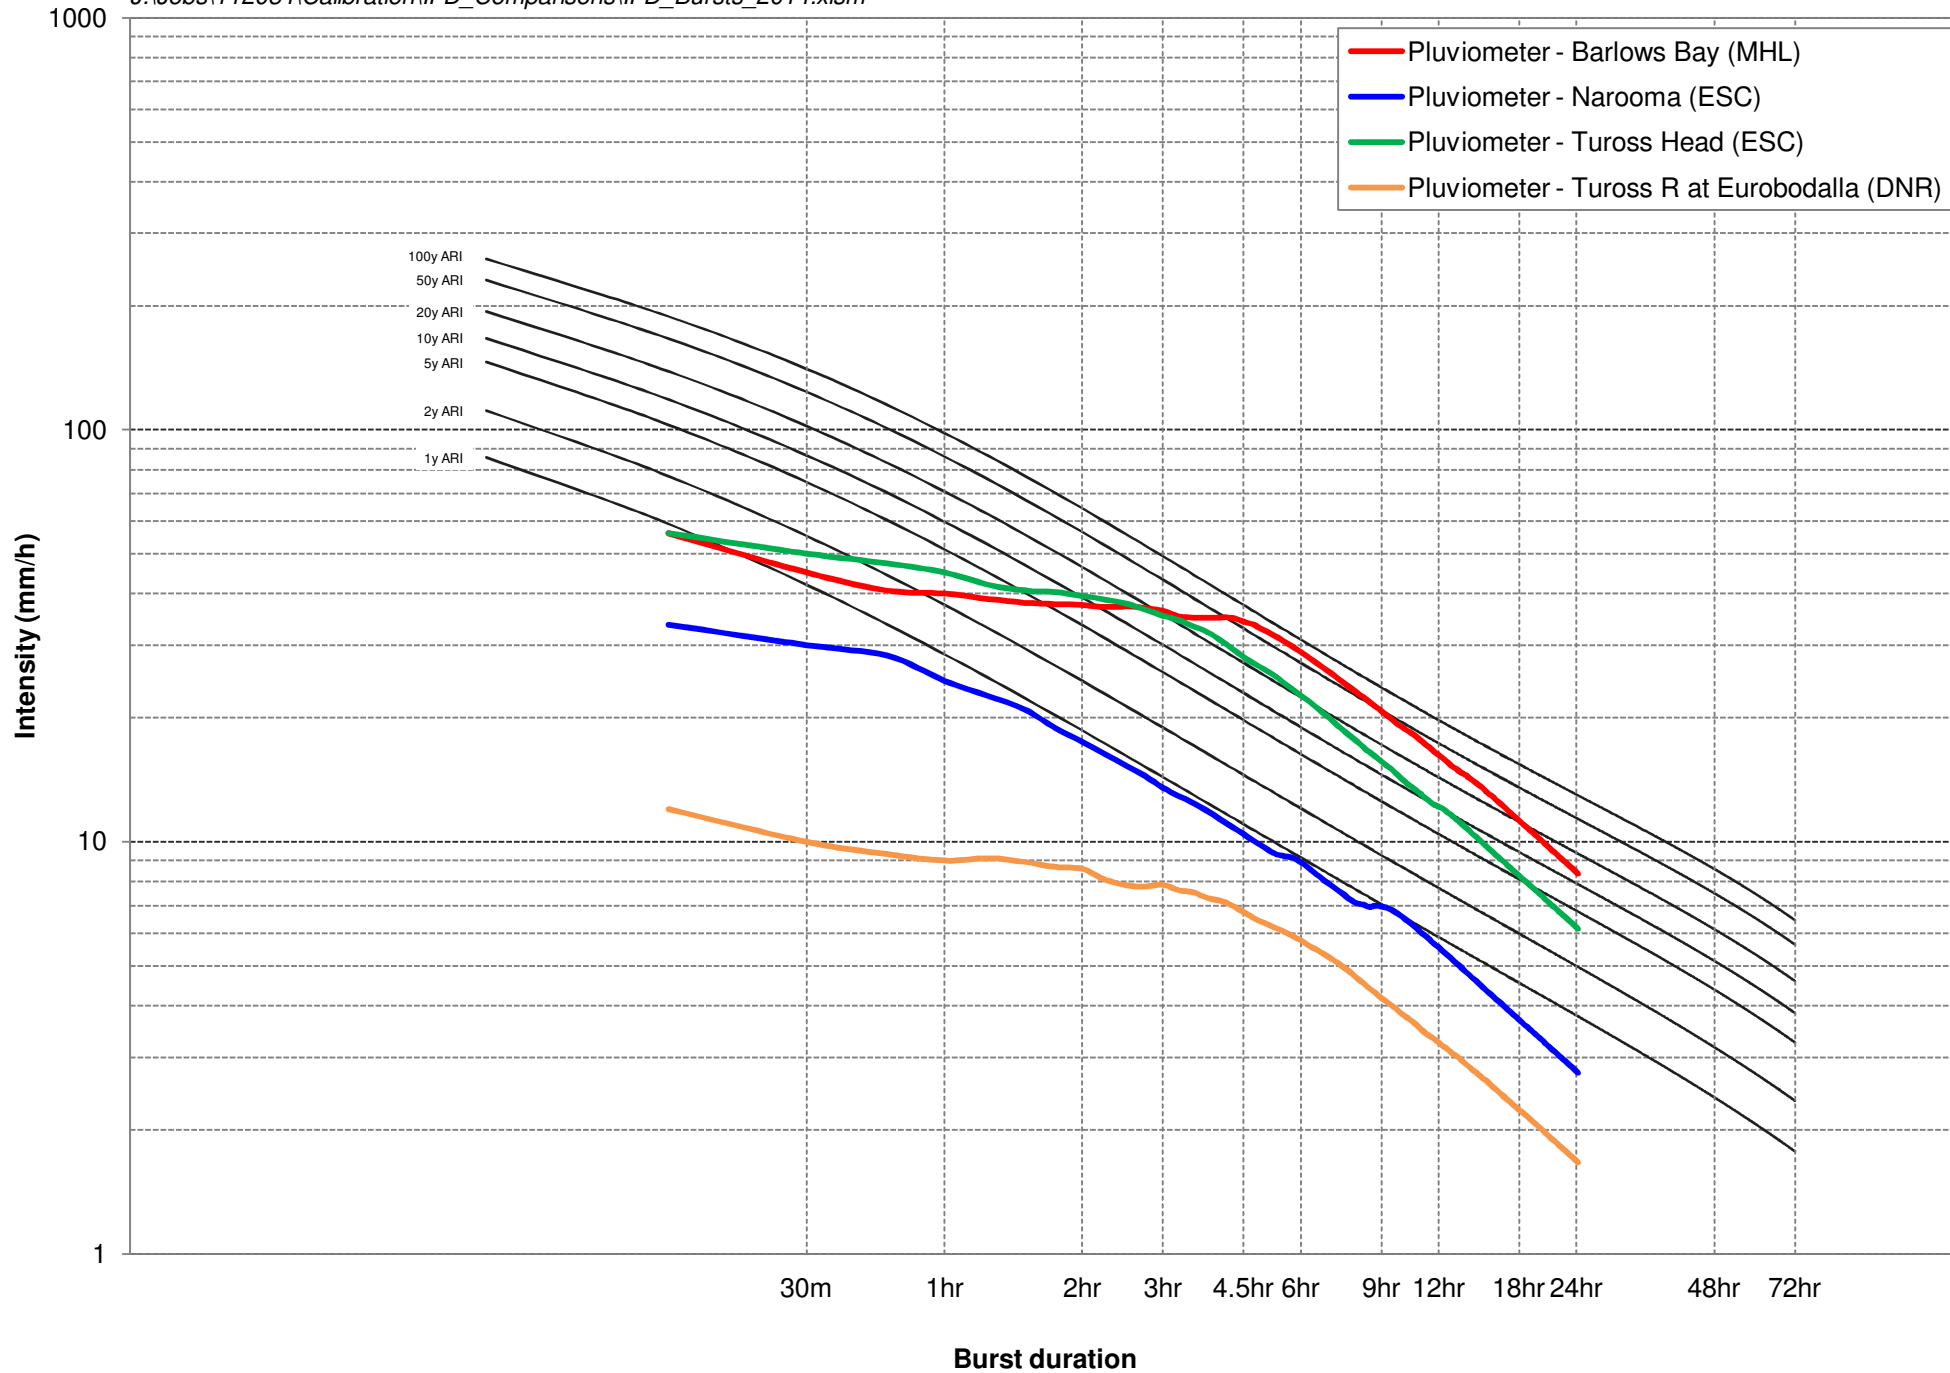
FIGURE E18  
14TH OCTOBER 2014 EVENT  
IFD DATA

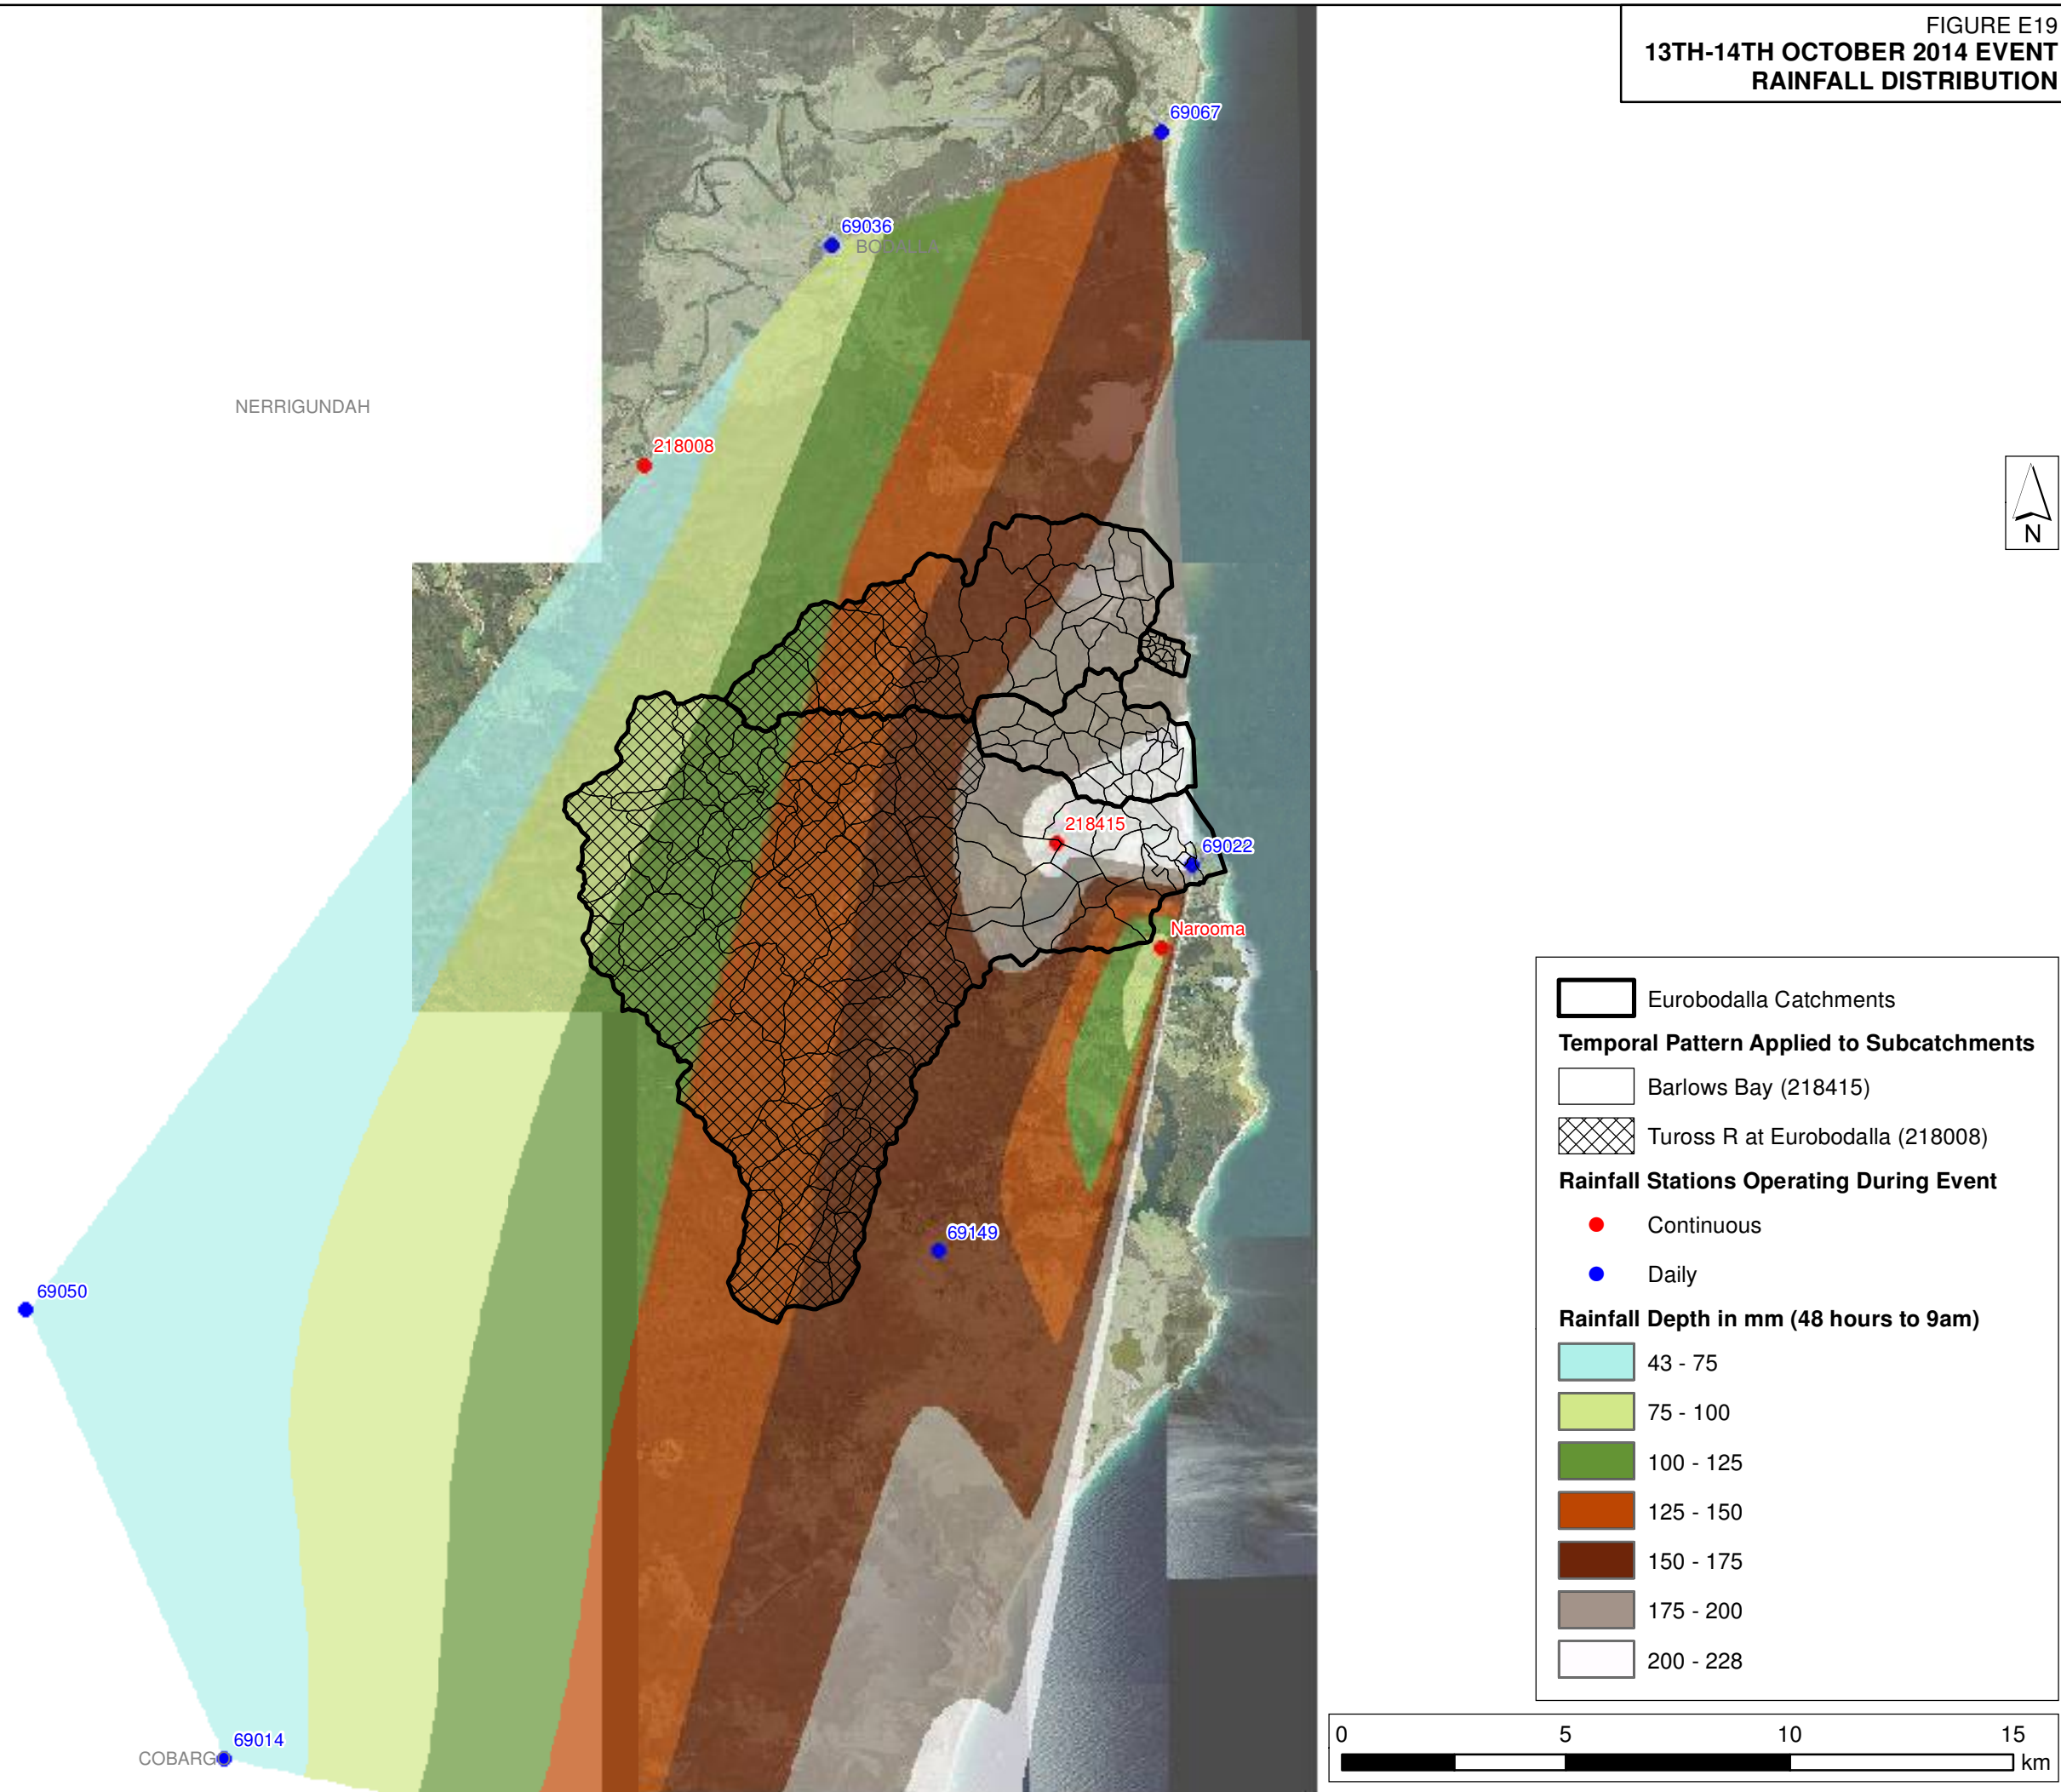
FIGURE E19  
13TH-14TH OCTOBER 2014 EVENT  
RAINFALL DISTRIBUTION

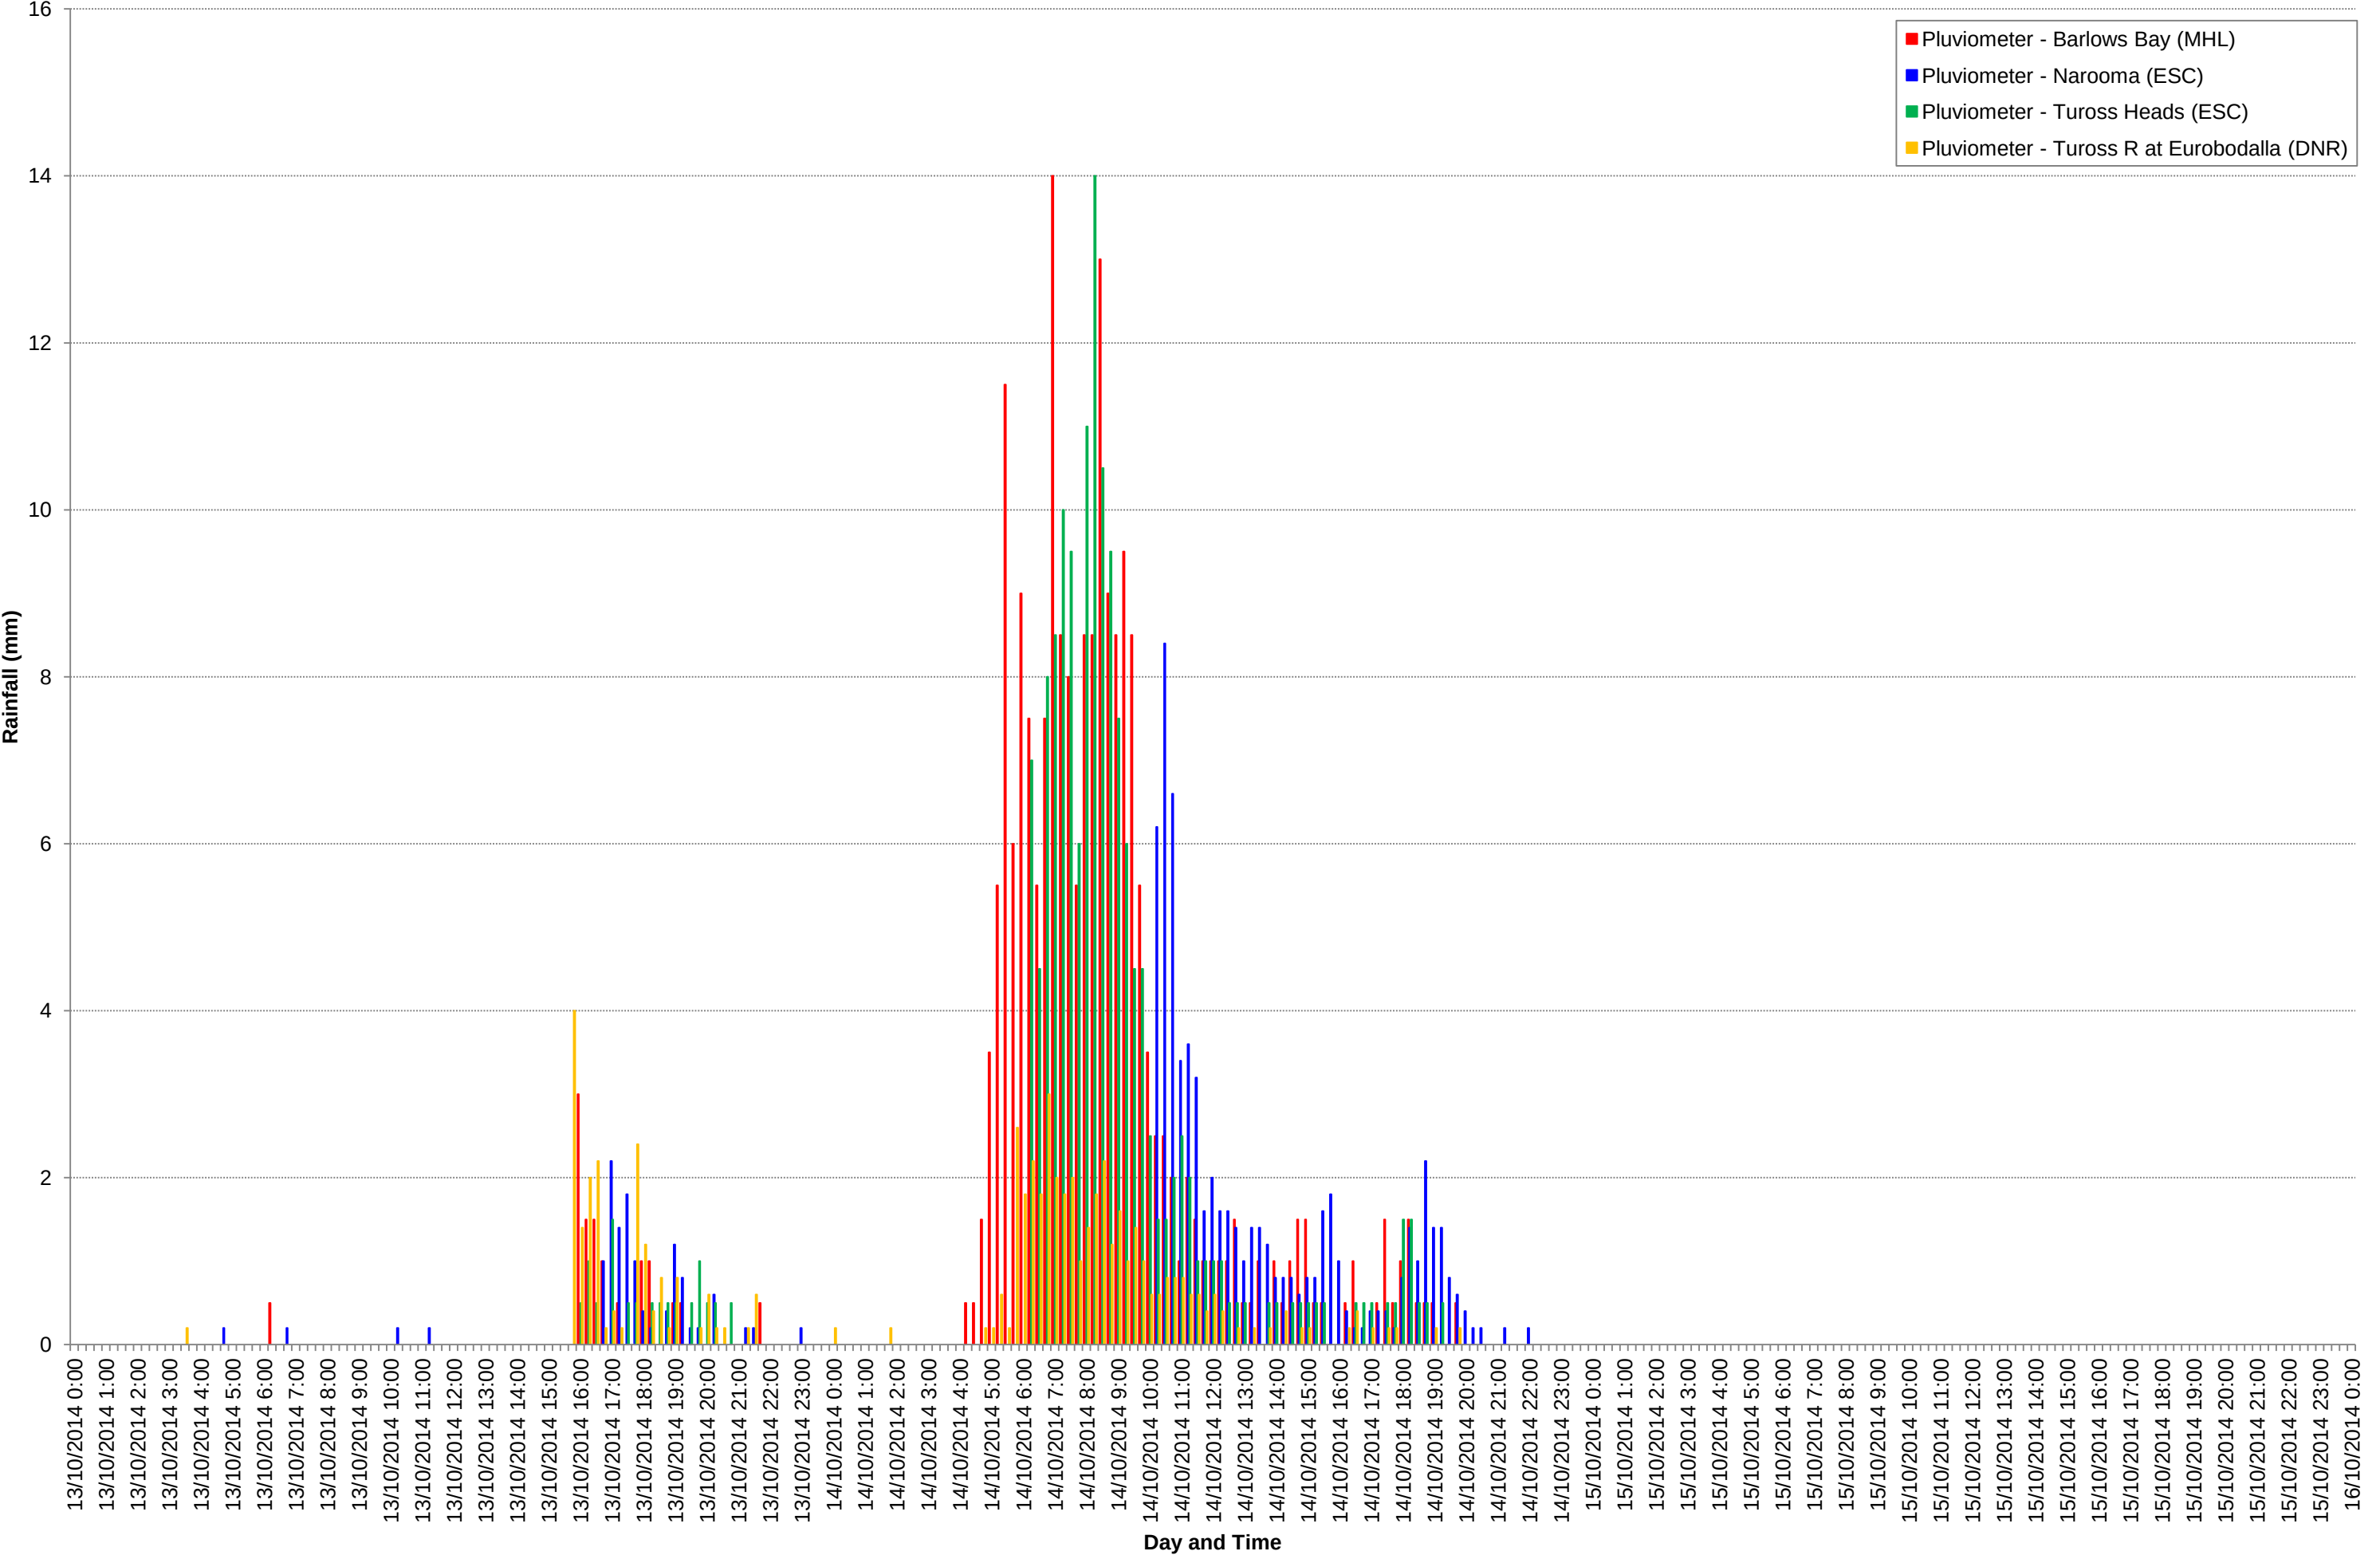
14TH OCTOBER 2014 EVENT  
RAINFALL HYETOGRAPH COMPARISON
