FIGURE E7A  
28TH JANUARY 1999 EVENT  
PEAK FLOOD DEPTH  
WAGONGA INLET

FIGURE E7B  
28TH JANUARY 1999 EVENT  
PEAK FLOOD DEPTH  
NAROOMA FLAT

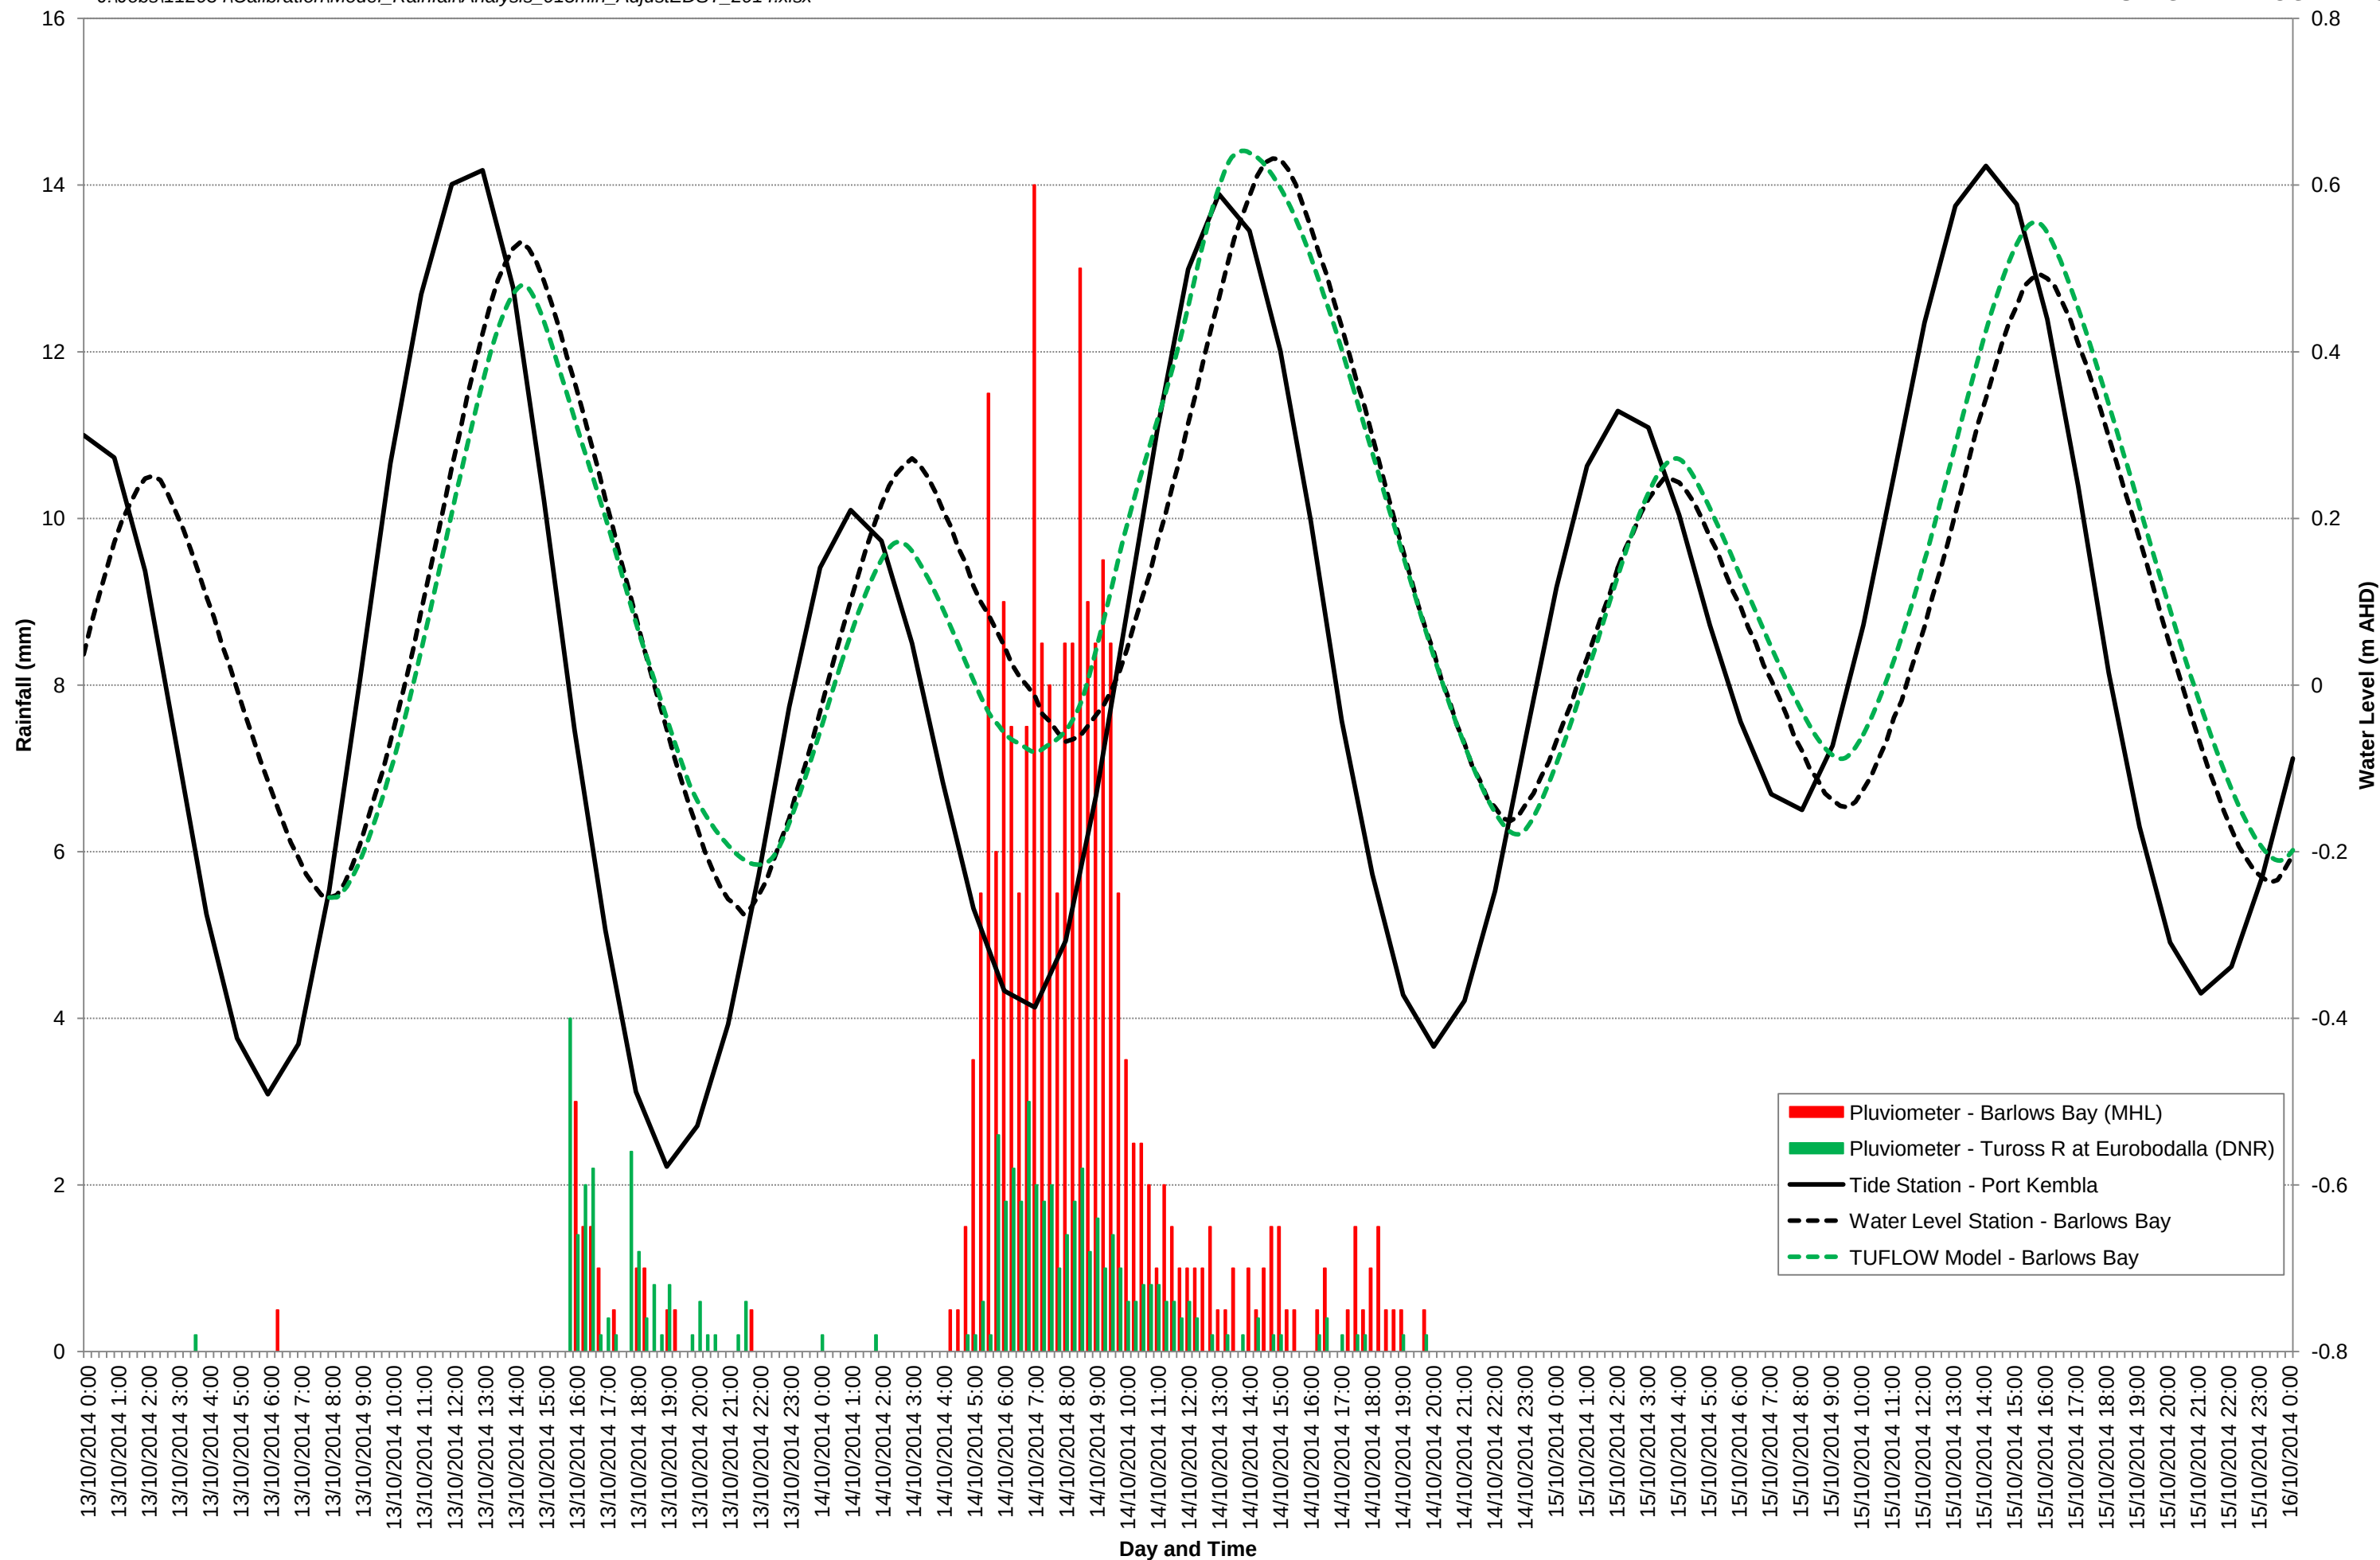
FIGURE E21  
14TH OCTOBER 2014 EVENT  
STAGE HYDROGRAPHS

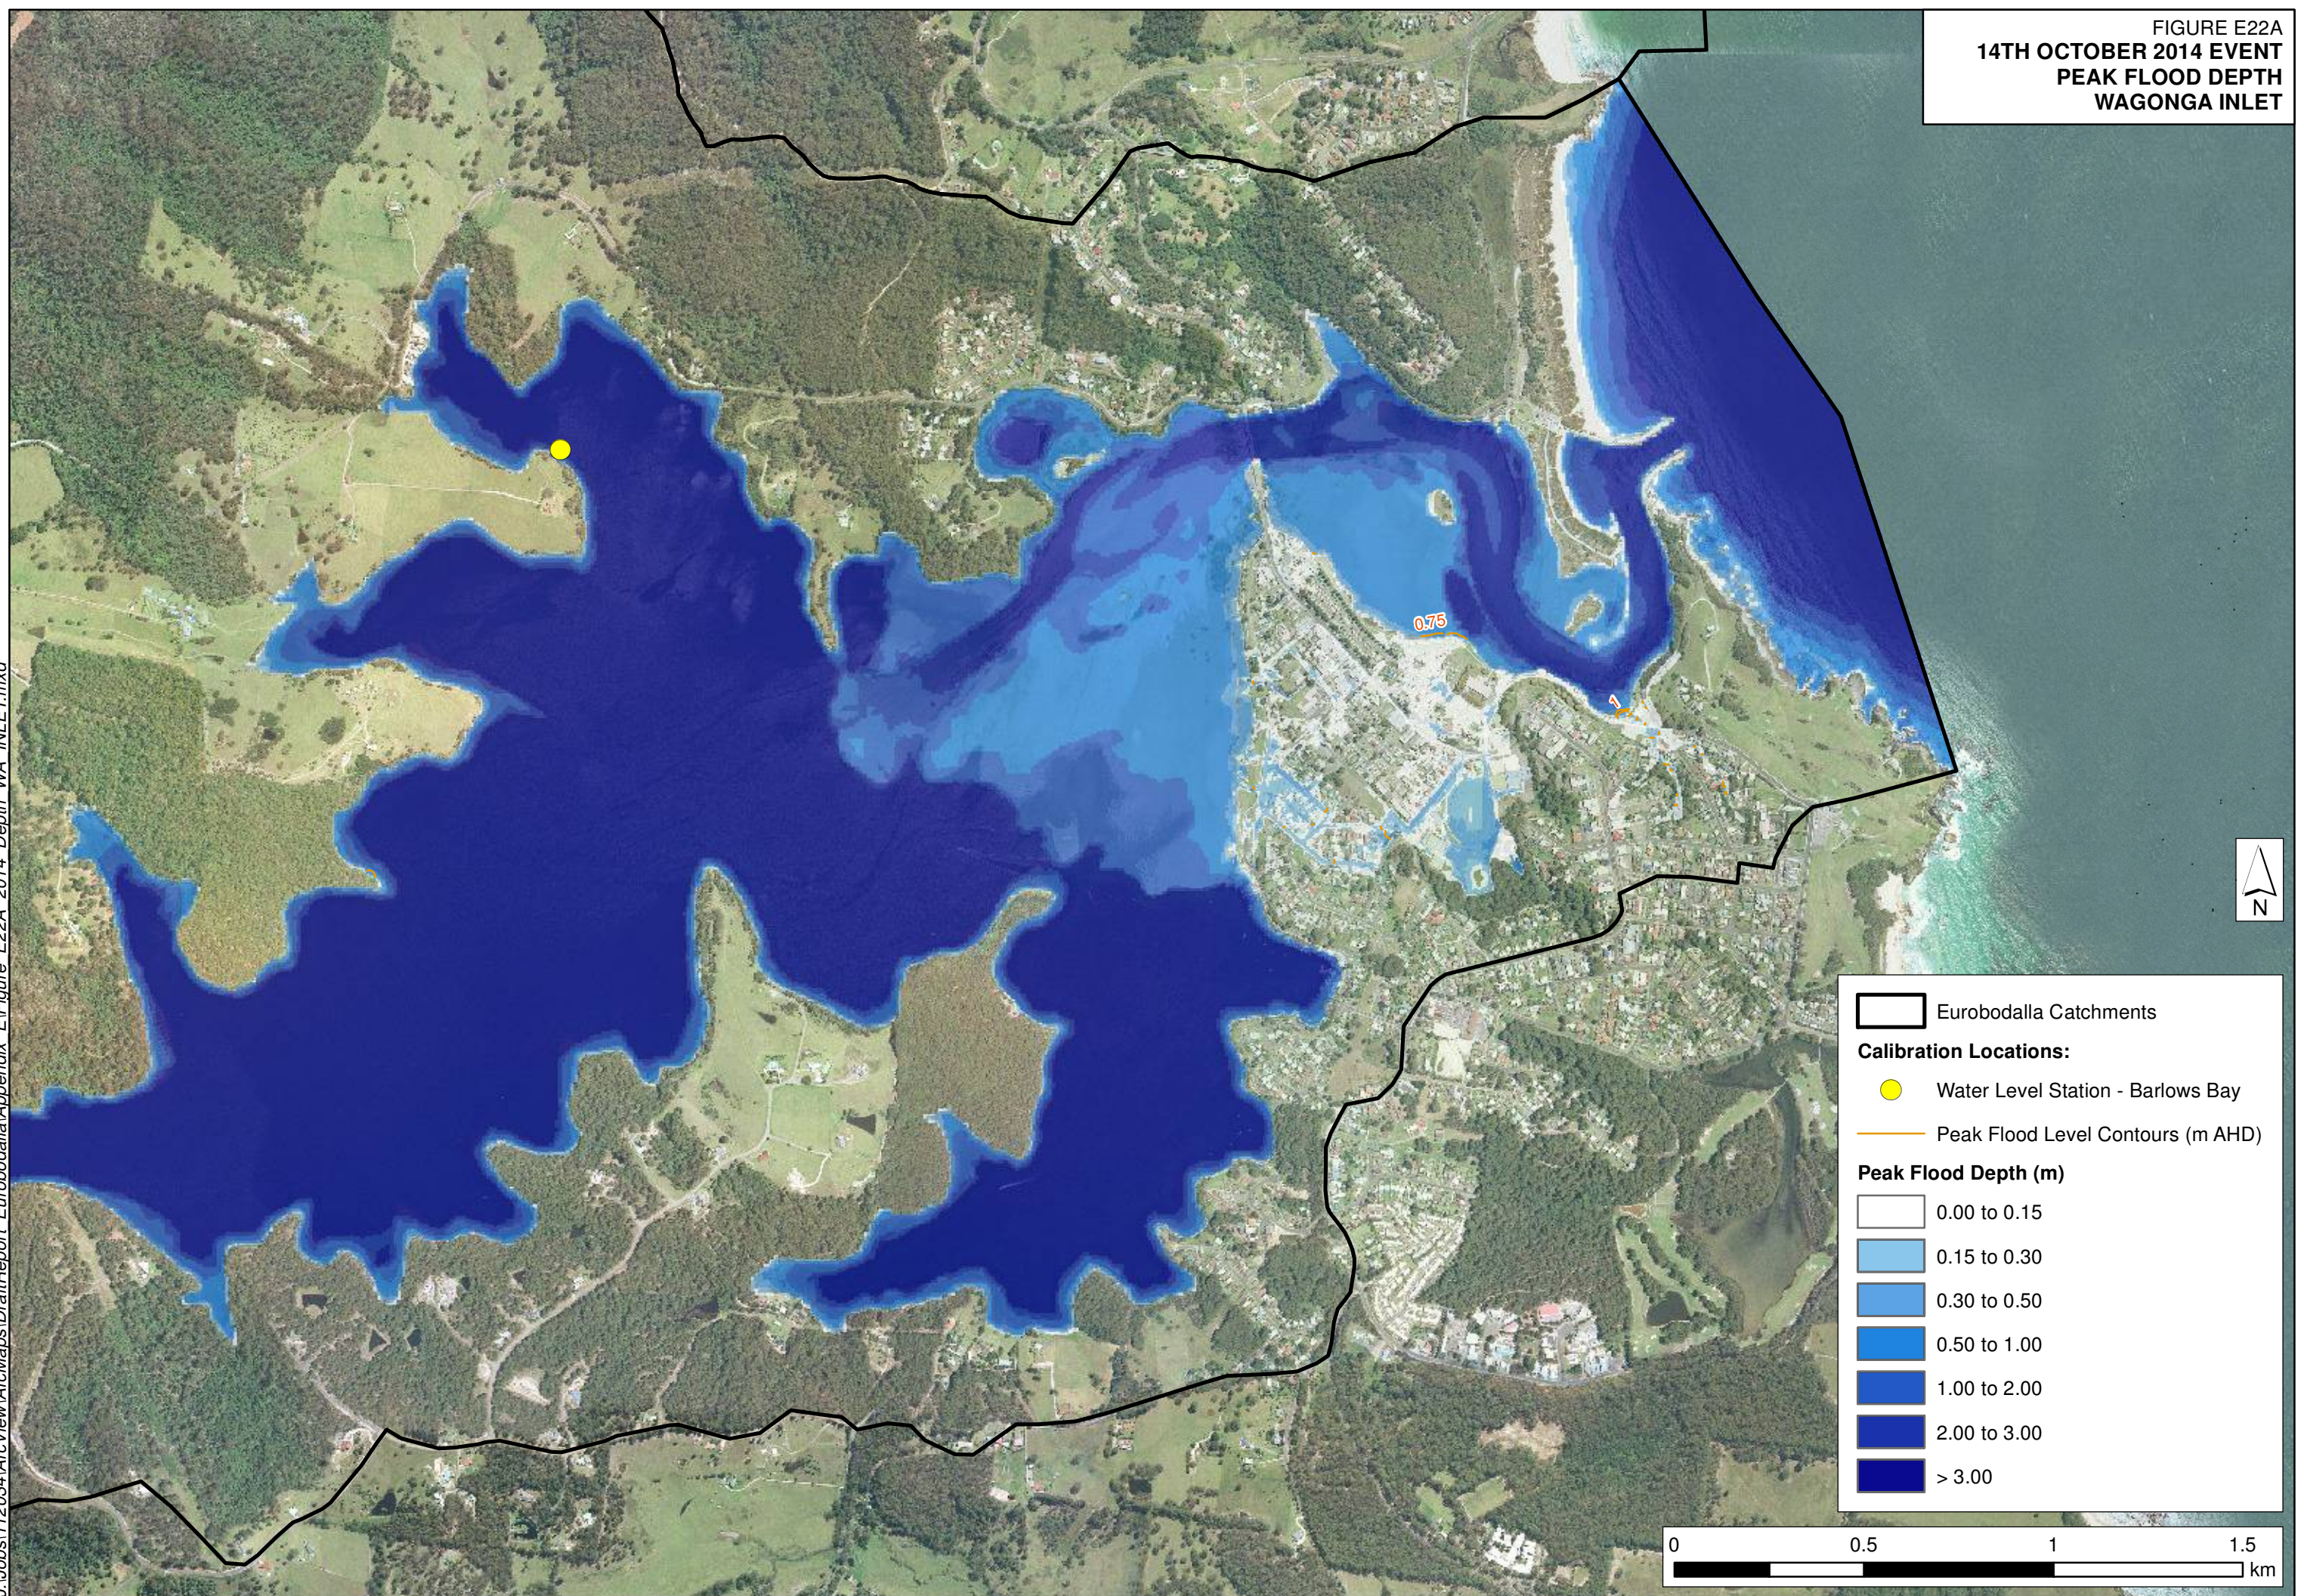
FIGURE E22A  
14TH OCTOBER 2014 EVENT  
PEAK FLOOD DEPTH  
WAGONGA INLET

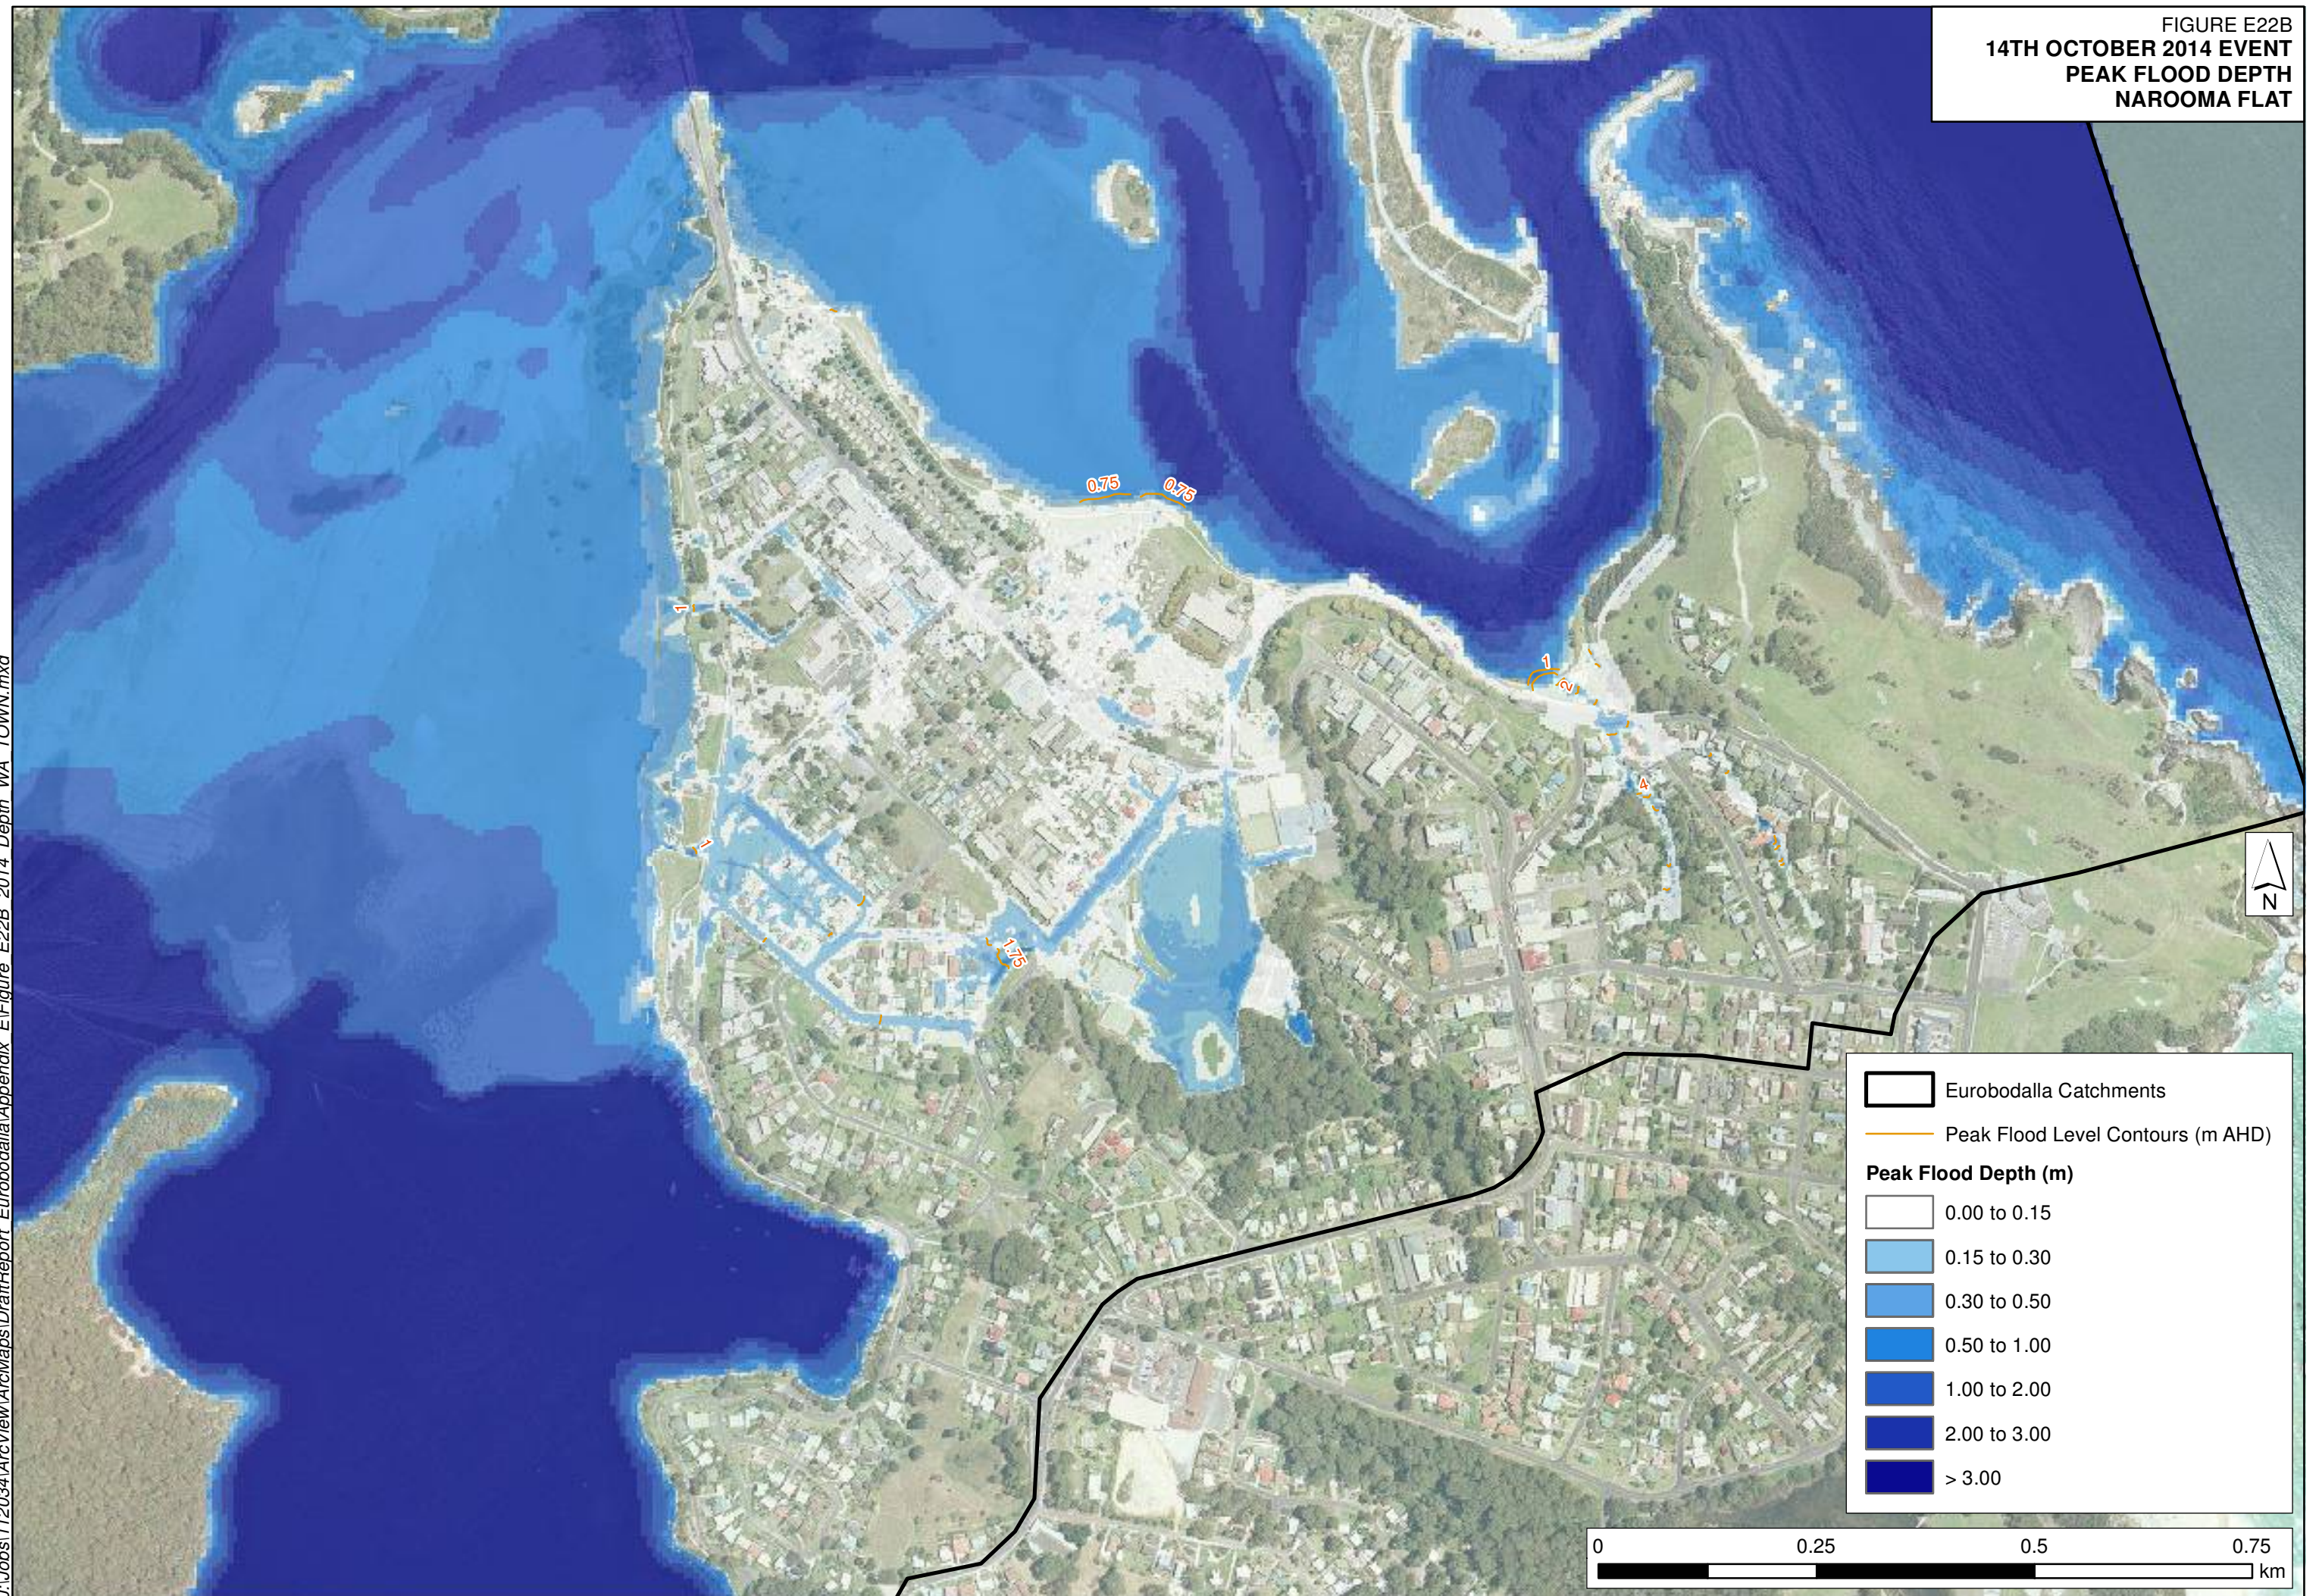
FIGURE E22B  
14TH OCTOBER 2014 EVENT  
PEAK FLOOD DEPTH  
NAROOMA FLAT

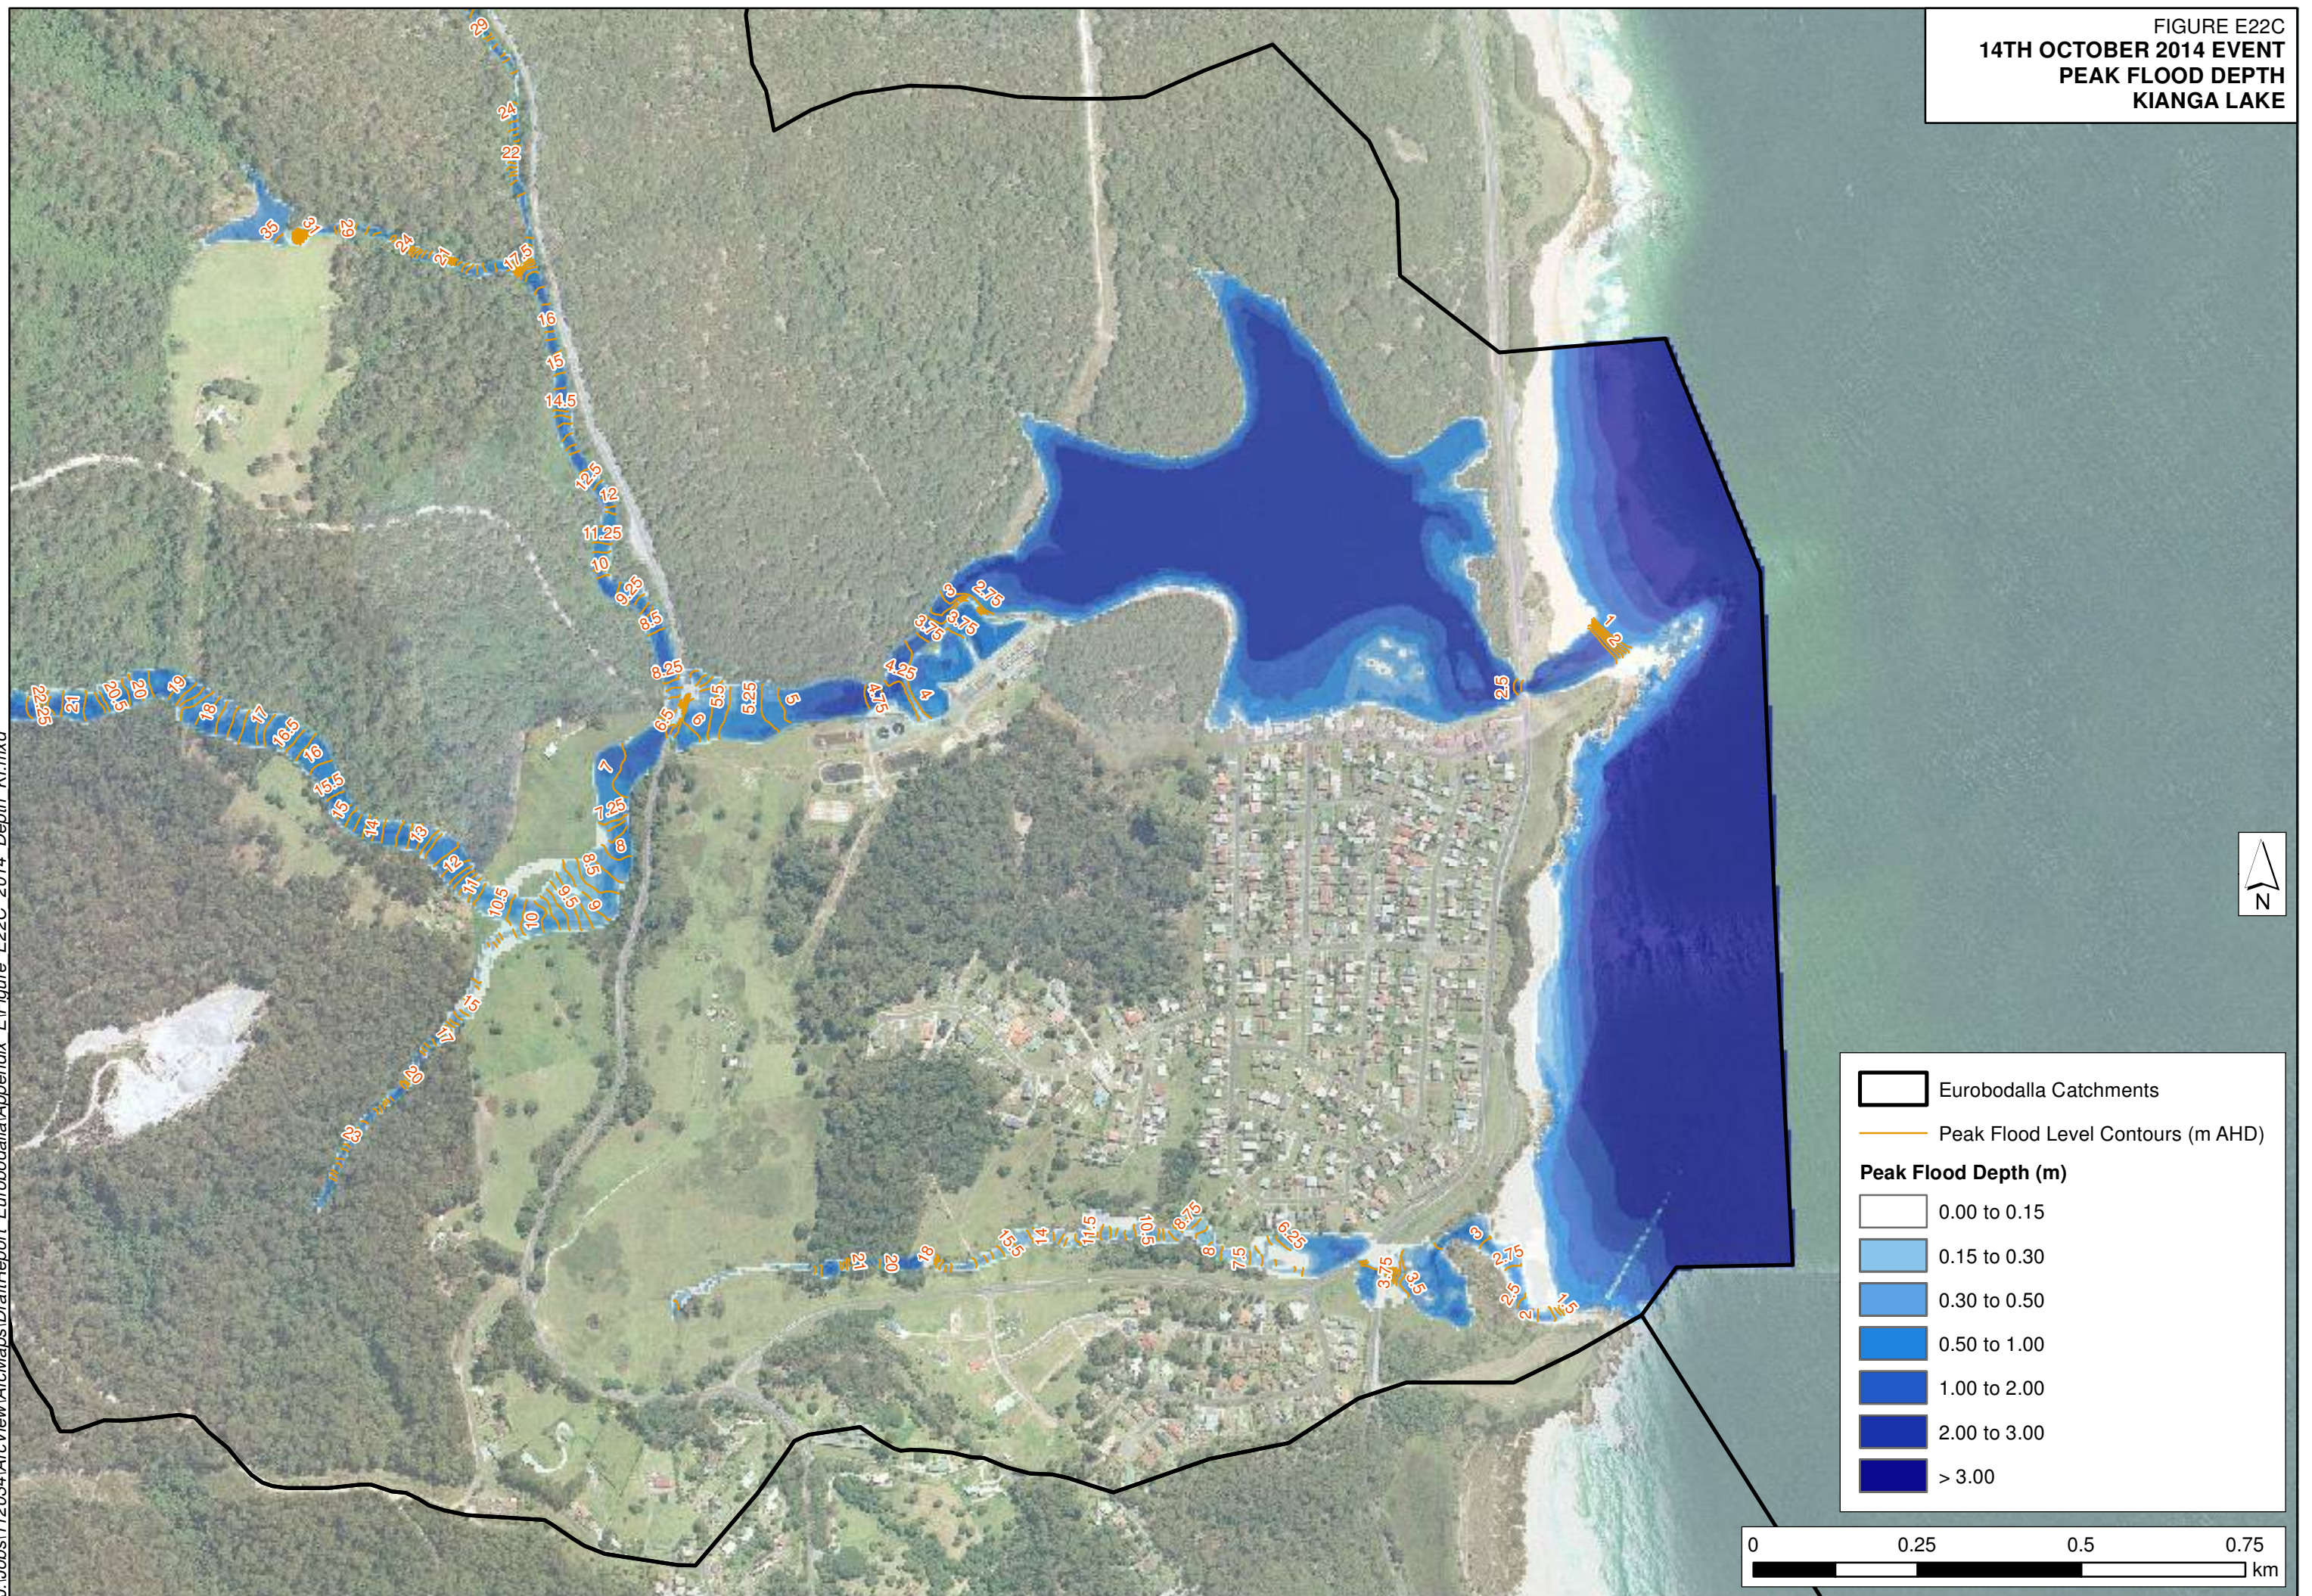
FIGURE E22C  
14TH OCTOBER 2014 EVENT  
PEAK FLOOD DEPTH  
KIANGA LAKE

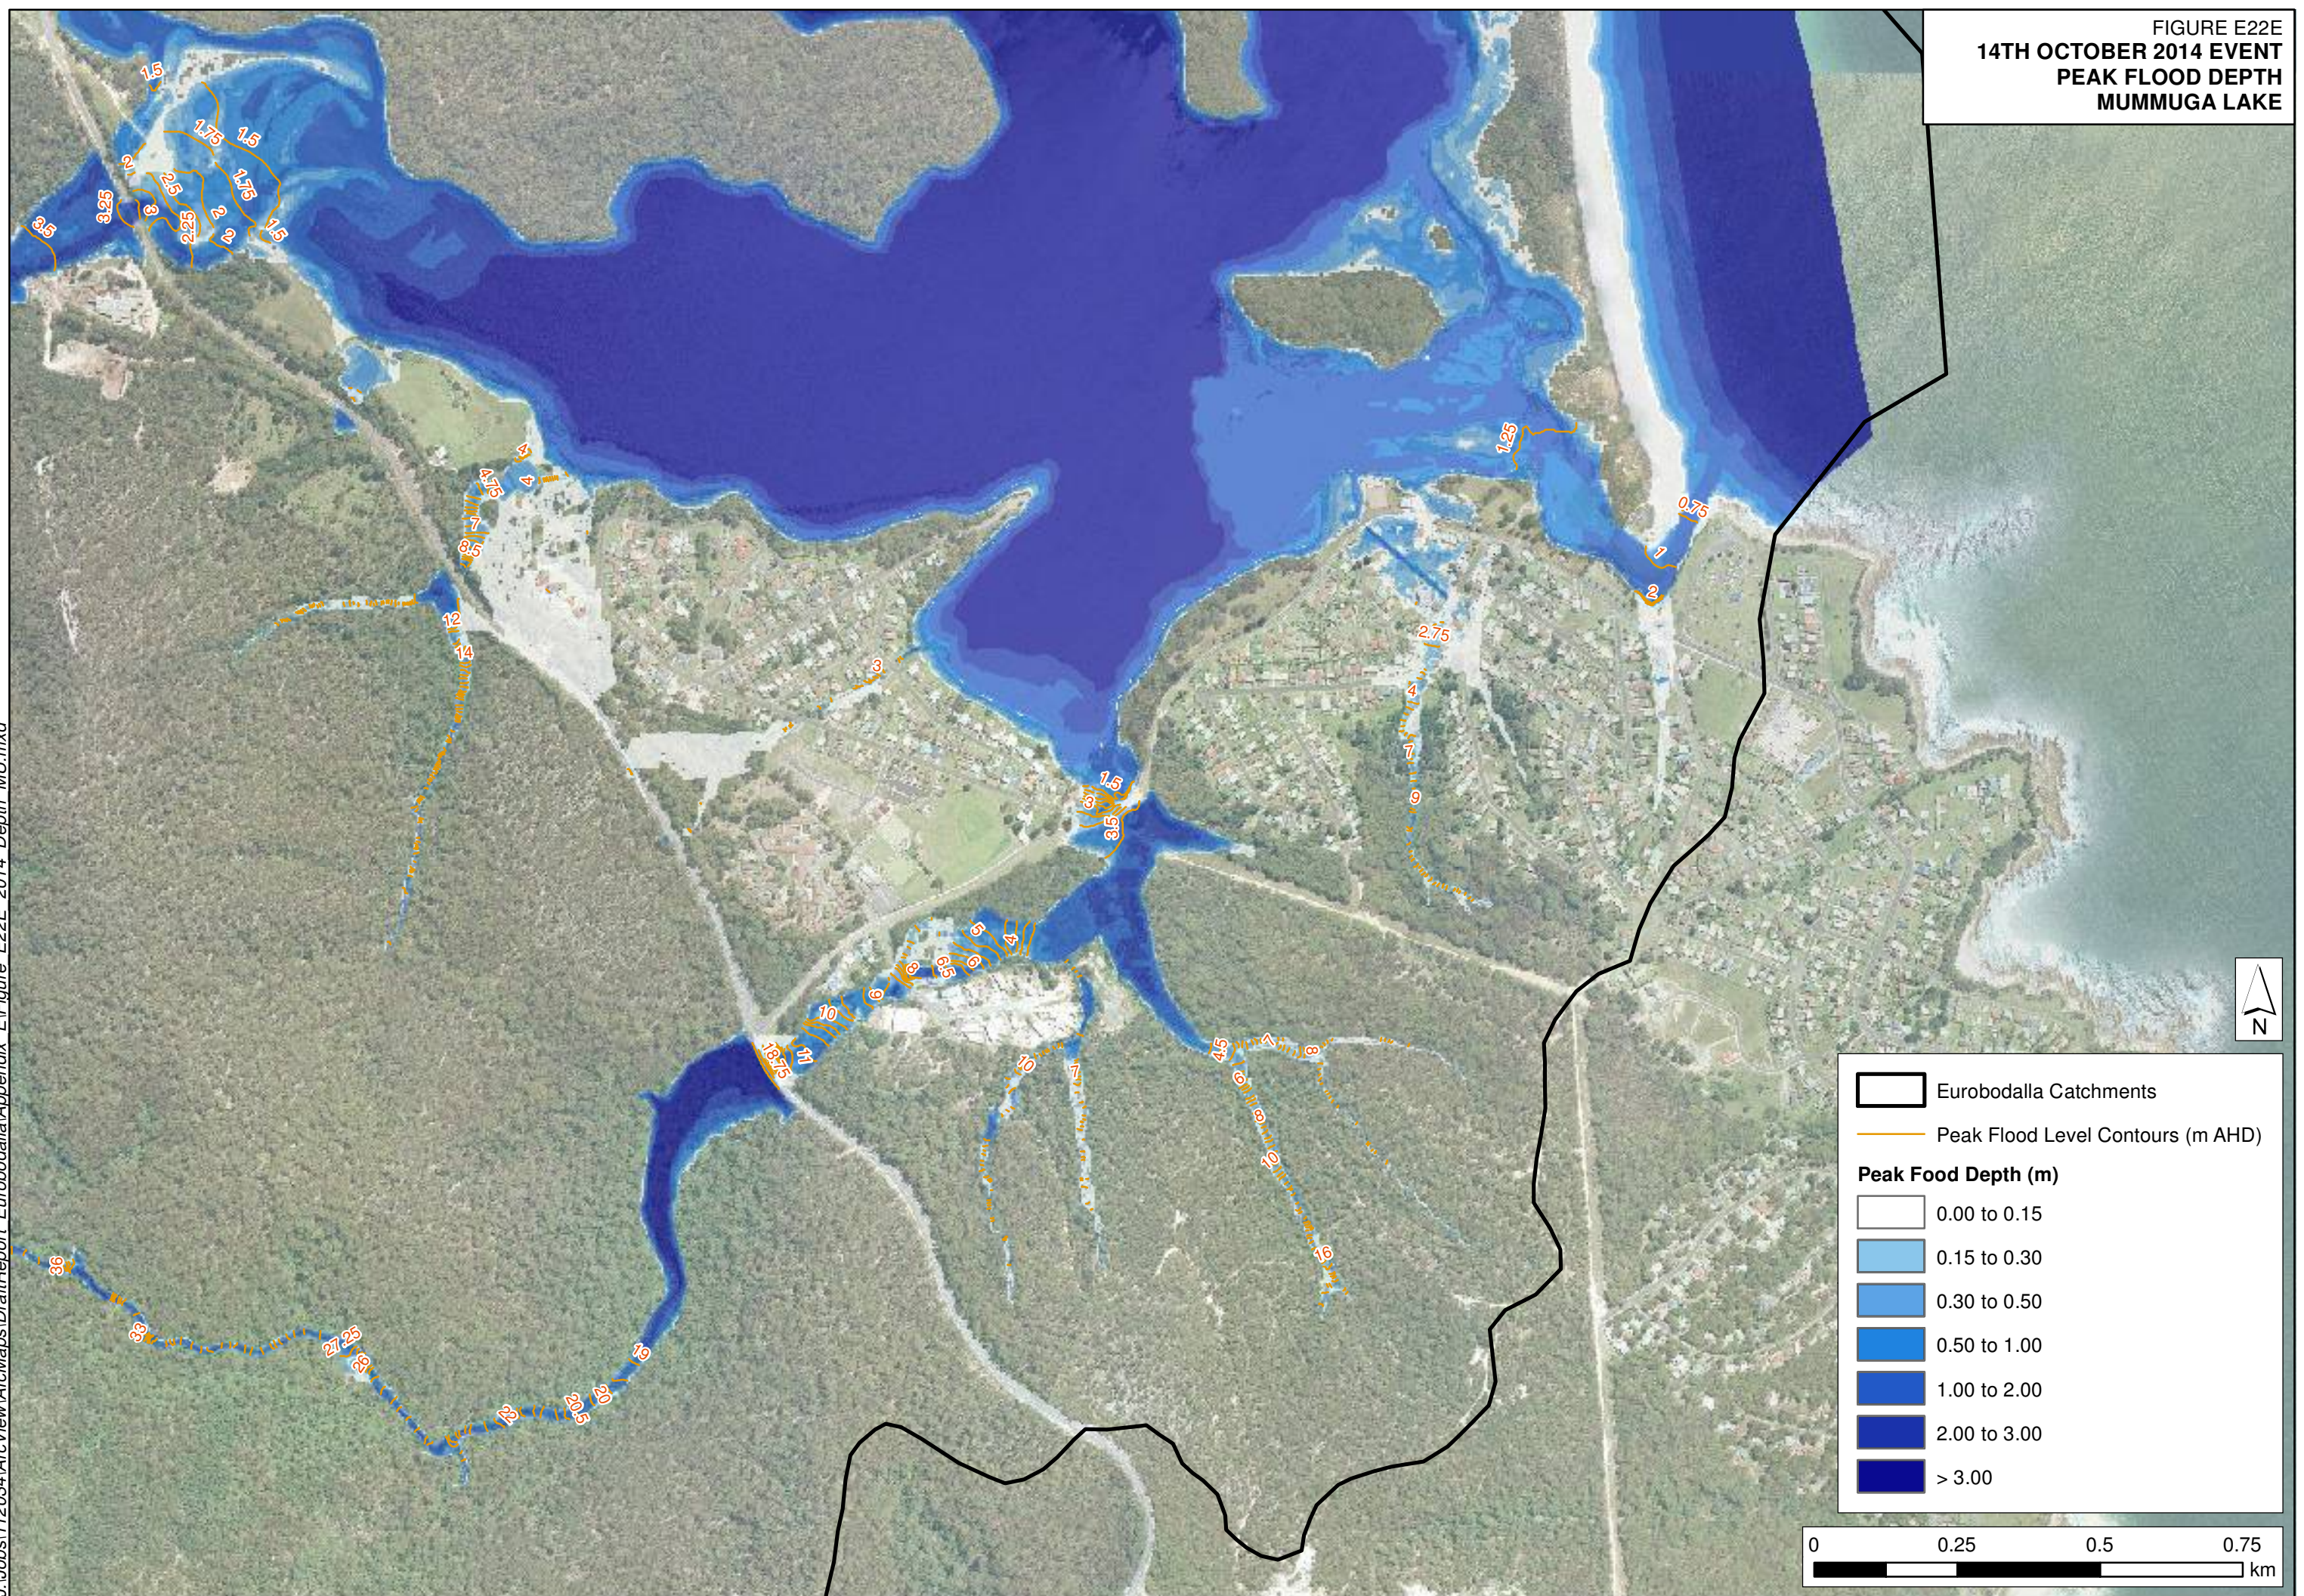
FIGURE E22E  
14TH OCTOBER 2014 EVENT  
PEAK FLOOD DEPTH  
MUMMUGA LAKE
