Appendix B: Location Summaries

B.1 Durras and Cookies Beaches

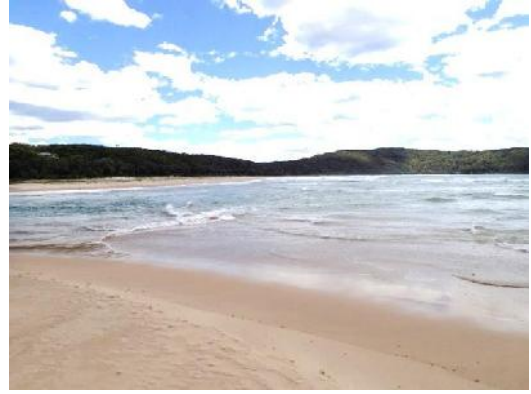
b) Durras Lake entrance at northern end

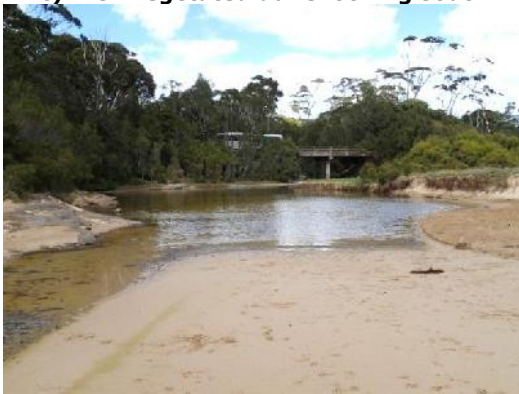
e) Durras Creek entrance at southern end

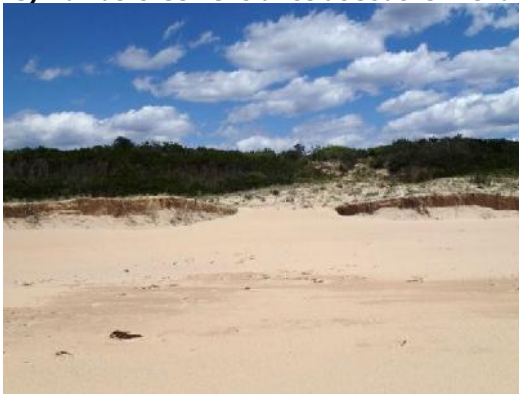
g) Dune scarp at the centre of the beach

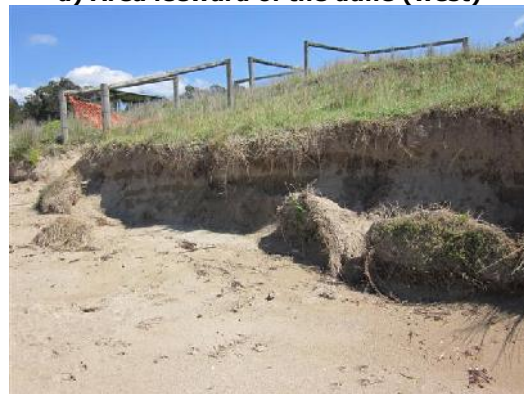
f) Scarp at western end of the beach

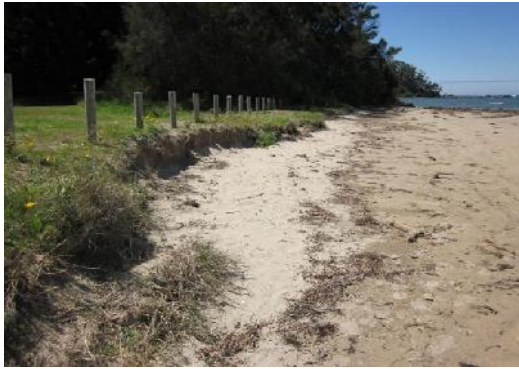
a) Scarp at eastern end of the beach

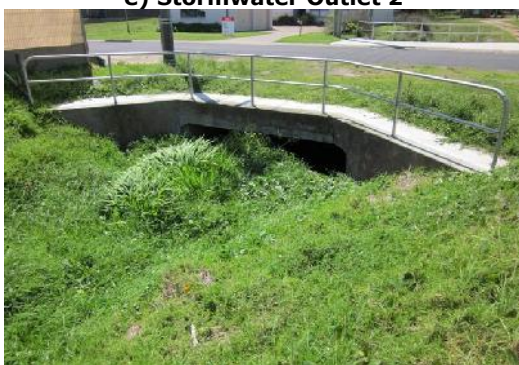
Reed Swamp backs the central third of Long Beach and has an outlet at Sandy Place (100 m west of Long Beach Road). This creek entrance appears to be moderately stable as it is controlled by a box culvert. It is constrained by rock gabions upstream of the culvert, but there is no sidewall protection downstream. The dune height is approximately 5 m AHD except near the Reed Swamp outlet where it drops to approximately 3 m AHD. The back beach area is developed on the southern side of Sandy Place. Seaward of this development the dune is moderately vegetated, but to the west of the developed section, the dune is well vegetated.

g) Reed Swamp outlet

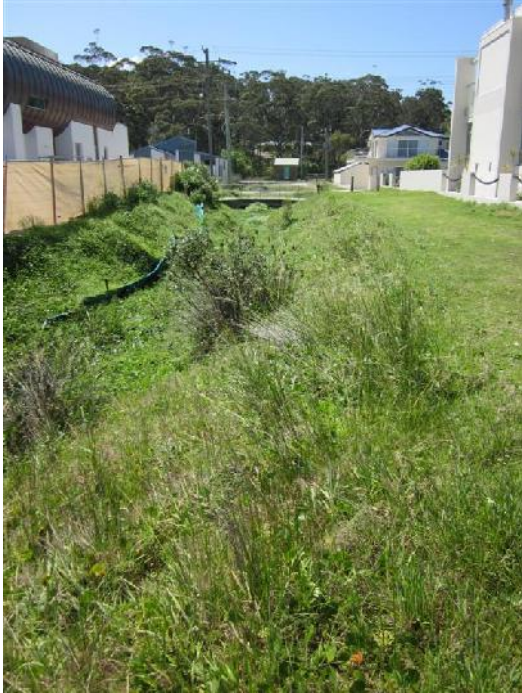
a) Vegetation at Reed Swamp outlet

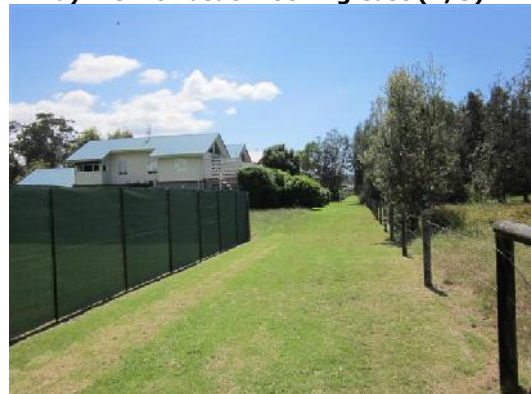
f) Setback development at western end

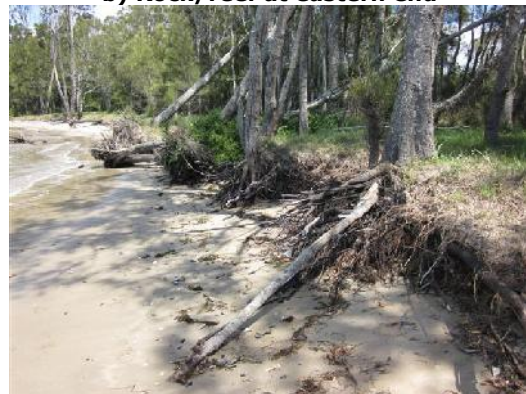
d) Scarp at eastern end of the beach

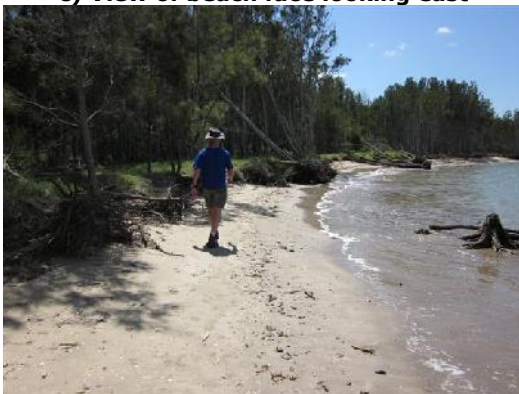
e) Scarp at the centre of the beach

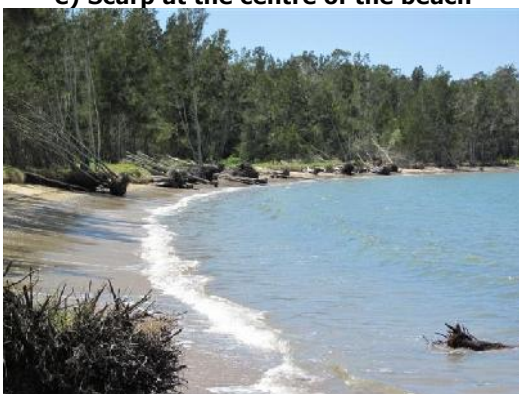
g) Evidence of recession along the beach

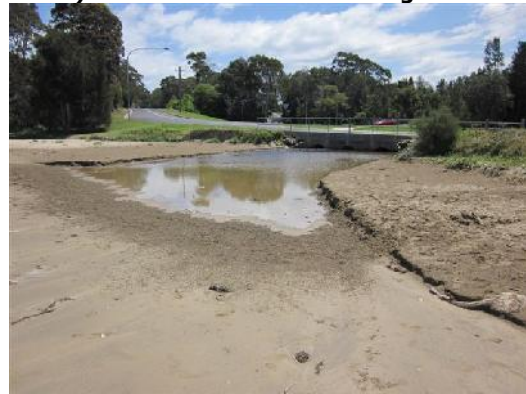
f) Surfside Creek outlet

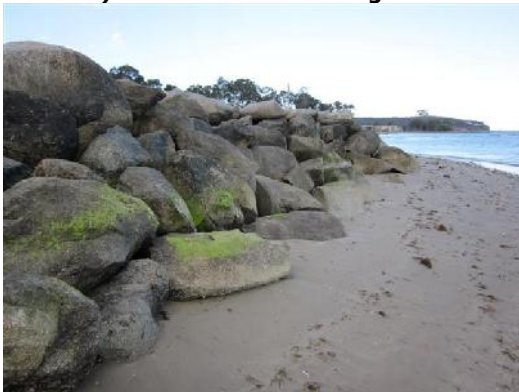
c) Rock armour at the head of the groyne

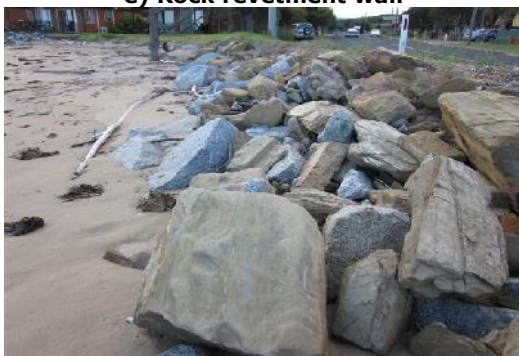
g) Rock wall armour properties are mixed

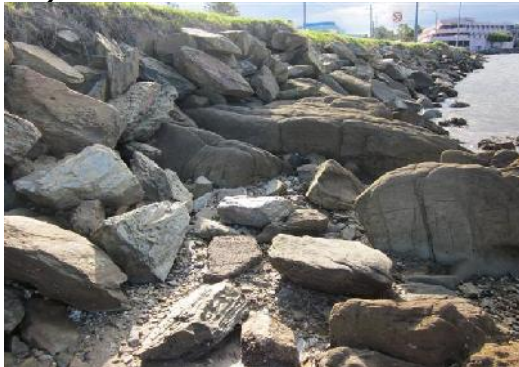
c) Revetment rock armour type 1 of 2

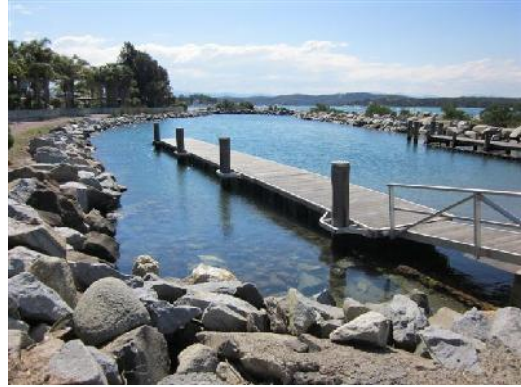
b) Boat ramp

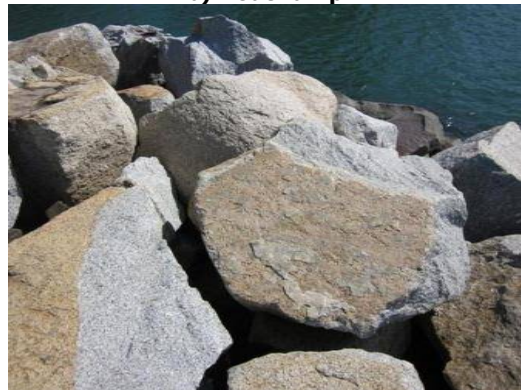
d) Typical primary rock armour

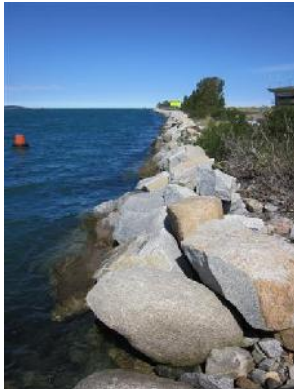
b) View of rock training wall looking east

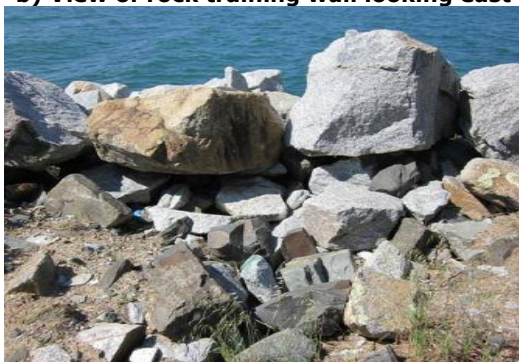
g) Typical secondary rock armour

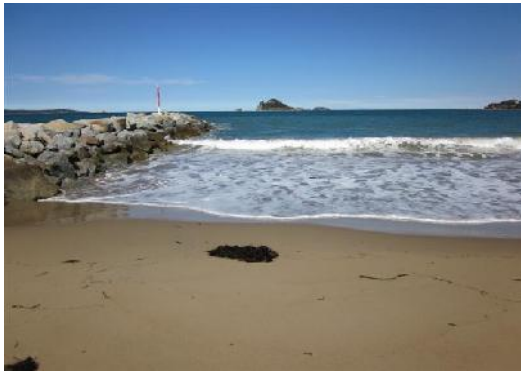
a) Training wall at northern end of beach

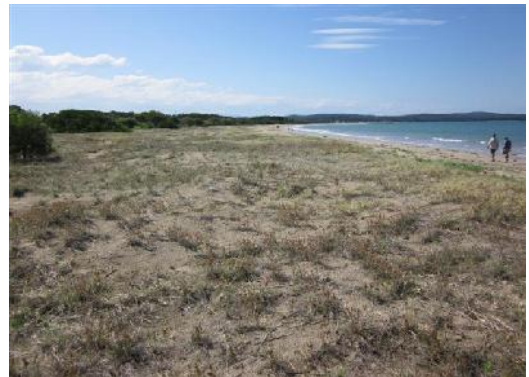
d) Moderately vegetated dune face

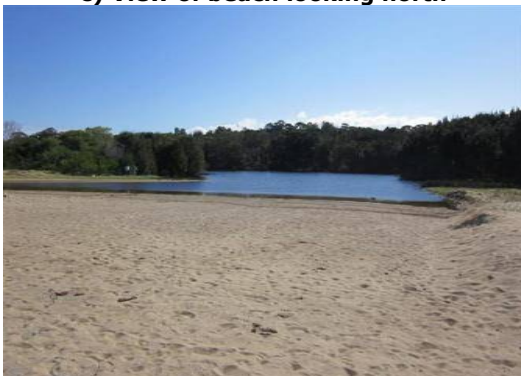
The entrance to Joes Creek exists at the centre of the beach but was not open at the time of the inspection. The seaward part of the creek entrance is not visibly structurally controlled save for the Beach Road bridge further inland. Three smaller creeks also have outlets at the southern end of the beach. 4WD beach access for boat launching and a car park exist at the southern end.

b) Joes Creek outlet

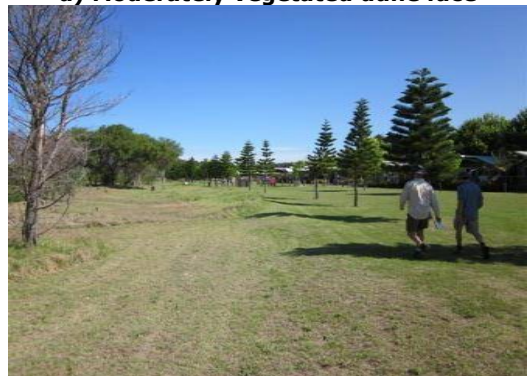
f) Typical setback of northern tourist park

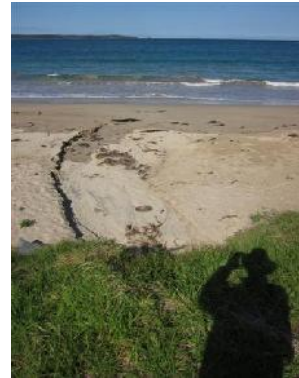
d) Stormwater outlet

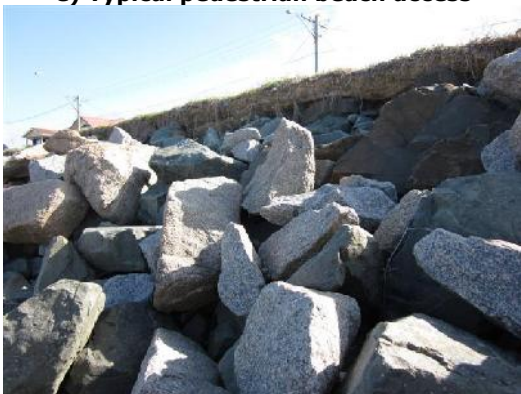
Overall, the condition of the seawall along the northern part of Caseys Beach is considered to be poor and requires immediate action and ongoing monitoring by ESC. The reader is referred to WRL's detailed condition assessment and design advice report for this seawall (Blacka and Coghlan, 2016).

g) Some slumping of armour at the crest

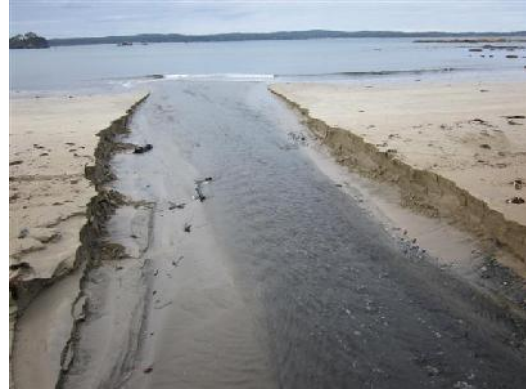
b) Creek outlet following "break out"

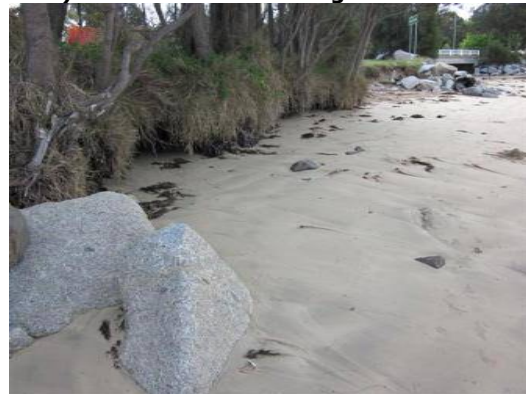
d) Unprotected section of beach

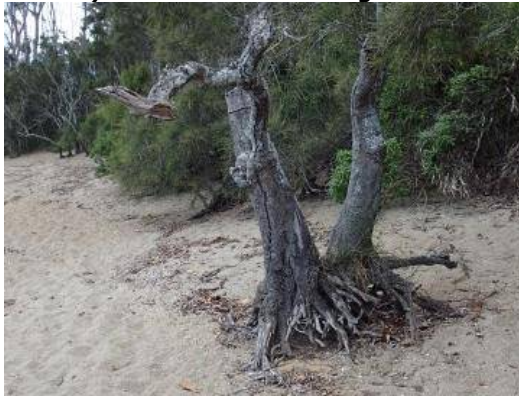
c) Loss of vegetation

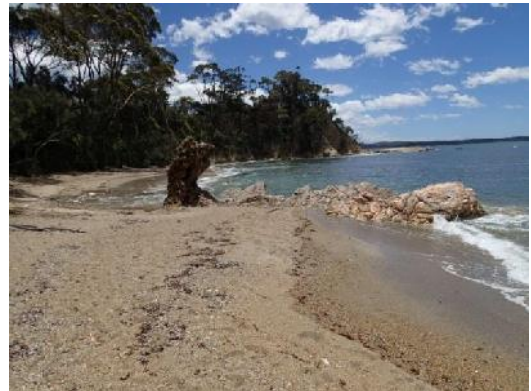
f) Rock outcrop with salient

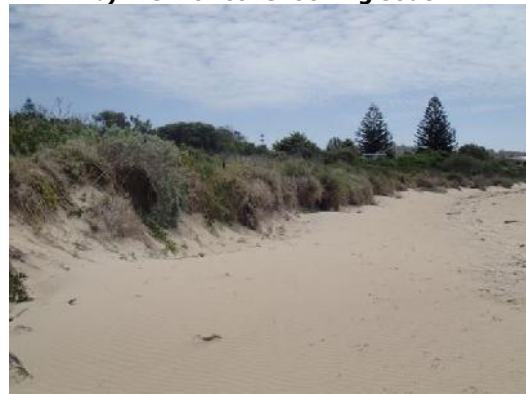
d) Scarp in the middle of the cove

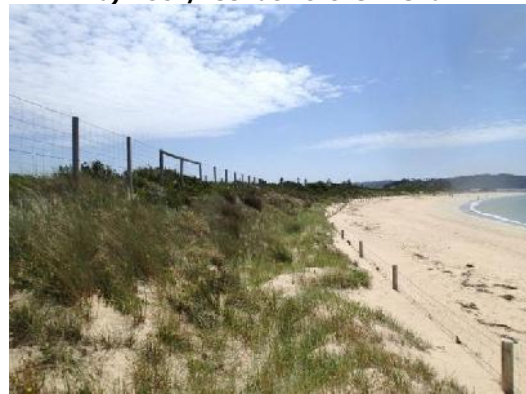
d) Typical regenerated dune face

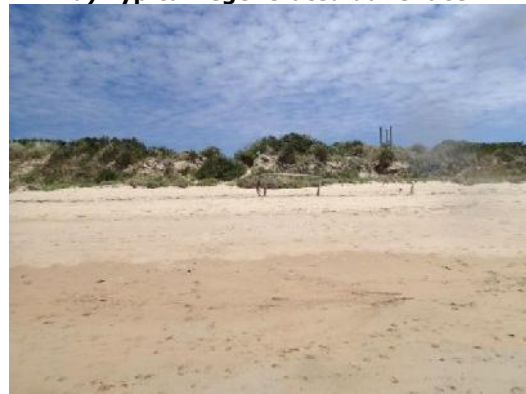
f) Scarp in the middle of the beach

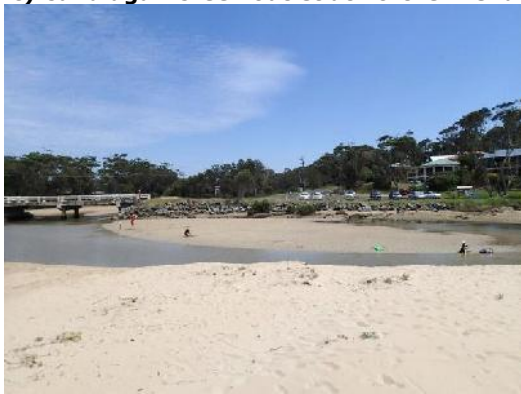
e) Rock protection for small car park

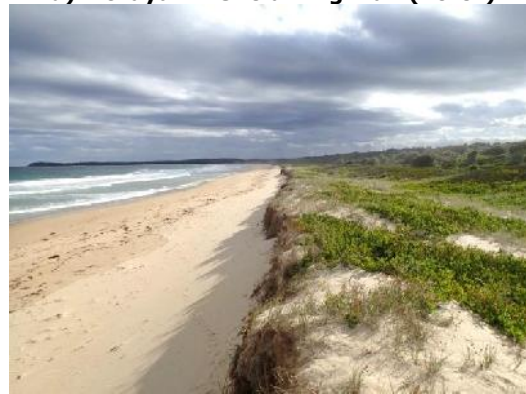
f) Dune scarp in the middle of the beach
